# **INDOOR AIR QUALITY ASSESSMENT WATER DAMAGE INVESTIGATION**

**Henry B. Burkland Intermediate School  
41 Mayflower Avenue  
Middleborough, Massachusetts**

Prepared by:  
Massachusetts Department of Public Health  
Bureau of Environmental Health  
Indoor Air Quality Program  
January 2015

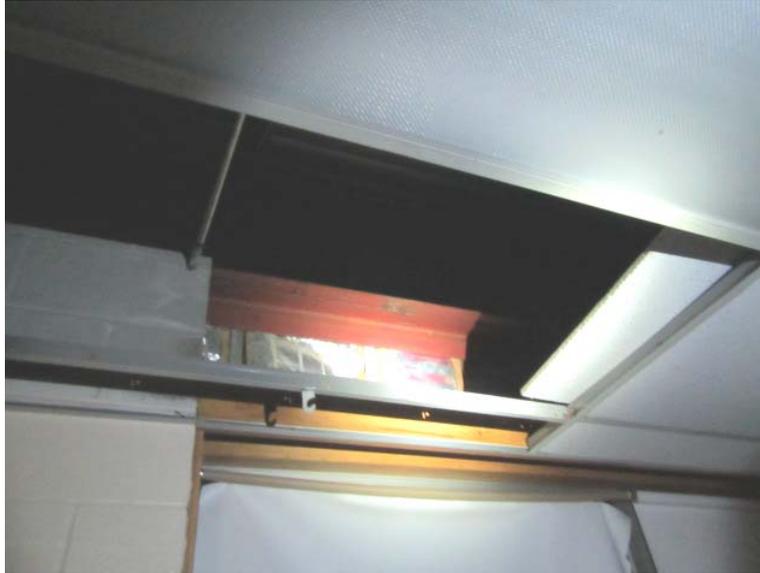
**Picture 1**

As reported by MPS officials, concerns were raised about possible water damage issues in the building. The mechanical ventilation system in each classroom consists of a unit ventilator (univent) that provides heating and fresh air supply and a ceiling-mounted exhaust vent ducted to motors on the roof. Each classroom has a ceiling tile system that is suspended from the underside of the building's roof decking; this forms a ceiling plenum. The building has a flat roof that overhangs the exterior wall of the building (Figure 1). This vertical section of the roof overhang inside the ceiling plenum has fiberglass insulation batts installed against a gypsum wallboard (GW) material, which appears to have been subjected to chronic water damage

(Picture 1). Moist air penetration through the exterior wall/roof junction or seams in the roof overhang material is the likely cause. The installation of porous GW directly against the cold surface of the exterior masonry can cause this material to generate condensation, moistening the GW under certain temperature and relative humidity conditions. Once wet, the GW cannot dry due to the fiberglass insulation installed over the wet interior side of the GW (Pictures 1 and 2).

**Affected gypsum wallboard (behind insulation) above ceiling tile system in classroom**

1. Ensure all affected GW above ceiling tiles are completely covered/tightly packed behind a layer of insulation.
2. Ensure all ceiling tile systems are fully intact.

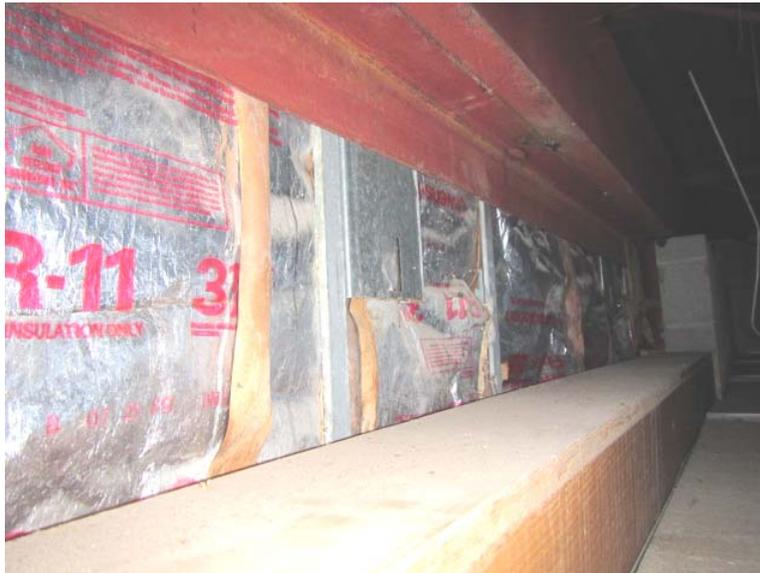
**Picture 2**

**Affected gypsum wallboard (behind insulation) above ceiling tile system in classroom**

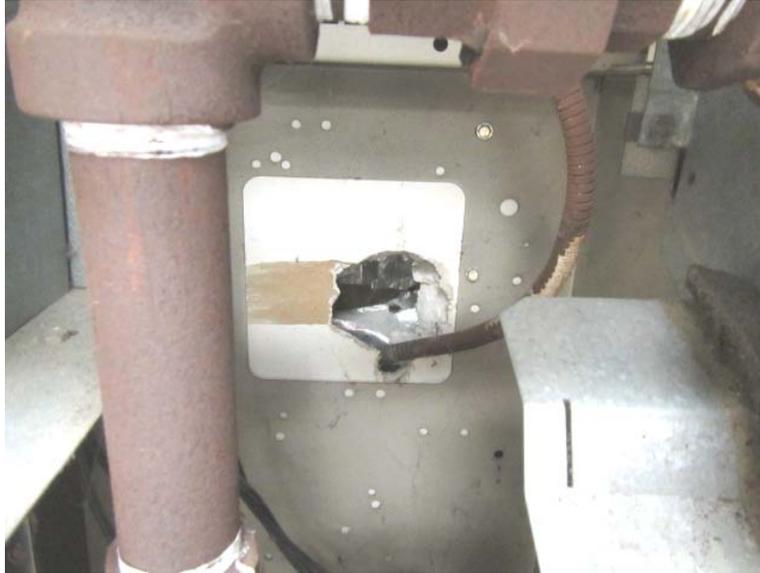
**Picture 3**

pathways for utilities within the univent cabinet (Pictures 3 and 4), should be sealed to prevent draw of air from wall cavities/crawlspaces into the univent.

**Breach in wall inside univent cabinet**

- Keep classroom doors shut to maintain positive pressure; and
  - Open classroom windows to provide comfort as needed.
4. Ensure all breaches in floors, walls and univent cabinets are properly sealed (Pictures 3 and 4).

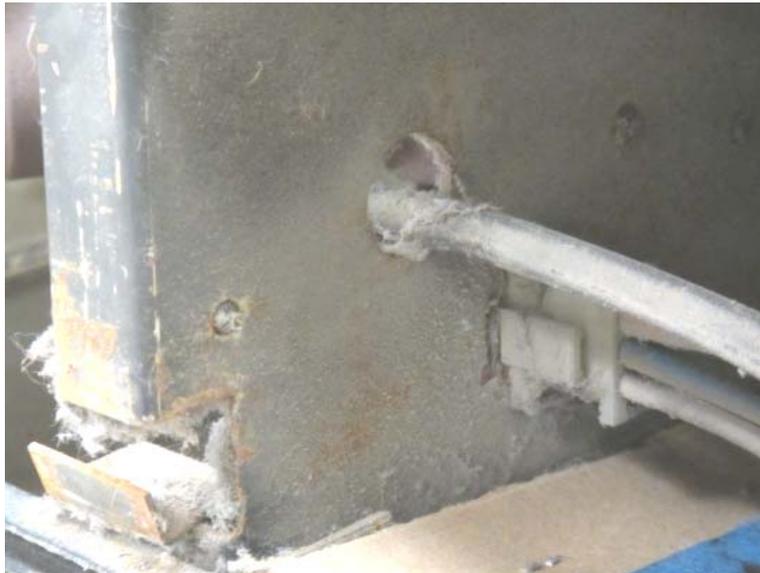
**Picture 4**

**Hole in univent cabinet, post-filter**
