INDOOR AIR QUALITY ASSESSMENT

**Oxford High School
495 Main Street
Oxford, MA**

Prepared by:
Massachusetts Department of Public Health
Bureau of Environmental Health
Indoor Air Quality Program
June 2015

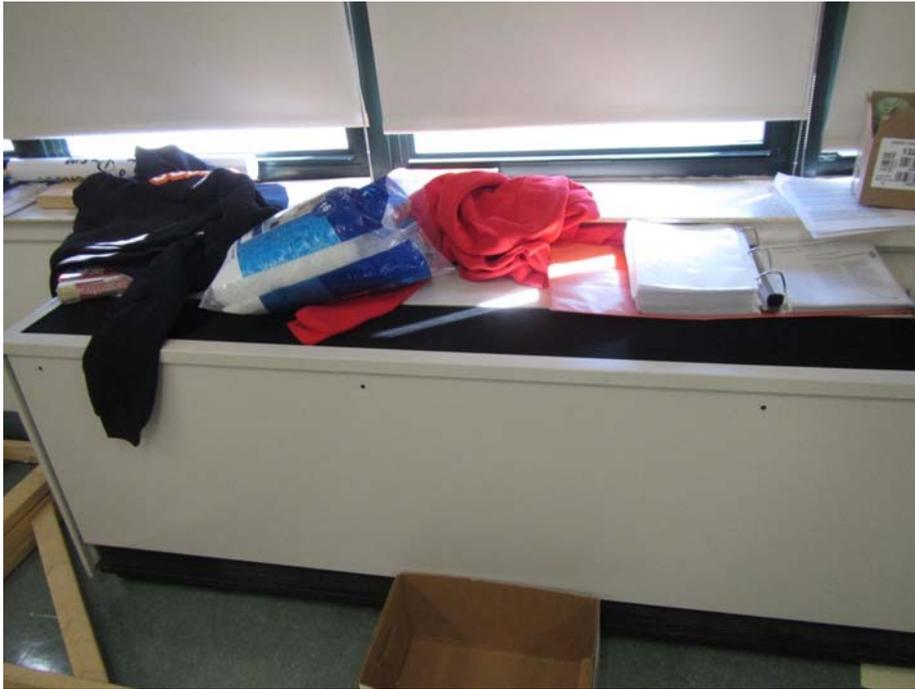
Picture 1

Fresh air in most classrooms is supplied by unit ventilators (univents) (Picture 1). A univent is designed to draw air from outdoors through a fresh air intake located on the exterior wall of the building (Picture 2). Return air is drawn through an air intake located at the base of each unit where fresh and return air are mixed, filtered, heated and provided to classrooms through an air diffuser located in the top of the unit ([Figure 1](#)). Univents were found obstructed with items in a few areas (Picture 1) and turned off in many classrooms (Table 1). In order for univents to provide fresh air as designed, they must remain free of obstructions. Importantly, these units must remain on and be allowed to operate while rooms are occupied. Wall-mounted exhaust vents (Picture 3) remove stale air from classrooms.

In some classrooms, items were observed on univent cabinets, floors, windowsills, tabletops, counters, bookcases and desks, which provide a source for dusts to accumulate (Picture 18). These items (e.g., papers, folders, boxes) make it difficult for custodial staff to clean. Items should be relocated and/or be cleaned periodically to avoid excessive dust build up. In addition, dust and debris can accumulate on flat surfaces (e.g., desktops, shelving and carpets) in occupied areas and subsequently be re-aerosolized causing further irritation.

Unit ventilator (univent) in classroom with items on top

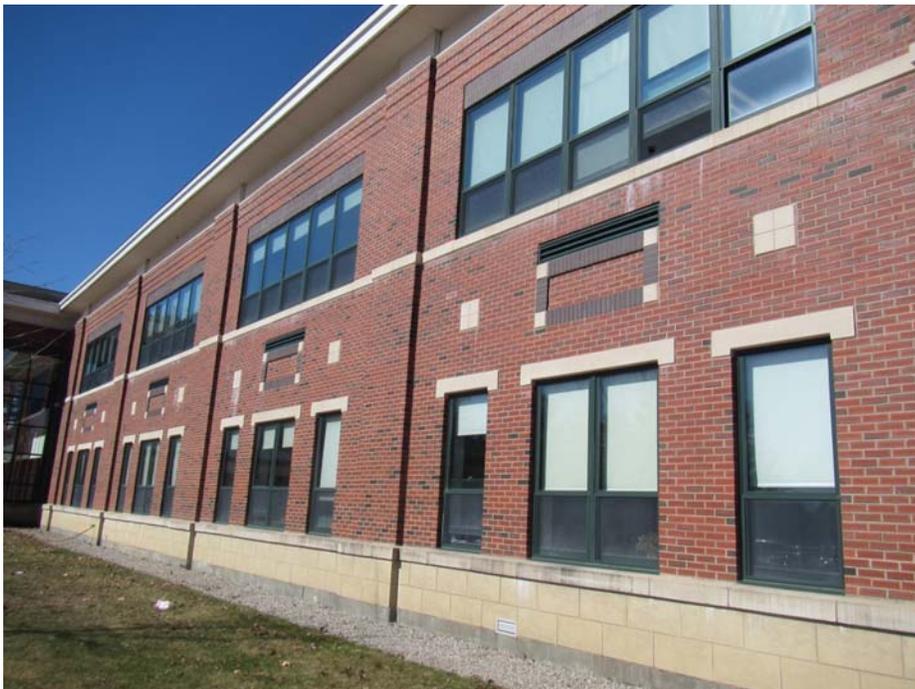
Picture 2

Univent air intakes outside of building

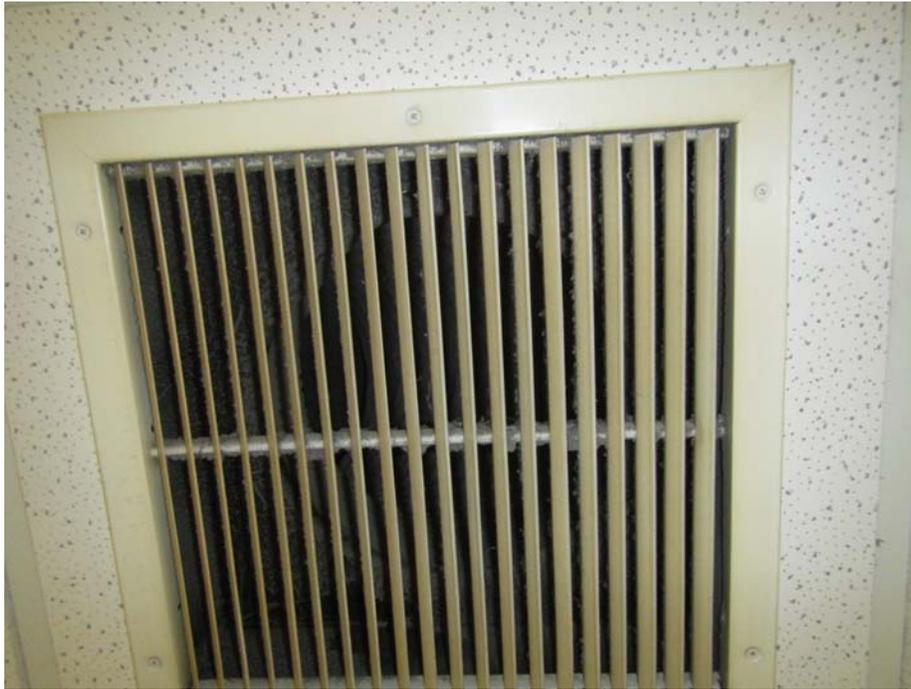
Picture 3

Ceiling-mounted exhaust vent

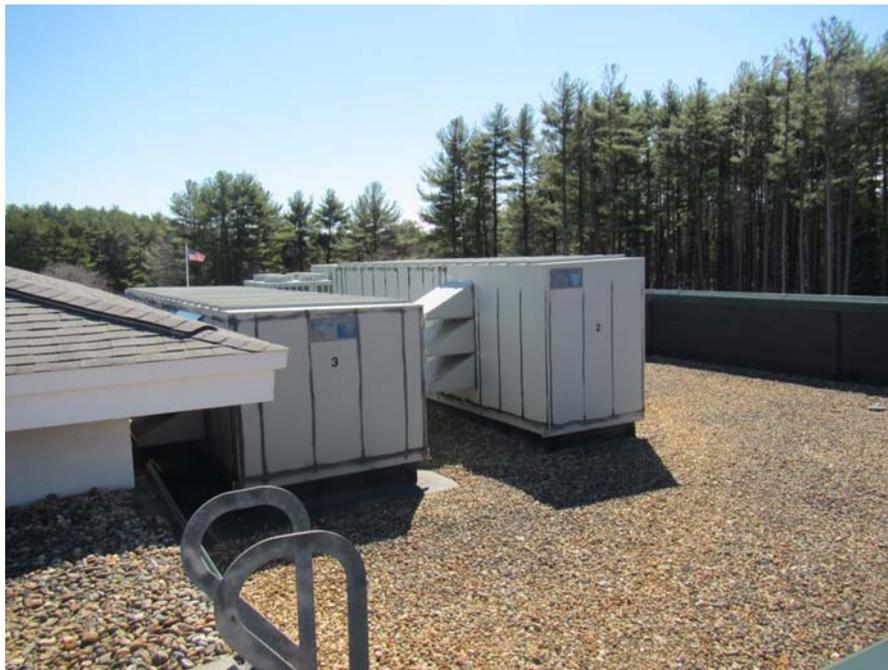
Picture 4

Outside air for common areas such as the library, gymnasium and auditorium, as well as administrative areas, is provided by rooftop air handling units (AHUs, Picture 4). Fresh air is drawn in through intakes, where it is filtered, heated or cooled and ducted to ceiling-mounted supply diffusers (Picture 5). Only some of the AHUs are equipped to provide cooling (e.g., administrative areas and auditorium). Return air is drawn in through ceiling-mounted return vents and ducted back to AHUs.

Some of the air handling units (AHU) on the roof

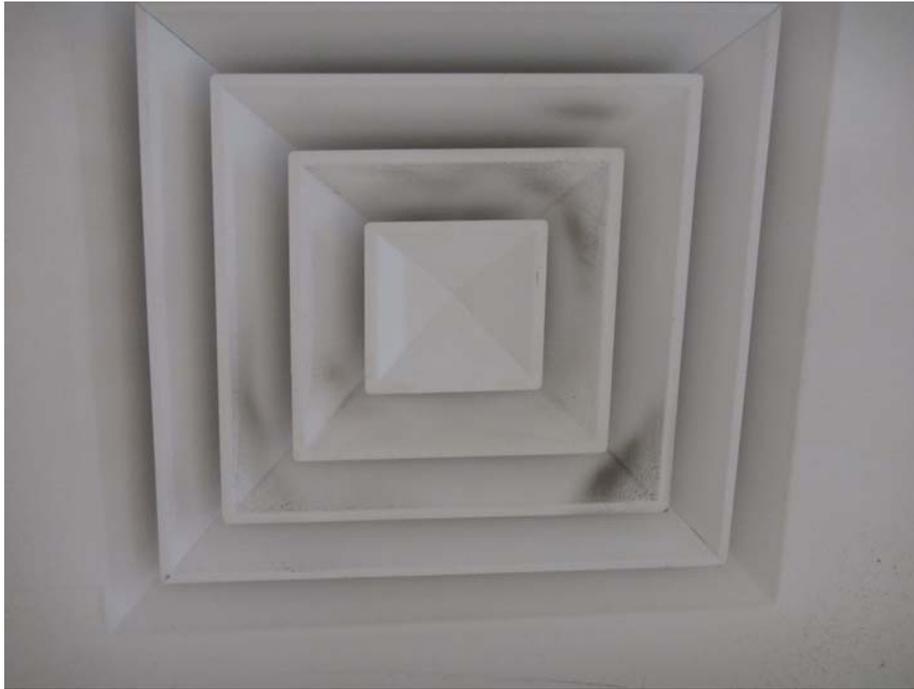
Picture 5

A number of air diffusers, exhaust/return vents and personal fans were found to have accumulated dust/debris (Table 1). Re-activated univents/supply vents and fans can aerosolize dust/materials accumulated in equipment or on vents/fan blades. If exhaust vents are not functioning, backdrafting can occur, which can re-aerosolize accumulated dust particles.

Ceiling-mounted supply vent (note dust on louvers)

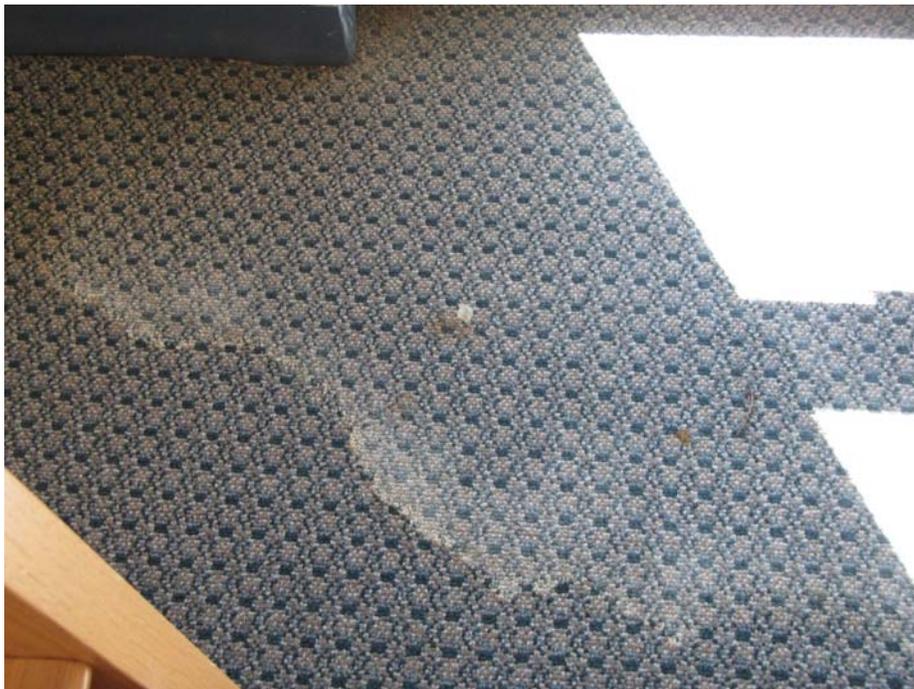
Picture 6

Some water-damaged materials were observed in the library. For example, water stains were visible on carpet near the exterior door, which was reportedly due to snow melt over the winter of 2014/2015 (Picture 6). Drainage adjacent to this door may be inadequate to prevent water infiltration during severe weather. The removal of carpeting and replacement with tile in this location may mitigate future water damage impacts. The ceiling showed signs of recent repainting near sprinklers, possibly from repairs to water-damaged materials. In addition, the gaskets of skylights appear to have failed as indicated by condensation visible between the two sets of panes.

Water-stained carpeting in library

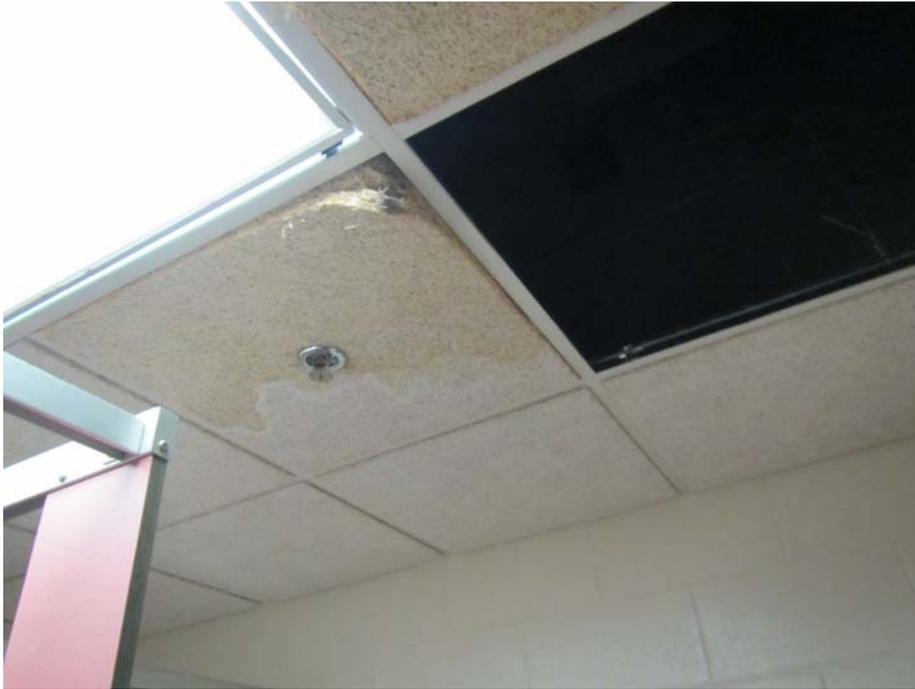
Picture 7

Due to the periodic roof leaks, water-damaged ceiling tiles and water-damaged walls/paint were observed in several classrooms and hallway areas (Pictures 7 through 9; Table 1). Some of these tiles appear to have been colonized by mold (Picture 10). Building occupants reported that the band instrument storage room had water-damaged instruments and other contents that were removed and replaced, water-damaged building materials were not remediated. Water damaged ceiling tiles were found in this location. Water-damaged ceiling

Water-damaged ceiling tile and missing tile

tiles can provide a source of mold and should be replaced after a water leak is discovered and repaired. Areas of water-damaged paint should be scraped and repainted or replaced if needed.

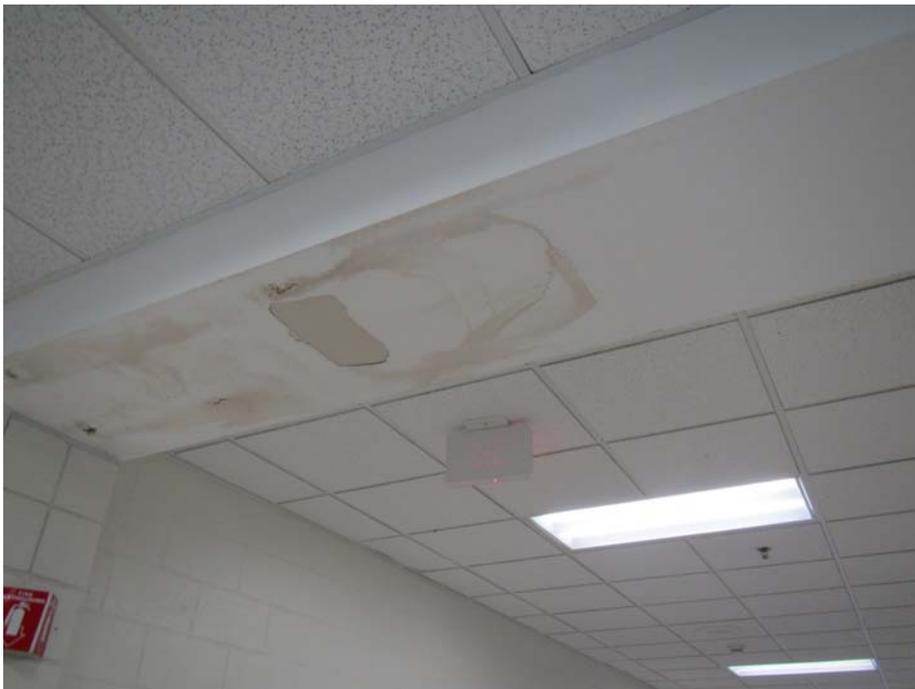
Picture 8

Water-damaged paint/plaster in hallway

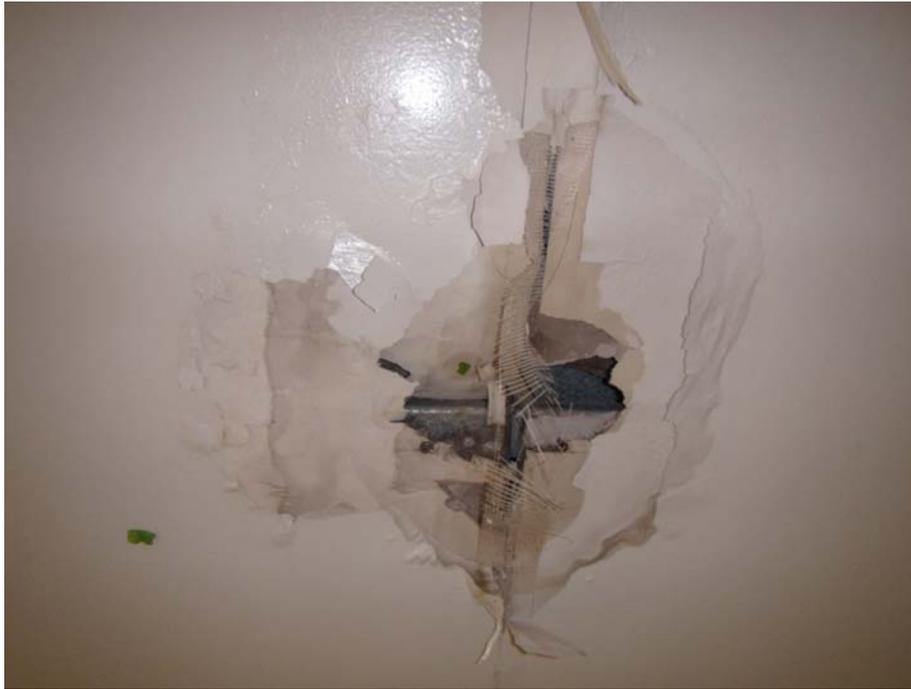
Picture 9

Water-damaged wall in hall just outside room D207

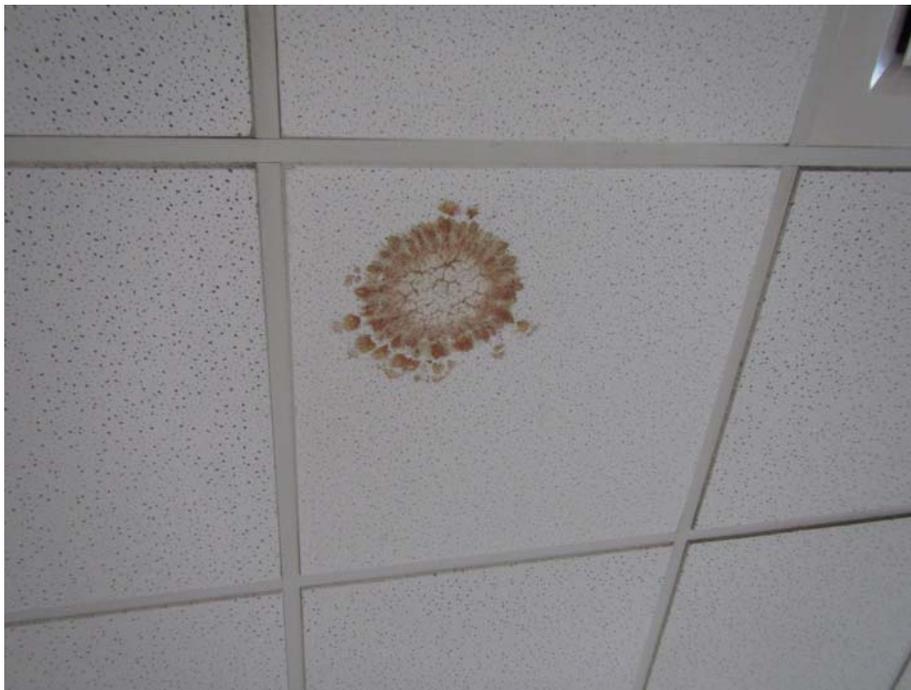
Picture 10

Likely mold-colonized ceiling tile

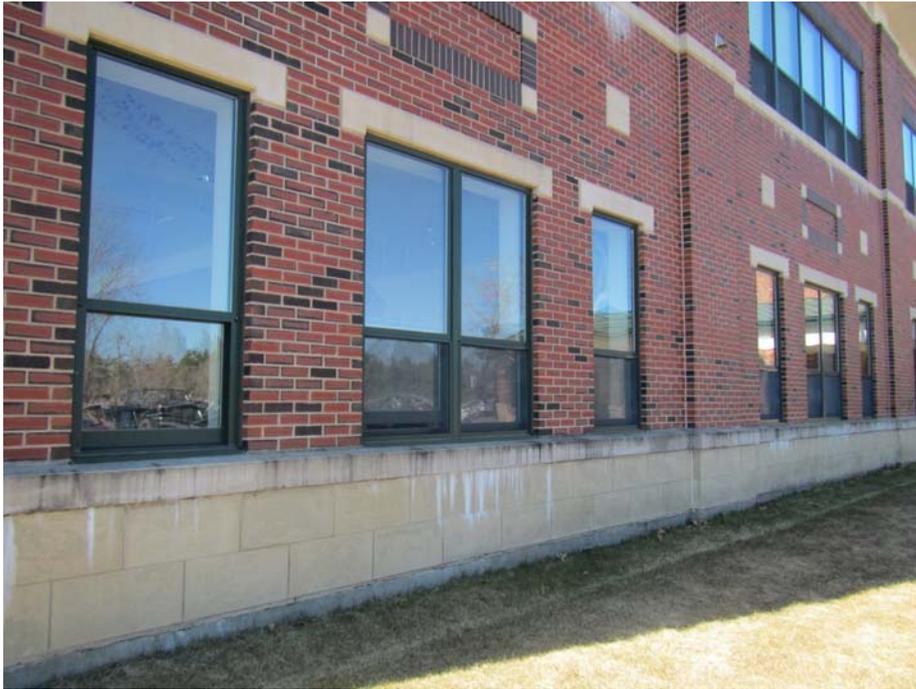
Picture 11

The exterior of the building was examined for conditions that could lead to water infiltration or other sources of indoor air pollutants. Efflorescence was observed along many of the seams and edges of the brick and block facings (Pictures 11 and 12). Efflorescence is a

characteristic sign of water damage to brick and mortar, but it is not mold growth. As moisture penetrates and works its way through mortar, brick or plaster, water-soluble compounds dissolve, creating a solution. As the solution moves to the surface of the material, the water evaporates, leaving behind white, powdery mineral deposits.

Efflorescence on building façade

17. Have the exterior of the building examined by a building envelope specialist to determine the best way to correct water infiltration leading to efflorescence. Weep holes may need to be restored and flashing repaired.

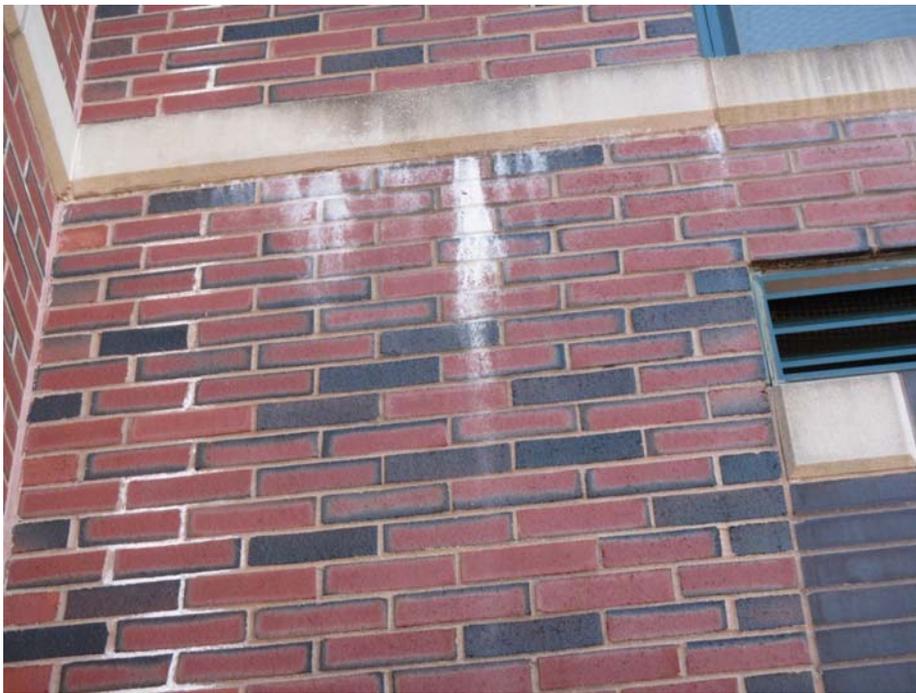
Picture 12

Efflorescence where concrete and brick meet on building façade

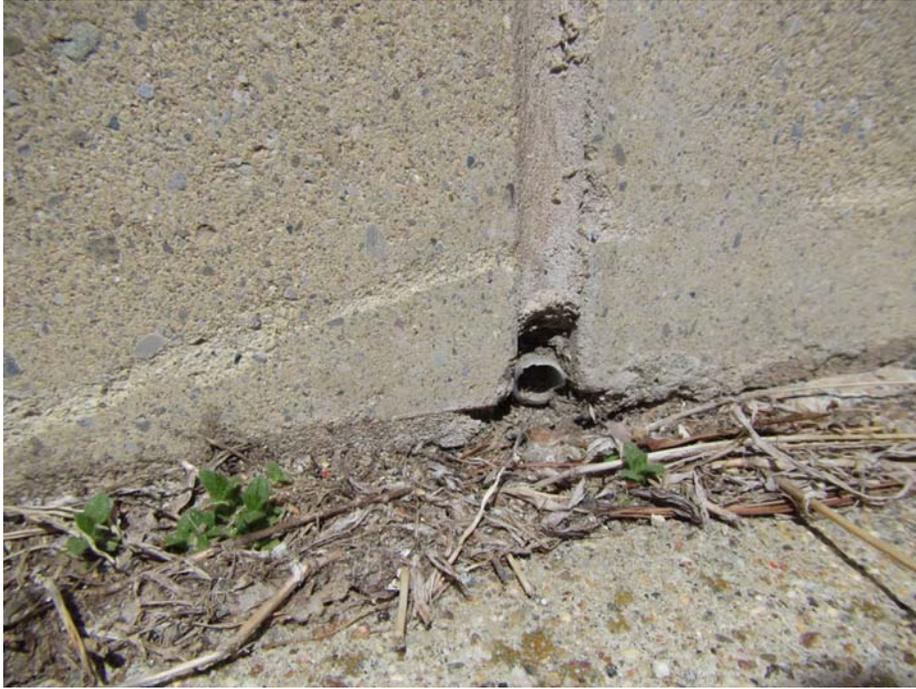
Picture 13

An exterior wall system should consist of an exterior curtain wall ([Figure 2](#)). Behind the curtain wall is an air space that allows for water to drain downward and for the exterior cladding system to dry. In order to allow for water to drain from the exterior brick system, a series of weep holes is customarily installed in the exterior wall, at or near the foundation slab/ exterior wall system junction. Weep holes allow for accumulated water to drain from a wall system (Dalzell, 1955). Opposite the exterior wall and across the air space is a continuous, water-resistant material adhered to the back-up wall that forms the drainage plane. The purpose of the drainage plane is to prevent moisture that crosses the air space from penetrating the interior of the building. The plane also directs moisture downwards toward the weep holes. The drainage plane should be continuous. Where breaks exist in the drainage plane (e.g., window systems, door systems, air intakes), additional materials (e.g., flashing) are installed as transitional surfaces to direct water to weep holes. If the drainage plane is discontinuous, missing flashing or lacking air space, rainwater may accumulate inside the wall cavity and lead to moisture penetration into the building ([Figure 3](#)). Weep holes were found at the bottom edges of the building (Picture 13) but they may be undersized and/or clogged to efficiently remove moisture from the drainage plane.

Weep hole at base of wall

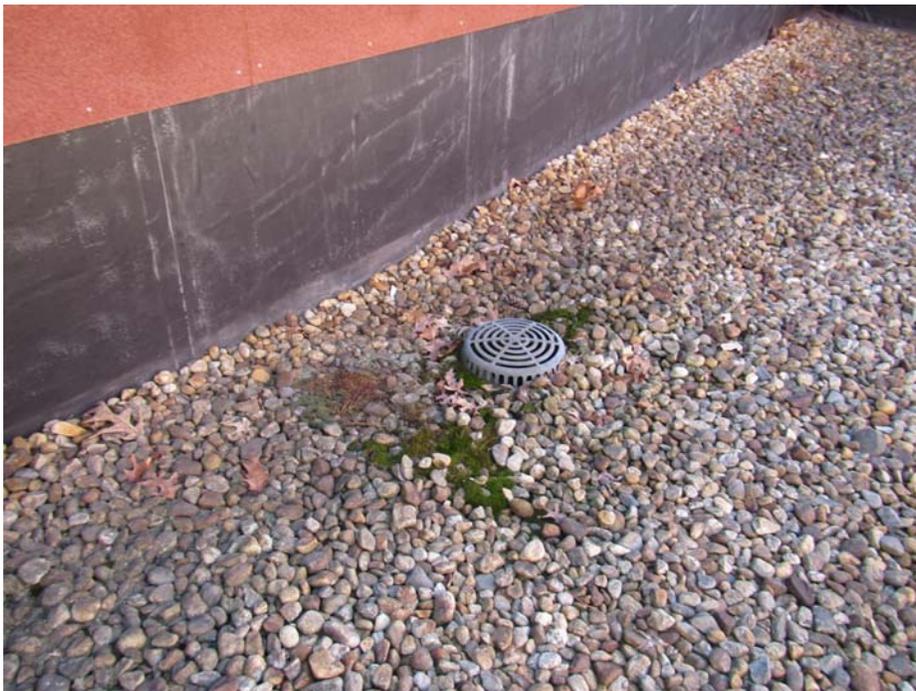
Picture 14

Most of the roof drains were found to be in good condition, but some were broken or had water pooling adjacent to them (Picture 14). Improper function of roof drains can lead to water pooling on the roof and exacerbate any roof leaks.

Moss growth next to roof drain indicating historic water pooling

18. Repair broken roof drains.
19. Investigate the functioning of the sawdust collector in the woodshop to ensure that it is properly collecting debris. Clean out this unit regularly and avoid dumping wood chips on the ground, especially in contact with the building.

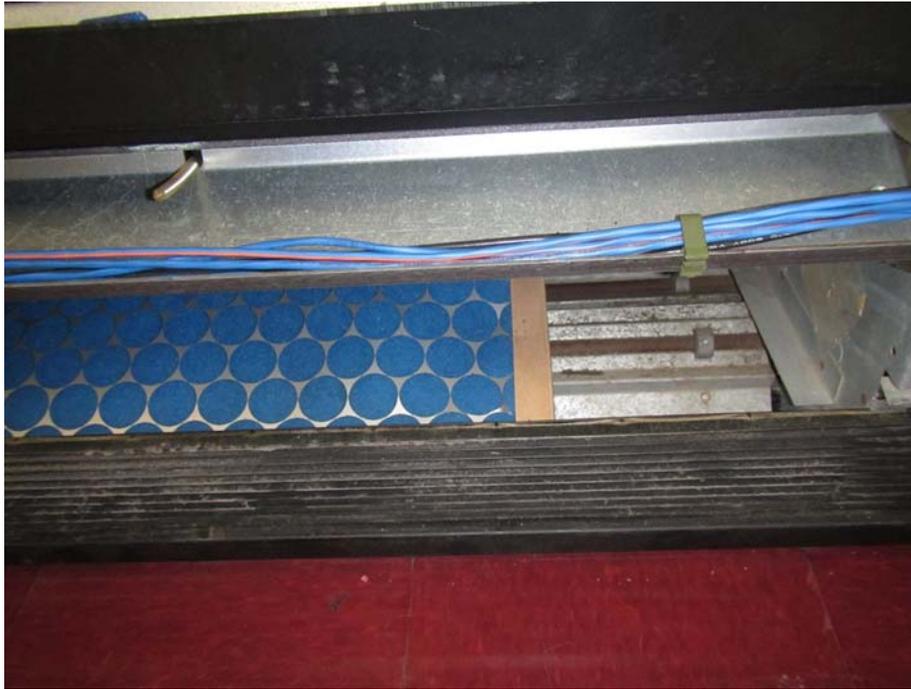
Picture 15

Other conditions that can affect IAQ were observed during the assessment. A typical classroom univent was opened for observation. It was noted that the type of filter medium for univents provides minimal filtration (Picture 15). It should be determined if filters with an increased dust spot efficiency can be installed. The dust spot efficiency is the ability of a filter to remove particulate matter of a certain diameter from air passing through the filter. Filters that have been determined by ASHRAE to meet its standard for a dust spot efficiency of a minimum of 40 percent would be sufficient to reduce airborne particulate matter (Thornburg, D., 2000; MEHRC, 1997; ASHRAE, 1992). Pleated filters with a Minimum Efficiency Reporting Value dust-spot efficiency of 9 or higher are recommended. Note that increasing filtration can reduce airflow (called pressure drop), which can subsequently reduce the efficiency of the unit due to increased resistance. Prior to any increase of filtration, each univent should be evaluated by a ventilation engineer to ascertain whether it can maintain function with more efficient filters. In addition, as shown in Picture 15, the filter is too small for the univent and therefore allows unfiltered air into the room. It was reported that when filters are changed, longer filters may be cut to fit smaller univents, leaving insufficient numbers of the longer filters for the larger

Filter in univalent cabinet, note low-dust-spot efficiency filter and filter does not fit

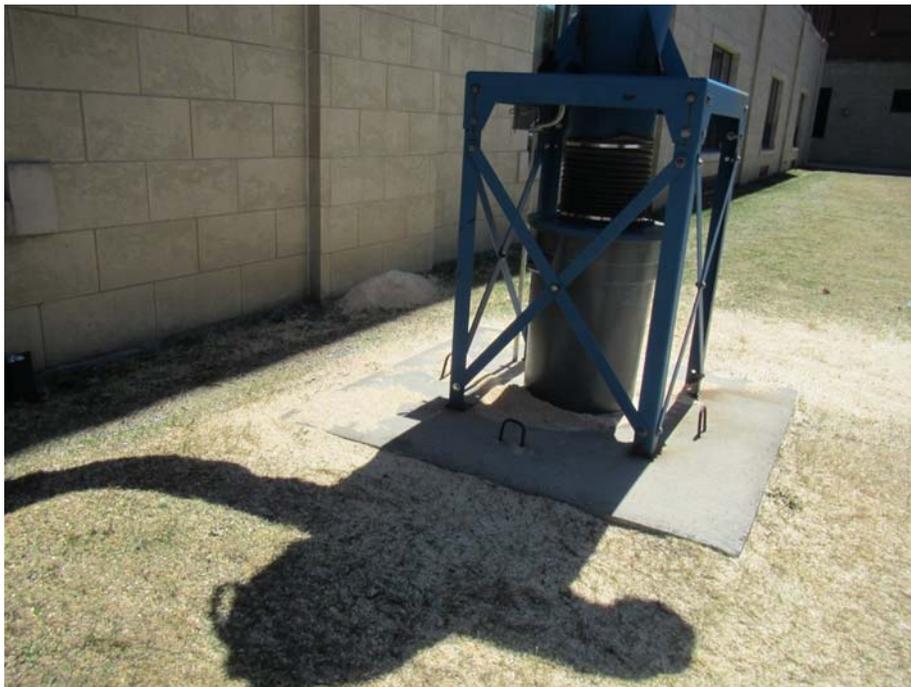
Picture 16

The wood shop was not accessible at the time of the assessment, but it was observed to be equipped with a wood-chip/sawdust collector (Picture 16). The portion of this collector outside the building had a large pile of wood chips next to it, while the receptacle (trash can) was empty inside. It was unclear if this device was malfunctioning and ejecting wood chips directly on the ground, or if these chips had been dropped during the last time the receptacle had been emptied. Proper maintenance/functioning of ventilation equipment is vital to good IAQ in shops and the rest of the building. In addition, improper disposal of wood chips on the ground next to the building can create a harborage for pests.

Wood chip/sawdust collector from wood shop; note piles of chips on ground

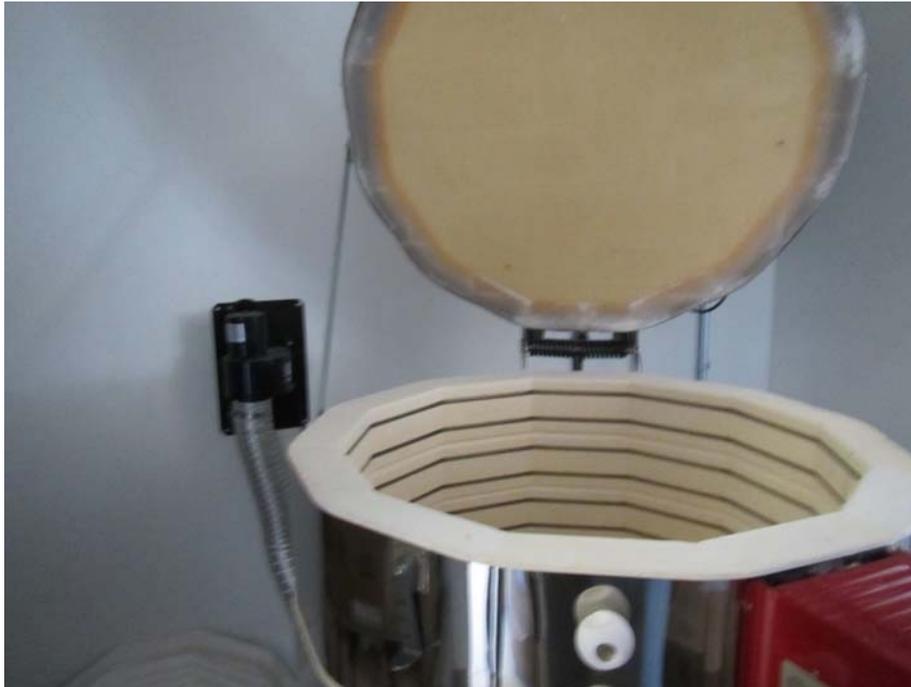
Picture 17

A kiln was observed in a small room inside the art classroom (Picture 17). This kiln was vented to the outdoors, which operates whenever the kiln is on. However, it was observed that the room also had a return vent for the general HVAC system, which may allow excess heat and any escaping odors to be recirculated to occupied areas. In addition, a ceiling tile was missing in this room, which would allow heat/odors to penetrate the plenum and possibly impact other occupied areas as well. Missing ceiling tiles, which were also found in several other areas (Picture 7; Table 1) should be replaced to prevent transfer of air into the plenum as well as prevent dust/debris in the plenum from entering occupied areas.

Kiln in art room

22. Replace missing ceiling tiles, especially in the kiln room.

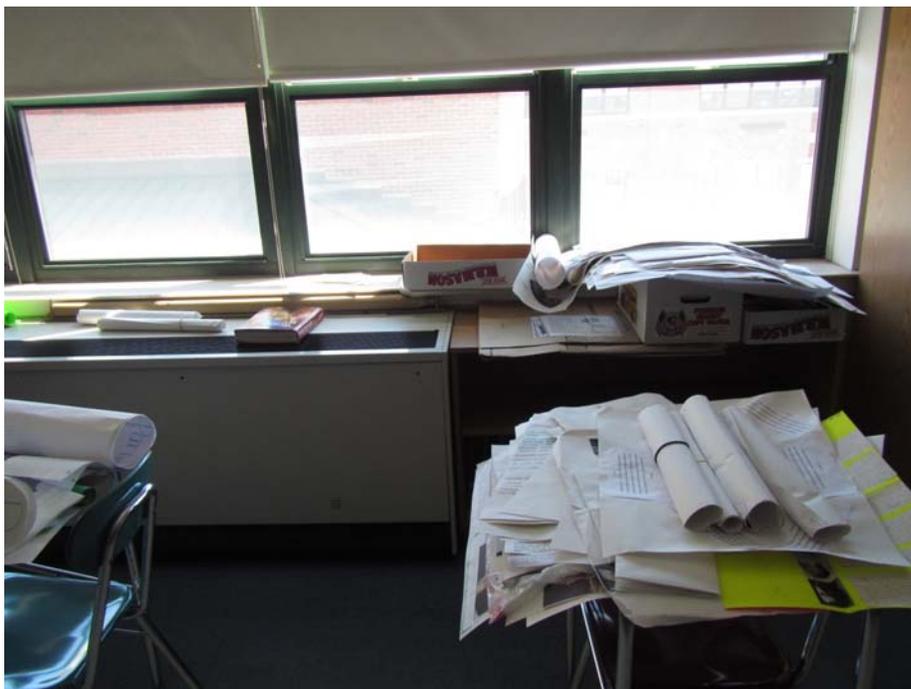
Picture 18

Papers and items on surfaces, including univent
