MOLD ASSESSMENT

**Charles A. Bernazzani Elementary School
701 Furnace Brook Parkway
Quincy, Massachusetts**

Prepared by:
Massachusetts Department of Public Health
Bureau of Environmental Health
Indoor Air Quality Program
January 2015

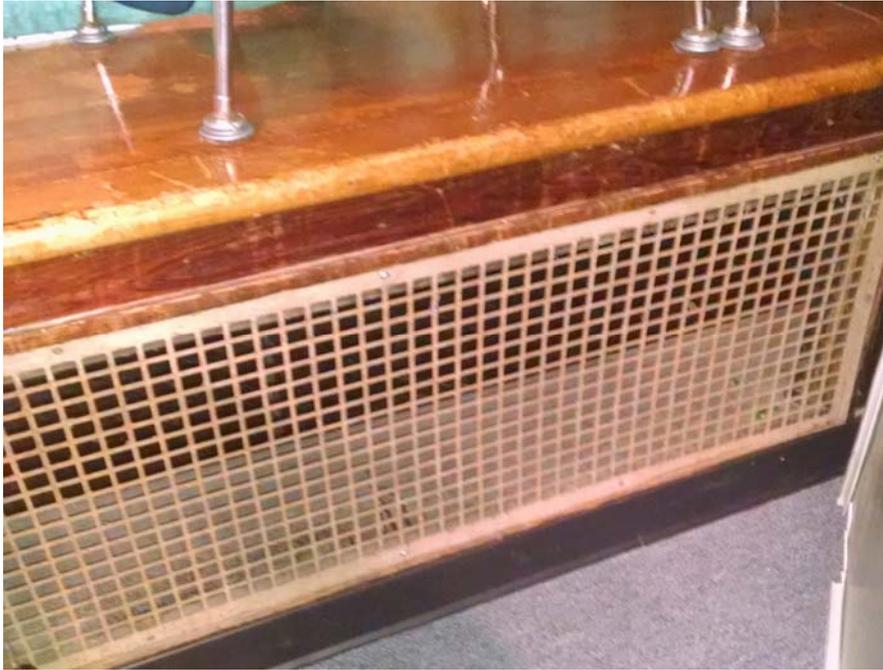
Picture 1

The elevated relative humidity indoors suggests that ventilation in the rear portion of the building may be inadequate. At the time of the assessment, BEH/IAQ staff examined the return vent for the media center, which is located under the stage (Picture 1). Draw of air could not be detected at this vent. Mr. Segalla indicated that the exhaust fan was not operating properly and a replacement was on order. Replacing the exhaust fan and thereby reestablishing exhaust ventilation is important to remove moisture from the building.

Exhaust vent located below stage

1. Replace/repair the exhaust motor for ventilation servicing the library/special education areas. Reestablishing exhaust ventilation will remove normally occurring indoor air pollutants, including excess moisture, from the building.

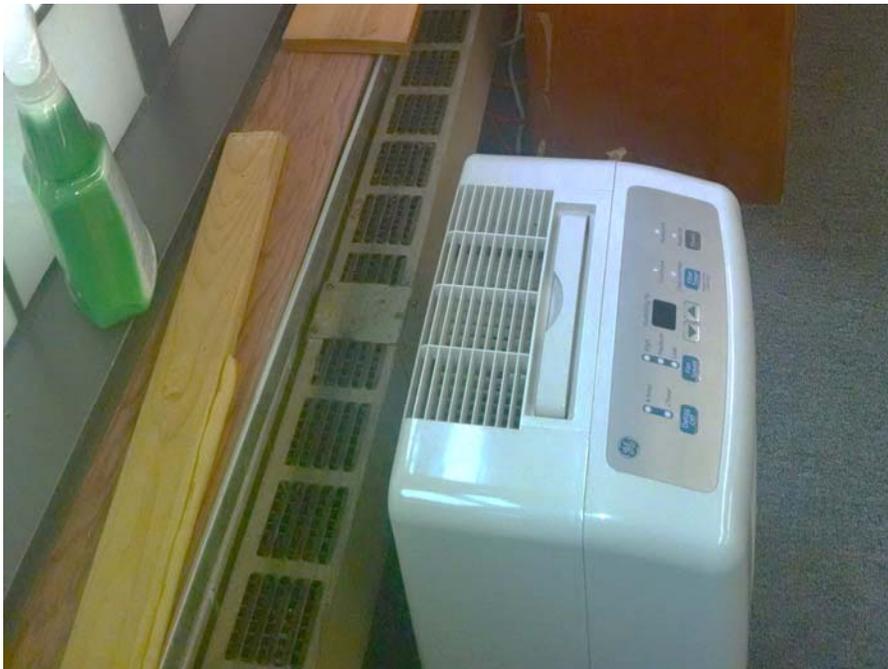
Picture 2

A dehumidifier was observed in the special education room (Picture 2). This dehumidifier does not appear to be sized appropriately for the room. A dehumidifier with a larger capacity may be needed to adequately remove moisture from the space. Consideration should be given to installing a drainage hose for the dehumidifier to allow the unit to operate continuously. If the hose is directed outdoors, measures should be taken to ensure water does not flow back towards the building. Dehumidifiers should be cleaned routinely and dried completely when not in use to prevent mold growth and associated unpleasant odors.

Dehumidifier in Special Education Area

2. Ensure dehumidifiers are sized appropriate for the space. Consider installing a hose to the unit to allow continuous operation. Ensure water drains away from the building.

3. Clean and service dehumidifiers periodically to ensure proper function and reduce the chance of odors from the units.
4. Ensure carpets are vacuumed regularly with a HEPA-filtered vacuum.

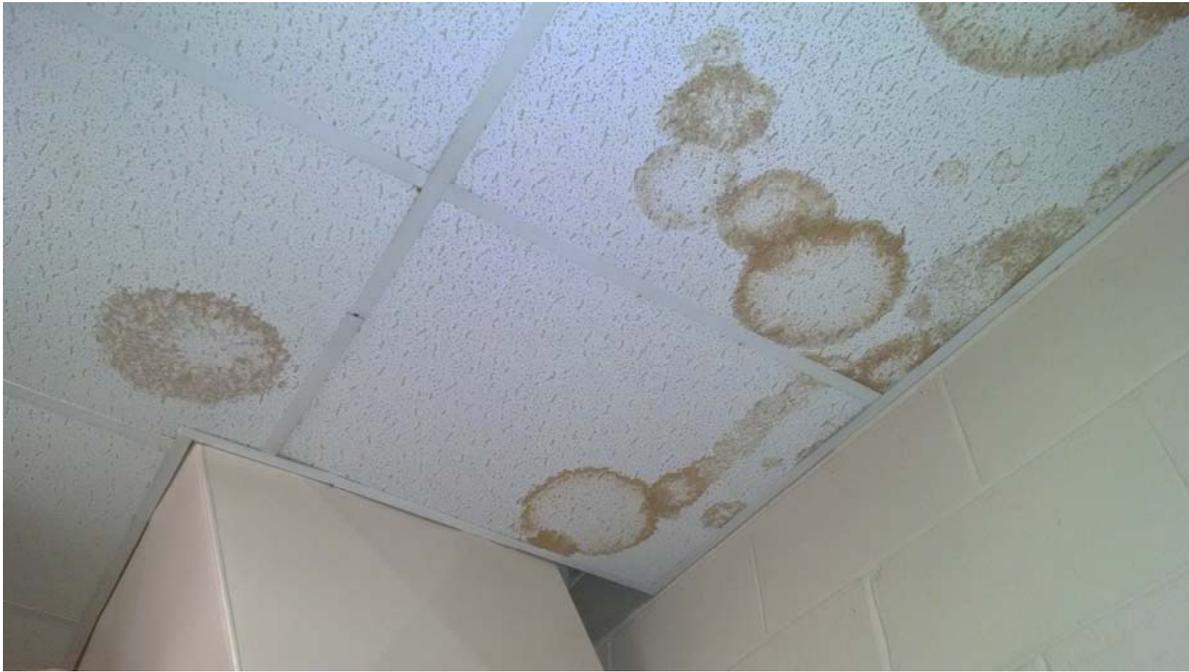
Picture 3

At the time of the assessment, BEH/IAQ staff also observed water-damaged ceiling tiles in the storage room (Picture 3). Staff reported that water penetrated the building during wind-driven rain events. Water-damaged ceiling tiles should be discarded and replaced after the source of moisture has been identified and remediated.

Water-damaged ceiling tiles

12. Replace water-damaged ceiling tiles.
13. Install elbows to downspouts to direct water away from the building.
14. Seal breaches in the building envelope (e.g. cracks in foundation, missing mortar) to prevent moisture and pest intrusion.

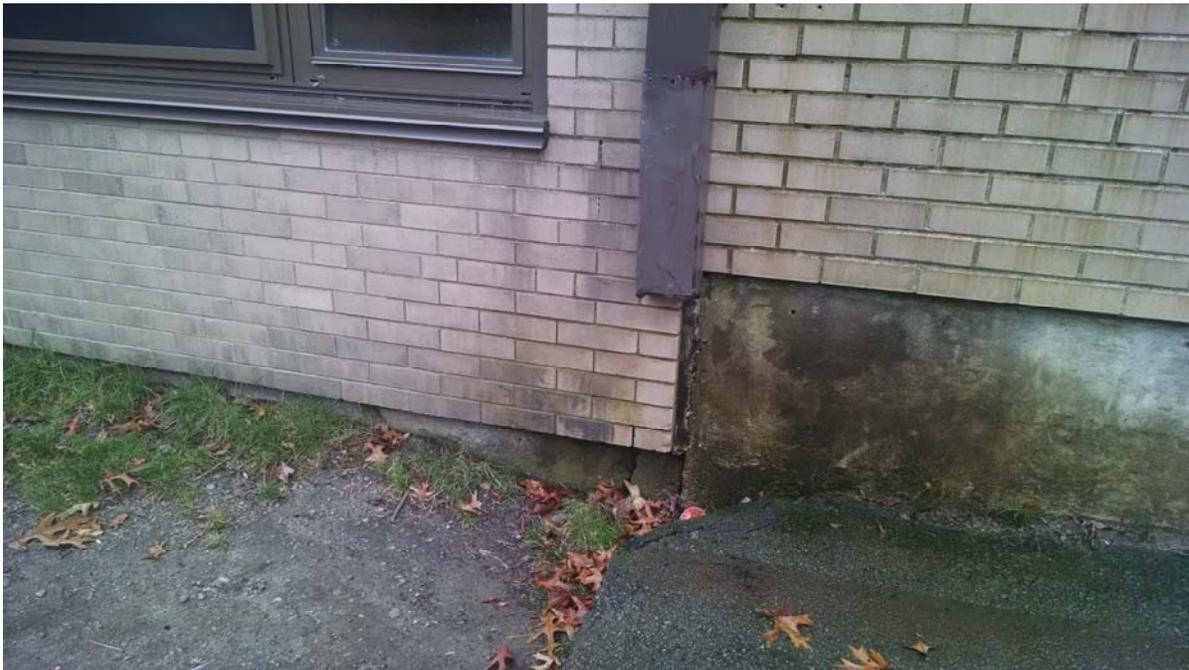
Picture 4

During an examination of the building exterior, BEH/IAQ staff noted that downspouts were missing elbows. In one instance, water was emptying directly against a crack in the foundation (Picture 4). Without proper drainage, water is funneled towards rather than directed away from the building. In addition, a patio at the rear of the building prevents adequate drainage of the outdoor space at the back of the building. Due to the slope and grade around the building, water drains towards the building. Continued moisture exposure can lead to

deterioration of the foundation as well as water infiltrating into the building. Measures should be taken to direct water away from the building.

Downspout missing elbow, directing water to into cracked foundation

15. Consider grading around the building to create a pitch that directs water away.
16. Employ methods outlined in the document “Preventing Mold Growth in Massachusetts Schools During Hot, Humid Weather” ([Appendix A](#)) to prevent water damage from hot, humid weather.

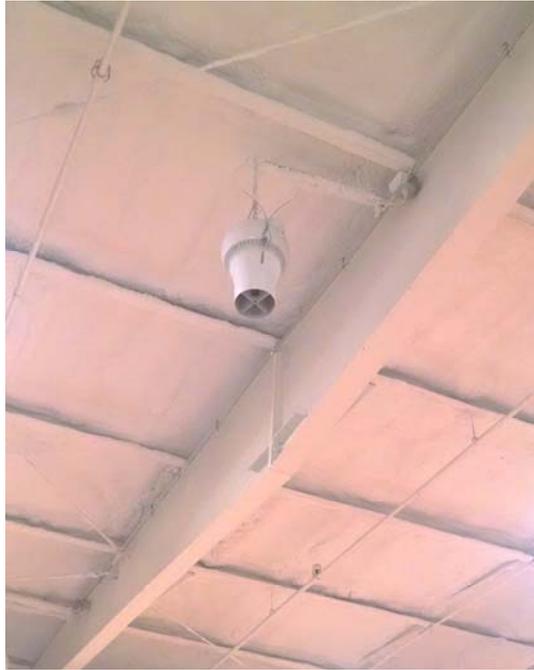
Picture 5

At the time of the assessment, Mr. Dionne reported that the gymnasium is experiencing periodic odors, reportedly associated with spray polyurethane foam insulation (SPFI) installed to the ceiling of the gymnasium. According to one manufacturer, the SPFI should not produce odors once the foam "cures" (or sets), a process that occurs within seconds of product application, and lingering odors should dissipate in 24 hours (Icynene, 2014). According to the US EPA, "if SPF was not applied properly, chemical contaminants may have migrated to hard and/or soft surfaces elsewhere in the building and may be the source of residual odors" (US EPA, 2014). No odors were noted at the time of the assessment. Ceiling fans were reportedly installed to increase ventilation and dissipate odors (Picture 5); however, these fans were not operating at the time of the assessment.

Ceiling fan hanging from insulated gymnasium ceiling

10. Contact the SPFI installer and manufacturer if odors persist in the gymnasium. Removal of the insulation may be necessary to abate odors.
11. Continue to operate fans in the gymnasium to dissipate odors.

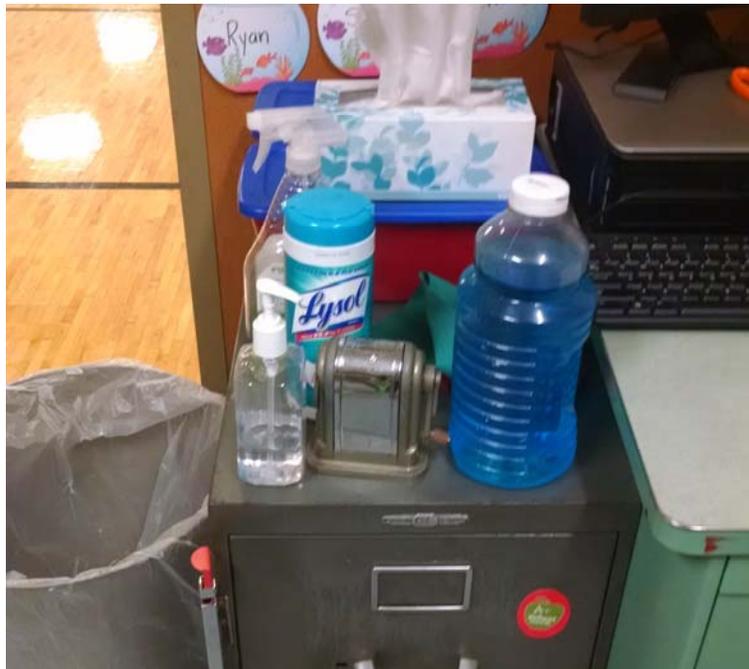
Picture 6

Cleaning and deodorizing products were observed in a number of areas, some of the items were unlabeled (Picture 6). These products contain chemicals that can be irritating to the eyes, nose and throat of sensitive individuals. Cleaning products should be properly labeled and stored in an area inaccessible to children. In addition, a Material Safety Data Sheet (MSDS) should be available at a central location for each product in the event of an emergency.

Unlabeled container
