INDOOR AIR QUALITY ASSESSMENT

**Tyringham Town Offices
2 Church Street
Tyringham, Massachusetts**

Prepared by:
Massachusetts Department of Public Health
Bureau of Environmental Health
Indoor Air Quality Program
March 2015

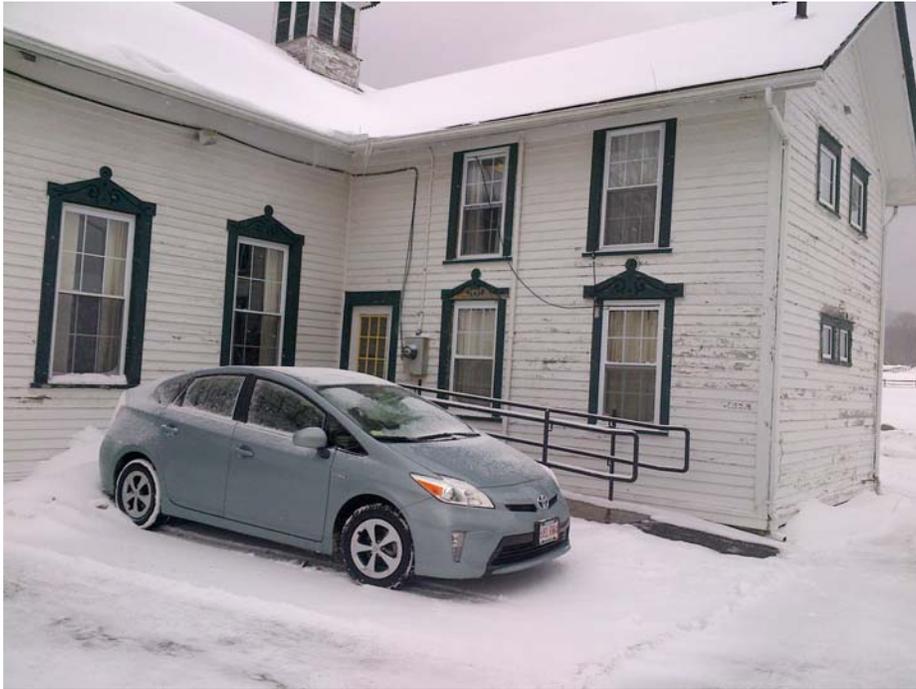
Picture 1

The TTO is a one-story, two room wood schoolhouse built in 1792. A two story addition to the rear of building was made during the 1960's (Picture 1). A cement block structure was also added to the rear of the building, which contains an air handling unit (AHU) (Picture 2). The building has a fieldstone foundation with a shallow crawlspace.

Two story addition at rear of original building

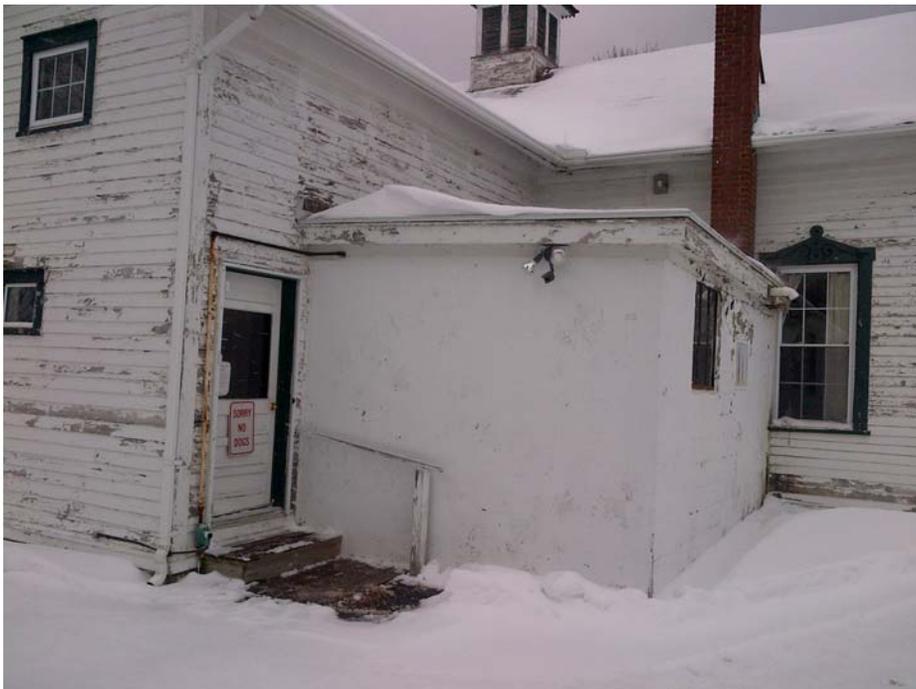
Picture 2

Cement block addition

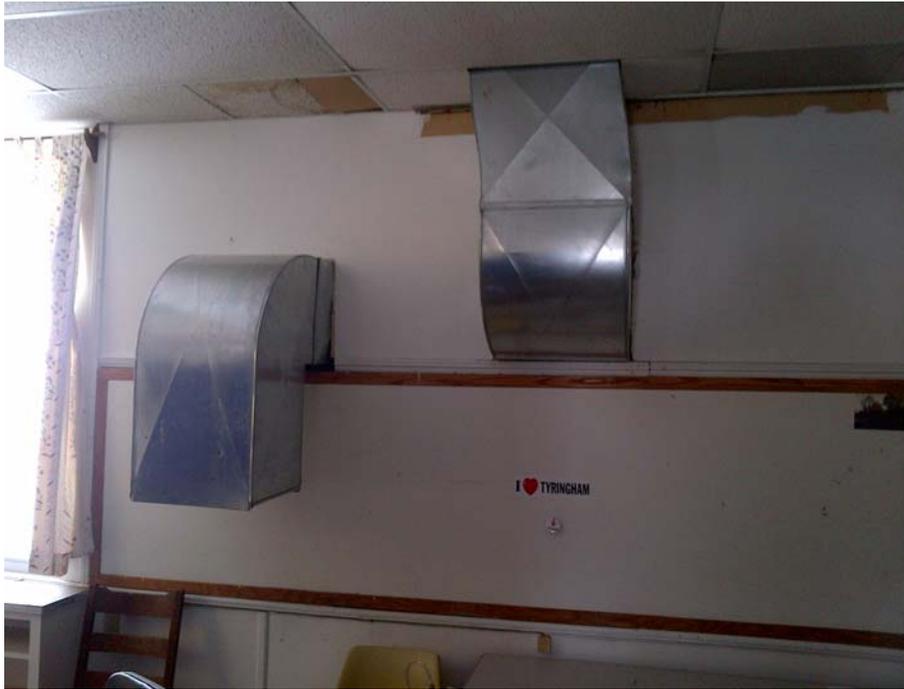
Picture 3

The TTO is heated by a gas-fired forced hot air (FHA) furnace unit. The FHA unit is located in a cement block room. This unit provides heating but does *not* introduce fresh air. Air from the Assessor's Office is drawn into a large return vent (Picture 3). A suspended ceiling was installed above the assessor's office and historic room. The suspended ceiling in both rooms has a plastic "egg crate" vent (Picture 4). It appears that the vent in the Assessor's Office is designed to draw air from the historic room via the egg crate in the suspended ceiling and an opening in the wall between the rooms in the ceiling plenum.

A factor increasing the odor penetration into the Assessor's Office is the configuration of the ductwork and operation of the FHA unit. The velocity of air drawn by the return vent of the FHA depressurizes the Assessor's Office, which in turn will draw air from cracks/crevices and other openings in walls and floors. This draw of air will also draw crawlspace odors and water vapor into the Assessor's Office, which can then moisten carpet, building materials and other materials which can lead to mold growth and musty odors.

Return vent in Assessor's Office

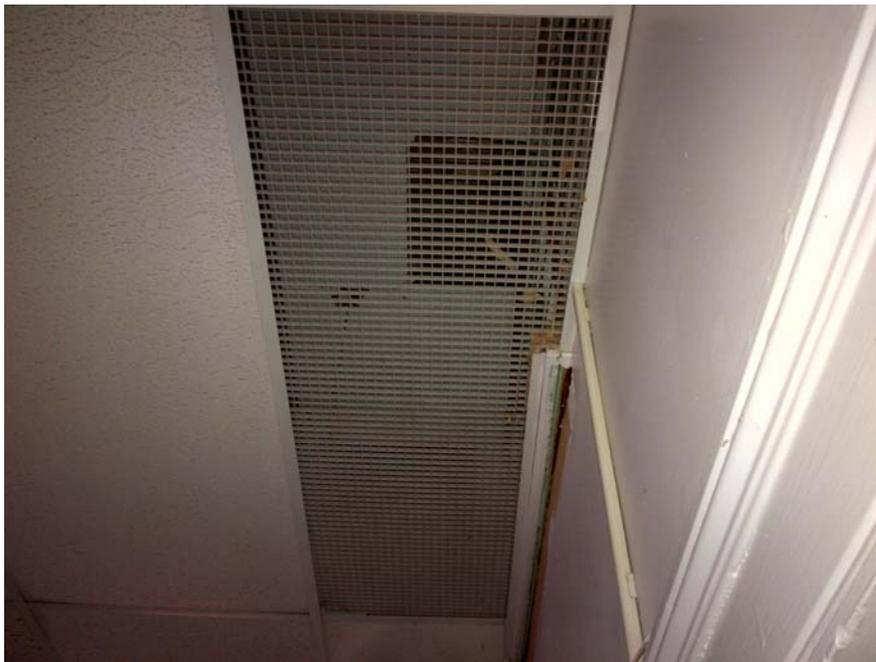
Picture 4

"Egg crate" in suspended ceiling serving as return vent for the Historical Room

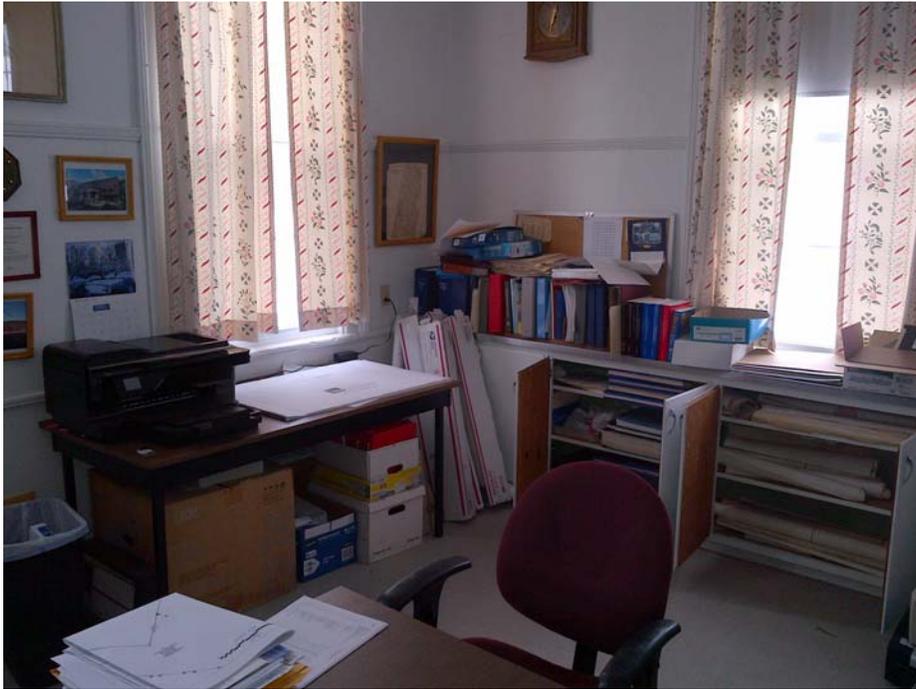
Picture 5

A significant mold/musty odor was noticeable upon entering the Assessor's Office from the rear foyer/kitchen area. This odor was traced to the east corner of the Assessor's Office (Picture 5). The odor lessened and appeared to be confined to the east corner of the Assessor's Office. The odor appeared to lessen when the FHA unit was deactivated. It is likely that an opening in the floor or walls exists in and around the east corner of the Assessor's Office; this would allow air to enter from the crawlspace. Rotted wood also exists at the base of the exterior

East corner of Assessor's Office

1. Consider installing a combustion air vent for the FHA unit to draw air from outdoors.
2. Examine the east corner of the Assessor's Offices for holes/cracks, crevices or other openings through the floor and exterior wall and seal with an appropriate material. This examination should include moving the bookshelf installed along the southeast wall in the east corner.
3. Consider removing the wall-to-wall carpet from the Assessor's Office.
4. Reconnect/install the gutter and downspout system to capture water and direct it away from the foundation.
5. Consult with a water intrusion contractor to take necessary actions to prevent storm water, groundwater, and associated moisture from entering the crawlspace. This may include:
 - a. sealing gaps in foundations;
 - b. installing perimeter drains;
 - c. providing vapor barrier to the underside of the floor and;

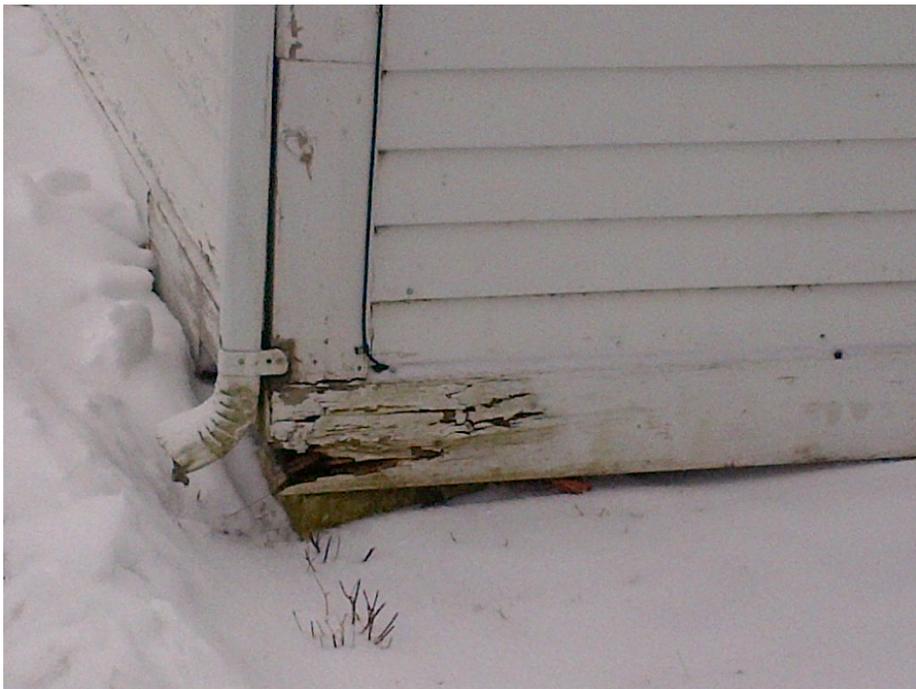
Picture 6

east corner of the TTO (Picture 6) which can also provide a pathway for odors from the crawlspace. It appeared that the lower section of the southeastern exterior wall was more recently replaced (Picture 7). There are three possible sources of water to enter the crawlspace and produce a musty odor that is penetrating into the Assessor's Office.

- The east corner downspout has come away from the gutter, which can directly moisten the wood at the foundation. In addition, the downspout empties at the base of the building. Downspouts should be directed to empty at least five feet away from a building to prevent water penetration through the foundation.
- Rainwater can penetrate through clapboard above the repaired southeast exterior section. Water can accumulate behind the new clapboard, wetting materials and possibly penetrating through the sill/foundation junction.
- Water from driving rain may accumulate along the foundation from the driveway.

Rotted wood at base of the east exterior corner of TTO

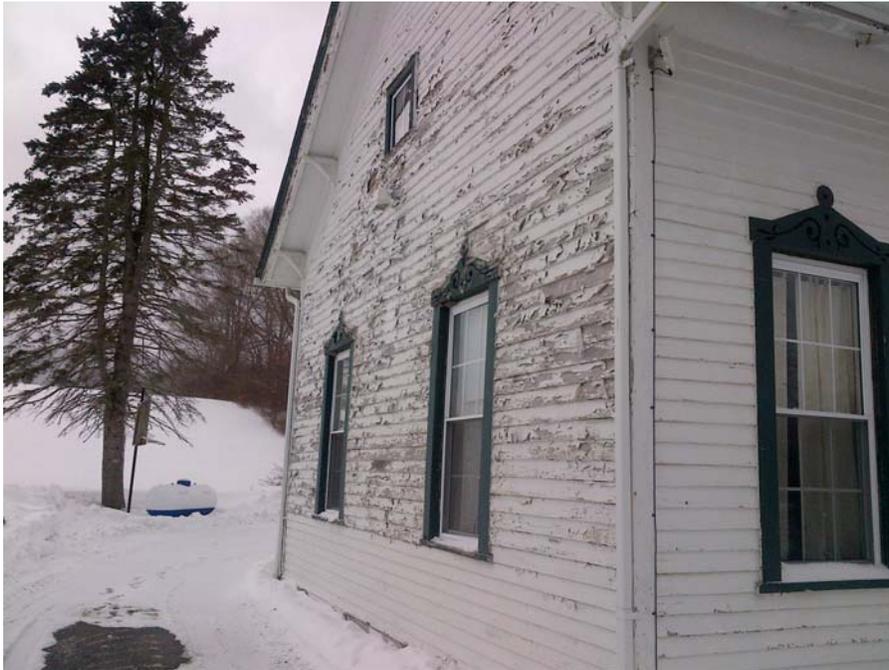
Picture 7

**Southeast exterior wall outside Assessor's Office
(Note lack of peeling paint on clapboard at the bottom of the wall)**

- d. installing a sloped, water impermeable surface barrier (clay cap);
6. Consult with a building engineer/contractor to evaluate strategies to stop water/moisture from penetrating the building envelope along the southeast wall, which may include addressing storm water runoff from the driveway.

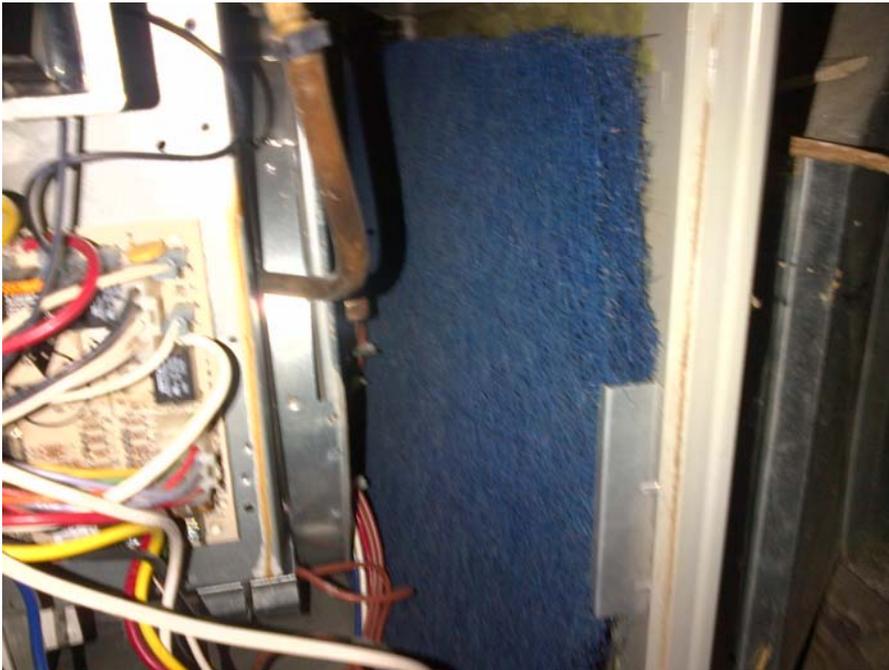
Picture 8

The FHA unit contains a filter that is not flush with the opening (Picture 8), which can allow for particles to bypass the filter and be distributed by the FHA unit as it operates. In addition, the filter is of a type that will provide minimal filtration of particulate matter from air. The dust spot efficiency is the ability of a filter to remove particulate matter of a certain diameter from air passing through the filter. Filters that have been determined by ASHRAE to meet its standard for a dust spot efficiency of a minimum of 40 percent would be sufficient to reduce many airborne particulates (Thornburg, 2000; MEHRC, 1997; ASHRAE, 1992). Pleated filters with a Minimum Efficiency Reporting Value (MERV) of 9 would normally be recommended, since this type of filter would remove common air particles such as pollen. Note that increasing filtration can reduce airflow (called pressure drop), which can subsequently reduce the efficiency of the unit due to increased resistance. Prior to any increase of filtration, the FHA unit should be evaluated by a ventilation engineer to ascertain whether it can maintain function with a more efficient filter.

Loose filter in FHA

7. Ensure that the filters have the recommended minimum 40% dust spot efficiency accounting for manufacturer limitations with pressure drop. Ensure they are installed correctly and changed on a regular schedule in accordance with manufacturer's recommendations.
