# **INDOOR AIR QUALITY ASSESSMENT**

**Wareham District Court  
2200 Cranberry Highway  
West Wareham, MA**

Prepared by:  
Massachusetts Department of Public Health  
Bureau of Environmental Health  
Indoor Air Quality Program  
January 2015

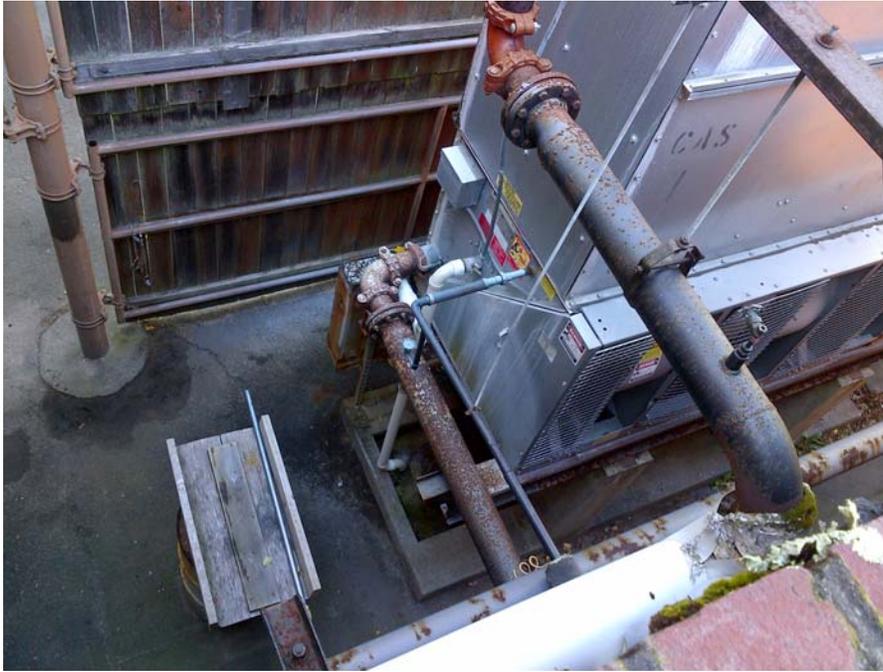
**Picture 1**

The building is a one-story brick building with an occupied ground level section that was constructed in 1970s. Court rooms and offices have wall to wall carpeting. Windows are openable. The rear of the building contains a sally port and heating, ventilating and air-conditioning (HVAC) chiller located immediately adjacent to the sally port (Picture 1).

**HVAC System Chiller**

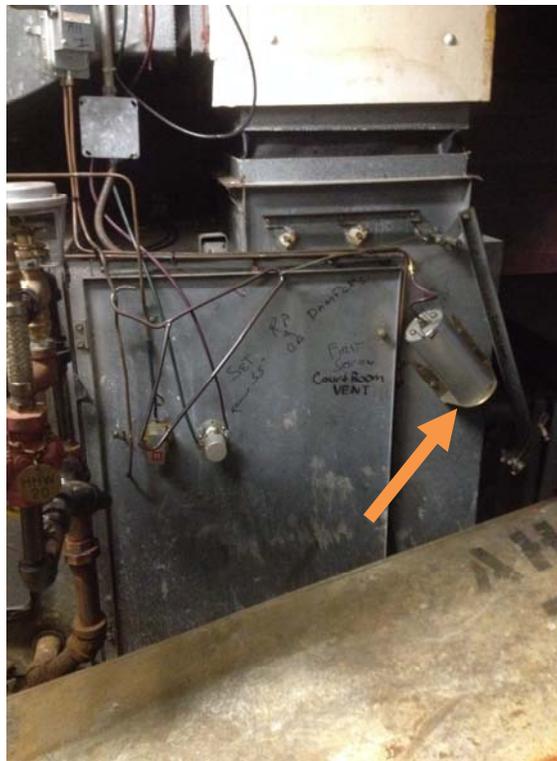
**Picture 2**

**AHU louver held in place by plastic coat hanger, note actuator motor (arrow) control rod missing**

2. Repair the HVAC system motor in Picture 2.
3. Clean the interior of each FCU. Install proper insulation on FCU pipework.
4. Remove and replace carpeting around FCU. Consider installing carpet tiles.

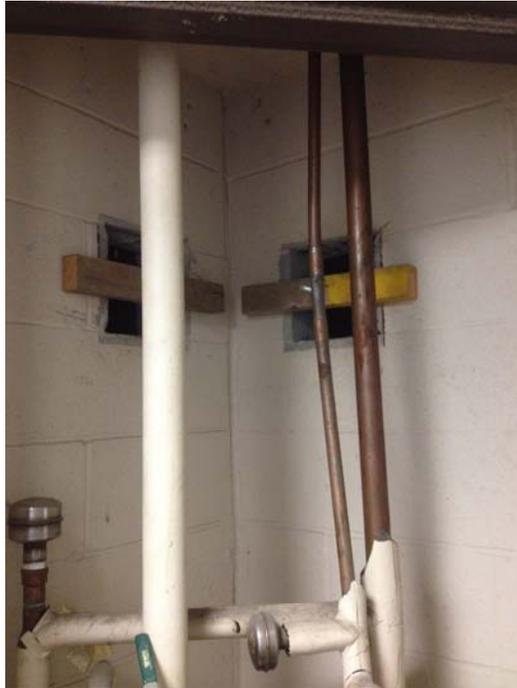
**Picture 3**

removed (Pictures 3 and 4), with one section crimped closed. This condition was noted in a MA Division of Occupational Safety 2010 letter requesting that this condition be investigated and “if necessary, eliminate them” (DOS, 2010). It appears that no action to restore the function of this ventilation system was implemented. At minimum, holding cells should have functioning exhaust ventilation to remove odor and water vapor from plumbing facilities.

**Interior view of HVAC cell vent opening with ductwork removed**

11. Ensure that holding cell exhaust vents are in working order. Reinstall ductwork as needed.
12. Consider a long-term plan to replace carpeting that is past its useful life as funds become available.

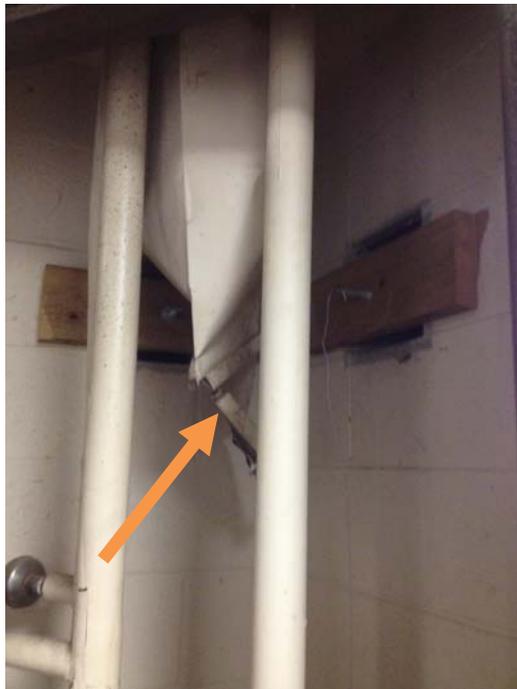
**Picture 4**

**Interior view of HVAC cell vent opening with ductwork removed, note crimped duct (arrow)**

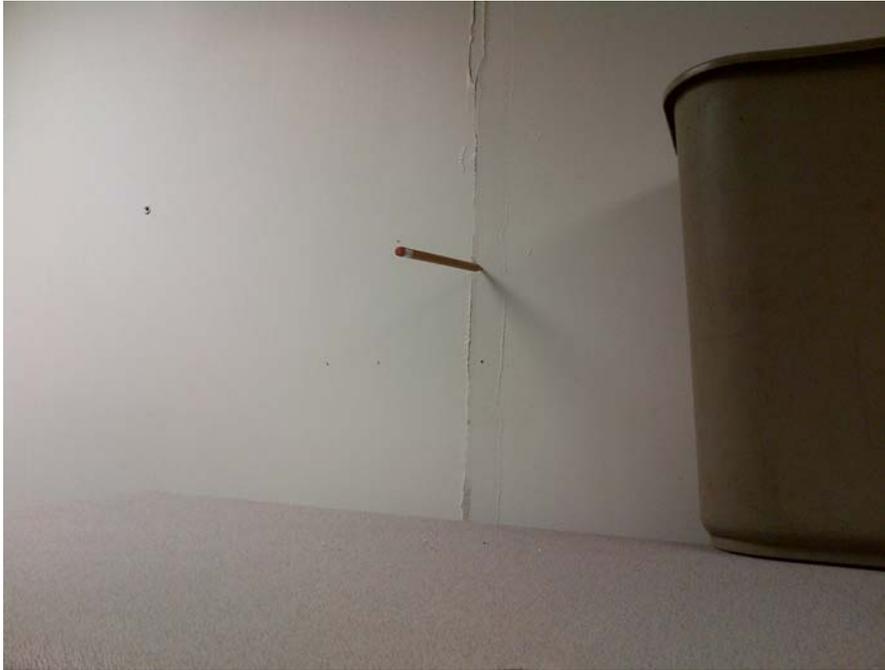
**Picture 5**

**GW softened enough to easily insert pencil into the wall, note trash bin used to collect water during rainstorms as reported by court staff**

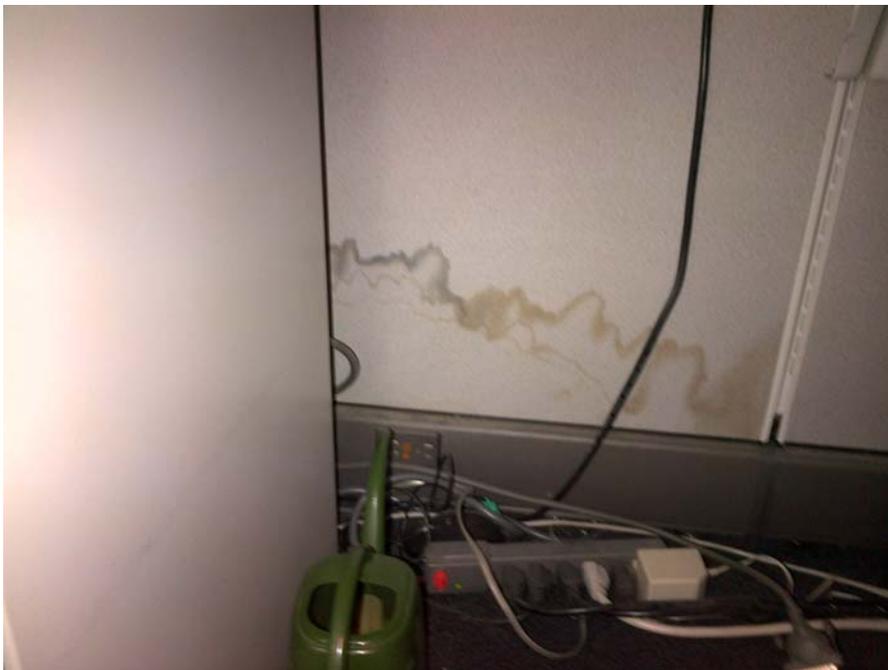
**Picture 6**

**Water damage to wall of modular furniture**

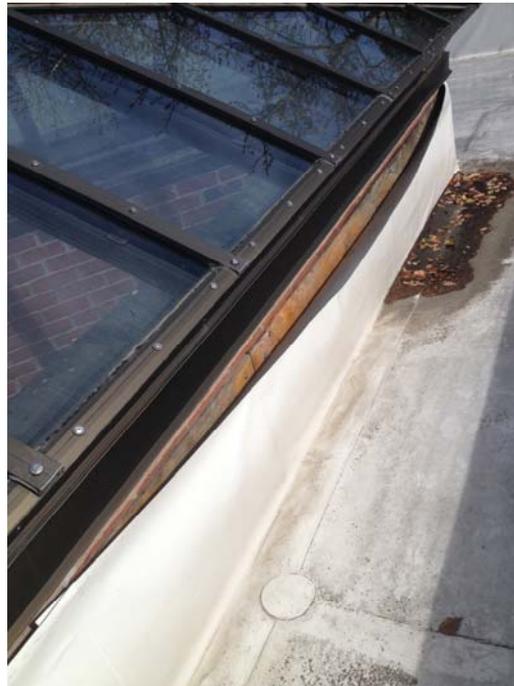
**Picture 7**

**Loose roof membrane**

5. Remove bird related waste from the entrance skylight. Install bird netting on its underside opening to prevent roosting.
6. Repair the roof membrane where damaged.

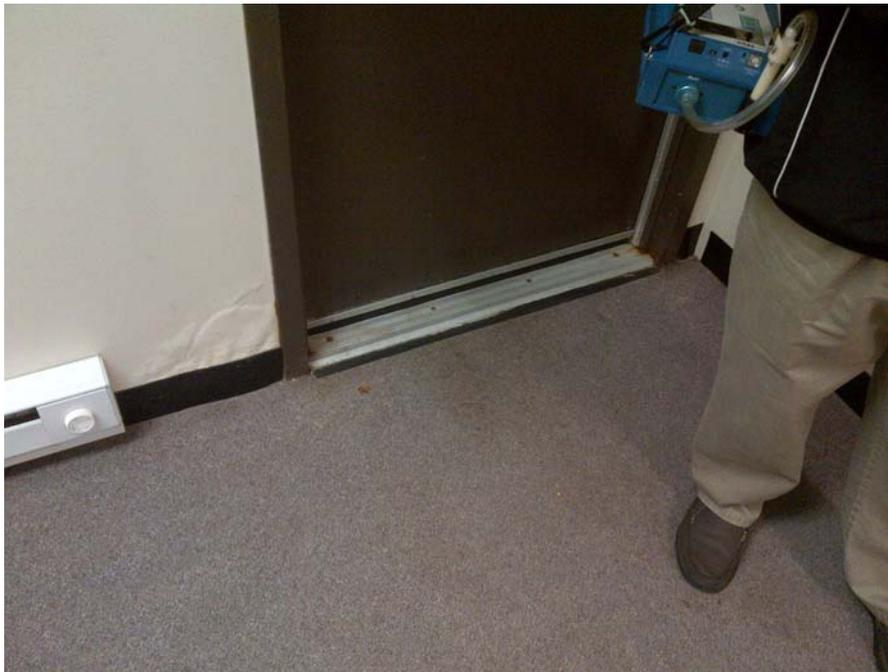
**Picture 8**

**Water-damaged GW around doorframe**

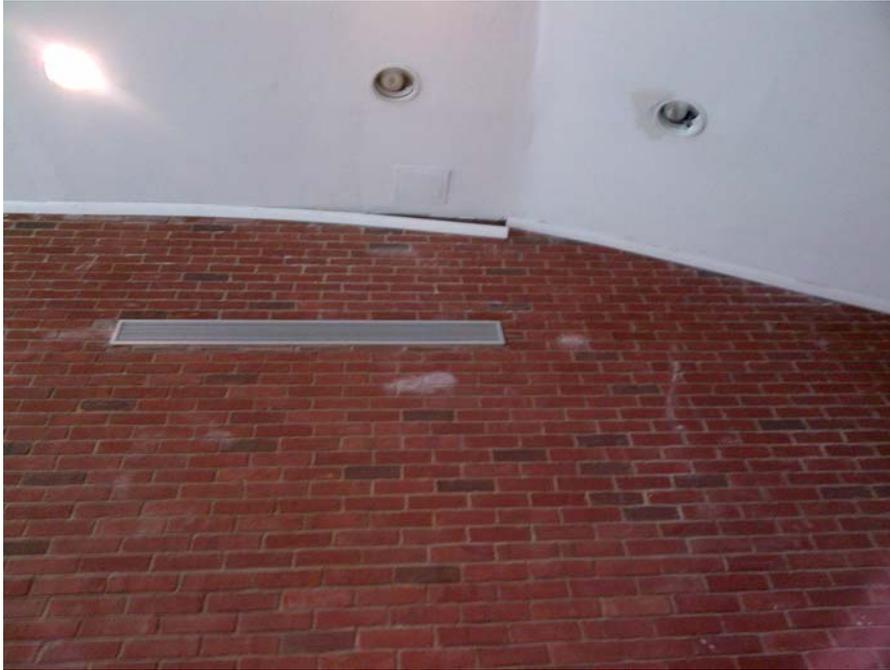
**Picture 9**

**Distended GW, note white spots on brick (efflorescence) which is a sign of water intrusion**

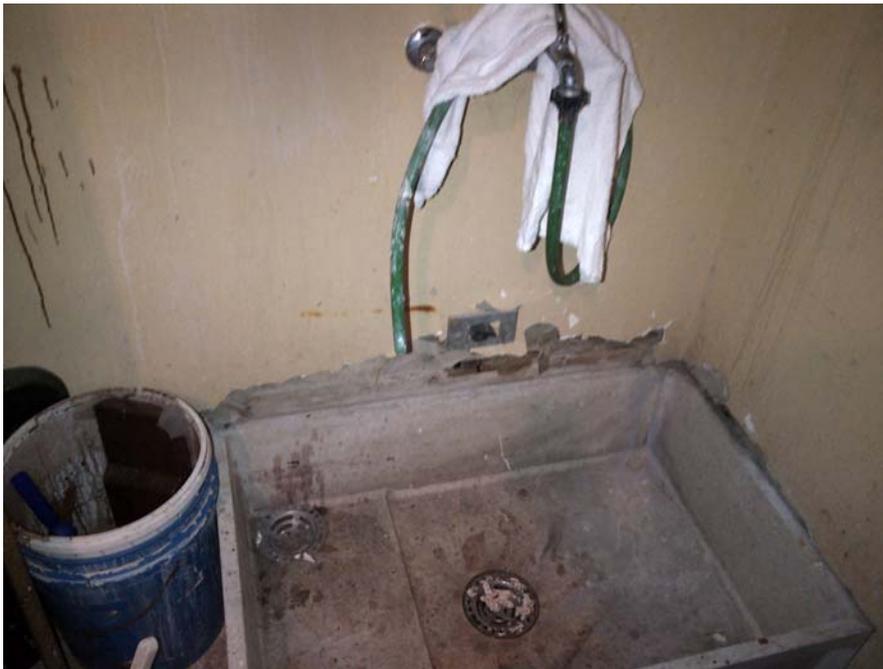
**Picture 10**

**Water-damaged GW around custodial sink**

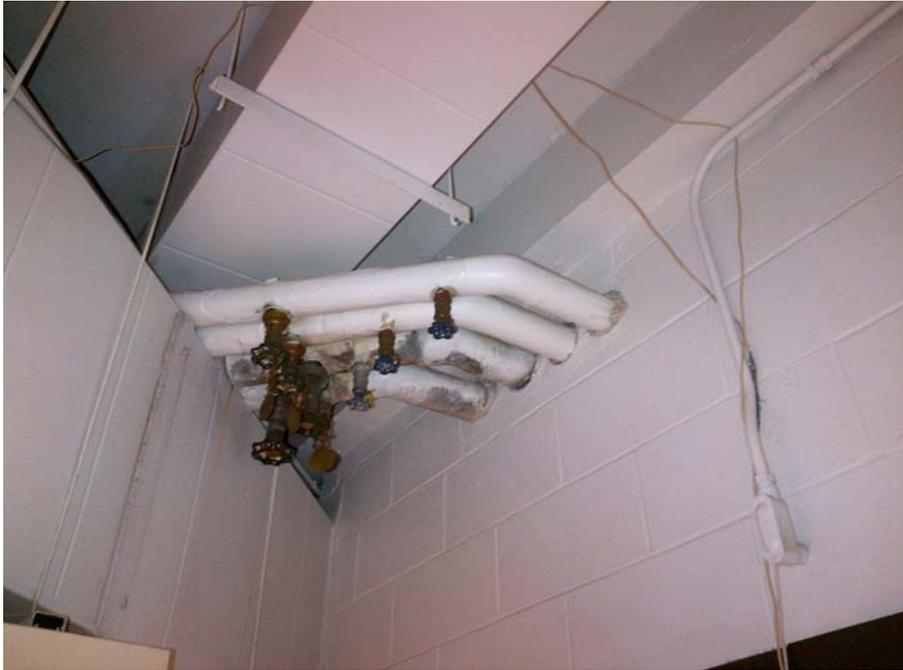
**Picture 11**

A number of other sources of mold colonization exist in areas within the building. The basement has a number of pipes that have water-damaged/mold colonized pipe insulation (Picture 11). Insulation in this condition will continue to degrade when exposed to moisture.

**Mold-colonized pipe insulation**

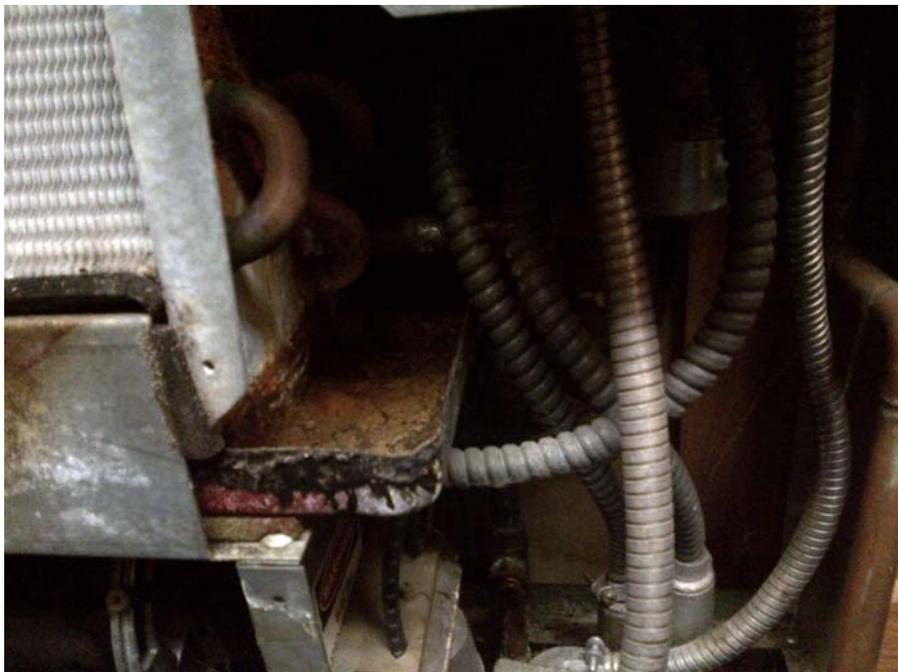
**Picture 12**

FCUs in offices provide both heating and air-conditioning and are equipped with drip pans to collect and drain condensation from cooling coils. The interior of the FCUs examined have not been appropriately cleaned or maintained for a significant period of time. The interior of each unit examined had a significant amount of scale from corroding coils (Picture 12).

**Scale in FCU drip pans, indicating lack of routine maintenance**

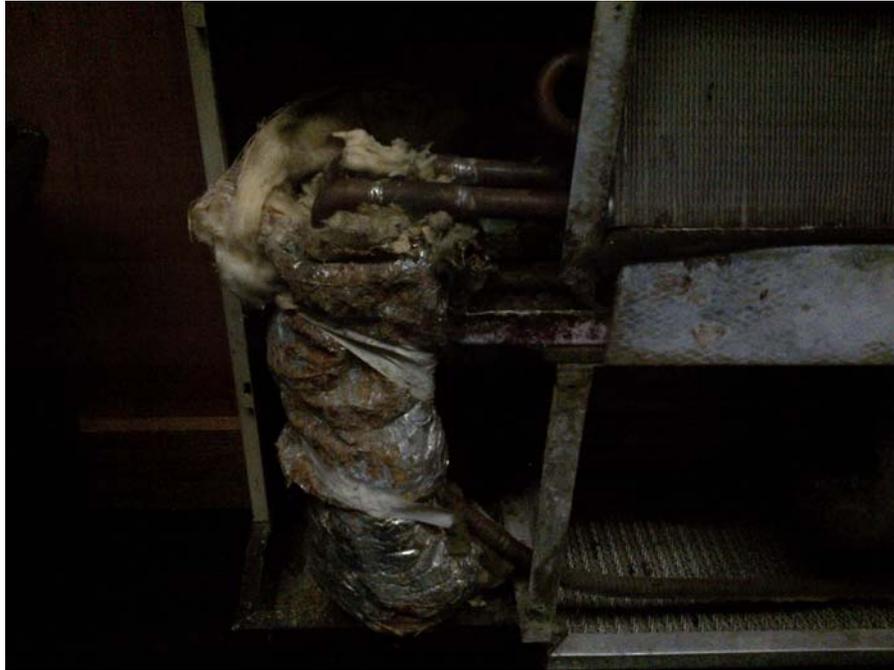
**Picture 13**

Insulation on FCU pipes had failed (Picture 13) likely resulting in wetting of the insulation, interior of the FCU cabinet and surrounding carpets due to accumulating condensation during the operation of the HVAC system in cooling mode during hot, humid weather. Water-damaged fiberglass insulation and GW, can also be a source of mold growth. Please note that the FCUs were installed when the building was constructed, approximately 40 years ago. The age of the equipment makes service and repairs of these units difficult. According to the American Society of Heating, Refrigeration and Air-Conditioning Engineers (ASHRAE), the service life for a unit heater using hot water or steam is 20 years, assuming routine maintenance of the equipment (ASHRAE, 1991). The operational lifespan of the equipment has been exceeded. The provision and control of heating and cooling air by the FCUs will become more difficult as the equipment ages and as replacement parts become increasingly difficult to obtain.

**Damaged fiberglass insulation inside FCU**

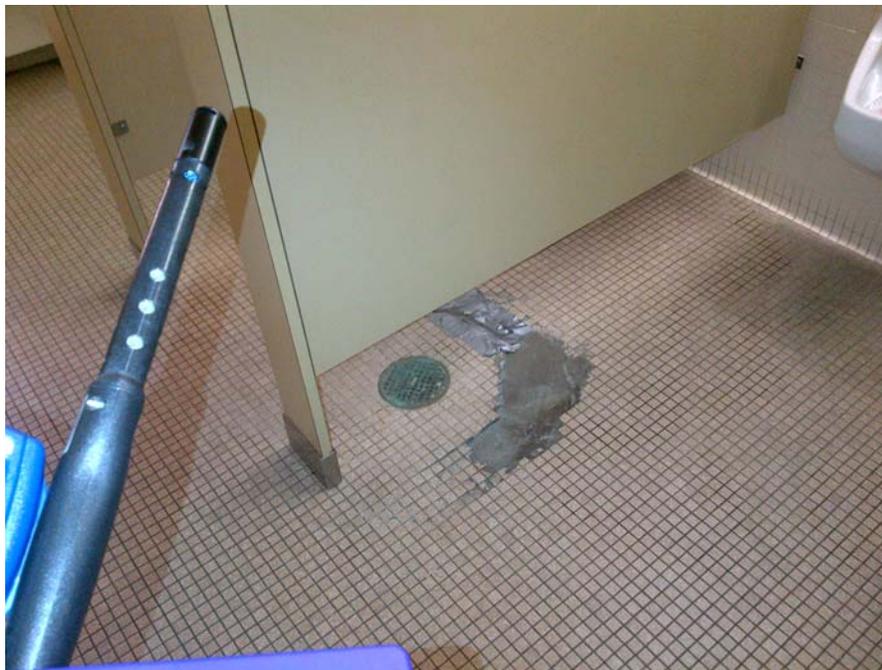
**Picture 14**

Other conditions that can affect indoor air quality were observed during the assessment. One restroom appeared to have a floor tile system that had failed near a toilet and was repaired using duct tape (Picture 14). Bathroom floors should be continuous consisting of a non-porous material. This condition would be considered unsanitary.

**Restroom floor repaired with duct tape**

7. Repair the floor of the restroom in Picture 14.
8. Have a building inspector/structural engineer examine the retaining wall above the HVAC chiller for structural integrity and repair as needed.

18. Clean fresh air diffusers, exhaust vents and personal fans on a regular basis.
19. Remove duct tape from the floor of the rest room in Picture 14 and repair with an appropriate, non-porous tile material.

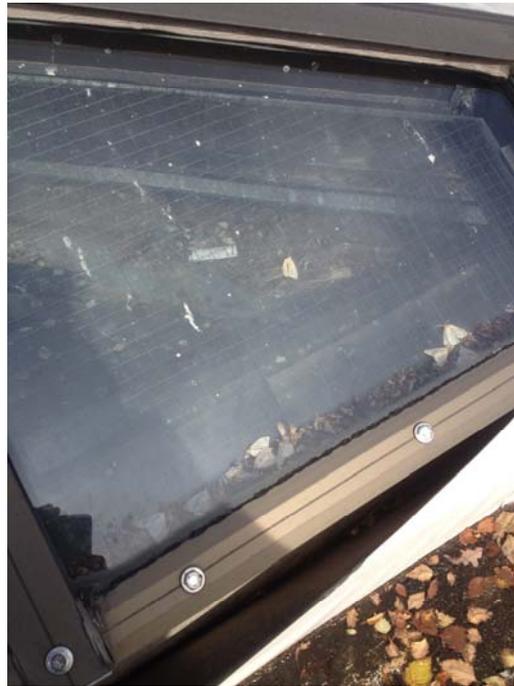
**Picture 15**

The building has a skylight in the section of its roof that shelters the front entrance. Due to its construction a ledge exist beneath the skylight glass. BEH staff noted dead birds, bird waste and other debris (Picture 15). Guidelines concerning the cleaning of bird waste are included in [Appendix B](#).

**Bird carcass and other debris in skylight**

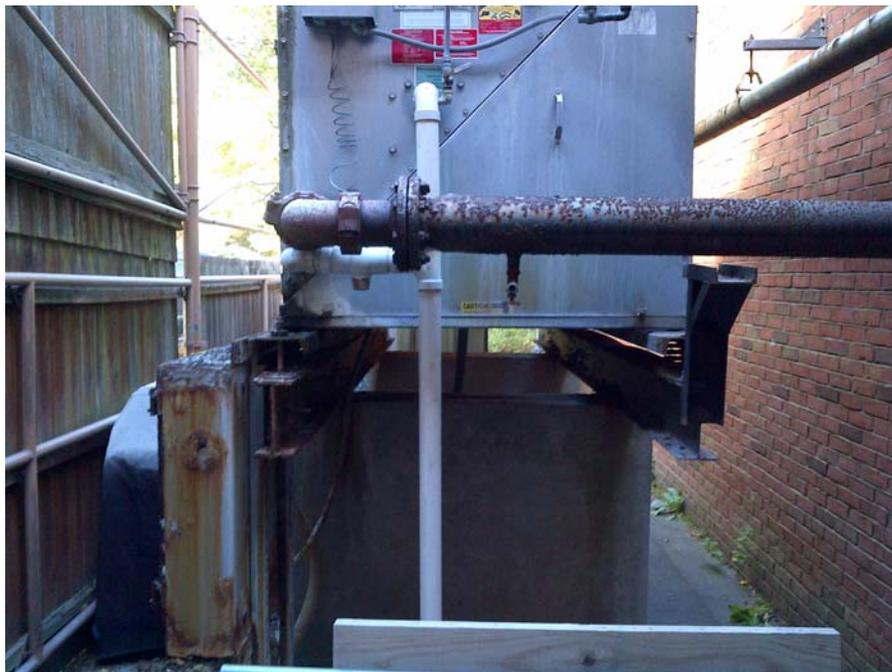
**Picture 16**

During this assessment, the HVAC system chiller was operating. The chiller had significant corrosion on its fixtures (Picture 16) and electrical control (Picture 17). In addition, a significant amount of water was seen spraying from the top of this unit (Picture 18). These conditions can indicate lack of preventive maintenance, which can rapidly reduce the service life and function of this equipment.

**Corroded chiller fixtures**

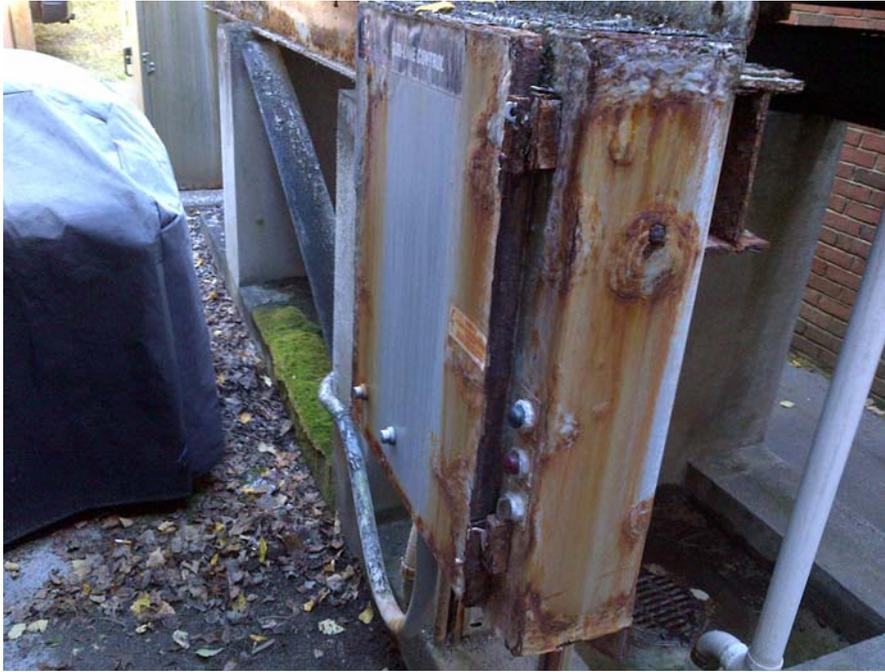
**Picture 17**

**Corroded chiller electrical control box**

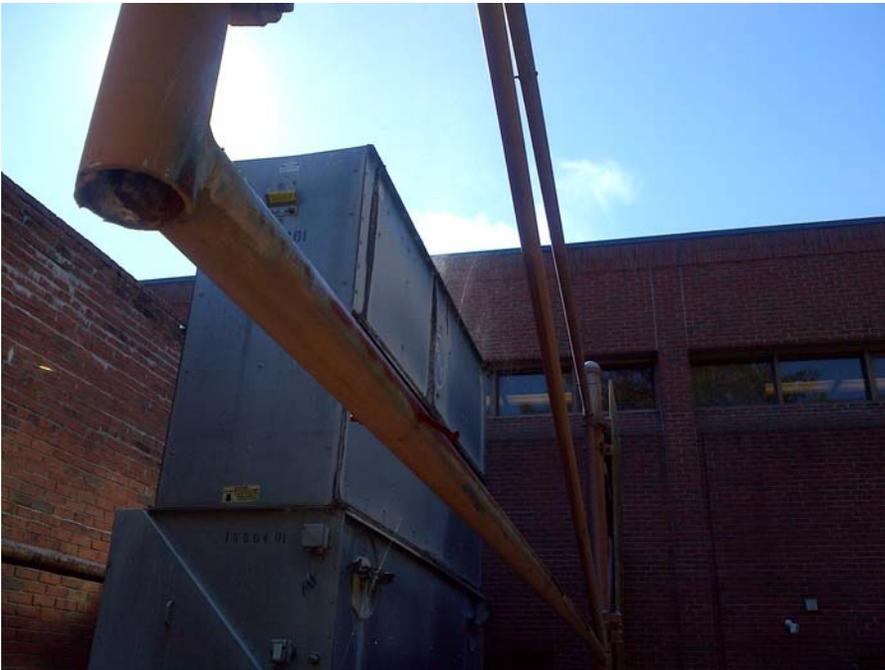
**Picture 18**

**Top of chiller unit**

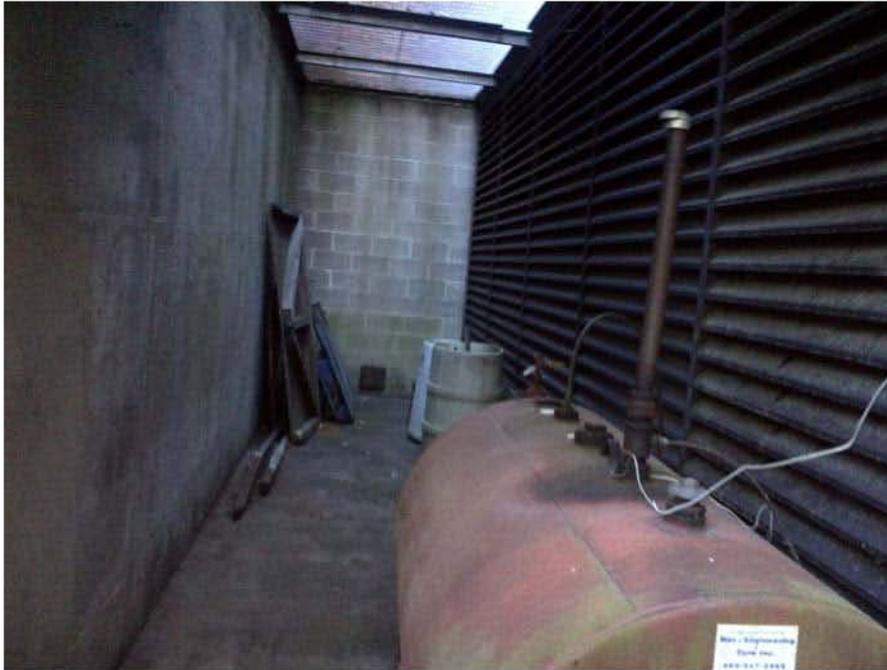
**Picture 19**

Of note is the location of an oil tank directly in front of a fresh air intake for the HVAC system (Picture 19). Court officials report oil odors in the building while this tank is filled. The odor is likely due to the oil pressure relief valve located in front of this fresh air intake.

**Oil tank in front of HVAC system fresh air intake**

9. Either move the tank in Picture 19, or extend the pressure relief valve over the building's roof edge.
10. Work with an HVAC engineering firm to examine all FCU and associated piping and ductwork to find/repair water damage, leaks and sources of condensation. Ensure insulation is intact and continuous over surfaces where needed.

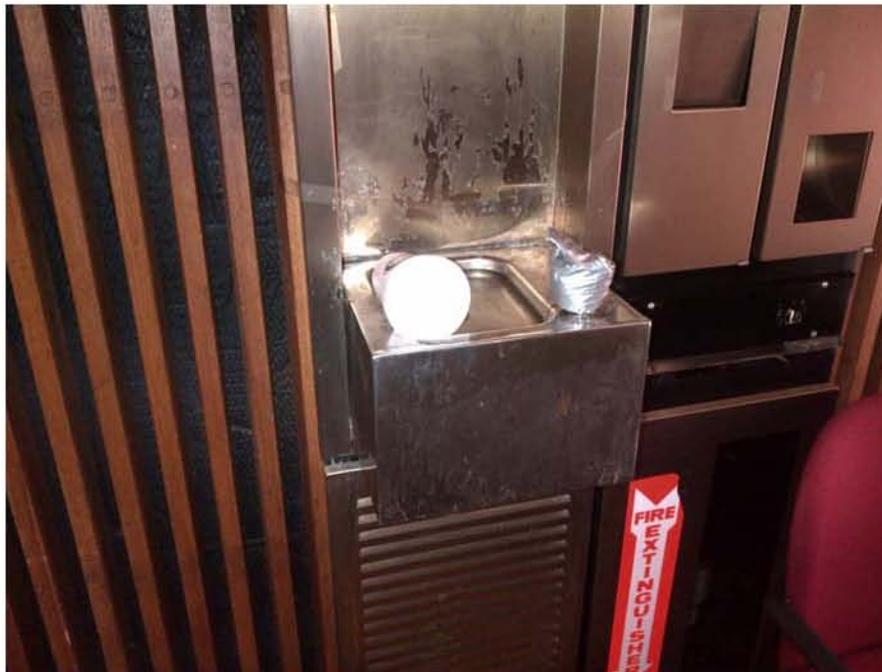
**Picture 20**

One area has an abandoned water bubbler (Picture 20). In addition, the AHU in the mechanical room has drip pan pipes that empty condensation directly over floor drains. The traps for these drains can dry out which can lead to sewer gas odors penetrating the room through unsealed traps. The purpose of a drain trap is to prevent sewer system gases and odors from entering the occupied space. When water is poured into a trap, an air tight seal is created by the water in the U-bend section of the pipe. These drains must have water poured into the traps at least twice a week to maintain the integrity of the seal. Without water, the drain opens the room to the sewer system. Sewer gas odors can be irritating to the eyes, nose, and throat. Of note is the drain pan pipe in Picture 21, which is drawing air at a sufficient rate to hold a dollar bill against its opening. This condition can allow for septic system odors to be drawn into the HVAC system when this trap is dry during the heating season.

**Abandoned water bubbler**

13. Pour water into the mechanical room drains twice a week to maintain the seal of its trap.
14. Seal the drain on abandoned water bubblers.
15. Ensure AHU filters are changed as per the manufacturers' instructions or more frequently if needed. Consider upgrading to pleated MERV 9 (or higher) dust-spot efficiency filters. Prior to any increase of filtration, HVAC system components should be evaluated by a ventilation engineer as to whether they can maintain function with more efficient filters.

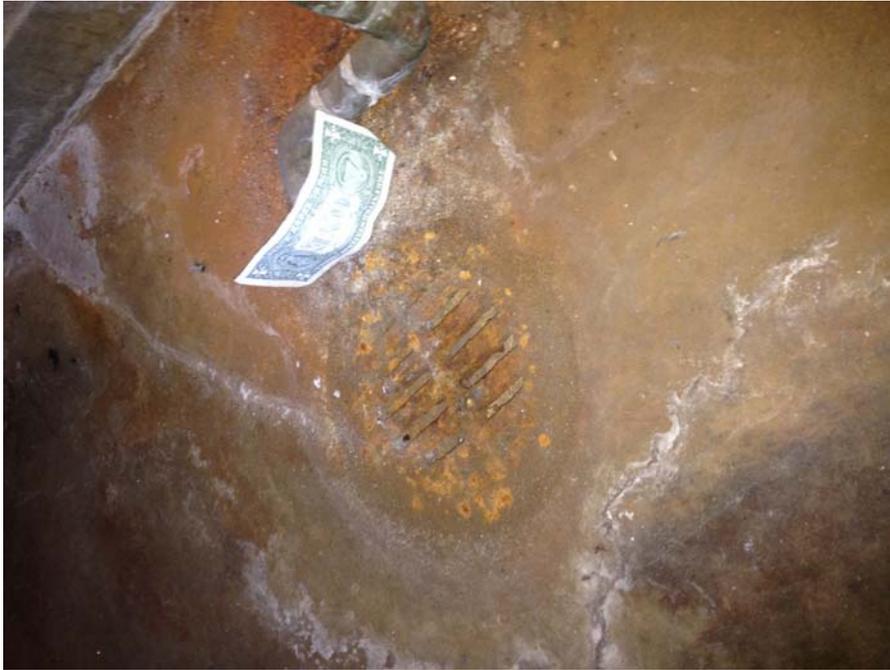
**Picture 21**

**AHU condensation drain is depressurized**

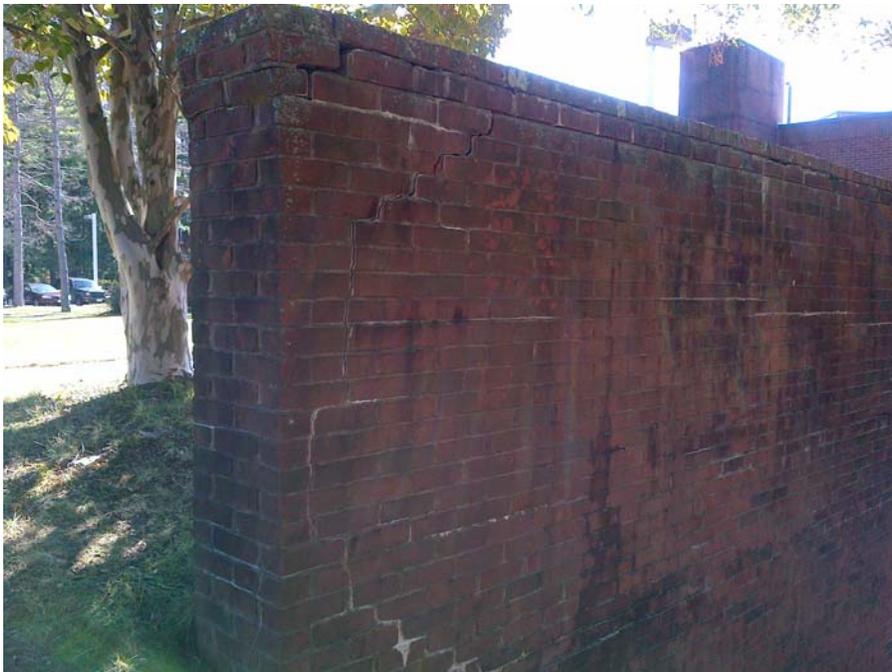
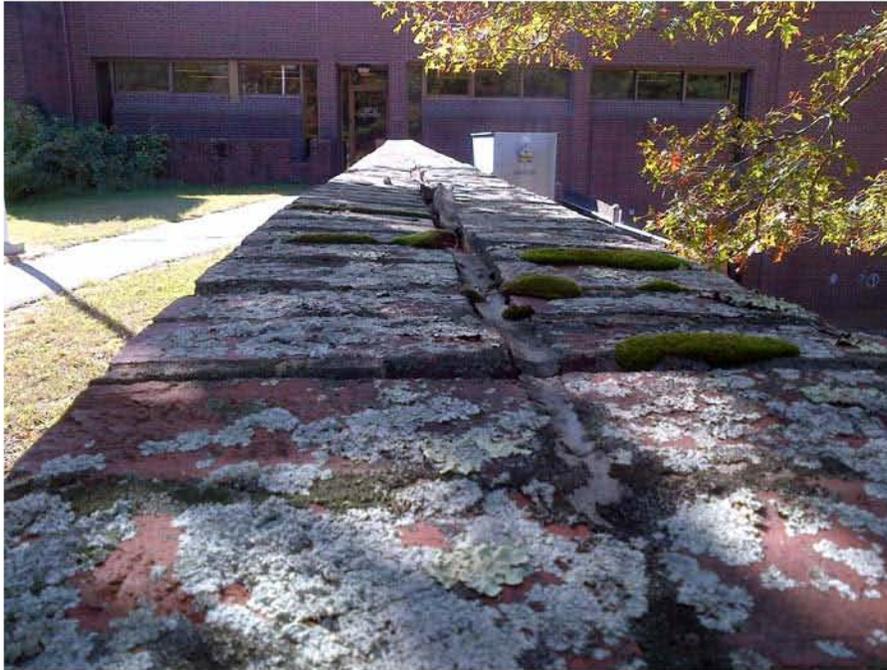
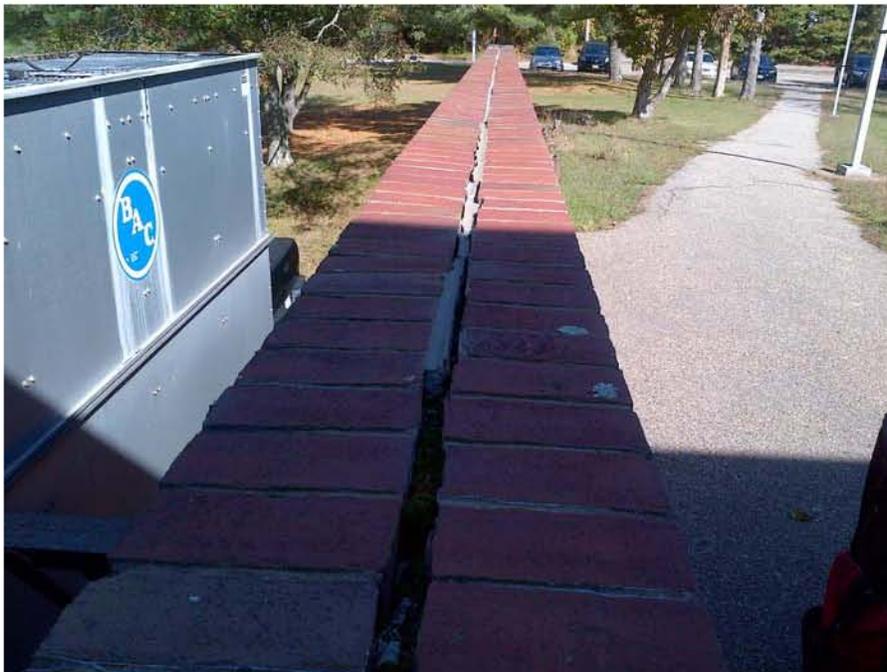
A retaining wall above the HVAC chiller appears to be splaying from water damage (Pictures 22 through 24). In addition, a section of the asphalt walkway that serves as the accessibility ramp for the building has subsided (Picture 25), indicating significant water pooling in this area around this wall. It is possible that the exposure to rainwater has undermined the structural integrity of this wall.

**Retaining wall above chiller**

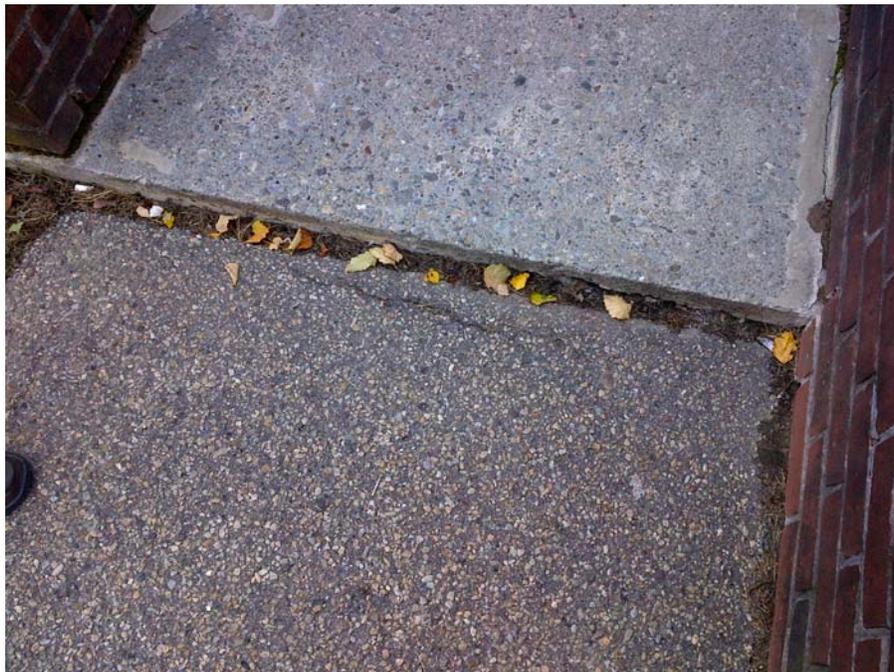
**Picture 25**

**Subsisting asphalt of access ramp for building**
