# **INDOOR AIR QUALITY ASSESSMENT**

**Spring Street School  
2 Spring Street  
West Bridgewater, Massachusetts**

Prepared by:  
Massachusetts Department of Public Health  
Bureau of Environmental Health  
Indoor Air Quality Program  
November 2015

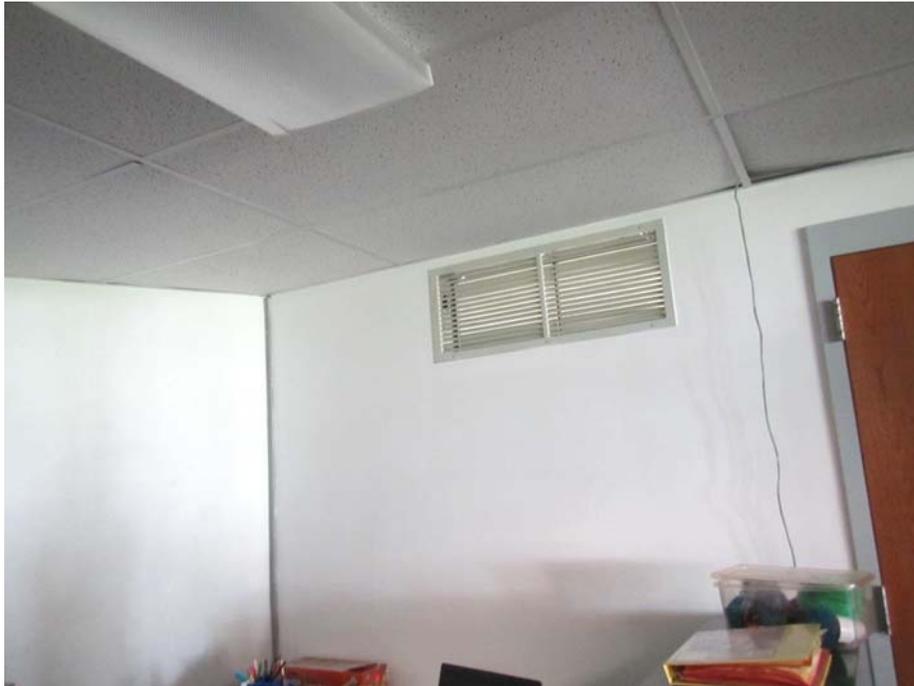
**Picture 1**

It can be seen from Table 1 that carbon dioxide levels were above 800 parts per million (ppm) in 8 out of 18 areas surveyed, indicating a lack of ventilation in about half the areas tested, mostly in classrooms. The majority of classrooms do not have mechanical ventilation to provide fresh air, and instead rely on openable windows and passive vents located in walls (Picture 1). Cross ventilation can be created when windows on opposing sides of the building are open, allowing movement of air through the passive vents.

**Passive vent in wall of classroom**

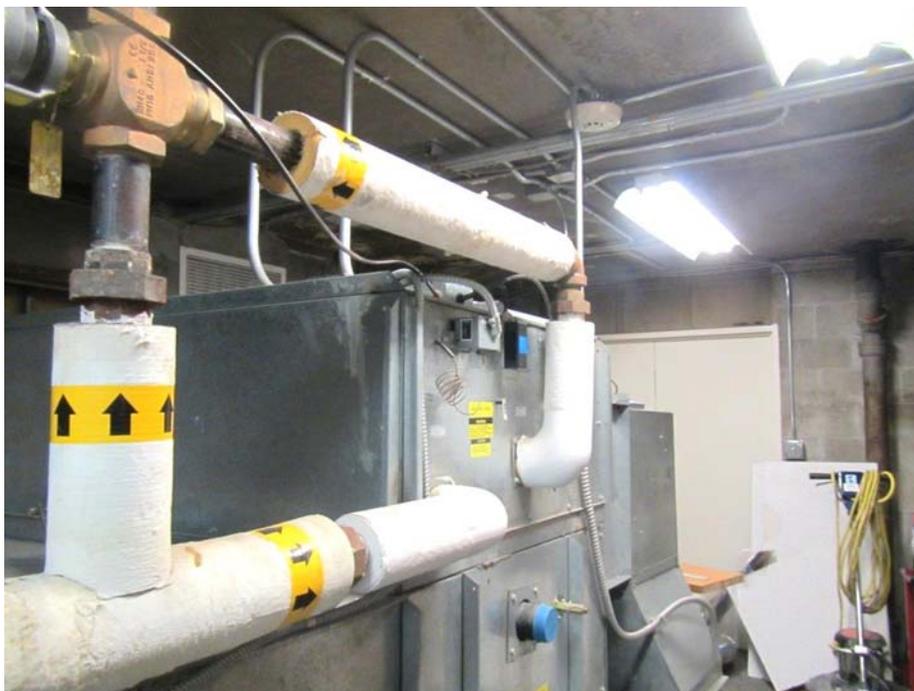
**Picture 2**

One of the classroom areas was retrofitted with an air-handling unit (AHU; Picture 2). Air is provided by a supply vent and returned to the AHU via a return vent. This system should be operated continuously during school hours to ensure provision of fresh air and prevent backdrafting. It was reported that due to allergy concerns in the area served by this AHU, it was recently fitted with a MERV (Minimum Efficiency Rating Value) 11 filter (Picture 3). The dust

**Air-handling unit**

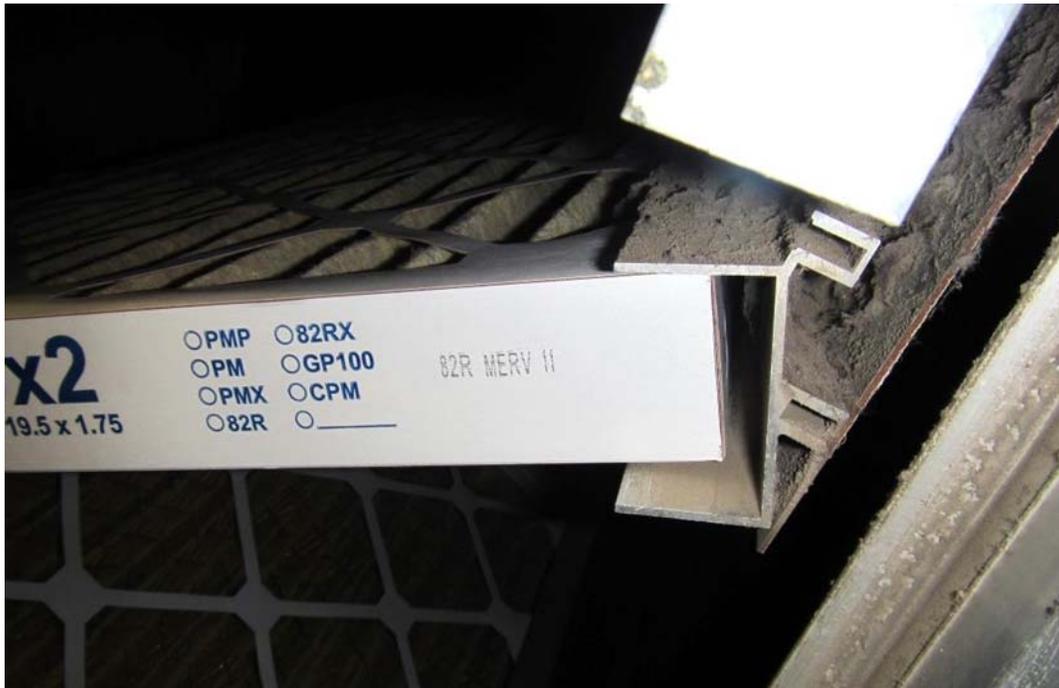
**Picture 3**

spot efficiency is the ability of a filter to remove particulate matter of a certain diameter from air passing through the filter. Filters that have been determined by the American Society of Heating, Air-conditioning Engineers (ASHRAE) to meet its standard for a dust spot efficiency of a minimum of 40 percent are considered sufficient to reduce many airborne particulates (Thornburg, 2000; MEHRC, 1997; ASHRAE, 1992); this would conform to a MERV 9 filter which is the minimum typically recommended in schools and commercial buildings. A MERV 11 filter would remove more and smaller particles, including dust. Note however, that the housing has accumulations of dust and debris which may become entrained in the air supply by short-circuiting the filter. Filter housings should be cleaned and filters changed at least twice a year.

**MERV 11 filter, but note dust and debris in filter housing**

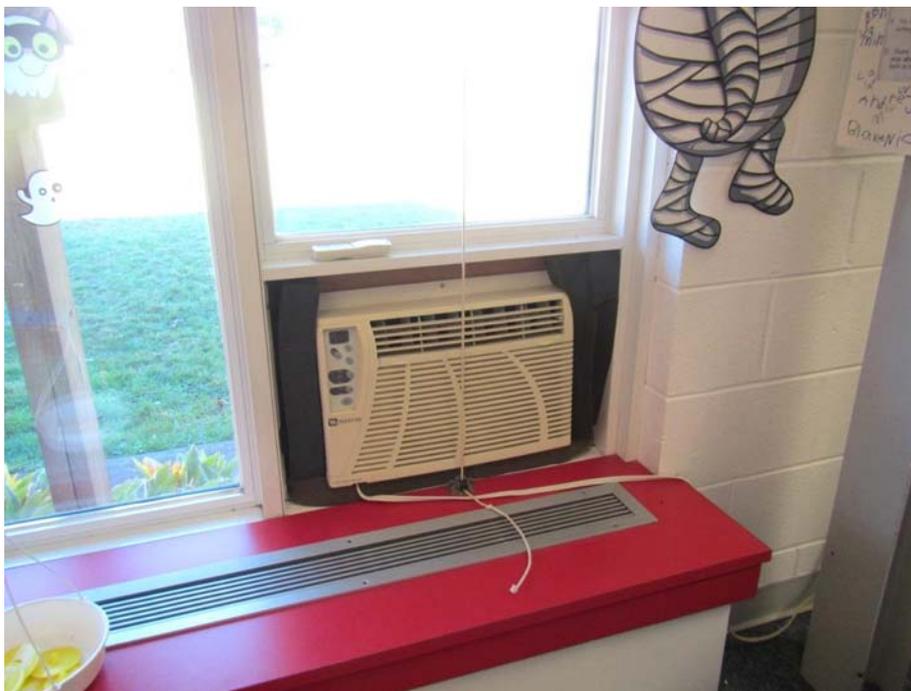
**Picture 4**

Window-mounted air conditioners were observed in a few areas (Picture 4). When operating in the “fan only” mode, these units can provide a limited amount of fresh air and increase airflow. Filters should be cleaned as per manufacturer’s recommendations or more frequently if needed.

**Window air conditioning unit**

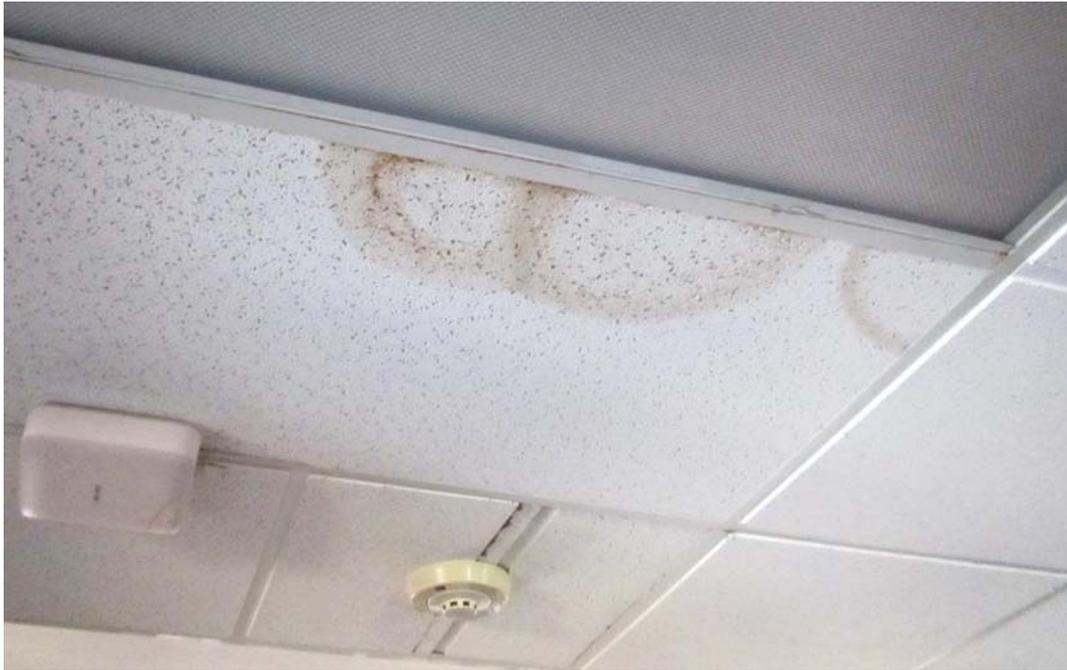
**Picture 5**

Water-damaged ceiling tiles were observed in some areas (Picture 5; Table 1). These likely originate from intermittent roof leaks. The roof is scheduled for replacement over the summer of 2016. An area of wet carpeting and staining was observed adjacent to a door to the

**Water-damaged ceiling tile**

2. Replace water-damaged ceiling tiles promptly. A thorough systematic replacement of ceiling tiles, including an examination of the area above the ceiling tile systems, should be conducted once the planned roof repairs have been completed.

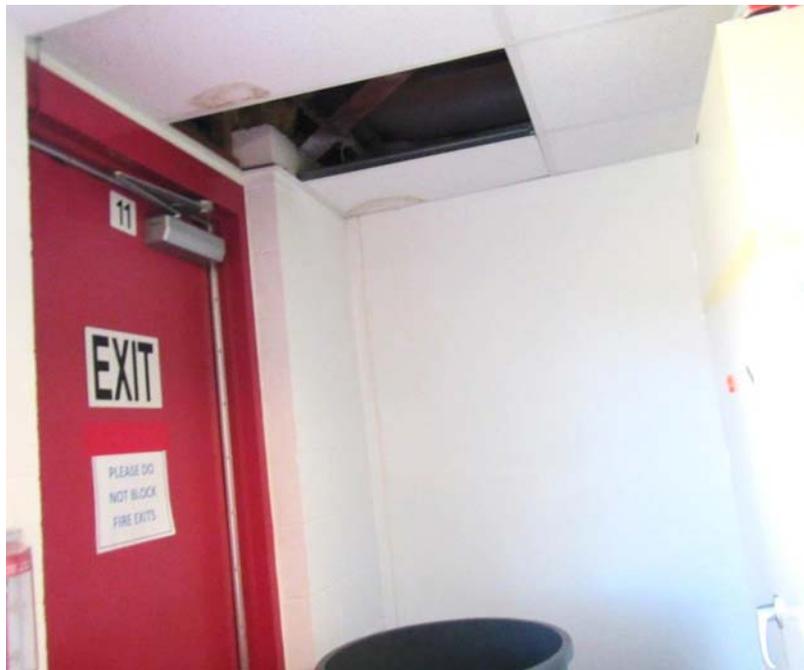
**Picture 6**

outside of one of the classrooms (Picture 6). This was reportedly the result of roof drainage issues during heavy rains the day before the visit. The US Environmental Protection Agency (US EPA) and the American Conference of Governmental Industrial Hygienists (ACGIH) recommend that porous materials (e.g., carpeting, gypsum wallboard) be dried with fans and heating within 24 to 48 hours of becoming wet (US EPA, 2001; ACGIH, 1989). If not dried within this time frame, mold growth may occur. Once mold has colonized porous materials, they are difficult to clean and should be removed.

**Missing ceiling tile and stained tile where water infiltration had occurred; carpet next to this door was also wet at the time of the visit**

3. Ensure that the carpeting in the area of the leak shown in Picture 6 has been thoroughly dried. If it has been colonized by mold, replace it.
4. Continue to use the dehumidification unit in the breezeway to control humidity and condensation. Maintain dehumidifiers by emptying collected water and cleaning them regularly.

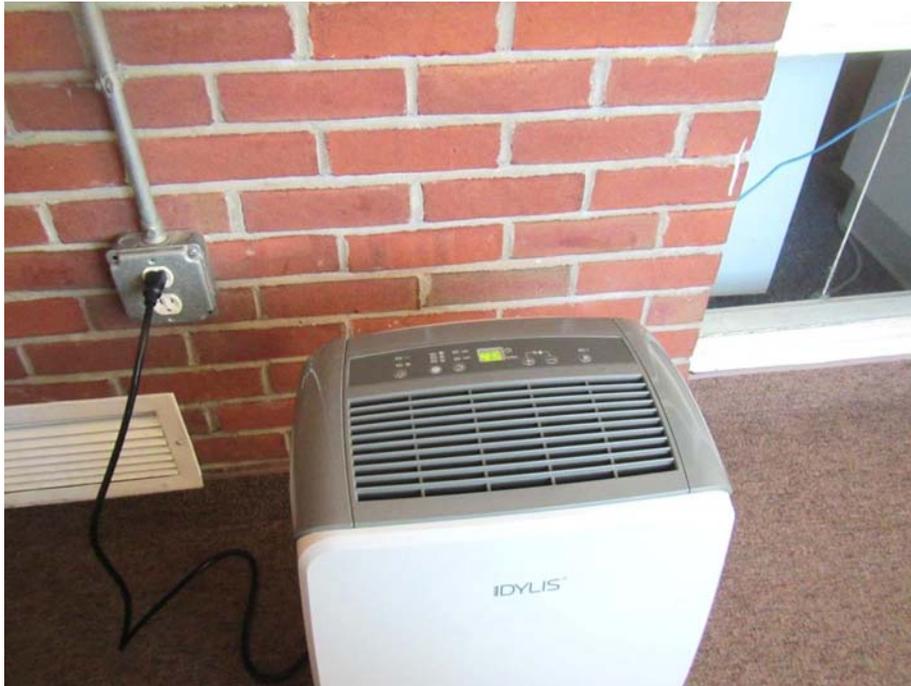
**Picture 7**

In the hallway/enclosed breezeway from the main office area to the classroom area, a faint musty odor was noted. The breezeway floor is directly on slab, which will be colder than the air inside during warmer weather, and may be prone to condensation. This area is currently carpeted, reportedly because of slippery conditions created due to condensation that had occurred on the floor when it was tiled. There are also signs of water penetration due to wind-driven rain, in the form of damaged paint at the top of the walls. Although a dehumidification unit has recently been added to this area (Picture 7) to help reduce humidity and the potential for condensation, it is likely that the carpeting has been repeatedly moistened and mold-colonized, and will need to be replaced. In general, carpeting should not be used in areas subject to chronic moistening.

**Dehumidifier in enclosed breezeway**

5. Consider replacing the carpeting in the breezeway with a non-porous, non-slip surface.
6. Trim plants away from the exterior of the building to a distance of approximately five feet.

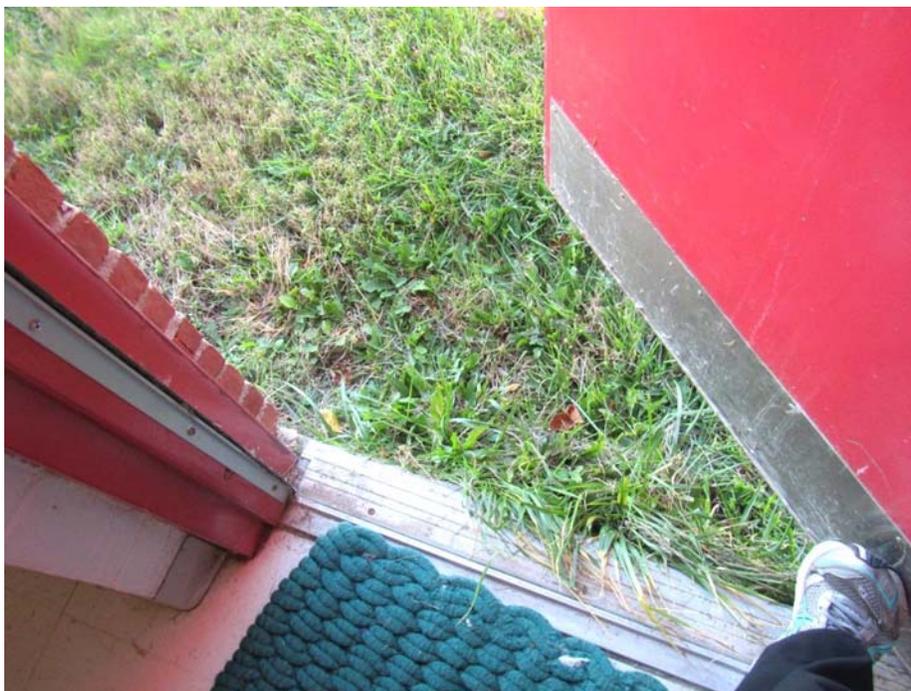
**Picture 8**

The exterior of the building was examined for potential water penetration and drainage issues. Plants were seen to be growing very close to the exterior, including long grass outside a fire door which may prevent it from closing properly (Picture 8), and vines up against the foundation and near windows (Picture 9). Plants hold water against the building, and the growth of roots may cause and widen cracks in foundation, brick and other parts of the building envelope, allowing for penetration of water and pests. In addition, plants can be a source of pollen or mold that may enter through windows or air intakes. Plants should be trimmed away from the building about five feet.

**Long grass outside fire door from classroom**

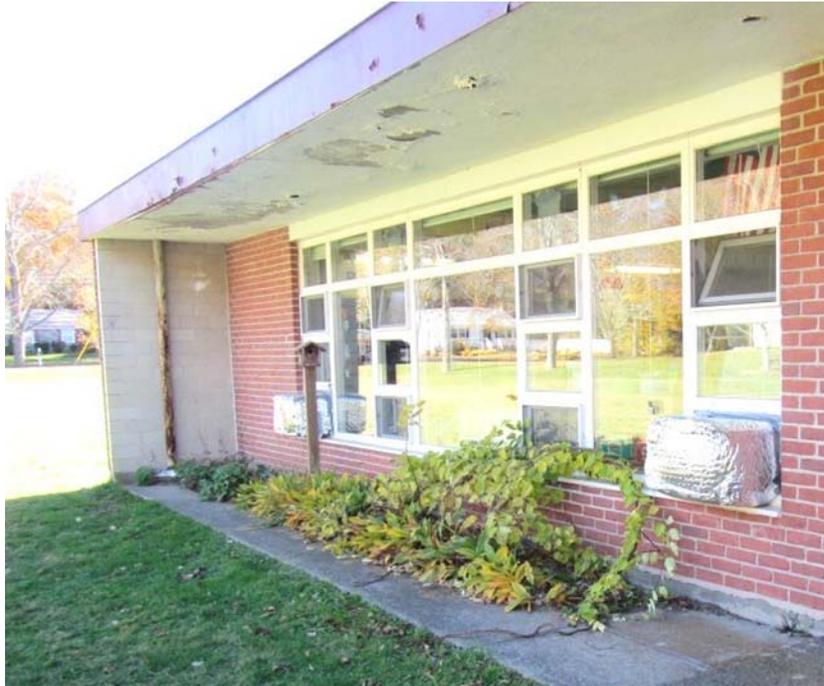
**Picture 9**

**Plants next to foundation and windows**

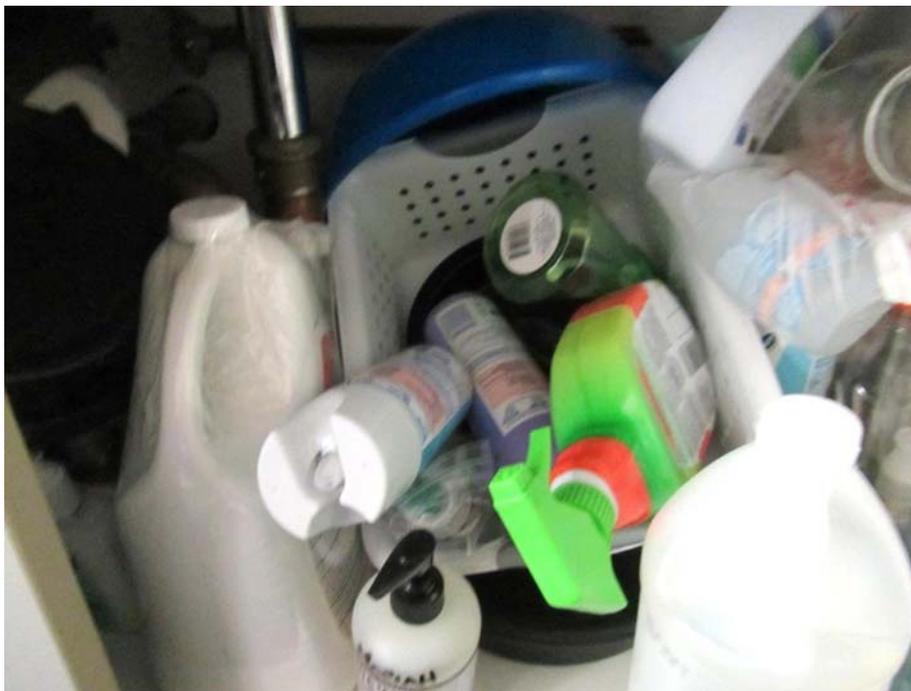
**Picture 10**

Exposure to low levels of total VOCs (TVOCs) may produce eye, nose, throat and/or respiratory irritation in some sensitive individuals. In order to determine if VOCs were present, BEH/IAQ staff examined rooms for products containing VOCs. BEH/IAQ staff noted air fresheners, hand sanitizer, cleaners (Picture 10) and dry erase materials in use within the space (Table 1). All of these have the potential to be irritants to the eyes, nose, throat and respiratory system of sensitive individuals.

**Cleaners found under a sink**

9. Repair backsplashes on sinks to prevent water penetration.
10. Reduce the use of items containing VOCs including scented cleaners, air fresheners, dry erase materials and hand sanitizer. Only school-issued products should be used and products should not be brought in from outside.

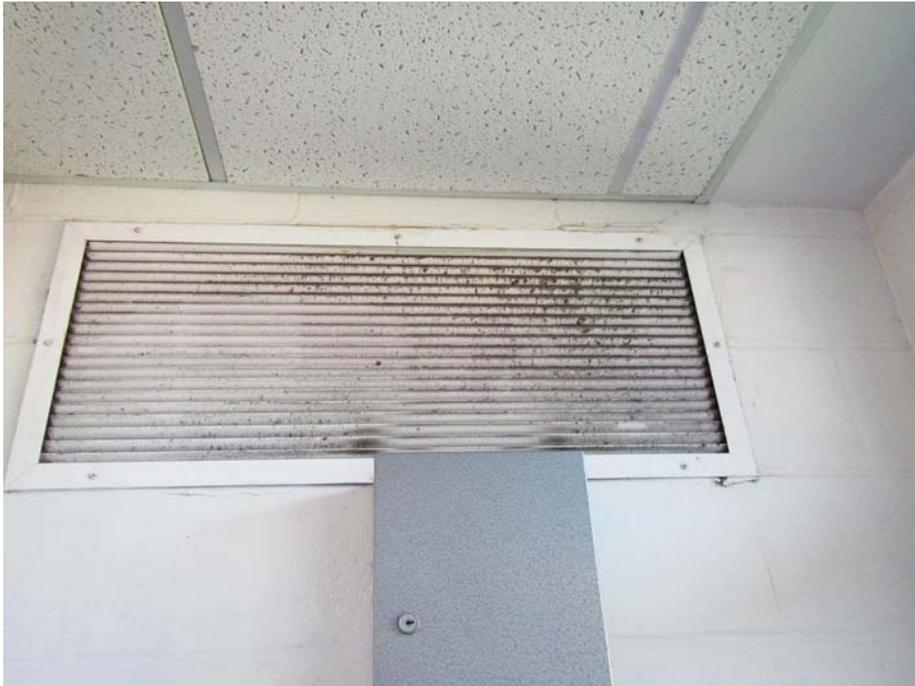
**Picture 11**

Other conditions that can affect IAQ were observed during the assessment. Some personal fans and vents were observed to be dusty (Picture 11). Dust on these items can be re-aerosolized and cause irritation or odors.

**Dusty vent**

11. Clean surfaces, carpets and vents on a preventative maintenance schedule.
12. Store items in an organized manner and move them to clean periodically to prevent a buildup of dust.

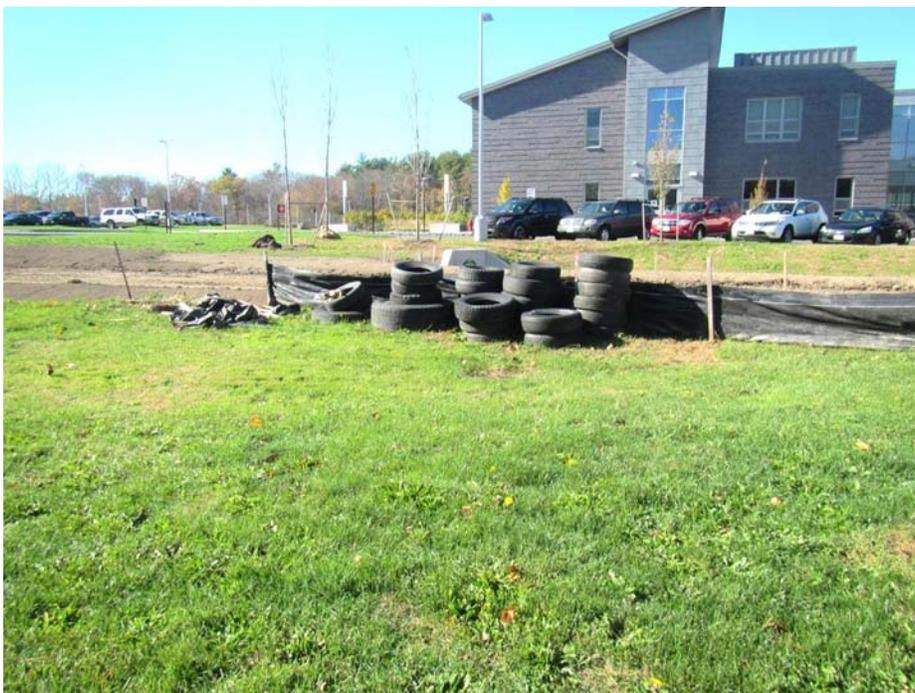
**Picture 12**

Ongoing construction was observed on adjacent land to the SS, which may produce particulates, odors and noise. Heavy construction should be limited to non-occupied hours whenever possible. Good construction practices should be followed at all times, including: covering piles of sand, dirt and other loose materials to prevent them becoming airborne, keeping soil damp to prevent dust generation, and keeping powered equipment in good repair. Doors and windows on the side of the school next to the construction area should be kept closed when active construction is occurring. A pile of tires was observed in this area (Picture 12). Used tires can be a source of rubber odors and may also collect water, which can become stagnant and cause odors as well as becoming a breeding ground for mosquitoes. This tire pile should be covered with a tarp.

**Pile of tires**

14. Remove the pile of tires shown in Picture 12 unless it is needed, in which case cover it with a tarp to prevent the creation of stagnant water and mosquito breeding.
