ODOR REASSESSMENT

**Community Enterprises
287 High Street
Holyoke, Massachusetts**

Prepared by:
Massachusetts Department of Public Health
Bureau of Environmental Health
Indoor Air Quality Program
January 2016

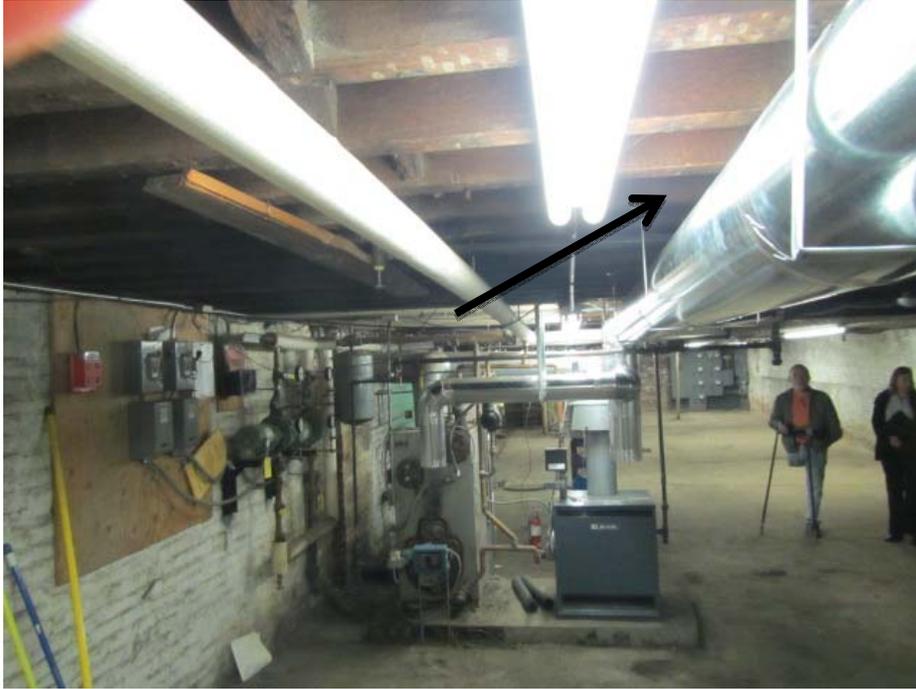
Picture 1

New combustion air vent

- *Recommendation:* Install a combustion air vent for the furnace and water heater to provide outdoor air to these devices.
- *Action:* A combustion air vent was installed in the basement (Pictures 1 and 2).
- *Recommendation:* Seal the basement passive door vent with an appropriate material, or replace the door with a solid one.
- *Action:* The passive door vent was sealed (Picture 3).
- *Recommendation:* Seal any openings in the shared wall on the CE side with an appropriate fire-rated sealant.
- *Action:* Openings were sealed using spray-foam insulation (Picture 4).
- *Recommendation:* Remove water-damaged/rotted floor materials in the basement.
- *Action:* The entire wooden floor in the basement was removed (Picture 5).

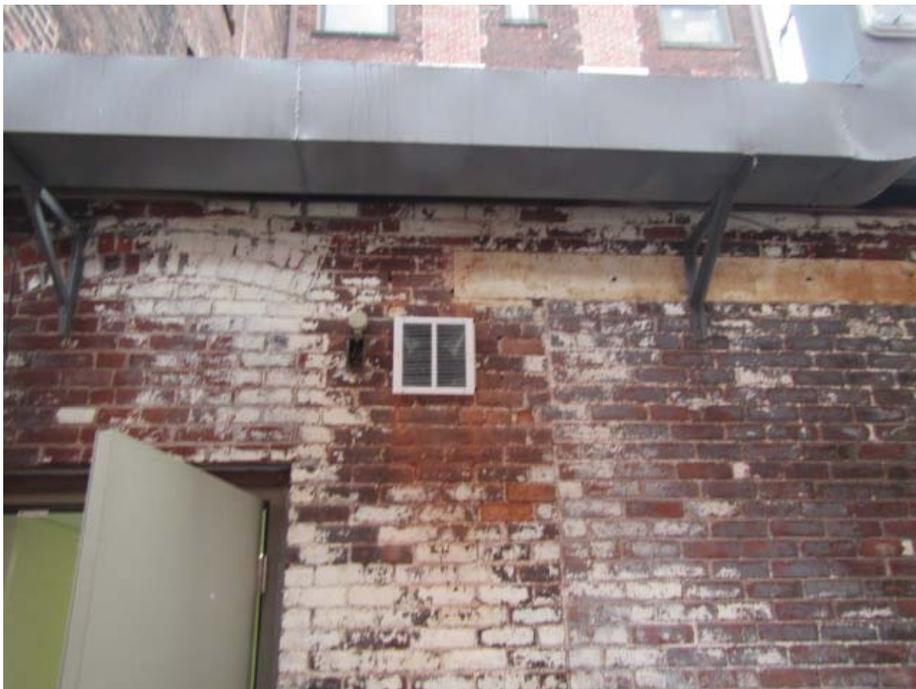
Picture 2

Opening for new air vent

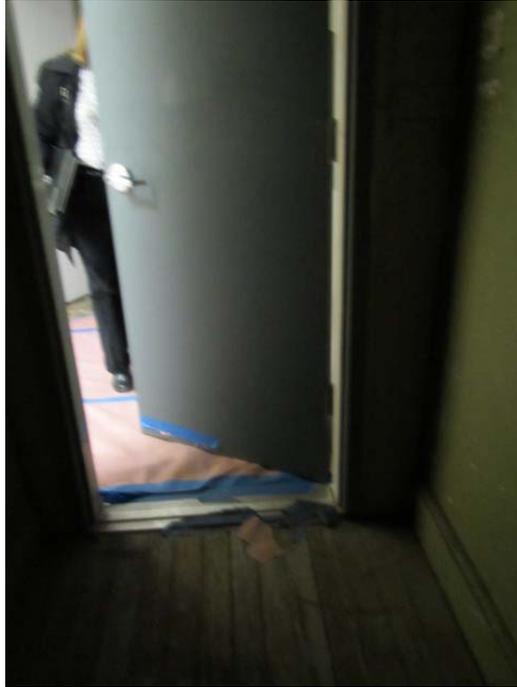
Picture 3

New basement door without passive air vent

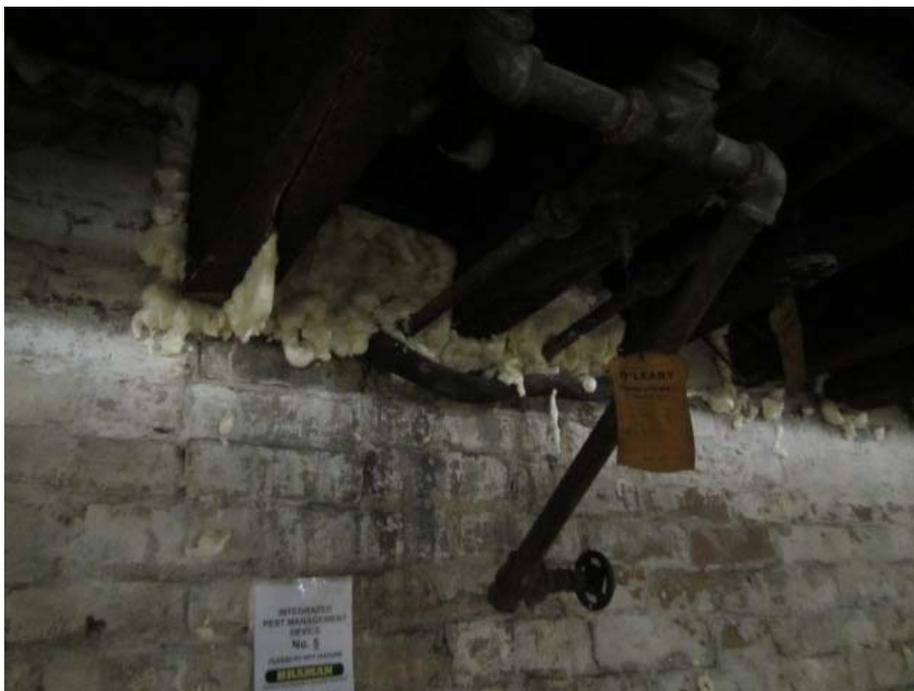
Picture 4

Example of wall opening sealed with spray foam insulation

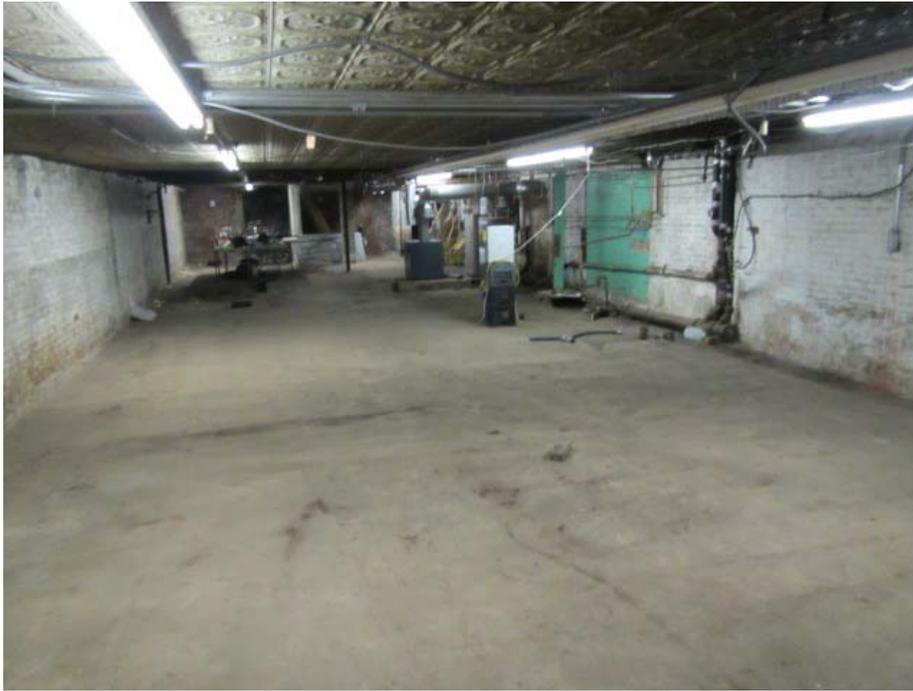
Picture 5

False wood floor and walls completely removed from the basement
