INDOOR AIR QUALITY ASSESSMENT

**Plymouth Town Hall
11 Lincoln Street
Plymouth, Massachusetts**

Prepared by:
Massachusetts Department of Public Health
Bureau of Environmental Health
Indoor Air Quality Program
January 2016

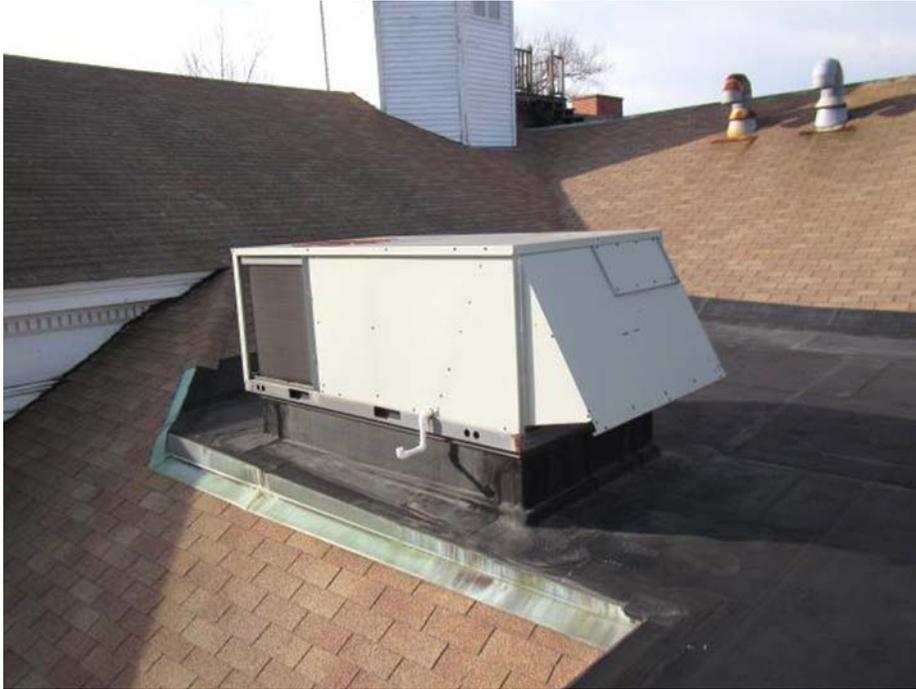
Picture 1

Rooftop air handling unit

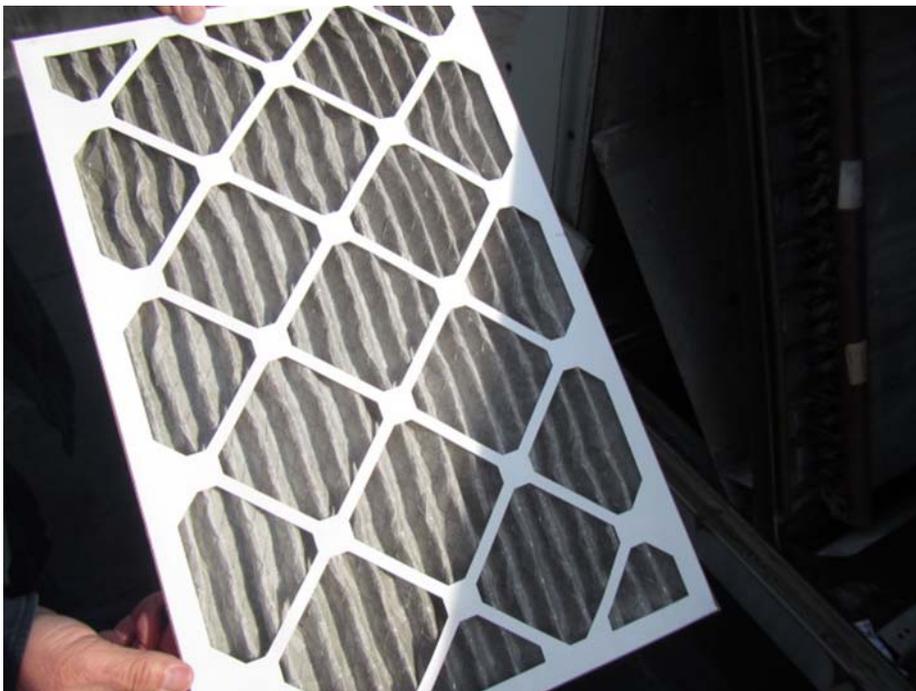
Picture 2

Pleated filter in air handling unit

11. Change AHU filters a minimum of twice per year (e.g. between heating/cooling seasons) or as per the manufacturer’s instructions.

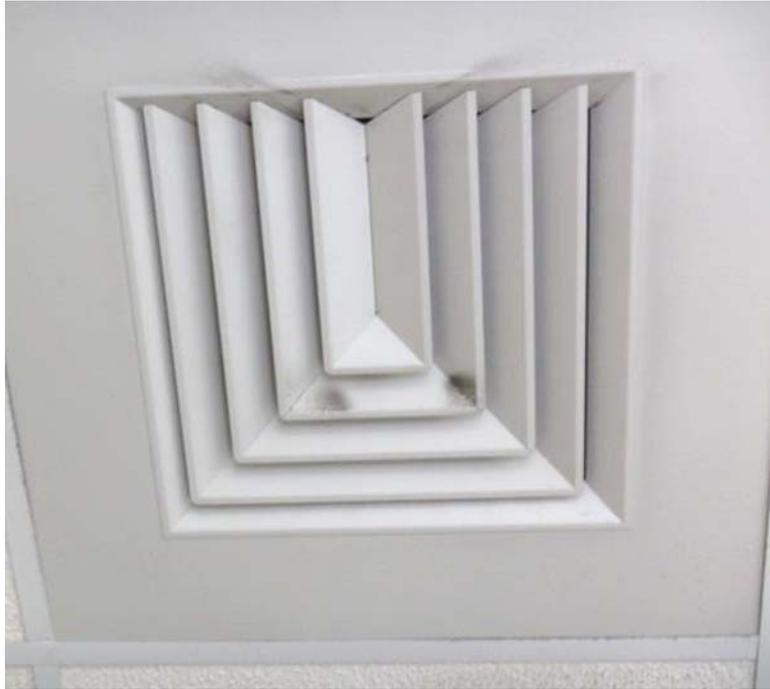
Picture 3

Several supply, exhaust and return vents were observed to have accumulated dust/debris (Pictures 3 and 4). If exhaust vents are not functioning, backdrafting can occur, which can re-aerosolize accumulated dust particles. Supply vents can aerosolize accumulated dust once activated.

Supply diffuser, note accumulated dust/debris on louvers

9. Empty, clean and maintain dehumidifiers as per the manufacturer’s instructions.
10. Clean supply, exhaust and return vents periodically of accumulated dust.

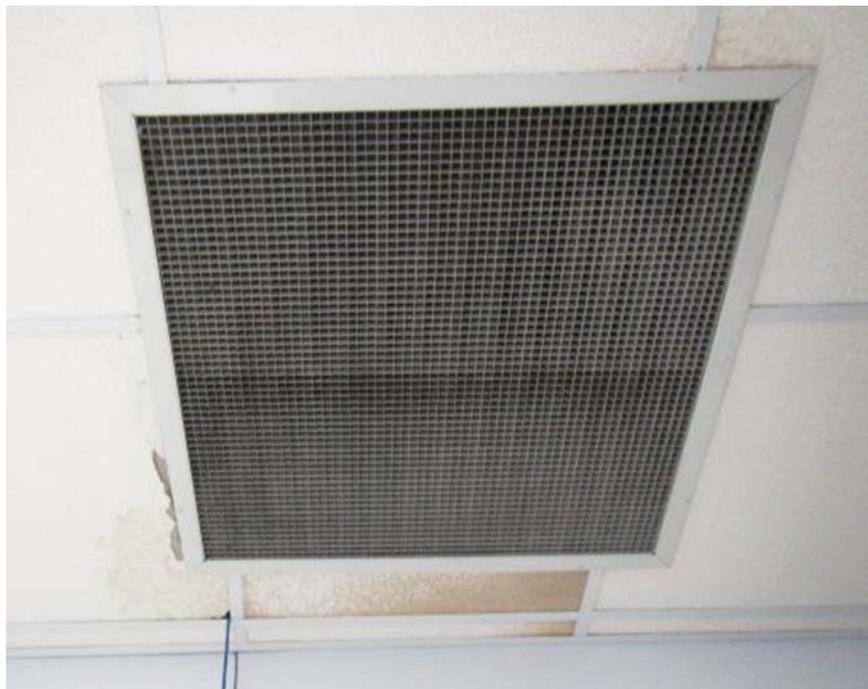
Picture 4

Water-damaged ceiling tiles were observed in some areas (Pictures 4 and 6; Table 1), which can indicate a current/historic leak. A dehumidifier was observed in the basement that had

Return vent, note water-damaged ceiling tiles

6. Ensure leaks are repaired and replace water-damaged ceiling tiles.
7. Consider placing water dispensers on non-carpeted areas or place a waterproof mat underneath them.

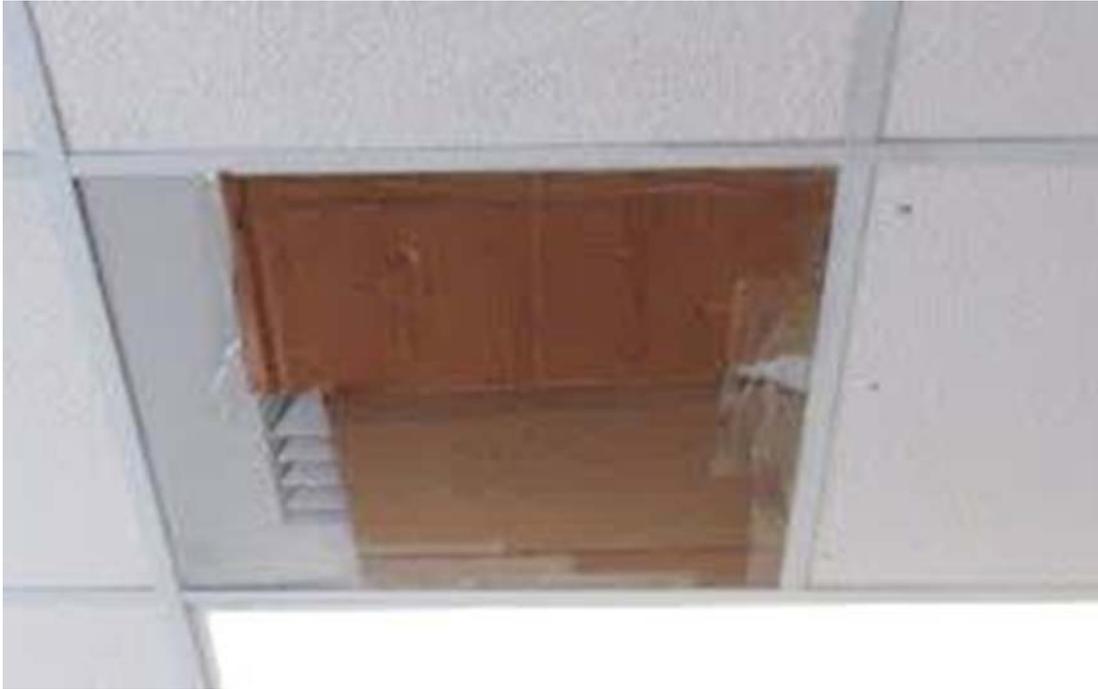
Picture 5

Supply vent sealed with cardboard

1. Consider setting fan settings for the mechanical ventilation system to “*on*” for continuous airflow/filtration.
2. To avoid comfort complaints, consider working with staff (who have complaints/sealed their vents) to relocate air diffusers.

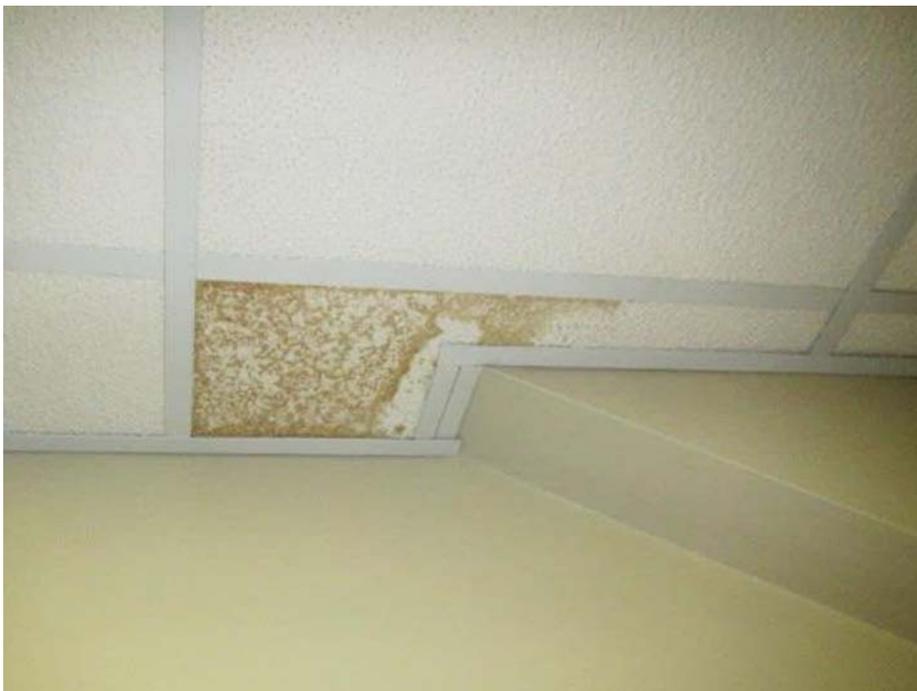
Picture 6

Water-damaged ceiling tiles

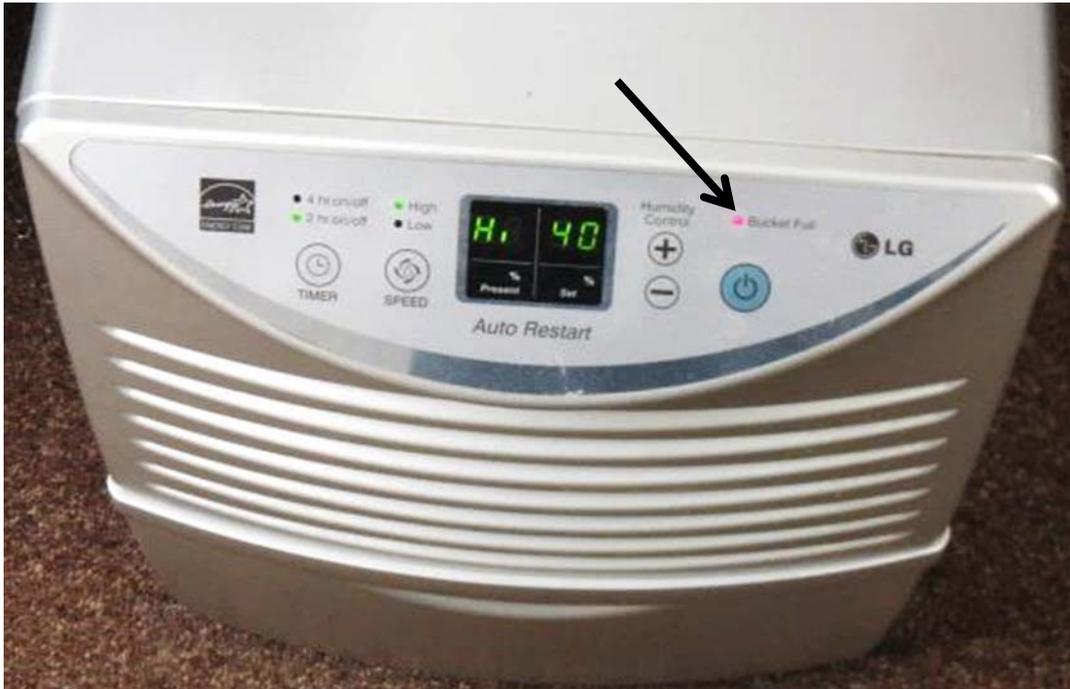
Picture 7

a lit indicator light that read “bucket full” (Picture 7). These reservoirs are designed to collect condensation during operation and should be emptied/cleaned regularly to prevent microbial and/or bacterial growth. A number of areas also had water coolers installed over carpeting (Picture 8). Water spillage or overflow of cooler catch basins can result in the wetting of the carpet, which can lead to mold growth, especially if wetted repeatedly.

Dehumidifier in basement with lit indicator light "Bucket Full" (arrow)

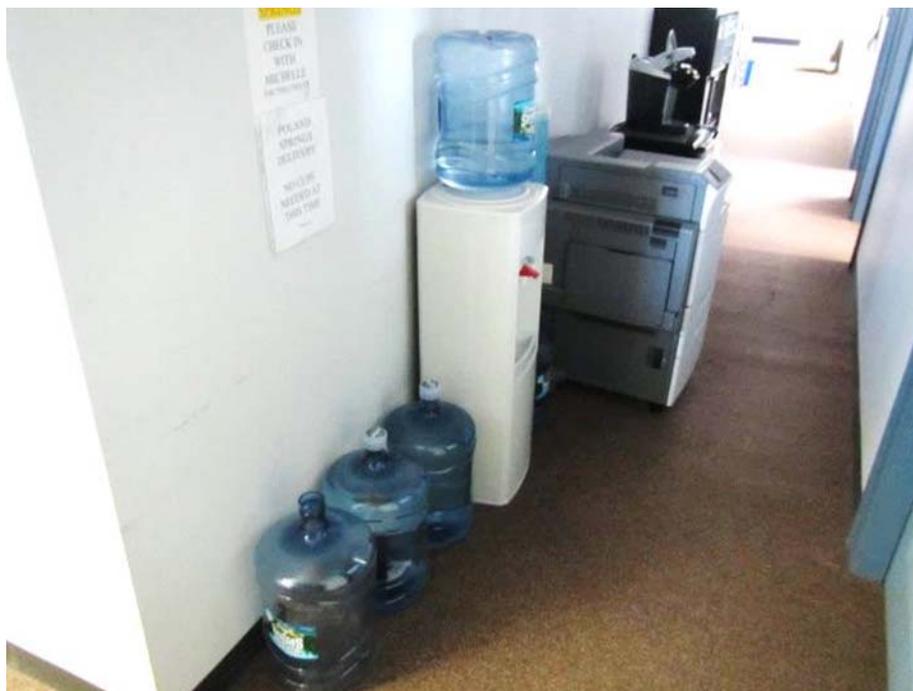
Picture 8

Water cooler on carpeting

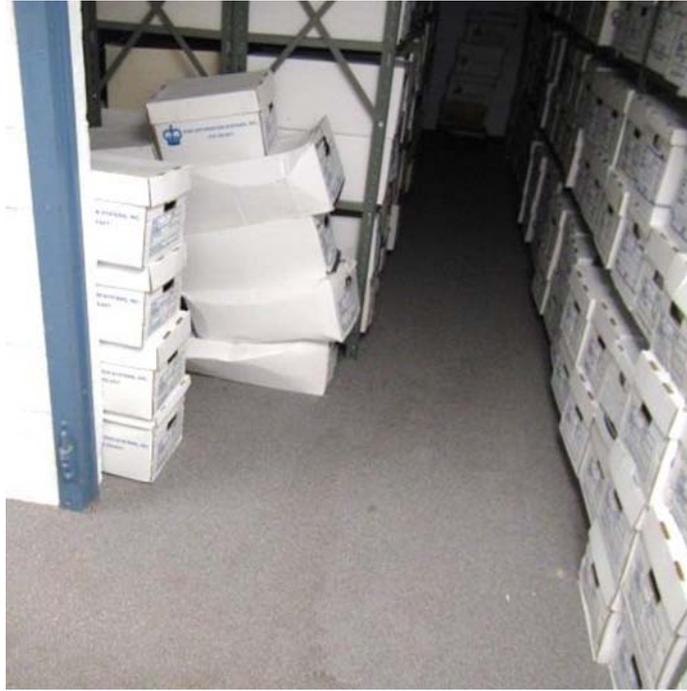
Picture 9

Cardboard boxes were observed placed directly on the floor of the basement and other areas (Picture 9). Cardboard boxes and other porous materials should be elevated off the floor in basement areas to prevent wetting from condensation/humidity, which can lead to water damage and mold growth.

Cardboard boxes directly on floor of basement

8. Do not store porous materials (e.g., cardboard boxes) directly on floors; elevate/place on pallets or shelving to prevent water damage and mold growth.

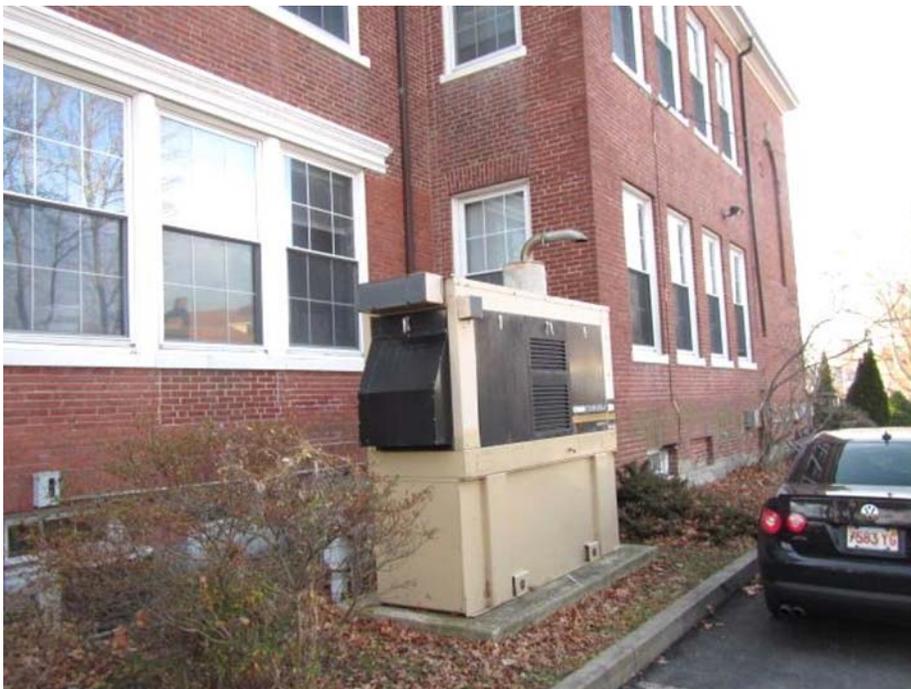
Picture 10

Outdoor PM_{2.5} concentrations were measured at 28 µg/m³ (Table 1). Indoor PM_{2.5} levels ranged from 7 to 17 µg/m³ (Table 1), which were below the NAAQS PM_{2.5} level of 35 µg/m³. PTH staff expressed concerns regarding the periodic operation of the emergency generator, which is in close proximity to the exterior of the building (Picture 10). The operation of this equipment, although necessary, can be a source of carbon monoxide and airborne particulates.

Emergency generator

12. Consider testing the generator after work hours or on weekends to prevent/reduce potential exposure to exhaust emissions.
13. Maintain air purifiers as per the manufacturer's instructions.

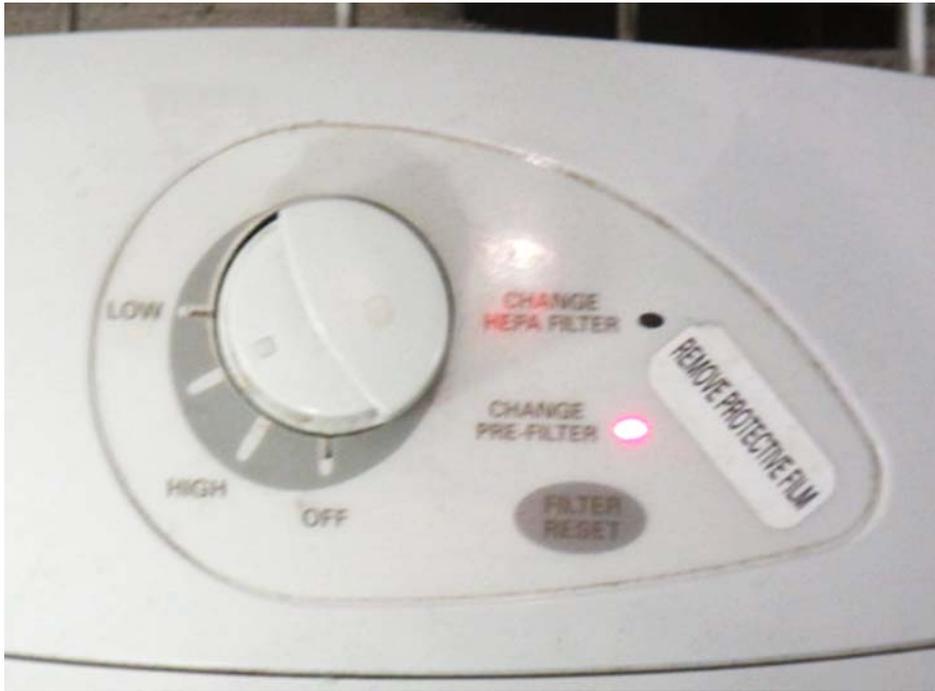
Picture 11

Several areas utilize air purifiers. The filters in one of the basement units were in need of attention, as indicated by the “pre-filter” alert light on the unit (Picture 11). Air purifiers/cleaners are typically equipped with filters that should be cleaned/changed as per manufacturer’s instructions.

Close up of air purifier in the basement, note “CHANGE PRE-FILTER” alert light
