## Occupational Fatality Report

### Municipal Police Officer Fatally Injured When Struck by a Backing Dump Truck – Massachusetts

Release Date: June 18, 2014  
Investigation: # 12-MA-016-01

Massachusetts Department of Public Health  
Occupational Health Surveillance Program

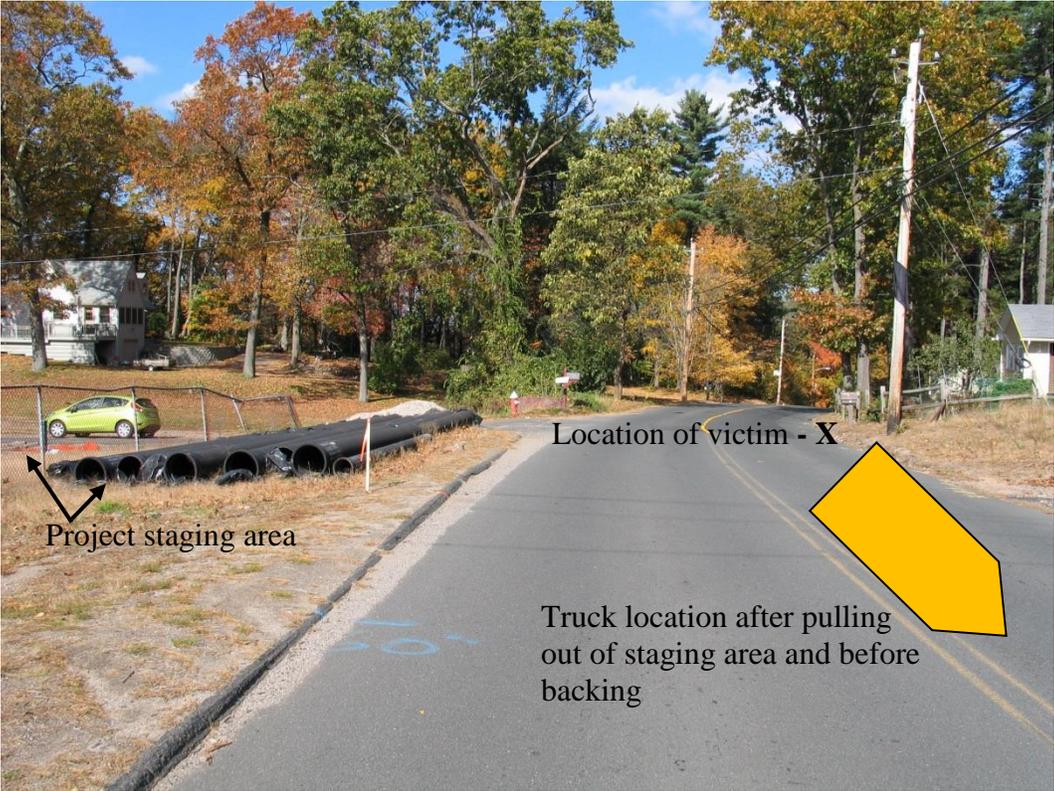
**Figure 1 – Incident location looking north**

The incident occurred on a rural residential roadway within a municipality incorporated as a city. The roadway was comprised of asphalt and had two lanes; a single northbound lane and a single southbound lane (Figure 1). The speed limit for the roadway was an un-posted 30 miles per hour (MPH) residential area. The roadway's markings consist of double center yellow lines separating the single northbound and southbound travel lanes. There were no painted white fog lines along the roadway edges. The width of each lane varied from 12 feet to 15 feet depending on the location along the roadway.

On the day of the incident both the northbound and southbound roadway traffic had been limited to using the southbound lane only directed by police personnel. The roadway was in poor condition due to the water line replacement project. At the time of the incident, the center of the roadway, which had been previously excavated, was filled with gravel and the roadway was wet due to light rain.

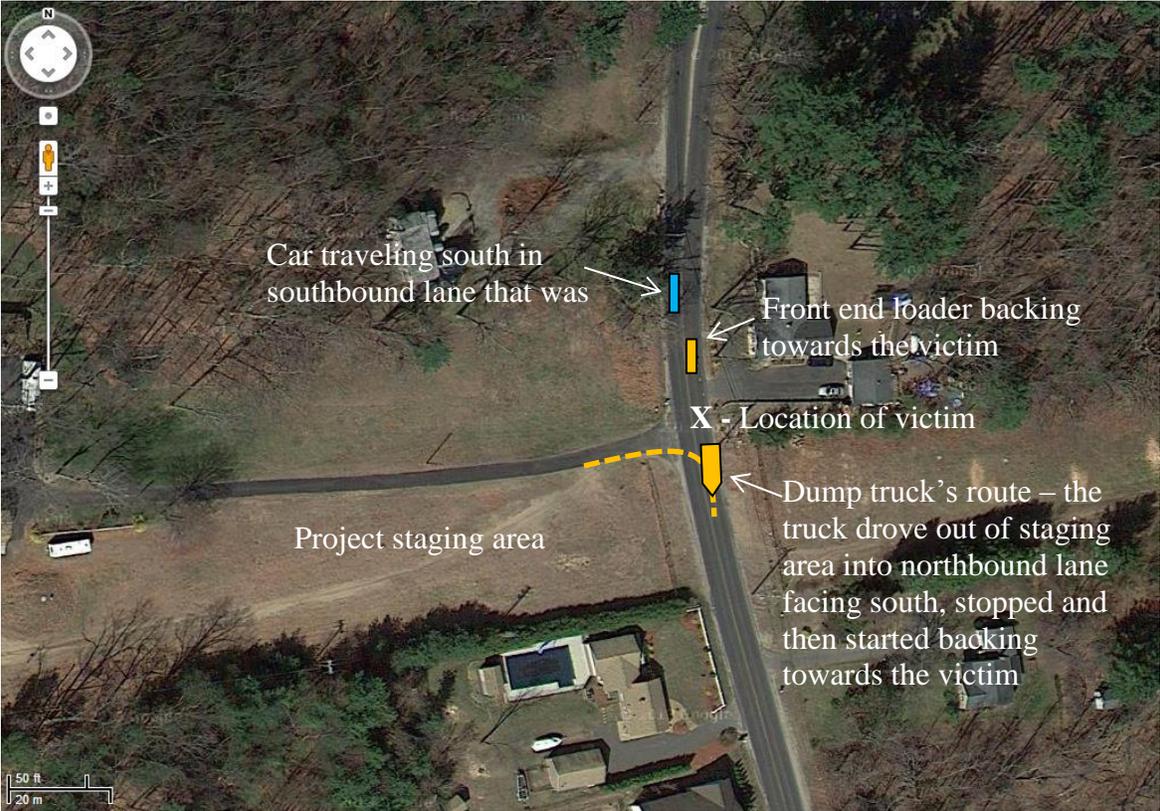
Figure 2 – Aerial view of the incident location

line replacement project. At the northern end of the incident location, the roadway curved to the east and declined while heading north (Figure 2).

The dump truck involved in the incident was parked in the construction project staging area prior to the incident. The dump truck drove out of the staging area in the forward direction and one of the officers performing a traffic detail was directing the truck. As the dump truck exited the staging area it pulled into the closed northbound travel lane facing south and then stopped. At this point the victim was standing behind and had his back to the dump truck concentrating on directing the oncoming traffic traveling in the southbound travel lane (Figure 2).
