Massachusetts FACE • Occupational Fatality Report

Laborer Dies After Being Backed Over by Dump Truck at a Nighttime Highway Work Zone Construction Site - Massachusetts

Investigation: # 08-MA-028-01

Release Date: February 25, 2011

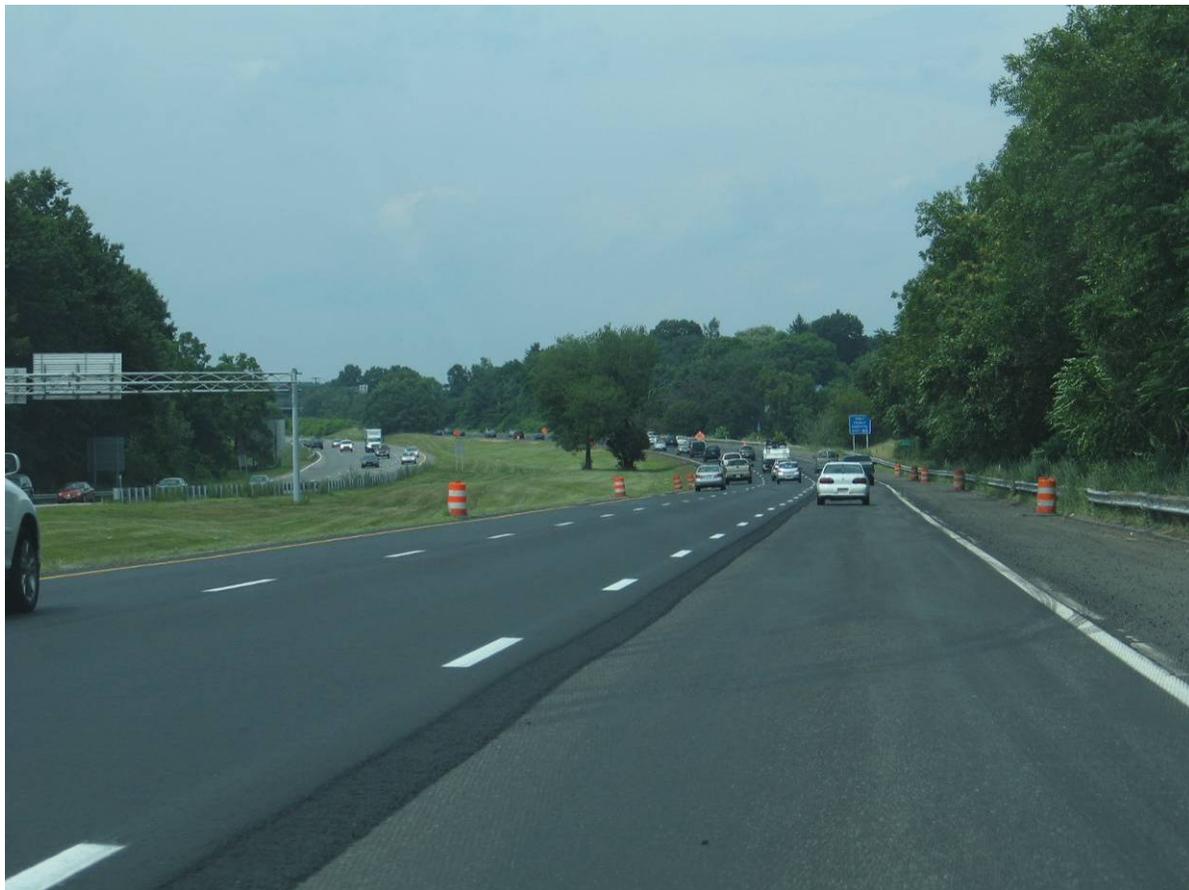
The project started in March of 2008 and was scheduled to be completed in September 2009. The work was scheduled to take place at night from, 9:00 p.m. to 6:00 a.m., Sundays through Thursdays. The two major components of the project were to mill down the current asphalt roadway surface and then repave the milled section of roadway. The project location was a major interstate consisting of a six-lane asphalt highway with a left hand asphalt shoulder, a right hand breakdown lane and a large grass median. The asphalt shoulder is four feet wide with a right hand solid yellow line. The three travel lanes are each 12 feet wide, separated by white dashed lines (skip lines), and the breakdown lane is ten feet wide with a continuous white fog line bordering the right lane (Figure 1). The section of the interstate roadway to be repaved was 2.9 miles long and 50 feet wide, the width of all travel lanes, shoulder, and breakdown lane. This section of roadway where the incident occurred is level and straight, with a very slight curve. At the time of the incident it was dark with temperatures in the 50s and the roadway was dry.

Figure 1 – Roadway where incident occurred.

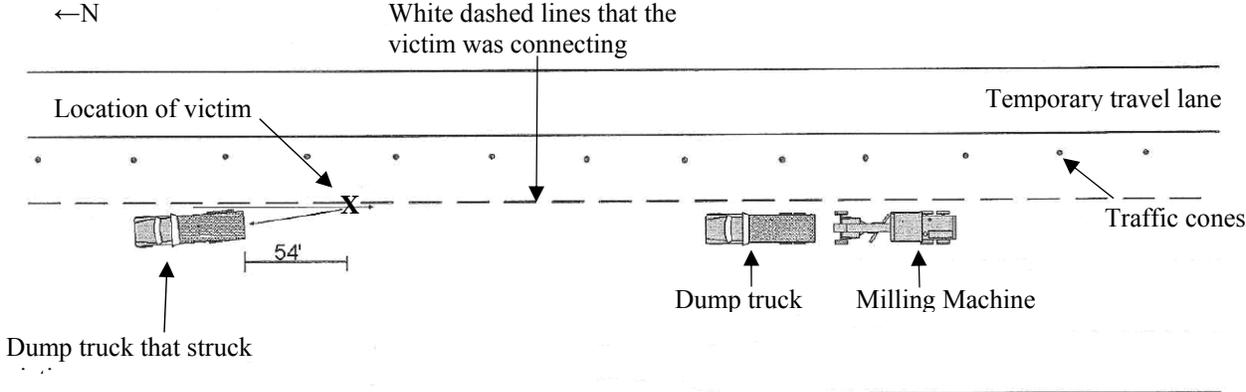
At approximately 8:00 p.m., the company's safety crew and construction superintendent, along with state troopers, arrived at the project site. The crew started setting up the work zone, which was about one mile long and included shutting down the three northbound travel lanes. The 10-foot break down lane and two feet of the right-hand travel lane were designated as the single travel lane for motorists to pass by the work zone. This temporary travel lane was separated from the work zone by traffic barrels. A right-hand entrance ramp merged with the single designated travel lane adjacent to the work zone. The southbound travel lanes were not affected on the night of the incident (Figure 2). The work zone set up was completed by 8:30 p.m.

Figure 2 – Diagram of the work zone.

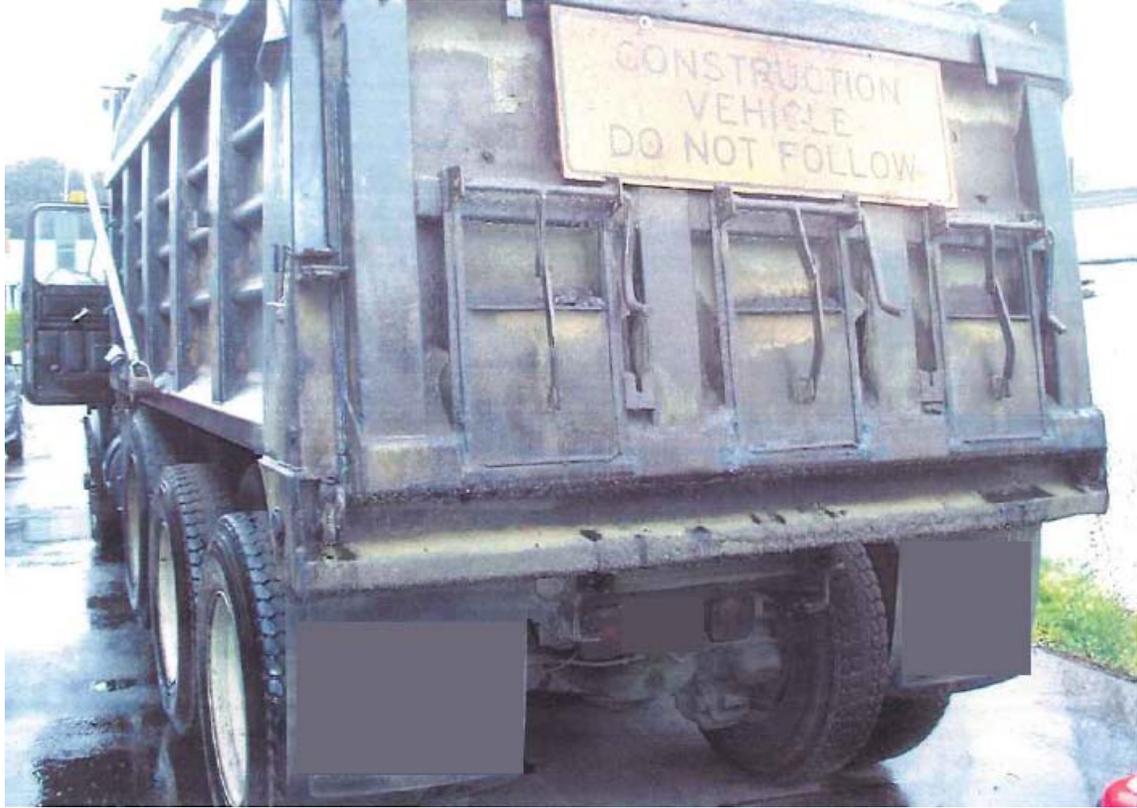
The driver of the dump truck had a passenger (non employee) present inside the cab at the time of the incident. According to federal law (49 CFR Part 392.60) unless authorized in writing by the motor carrier under whose authority the commercial motor vehicle is being operated, no driver shall transport any person on any commercial motor vehicle other than a bus.¹ After the incident the dump truck was impounded by the Department of Transportation and a full inspection of the truck was conducted. The truck appeared to be in good working order with a functioning backup alarm and backup lights.

Figure 3 – Truck involved in the incident.
