Massachusetts FACE • Occupational Fatality Report

Iron Worker Crushed in Collapse of a Telescopic Boom Lift - Massachusetts

Investigation: # 07-MA-045-01

Release Date: December 3, 2008

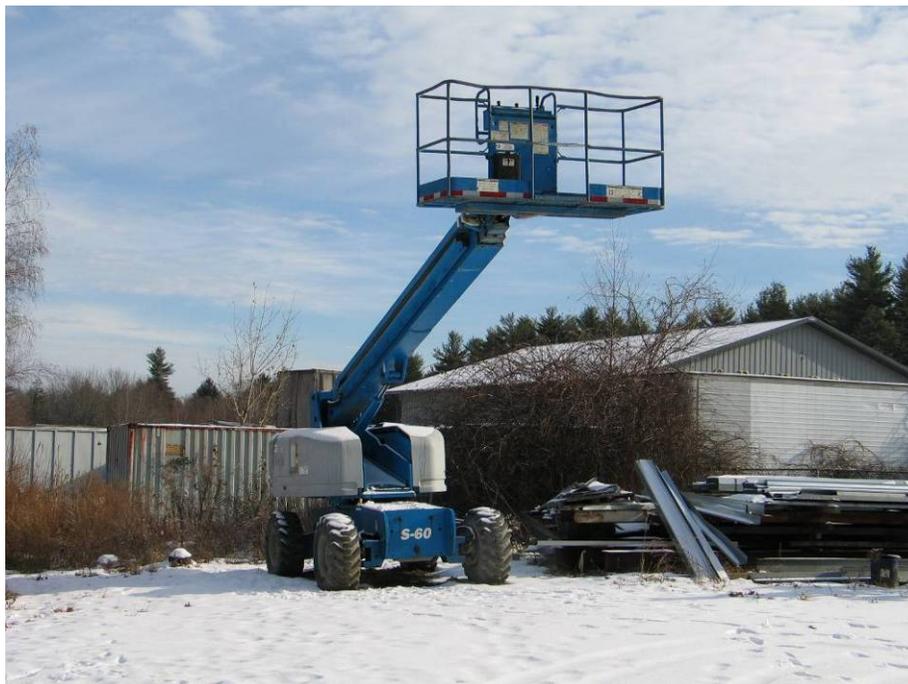
The company is a steel erection, welding, and steel beam manufacturer. The machine involved in the incident was a 60 foot telescopic boom lift (Figure #1). The lift was manufactured in 1999 and had been purchased by the employer in 2005 from an equipment rental company. The lift is equipped with a three cylinder diesel engine and a hydraulic-based boom. The work platform located at the end of the boom measures three feet by eight feet and has a 500 pound capacity. The lift weighs approximately 20,000 pounds, of which 2,000 pounds is the weight of the lift's boom. It was reported by the employer that the lift had not been altered and that it has not needed any major repairs since the date it was purchased. General maintenance and minor repairs, such as changing tires and grease and oil changes for the company's equipment, including the lift, were performed by the company's in-house mechanic. Repairs to equipment that were considered to be complex were typically contracted out.

**Figure 1 – Boom lift involved in the incident.
This is looking at the front of the lift.**

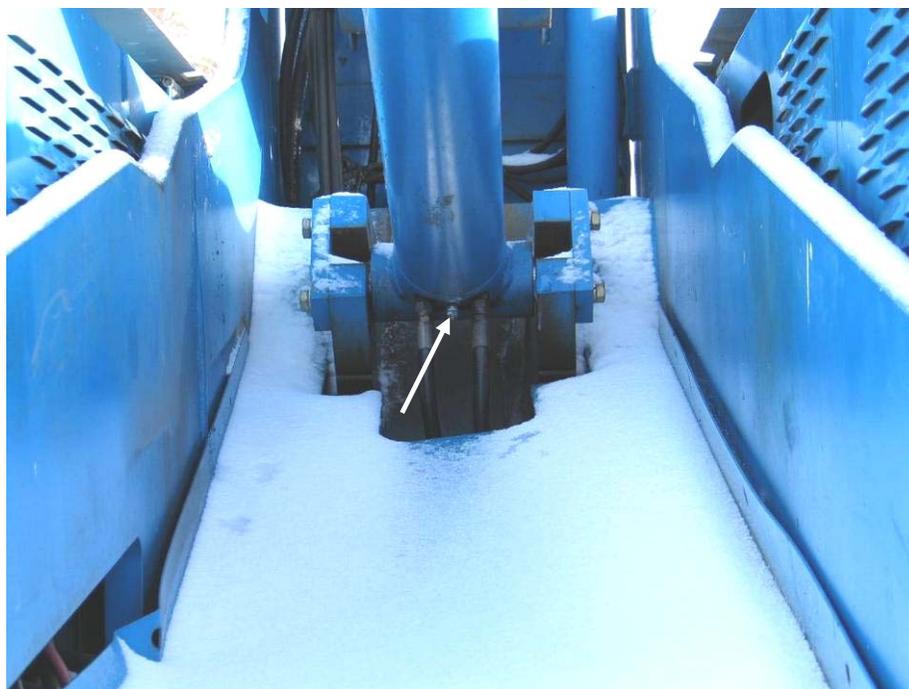
coming up and decided to have employees repair the lift during the expected slow period. A counterbalance valve (Figure #2) that was not operating properly was reported as the reason that the lift's boom was moving slowly. The counterbalance valve has two functions. One function is to control the amount of hydraulic oil present in the boom's pistons, which in turn control the raising and lowering of the boom. The second function is to prevent boom movement in the event of a hydraulic line failure.

Figure 2 – Counterbalance valve is located between the two vertical hydraulic hoses.

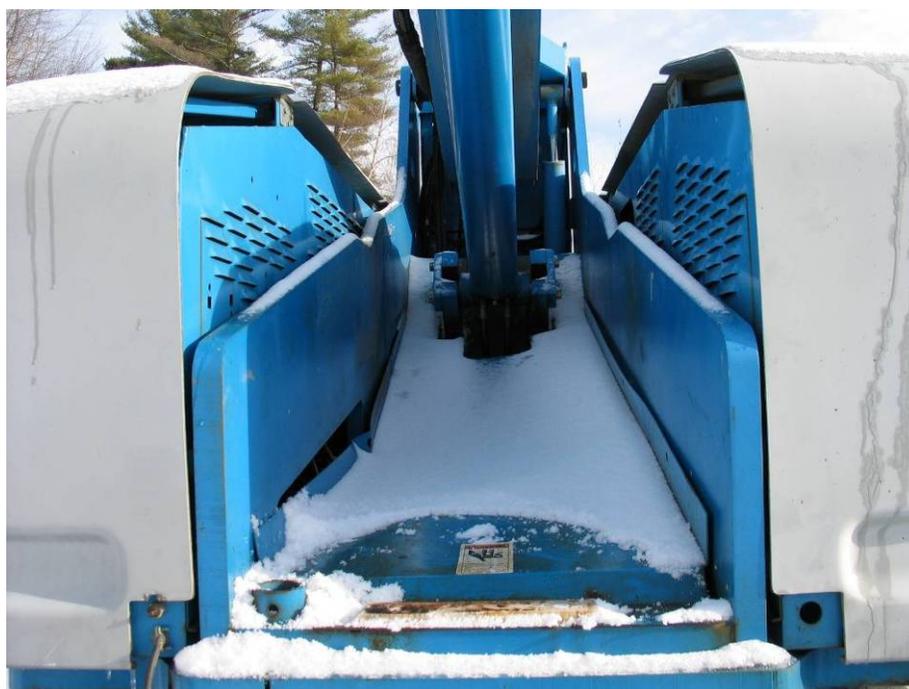
At approximately 8:00 a.m., the victim had started to loosen the counterbalance valve accessing it from underneath the rear of the lift. Once the valve was loosened, the co-worker went to take a restroom break. While the co-worker was away, the victim continued with the repair and climbed onto the lift's base to access the counterbalance valve (Figure #3) from the front of the lift. At the location where the victim would have climbed onto the lift's base, there was a manufacturer's decal that stated "Warning Crushing Hazard." While on the lift's base, which positioned the victim directly underneath the raised boom, the victim continued to loosen the valve. When the valve was loosened further this allowed the hydraulic pressure/oil to be released from the hydraulic system. As the hydraulic pressure/oil was released, the raised boom collapsed onto the victim, crushing him between the boom and the top of the lift's base.

Figure 3 – Location where victim was crushed and a decal warning of a crushing hazard.

Recommendation #1: Employers should ensure that prior to starting work on hydraulic boom lifts that either the booms are properly supported or that the booms are in the stowed position.

Discussion: Hydraulic systems need to be pressurized to have controlled movement of the hydraulic powered object, in this case the lift's boom. Prior to working on any component of a hydraulic system, the first steps should be to conduct a job safety analysis (Recommendation #3) and to implement lockout/tagout procedures (Recommendation #4). One of the next crucial steps, which should be part of the hazardous energy control program, is to ensure that any potentially movable parts are blocked and secured. In this case, the boom should have been either in the lowest position, the stowed position, or if the boom was required to be in a raised position during the maintenance task, the boom should be properly secured from moving with blocking.
