Massachusetts FACE • Occupational Fatality Report

Apprentice Electrician Electrocuted while Wiring an Elevator Disconnect Switch - Massachusetts

Investigation: # 06-MA-043-01
Release Date: December 23, 2008

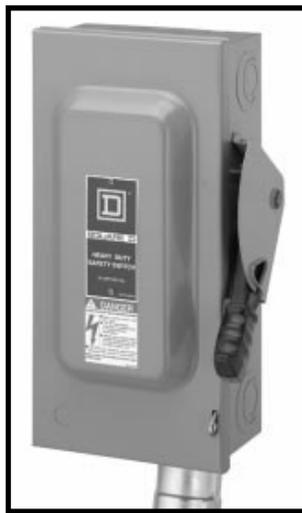
The three temporary feed wires that ran from the main electrical room to the elevator's mechanical room were installed into the top of a disconnect switch (Figure 1) located inside the elevator's mechanical room and attached to the disconnect switch's top mechanical lugs, the switch's supply side (Figure 2). Temporary wiring had also been installed from the bottom mechanical lugs of the elevator mechanical room disconnect switch to the control unit for the elevator that were also located in the elevator mechanical room. These were the wires being replaced at the time of the incident.

Figure 1* – Similar heavy duty disconnect switch with front cover closed

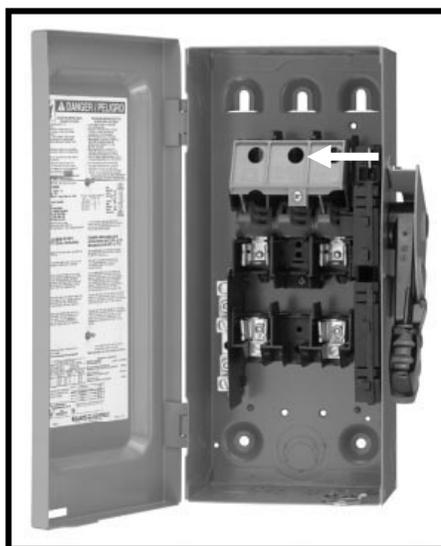
The task of permanently wiring the elevator included installing rigid conduit from the elevator mechanical room disconnect switch to the elevator controls, feeding the new permanent wiring through the rigid conduit, inserting the wire into the top of the disconnect switch, feeding the wire down through the disconnect switch, and attaching the wire to the disconnect switch's bottom mechanical lugs. The other end of the permanent wire would then be connected to the elevator's control unit. The main function of this disconnect switch is to cut off power to the elevator controls. The disconnect switch involved in this incident was equipped with three 100-amp fuses that provided overload and short circuit protection and an arc shield that covered the top lugs. The shield was reportedly in place during the incident.

The employer reported that the three energized feed wires from the main electrical room had been disconnected from the disconnect switch's top lugs by inserting a screwdriver into the holes in the arc shield and loosening the lugs to which the wires were attached. These wires were also bent outward towards the front of the switch's housing. It was also reported by the employer that the disconnect switch's three 100-amp fuses had been removed and that the disconnect switch's throw, located on the right side of the switch's housing, was in the off position and locked out by both the victim's foreman and one of the elevator contractor's employees, but there was only one lock location and the lock used was that of the elevator contractor.

The disconnect switch being in the off position and locked out would only de-energize the bottom section of the disconnect switch including the wiring between the disconnect switch's bottom lugs and the elevator controls. The feed wires from the main electrical room that were attached to the disconnect switch's top mechanical lugs would remain energized. It was reported that a second disconnect switch should have been installed between the main electrical room and the elevator mechanical room. If this was installed the feed wires could have been de-energized

**Figure 2* – Similar heavy duty disconnect switch with front cover open
Arrow pointing to arc suppressor shield**

Recommendation #1: Employers should ensure that electrical circuits and equipment are de-energized and that lockout/tagout procedures are implemented and enforced prior to beginning work.

In this case, the victim was working on an elevator disconnect switch where the supply side of the switch was energized. The disconnect switch had been locked out, but the lock used was not the victim's lock, the person performing the work, it belonged to an employee of the elevator contractor. Prior to the incident, the switch should have been totally de-energized and tested to verify that it was totally de-energized and in an electrically safe work condition and locked out by the employees performing the work. The company had an electrical safety program that included procedures for locking out and tagging of circuits. The company also provided employees training on these procedures. However, as this case demonstrates, training alone will not ensure that hazardous energy control programs and the required procedures, such as requiring electrical systems to be de-energized, tested, and locked out prior to beginning work, are being properly implemented and followed. To ensure the effectiveness of these procedures, management must provide oversight ensuring that procedures are being followed.
