Massachusetts FACE • Occupational Fatality Report

A Painter Falls 12 Feet While Painting a Pump Hose Platform System - Massachusetts

Investigation: # 07-MA-025-01

Release Date: January 5, 2009

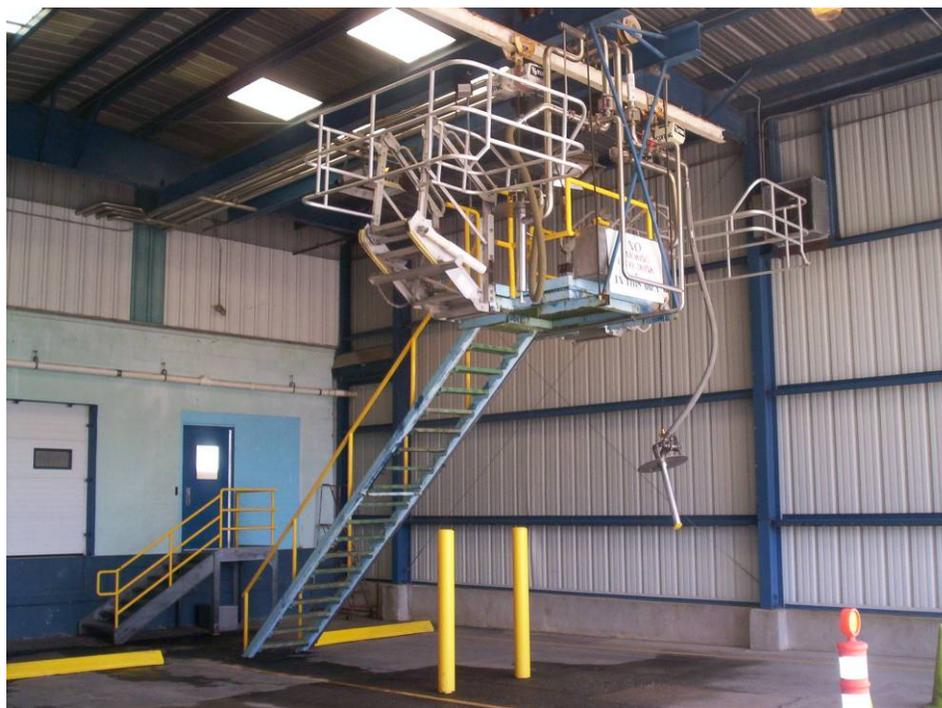
An agricultural cooperative had hired the painting contractor to repaint sections of their fixed raised metal pump hose platform system (Figure 1) and some structural steel beams in the section of building where the platform system was located. This section of building is a hanger style building with a roof and walls enclosing three sides. The fourth side of the building is open to create access for trucks to back under the pump hose platform.

Figure 1 – Pump hose platform system.

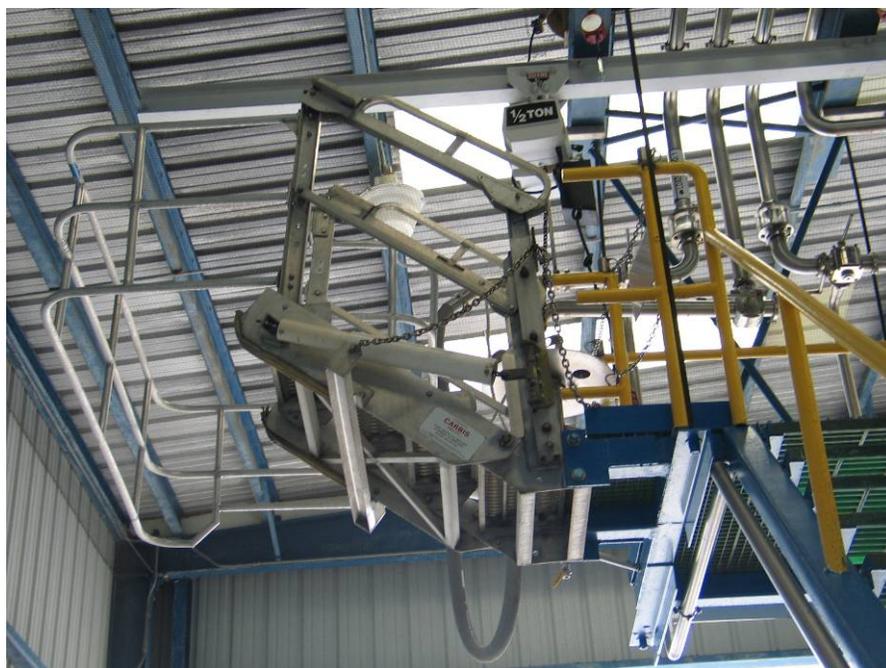
The platform system has one set of stairs that leads from the ground level to a raised fixed platform area located approximately 10 feet above the floor. Gangways are located on the left and right sides of the raised fixed platform area (Figure 2). The gangways have three hinged steps and are used to access ports located on the top of a tanker trailer when the trailer is positioned properly next to the platform system. The ends of the gangways are equipped with guardrails that enclose the end of the gangways where there is no flooring. These guardrails provide fall protection to the platform system user when a truck is in the appropriate position and the gangways are in use. When needed, the hinged gangways are manually lowered to a truck's tank enabling a worker to access the top of the truck's tank from the platform system via the gangway (Figure 3). When not in use, the gangways should be placed in the up or stored position and locked. The platform system is also equipped with a loading arm and a pump system. The loading arm and pump system are used to deliver liquid product into the truck's tank. The end of the loading arm is placed in the truck's port and the pump system is turned on to fill the tank.

Multiple witnesses did state that they heard a loud noise which caused them to look towards the platform system and then observed the victim falling. It appears that the victim had stepped from the fixed raised platform out onto the unlocked gangway that would have been to his left while standing at the top of the platform's stairs to reach a section of the overhead steel beam he was painting. When he stepped onto the gangway, the weight of his body may have caused the gangway to lower causing the victim to lose his balance and fall approximately 12 feet to the concrete floor below, landing head first.

At the time of this incident, the victim was working from one of the gangways in the stored position and was consequentially exposed to a fall hazard of more than six feet. Therefore, the victim should have been supplied with fall protection, such as a personal fall arrest system, and been provided training on the fall protection. Another option would have been to use the rented aerial lift that was onsite at the time of the incident. Management procedures should be in place to ensure that employees are following required safety practices. In either scenario, because of the nature of the work and the availability of an aerial lift for use by the painting contractor employees, training should have been provided by the painting contractor to their employees about personal fall arrest systems and aerial lifts.

Figure 2 – Platform system’s gangway that the victim fell from in the stored position.

Recommendation #1: Employers should ensure that fall protection and relevant training are provided to employees who are exposed to fall hazards when working six feet or more above the lower level.

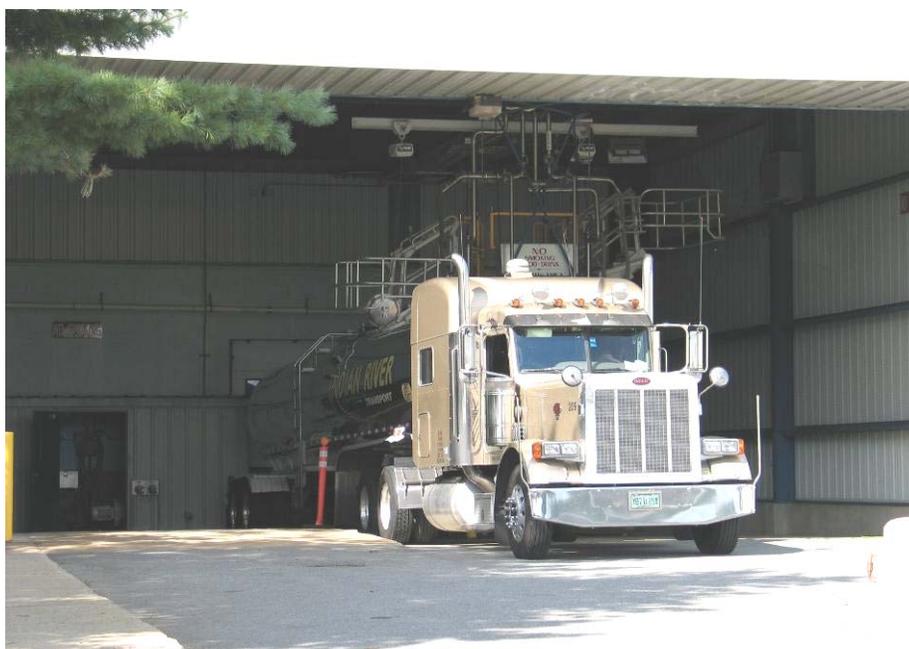
Figure 3 – Tanker truck positioned next to the platform system with a gangway lowered onto the truck’s tank.

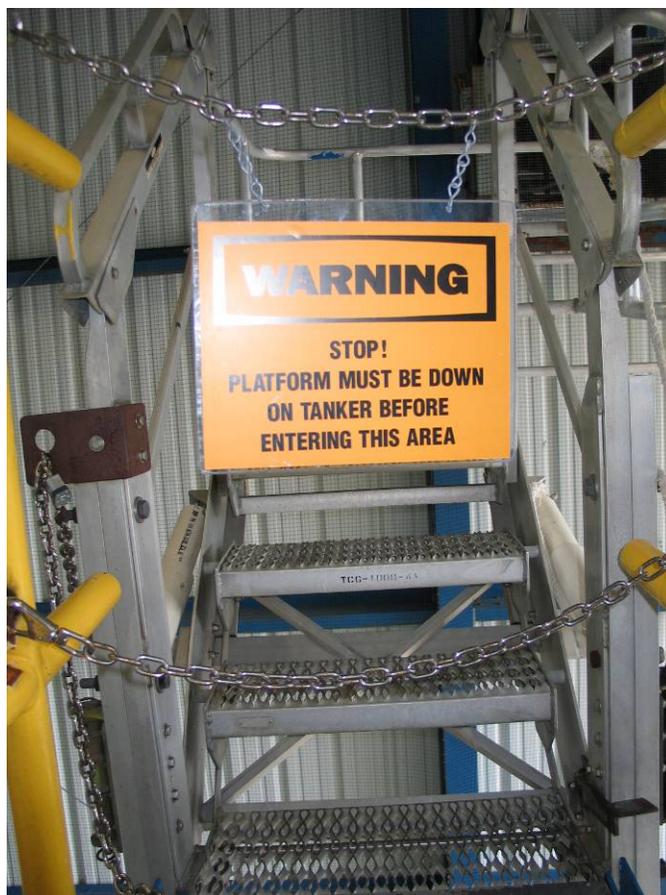
Figure 4 – Gangway entrance area with warning sign.

The agricultural cooperative representative stated that they were currently reviewing their qualified vendor process. In addition, the liquid product manufacturer had added signs attached to chains strung across the gangway entrance areas that state "Warning Stop! Platform Must Be Down on Tanker Before Entering This Area".

Discussion: The pump hose platform system involved in this incident has raised platforms leading to gangways. When in use, these gangways are lowered to the top of tanker trucks. Since the incident, the agricultural cooperative has implemented procedures to be followed when the pump hose platform system is not in use. These procedures include, ensuring that the gangways are locked in the stored position and placing warning signs at the gangway entrance areas that state "Warning Stop! Platform Must Be Down on Tanker Before Entering This Area" (Figure 4).
