Massachusetts Department of Public Health
Occupational Health Surveillance Program
Fatality Assessment and Control Evaluation Project

Two Hospital Workers Die when a Motor Vehicle Crashes into a Hospital Lobby - Massachusetts

Investigation: # 07-MA-040-01/02

Release Date: May 29, 2009

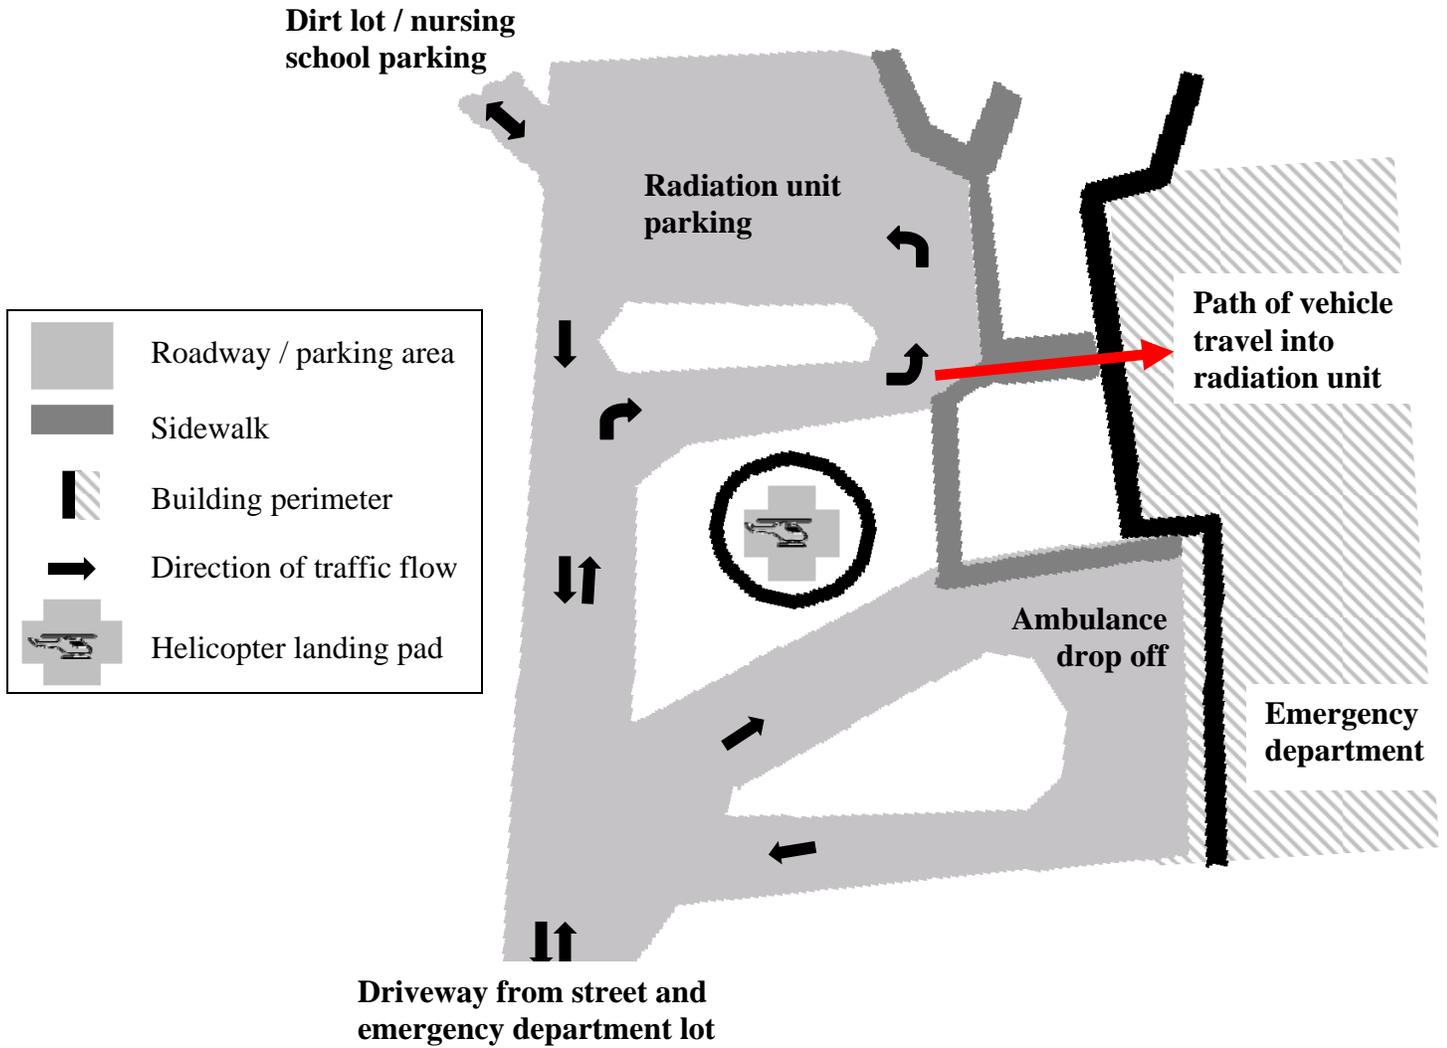
Figure 1 – Diagram of driveway layout
Black arrows indicate direction of traffic flow
Black line marks outside wall of building

The radiation therapy unit has a separate parking lot accessed by a driveway that also provides access to the emergency department, ambulance drop-off area, helicopter landing pad, nursing school, and a dirt overflow parking lot (Figure 1). Drivers going to the radiation therapy unit or nursing school must drive past the emergency department, ambulance drop-off area and helicopter landing pad. Once past these locations, the driver must make a series of turns prior to entering the radiation therapy unit's parking lot. The first turn is a right-hand turn that positions vehicles directly perpendicular to (heading towards) the lobby doors. Two subsequent left-hand turns take vehicles alongside the walkway in front of the building and then into the radiation therapy unit's parking lot.

At approximately 1:30 p.m. on the day of the incident, an elderly patient was driving alone to the hospital's radiation therapy unit for a scheduled appointment. While attempting to access the radiation therapy unit parking lot, the driver completed the first 90-degree turn, but failed to negotiate the second turn. The vehicle, now positioned directly perpendicular to the lobby doors, traveled straight ahead, leaving the driveway and entering the pedestrian walkway leading to the radiation unit's main entrance. The vehicle entered the building by crashing through two sets of sliding glass doors separated by a distance of approximately six feet. The vehicle continued for an additional ten feet inside the radiation therapy unit's main lobby area before striking the reception desk and pushing it into a wall.

Recommendation #1: Employers and property managers should evaluate the layout of parking lots and driveways to determine locations susceptible to damage from vehicle intrusion.
