Massachusetts FACE • Occupational Fatality Report

Municipal Laborer Dies after being Struck by a Motor Vehicle while Closing a Water Gate Valve – Massachusetts

Investigation: # 09-MA-031-01

Release Date: June 16, 2010

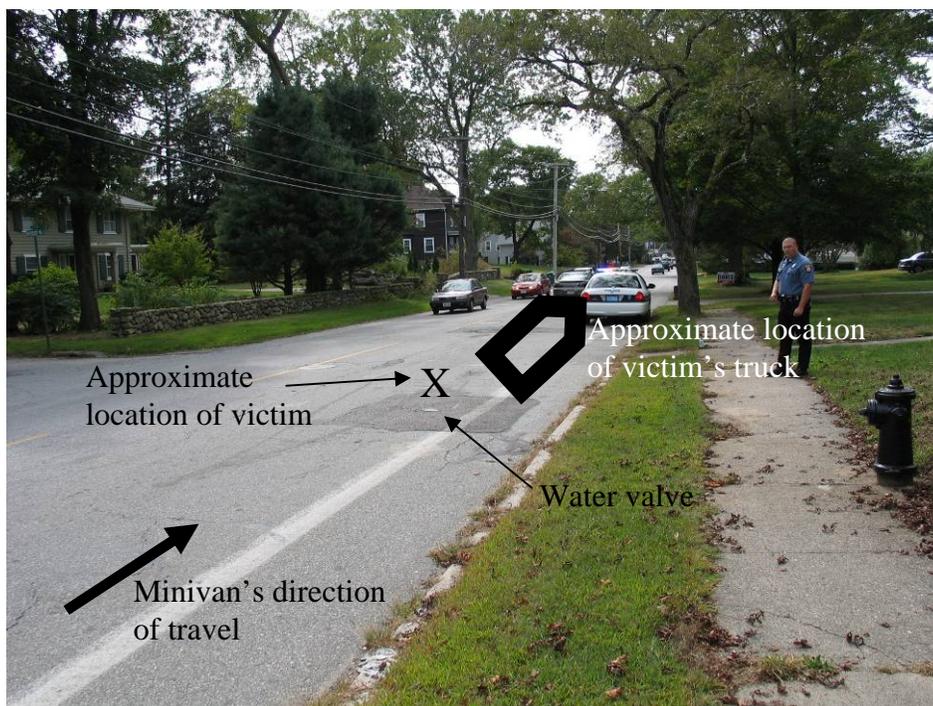
The morning of the incident, a water main located under a major roadway in the city broke at around 5:30 a.m. The victim, who was on the city's overtime list for such events, was called into work after the break occurred. At the water main break location a police detail was provided and a work zone was set up. The victim and a co-worker were at the water main break location and then were assigned to close a water gate valve to control the flow of water. They left the work zone area and traveled approximately 900 feet to the east, where the water gate valve was located (Figure #1).

When the victim and the co-worker arrived at the incident site, they positioned the ½ ton work pickup truck approximately four feet beyond the gate valve lid, facing west in the westbound lane. This is the same direction as the traffic flow in that lane. The truck's hazard lights were on as well as the yellow beacon located on the roof of the truck's cab. There were no other traffic control devices being used at the incident location at the time of the incident. Both the victim and the co-worker were wearing ANSI Class II green vests at the time of the incident.

Figure 1 – Incident location.

At the time of the incident, the pickup truck was located beyond the victim facing west in the westbound travel lane. The truck's location did not provide the victim protection from the approaching motorists traveling in this westbound lane. In this case, the pickup truck could have been located between the victim and the approaching traffic by parking it before the gate valve lid with the truck's wheels turned to the left. Having the truck in this location with the wheels turned to the left would provide protection to the workers on foot in the event that the truck was struck from behind by an approaching motorist. If struck from behind, the truck would move towards the left, away from the workers in the roadway and sidewalk, and in front of the vehicle that struck it, blocking that vehicle from continuing forward towards the workers.

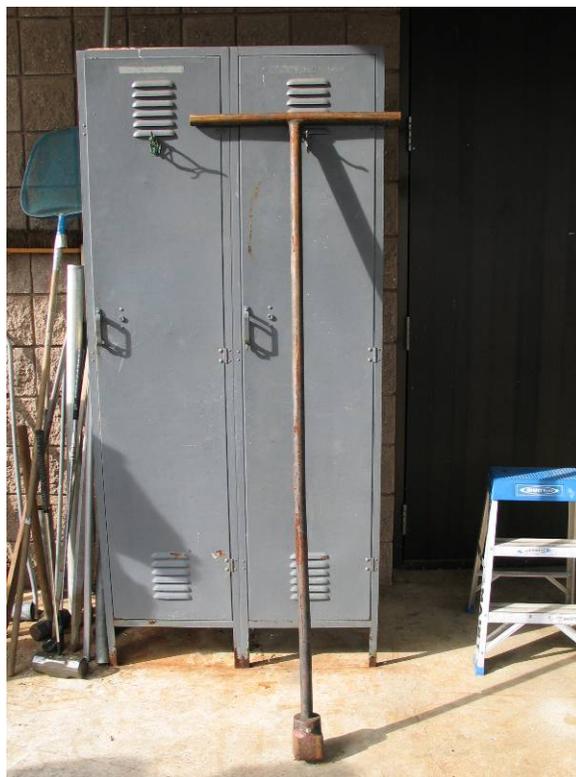
The gate valve is encased in a steel valve box and has a steel pipe that runs from the valve box up to the street level. This steel pipe provides access to the gate valve. At the street level there is a lid that covers the steel pipe. To open and close the water gate valve, a valve wrench is used. The valve wrench used during this incident has a pipe base that is approximately nine feet long with a perpendicular section of pipe at one end that is used as a handle. The other end of the wrench has a key that fits onto the gate valve (Figure #2). Using the handle the valve wrench is turned to open or close the water gate valve.

Figure 2 – Similar valve wrench to the one being used.

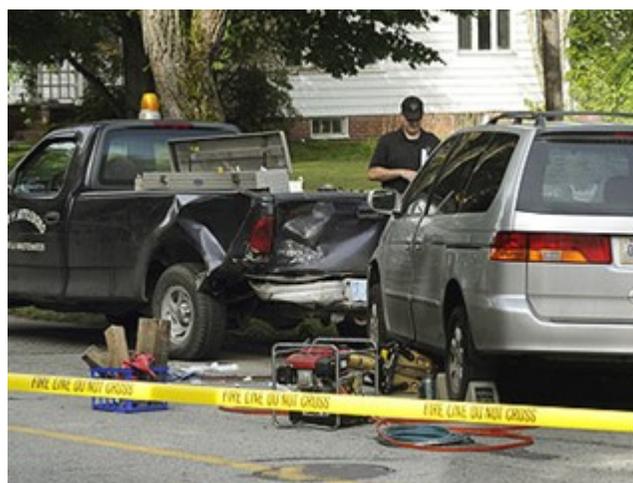
While walking in a circular motion to close the gate valve, the victim might have had his back to oncoming traffic as a minivan traveling west in the westbound travel lane approached. The minivan struck the victim, pushing him into the work pickup truck and pushing the pickup truck forward. The minivan then bounced backwards and then forwards, stopping partially on top of the victim. Reportedly, the minivan driver did not apply the minivan's breaks prior to the crash. The co-worker heard the noise of the crash and turned to see the victim trapped underneath the minivan (Figure #3). The co-worker went to the victim then placed a call to Emergency Medical Services (EMS) and to other co-workers. Within minutes EMS and the local police arrived at the incident location and the victim was freed and transported to a local hospital where he was pronounced dead. Since the incident, the municipality has instituted additional work zone safety measures, including providing comprehensive work zone training for city employees and a cooperative agreement between the water department and police department which calls for police officers to control traffic when water department employees are accessing water valves located in roadways.

Figure 3 – Scene after the incident.
