**DEPARTMENT OF
TELECOMMUNICATIONS & ENERGY**

PIPELINE ENGINEERING AND SAFETY DIVISION

INCIDENT REPORT

9 Bonito Drive, Framingham, Massachusetts
May 24, 2002

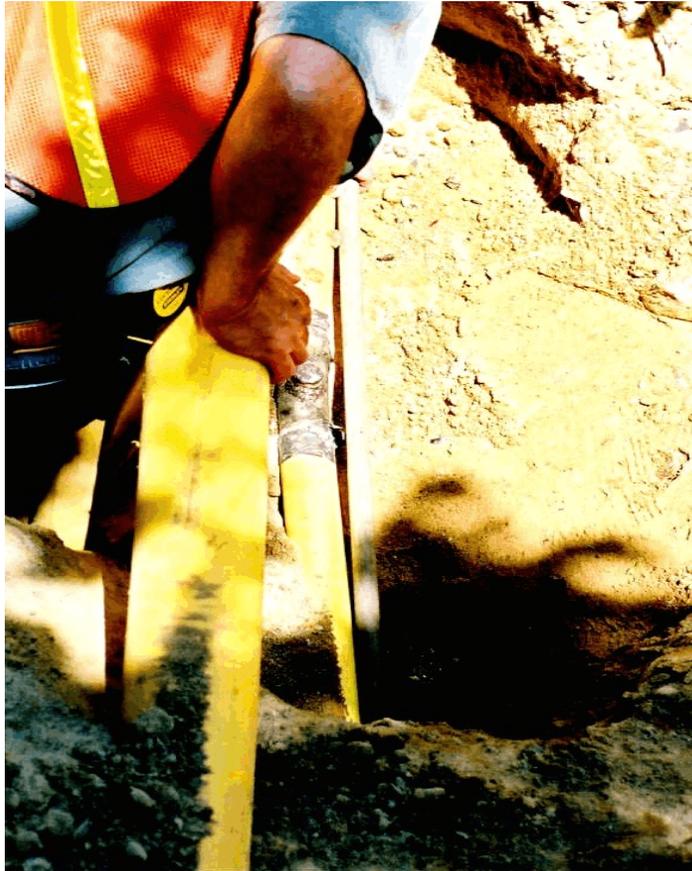
Exhibit 6: Four-inch diameter plastic main above and parallel to the two-inch steel main. Note the plug tap in the hole on the steel main.

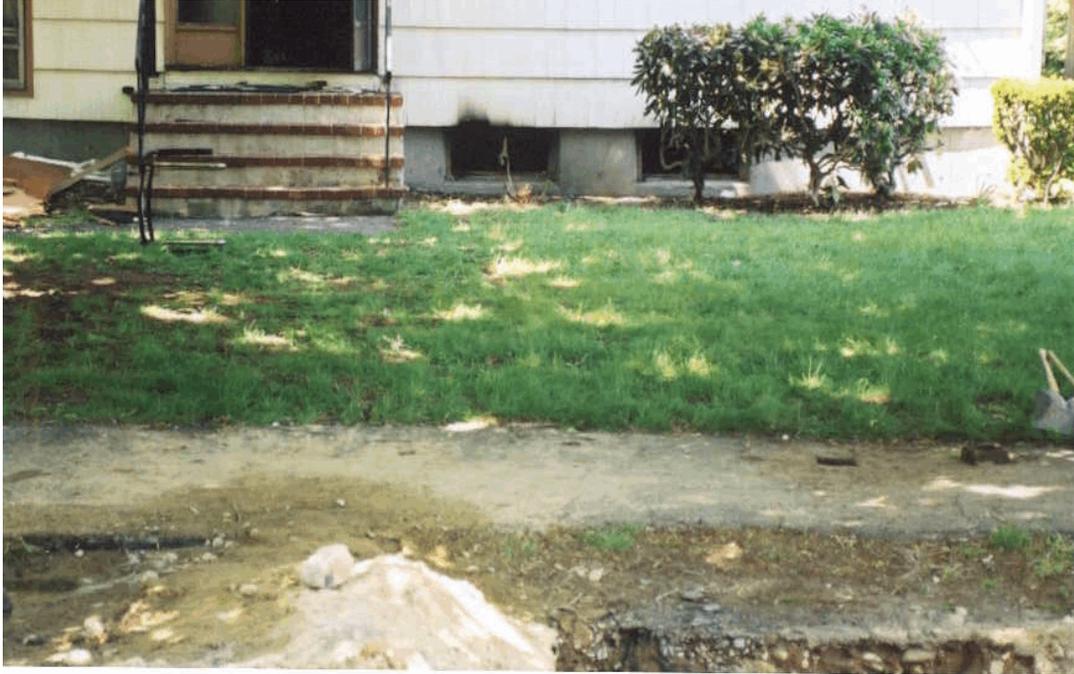
Exhibit 10a: Front view of the house showing damage from the explosion and fire.

the half-basement level. The upper level of the house had smoke and soot damage. Windows and doors had been damaged and blown from the house (Exh. 10).

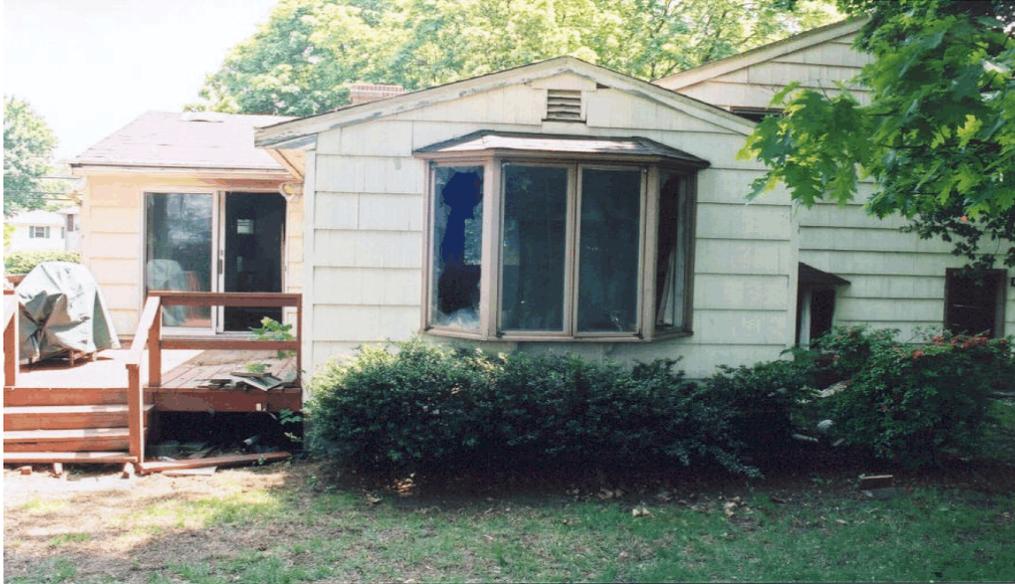
Exhibit 10b: Side view of the house showing damage from the explosion and fire.

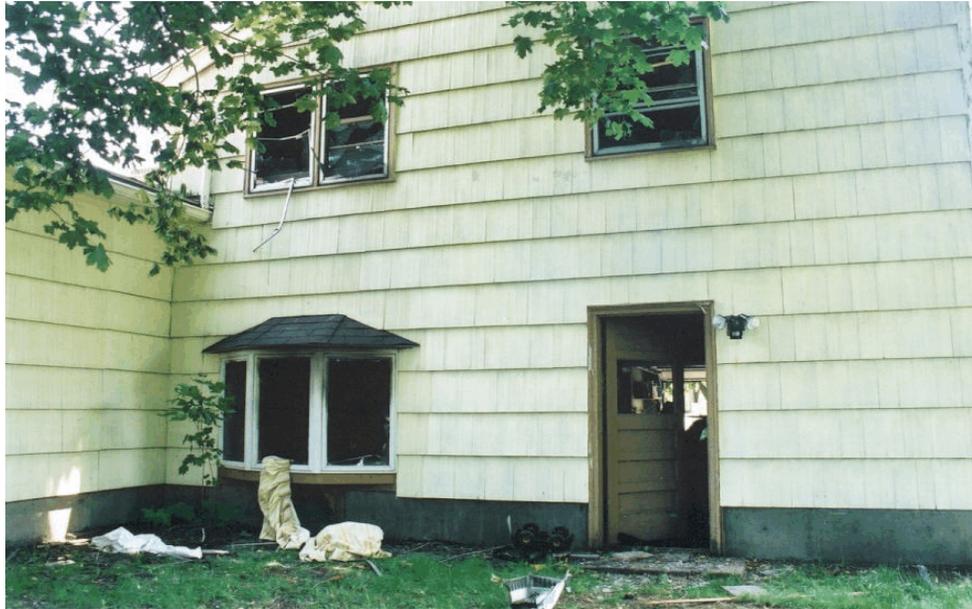
Exhibit 10c: Rear view of the house showing damage from the explosion and fire.

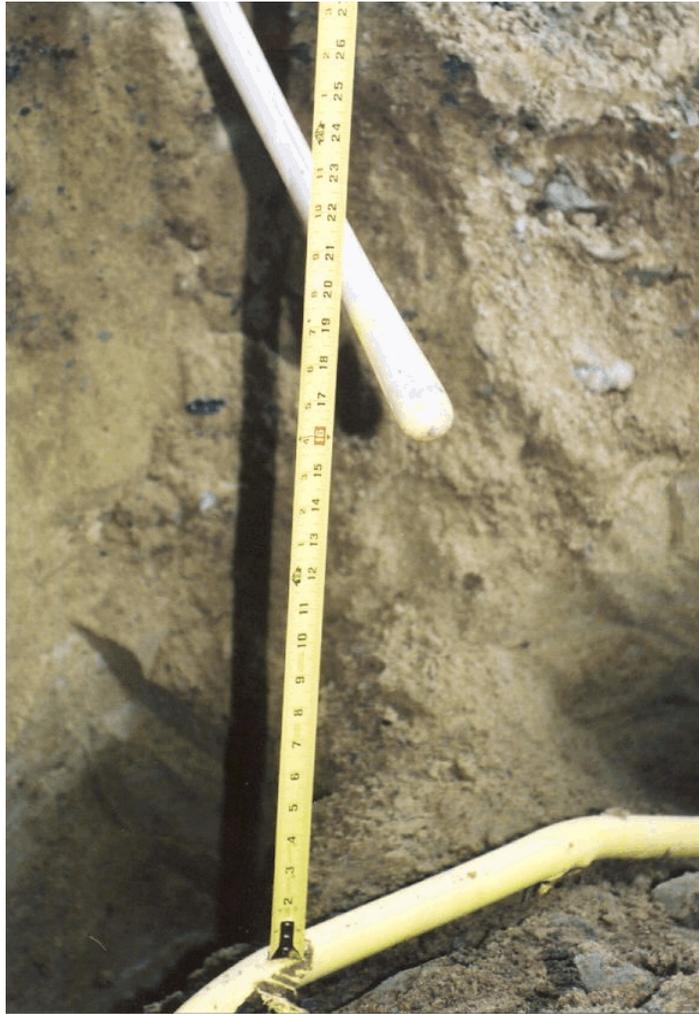
Exhibit 11: Depth of the service line at the point where it was hit by the backhoe.

There was an open excavation in the street. Within the excavation, the investigators observed a bow in the pipe near the service connection to the two-inch diameter main (Exh. 25). The X-Trucoat coating on the service line was ripped, and there were scratch marks on the service line at the location of the bend (Exh. 25). The service line was 19 inches below the surface of the ground at this point (Exh. 11).

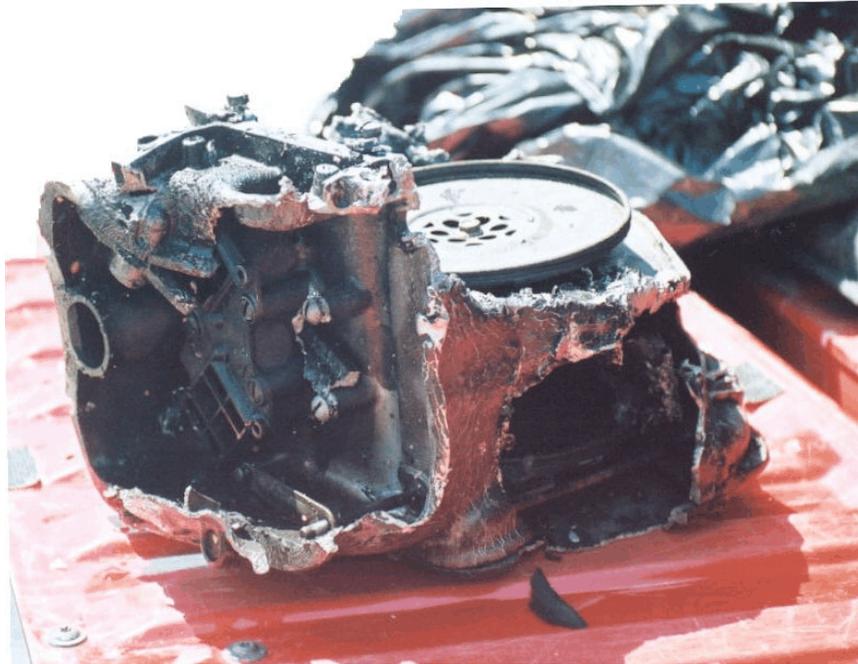
Exhibit 12: Gas meter damaged by the explosion and fire.

The D.T.E. investigators also examined the gas meter and the bowed area of the service line struck by the backhoe. The gas meter was badly damaged in the explosion and subsequent fire (Exh. 12). The investigators were unable to read the meter.

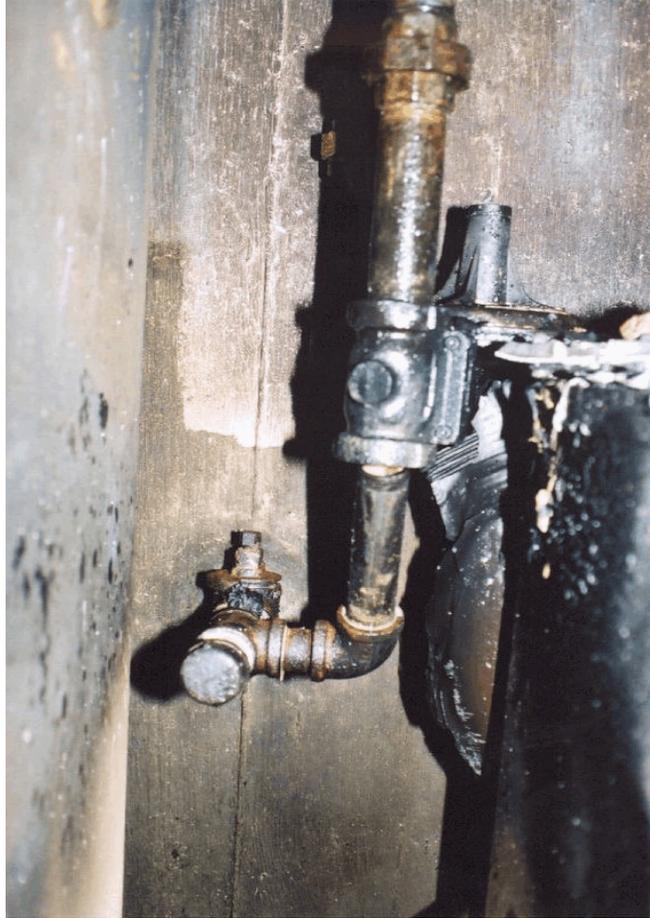
Exhibit 13: The service valve and service regulator with the crack at the regulator inlet.

It appears that the pipe fractured at the inlet connection to the service regulator. As the pipe was being pulled by the backhoe, it moved horizontally underground. Then, something, possibly the service regulator or the meter, was pulled up against the inner foundation wall. The pipe began to bend until it fractured at a stress concentration point, in this case, the regulator inlet connection.

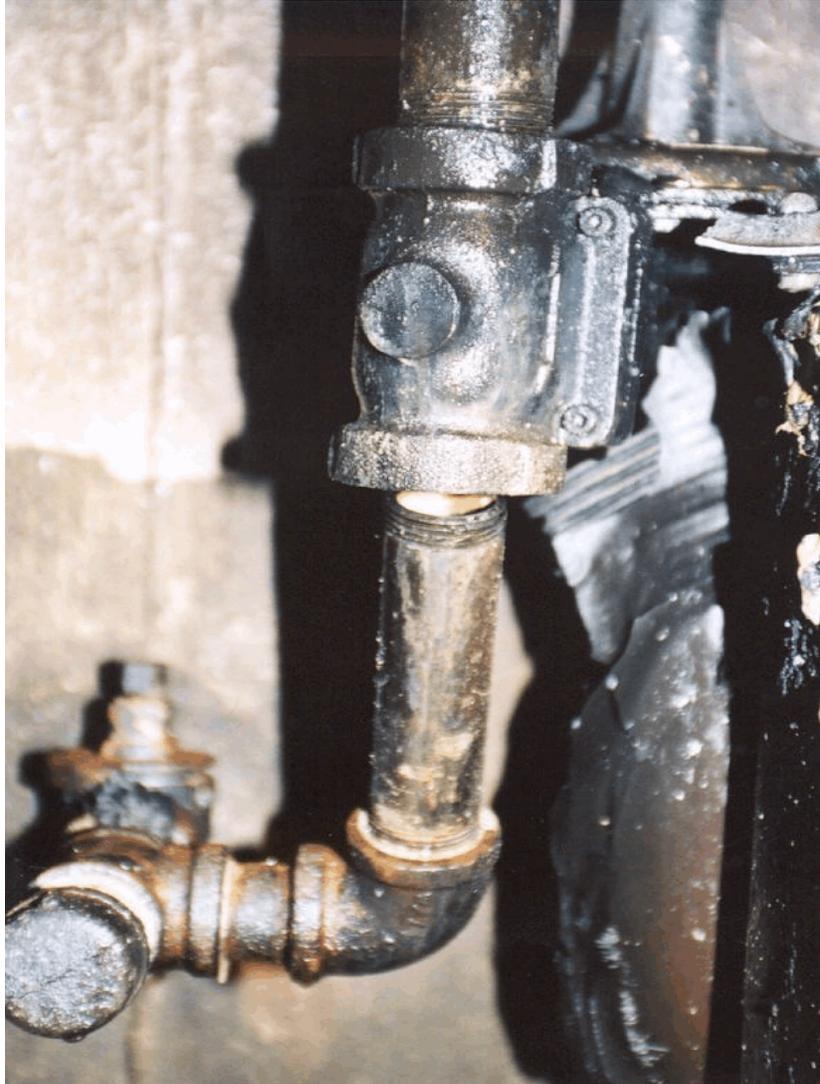
Exhibit 22: Close up view of the crack in the piping at the service regulator inlet.

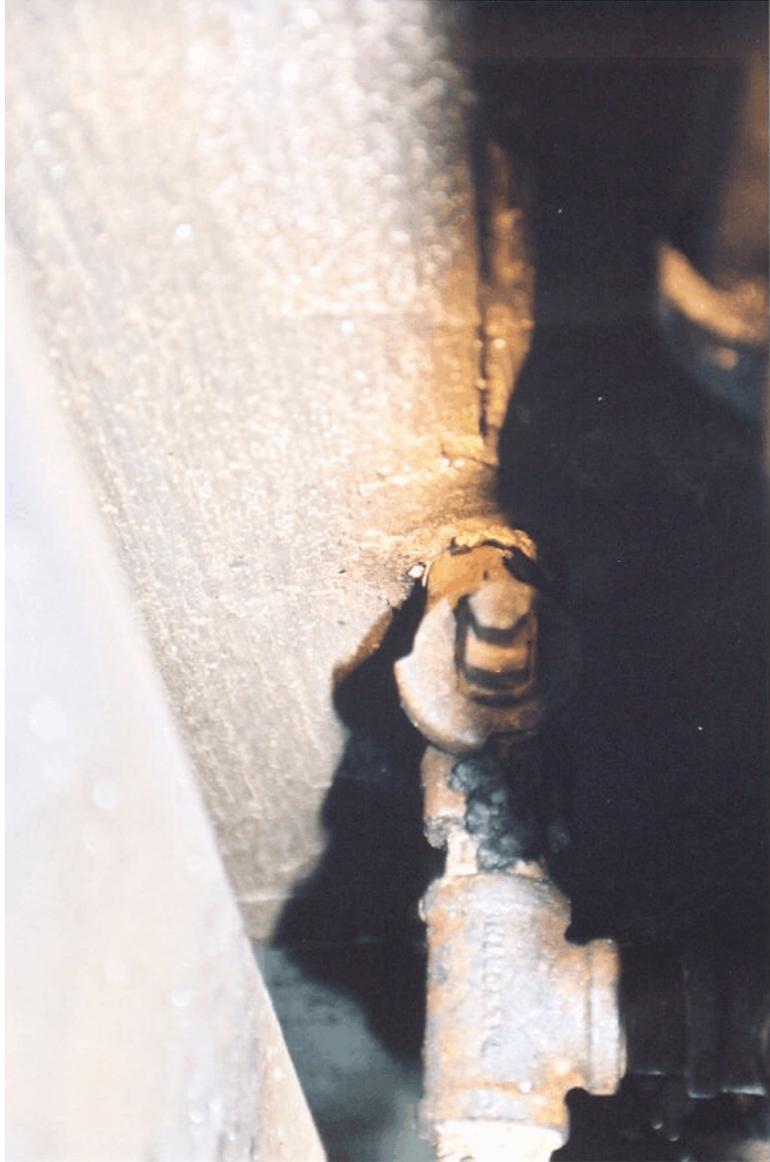
Exhibit 23: Close up view of the service valve pulled up against the foundation wall.

Two sections of pipe were recovered from #9 Bonito Drive by the D.T.E.'s investigators. The first section consisted of the manual shutoff valve, a tee, an elbow, and a broken length of pipe. This section extended from the foundation wall to the service regulator inlet. The break occurred where the pipe was connected to the inlet of the service regulator (Exh. 22). The manual shutoff valve was pulled up against the foundation wall when the backhoe pulled on the service line (Exh. 23).

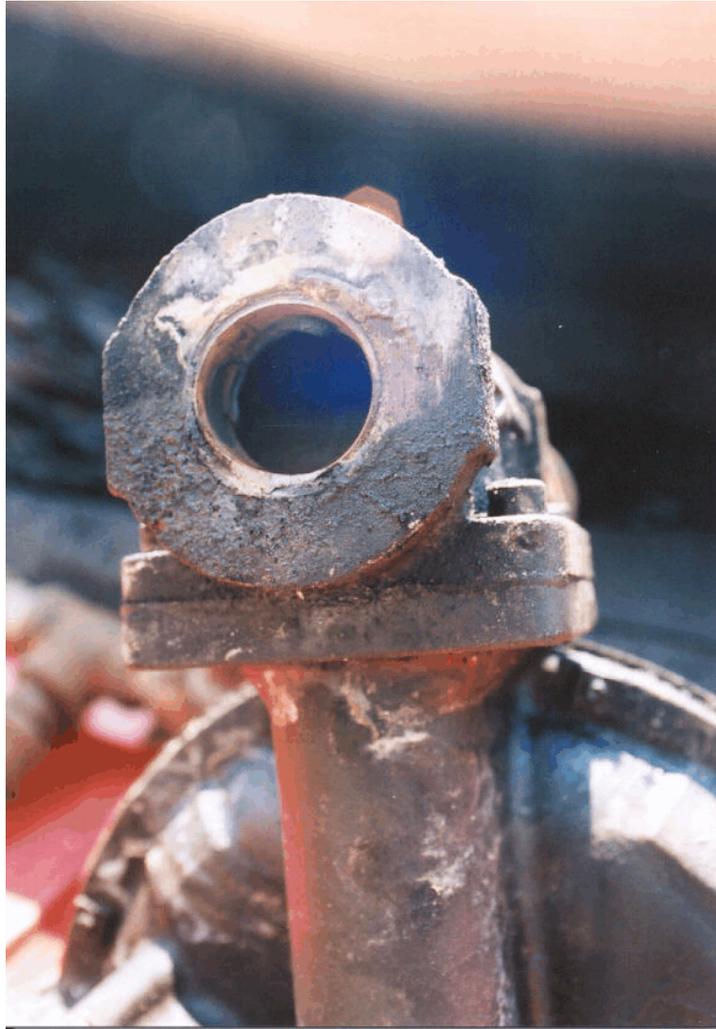
Exhibit 24a: Close up view of the downstream fracture surface on the service line inside the service regulator inlet fitting.

The second section of pipe consisted of the service regulator itself. A piece of pipe remained threaded into the inlet side of the regulator (Exh 24a). The exposed end of this piece had been fractured. The fracture surface closely matches the fracture surface of the downstream end of the pipe that is part of the first section (Exh. 24b).

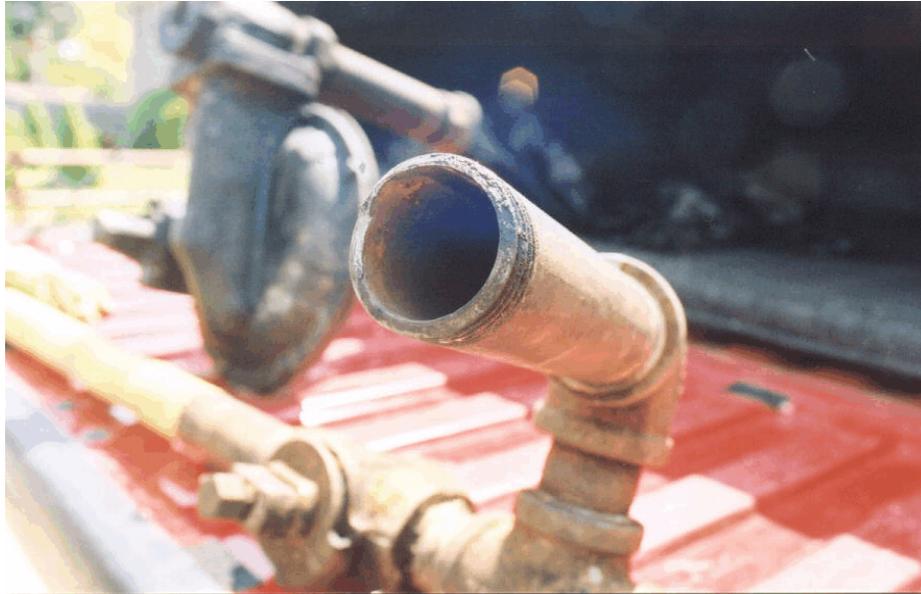
Exhibit 24b: Close up view of the upstream fracture surface on the service line.

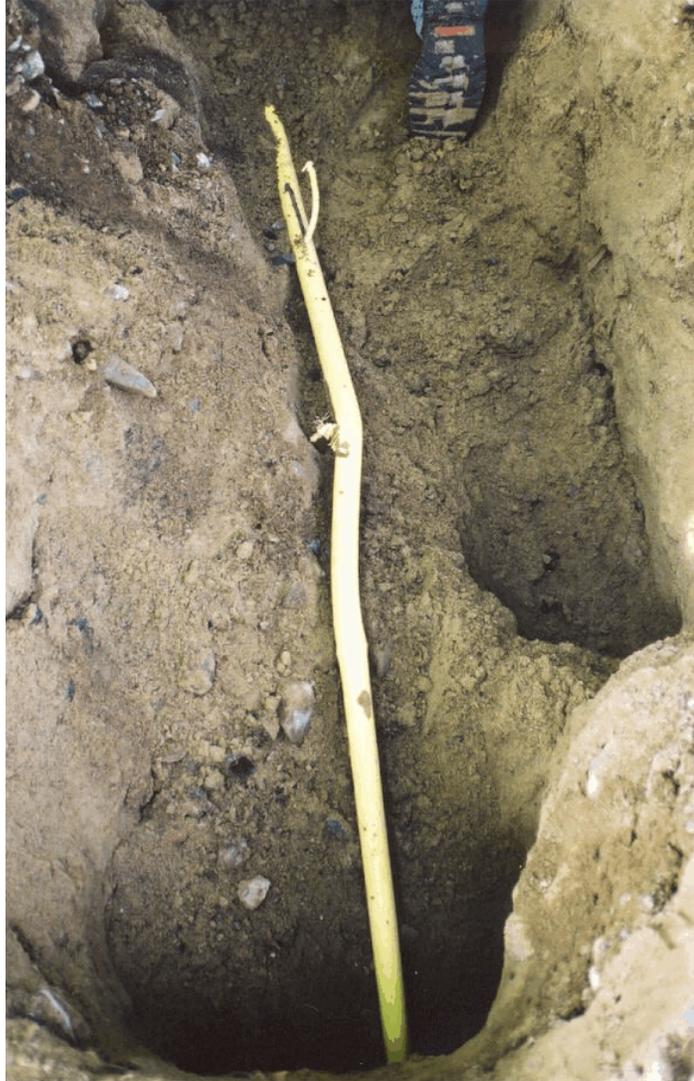
Exhibit 25: Service line showing the tears in the coating and bends caused by the backhoe.

The section of service line that was struck by the backhoe showed damage to the coating and scrape marks on the steel (Exh. 25). The service line was also bent in two places. There were no punctures in the pipe (Exh. 25).
