INDOOR AIR QUALITY REASSESSMENT

**Winthrop Elementary School
162 First Street
Melrose, MA 02176**

Prepared by:
Massachusetts Department of Public Health
Center for Environmental Health
April 2007

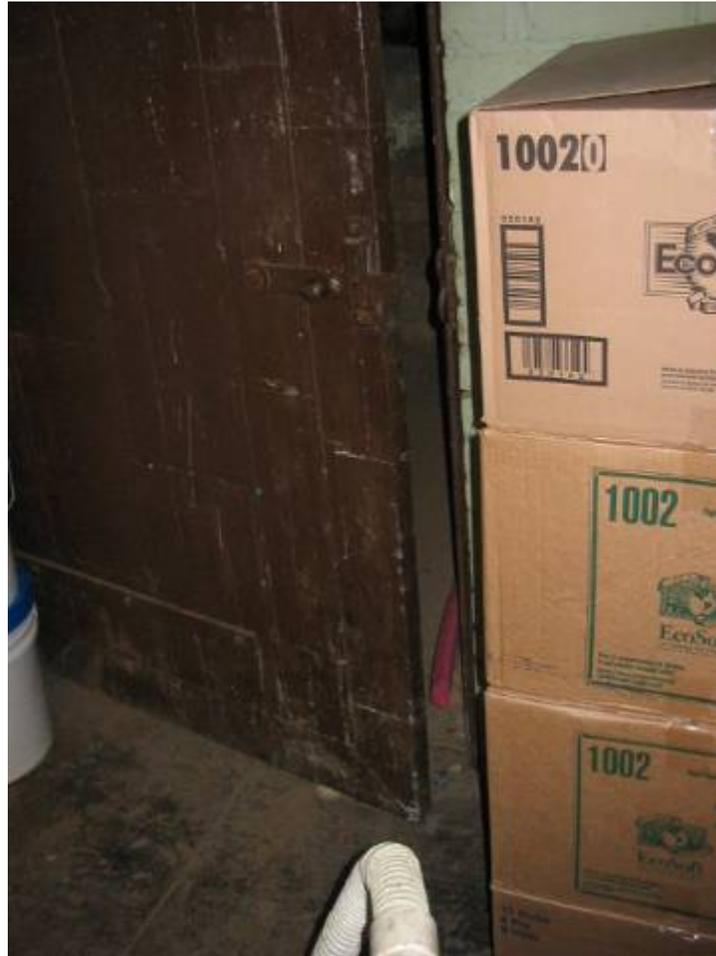
Picture 1

Outdoor PM_{2.5} concentrations were measured at $18 \mu\text{g}/\text{m}^3$ (Table 1). PM_{2.5} levels measured indoors ranged from 10 to $40 \mu\text{g}/\text{m}^3$, below the NAAQS PM_{2.5} level of $35 \mu\text{g}/\text{m}^3$ in all but two areas. In classroom 35, where CEH staff measured a PM_{2.5} level of $38 \mu\text{g}/\text{m}^3$, students had recently exited the building for lunch. In art hallway, a PM_{2.5} level of $38 \mu\text{g}/\text{m}^3$ was measured. This can be attributed to the open crawlspace door

(Picture 1). An earthy odor was also detected in the hallway outside the art room. This odor is also related to the open crawlspace door. This door should remain closed at all times to prevent movement of crawlspace odors and particulates into occupied areas.

Door to crawlspace ajar in art hallway

1. Ensure hallway door crawlspace is closed during school hours.
2. Repair water leak that is causing wetting of woodwork in classroom 35
3. Use openable windows in conjunction with classroom mechanical ventilation to increase air exchange. Care should be taken to ensure windows are properly closed at night and weekends to avoid the freezing of pipes and potential flooding.
4. Consider installing local exhaust ventilation in the photocopier area.
5. Discontinue the use of tennis balls on chairs to prevent latex dust generation.
6. Remove and replace damaged floor tile in classroom.
