INDOOR AIR QUALITY ASSESSMENT

**East Junior High School
464 Centre Street
Brockton, Massachusetts 02302**

Prepared by:
Massachusetts Department of Public Health
Bureau of Environmental Health
Indoor Air Quality Program
June 2008

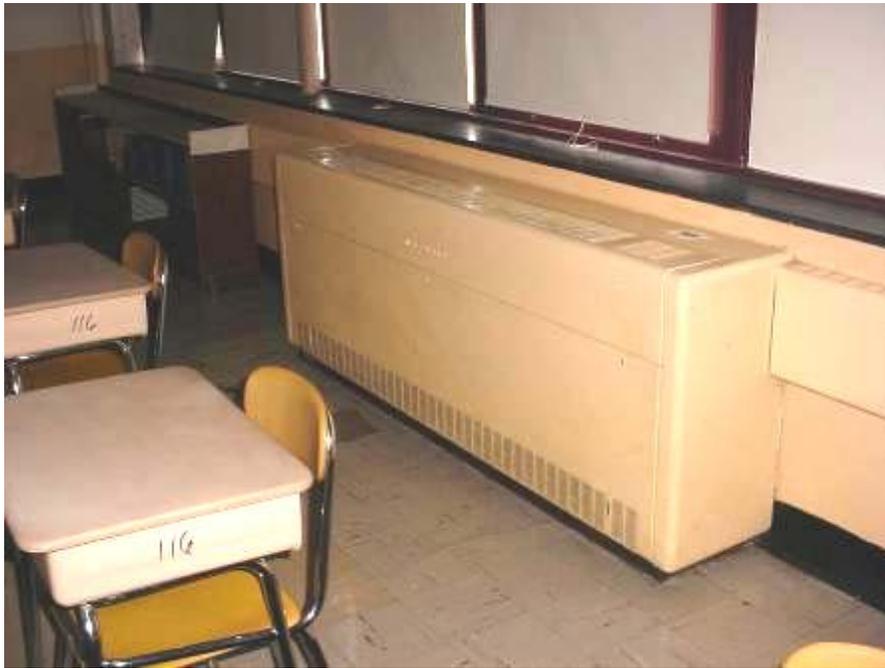
Picture 1

Fresh air in classrooms is supplied by unit ventilator (univent) systems (Picture 1). A univent draws air from the outdoors through a fresh air intake located on the exterior wall of the building (Picture 2) and returns air through an air intake located at the base of the unit ([Figure 1](#)). Fresh and return air are mixed, filtered, heated and provided to classrooms through an air diffuser located in the top of the unit. Univents are original to the building; therefore, efficient function of such equipment can be difficult to maintain since compatible replacement parts are often unavailable. Univents were found operating weakly or deactivated in a number of areas. Therefore, limited means at best exists to provide mechanical ventilation in these rooms at the time of the assessment. Univents were also found obstructed by books, furniture and stored

Classroom Univent

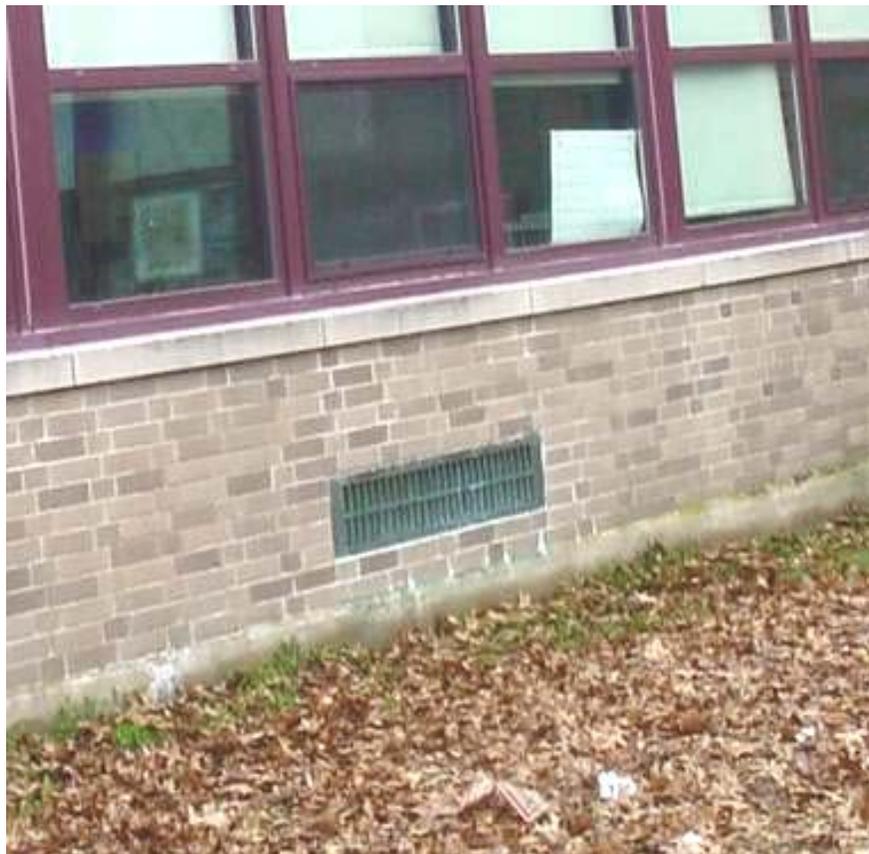
Picture 2

Univent Fresh Air Intake

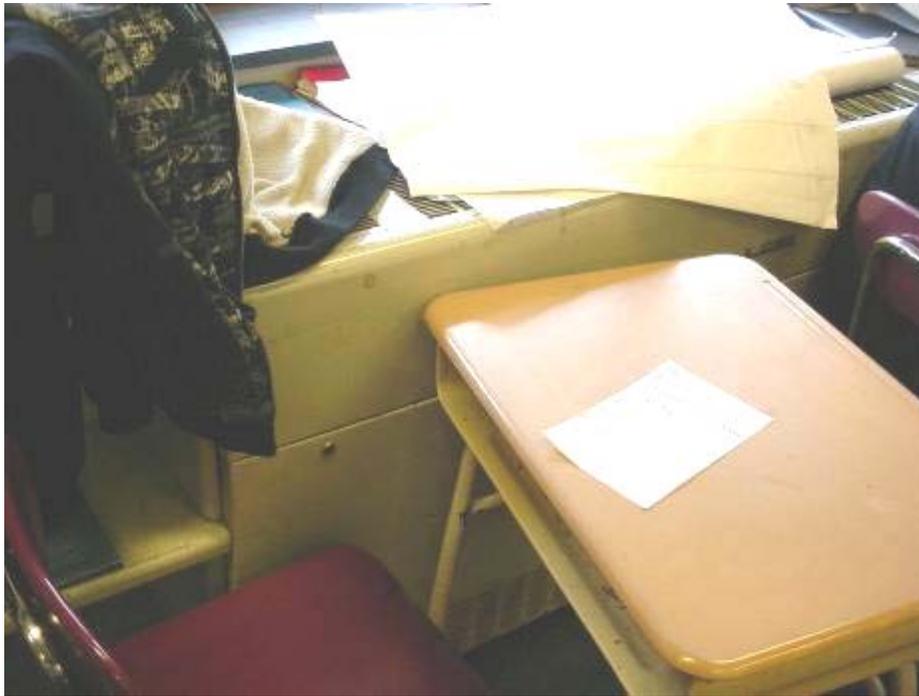
Picture 3

materials (Picture 3). In order for univents to provide fresh air as designed, intakes/returns must remain free of obstructions. Importantly, these units must remain “on” and be allowed to operate while rooms are occupied.

Univent Blocked by Desk and Papers

1. Continue to implement corrective actions listed in the DOS report (MDLWD, 2005).
2. Operate all ventilation systems throughout the building (e.g., gym, cafeteria, classrooms) continuously during periods of school occupancy and independent of thermostat control. To increase airflow in classrooms, set univent controls to “high”.
3. Inspect exhaust motors and belts for proper function. Repair and replace as necessary.
4. Remove all blockages from univents and exhaust vents to ensure adequate airflow.

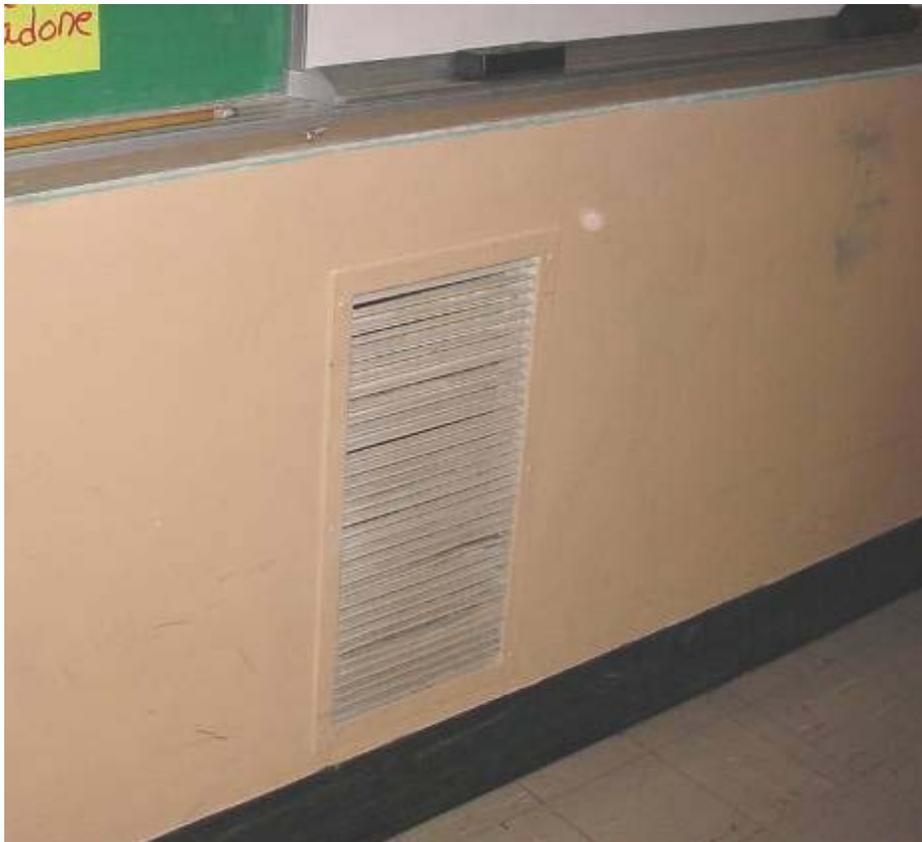
Picture 4

Exhaust ventilation in classrooms is provided by wall or ceiling vents ducted to rooftop motors (Pictures 4 and 5). Exhaust ventilation was found deactivated in a number of areas during the assessment (Table 1). In addition, a heavy accumulation of dirt, dust and debris was observed in several exhaust vents (Pictures 6 and 7), which limits airflow. As with univents, in order to function properly, exhaust vents must be activated and allowed to operate while rooms are occupied. Without adequate supply and exhaust ventilation, excess heat and environmental pollutants can build up and lead to indoor air/comfort complaints.

Wall-mounted Exhaust Vent

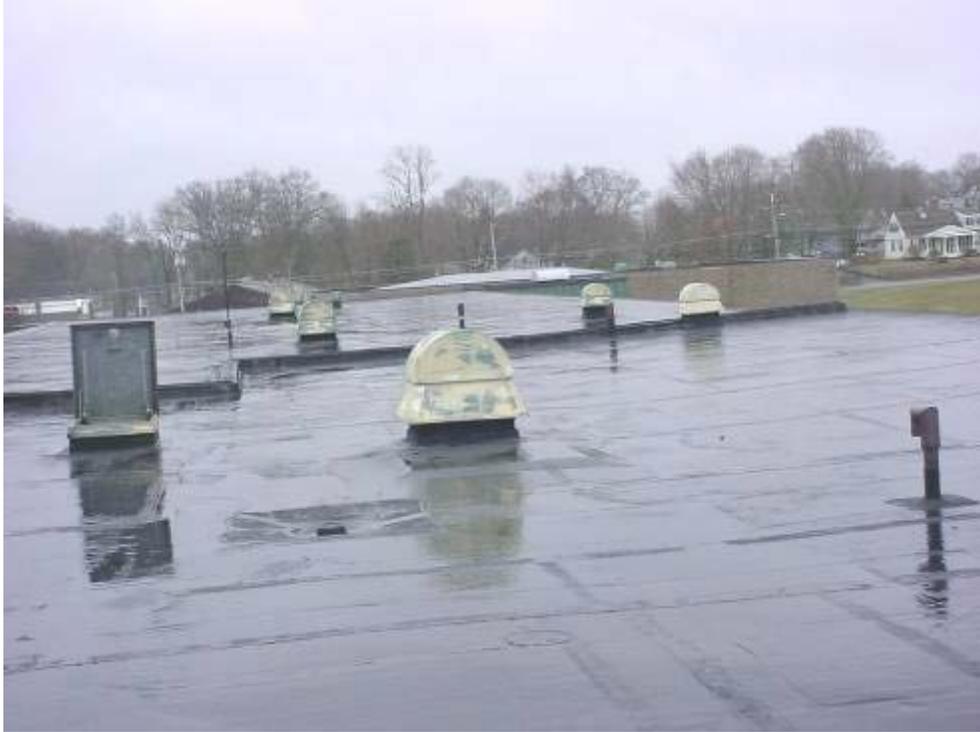
Picture 5

Rooftop Exhaust Motors

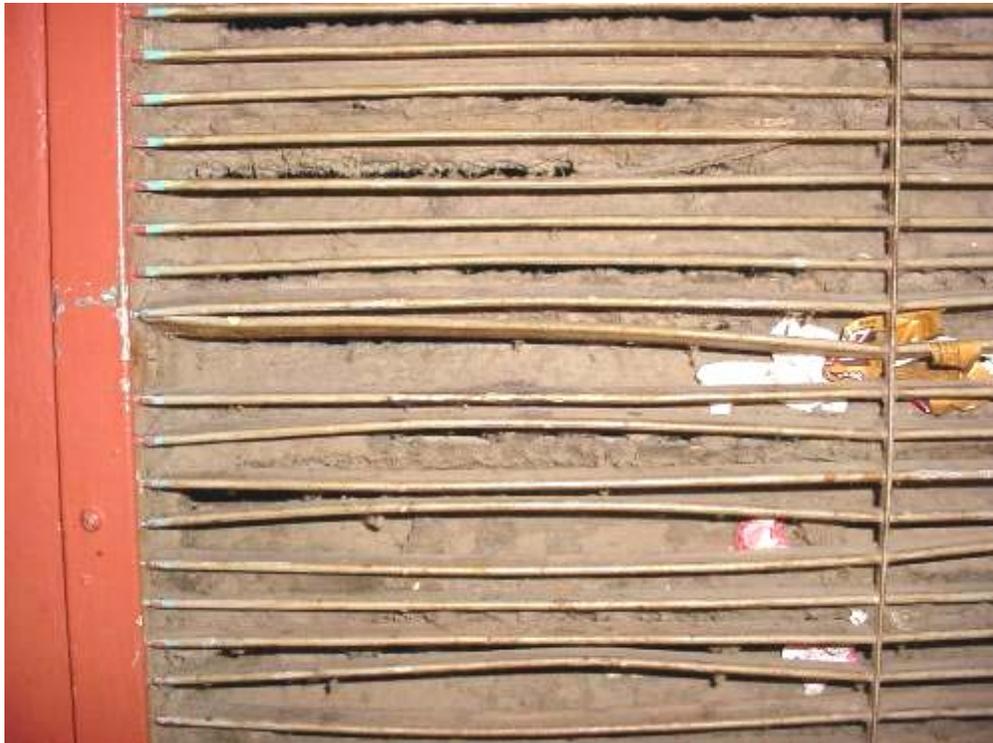
Picture 6

A number of exhaust/return vents, univent air diffusers and personal fans were observed to have accumulated dust/debris (Pictures 6 and 7). If exhaust vents are not functioning, backdrafting can occur, which can re-aerosolize accumulated dust particles. Re-activated univents and fans can also aerosolize dust accumulated on vents/fan blades.

Accumulation of Dirt, Dust and Debris in Cafeteria Exhaust Vent, Note Vent is almost Completely Occluded Preventing Airflow

16. Clean personal fans, univent air diffusers, return vents and exhaust vents periodically of accumulated dust.
17. Clean chalk and dry erase trays to prevent accumulation of materials.

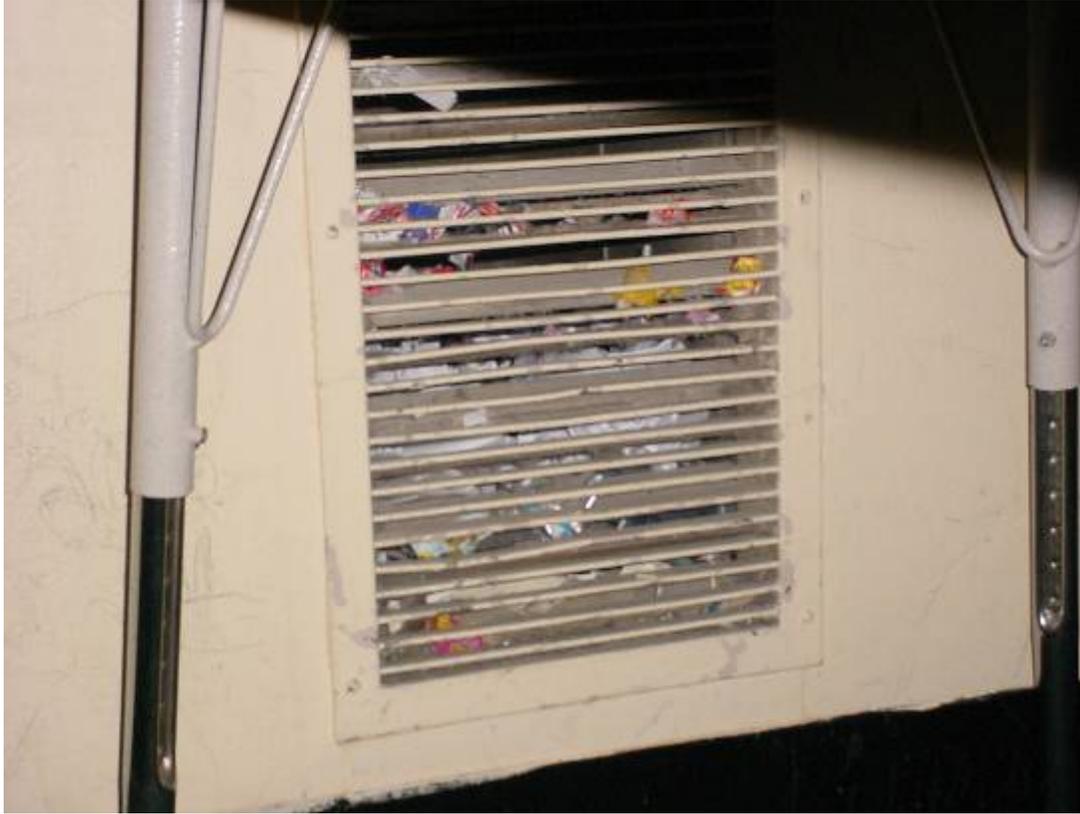
Picture 7

Accumulation of Dust and Debris in Exhaust Vent in classroom

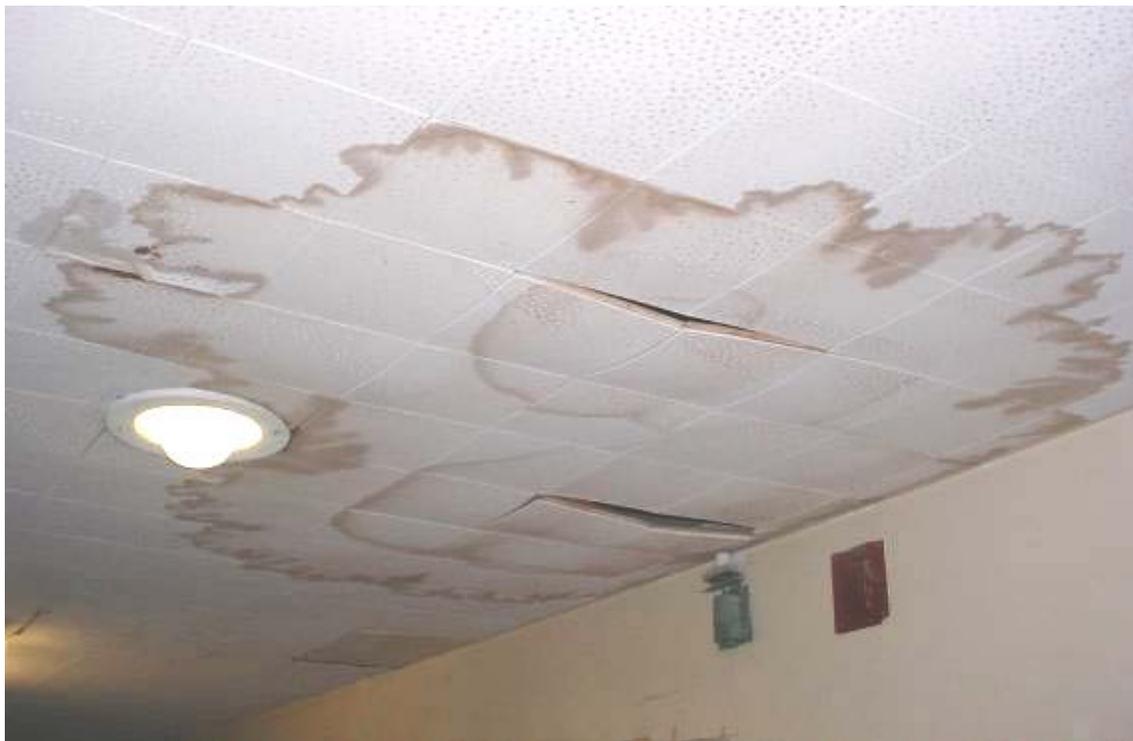
Picture 8

Several potential sources of water damage and/or mold growth were observed. Numerous areas had water-damaged/missing ceiling tiles and/or stains on walls, which can indicate leaks from either the roof or plumbing system (Picture 8/Table 1). Active roof leaks were reported and evidenced in the form of water damaged building materials in various rooms and hallways throughout the building. In order to prevent water from pooling above the ceiling, holes were cut in ceiling tiles allowing water to drain (Picture 9). The ceiling tile system at EJHS consists of inter-locking tiles that necessitate removal of portions of the ceiling, which makes removal/replacement difficult. In the gym hallway, mold was visible on a ceiling tile (Picture 10). However, there was no evidence of further mold growth above the ceiling tiles. Dark staining was observed on the gym hallway wall; however, the substance appeared to be from roofing material and not mold growth (Picture 11). Water-damaged ceiling tiles can

Water-damaged Ceiling Tiles

indicate sources of water penetration and provide a source of mold. Ceiling tiles should be replaced after a water leak is discovered and repaired.

8. Until roof can be replaced, continue to patch roof leaks as needed. Remove/replace any water damaged ceiling tiles.
9. Clean staining on walls in gym hallway (shown in Picture 11).

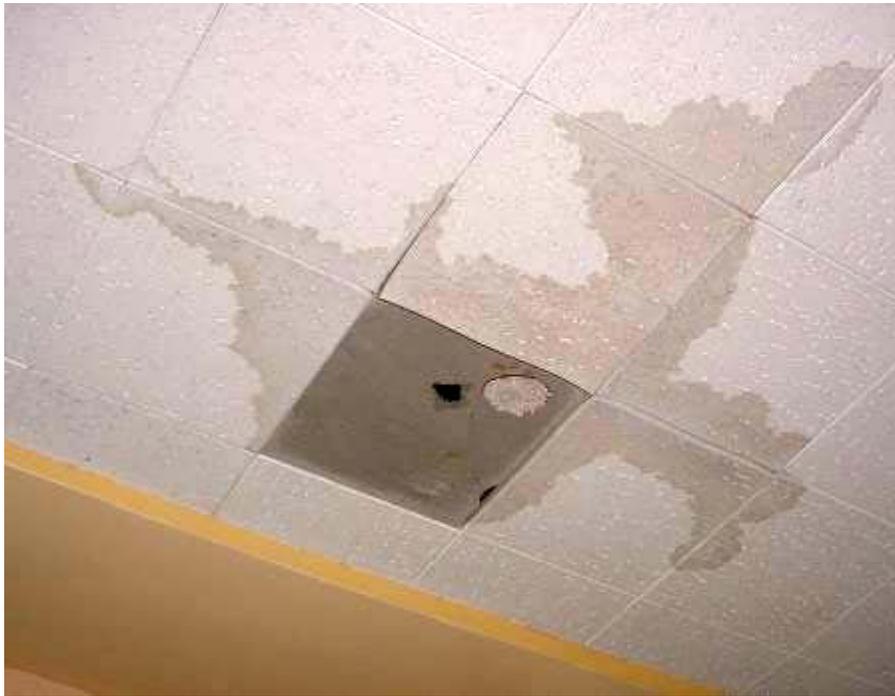
Picture 9

Holes Cut in Ceiling Tile to Allow Water to Drain

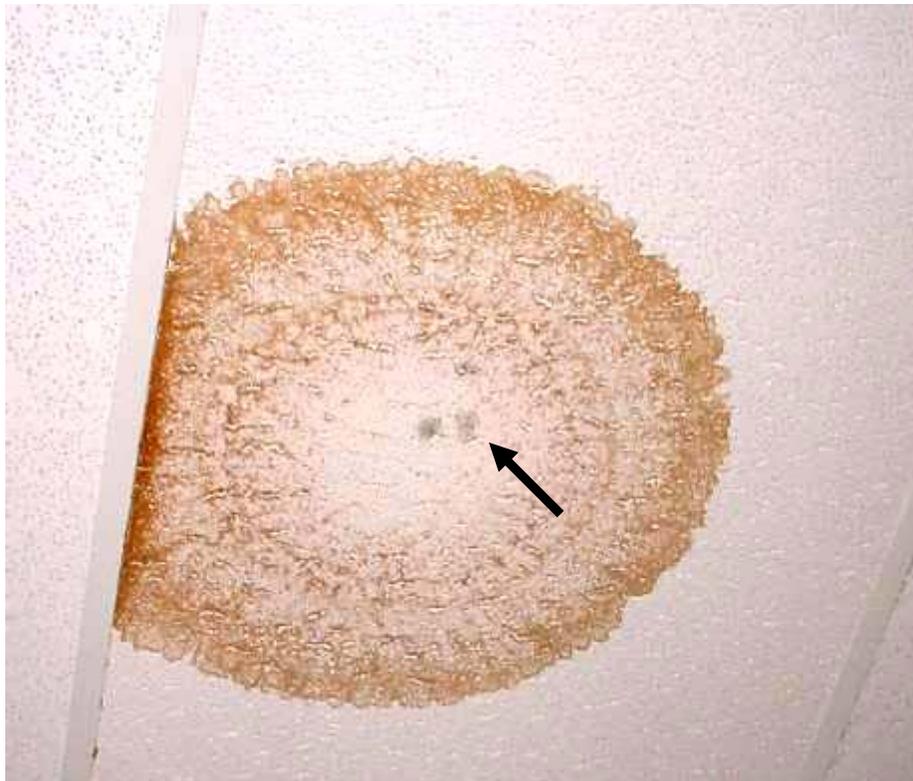
Picture 10

**Visible Mold (Dark Staining in Center)
on Water Damaged Ceiling Tile in Gymnasium Hallway**

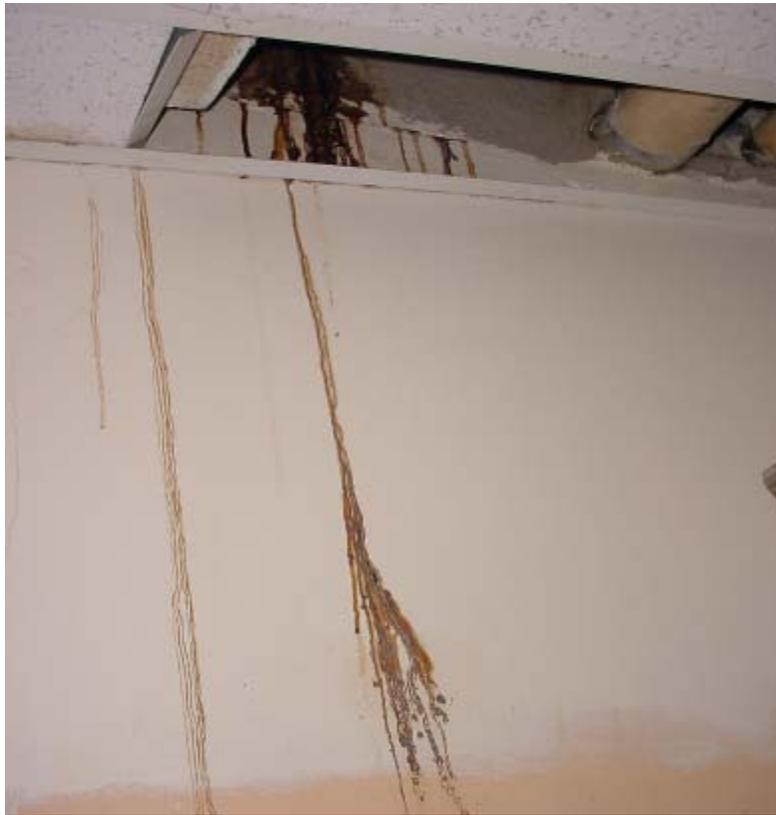
Picture 11

Dark Staining on Wall in Gym Hallway

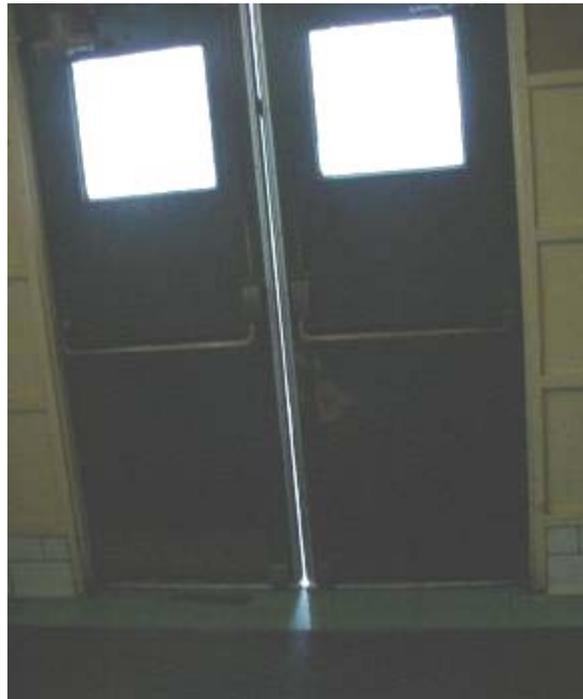
Picture 12

Several exterior doors throughout the building had damaged weather stripping, and light could be seen penetrating through the spaces underneath the door from the outdoors (Picture 12). Spaces beneath exterior doors can serve as a source of water entry into the building, causing water damage and potentially leading to mold growth. In addition, these spaces can serve as pathways for insects, rodents and other pests into the building. Rodent droppings were observed in one classroom (105).

Damaged Weather Stripping on Exterior Door, Note Light Penetration

10. Install weather stripping around exterior doors to prevent drafts, water penetration and pest entry.
11. Examine all expansion joint seals on the exterior wall system. Reseal all expansion joints with damaged, missing or eroded sealant.

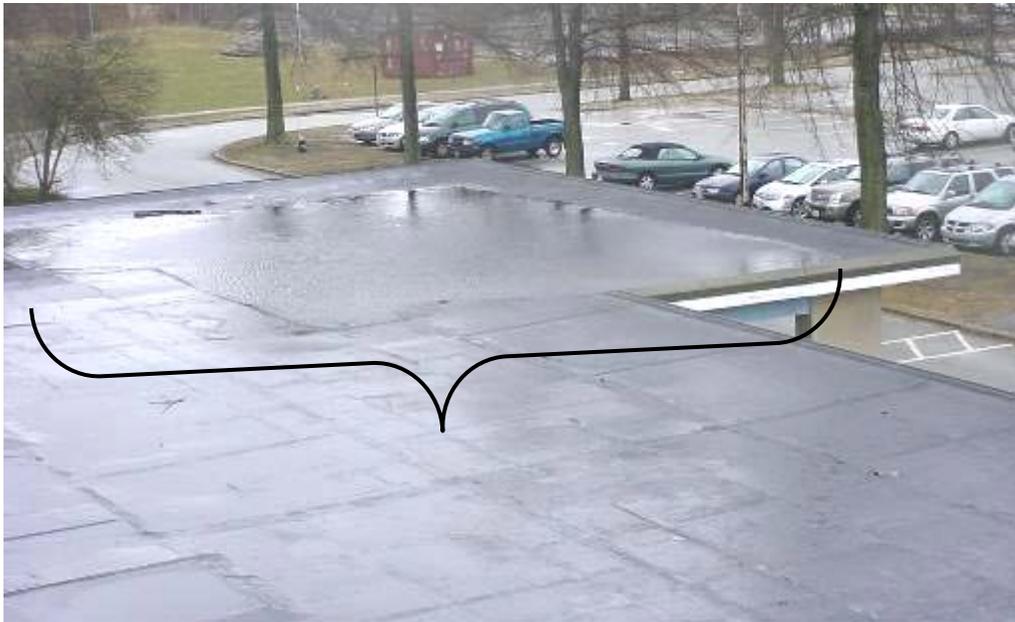
Picture 13

Pooling water was observed in a number of areas on the roof (Picture 13) due to lack of drainage. The freezing and thawing of water during winter months can lead to roof leaks and subsequent water penetration into the interior of the building. Pooling water can also become

stagnant, which can lead to mold and bacterial growth, and serve as a breeding ground for mosquitoes.

Water Pooling on Roof over Main Entrance

1. Continue with plans for roof replacement to prevent further leaks into the building interior. Plans for roof work should include improved drainage to prevent pooling.
2. Consider total removal/replacement of interlocking ceiling tile system.
3. Contact an HVAC engineering firm for an assessment of the ventilation system (e.g., controls, air intake louvers, thermostats). Based on the age, physical deterioration and availability of parts for ventilation components, such an evaluation is necessary to determine the operability and feasibility of repairing/replacing the equipment.

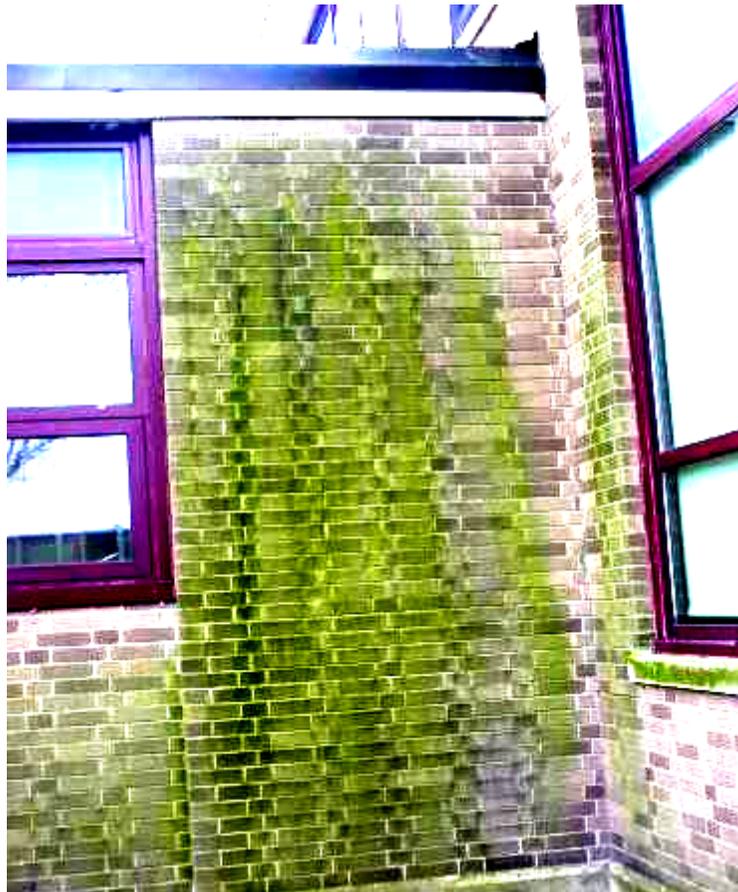
Picture 14

- Exterior brickwork was visibly moist and had moss growth on the surface (Pictures 14 and 15). Moss growth is a sign of heavy/continuous water exposure and holds moisture against the building;
- Shrubbery/trees growing in close proximity to the building (Picture 15), which holds moisture against exterior brick and prevents drying;
- Missing/damaged mortar and exterior brick (Pictures 16 and 17);
- Open utility holes (Picture 18);
- Corroded/damaged metal bulkhead in the rear of the building (Picture 19);
- Missing/damaged joint compound (Picture 20); and
- Missing/damaged caulking around univent fresh air intakes (Picture 16).

Moss Growth (Dark Staining) on Exterior Brickwork

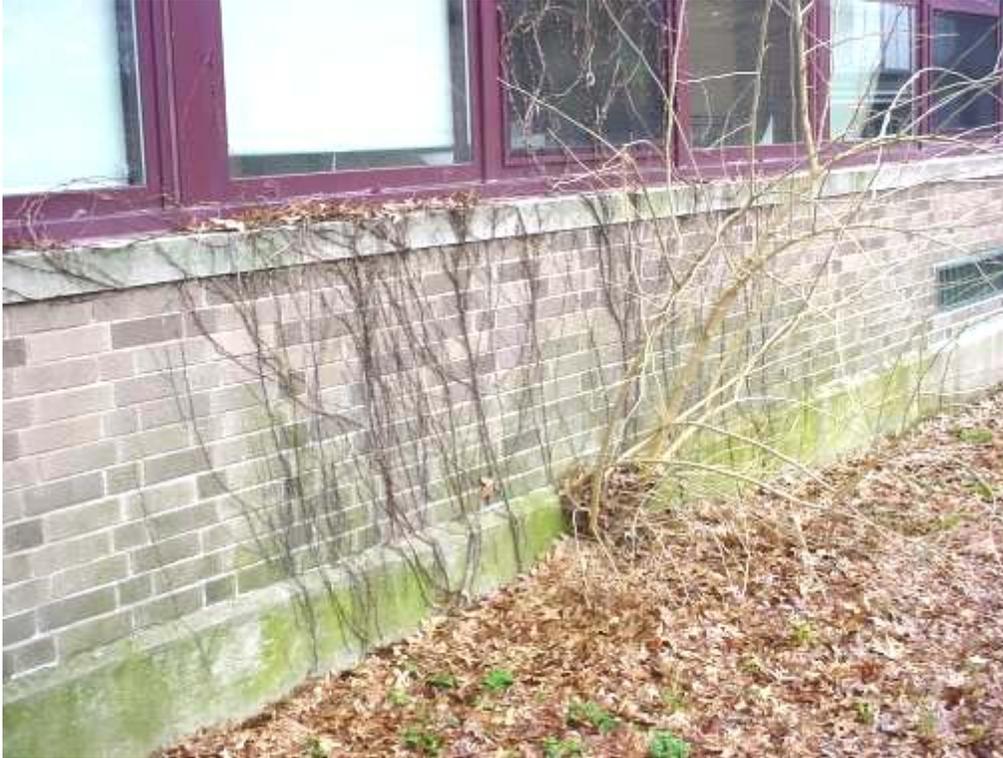
Picture 15

Moss (Dark Staining along Base) and Tree Growth on/near Exterior Brickwork

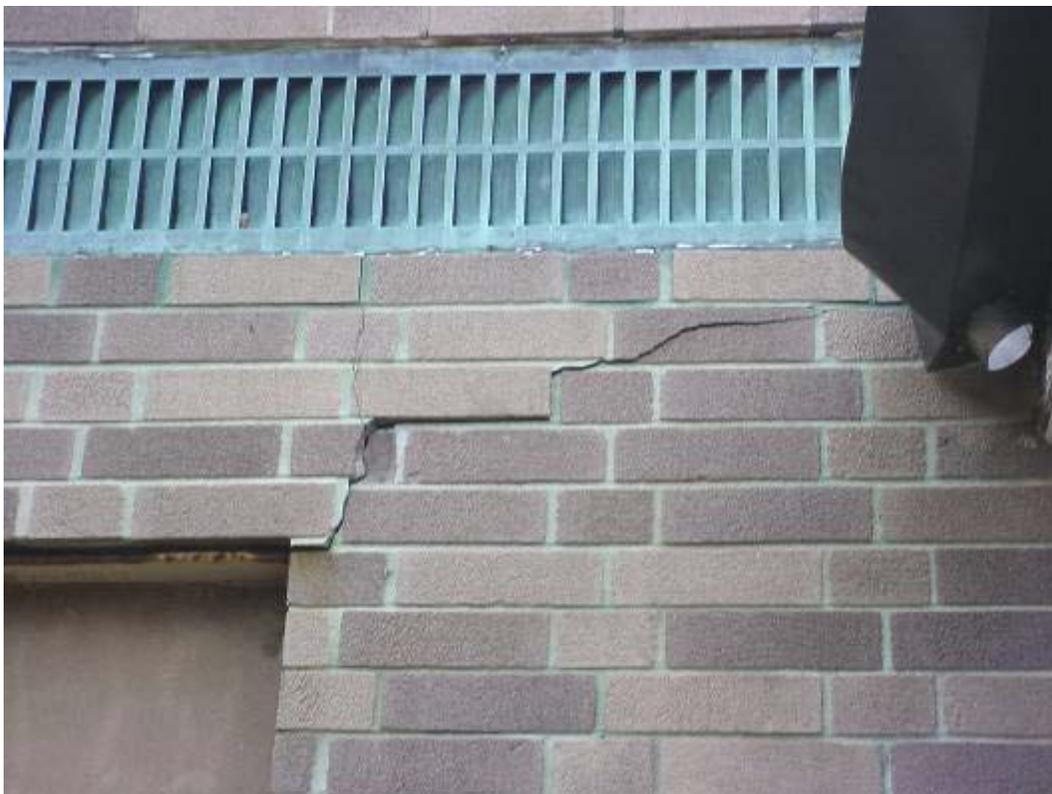
Picture 16

Damaged Mortar and Exterior Wall Cracks

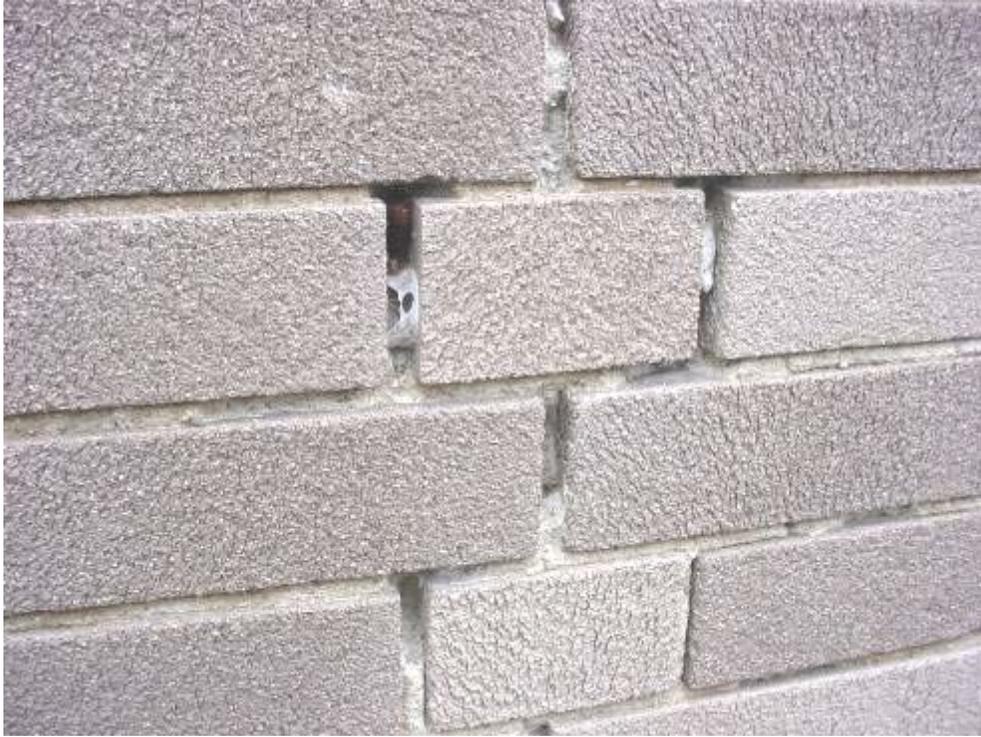
Picture 17

Damaged Mortar and Exterior Brick

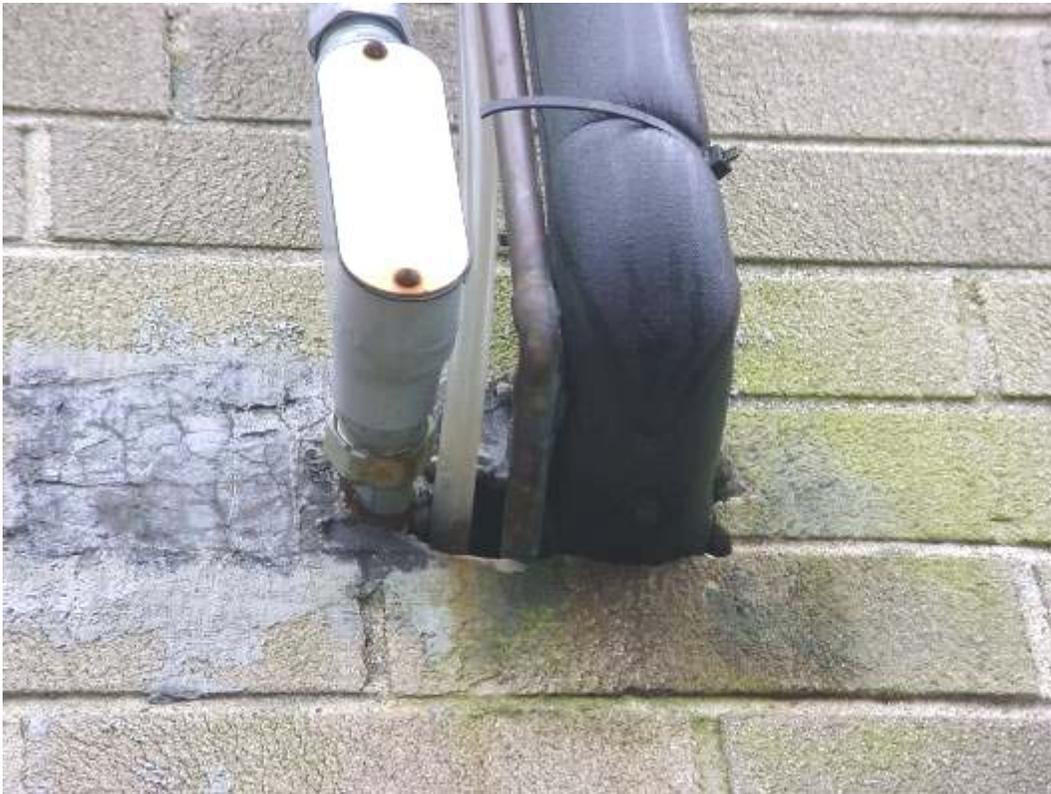
Picture 18

Open Utility Hole on Building Exterior

12. Make repairs/replace damaged metal bulkhead at the rear of the building and seal spaces around exterior utility holes.

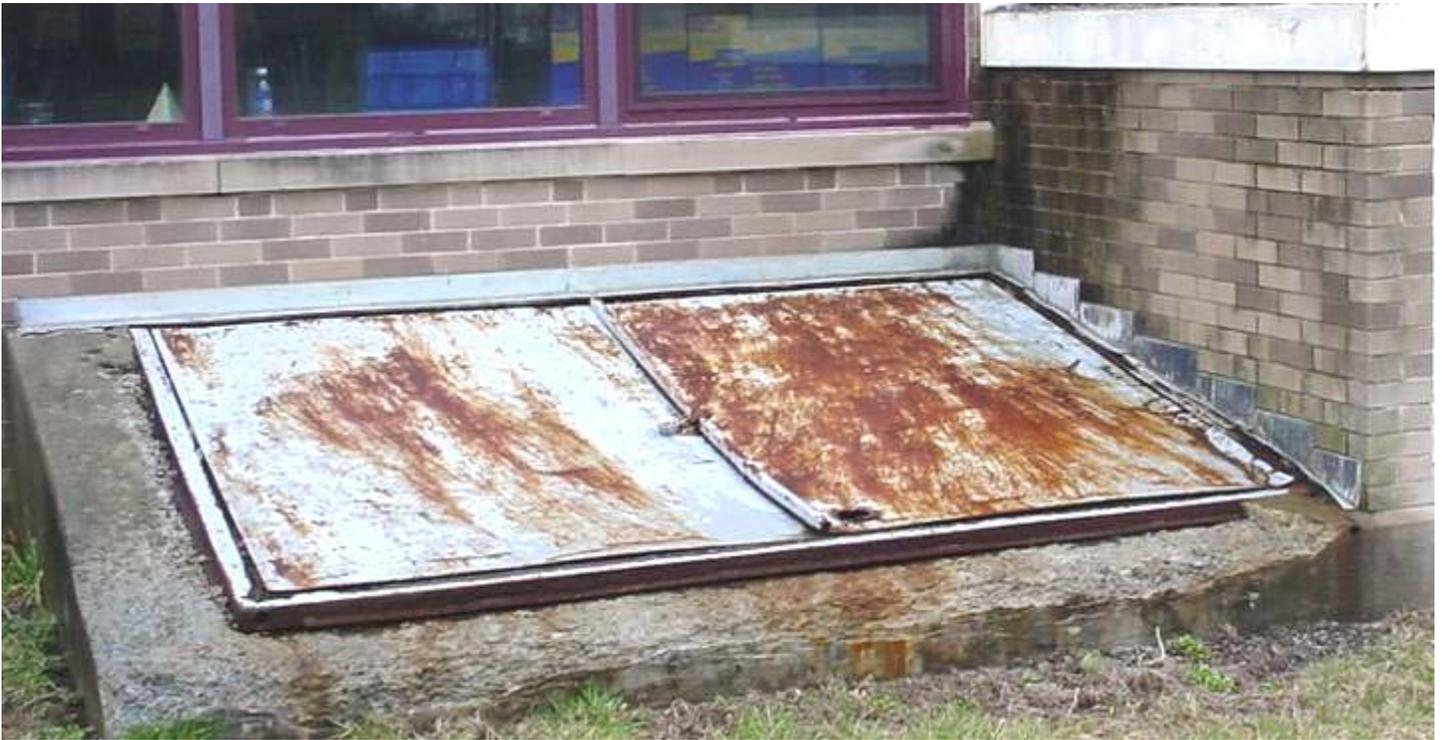
Picture 19

Corroded/Damaged Metal Bulkhead at Rear of Building

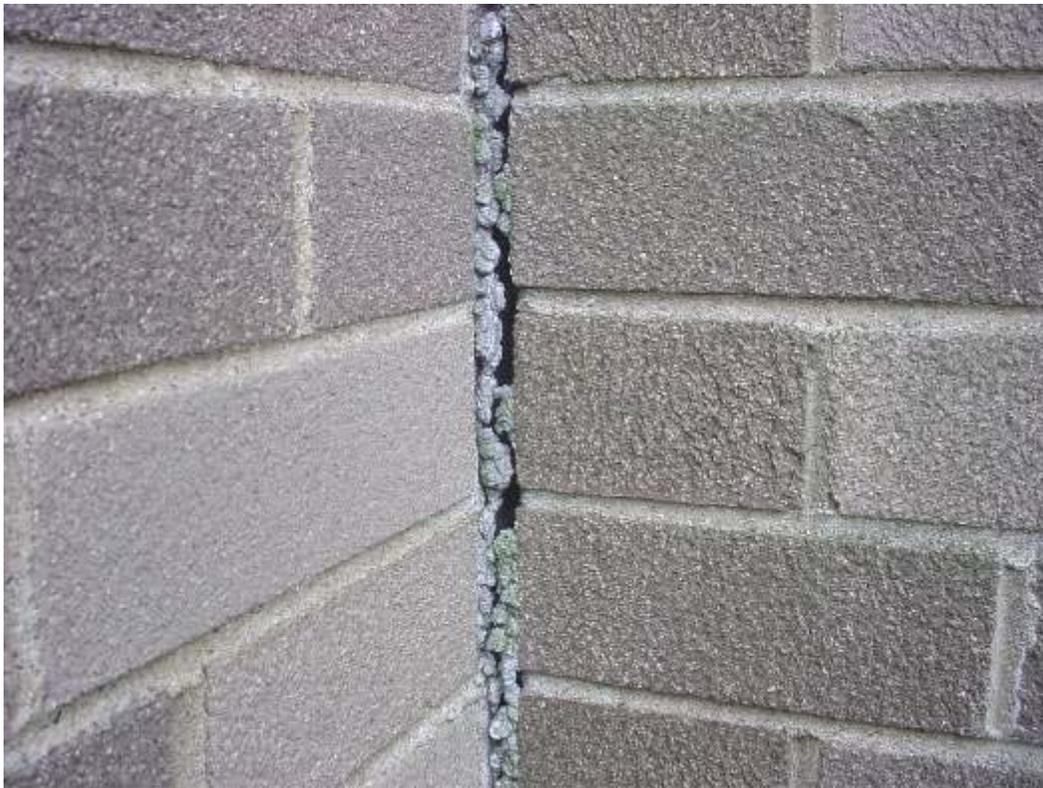
Picture 20

Missing/Damaged Joint Compound

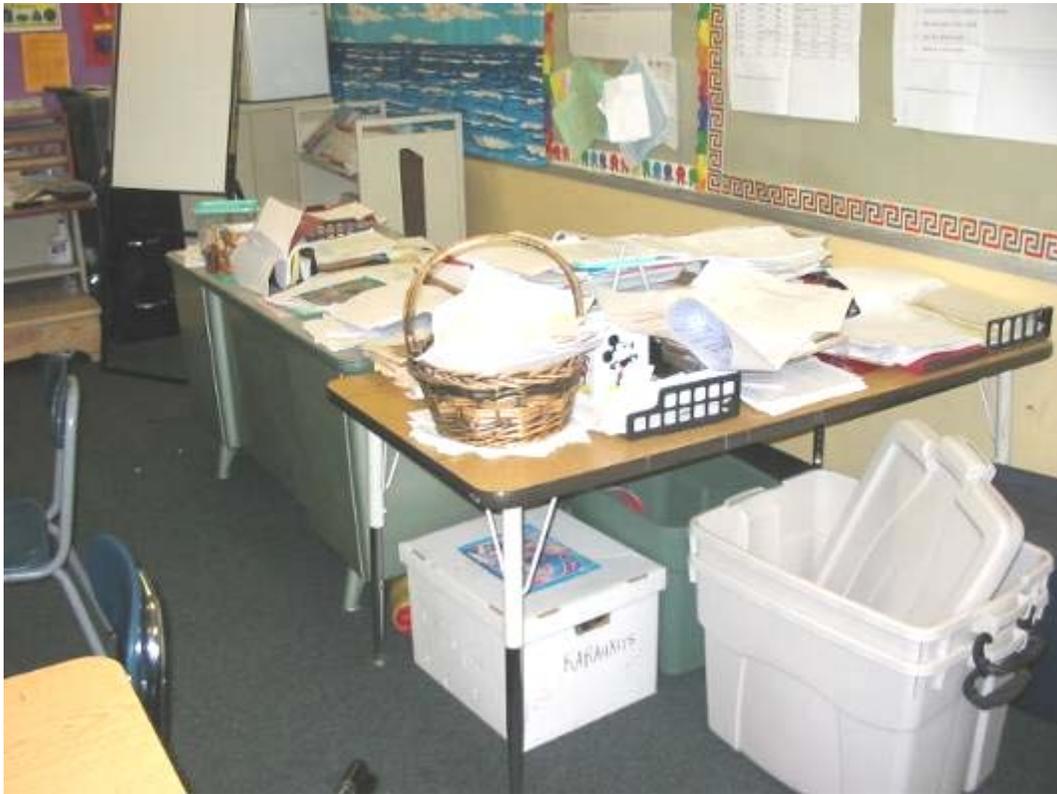
Picture 21

Other conditions that can affect indoor air quality were observed during the assessment. In several classrooms, items were observed on windowsills, tabletops, counters, bookcases and desks (Pictures 21 and 22). The large number of items stored in classrooms provides a source for dusts to accumulate. These items (e.g., papers, folders, boxes) make it difficult for custodial staff to clean. Items should be relocated and/or be cleaned periodically to avoid excessive dust build up. In addition, these materials can accumulate on flat surfaces (e.g., desktops, shelving and carpets) in occupied areas and subsequently be re-aerosolized causing further irritation.

Accumulated Items on Flat Surfaces in Classroom

15. Relocate or consider reducing the amount of materials stored in classrooms to allow for more thorough cleaning of classrooms. Clean items regularly with a wet cloth or sponge to prevent excessive dust build-up.

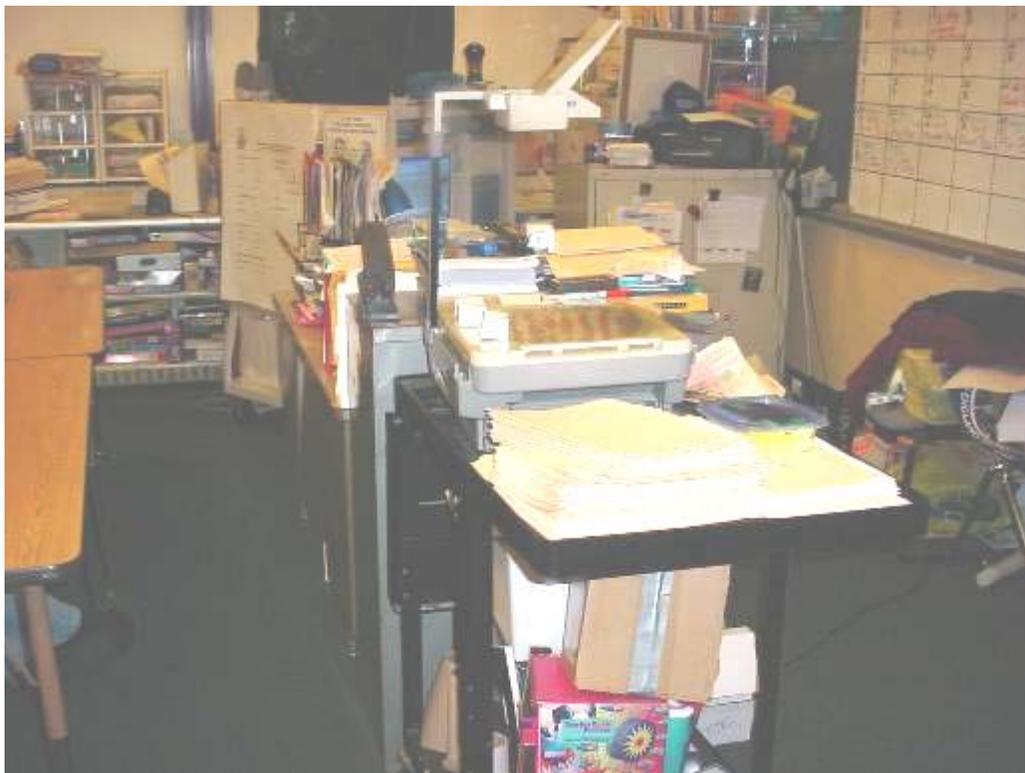
Picture 22

Accumulated Items on Flat Surfaces in Classroom

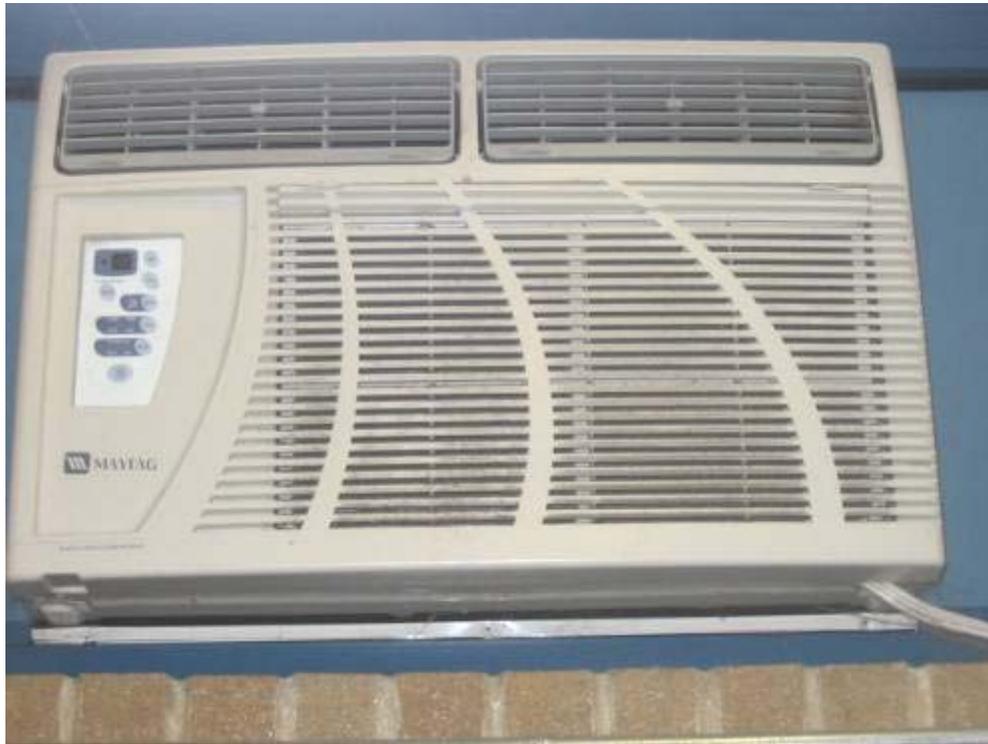
Picture 23

Several areas had window-mounted air conditioners (ACs) (Picture 23). ACs are normally equipped with filters, which should be cleaned or changed as per manufacturer's instructions to avoid the build-up and re-aerosolization of dirt, dust and particulate matter.

Window-mounted AC

18. Change filters for air-handling equipment (e.g., univents, AHUs and ACs) as per the manufacturer's instructions or more frequently if needed. Vacuum interior of units prior to activation to prevent the aerosolization of dirt, dust and particulates. Ensure filters fit flush in their racks with no spaces in between allowing bypass of unfiltered air into the unit.

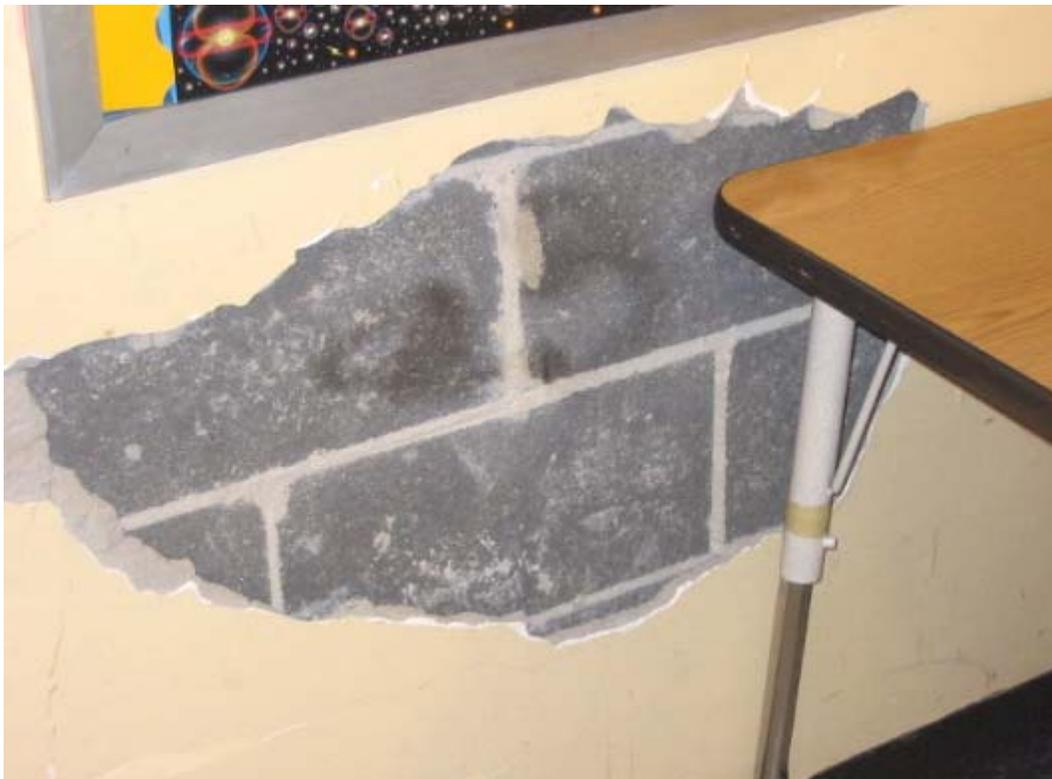
Picture 24

Finally, in several areas of the building, BEH staff observed extensive wall damage (Picture 24). These breaches (if opened into wall cavities) can provide pathways for drafts, dust, odors and particulates to migrate into occupied areas.

Damaged Interior Wall in Classroom

19. Seal any open holes/breaches in interior walls to prevent the migration of drafts, odors, particulates from wall cavities into occupied areas.
20. Consider adopting the US EPA (2000) document, "Tools for Schools", as an instrument for maintaining a good indoor air quality environment in the building. This document is available at: <http://www.epa.gov/iaq/schools/index.html>.
