INDOOR AIR QUALITY ASSESSMENT

**Gilmore Academy
150 Clinton Street
Brockton, Massachusetts 02302**

Prepared by:
Massachusetts Department of Public Health
Bureau of Environmental Health
Indoor Air Quality Program
September 2008

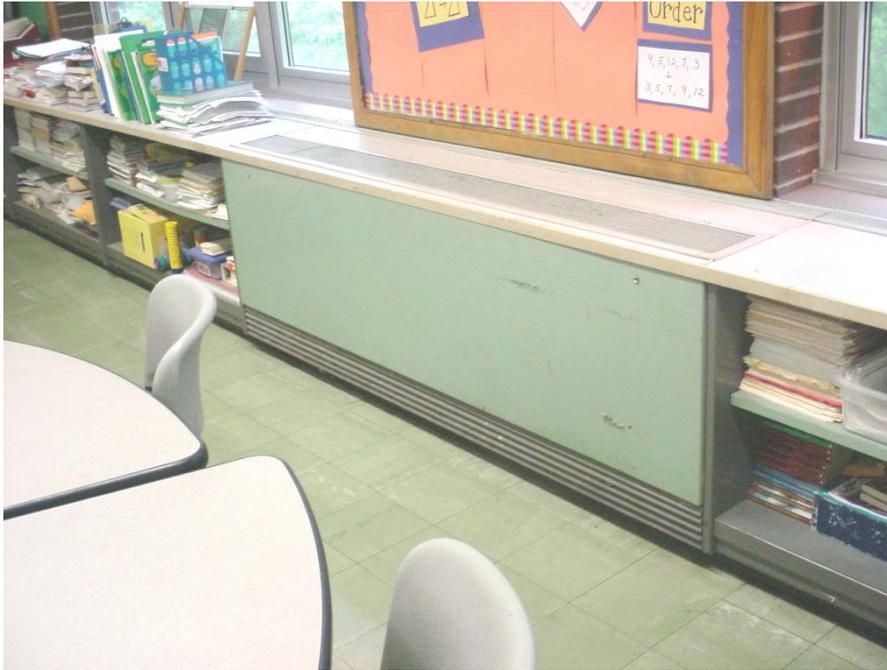
Picture 1

Fresh air is supplied to classrooms by unit ventilator (univent) systems (Picture 1). A univent draws air from the outdoors through a fresh air intake located on the exterior wall of the building (Picture 2) and returns air through an air intake located at the base of the unit ([Figure 1](#)). Fresh and return air are mixed, filtered, heated and provided to classrooms through an air diffuser located in the top of the unit. Univents were found deactivated in a number of areas, therefore no means of mechanical ventilation was being provided to these areas at the time of the assessment. Univents were also observed to be obstructed by furniture, books and other stored materials (Picture 3 and 4). The univent in classroom 207 was emitting a “buzzing” noise, which may indicate a mechanical problem. Further, a heavy buildup of dust and debris was observed

Classroom Univent

1. Operate all ventilation systems throughout the building (e.g., gym, locker rooms, cafeteria, classrooms) continuously during periods of school occupancy and independent of thermostat control. To increase airflow in classrooms, set univent controls to “high”.
2. Investigate “buzzing” noise in univent for classroom 207 and make repairs/adjustments as needed.
3. Use openable windows in conjunction with mechanical ventilation to facilitate air exchange. Care should be taken to ensure windows are properly closed at night and weekends to avoid the freezing of pipes and potential flooding.
4. Inspect exhaust motors and belts for proper function. Repair and replace as necessary.
5. Consider adopting a balancing schedule of every 5 years for all mechanical ventilation systems, as recommended by ventilation industrial standards (SMACNA, 1994).

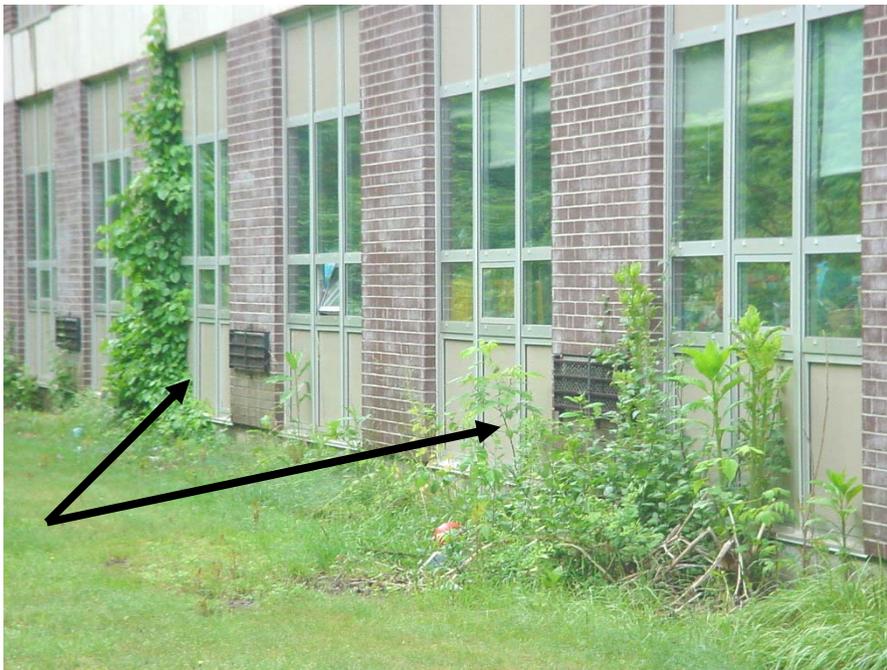
Picture 2

Plants/shrubbery was also observed growing in close proximity to the building and on exterior walls (Picture 2). Plant growth against exterior walls can hold moisture against the building. Plant roots/tendrils can eventually penetrate, leading to cracks and/or fissures in building materials. Over time, this process can undermine the integrity of the building envelope, providing a means of water entry into the building via capillary action through foundation concrete and masonry (Lstiburek & Brennan, 2001).

Univent Fresh Air Intakes, Note Plant Growth on Exterior Walls

12. Move plants approximately 5-feet away from the exterior of univent air intakes/walls to prevent moisture impingement and the entrainment of pollen, moisture or mold.

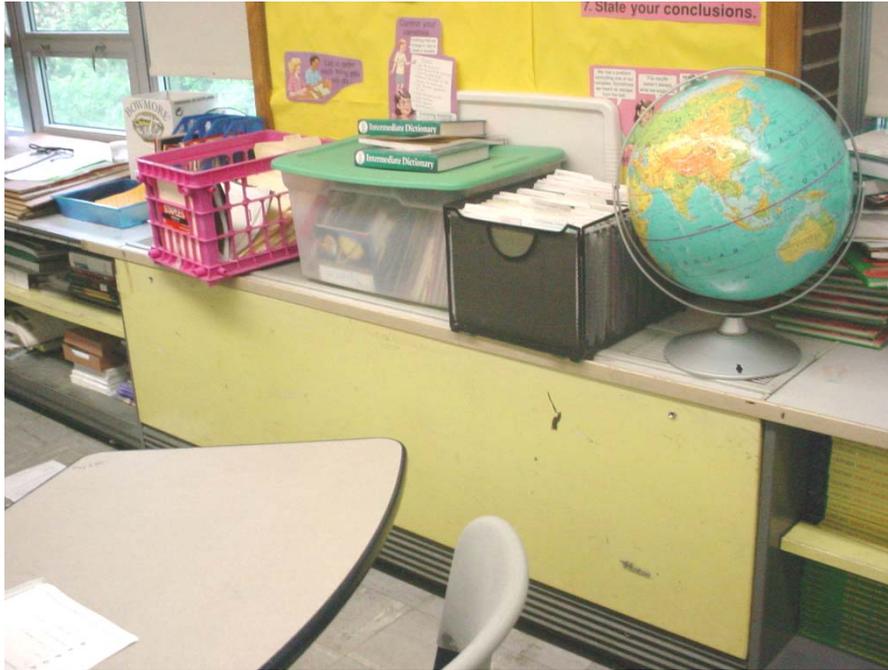
Picture 3

Univent Air Diffusers Blocked by Stored Materials

14. Relocate or consider reducing the amount of materials stored in classrooms to allow for more thorough cleaning of classrooms. Clean items regularly with a wet cloth or sponge to prevent excessive dust build-up.

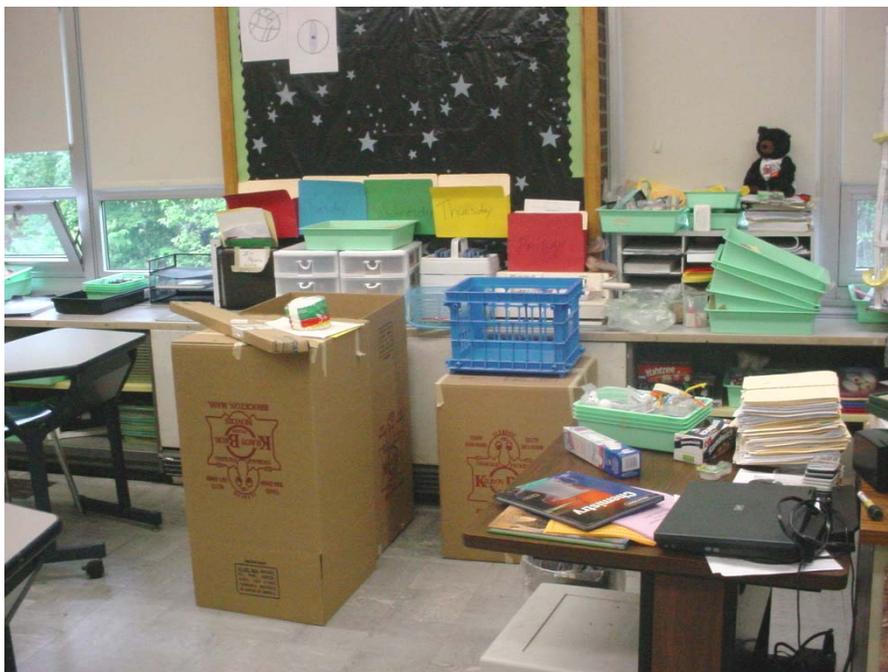
Picture 4

Other conditions that can affect indoor air quality were observed during the assessment. In several classrooms, items were observed on the floor, windowsills, tabletops, counters, bookcases and desks (Pictures 4 and 11). The large number of items stored in classrooms provides a source for dusts to accumulate. These items (e.g., papers, folders, boxes) make it difficult for custodial staff to clean. Items should be relocated and/or be cleaned periodically to avoid excessive dust build up. In addition, these materials can accumulate on flat surfaces (e.g., desktops, shelving and carpets) in occupied areas and subsequently be re-aerosolized causing further irritation.

Univent Blocked by Stored Materials

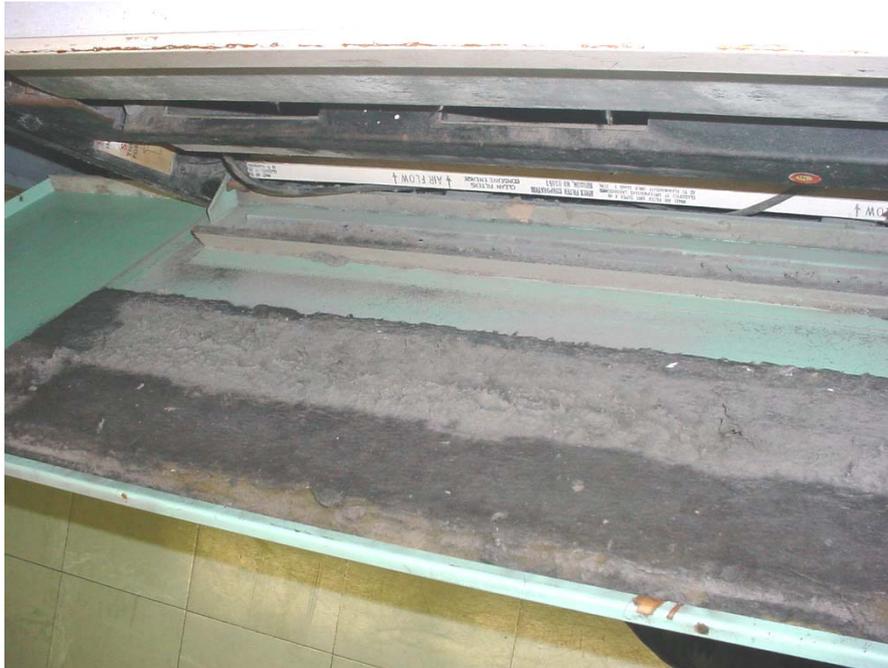
Picture 5

inside univent cabinets and on the surface of air diffusers in several areas (Picture 5). In order for univents to provide fresh air as designed, air diffusers, intakes and return vents must remain free of obstructions. Importantly, these units must remain “on” and be allowed to operate while rooms are occupied.

Buildup of Dirt, Dust and Debris inside Univent Cabinet

6. Change filters for air-handling equipment (e.g., univents, AHUs and ACs) as per the manufacturer's instructions or more frequently if needed. Vacuum interior of units prior to activation to prevent the aerosolization of dirt, dust and particulates. Ensure filters fit flush in their racks with no spaces in between allowing bypass of unfiltered air into the unit.

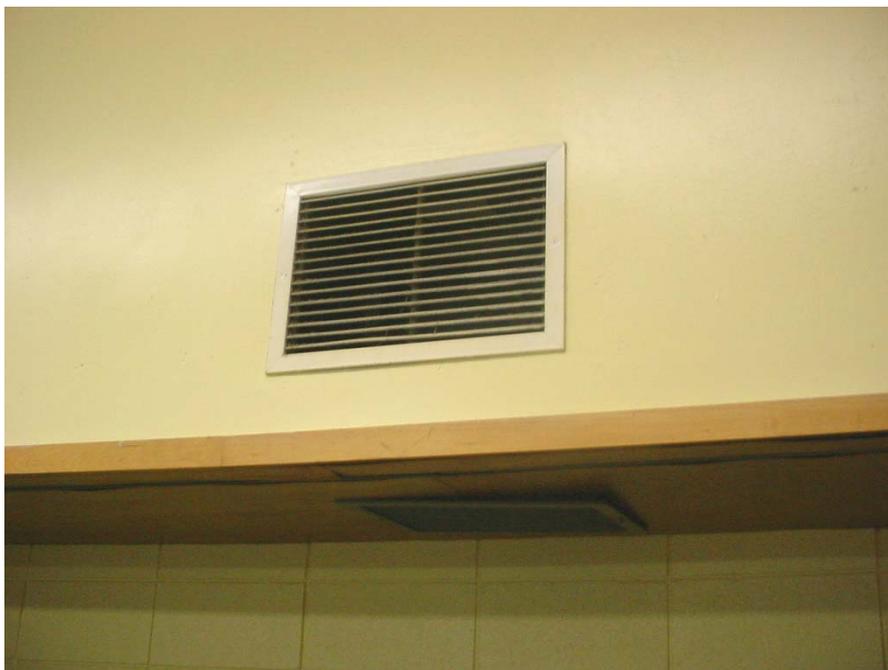
Picture 6

Exhaust ventilation in classrooms is provided by wall or ceiling-mounted vents ducted to rooftop motors (Picture 6). Many exhaust vents were deactivated at the time of the assessment. Additional classroom exhaust vents were located in the coat closets; however, these appeared to be sealed. As with univents, in order to function properly, exhaust vents must be activated and allowed to operate while rooms are occupied. Without adequate supply and exhaust ventilation, excess heat and environmental pollutants can build up and lead to indoor air/comfort complaints.

Wall Mounted Exhaust Vent

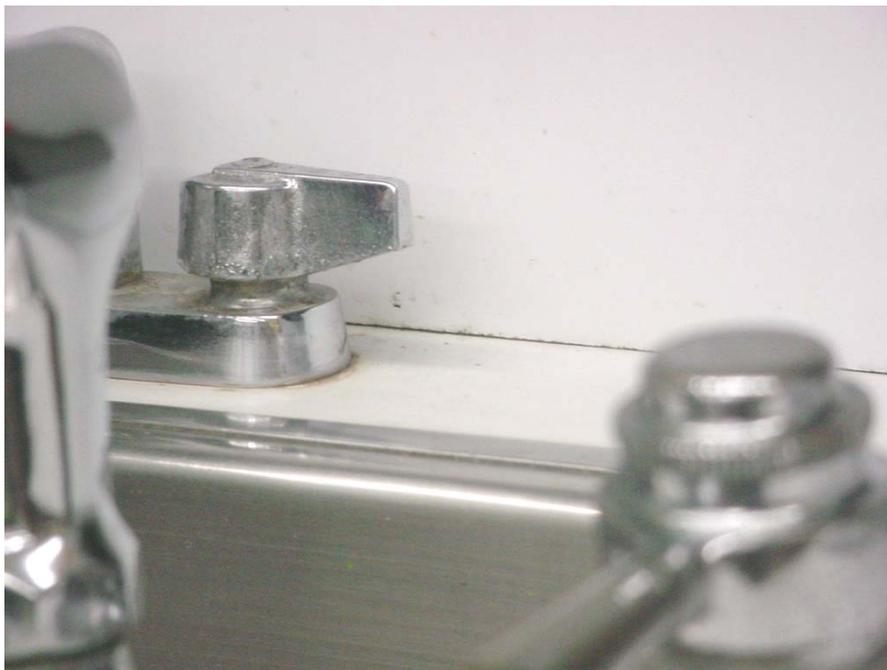
Picture 7

Open seams between sink countertops and walls were observed in several rooms (Picture 7). If not watertight, moisture can penetrate through the seam, causing water damage. Improper drainage or sink overflow can lead to water penetration into the countertop, cabinet interior and areas behind cabinets. Water penetration and chronic exposure of porous and wood-based materials can cause these materials to swell and show signs of water damage.

Open Seam between Sink Countertop and Backsplash

10. Seal areas around sinks to prevent water damage to the interior of cabinets and adjacent wallboard. Inspect wallboard for water damage and mold growth, repair/replace as necessary. Disinfect areas with an appropriate antimicrobial, as needed.

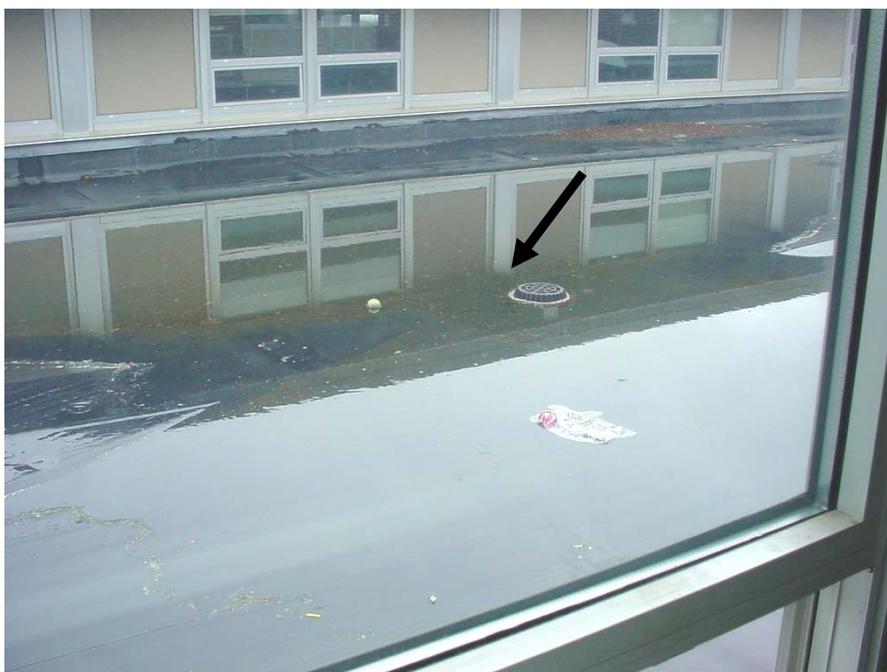
Picture 8

Pooling water was observed on the roof of the building due to lack of drainage (Pictures 8 and 9). The roof drain is not the lowest point on the roof; therefore, water flows away from the drain. In addition, a buildup of debris and leaves surrounding the drain was observed, preventing drainage. The freezing and thawing of water during winter months can lead to roof leaks and subsequent water penetration into the interior of the building. Pooling water can also become stagnant, which can lead to mold and bacterial growth, and serve as a breeding ground for mosquitoes.

Pooling Water on Roof, Note Roof Drain

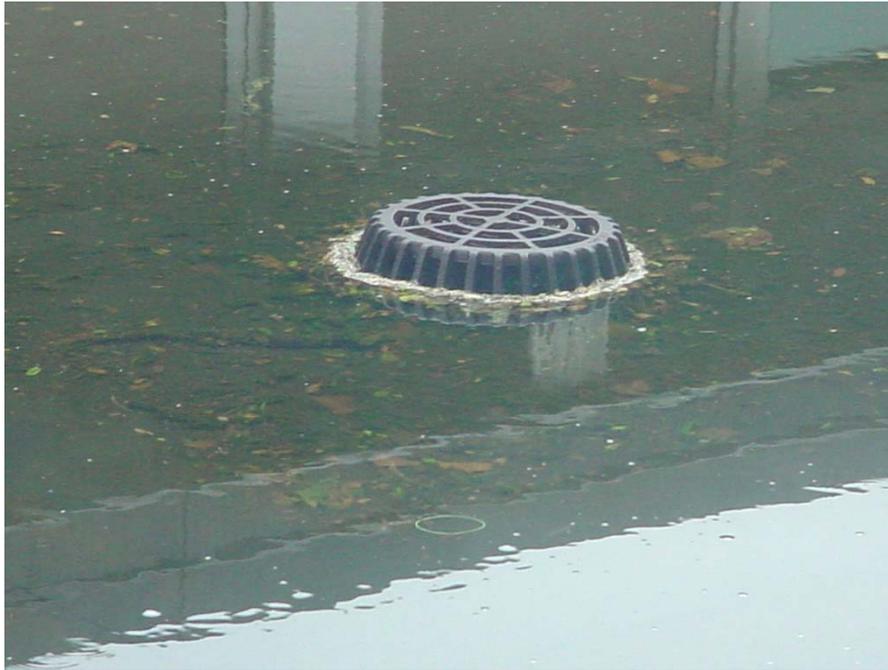
Picture 9

Roof Drain Clogged by Debris and Leaves

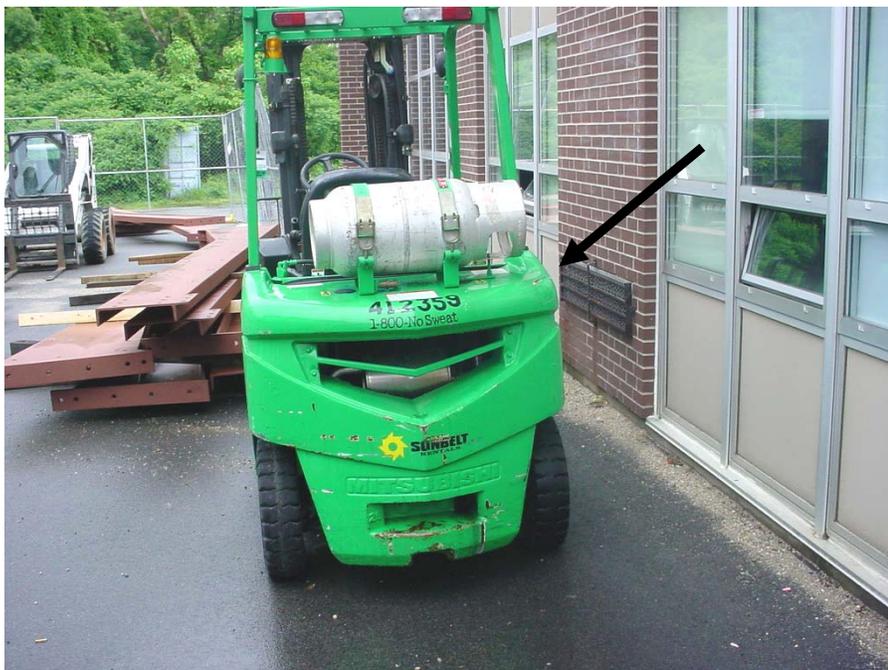
Picture 10

BEH staff observed construction vehicles parked near univent air intakes along the exterior of the building (Picture 10). At the time of the assessment, the vehicles were not operating; however, there is potential for carbon monoxide to become entrained (drawn into) these air intakes when this equipment *is* operated. The opening of windows allows for unfiltered air to enter the classroom environment carrying with it exhaust emissions as well as airborne dirt, dust and particulates. Thus, opening windows along this area of the building should be done with caution.

Construction Vehicles Parked Near Univent Fresh Air Intake

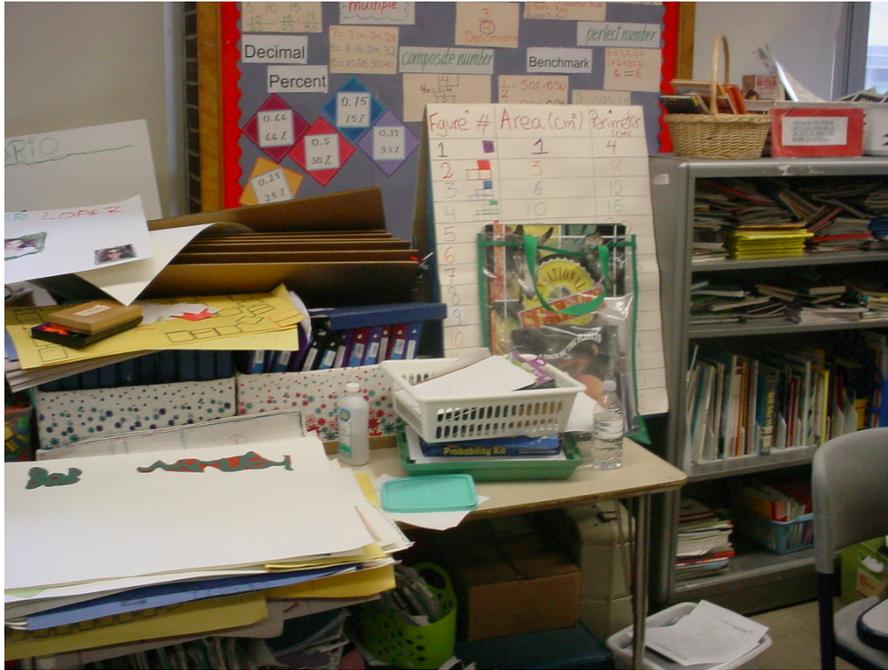
Picture 11

Accumulation of Classroom Items

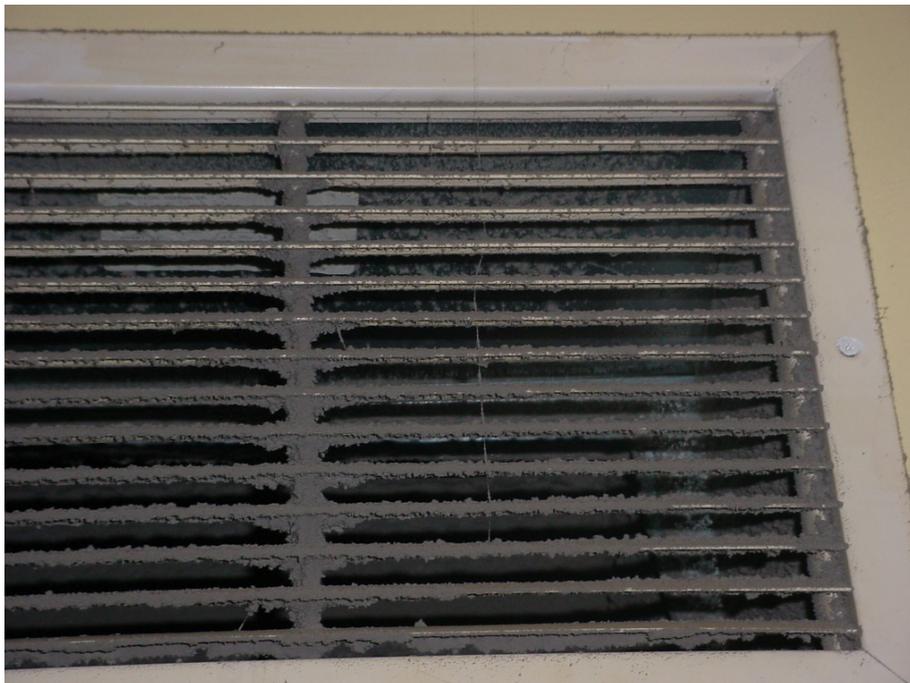
Picture 12

Lastly, a number of exhaust/return vents, univent air diffusers and personal fans (Pictures 12 and 13) were observed to have accumulated dust. If exhaust vents are not functioning, backdrafting can occur, which can re-aerosolize accumulated dust particles. Re-activated univents and fans can also aerosolize dust accumulated on vents/fan blades.

Dust/Debris Accumulation on Exhaust Vent

15. Clean personal fans, univent air diffusers, return vents and exhaust vents periodically of accumulated dust.
16. Consider adopting the US EPA (2000) document, "Tools for Schools", as an instrument for maintaining a good indoor air quality environment in the building. This document is available at: <http://www.epa.gov/iaq/schools/index.html>.

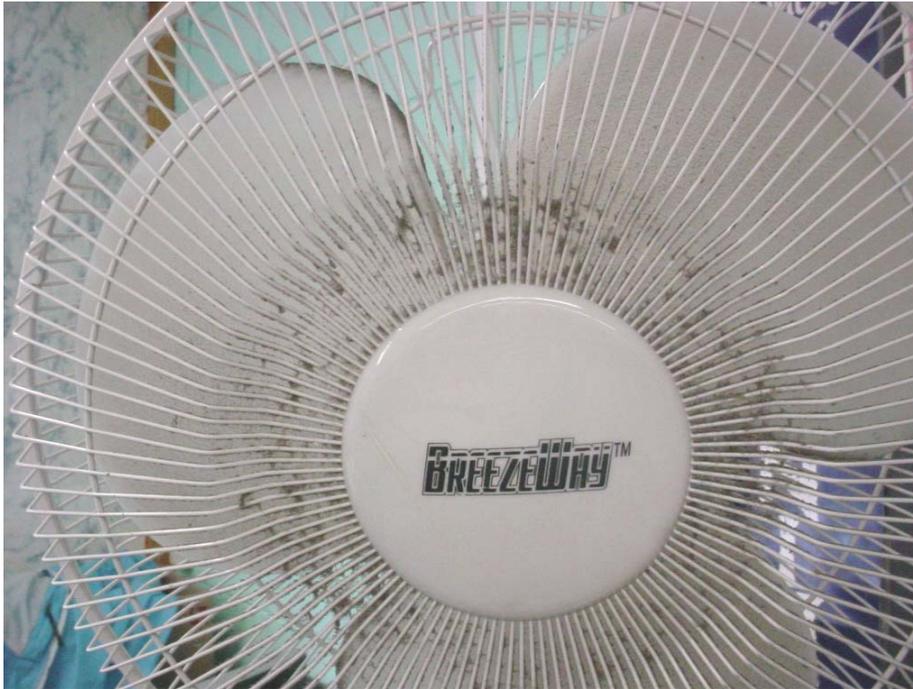
Picture 13

Dust/Debris Accumulation on Personal Fan Cage and Blades
