# **INDOOR AIR QUALITY ASSESSMENT**

**C.D. Hunking Middle School  
98 Winchester Street  
Haverhill, MA 01835**

Prepared by:  
Massachusetts Department of Public Health  
Bureau of Environmental Health  
Indoor Air Quality Program  
October 2008

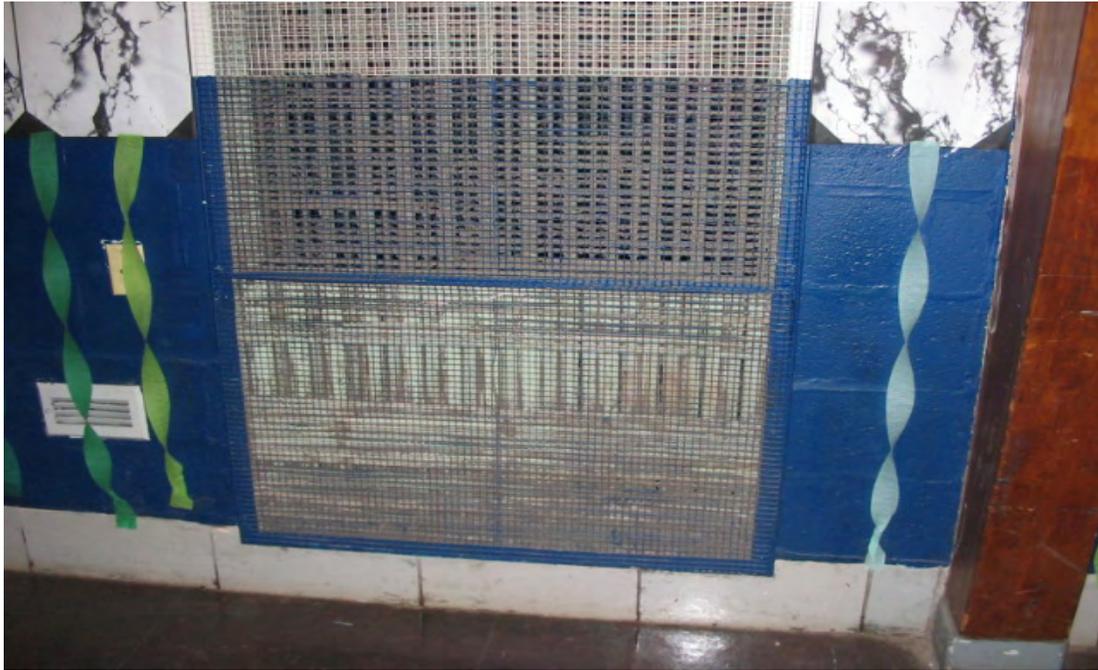
**Picture 1**

Exhaust ventilation in classrooms is provided by wall-mounted vents ducted to rooftop motors (Picture 1). Several exhaust vents were found blocked by newspapers and other items. In addition, exhaust ventilation was found deactivated in a number of areas during the assessment (Table 1). As with univents, in order to function properly, exhaust vents must be activated and allowed to operate while rooms are occupied. Without adequate supply and exhaust ventilation, excess heat and environmental pollutants can build up leading to indoor air/comfort complaints.

**Exhaust Vent**

3. Remove all blockages from univents and exhaust vents to ensure adequate airflow.
4. Ensure classroom doors are closed to maximize air exchange.
5. Consider adopting a balancing schedule of every 5 years for all mechanical ventilation systems, as recommended by ventilation industrial standards (SMACNA, 1994).

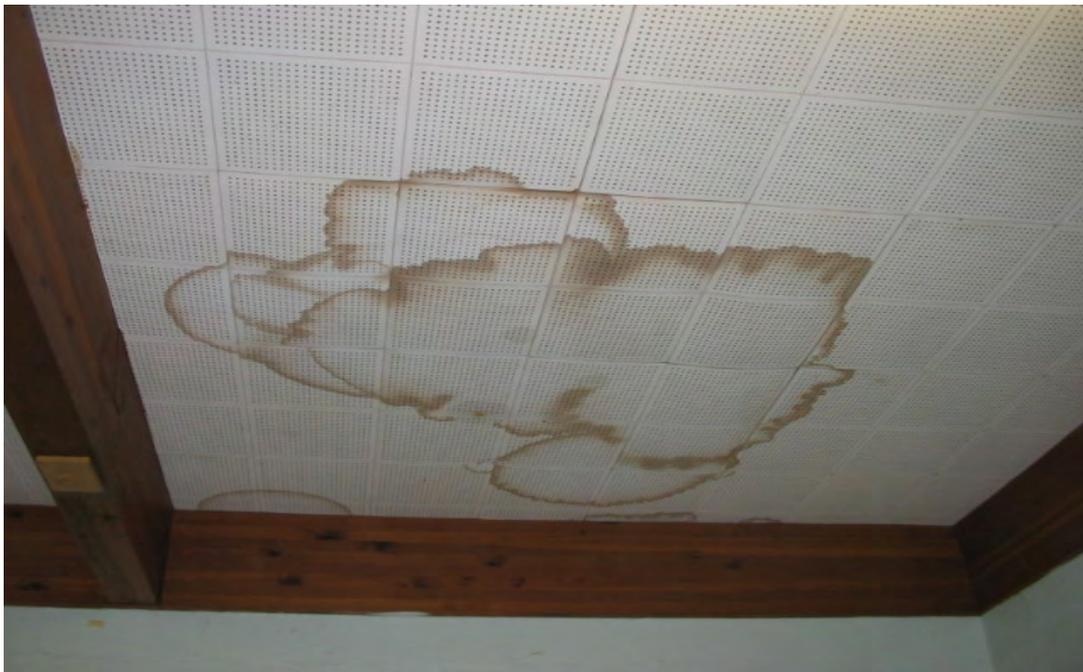
**Picture 2**

Several potential sources of water damage/water infiltration were observed in the building. Water-damaged materials, including gypsum wallboard, were observed in several classrooms and offices. Numerous areas had water-damaged ceiling tiles which can indicate

leaks from either the roof or plumbing system (Pictures 2 and 3). Water-damaged ceiling tiles can provide a source for mold growth and should be replaced after a water leak is discovered and repaired.

**Water-Damaged Ceiling Tiles**

10. Remove or replace water damaged ceiling tiles, if feasible, and repair interior water damaged surfaces. Sources of water damage should be identified and remedied.

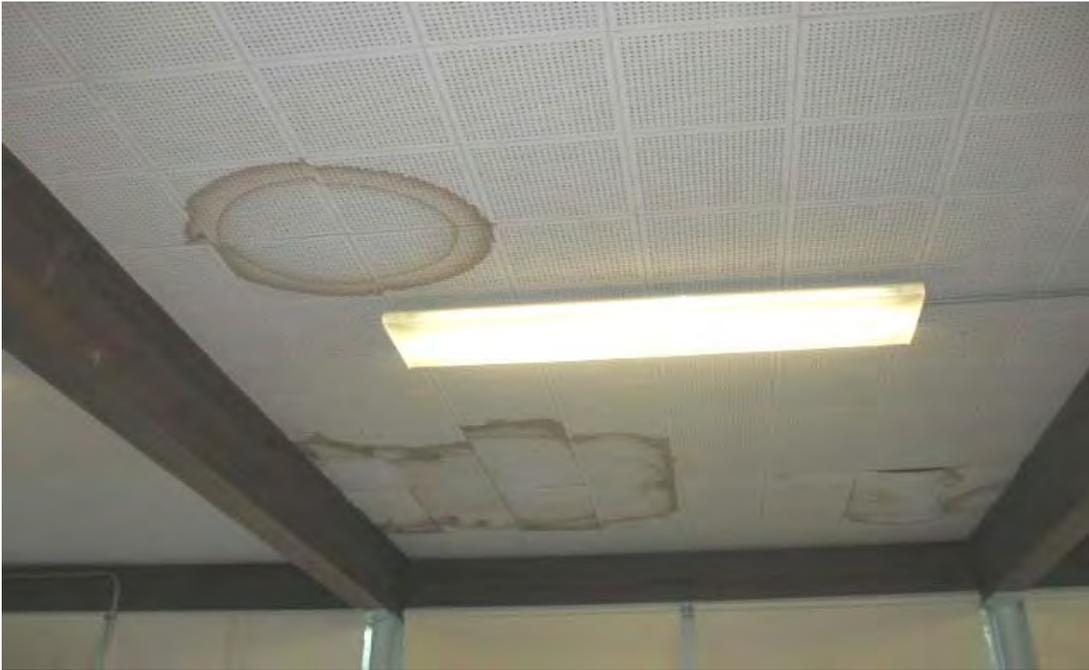
**Picture 3**

**Water-Damaged Ceiling Tiles**

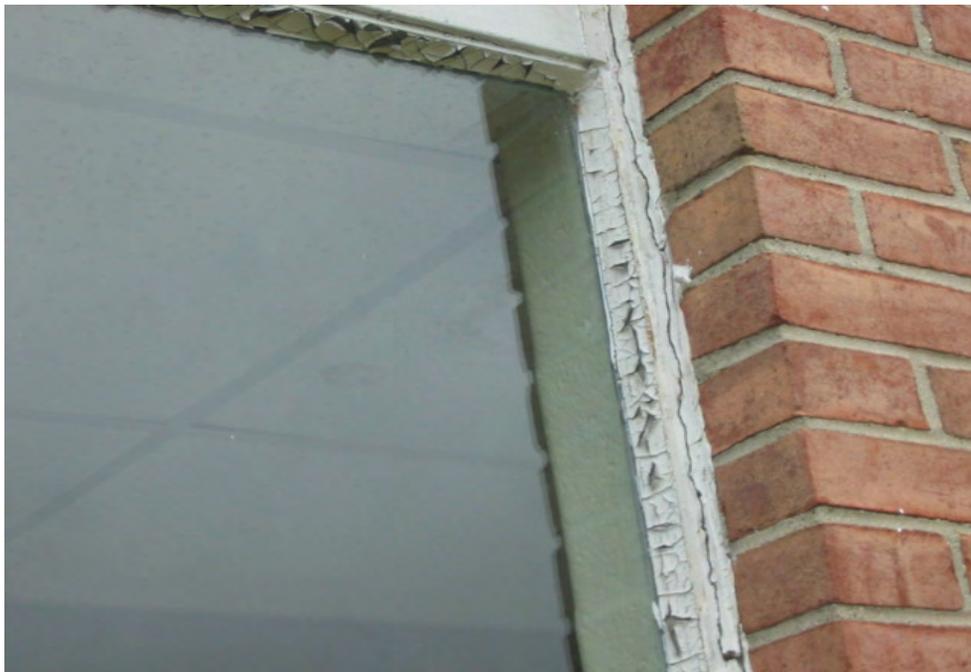
**Picture 4**

Caulking around the exterior windowpanes was crumbling, missing, or damaged (Picture 4). Air infiltration was noted around windows and wall/window-mounted air conditioning units (Picture 5), which can result in water penetration through the window frames and air conditioning unit gaps. Water penetration through window frames can lead to mold growth under certain conditions. Repair of window sealant and weather stripping around air conditioning units is necessary to prevent water penetration.

**Crumbling/damaged Window Caulking**

11. Replace/repair caulking around windows to prevent air infiltration and water penetration.
12. Consider replacing window systems to prevent air infiltration and water penetration.

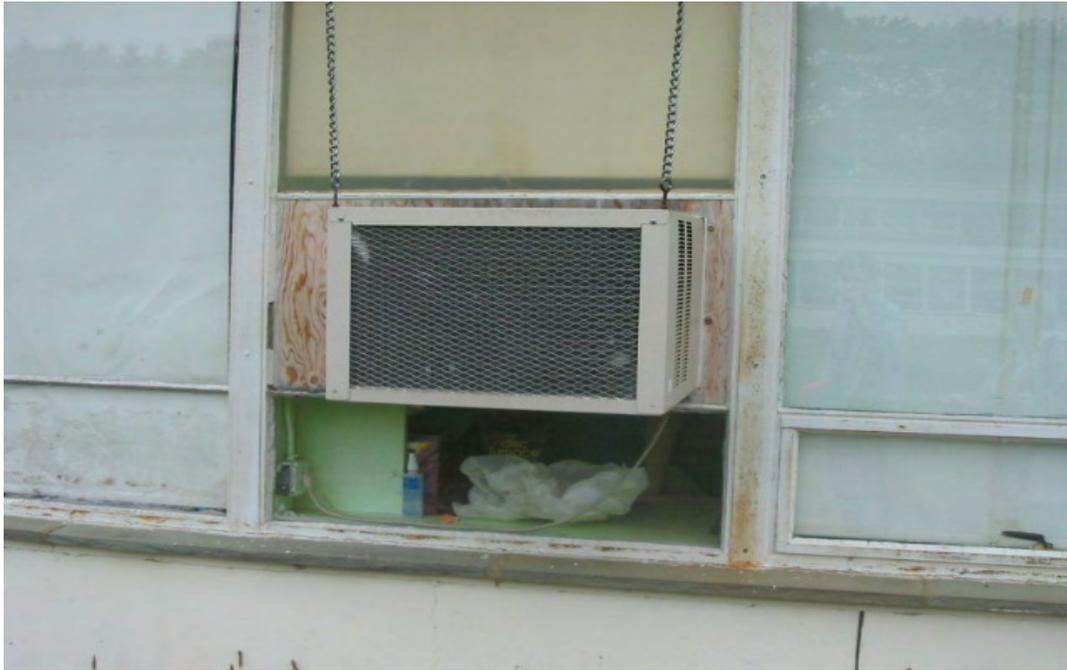
**Picture 5**

**Air Infiltration around Window-Mounted AC**

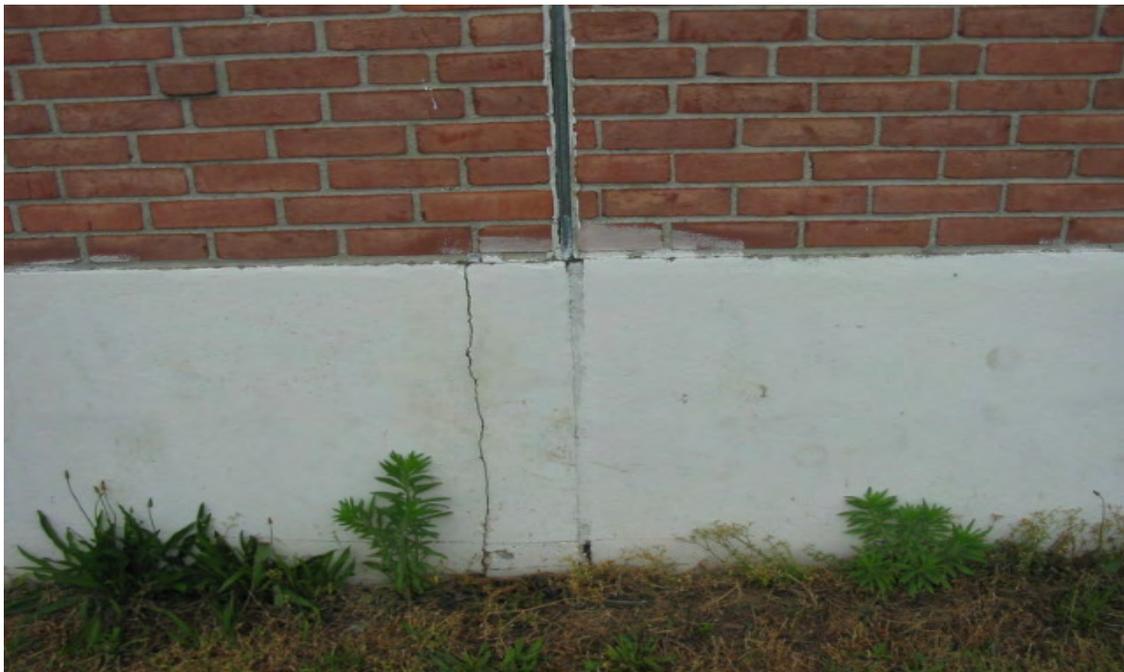
**Picture 6**

- Missing/damaged sealant between expansion joints (Picture 6);
- Exterior wall cracks in cement and brick (Picture 6);
- Gutter/downspout buried below ground (Picture 7 and 8);
- Wood exterior doors were damaged/rotted and light could be seen penetrating through the spaces around the doors from the outdoors (Pictures 9 and 10)
- Exterior brickwork was visibly moist and had moss growth on the surface indicating heavy/continuous water exposure (Picture 11).
- Open utility holes with exposed electrical wires (Picture 12); and
- Plants/debris in/near univent fresh air intakes (Picture 13).

The conditions listed above can undermine the integrity of the building envelope and create/provide a means of water entry by capillary action into the building through exterior walls, foundation concrete and masonry (Lstiburek & Brennan, 2001). The freezing and thawing action of water during the winter months can create cracks and fissures in the foundation. In addition, they can serve as pathways for insects, rodents and other pests into the building.

**Missing/damaged sealant between Expansion Joints, Note Wall Cracks**

17. Repair cracks in the exterior cement walls and brick work
18. Consider having exterior walls re-pointed and waterproofed to prevent water intrusion. This measure should include a full building envelope evaluation.

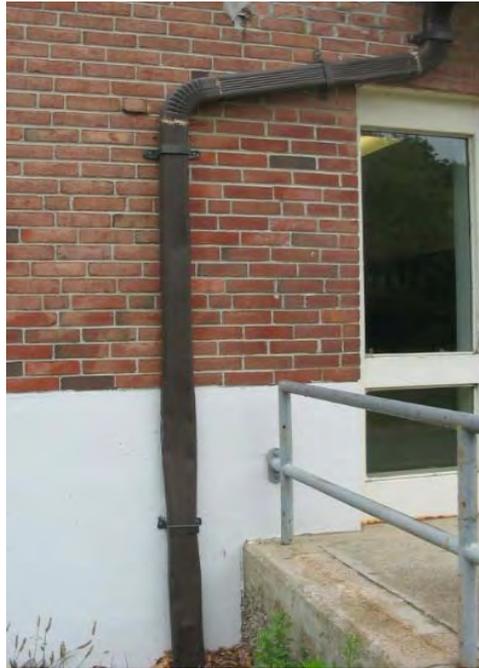
**Picture 7**

**Gutter/downspout**

13. Replace damaged/rotted wood exterior doors.
14. Install gutters/downspout system to direct water away from the building to prevent water from pooling at the base of the school.

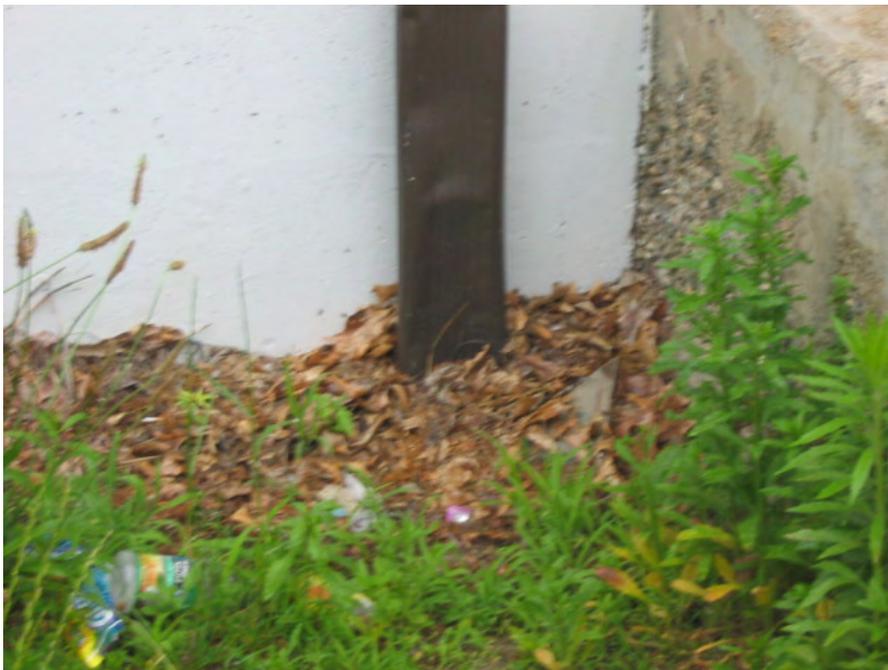
**Picture 8**

**Gutter/downspout buried below ground**

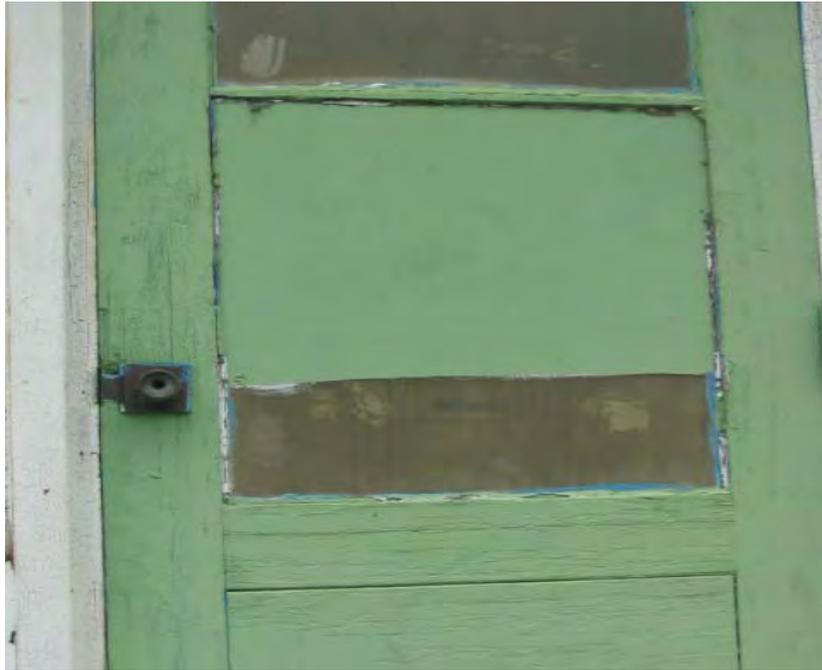
**Picture 9**

**Damaged/Rotted Wood Exterior Door**

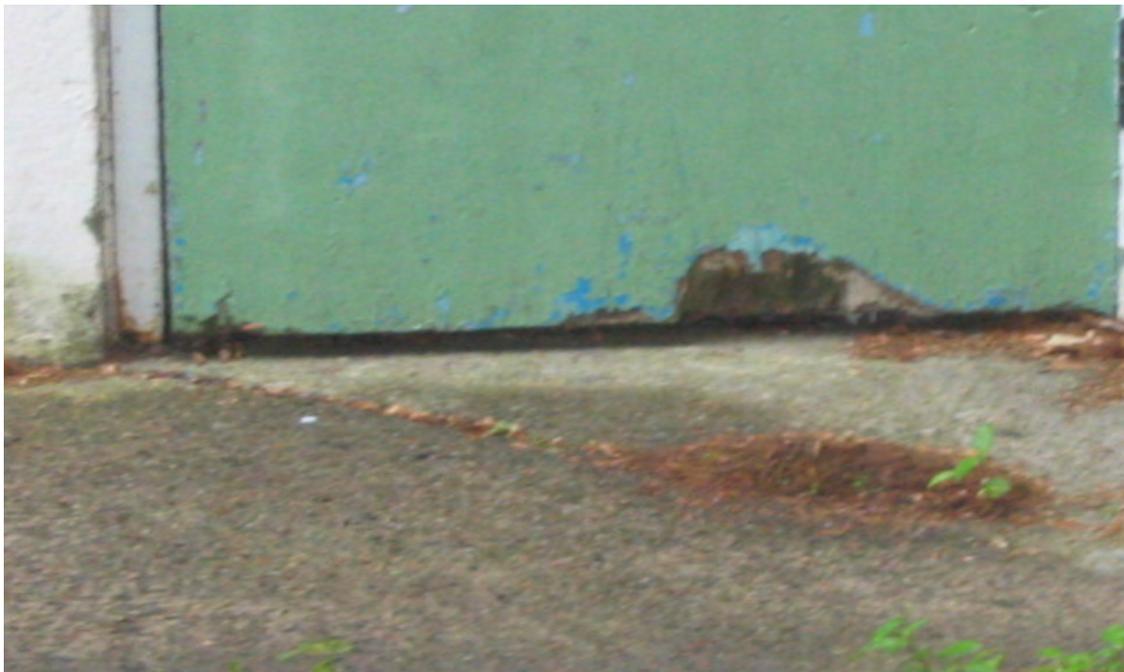
**Picture 10**

**Space around Damaged/Rotted Wood Exterior Door**

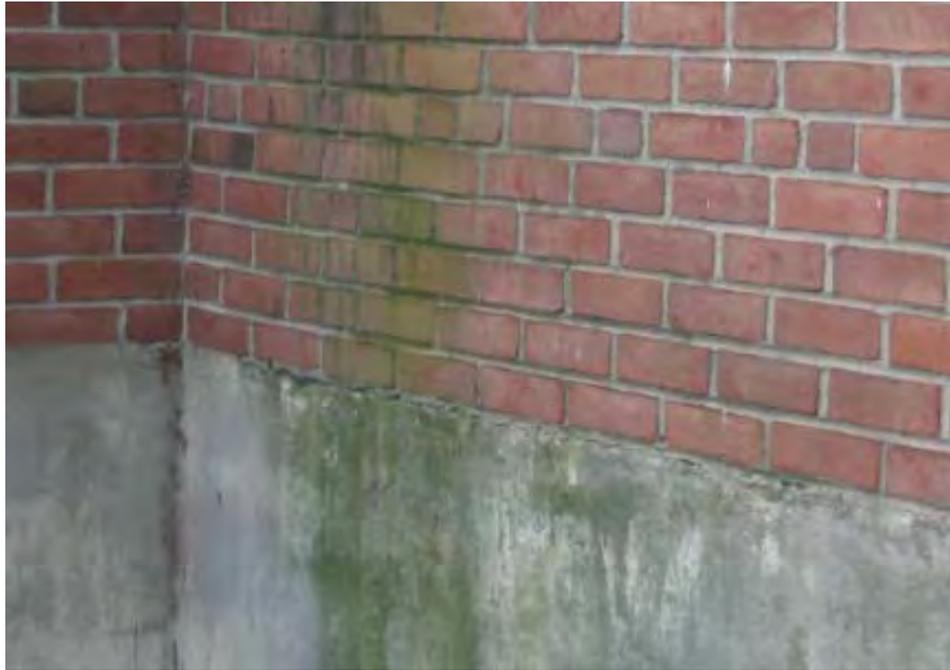
**Picture 11**

**Moss Growth on Exterior Wall**

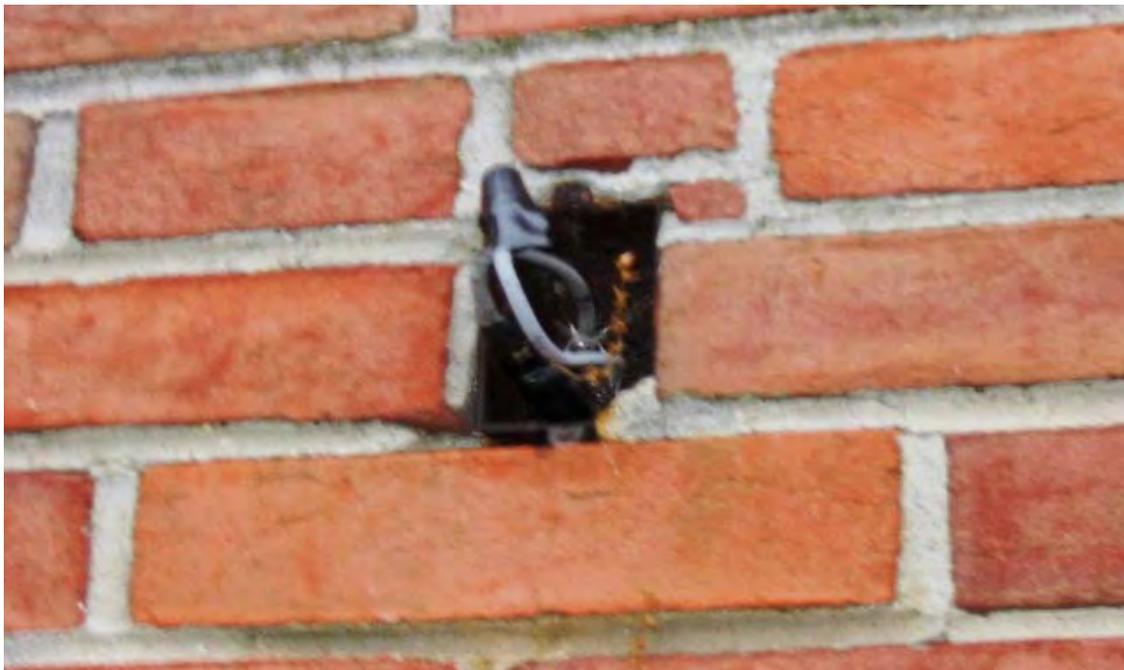
**Picture 12**

Open utility holes and ajar ceiling tiles were observed in several areas (Table 1), which can provide pathways for drafts, dust and particulates to migrate into occupied areas.

**Open Utility Hole with Exposed Wires**

15. Seal open utility holes to prevent water penetration and block insect and rodent pathways into the building.
16. Clear plants/debris away from the exterior of univent fresh air intakes.

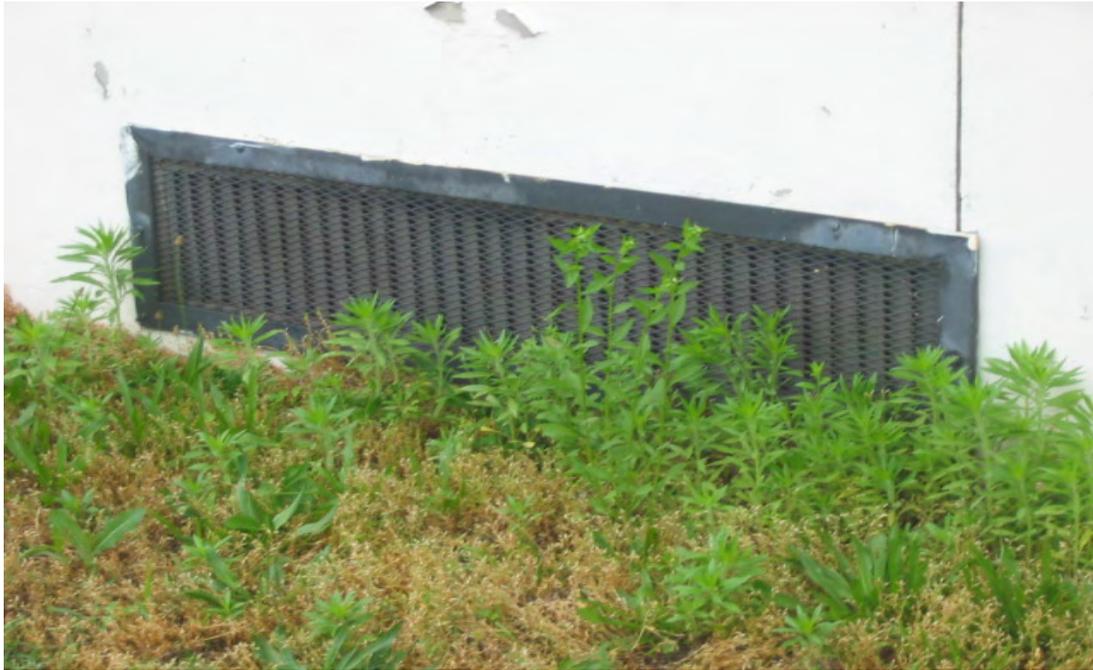
**Picture 13**

**Plants near Univent Fresh Air Intake**

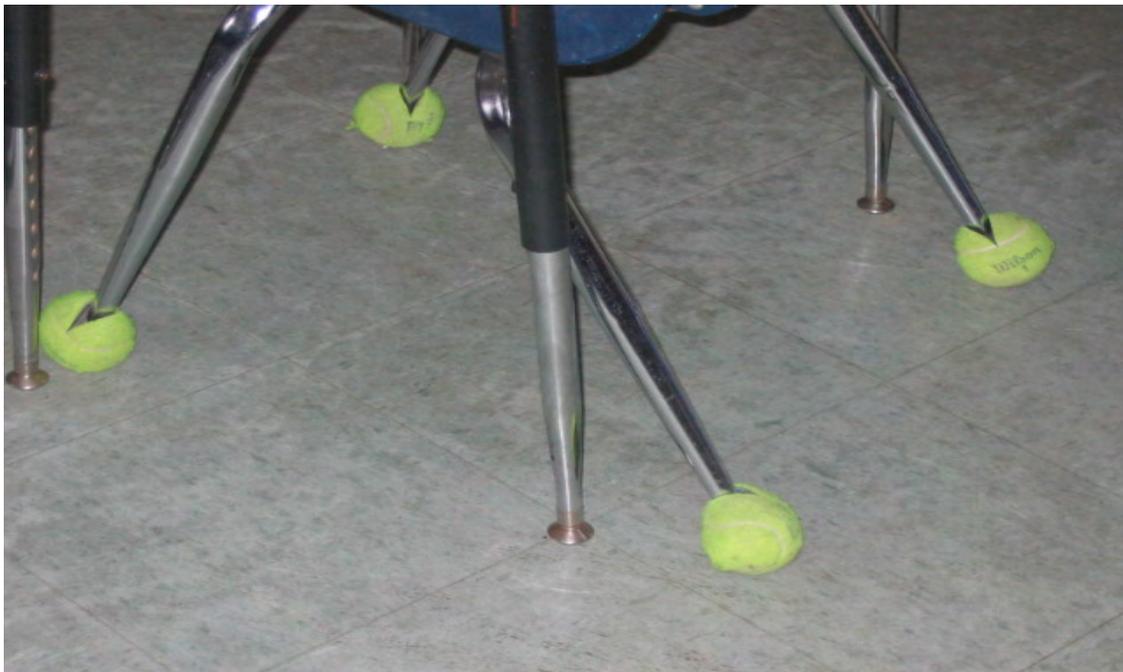
**Picture 14**

In an effort to reduce noise from sliding chairs, tennis balls had been spliced open and placed on chair legs (Picture 14). Tennis balls are made of a number of materials that are a source of respiratory irritants. Constant wearing of tennis balls can produce fibers and cause TVOCs to off-gas. Tennis balls are made with a natural rubber latex bladder, which becomes abraded when used as a chair leg pad. Use of tennis balls in this manner may introduce latex dust into the school environment. Some individuals are highly allergic to latex (e.g., spina bifida patients) (SBAA, 2001). It is recommended that the use of materials containing latex be limited in buildings to reduce the likelihood of symptoms in sensitive individuals (NIOSH, 1997).

**Spliced Tennis Balls on Chair Legs**

20. Replace latex-based tennis balls with latex-free tennis balls or glides.
21. Replace damaged/missing floor tiles in the 6<sup>th</sup> and 7<sup>th</sup> grade wing and catwalk.

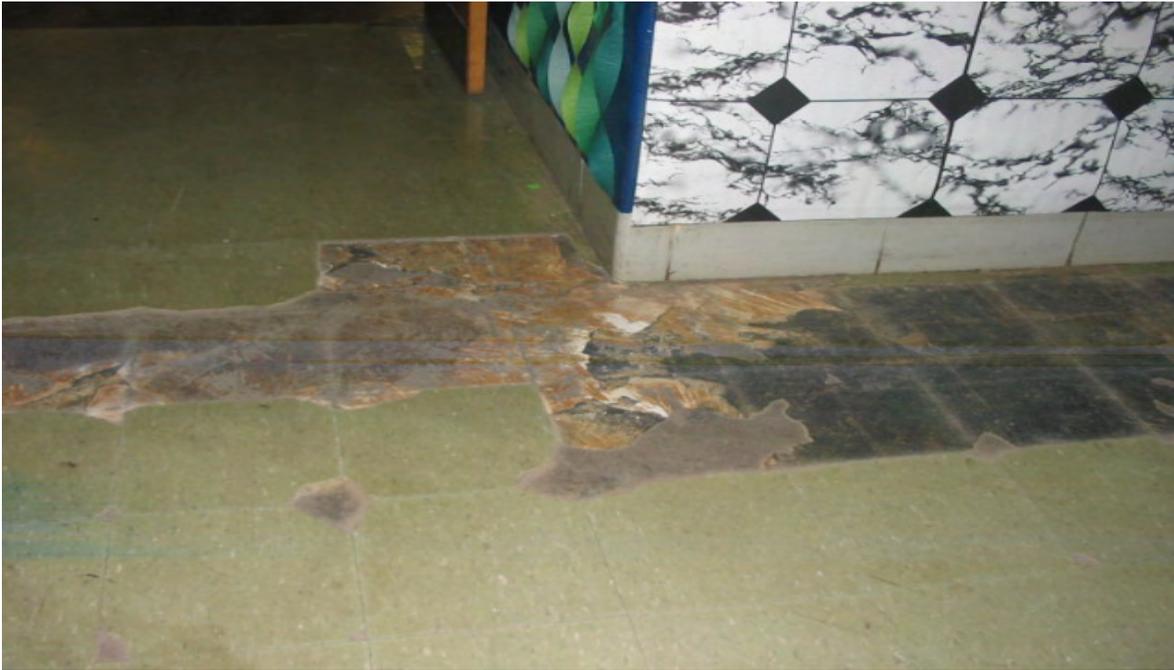
**Picture 15**

Missing and/or damaged floor tiles were observed in the catwalk area, in the café, and in various classrooms in the 6<sup>th</sup> and 7<sup>th</sup> grade wings. BEH staff were informed that these tiles were due to be replaced during summer vacation 2008 (Picture 15). At the time of BEH's second visit, these tiles were being replaced.

**Missing/damaged Floor Tiles**

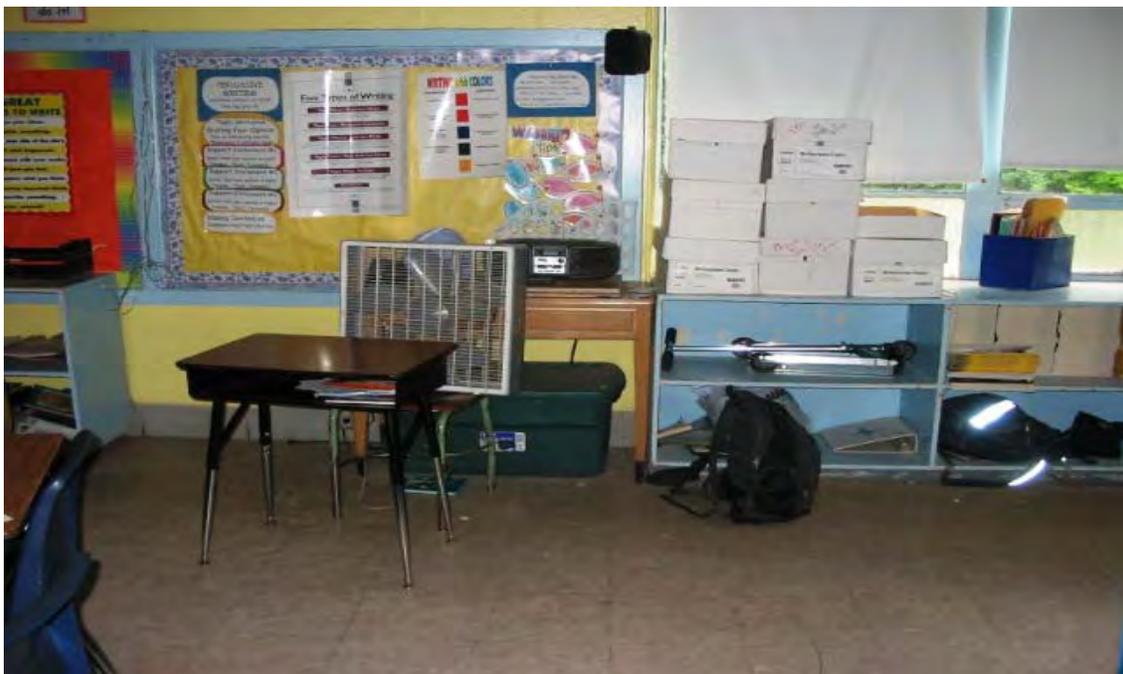
**Picture 16**

In several classrooms, items were observed on the floors, windowsills, tabletops, counters, bookcases and desks (Picture 16). The large number of items stored in classrooms provides a source for dusts to accumulate. These items (e.g., papers, folders, boxes) make it difficult for custodial staff to clean. Items should be relocated and/or be cleaned periodically to avoid excessive dust build up. In addition, these materials can accumulate on flat surfaces (e.g.,

**Store Items in Classroom**

22. Relocate or consider reducing the amount of materials stored in classrooms to allow for more thorough cleaning of classrooms. Clean items regularly with a wet cloth or sponge to prevent excessive dust build-up.

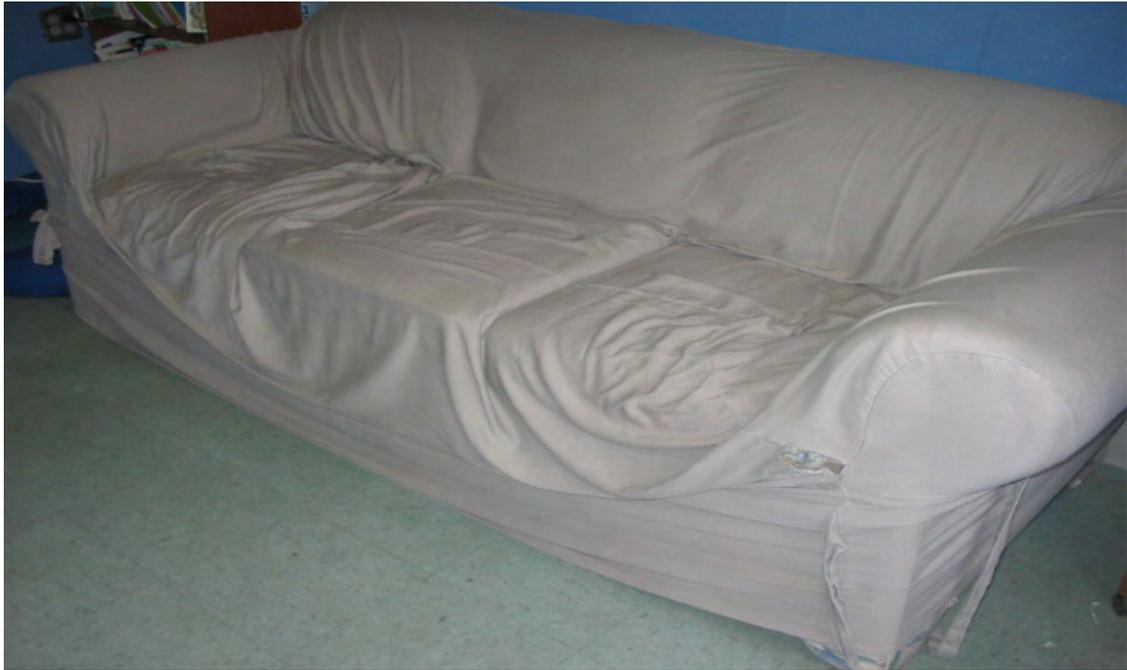
**Picture 17**

A couch with a fabric cover was in room 174 (Picture 17). Upholstered furniture is covered with fabric that comes in contact with human skin. This type of contact can leave oils, perspiration, hair and skin cells. Dust mites feed upon human skin cells and excrete waste products that contain allergens. In addition, if relative humidity levels increase above 60 percent, dust mites tend to proliferate (US EPA, 1992). It is also recommended that upholstered furniture (if present in schools), be professionally cleaned on an annual basis or every six months if dusty conditions exist (IICRC, 2000).

**Couch with Fabric Cover**

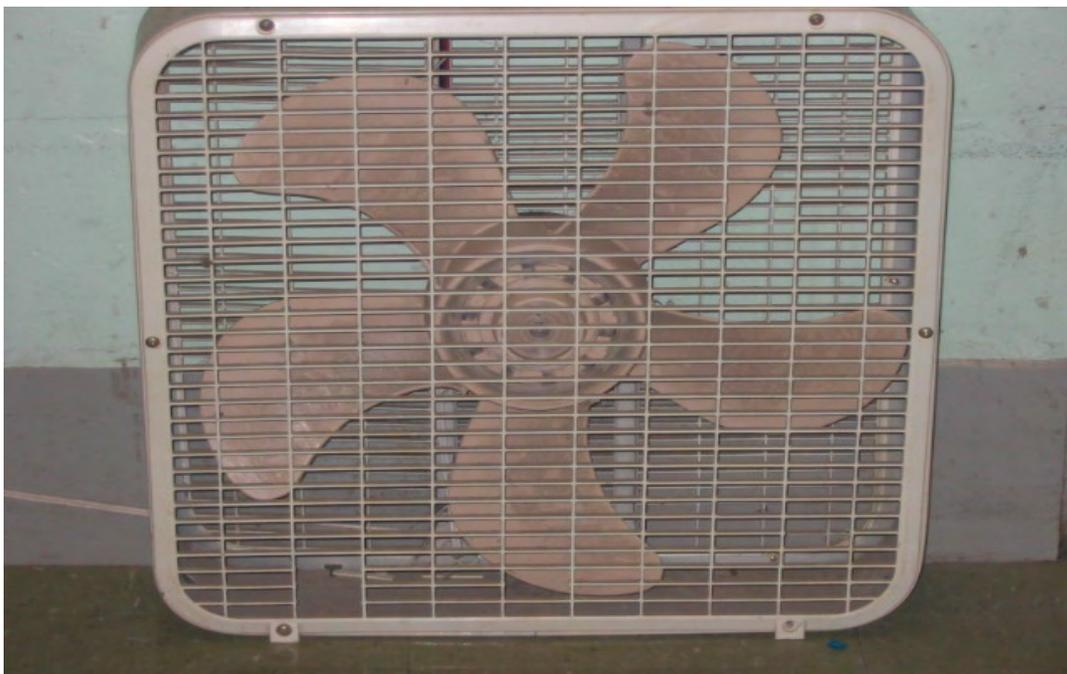
**Picture 18**

A number of exhaust/return vents, univent air diffusers and personal fans were observed to have accumulated dust/debris (Picture 18). Dust can be a source for eye and respiratory irritation. If exhaust vents are not functioning, backdrafting can occur, which can re-aerosolize accumulated dust particles. Re-activated univents and fans can also aerosolize dust accumulated on vents/fan blades. In addition, an accumulation of chalk dust was observed in some classrooms. When windows are opened or univents are operating, chalk dust can become airborne. Once aerosolized, it can act as irritants to eyes and the respiratory system.

**Personal Fan with Accumulated Dust and Debris**

23. Clean personal fans, univent air diffusers, return vents and exhaust vents periodically of accumulated dust.
24. Clean chalk and dry erase trays to prevent accumulation of materials.
