# **INDOOR AIR QUALITY ASSESSMENT**

**Morningside Community School  
100 Burbank Street  
Pittsfield, Massachusetts 01201**

Prepared by:  
Massachusetts Department of Public Health  
Bureau of Environmental Health  
Indoor Air Quality Program  
October 2008

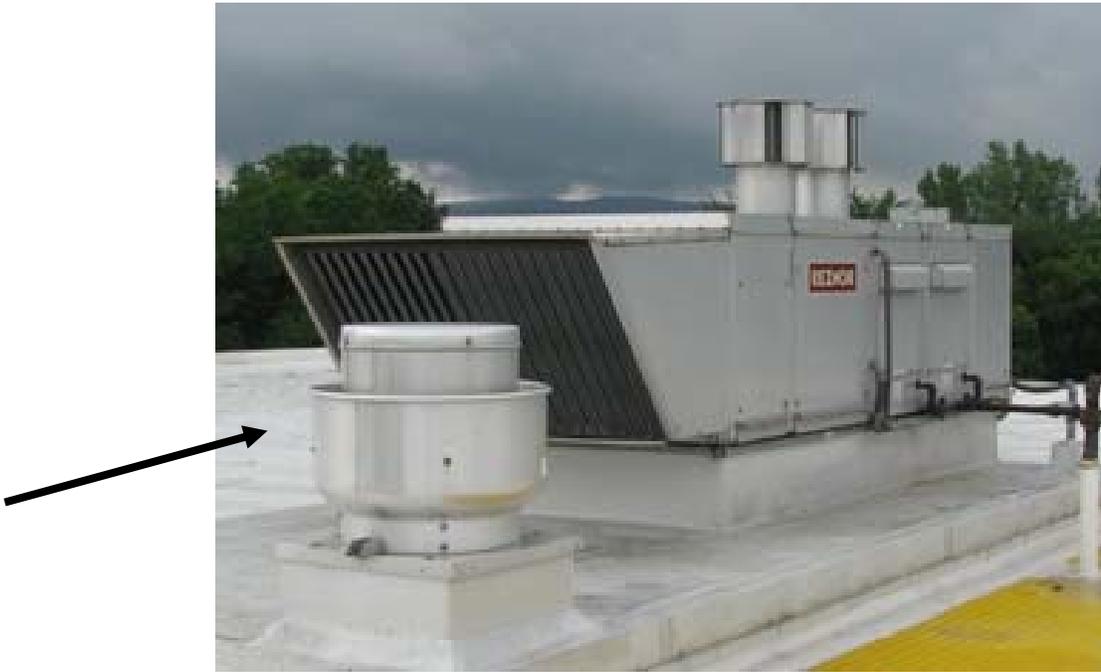
**Picture 1**

BEH staff found the exhaust vent on one AHU located within several feet of the fresh air intake (Picture 1). In this configuration, the exhaust may be drawn in by the air intake and pollutants can be distributed back into the building. The building code requires that pollutant sources must be ten feet away from and two feet above fresh air intakes (BOCA, 1993; SBBRS, 1997). An extension several feet above the fresh air intake may be needed to prevent exhaust entrainment.

**Exhaust in front of Fresh Air Intake**

5. Consider extending or moving exhaust vent away from fresh air intake of AHU to prevent entrainment of exhaust.

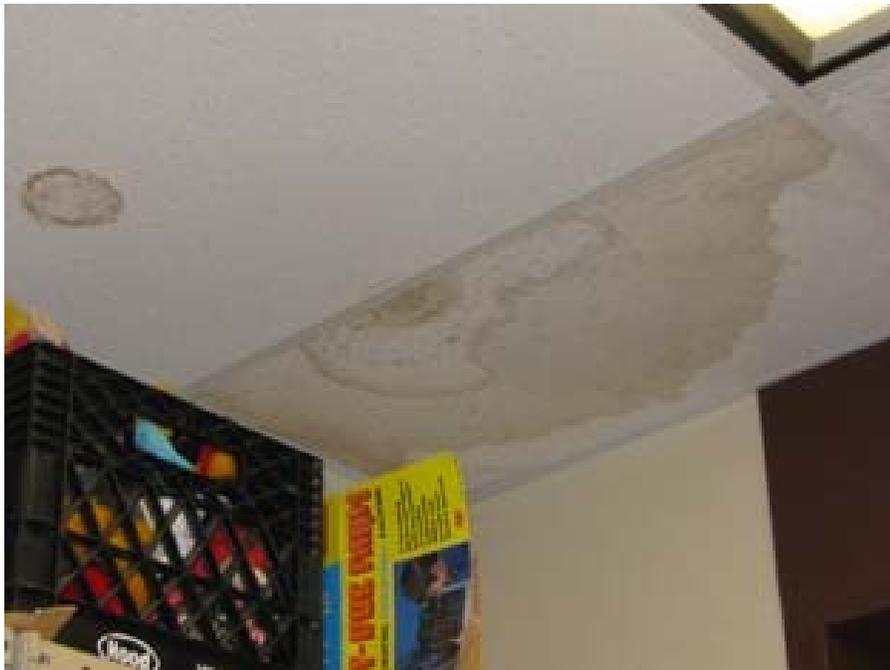
**Picture 2**

Several potential sources of water damage and/or mold growth were observed. Numerous areas including classrooms and hallways had water-damaged ceiling tiles which can indicate leaks from either the roof or plumbing system (Picture 2; Table 1). Water-damaged ceiling tiles can provide a source of mold and should be replaced after a water leak is discovered and repaired.

**Water-damaged Ceiling Tiles**

8. Replace water damaged ceiling tiles. Examine the area above and around these areas for mold growth. Disinfect areas of water leaks with an appropriate antimicrobial.

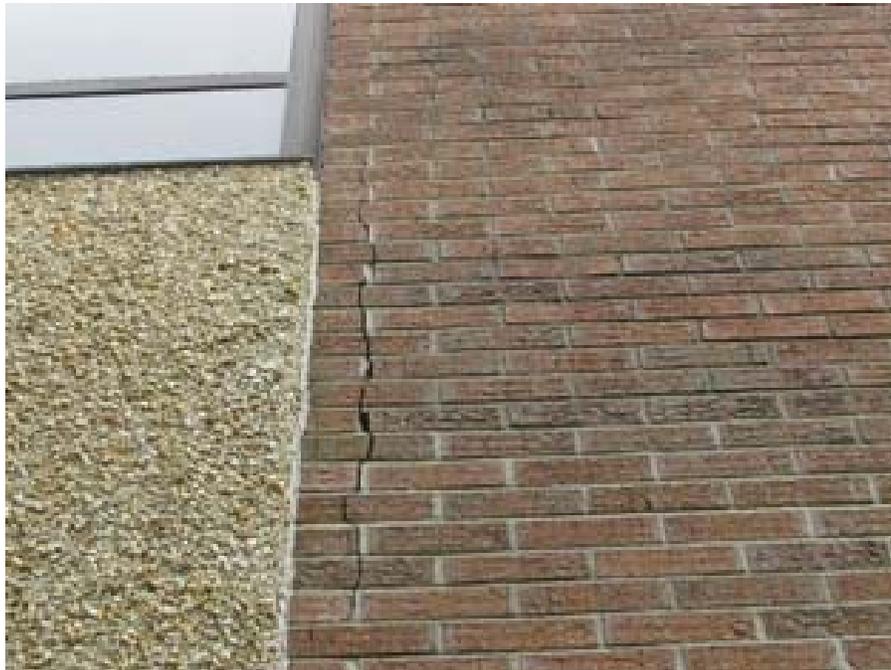
**Picture 3**

- Missing/damaged mortar and exterior brick (Picture 3);
- Exterior wall cracks (Picture 3);
- Missing/damaged caulking between brick and pebble board (Picture 4);
- Missing/damaged sealant between expansion joints (Picture 5);
- Exterior doors had damaged weather stripping and light could be seen penetrating through the spaces underneath the door from the outdoors; in particular, a metal door near the kitchen was rusted through creating large holes at the base of the door (Picture 6);
- Slanted concrete apron adjacent to the school directing water toward the building (Picture 7);
- Damaged scupper without supplemental gutter/downspout allowing water to empty against the exterior of the building and pool on the ground at the base of the building (Picture 8);

**Damaged Brick and Mortar, Wall Cracks**

11. Repair damaged brick and mortar and wall cracks on the exterior of the building.
12. Consider re-pointing and waterproofing exterior walls to prevent water intrusion. This measure should include a full building envelope evaluation.

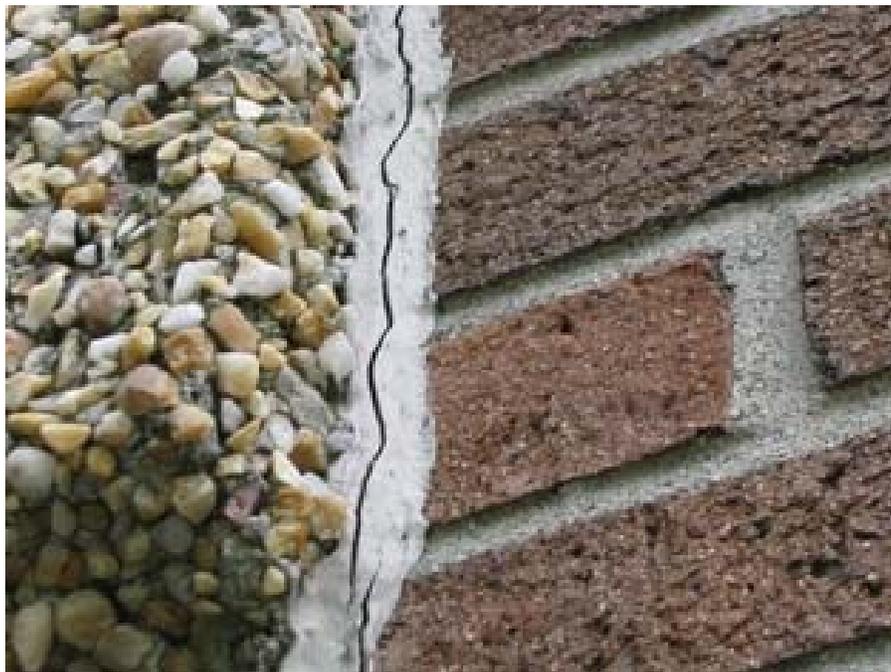
**Picture 4**

**Damaged Caulking between Brick and Pebble Board**

13. Replace/repair missing/damaged caulking between brick and pebble board.

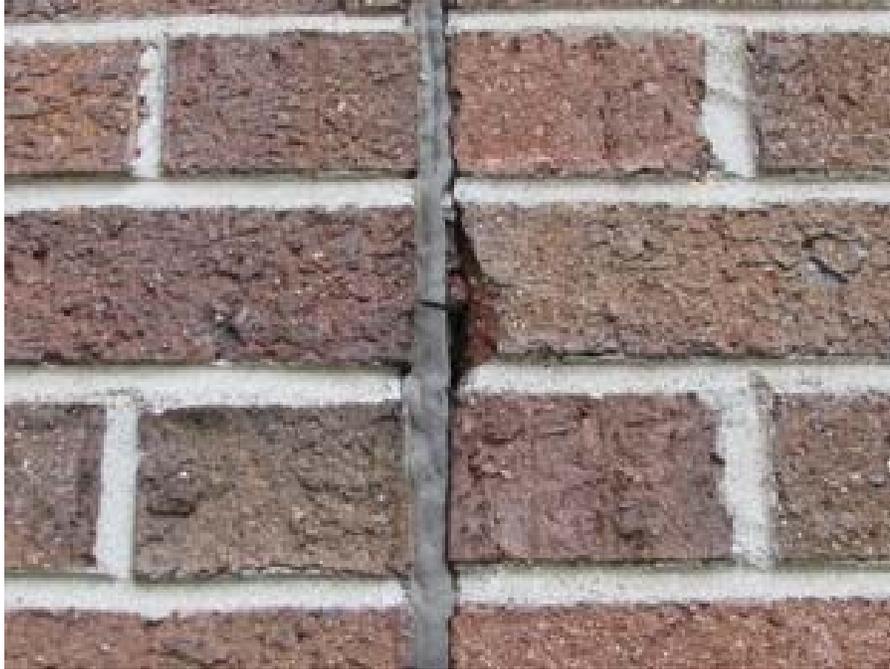
**Picture 5**

**Damaged Expansion Joint Sealant**

14. Examine all expansion joint seals on the exterior wall system. Reseal all expansion joints with damaged, missing or eroded sealant.
15. Install weather stripping around exterior doors to prevent drafts, water penetration and pest entry. Replace rusted exterior door.

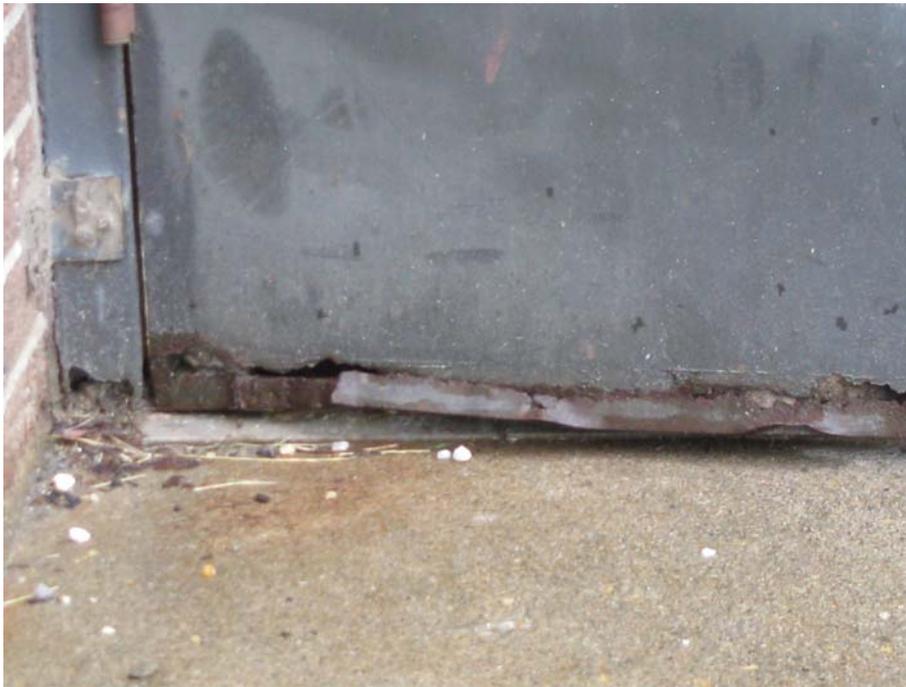
**Picture 6**

**Rusted and Damaged Exterior Door**

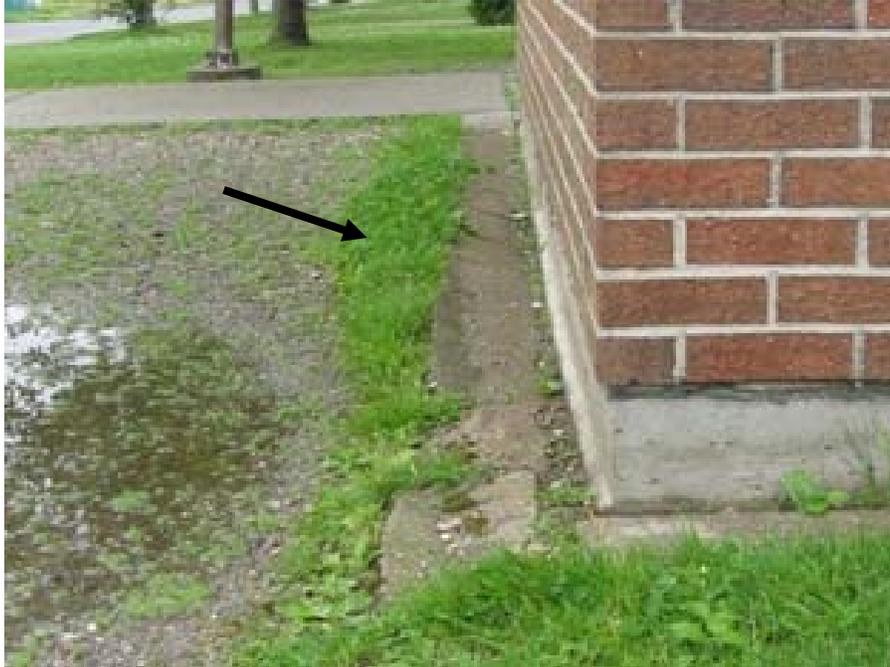
**Picture 7**

**Sloped Apron Directs Water toward Building**

16. Reestablish concrete apron around school to have it slope away from the base of the building to prevent water pooling. Seal open spaces/seams between apron/sidewalk and building exterior wall to prevent water penetration.

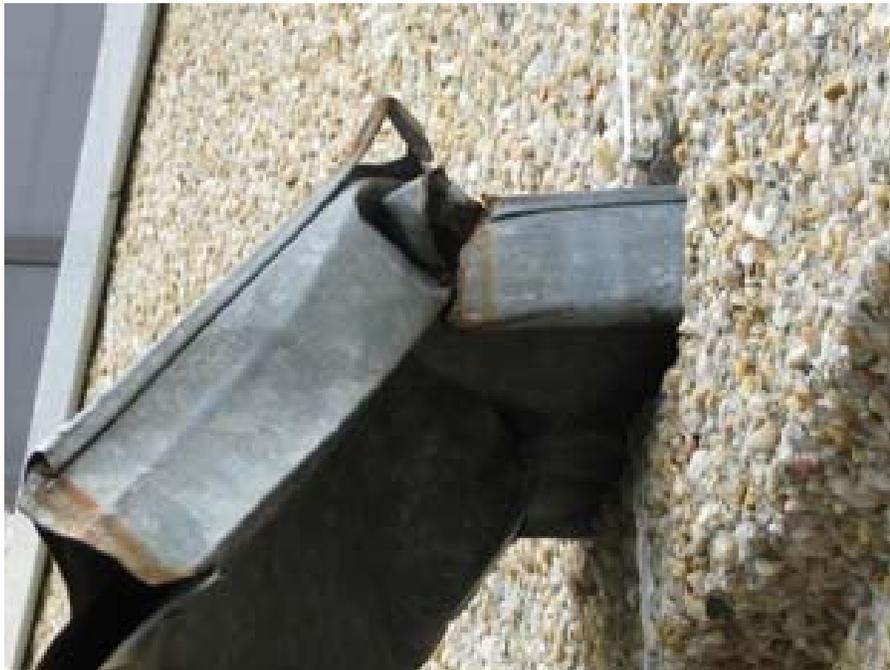
**Picture 8**

**Damaged Scupper without Gutter/Downspout**

17. Repair/replace scupper on the exterior of the building. Install a gutter/downspout to direct water away from the building.
18. Clear plants/shrubbery along exterior walls approximately 5-feet to prevent moisture impingement.

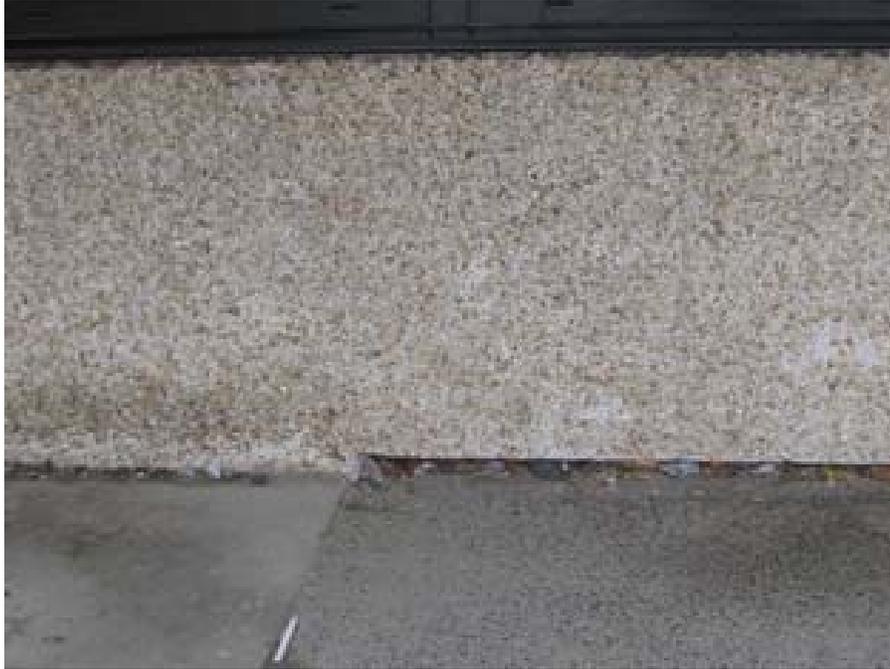
**Picture 9**

- Open spaces between pebble board wall at the base of the building and the sidewalk (Picture 9); and
- Plants/shrubbery growing in close proximity to the building, which can hold moisture against the building.

**Open Space between Pebble Board and Sidewalk**

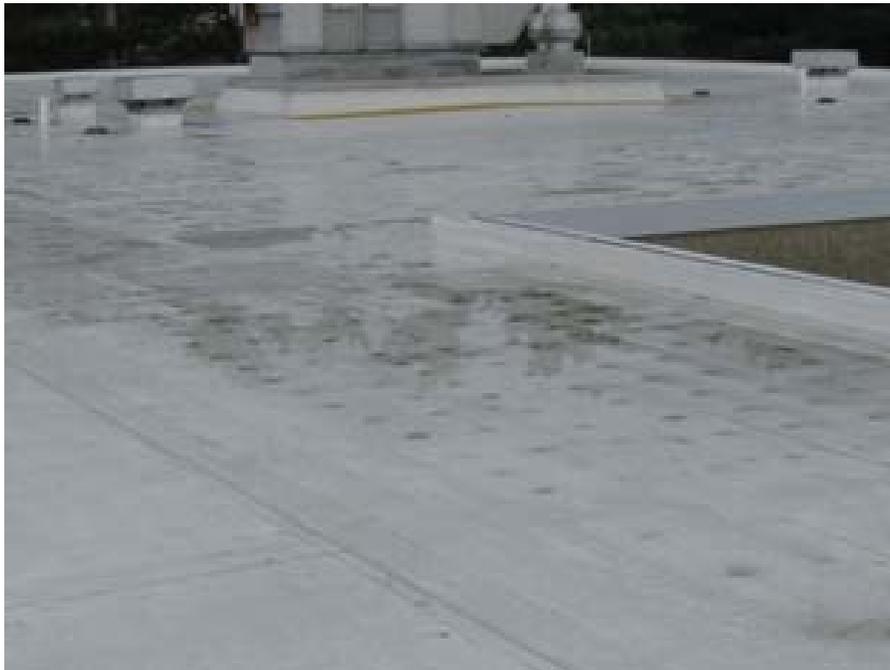
**Picture 10**

Standing water was observed on portions of the roof (Picture 10). Roof drains were blocked by a build up of debris, which can prevent water from draining (Picture 11). The freezing and thawing of water during winter months can lead to roof leaks and subsequent water penetration into the interior of the building. Pooling water can also become stagnant, which can lead to mold and bacterial growth, and serve as a breeding ground for mosquitoes.

**Standing Water on Roof**

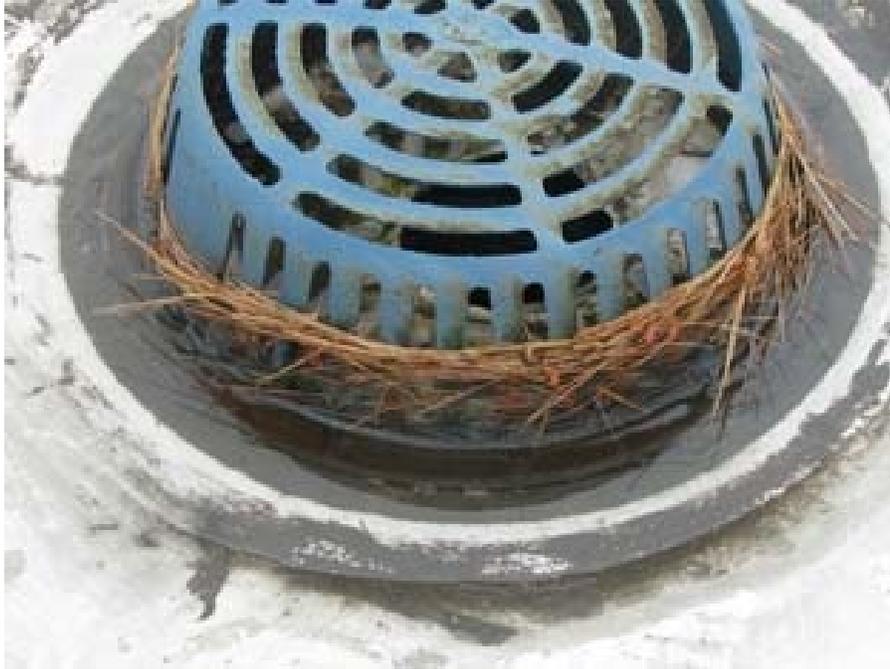
**Picture 11**

**Debris Blocking Roof Drain**

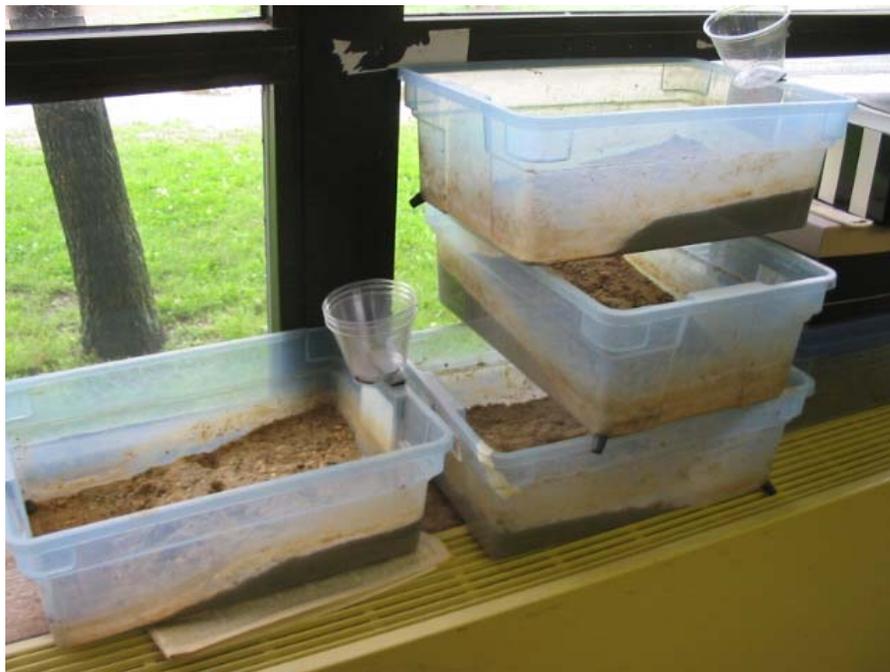
**Picture 12**

Terrariums were also observed in several classrooms (Picture 12). Terrariums should be properly maintained to ensure soil does not become a source for mold growth.

**Terrariums in Classroom**

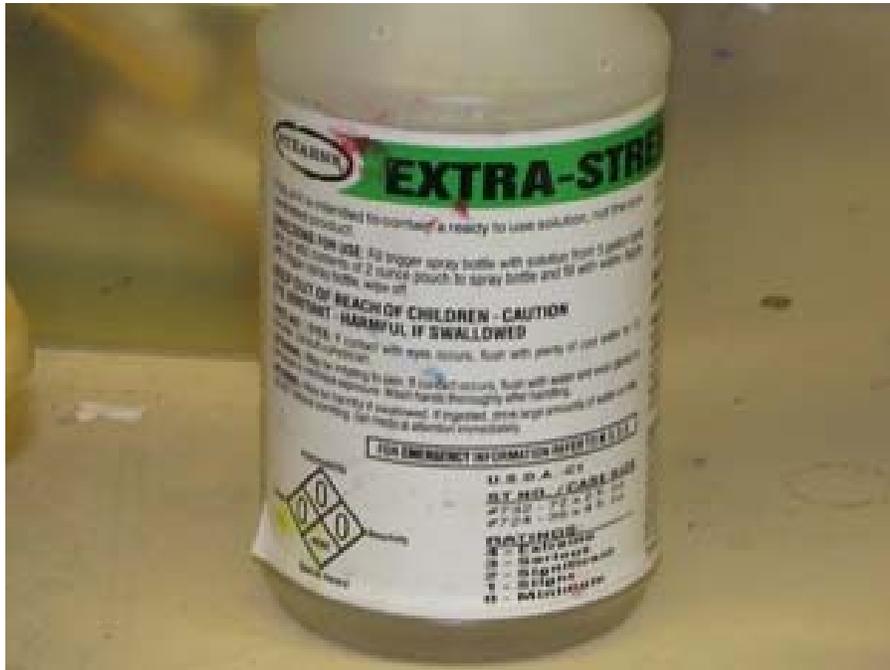
Picture 13

Cleaning products were also found on countertops in some classrooms (Picture 13). Like dry erase materials, cleaning products contain VOCs and other chemicals that can be irritating to

the eyes, nose and throat of sensitive individuals. Unlabeled/poorly labeled spray bottles were also observed in some classrooms. Products should be kept in their original containers, or should be clearly labeled as to their contents, for identification purposes in the event of an emergency. Further, material safety data sheets (MSDS) for all cleaning products must be available at a central location in the building.

Cleaners found in Classrooms

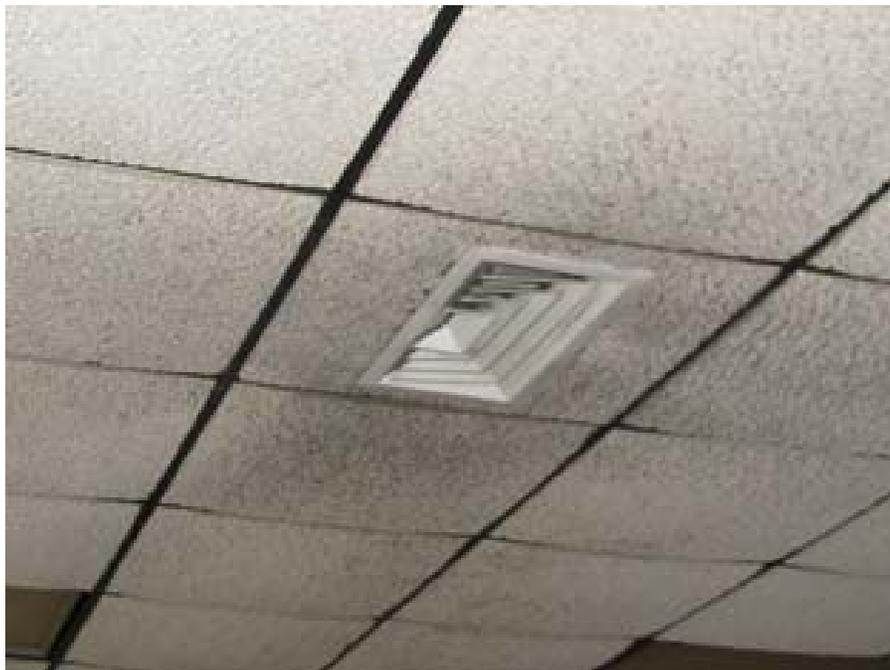
Picture 14

A number of air diffusers, exhaust/return vents and adjacent ceiling tiles were occluded with dust and debris (Pictures 13 through 16). In addition, personal fans were observed to have accumulated dust/debris. Dust can be a source for eye and respiratory irritation. If exhaust vents

Air Diffuser and Ceiling Tiles occluded with Dust and Debris

24. Clean personal fans, air diffusers, exhaust/return vents and adjacent ceiling tiles periodically of accumulated dust. If soiled ceiling tiles cannot be cleaned, they should be replaced.

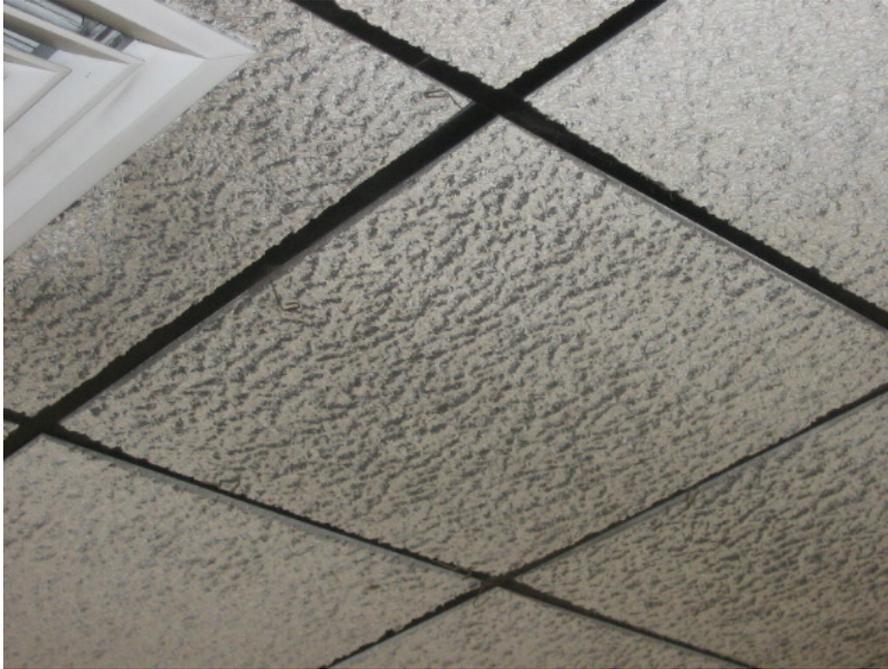
**Picture 15**

**Dust and Debris on Ceiling Tiles**

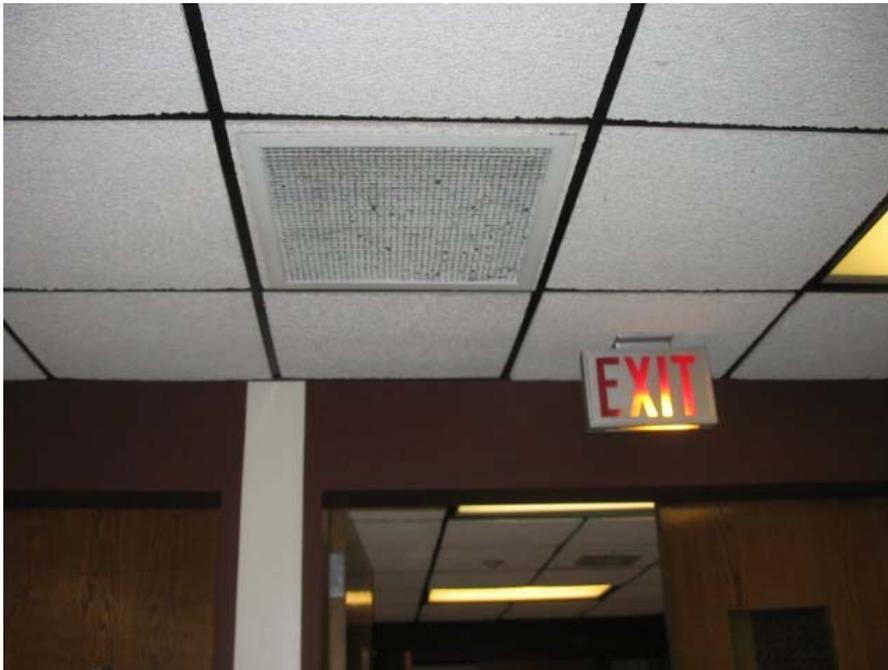
**Picture 16**

are not functioning, backdrafting can occur, which can aerosolize dust particles. Re-activated personal fans can serve to distribute dust and debris.

**Heavy Accumulation of Debris on Exhaust Vent**

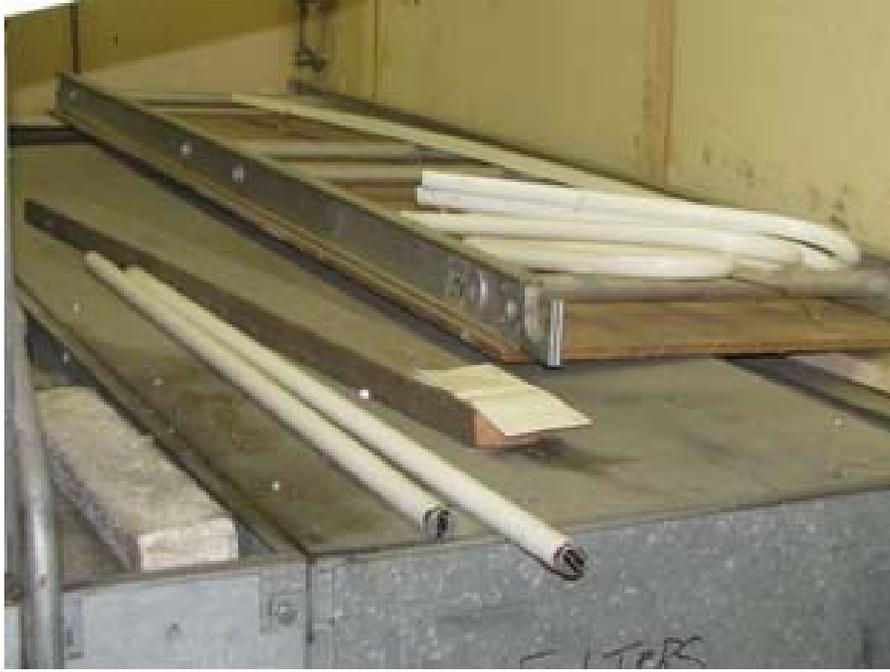
**Picture 17**

Fluorescent light bulbs were stored in the mechanical room (Picture 17). These bulbs contain mercury, and must be properly handled and stored in order to prevent breaks and mercury spills.

**Fluorescent Light Bulbs stored in Mechanical Room**

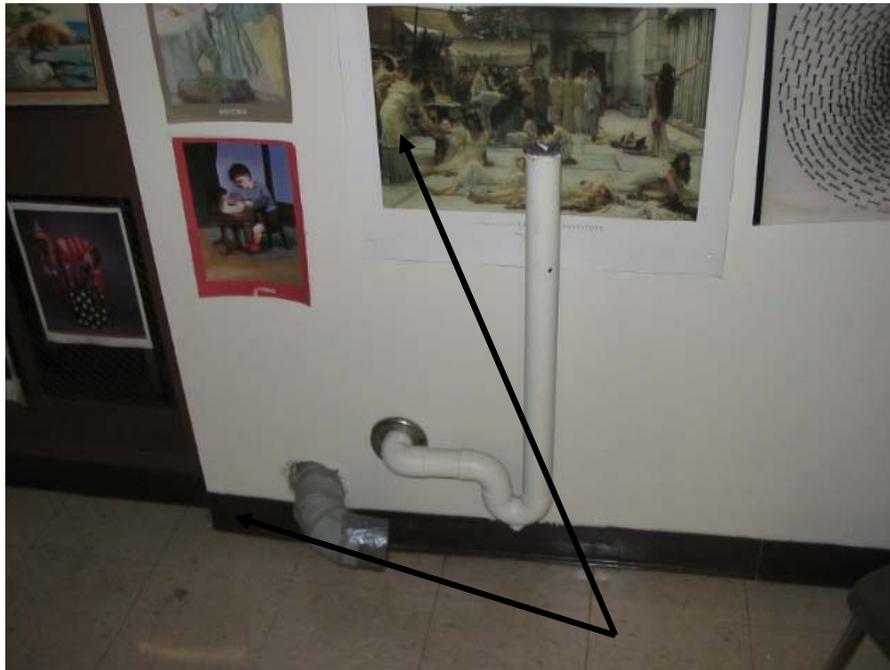
**Picture 18**

A washer/dryer hookup that was not in use was observed in one of the art rooms. The drain line for the washing machine was sealed with duct tape. The drain may have a dry trap, which can allow sewer gases/odors to migrate from the drain system into occupied space (Picture 18). Additionally, the penetration of the dryer vent through the wall is not properly sealed,

which can provide pathways for rodents, drafts, dust and particulates to migrate into occupied areas.

**Abandoned Washer and Dryer Hookup**

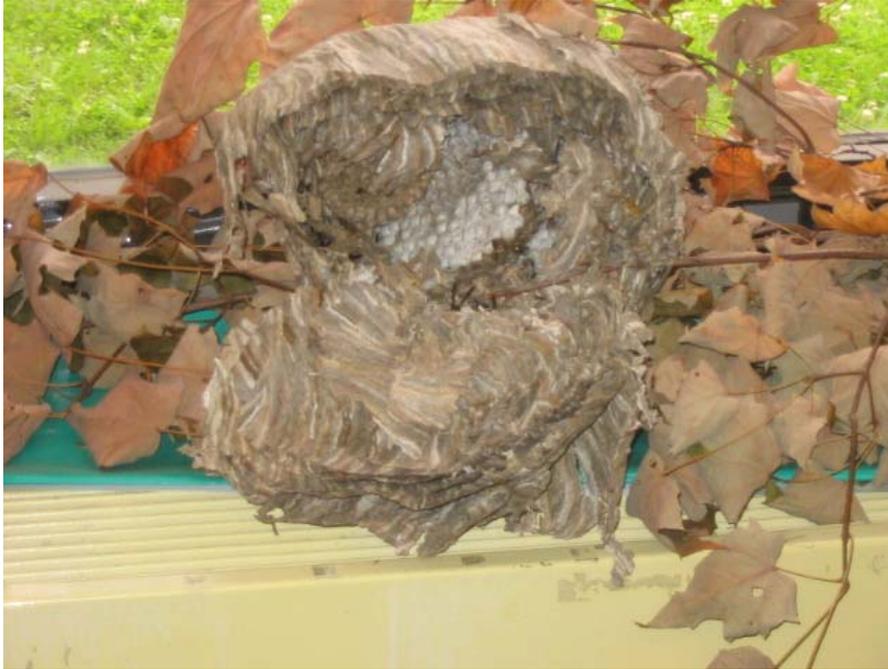
**Picture 19**

Lastly, insect nests were observed in classrooms (Picture 19). Nests can contain bacteria and may also be a source of allergenic material. Nests should be placed in re-sealable bags to prevent aerosolization of allergenic material.

**Insect Nest in Classroom**
