# **INDOOR AIR QUALITY ASSESSMENT**

**Paul F. Doyon Memorial School  
216 Linebrook Road  
Ipswich, Massachusetts 01938**

Prepared by:  
Massachusetts Department of Public Health  
Bureau of Environmental Health  
Indoor Air Quality Program  
October 2009

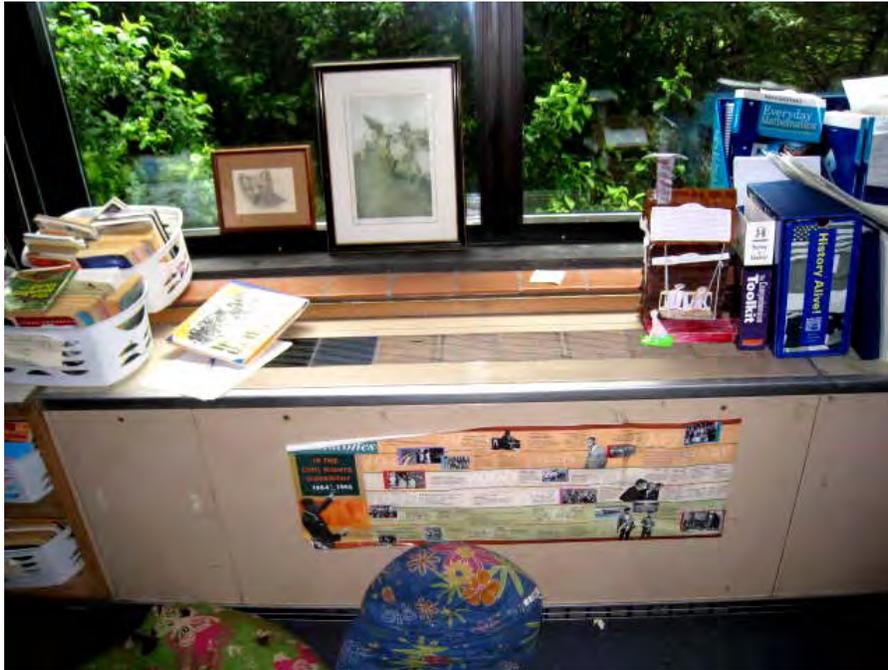
**Picture 1**

Fresh air for classrooms is supplied by unit ventilator (univent) systems (Picture 1). A univent draws outdoor air through a fresh air intake located on the exterior wall of the building (Picture 2), and return air from the room through an air intake located at the base of the unit ([Figure 1](#)). Fresh and return air are mixed, filtered, heated and distributed to the room through an air diffuser located in the top of the unit. Univents were operating in the majority of rooms at the time of the assessment; however, BEH staff found several univents switched 'off', preventing fresh air from being introduced into these rooms. Univent air diffusers and returns were blocked

by furniture and other stored items in front and on top of the unit, thereby limiting airflow. BEH staff also noted that the univent air diffuser in room 110 was damaged (Picture 3). In order for univents to provide fresh air as designed, air diffusers, intakes and returns must remain free of obstructions. Importantly, these units must remain “on” and be allowed to operate while rooms are occupied. A univent operating in a mode that provides a continual supply of fresh, outdoor air can improve both indoor air quality and comfort, since this continual source of fresh air dilutes pollutants that typically accumulate in indoor environments.

**Classroom Univent, Note Books and Stored Items on Top**

3. Remove all blockages from univents and exhaust vents to ensure adequate airflow.
4. Make repairs to univent air diffusers as needed.
5. Consider installing local exhaust ventilation in work room for photocopiers and laminator.

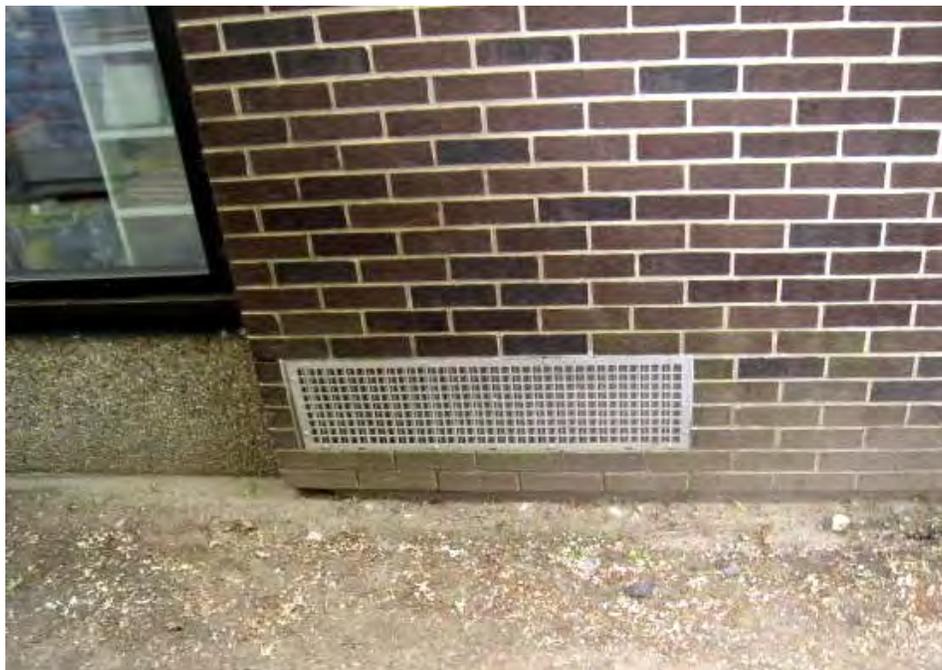
**Picture 2**

**Univent Fresh Air Intake on Exterior Wall**

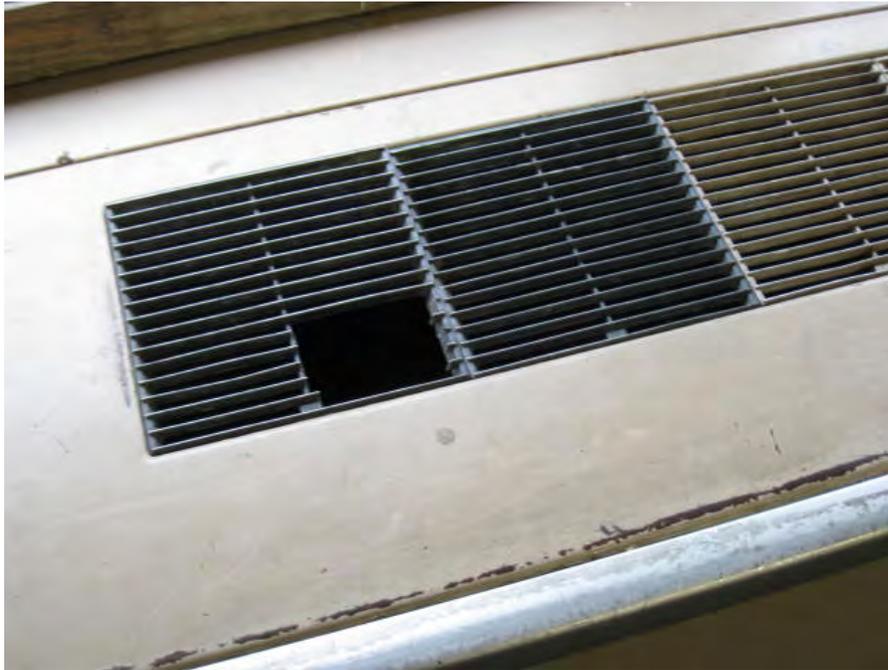
**Picture 3**

**Damaged Univent Air Diffuser**

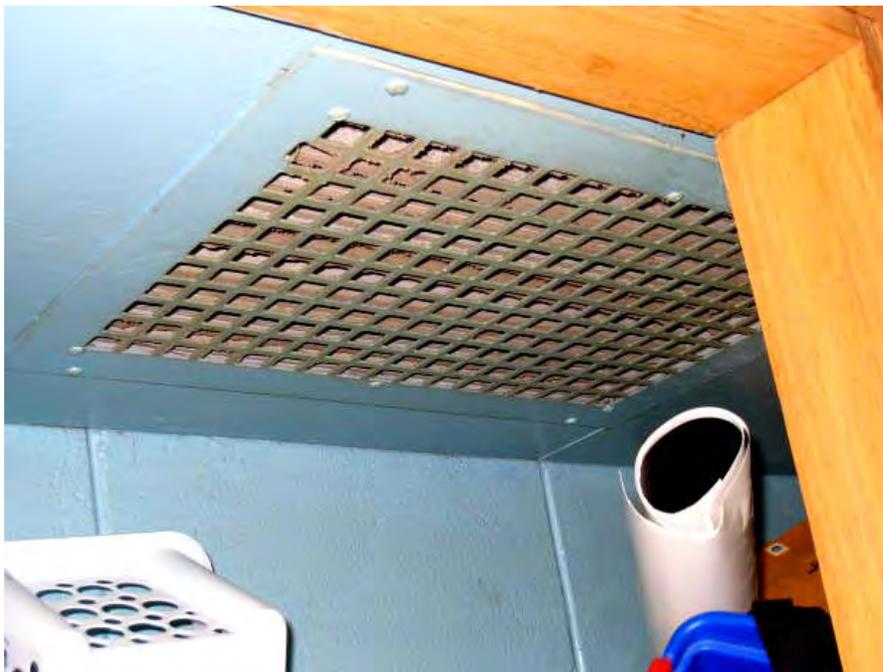
**Picture 4**

Exhaust ventilation is provided by vents ducted to rooftop motors. Classroom exhaust vents are located in storage closets with undercut doors in order to allow air to move freely to the vent at the top of the closet (Pictures 4 through 6). Exhaust vents in some classrooms and offices were obstructed, and in one area, cardboard was used to block the vent. Exhaust ventilation systems in operation continuously remove air that has become stale from moisture, odors, and pollutants. In order to function properly, exhaust vents must be activated and allowed to operate without obstruction while rooms are occupied. Without adequate exhaust ventilation, excess heat and stale air can build up leading to indoor air quality and comfort complaints.

**Classroom Exhaust Vent**

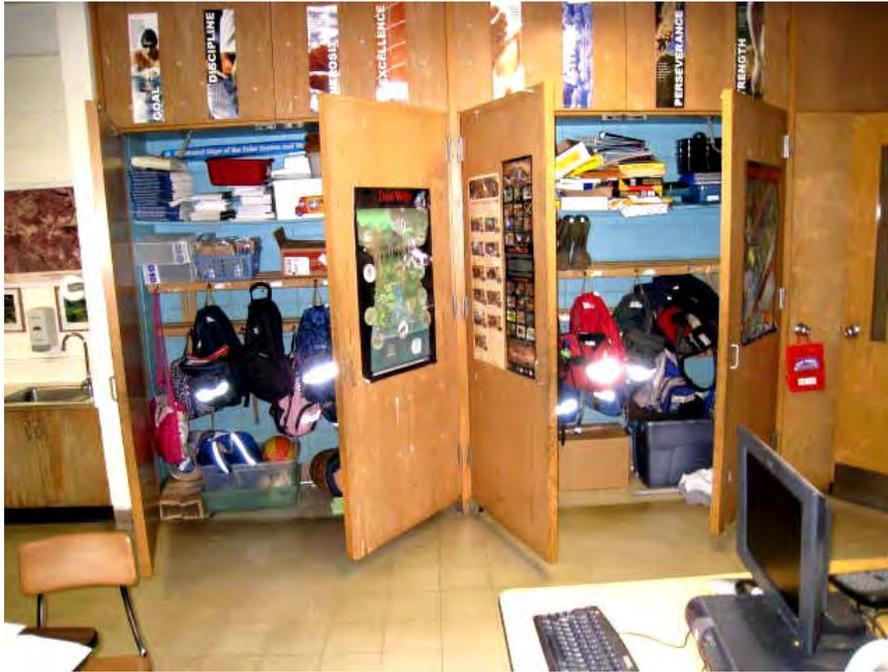
**Picture 5**

**Classroom Storage Closet with Exhaust Vent**

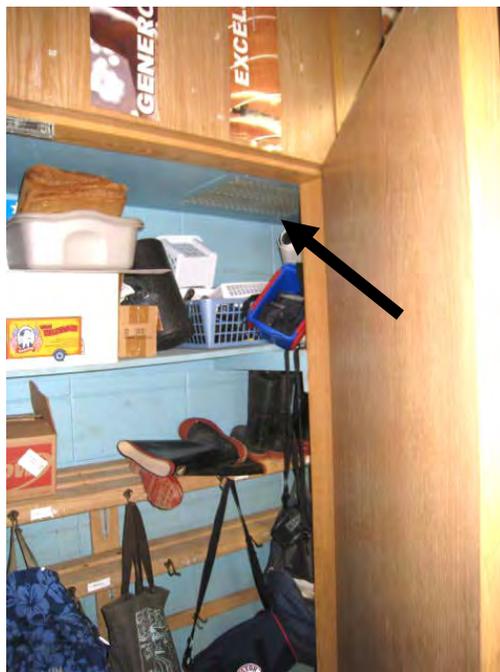
**Picture 6**

**Exhaust Vent at the Top of the Closet**

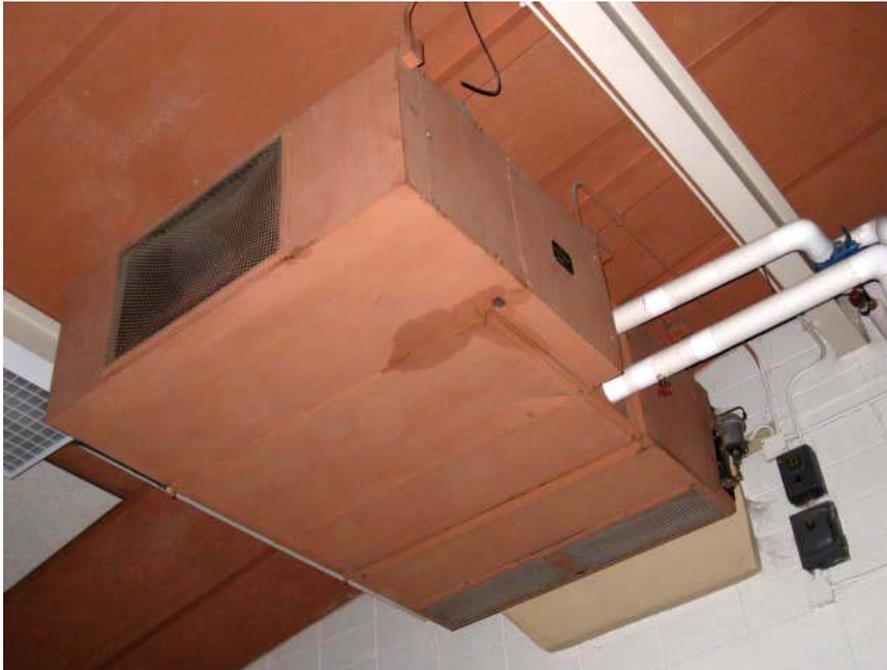
**Picture 7**

In addition to univents, the gymnasium has ceiling mounted air handling units (AHUs) to provide ventilation. AHUs distribute fresh air to the gymnasium through air diffusers and duct air back via return vents at the base of the unit (Picture 7). The AHUs in the gymnasium were

not activated at the time of testing, as illustrated by the elevated carbon dioxide levels that were measured during the assessment (Table 1).

**Gymnasium Air Handling Unit**

1. Operate all ventilation systems (e.g., AHUs, univents and exhaust vents) throughout the building *continuously* during periods of school occupancy. To increase airflow in classrooms, set univent controls to “high”. School staff should be encouraged not to deactivate classroom univents; rather, report any complaints to the facilities department.
2. Contract with a ventilation engineer to inspect HVAC equipment for proper function. Repair or replace components as necessary to ensure adequate air supply and exhaust capability throughout the school’s classrooms, offices and common areas.

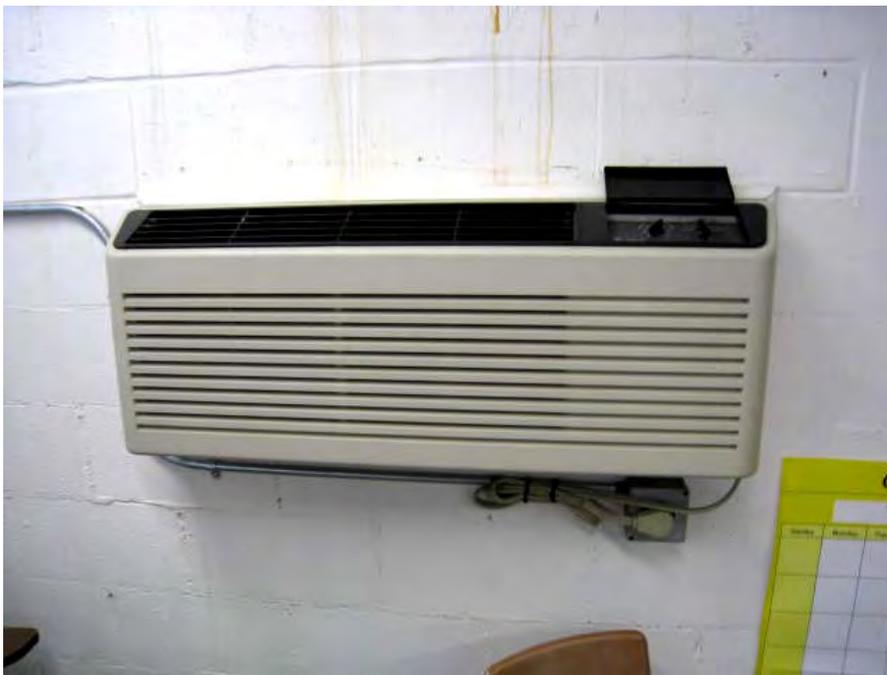
**Picture 8**

Air conditioners (AC) were used in several rooms (Picture 8). ACs are normally equipped with filters, which should be cleaned or changed as per manufacturers' instructions to avoid the build-up and re-aerosolization of dirt, dust and particulate matter.

**Wall mounted Air Conditioner**

8. Change filters for air-handling equipment (e.g., ACs, AHUs and univents) as per the manufacturer's instructions or more frequently if needed. Vacuum interior of units prior to activation to prevent the aerosolization of dirt, dust and particulates. Ensure filters fit flush in their racks with no spaces in between allowing bypass of unfiltered air into the unit.

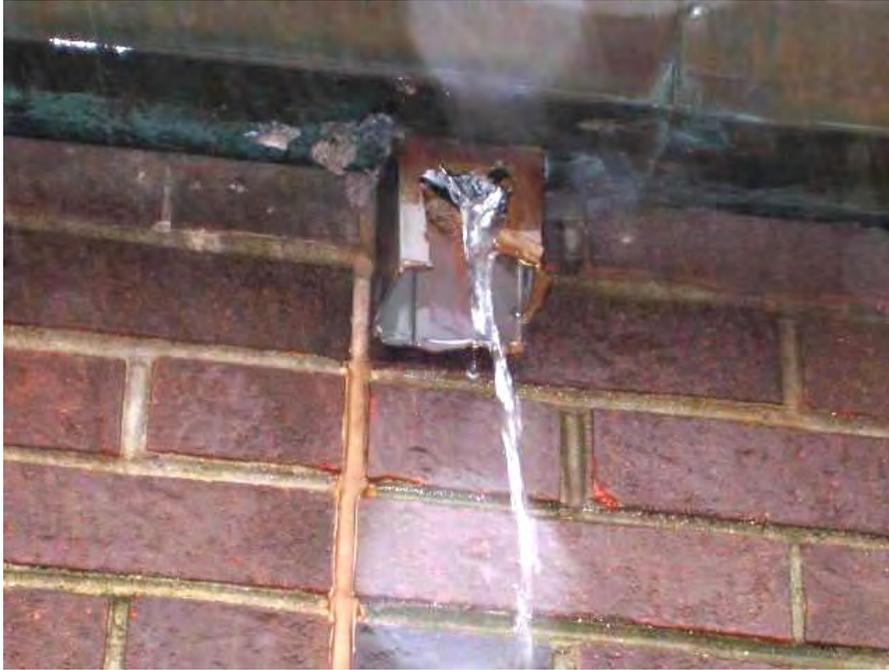
**Picture 9**

- Damaged and/or missing drip edges, gutters and downspouts allowing water to empty against the side of the building and pool at the base of the building (Pictures 9 through 11, and 15);
- Shrubs and trees growing against the building and in front of univent fresh air intakes, holding moisture against exterior brick and allowing moisture-laden air to be drawn in by the fresh air intakes (Pictures 12 through 14);
- Tree branches overhanging the roof (Pictures 14 and 15);
- Cracks and damaged caulking around fresh air intakes on exterior wall (Picture 16);
- Siding was damaged exposing insulation (Picture 17);
- Exterior brick and mortar was damaged and/or missing (Picture 10 and 18);
- Exterior brick was significantly water stained indicating a heavy and/or continuous water exposure (Pictures 11, 14, 15, 18 and 19); and,
- Efflorescence<sup>1</sup> on exterior brick (Picture 20).

**Damaged/Missing Downspout**

10. Repair and replace damaged/missing drip edges, gutters and downspouts. Ensure gutters and downspouts are clean and connected, and gutters drain water away from the foundation.

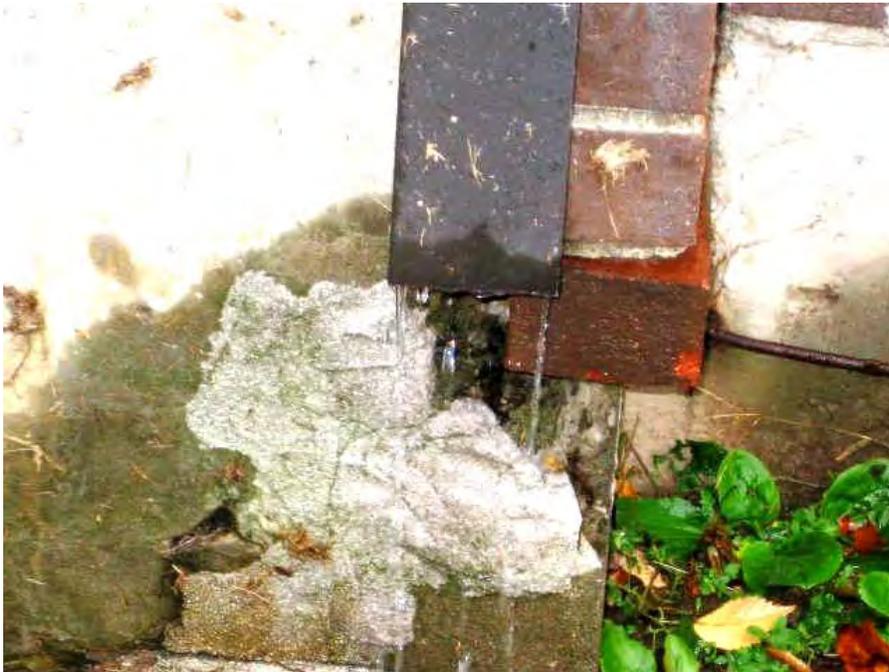
**Picture 10**

**Damaged Downspout; Damaged Exterior Brick and Cement**

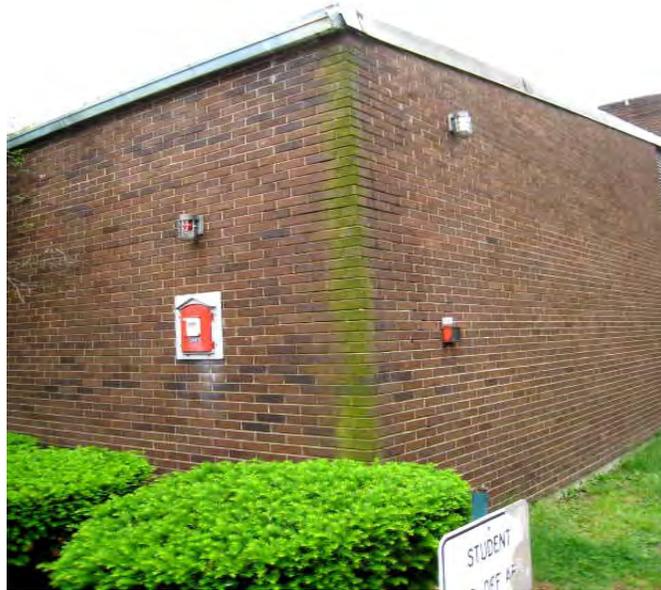
**Picture 11**

**Water Stained Bricks under Damaged Drip Edge**

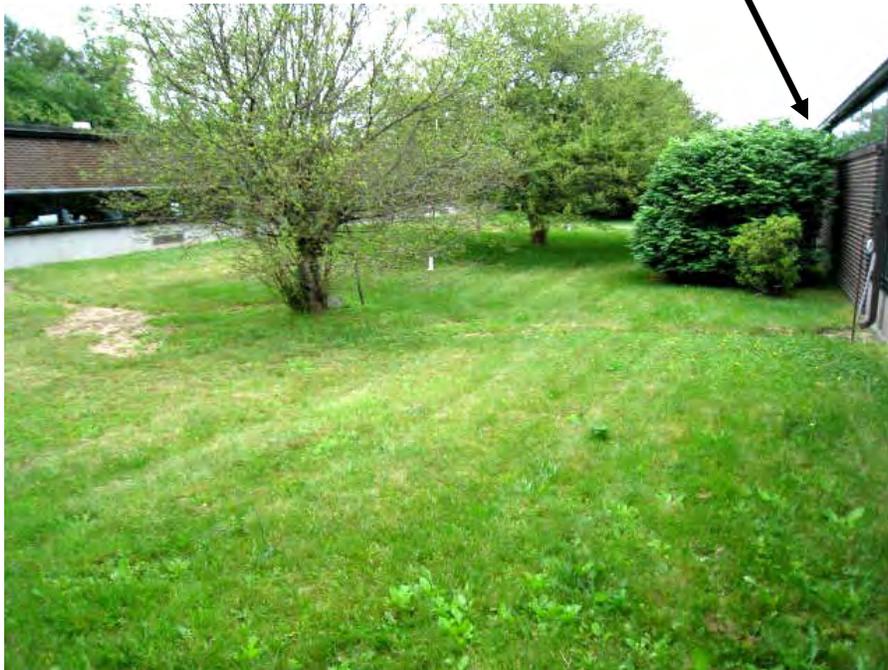
**Picture 12**

**Shrubs and Trees Growing in Courtyard; Note Shrubs Growing Against Building**

11. Cut shrubs and trees in a manner to maintain a space of 3 to 5 feet from the building exterior and univent fresh air intakes, to prevent moisture from being held against exterior brick and moisture-laden air to be drawn in by the fresh air intake.

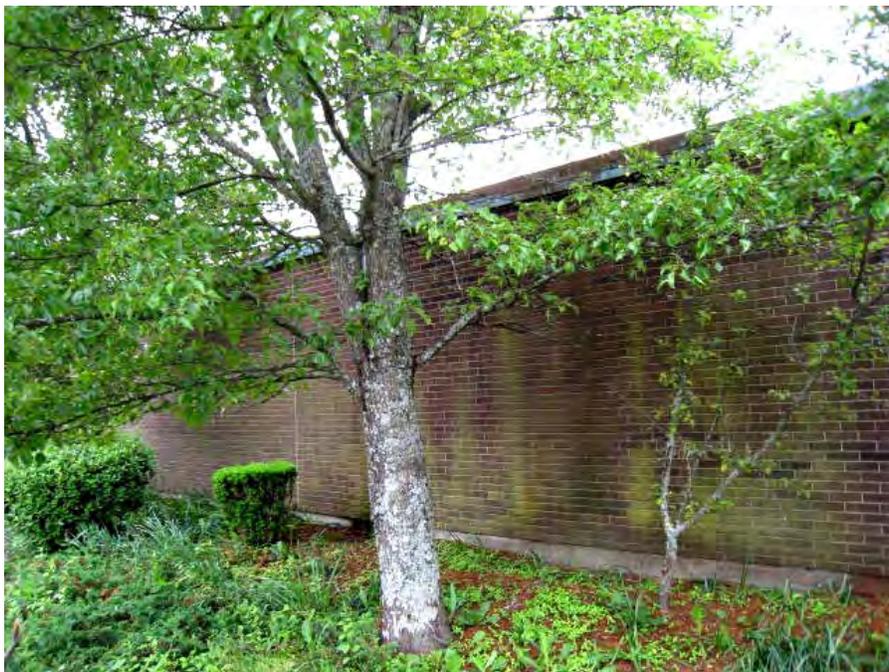
**Picture 14**

**Water Stained Exterior Brick; Trees Overhanging Roof**

12. Trim tree branches that overhang the roof.
13. Seal around univent fresh air intakes to prevent water/pest penetration.
14. Consider having exterior walls re-pointed and waterproofed to prevent water intrusion. This measure should include a full building envelope evaluation.

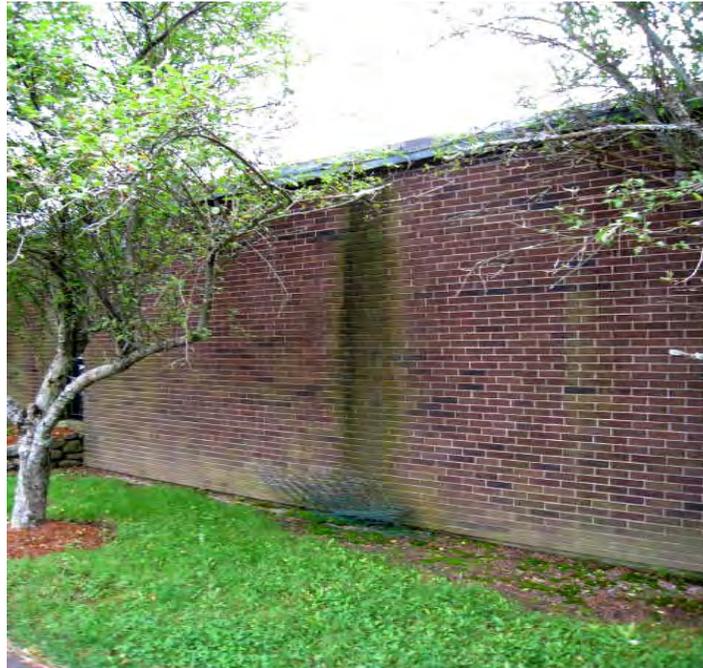
**Picture 15**

**Water Stained Exterior Brick under Damaged Drip Edge; Trees Overhanging Roof**

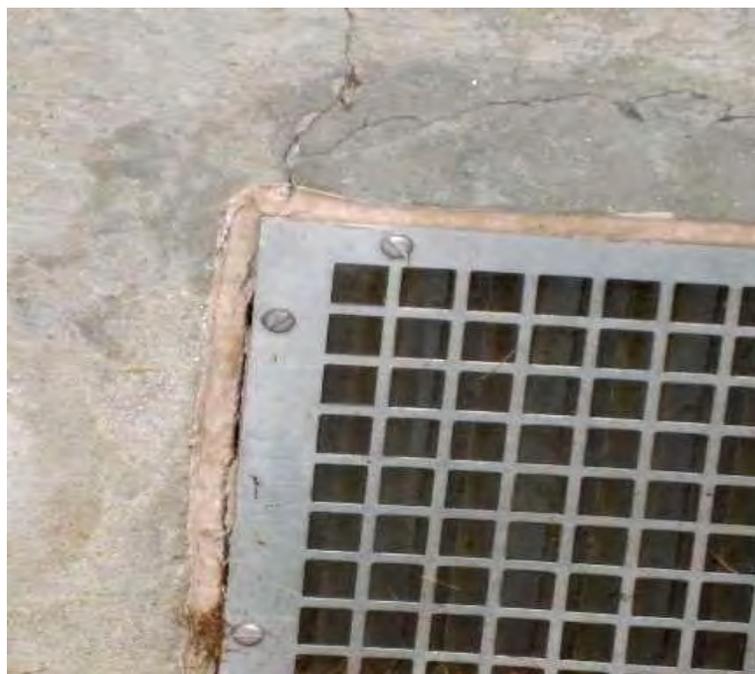
**Picture 16**

**Cracks and Damaged Caulking around Fresh Air Intake**

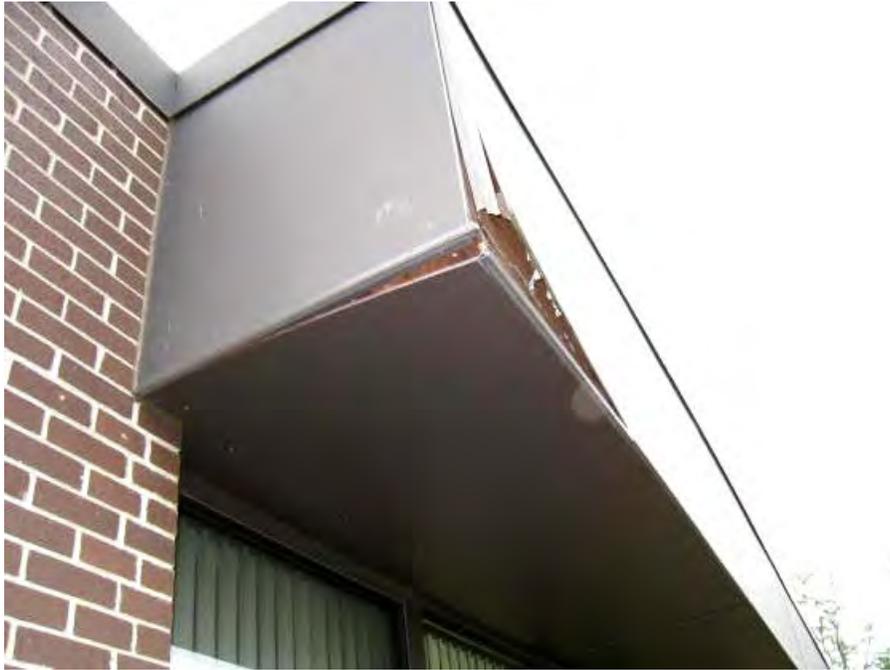
**Picture 17**

**Damaged Siding Exposing Insulation**

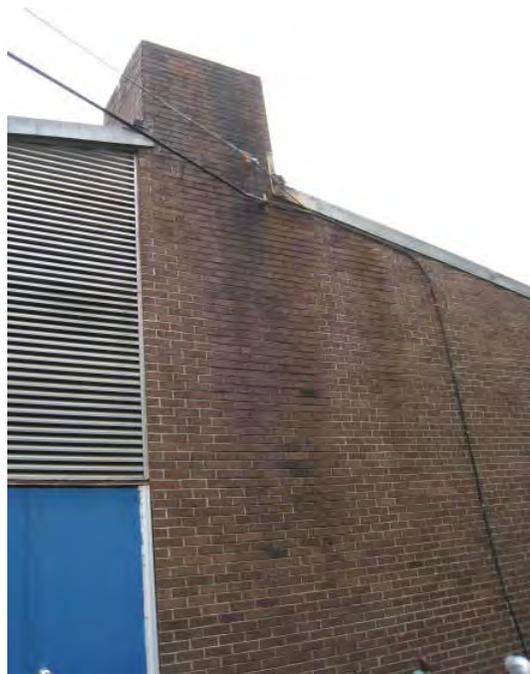
**Picture 18**

**Damaged and Water Stained Exterior Brick**

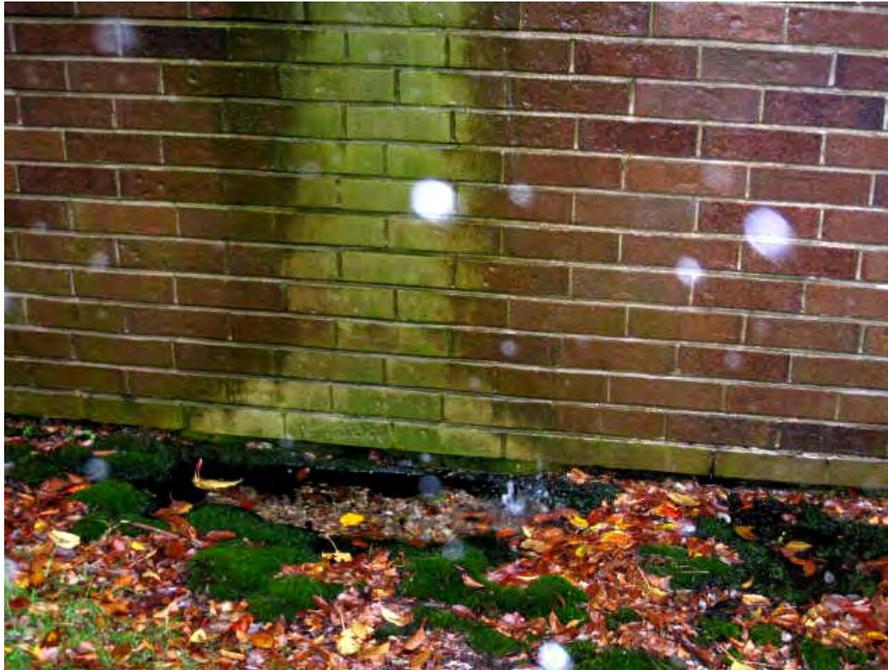
**Picture 19**

**Water Stained Brick**

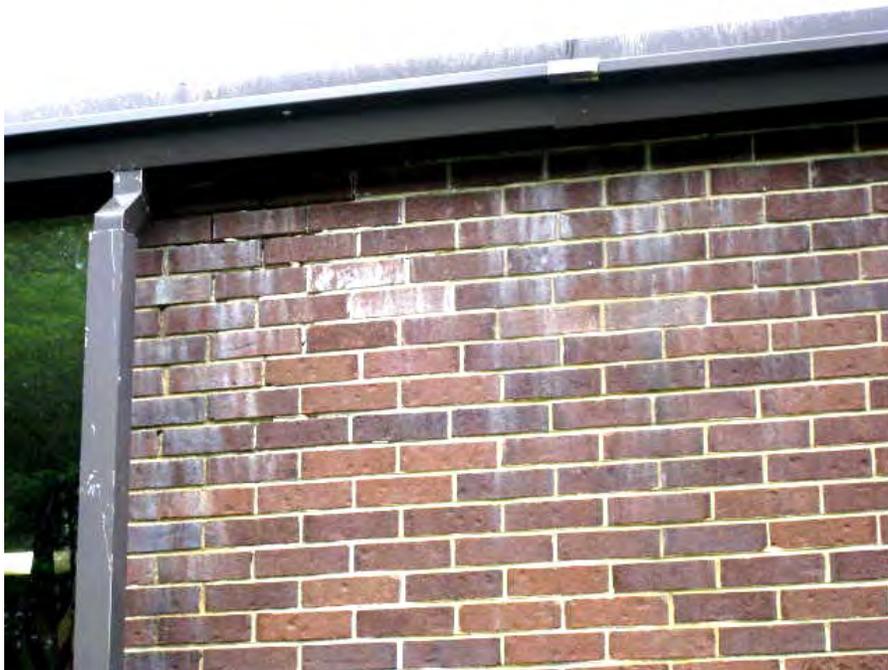
**Picture 20**

<sup>1</sup> As moisture penetrates and works its way through building materials (e.g., masonry), water-soluble compounds dissolve, creating a solution. As this solution moves to the surface, the water evaporates, leaving behind white, powdery mineral deposits.

**Efflorescence on Exterior Brick**

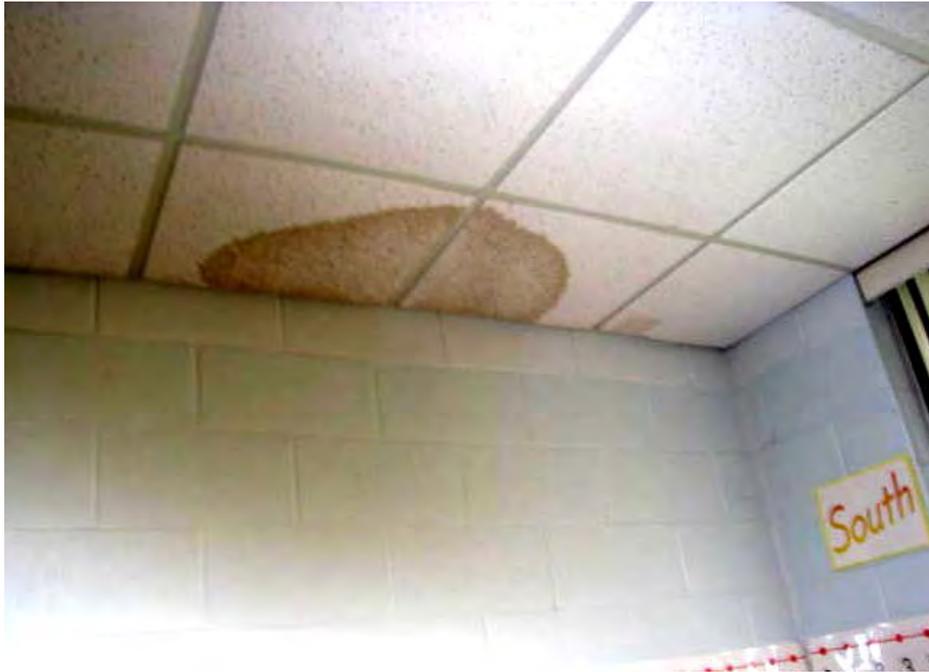
**Picture 21**

A number of rooms had water-damaged ceiling tiles, which can indicate leaks from the roof, plumbing system or through the building envelope. In room 305, water-damaged ceiling tiles were located on the south wall, adjacent to the hallway leading to the back of the school (Picture 21) and holes were observed in the ceiling tile system (Picture 22). A breach in a ceiling can allow dust, odors, and other pollutants to move into occupied areas. Water-damaged ceiling tiles can indicate sources of water penetration and provide a source of mold growth. Ceiling tiles should be replaced after a water leak is discovered and repaired.

**Water Damaged Ceiling Tiles**

15. Repair any existing water leaks and replace any remaining water-damaged ceiling tiles. Examine the area above these tiles for mold growth. Disinfect areas of water leaks with an appropriate antimicrobial, as needed.

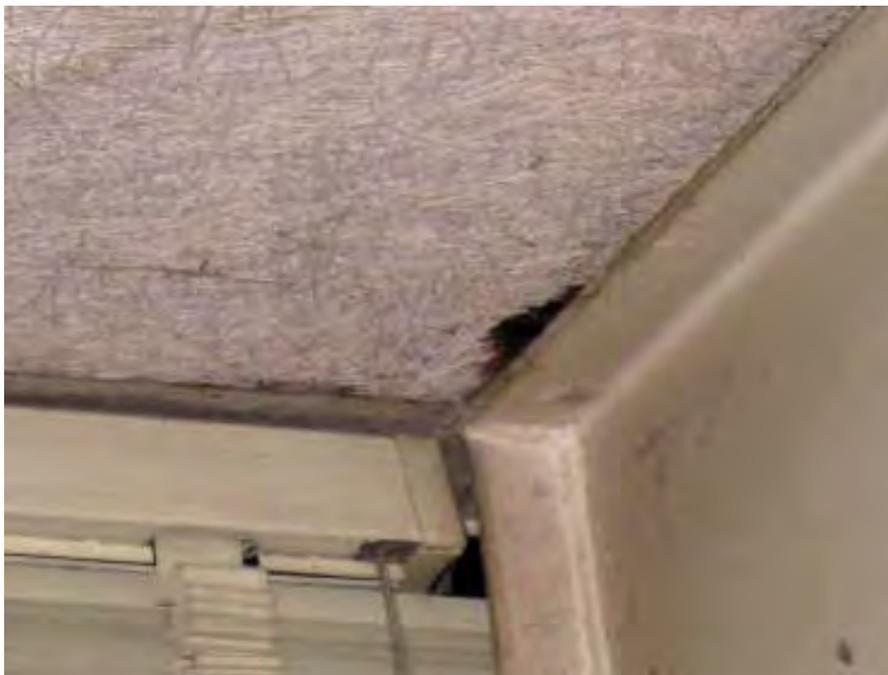
**Picture 22**

**Breach in Ceiling Tile**

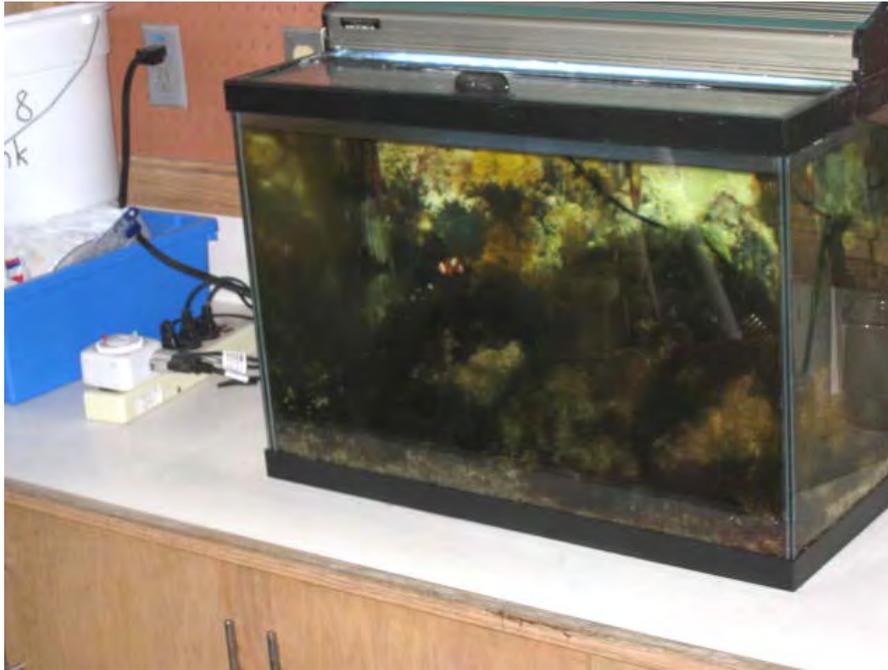
**Picture 23**

Aquariums were also located in a number of classrooms (Picture 23). Aquariums should be properly maintained to prevent microbial/algae growth, which can emit unpleasant odors.

**Aquarium in Classroom**

17. Clean and maintain aquariums to prevent mold growth and associated odors.
18. Store cleaning products properly and out of reach of students. All cleaning products used at the facility should be approved by the school department with MSDS' available at a central location.

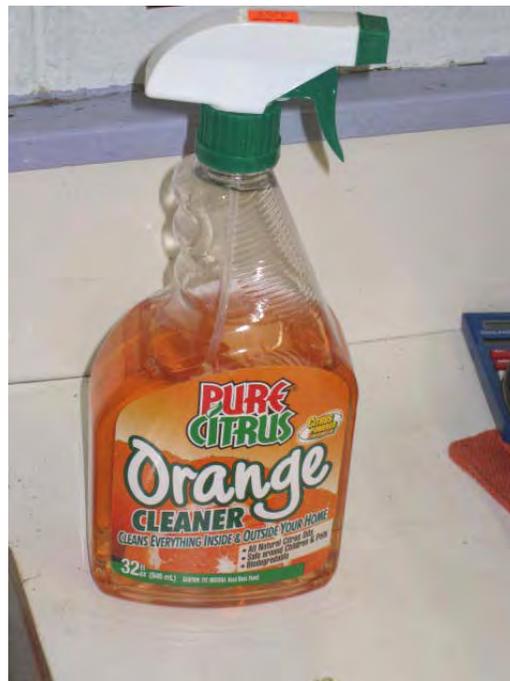
**Picture 24**

Cleaning products were found in rooms throughout the building (Picture 24). The type and brand of these products varied from room to room. Cleaning products contain chemicals that can be irritating to the eyes, nose and throat of sensitive individuals. These products should be properly labeled and stored in an area that is not accessible to children. Additionally, a Material

**Cleaning Product in Classroom**

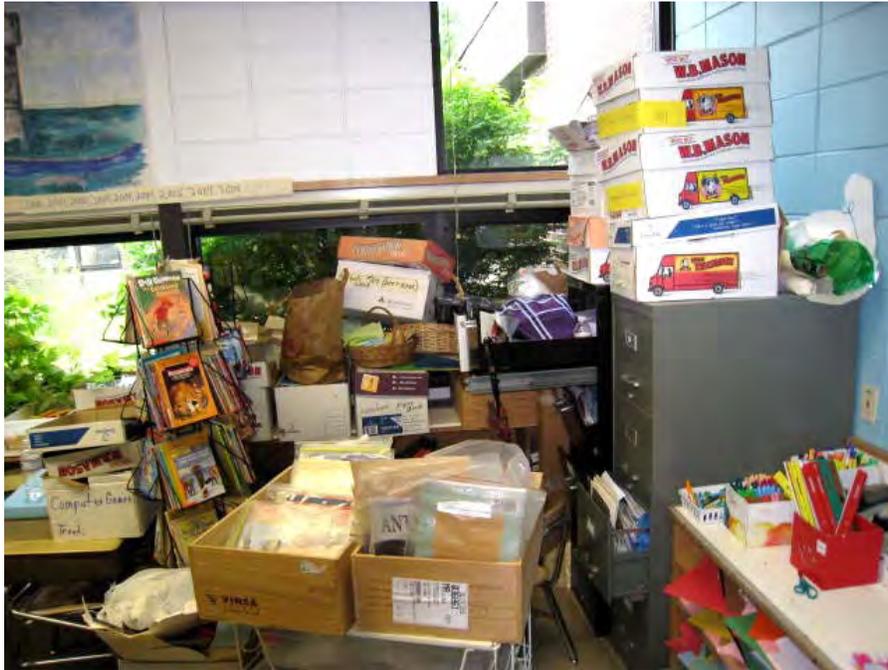
**Picture 25**

Other conditions that can affect indoor air quality were observed during the assessment. In several classrooms, stored items were observed on windowsills, tabletops, counters, bookcases and desks (Picture 25). The large number of items stored in classrooms provides a source for dusts to accumulate. These items (e.g., papers, folders, boxes) make it difficult for custodial staff to clean. Items should be relocated and/or be cleaned periodically to avoid excessive dust build up. In addition, these materials can accumulate on flat surfaces (e.g., desktops, shelving and carpets) in occupied areas and subsequently be re-aerosolized causing further irritation.

**Accumulated Items in Classroom**

19. Relocate or consider reducing the amount of materials stored in classrooms to allow for more thorough cleaning of classrooms. Clean items regularly with a wet cloth or sponge to prevent excessive dust build-up.

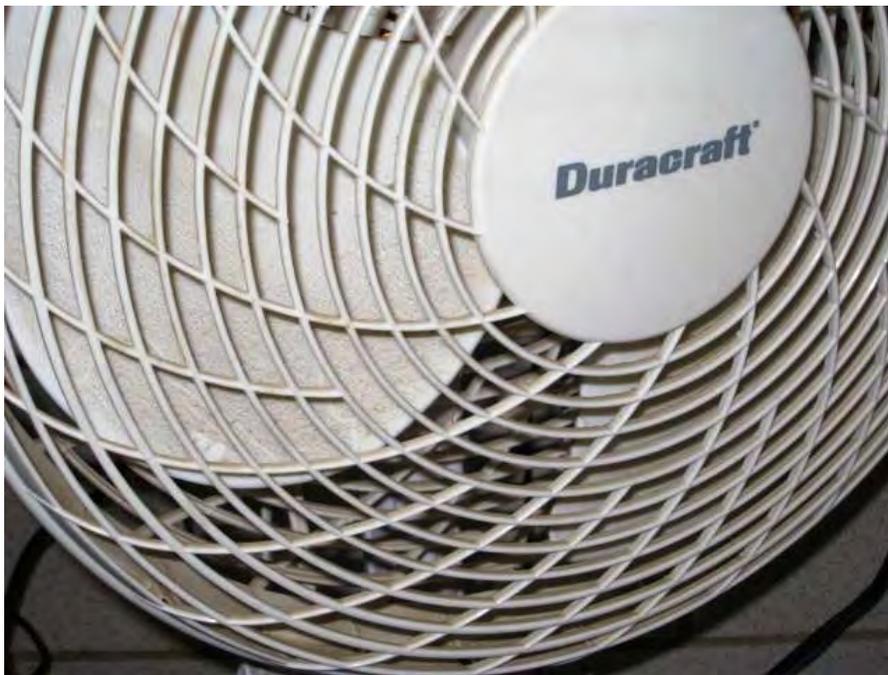
**Picture 26**

A number of univent/supply air diffusers, exhaust vents and personal fans in classrooms were observed to have accumulated dust/debris (Picture 26). Re-activated supply vents/fans can aerosolize dust accumulated on fan blades/housing. If exhaust vents are not functioning, backdrafting can occur, which can re-aerosolize dust particles.

**Accumulated Dust on Fan Blades**

20. Clean accumulated dust and debris periodically from univent air diffusers, exhaust vents and blades of personal fans.
21. Bird and insect nests should be placed in resealable bags to prevent aerosolization of allergenic material.

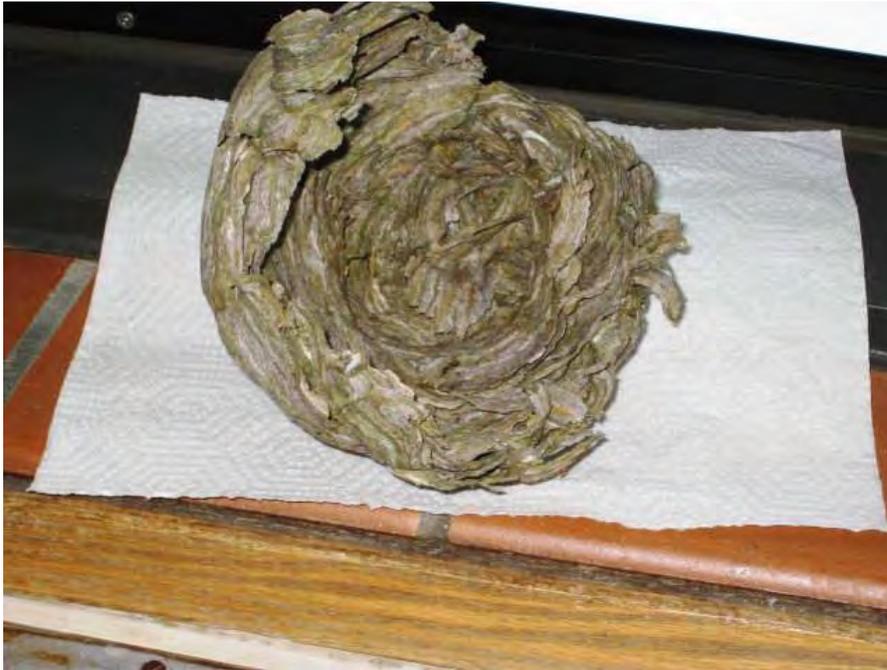
**Picture 27**

Bird and insect nests were found in classrooms (Picture 27). Nests can contain bacteria and may also be a source of allergenic material. Nests should be placed in resealable bags to prevent aerosolization of allergenic material.

**Insect Nest in Classroom**

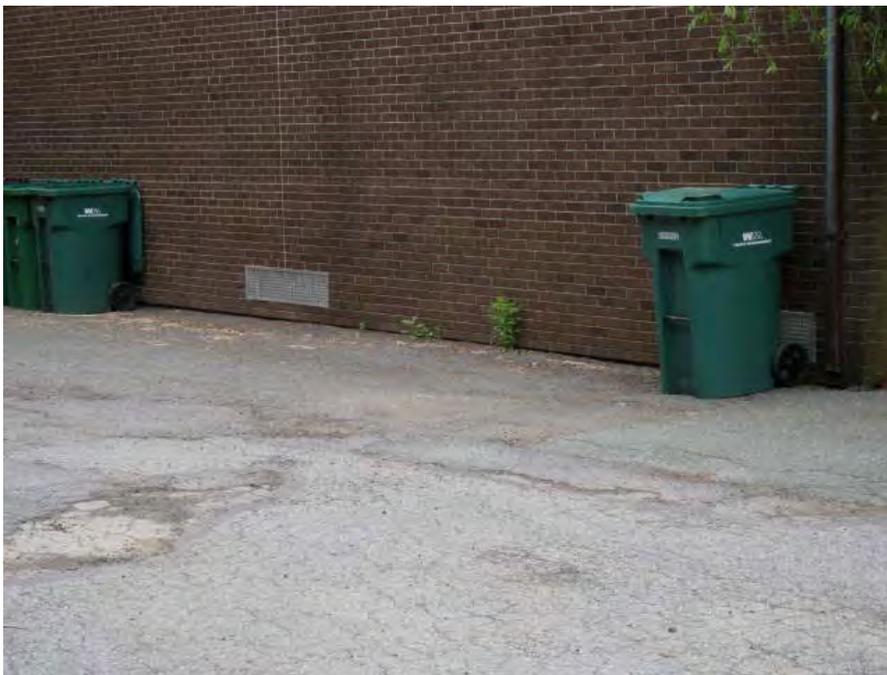
**Picture 28**

While examining the exterior of the building, BEH staff found trash cans located near fresh air intakes in the exterior wall (Picture 28). Fresh air intakes can draw in odors from the trash, which can cause indoor air quality complaints.

**Trash Cans Located near Fresh Air Intake**

22. Store outdoor trash cans away from fresh air intakes on exterior wall.
23. Consider cleaning carpeting annually (or semi-annually in soiled high traffic areas) as per the recommendations of the Institute of Inspection, Cleaning and Restoration Certification (IICRC). Copies of the IICRC fact sheet can be downloaded at: [http://www.cleancareseminars.com/carpet\\_cleaning\\_faq4.htm](http://www.cleancareseminars.com/carpet_cleaning_faq4.htm) (IICRC, 2005).

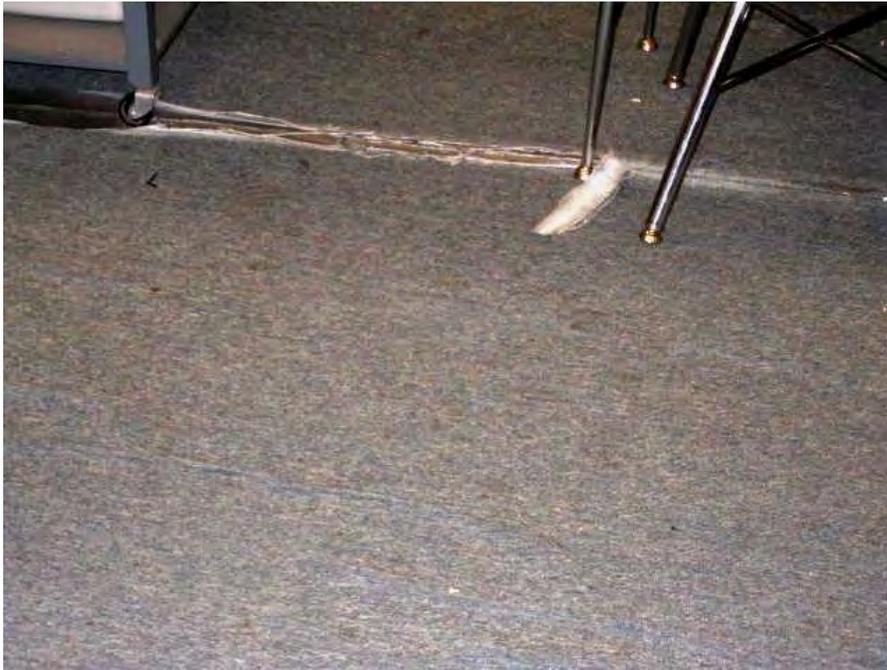
**Picture 29**

Lastly, BEH staff found carpet in several areas damaged and worn (Picture 29). In some areas duct tape was used in an effort to repair carpeting (Picture 30). Disintegrating textiles can be a source of airborne particulates, which can be irritating to the eyes, nose and throat. Carpet in schools has a normal life span of approximately eleven years (IICRC, 2002). The useful life span of a carpet and other flooring materials should be considered when long term planning for replacement is conducted.

**Classroom Carpet Damaged and Torn**

24. Consider establishing a schedule for replacement of carpets based on IICRC recommendations.
25. Consider adopting the US EPA (2000) document, “Tools for Schools”, as an instrument for maintaining a good indoor air quality environment in the building. This document is available at: <http://www.epa.gov/iaq/schools/index.html>.

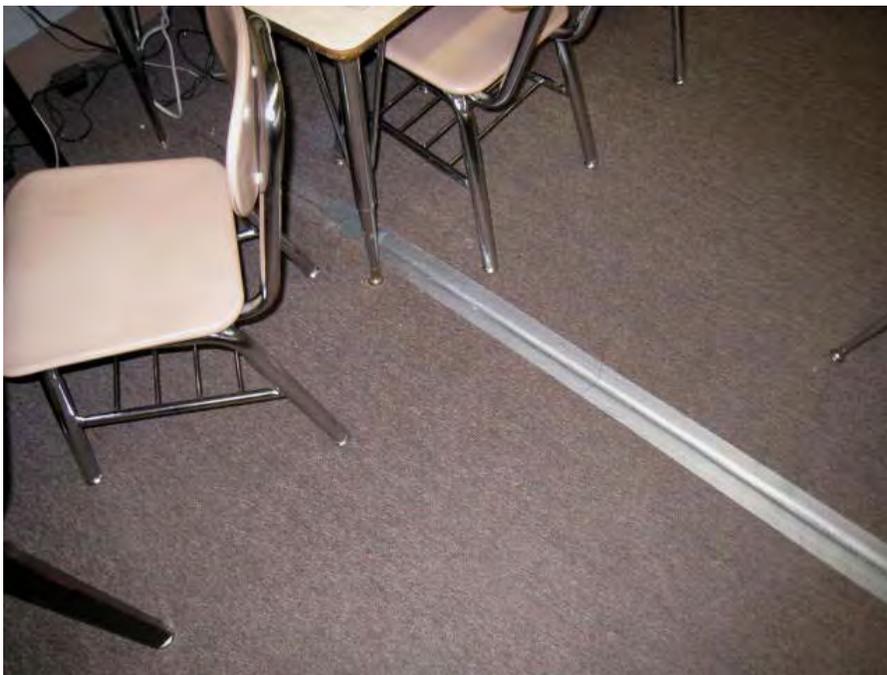
**Picture 30**

**Classroom Carpet Fixed using Duct Tape**
