INDOOR AIR QUALITY ASSESSMENT

**Winthrop Elementary School
65 Central Street
Ipswich, Massachusetts 01938**

Prepared by:
Massachusetts Department of Public Health
Bureau of Environmental Health
Indoor Air Quality Program
October 2009

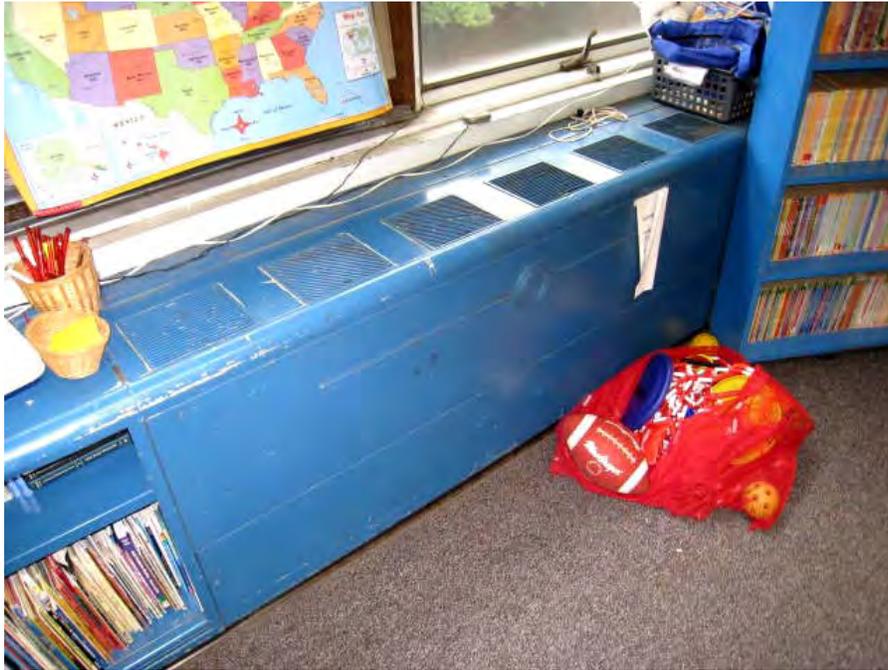
Picture 1

Fresh air for classrooms is supplied by unit ventilator (univent) systems (Picture 1). A univent draws outdoor air through a fresh air intake located on the exterior wall of the building (Picture 2), and return air from the room through an air intake located at the base of the unit ([Figure 1](#)). Fresh and return air are mixed, filtered, heated and distributed to the room through an air diffuser located in the top of the unit. Univents were operating in the majority of rooms at the time of the assessment; however, BEH staff found several univents switched 'off', preventing fresh air from being introduced into these rooms. Univent air diffusers and returns were blocked by furniture and other stored items in front and on top of the unit, thereby limiting airflow in these rooms. In one area, the univent had a missing panel exposing the interior of the unit (Picture 3). In order for univents to provide fresh air as designed, air diffusers, intakes and returns must remain free of obstructions. Importantly, these units must remain "on" and be

Classroom Univent

1. Operate all ventilation systems throughout the building *continuously* during periods of school occupancy. To increase airflow in classrooms, set univent controls to “high”. School staff should be encouraged not to deactivate classroom univents; rather, report any complaints to the facilities department.

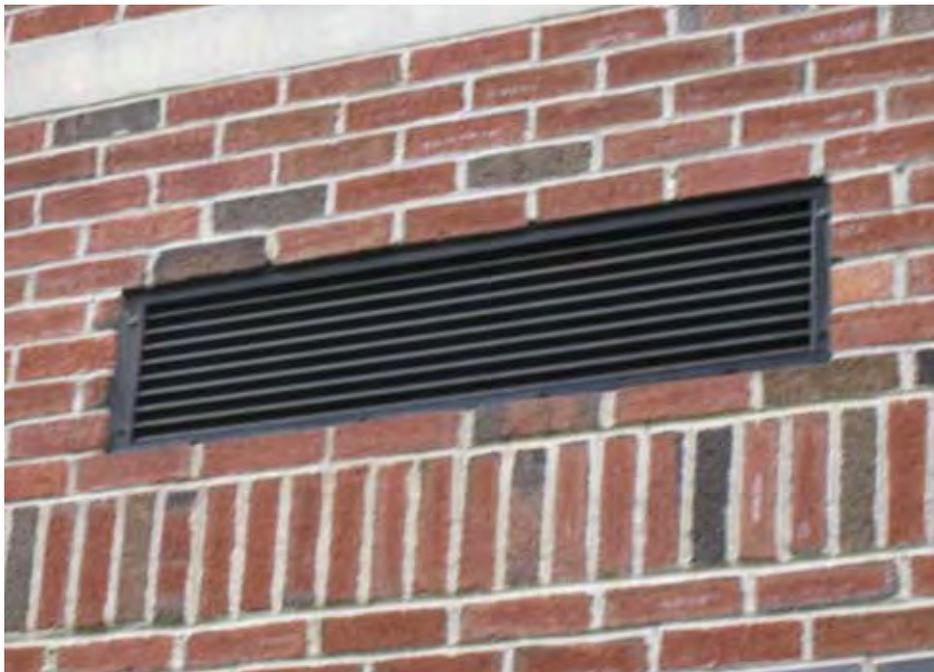
Picture 2

Univent Fresh Air Intake on Exterior Wall

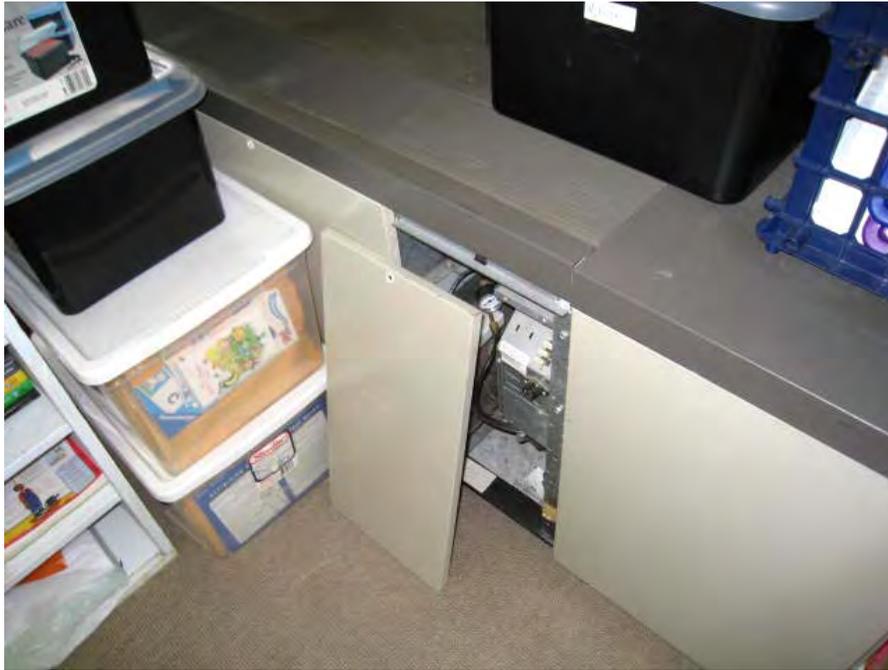
Picture 3

Stored Items on Top and in Front of Univent, Note Panel Removed

2. Inspect all exhaust motors and belts periodically for proper function. Repair and replace as necessary.
3. Remove all blockages from univents and exhaust vents to ensure adequate airflow.

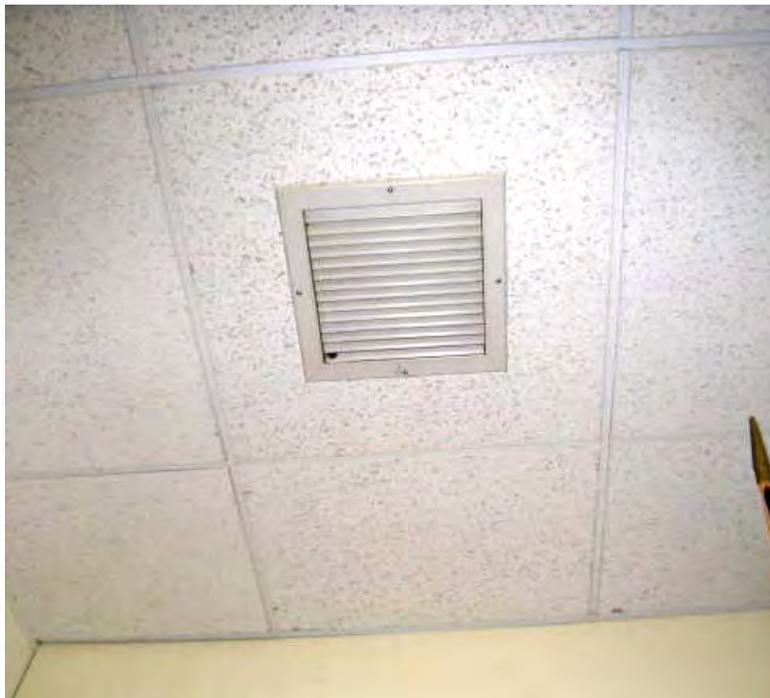
Picture 4

Exhaust ventilation is provided by vents ducted to rooftop motors. Exhaust vents at the WES are located on the ceiling, wall, or at the top of storage closets/shelving (Pictures 4 through 7). Exhaust ventilation systems continuously remove air that has become stale from moisture, odors, and pollutants. In order to function properly, exhaust vents must be activated and allowed to operate without obstruction while rooms are occupied. Without adequate exhaust ventilation, excess heat and stale air can build up leading to indoor air quality and comfort complaints. The work room is not equipped with exhaust ventilation. This area contains photocopiers and a lamination machine each of which can be a source of pollutants such as heat and odors, particularly if the equipment is older and in frequent use.

Exhaust Vent on Ceiling

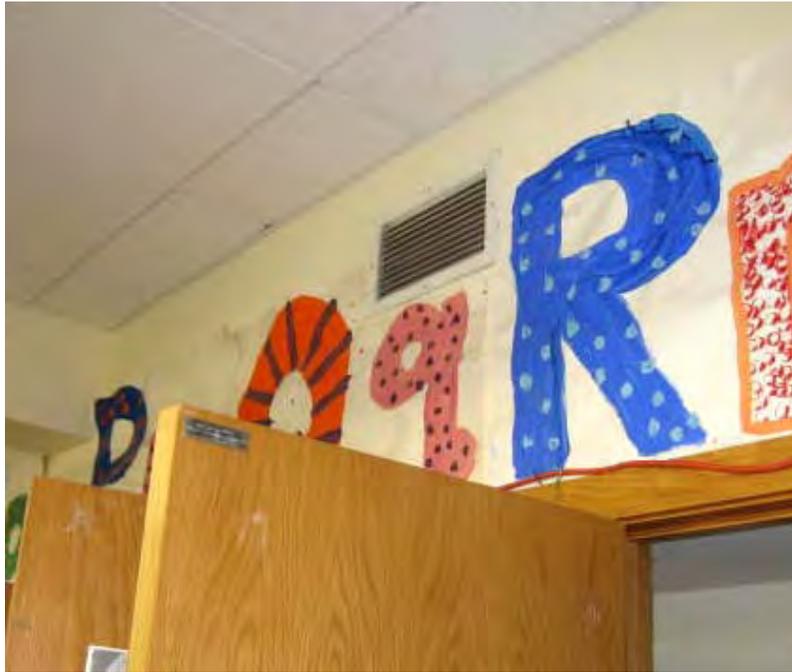
Picture 5

Exhaust Vent on Wall

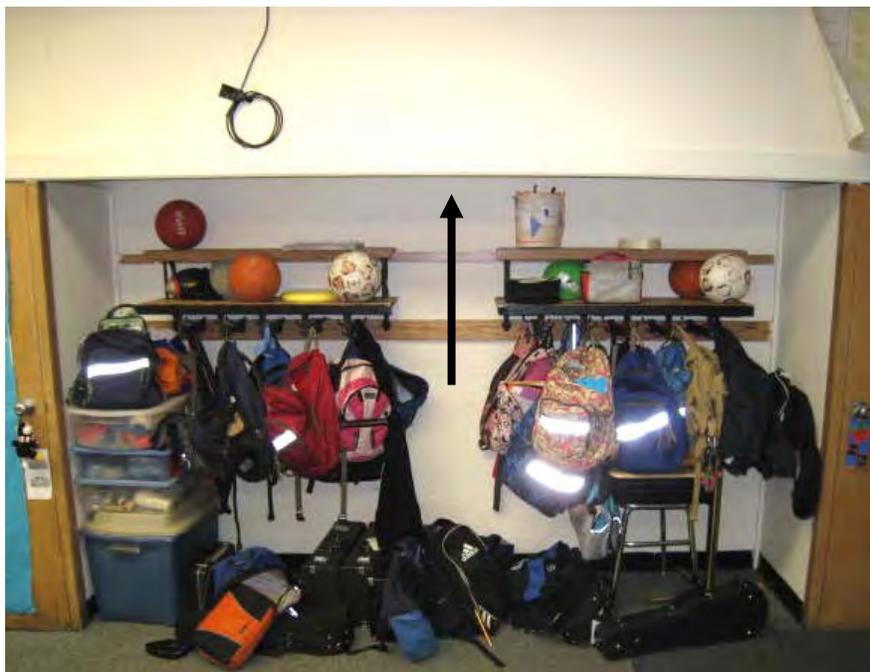
Picture 6

Exhaust Vent in Storage Closet

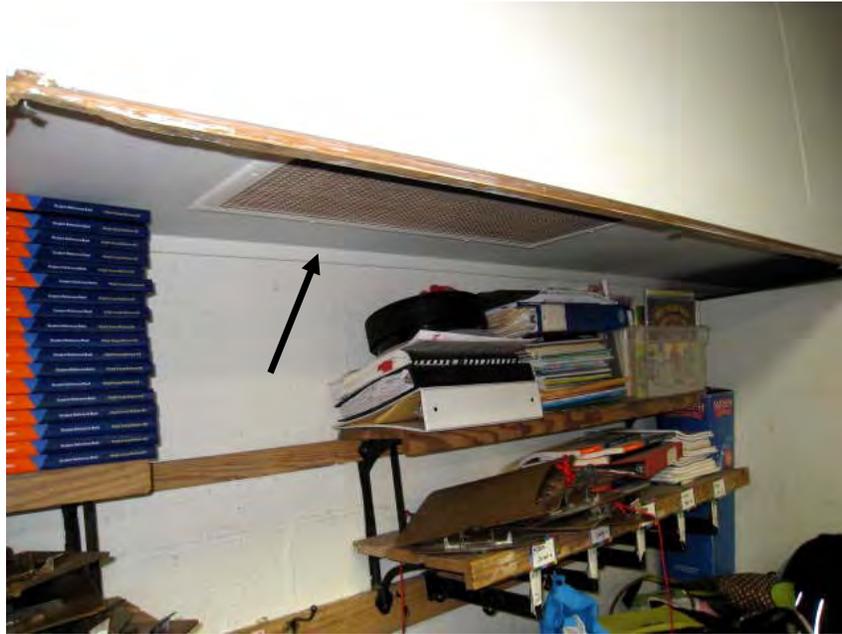
Picture 7

Exhaust Vent in Classroom Shelving

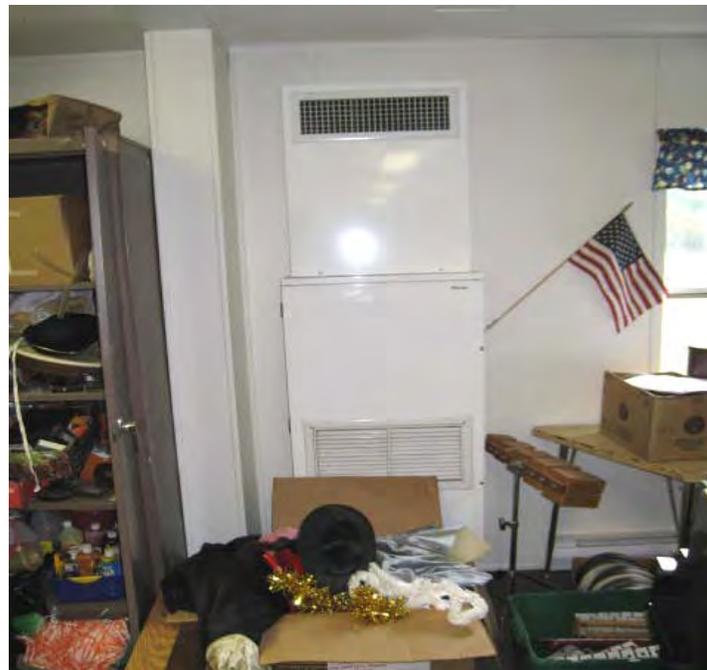
Picture 8

Wall-mounted air handling units (AHUs) provide ventilation for the modular classroom wing (Picture 8). The modular wing houses three rooms; however, only two AHUs exist. One room lacks mechanical ventilation; therefore, windows and an exterior door are the only means of introducing fresh air to this area. AHUs draw fresh air through an air intake on the exterior of the modular classroom and then distribute it to the room through an air diffuser at the top of the AHU. Stale air from the room is returned to the AHU through a vent at the base of the unit to an exhaust vent on the building exterior. Thermostats that control the AHU system in the modular classrooms have fan settings of “on” and “automatic”. The “automatic” setting on the thermostat activates the AHU system at a preset temperature, and then deactivates the system once the preset temperature is reached. In the fan “on” setting, the AHU system provides continuous airflow to the rooms.

**Air Handling Unit on Wall in Modular Classroom
Air Diffuser at Top, Exhaust Vent at Base**

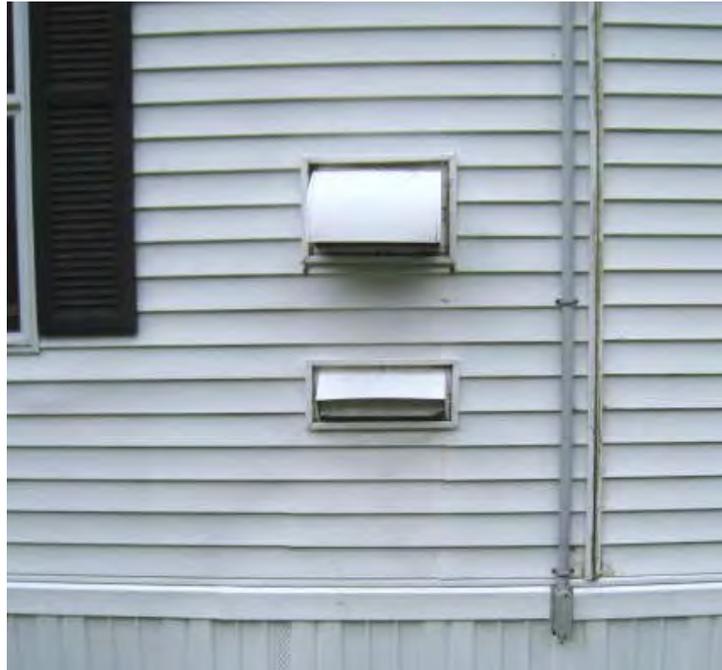
Picture 9

On the exterior wall of the modular classroom, the fresh air intake is directly above the exhaust vent (Picture 9). The configuration of the intake and vent is problematic since pollutants that are exhausted from the classroom can be brought back inside via the air intake. The exhaust vent should be ducted away from the fresh air intake. BEH staff also found the fresh air intakes coated with accumulated dust and debris (Picture 10).

Air Intake Directly Above Exhaust Vent on Exterior Wall

6. Duct exhaust vents away from fresh air intakes on exterior wall of modular classrooms.
7. Clean accumulated dust and debris from fresh air intakes on exterior wall of modular classrooms.

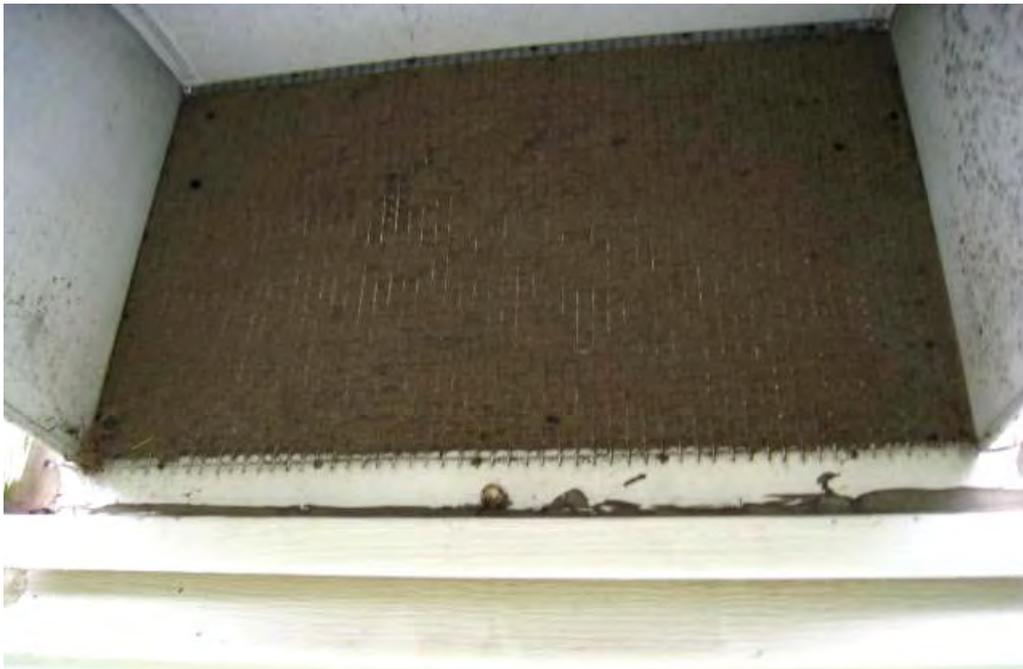
Picture 10

Accumulated Dust and Debris on Air Intake

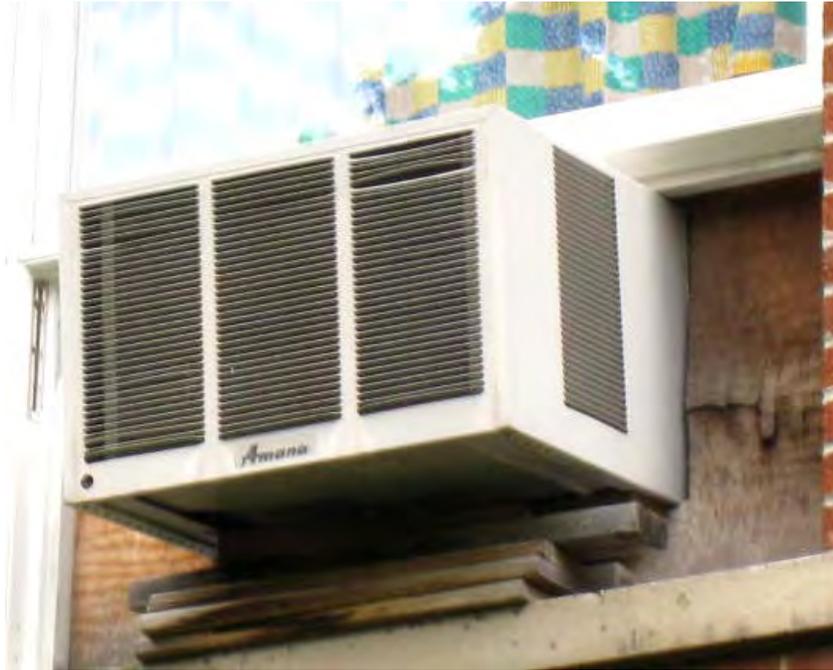
Picture 11

Air conditioners (AC) were used in several rooms (Pictures 11 and 12). ACs are normally equipped with filters, which should be cleaned or changed as per manufacturers' instructions to avoid the build-up and re-aerosolization of dirt, dust and particulate matter.

Air Conditioner in Window

9. Change filters for air-handling equipment (e.g., univents, AHUs and ACs) as per the manufacturer’s instructions or more frequently if needed. Vacuum interior of units prior to activation to prevent the aerosolization of dirt, dust and particulates. Ensure filters fit

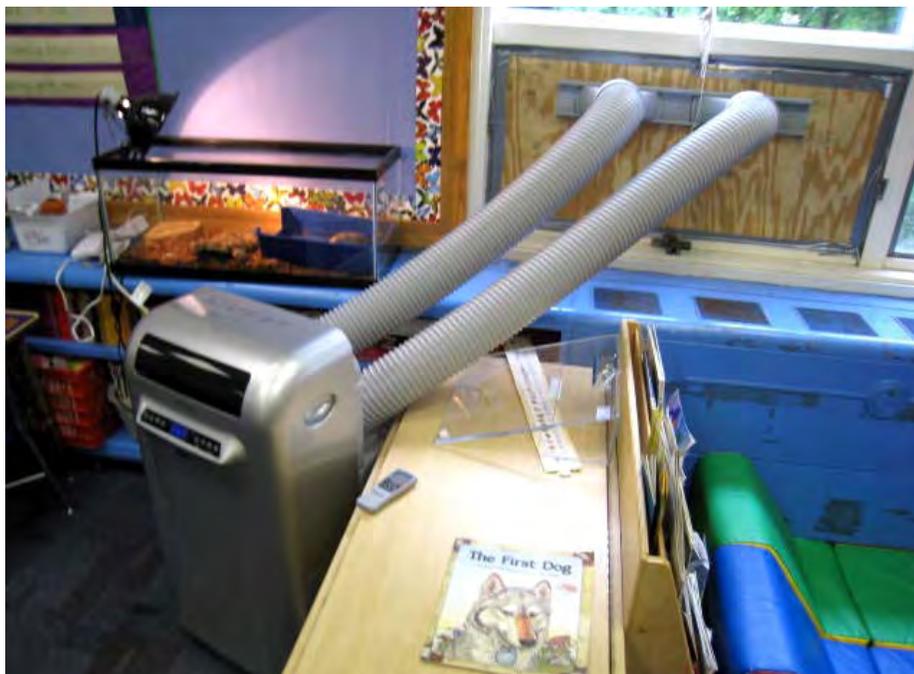
Picture 12

Air Conditioner Ducted to Window by Hoses

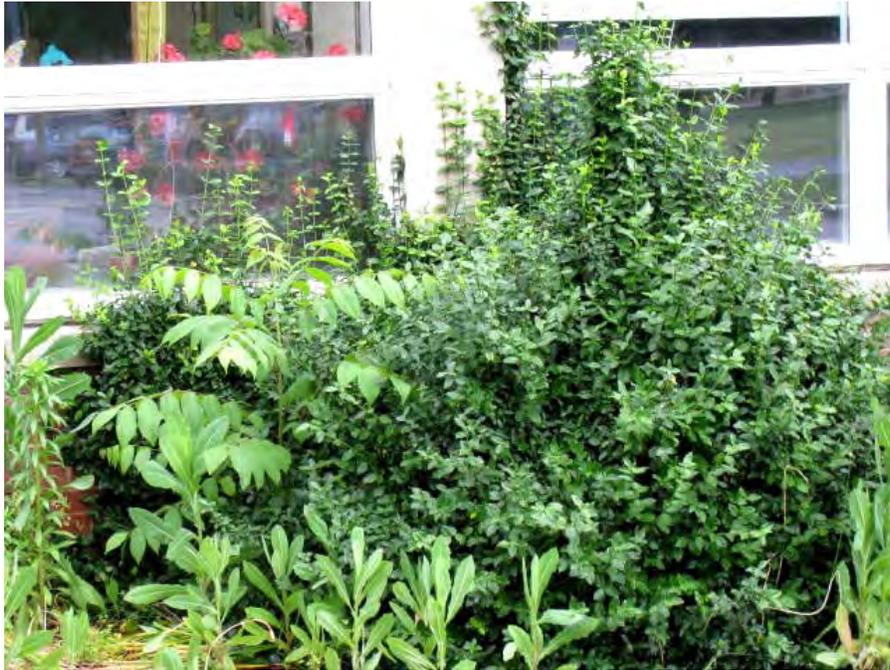
Picture 13

- Shrubs and trees growing against the building, holding moisture against exterior brick (Pictures 13 through 15);
- Plants and shrubs growing in front of fresh air intakes allowing moisture-laden air to be drawn in by the fresh air intake (Pictures 15 through 17); and,
- Exterior brick was damaged and water stained indicating a heavy and/or continuous water exposure (Pictures 18 and 19).

Shrubs Growing Against Building

11. Cut shrubs and trees in a manner to maintain a space of 3 feet from the building exterior and univent fresh air intakes, to prevent moisture from being held against exterior brick and moisture-laden air to be drawn in by the fresh air intake.

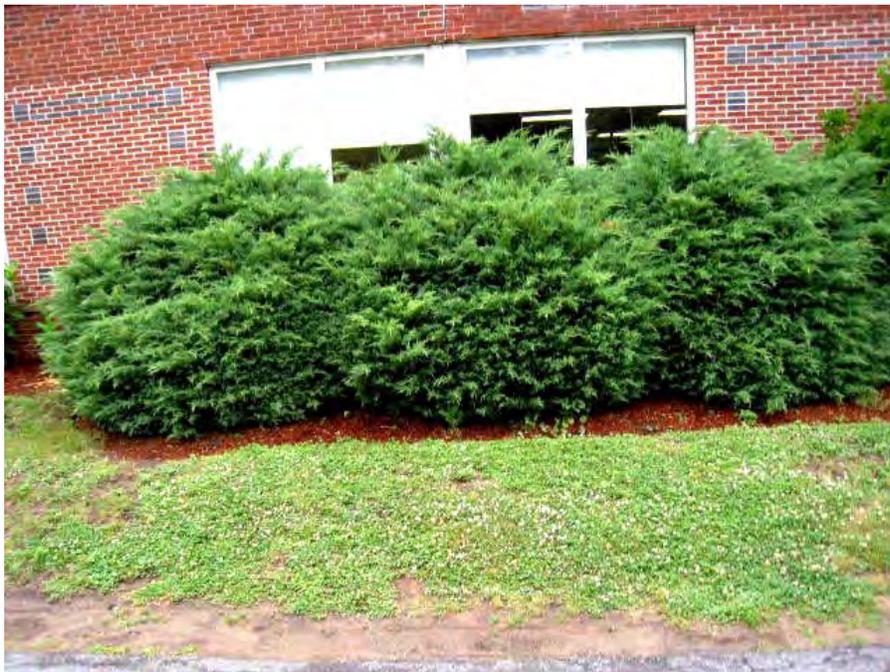
Picture 14

Shrubs Growing Against Building

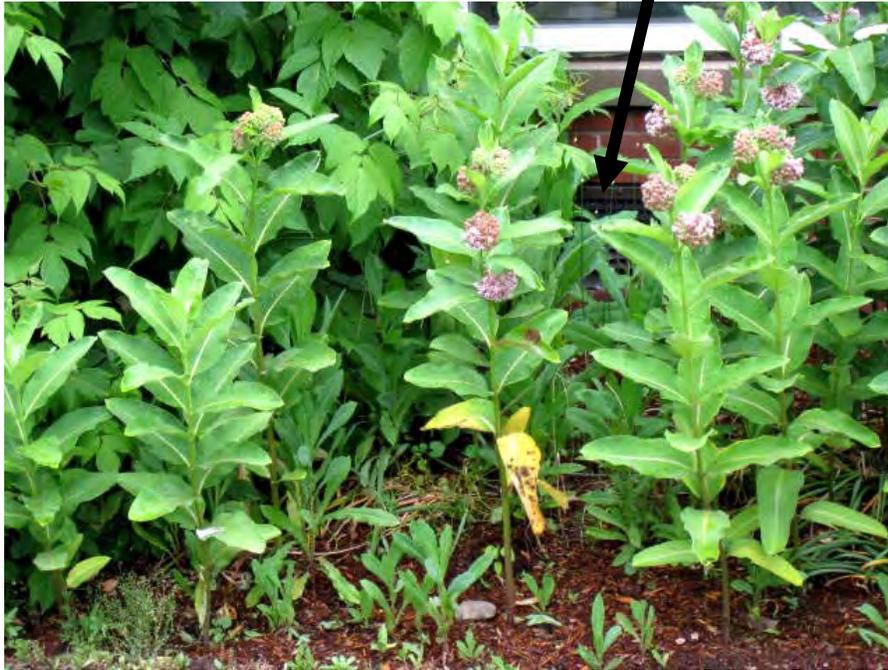
Picture 15

Plants and Shrubs Growing in Front of Fresh Air Intake

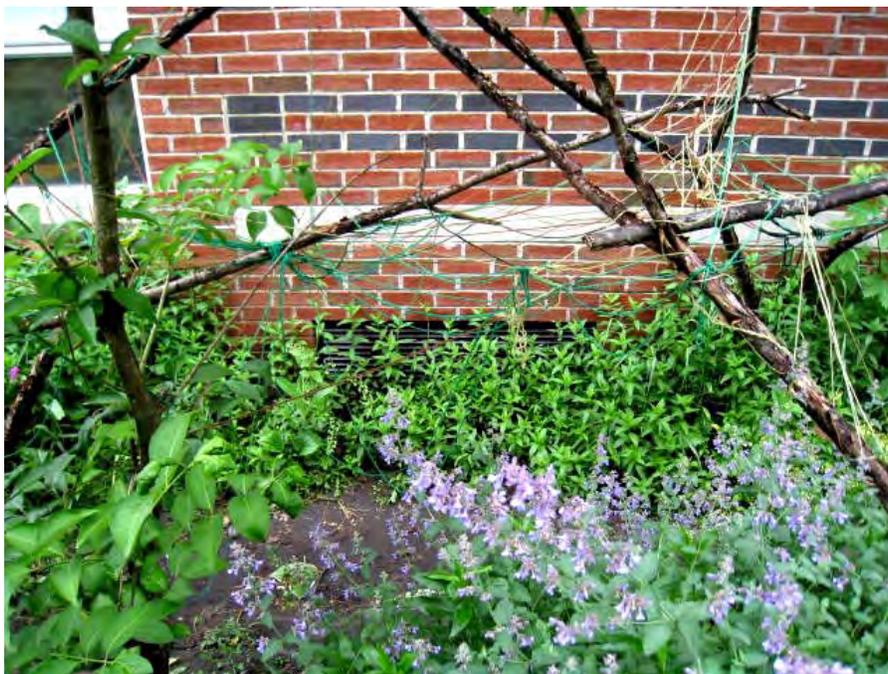
Picture 16

Plants Growing in Front of Fresh Air Intake

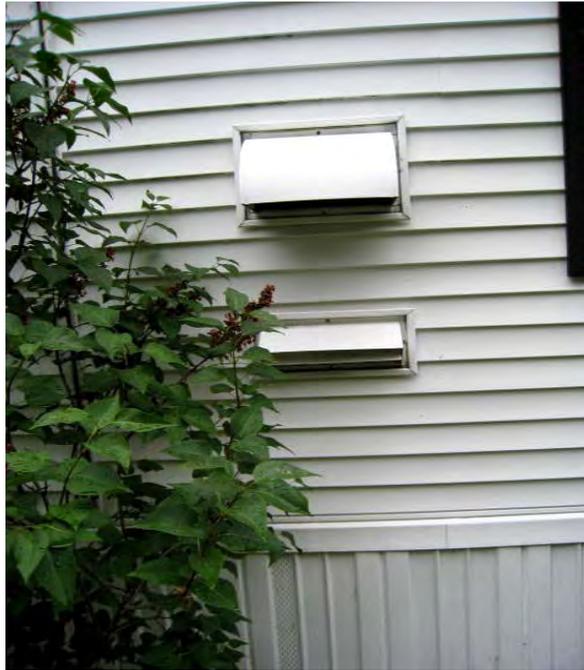
Picture 17

Shrubs Growing near Fresh Air Intake

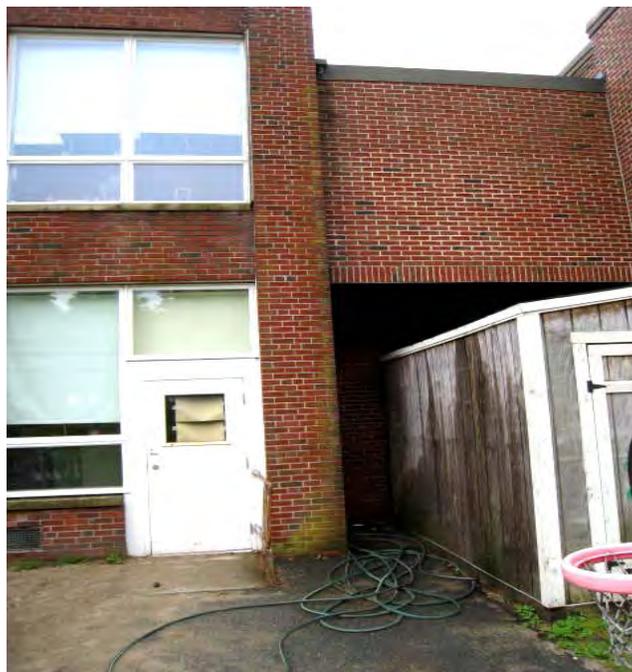
Picture 18

These conditions indicate that water has penetrated through the building envelope. Moisture laden air can infiltrate through breaches and condense on building materials. A heavy and/or continuous water exposure to the building exterior can undermine the integrity of the building

Water Stains on Exterior Brick and Storage Shed

12. Consider having exterior walls re-pointed and waterproofed to prevent water intrusion. This measure should include a full building envelope evaluation.

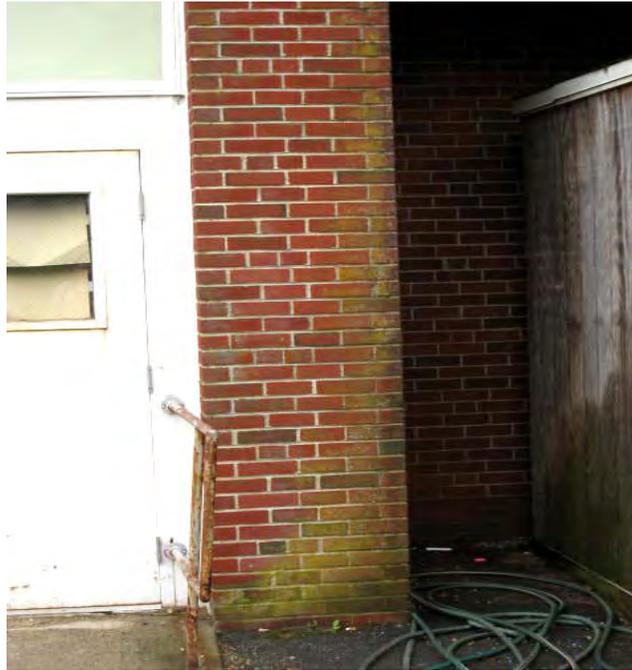
Picture 19

Water Stains on Exterior Brick

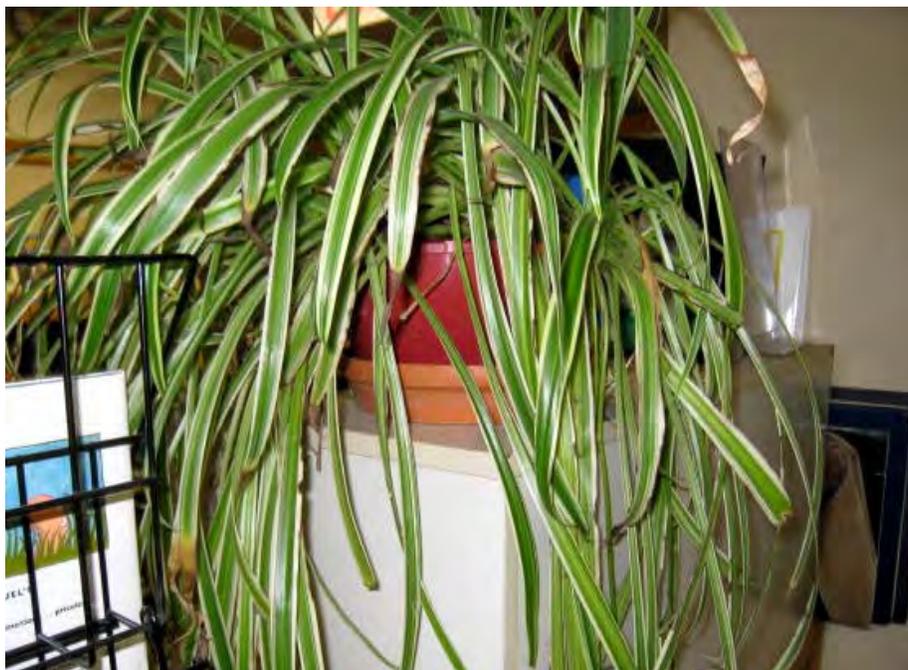
Picture 20

A number of classrooms had plants (Picture 20). Plants can be a source of pollen and mold, which can be respiratory irritants for individuals. Plants should be properly maintained and equipped with drip pans to prevent water damage to porous building materials, which can lead to mold growth. Plants should also be located away from ventilation sources (e.g., air intakes, univent diffusers) to prevent the entrainment and/or aerosolization of dirt, pollen or mold.

Plants in Classrooms

14. Move plants away from univents in classrooms. Avoid over-watering and examine drip pans periodically for mold growth. Disinfect with an appropriate antimicrobial where necessary.

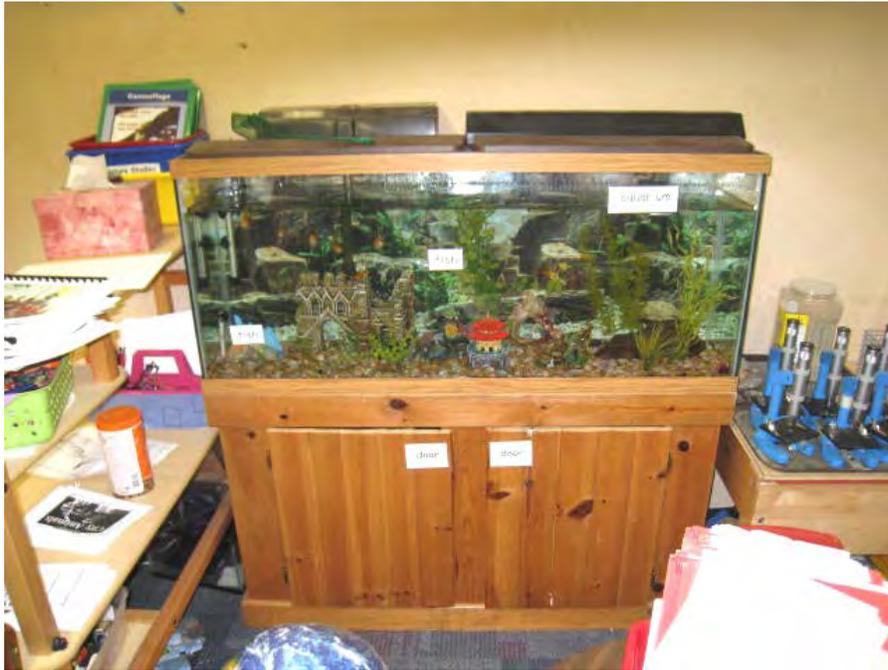
Picture 21

Aquariums were also located in a number of classrooms (Picture 21). Aquariums should be properly maintained to prevent microbial/algae growth, which can emit unpleasant odors.

Aquarium in Classrooms

15. Clean and maintain aquariums and animal cages to prevent mold growth and associated odors.

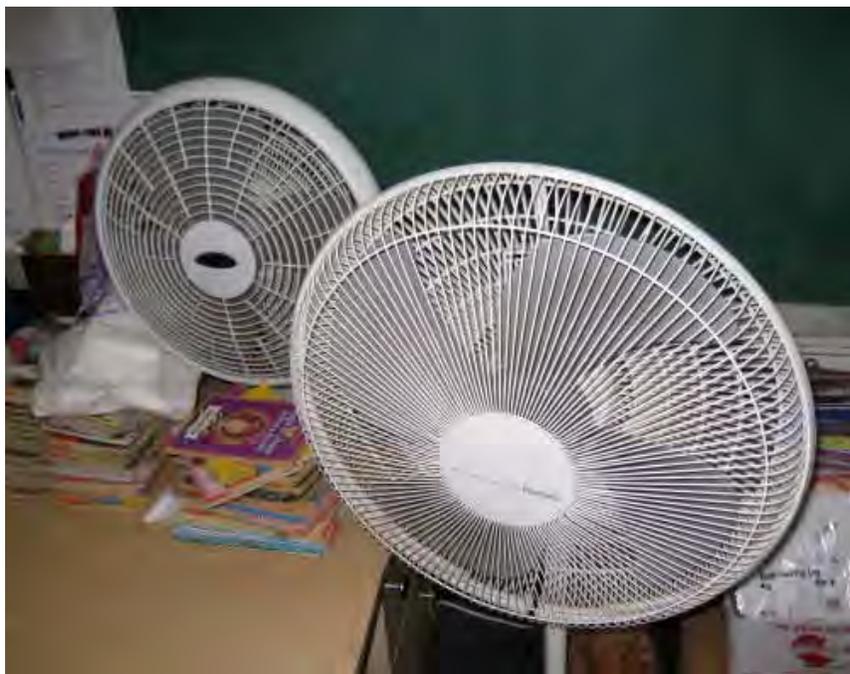
Picture 22

A number of univent/supply air diffusers, exhaust vents and personal fans in classrooms were observed to have accumulated dust/debris (Picture 22). Re-activated supply vents/fans can aerosolize dust accumulated on fan blades/housing. If exhaust vents are not functioning, backdrafting can occur, which can re-aerosolize dust particles.

Accumulated Dust and Debris on Fan Blades

18. Clean accumulated dust and debris periodically from univent air diffusers, exhaust vents and blades of personal fans.
19. Consider adopting the US EPA (2000) document, "Tools for Schools", as an instrument for maintaining a good indoor air quality environment in the building. This document is available at: <http://www.epa.gov/iaq/schools/index.html>.

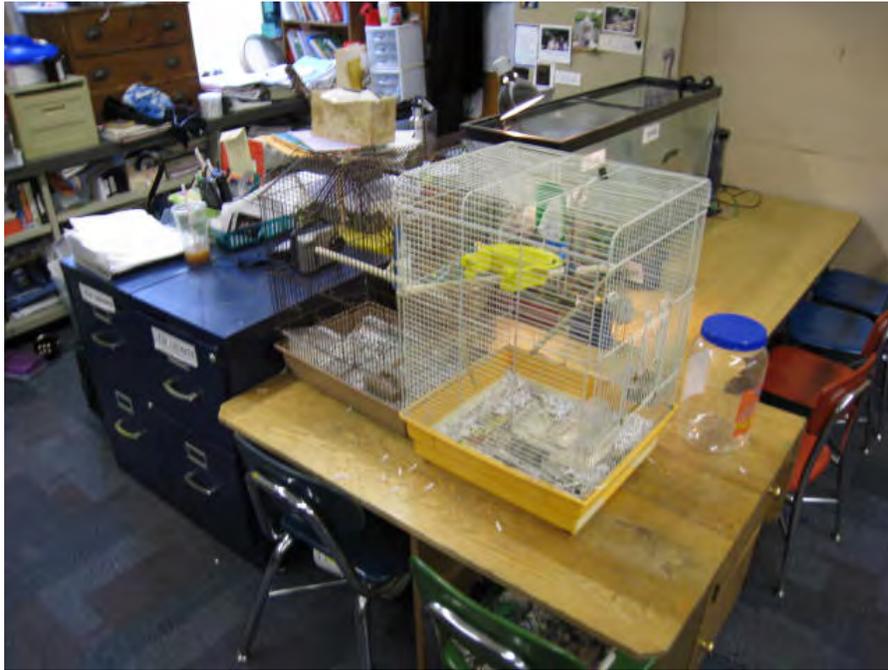
Picture 23

Lastly, a classroom had a pet bird who was housed in a cage (Picture 23). Animal dander, fur and wastes can all be sources of respiratory irritants. Animal cages should be cleaned regularly to avoid the aerosolization of allergenic materials and/or odors.

Bird in Classroom
