INDOOR AIR QUALITY ASSESSMENT

**Memorial Elementary School
12 Walnut Street
Milford, Massachusetts**

Prepared by:
Massachusetts Department of Public Health
Bureau of Environmental Health
Indoor Air Quality Program
December 2009

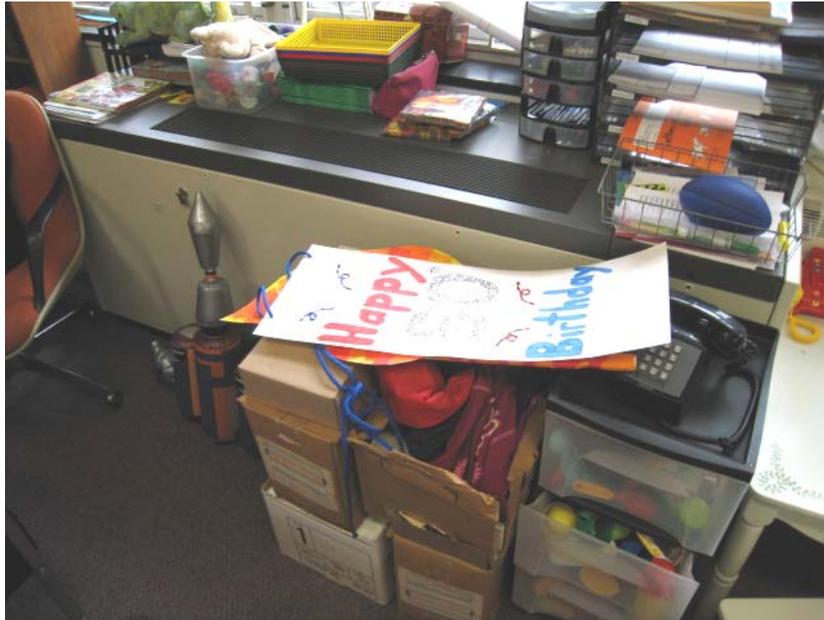
Picture 1

Fresh air is supplied to most classrooms by unit ventilators (univent) systems ([Pictures 1 and 2](#)). A univent draws air from the outdoors through a fresh air intake located on the exterior wall of the building. Return air from the classroom is drawn through an air intake located at the base of the unit ([Figure 1](#)). Fresh and return air are mixed, filtered, heated and provided to classrooms through an air diffuser located in the top of the unit.

A number of univents appeared to be original equipment, approximately 40 to 50 years old. Univents of this age are often difficult to maintain because replacement parts are often unavailable. BEH staff found univents deactivated in several areas ([Table 1](#)); therefore, there

was no means to provide mechanical ventilation to these classrooms at the time of the assessment. In several cases, univents were found obstructed by furniture and other items on top of air diffusers and/or in front of return vents along the bottom front of the units (Pictures 1 and 2). In order for univents to provide fresh air as designed, intakes/returns must remain free of obstructions. Importantly, these units must remain “on” and be allowed to operate while rooms are occupied.

Classroom Univent 1990's Vintage, Note Return Vent (along bottom front of unit) Obstructed by Furniture and Other Items

1. Operate all ventilation systems throughout the building (e.g., gymnasium, cafeteria, classrooms) continuously during occupied periods. To increase airflow in classrooms, set univent controls to “high”.

4. Remove all blockages from univents and exhaust vents to ensure adequate airflow.
5. Close classroom doors to maximize exhaust function.
6. Use openable windows in conjunction with mechanical ventilation to facilitate air exchange. Care should be taken to ensure windows are properly closed at night and weekends to avoid the freezing of pipes and potential flooding.

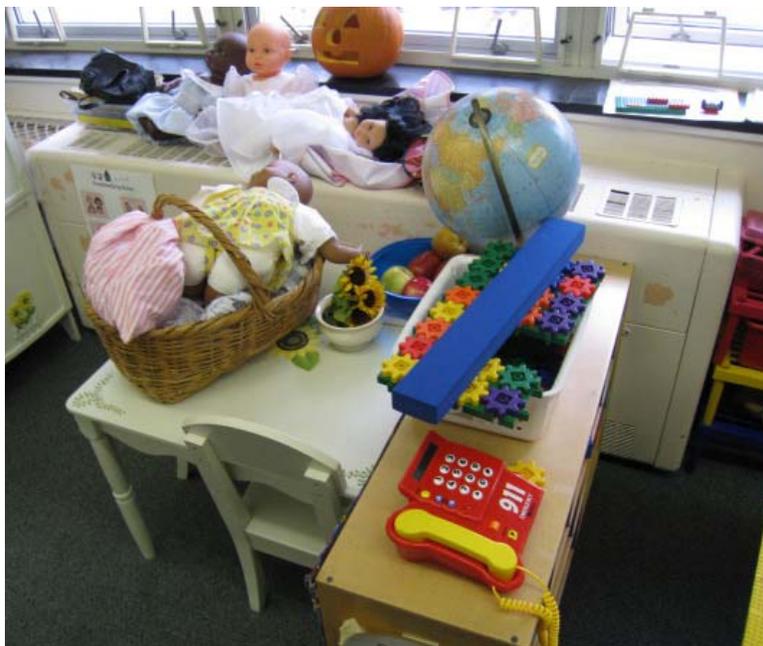
Picture 2

Classroom Univent 1950's Vintage, Note Air Diffuser (top of unit) and Return Vent (along bottom front of unit) Obstructed by Furniture and Other Items

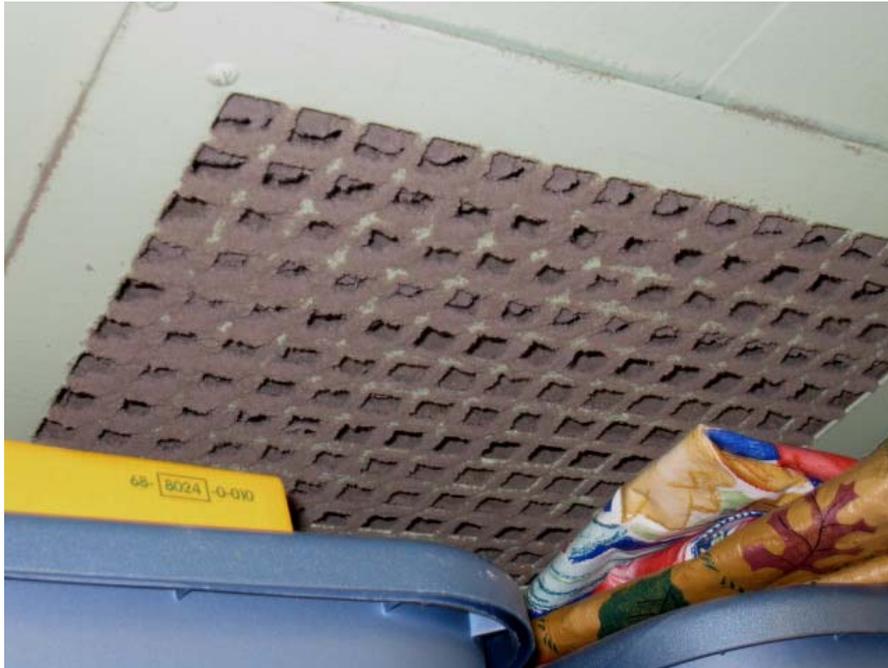
Picture 3

Exhaust ventilation in classrooms is provided by grilled vents located on walls or in the ceilings of coat/storage closets ducted to rooftop motors ([Pictures 3](#) and 4). Many exhaust vents were obstructed (Picture 4) and/or deactivated at the time of the assessment ([Table 1](#)). In addition, several classroom wall vents are located near hallway doors ([Picture 5](#)). When these classroom doors are open, exhaust vents for these rooms will tend to draw air from both the hallway and the classroom, reducing the effectiveness of the exhaust vent to remove common environmental pollutants. As with univents, in order to function properly, exhaust vents must be activated and allowed to operate while rooms are occupied. Without adequate supply and exhaust ventilation, excess heat and environmental pollutants can build up and lead to indoor air/comfort complaints.

A number of univent/supply air diffusers, exhaust vents and personal fans in classrooms were observed to have accumulated dust/debris (Pictures 3 and 10). Re-activated supply vents/fans can aerosolize dust accumulated on fan blades/housing. If exhaust vents are not functioning, backdrafting can occur, which can re-aerosolize dust particles.

Closet Exhaust Vent, Note Dust/Debris Accumulation on Grill

15. Consider providing local exhaust ventilation for photocopiers and lamination machines, or relocate to an area with mechanical ventilation.
16. Clean personal fans, univent air diffusers, return vents and exhaust vents periodically of accumulated dust.

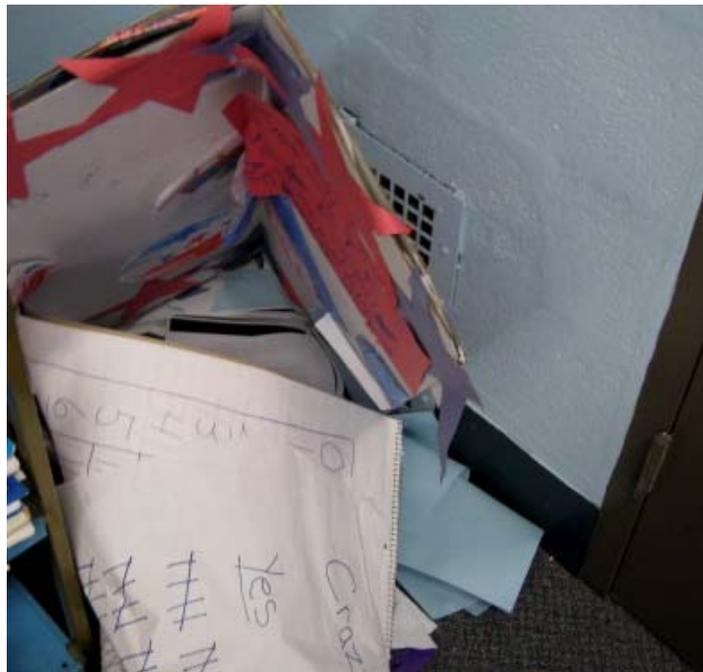
Picture 4

Wall-Mounted Exhaust Vent Partially Obstructed by Classroom Items

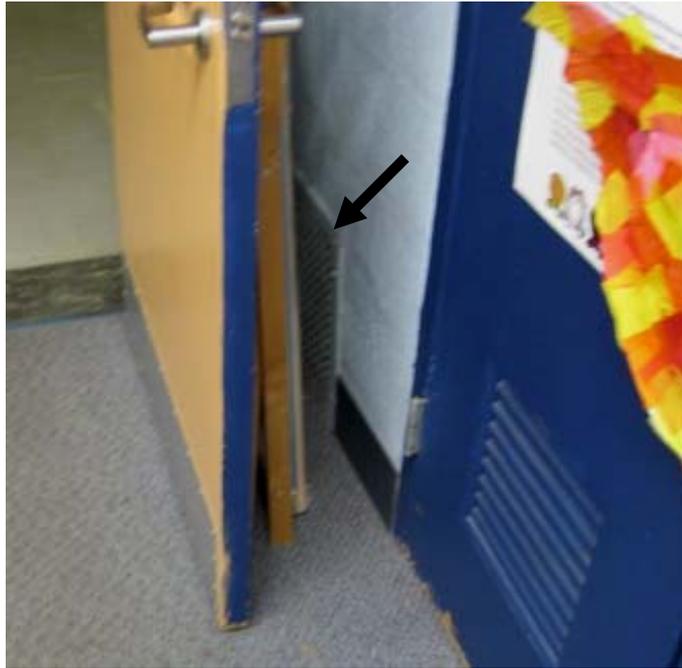
Picture 5

Wall-Mounted Exhaust Vent Obstructed by Open Classroom Door

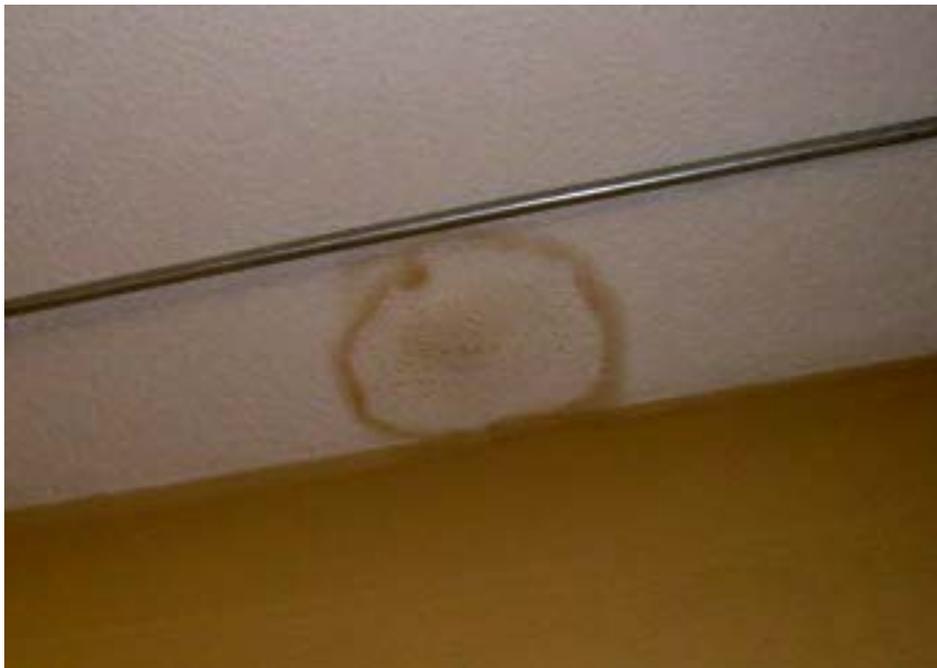
Picture 6

In order for building materials to support mold growth, a source of water exposure is necessary. Identification and elimination of the source of water moistening building materials is necessary to control mold growth. Water damaged ceiling plaster was observed in several areas ([Table 1](#)/[Picture 6](#)), which is evidence of current and/or former roof/plumbing leaks. In order to determine if porous building materials were wet at the time of the assessment, BEH staff conducted moisture measurements of plaster ceilings and carpeting. Materials with increased

Water Damaged Ceiling Plaster

The US Environmental Protection Agency (US EPA) and the American Conference of Governmental Industrial Hygienists (ACGIH) recommend that porous materials be dried with fans and heating within 24 to 48 hours of becoming wet (US EPA, 2001; ACGIH, 1989). If not dried within this time frame, mold growth may occur. Once mold has colonized porous materials, they are difficult to clean and should be removed/discarded.

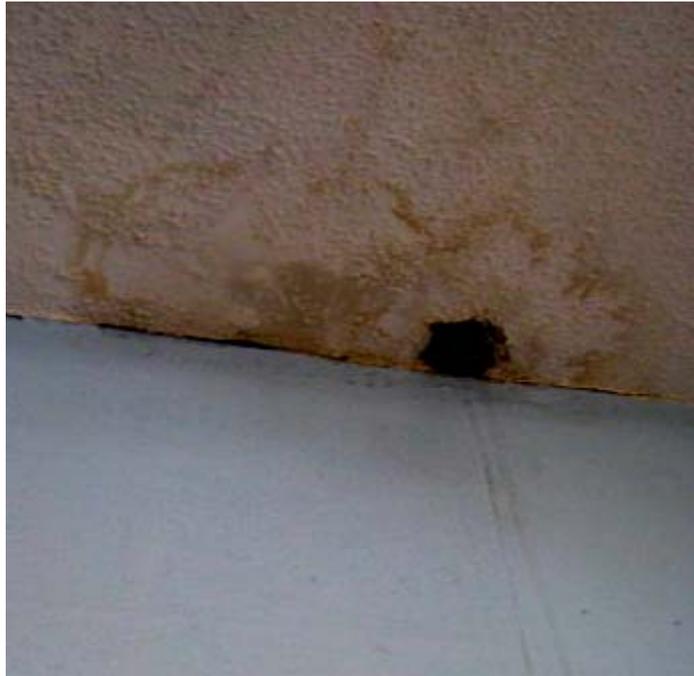
Picture 7

moisture content over normal concentrations may indicate the possible presence of mold growth. An active leak was discovered in classroom 10, as evidenced by moist ceiling plaster ([Picture 7](#)). No visible mold growth was observed. Carpeting directly below this area was dry at the time of the assessment. Moisture content of materials measured is a real-time measurement of the conditions present at the time of the assessment. Moisture levels of the carpeting was normal.

Moistened/Water Damaged Ceiling Plaster in Classroom 10

11. Ensure roof leak in classroom 10 is repaired.
12. Store cleaning products properly and out of reach of students. Ensure spray bottles are properly labeled. All cleaning products used at the facility should be approved by the school department with MSDS' available at a central location.

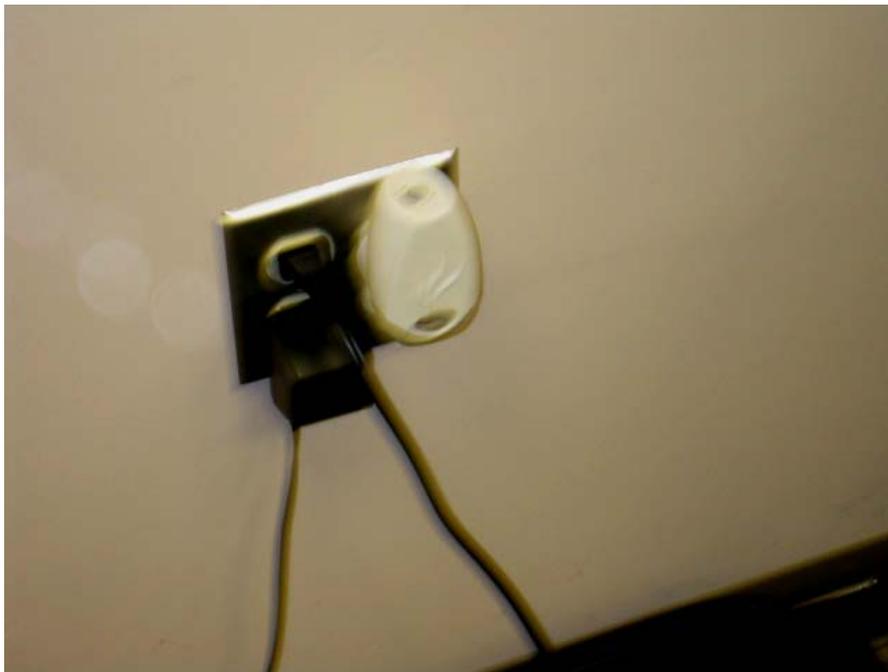
Picture 8

Plug-in air fresheners were in use in a few areas (Picture 8). Air fresheners contain chemicals that can be irritating to the eyes, nose and throat of sensitive individuals. Many air

fresheners contain 1,4-dichlorobenzene, a VOC which may cause reductions in lung function (NIH, 2006). Further, air fresheners do not remove materials causing odors, but rather, mask odors which may be present in the area.

Plug-in Air Freshener in Classroom

17. Refrain from using air fresheners and deodorizers to prevent exposure to VOCs.
18. Replace latex-based tennis balls with latex-free tennis balls or glides.

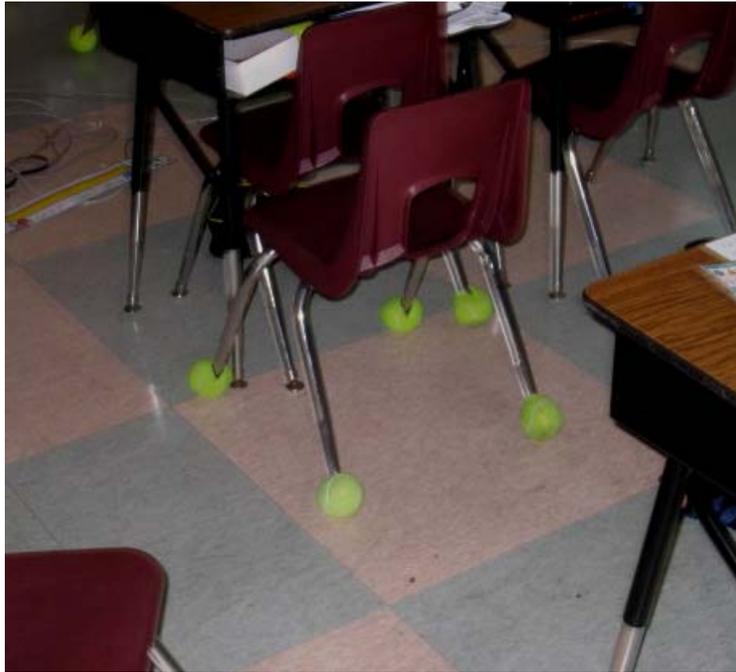
Picture 9

In an effort to reduce noise from sliding desks/chairs, tennis balls had been sliced open and placed on the base of the legs (Picture 9). Tennis balls are made of a number of materials that are a source of respiratory irritants. Constant wearing of tennis balls can produce fibers and cause VOCs to off-gas. Tennis balls are made with a natural rubber latex bladder, which becomes abraded when used as a chair leg pad. Use of tennis balls in this manner may introduce latex dust into the school environment. Some individuals are highly allergic to latex (e.g., spina bifida patients) (SBAA, 2001). It is recommended that the use of materials containing latex be limited in buildings to reduce the likelihood of symptoms in sensitive individuals (NIOSH, 1997).

Tennis Balls on Chair Legs in Classroom

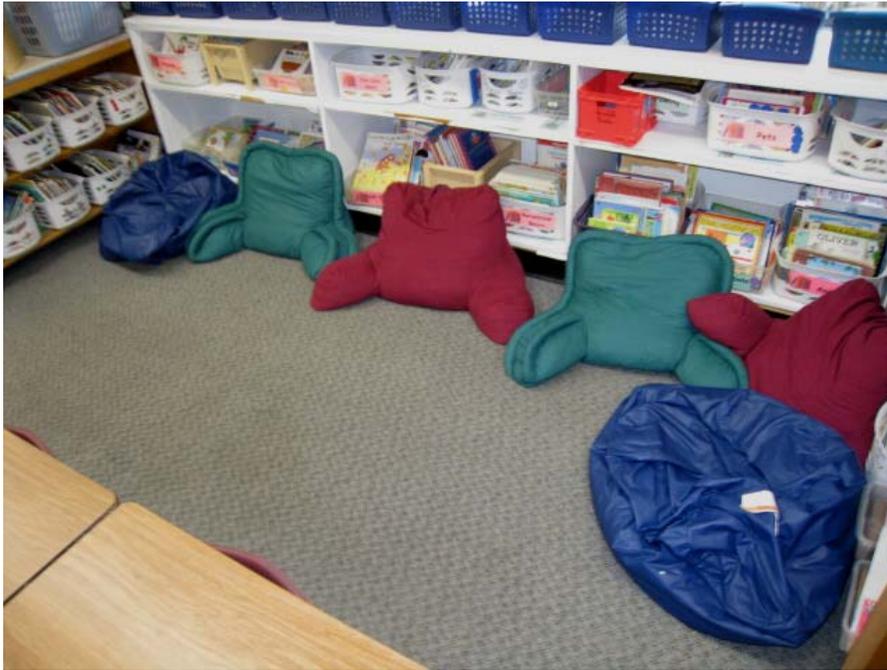
Picture 11

Several classrooms contained upholstered furniture and/or pillows/cushions (Table 1/Pictures 11 and 12). Upholstered furniture is covered with fabric that encounters human skin. This type of contact can leave oils, perspiration, hair and skin cells. Dust mites feed upon human skin cells and excrete waste products that contain allergens. In addition, if relative humidity levels increase above 60 percent (e.g., during spring/summer), dust mites tend to proliferate (US EPA, 1992). In order to remove dust mites and other pollutants, frequent vacuuming of upholstered furniture is recommended (Berry, 1994). It is also recommended that if upholstered furniture is present in schools, it should be professionally cleaned on an annual basis or every six months if dusty conditions exist outdoors (IICRC, 2000).

Large Pillows/Cushions in Classroom

13. Clean upholstered furniture/pillows/cushions on an annual basis or every six months if dusty conditions exist outdoors (IICRC, 2000). If not possible/practical, remove upholstered furniture from classrooms.

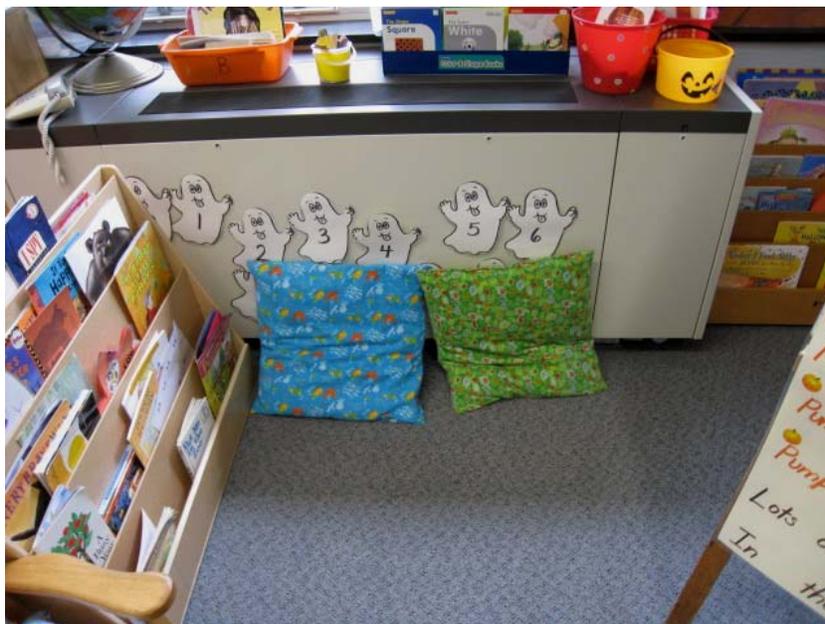
Picture 12

Large Pillows in Classroom, Also Note Pillows Obstructing Airflow Into Univent Return Vent (Front Bottom)

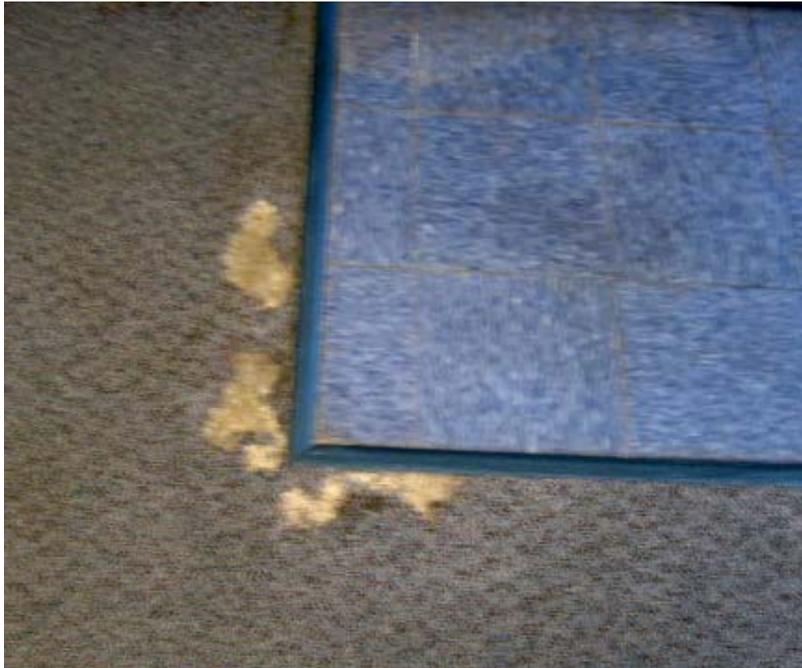
Picture 13

Lastly, carpeting in several areas was extremely worn and damaged ([Pictures 13](#) and 14). Disintegrating textiles can be a source of airborne particulates, which can be irritating to the eyes, nose and throat.

Worn/Damaged Carpeting

20. Consider developing a program to replaced damaged/worn carpeting as funds become available. Consider replacing carpeting with a non-porous flooring material (e.g., tile).

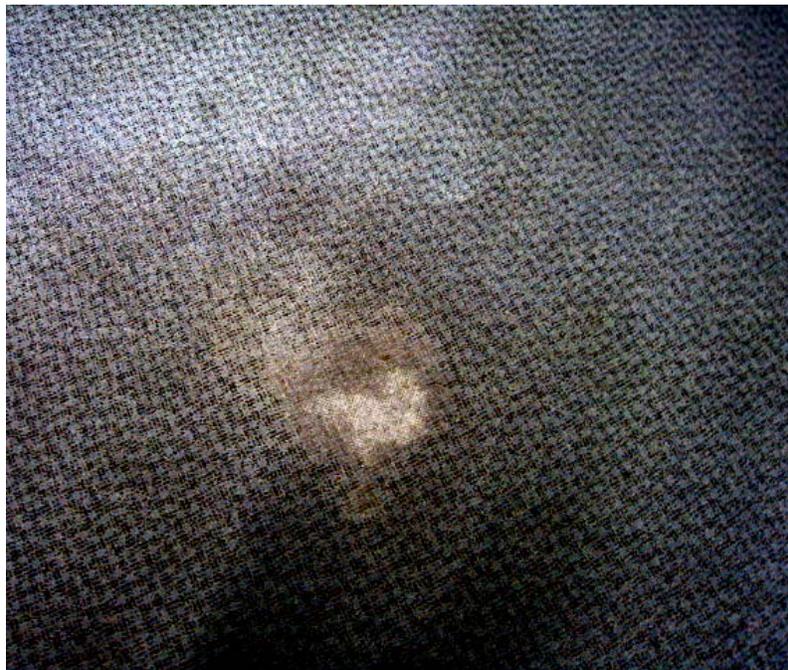
Picture 14

Worn/Damaged Carpeting
