INDOOR AIR QUALITY ASSESSMENT

**Casimir Pulaski Elementary School
1097 Braley Road
New Bedford, MA 02745**

Prepared by:
Massachusetts Department of Public Health
Bureau of Environmental Health
Indoor Air Quality Program
February 2009

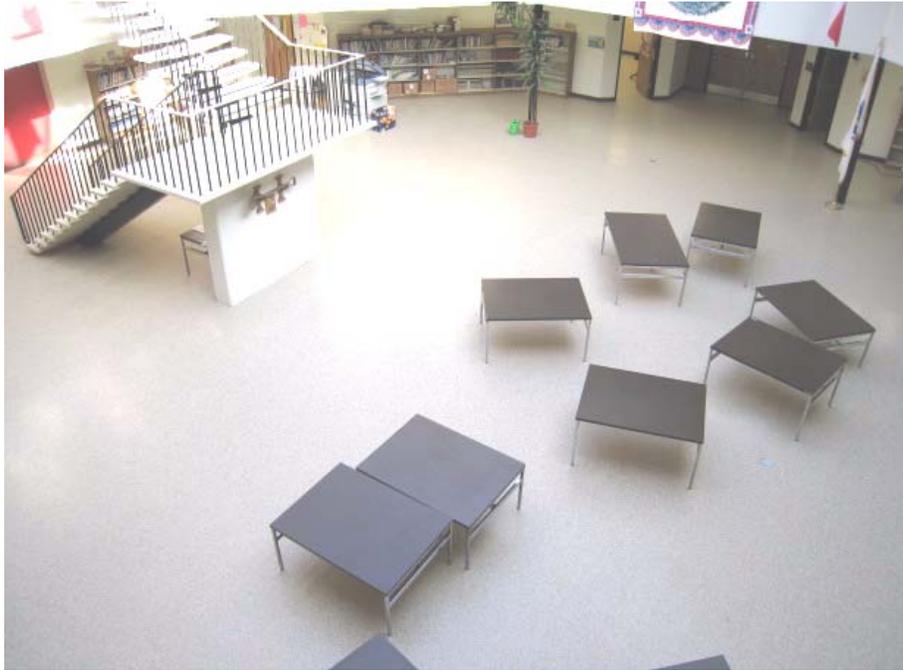
Picture 1

replace with non-porous floor tiles as funds become available. As previously discussed, carpeting in the library and adjacent areas has been removed. Windows are openable throughout the building.

Carpeting Removed in Lower Level Media Center and Replaced with Tile

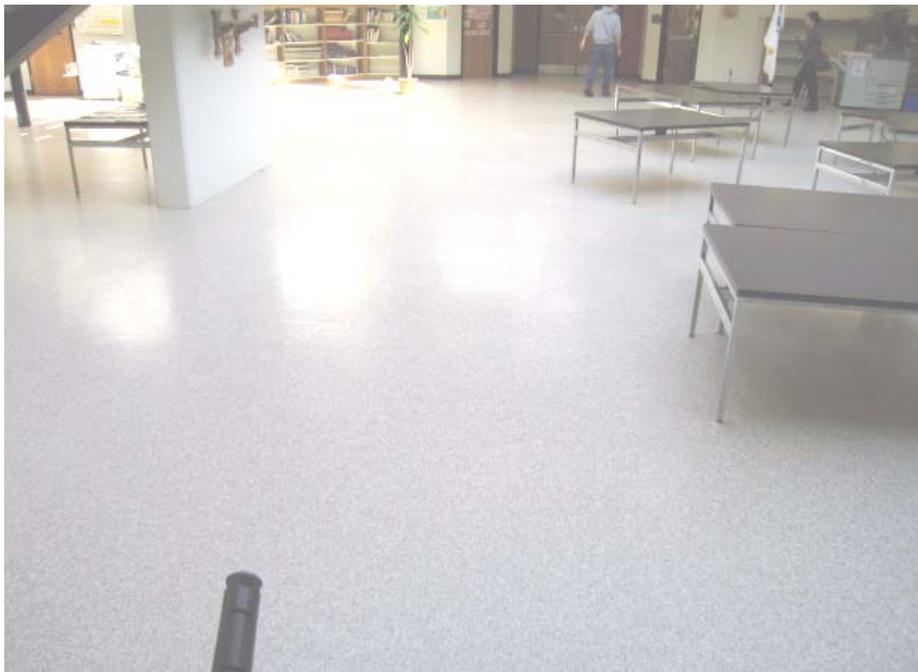
Picture 2

Carpeting Removed in Lower Level Media Center Replaced with Tile

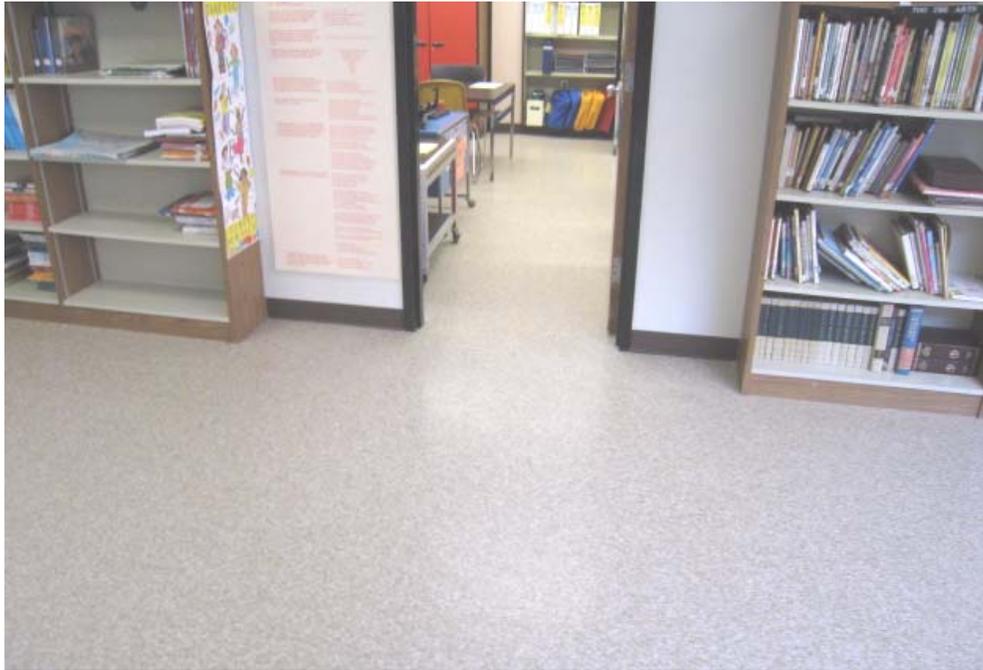
Picture 3

**Carpeting Removed in Lower Level Media Center/Perimeter Rooms
and Replaced with Tile**

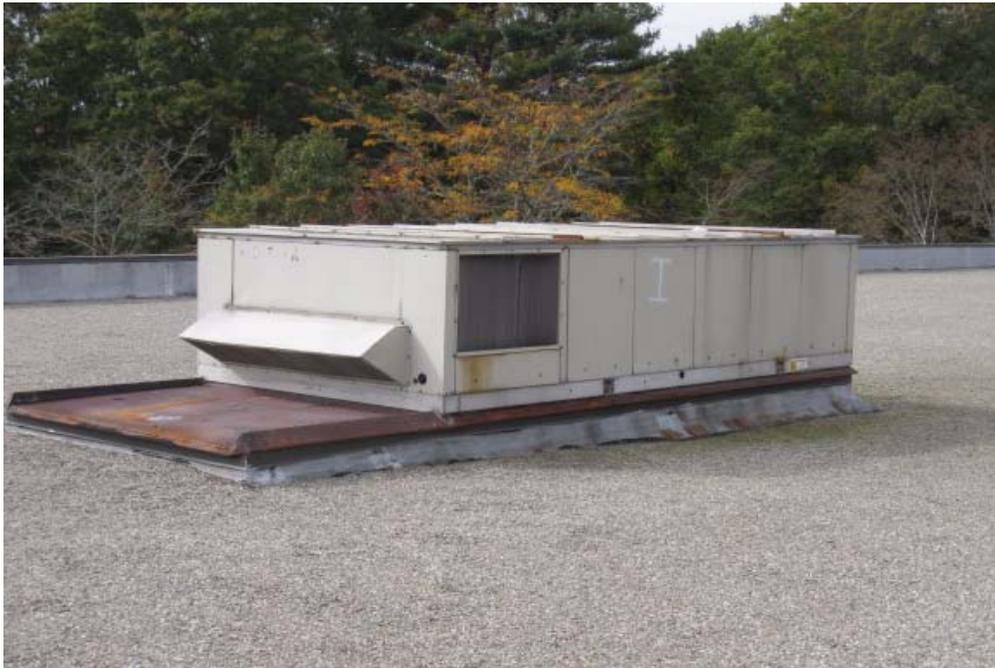
Picture 4

Mechanical ventilation for classrooms is supplied by rooftop air-handling units (AHUs) (Picture 4). Fresh air supplied by the AHUs is ducted to classrooms via ceiling mounted fresh air diffusers (Picture 5). Exhaust air is drawn through wall or ceiling-mounted vents and ducted back to the AHUs (Picture 6). Ventilation for common areas (auditorium, cafeteria, gymnasium) is provided by ceiling-mounted AHUs. These systems were functioning at the time of the assessment. It is important to note however, that rooftop AHUs appear to be original 1970s era equipment, making them approximately 30+ years old. Efficient function of such equipment can be difficult to maintain since compatible replacement parts are often unavailable.

Rooftop Air Handling Unit

1. Contact an HVAC engineering firm for an assessment of the ventilation system’s control system (e.g., controls, air intake louvers, thermostats). Based on the age, physical deterioration and availability of parts for ventilation components, such an evaluation is recommended to determine the operability and feasibility of repairing/replacing the equipment.

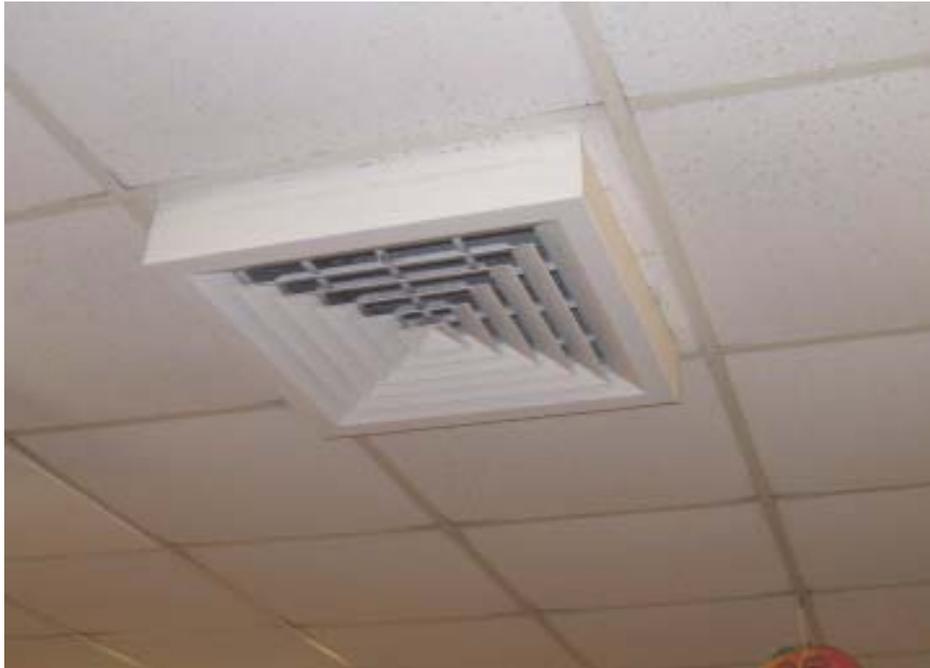
Picture 5

Ceiling-Mounted Supply Diffuser

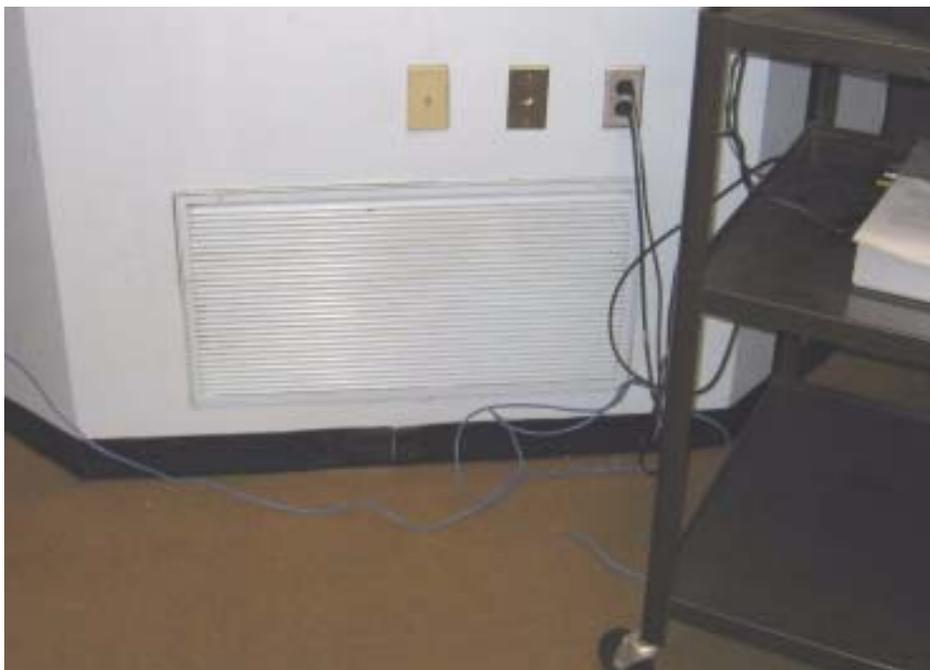
Picture 6

Wall-Mounted Exhaust Vent in Classroom

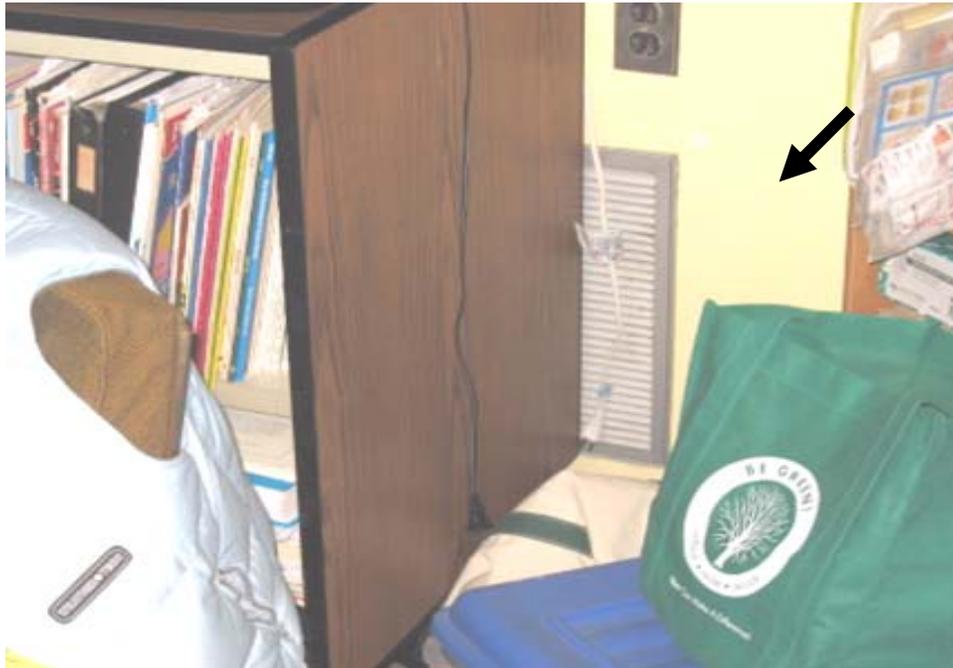
Picture 7

A number of classroom exhaust vents were obstructed by furniture and other items, limiting airflow (Picture 7). Some exhaust vents are located behind classroom doors (Table 1). Due to their location, these vents are prone to blockage when the doors are left open (Picture 8). In addition, with the classroom doors open the exhaust vent tends to draw air from the hallway *into* the classroom instead of stale air *out* of the classroom.

Wall-Mounted Exhaust Vent in Classroom Obstructed by Bookcase

5. Remove all blockages from exhaust vents to ensure adequate airflow.
6. Use openable windows in conjunction with mechanical ventilation to increase air exchange. Care should be taken to ensure windows are properly closed at night and weekends to avoid the freezing of pipes and potential flooding.

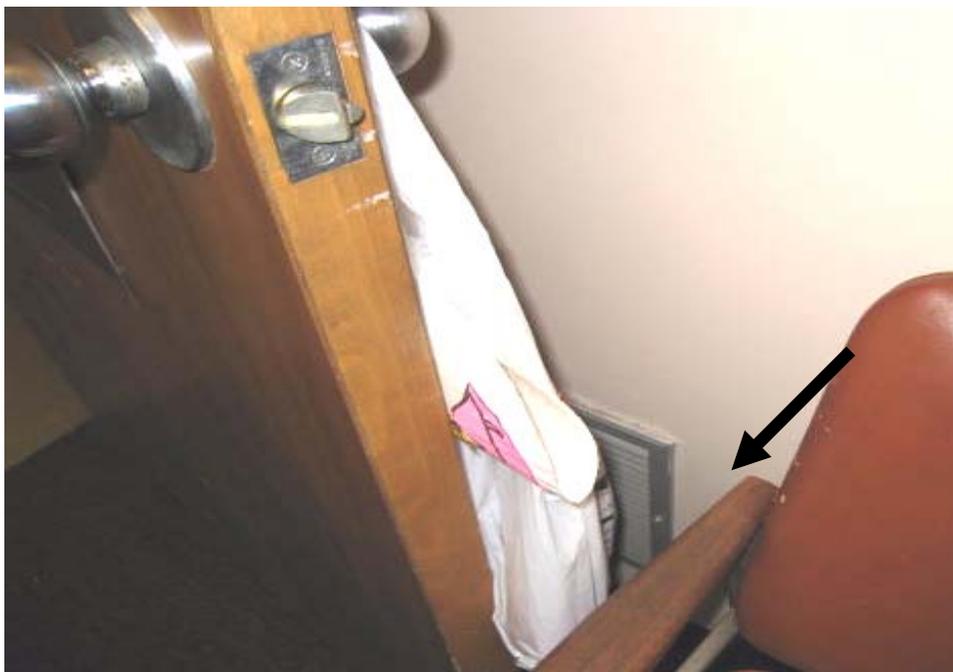
Picture 8

Wall-Mounted Exhaust Vent in Classroom Obstructed by Open Classroom Door

2. Restore restroom exhaust ventilation.
3. Inspect all exhaust motors and belts periodically for proper function. Repair and replace as necessary.
4. Close classroom doors to maximize air exchange.

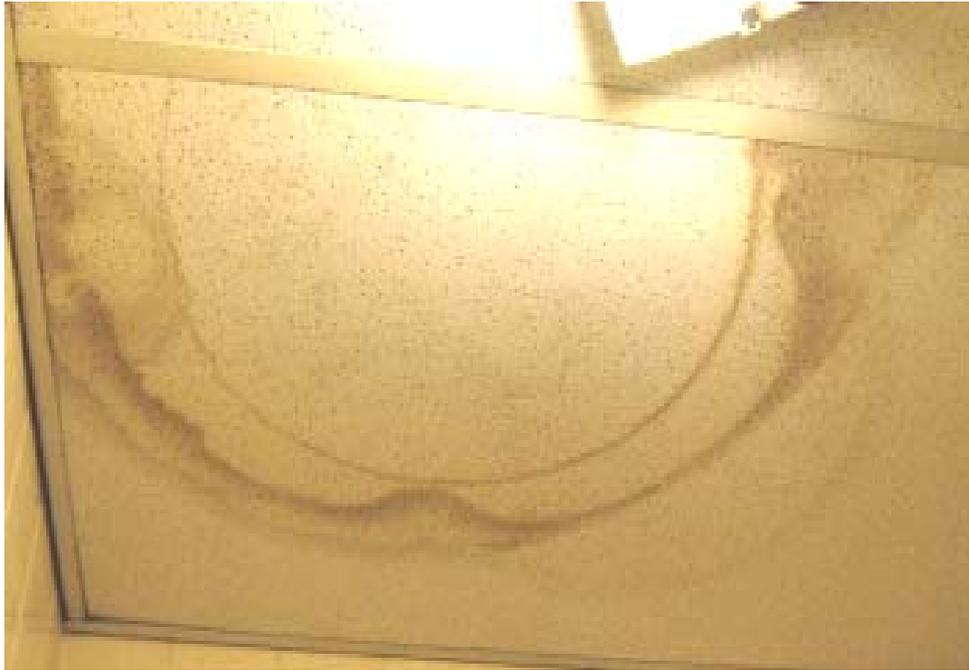
Picture 9

Several areas had water-damaged ceiling tiles, which can indicate leaks from the roof or plumbing system (Pictures 9 and 10/Table 1). Water-damaged ceiling tiles can indicate sources of water penetration and provide a source of mold growth. In classroom H-4, dark staining that appeared to be mold was visible on a ceiling tile (Picture 10). However, there was no evidence of further mold growth above the ceiling tiles. Ceiling tiles should be replaced after a water leak is discovered and repaired. At the time of assessment, BEH staff recommended that this ceiling tile be removed.

Water Damaged Ceiling Tile in Classroom/Restroom

9. Ensure roof leaks are repaired. Remove/replace any water-damaged ceiling tiles.

10. Encourage staff to monitor their classrooms for active leaks/water damage and report to school maintenance staff for prompt remediation.
11. Seal areas around sinks to prevent water damage to the interior of cabinets and adjacent wallboard.

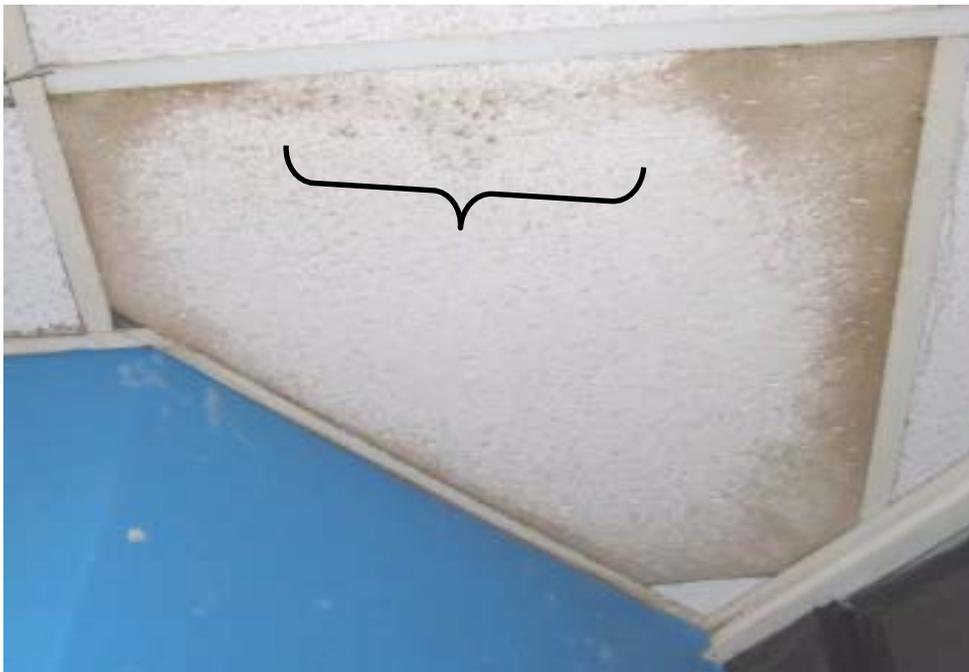
Picture 10

Water Damaged Ceiling Tile in Classroom, Noted Area Indicates Possible Mold Growth

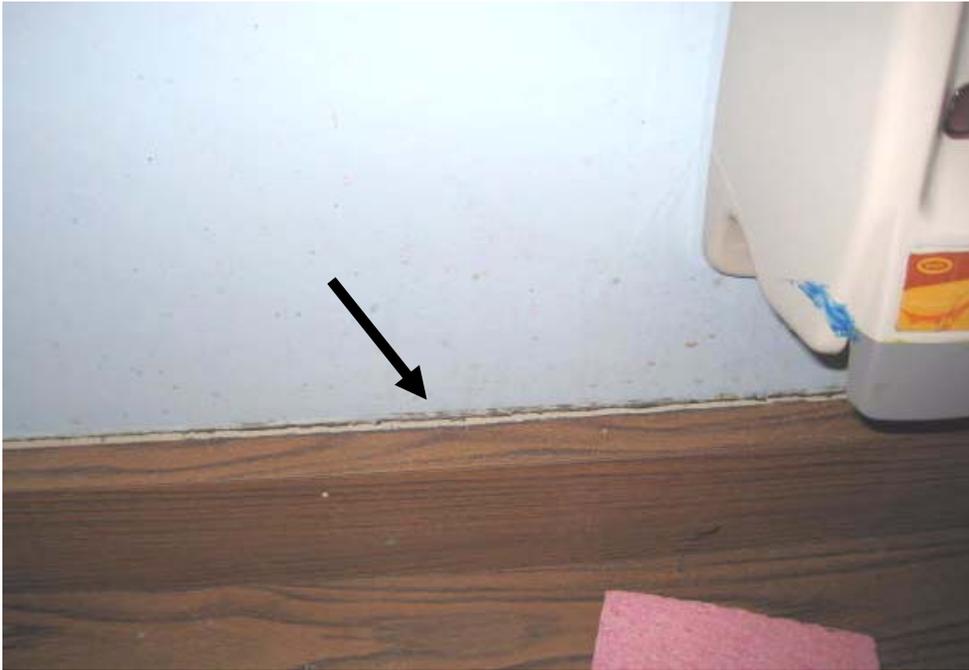
Picture 11

Open seams between sink countertops and walls were observed in several rooms (Picture 11/Table 1). Improper drainage or sink overflow can lead to water penetration into the countertop, cabinet interior and areas behind cabinets. If not watertight, moisture can penetrate through the seam, causing water damage and potential mold growth.

Breach between Sink Countertop and Backsplash

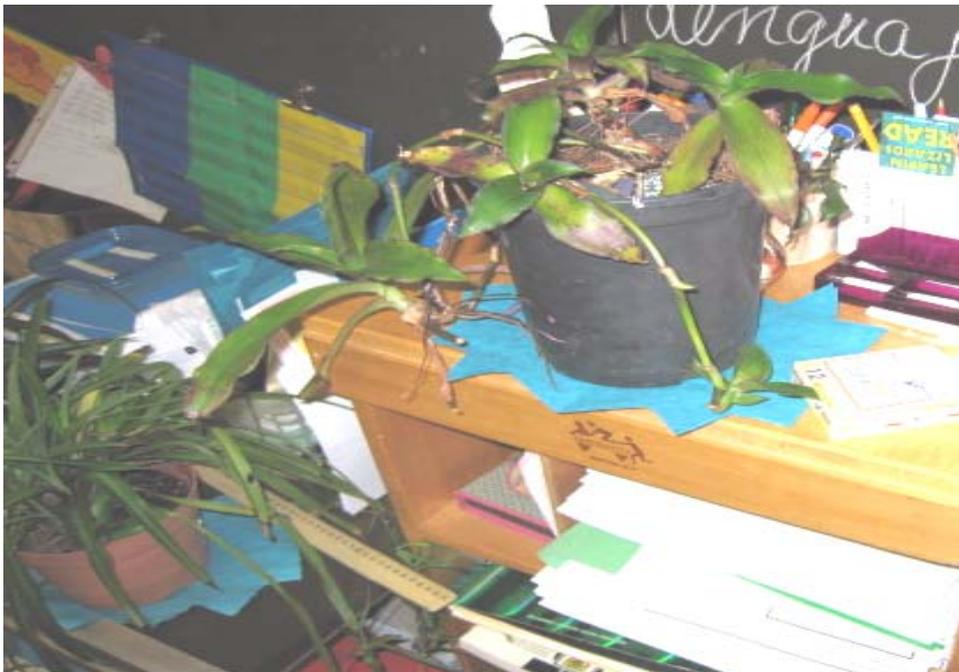
Picture 12

Several classrooms had a number of plants. Moistened plant soil and drip pans can be a source of mold growth. Plants in one area were observed on paper (Picture 12), which is a porous material that is susceptible to mold growth if moistened repeatedly. Plants should be equipped with drip pans; the lack of drip pans can lead to water pooling and mold growth on

Plants on Paper in Classroom

12. Avoid over-watering plants and examine drip pans periodically for mold growth. Disinfect with an appropriate antimicrobial where necessary.
13. Trim shrubbery/trees back approximately 5-feet to prevent water impingement on exterior brick.

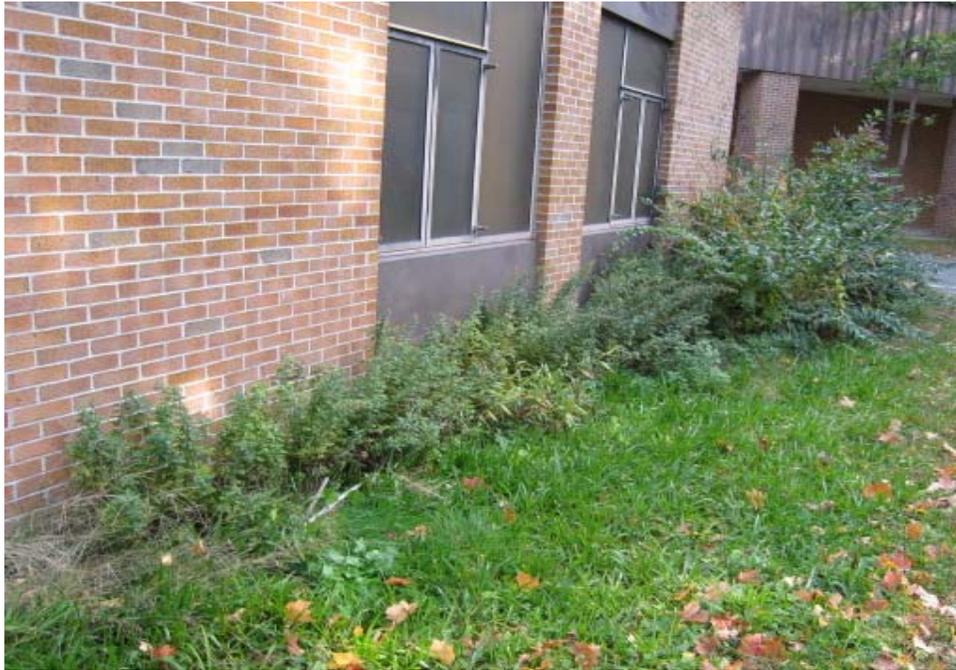
Picture 13

Shrubs/trees were observed growing in close proximity to exterior walls (Picture 13 and 14). Accumulated leaves, moss and plant debris was observed on the roof (Pictures 15 and 16). These conditions can hold moisture against exterior brick or on the roof, preventing drying and serving as sources for potential water penetration. Over time, these conditions can undermine the integrity of the building envelope and provide a means of water entry into the building via roof leaks or capillary action through concrete and masonry (Lstiburek & Brennan, 2001).

Plant Growth against Exterior Brick

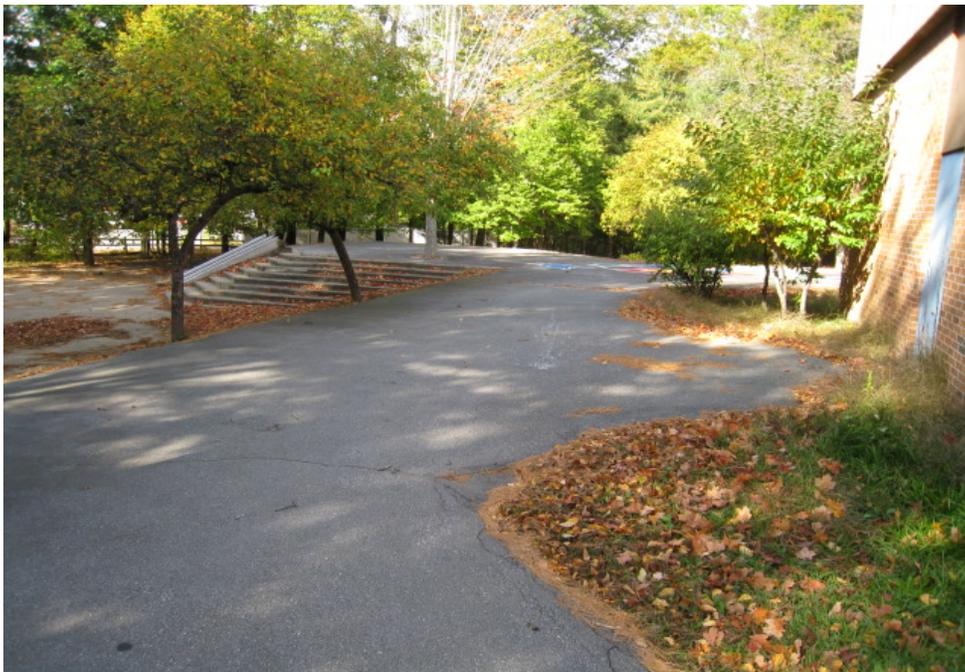
Picture 14

Trees in Close Proximity to Exterior Brick

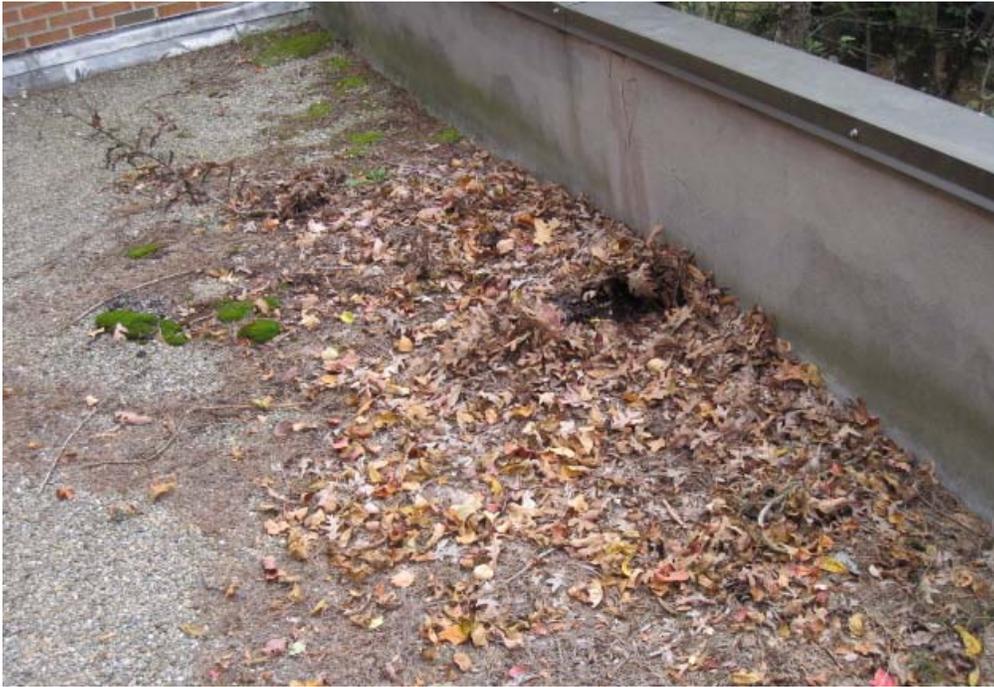
Picture 15

Accumulated Leaves, Moss and Plant Debris on Roof

14. Remove accumulated plant debris from roof to prevent water pooling.
15. Store cleaning products properly and out of reach of students. Ensure spray bottles are properly labeled.

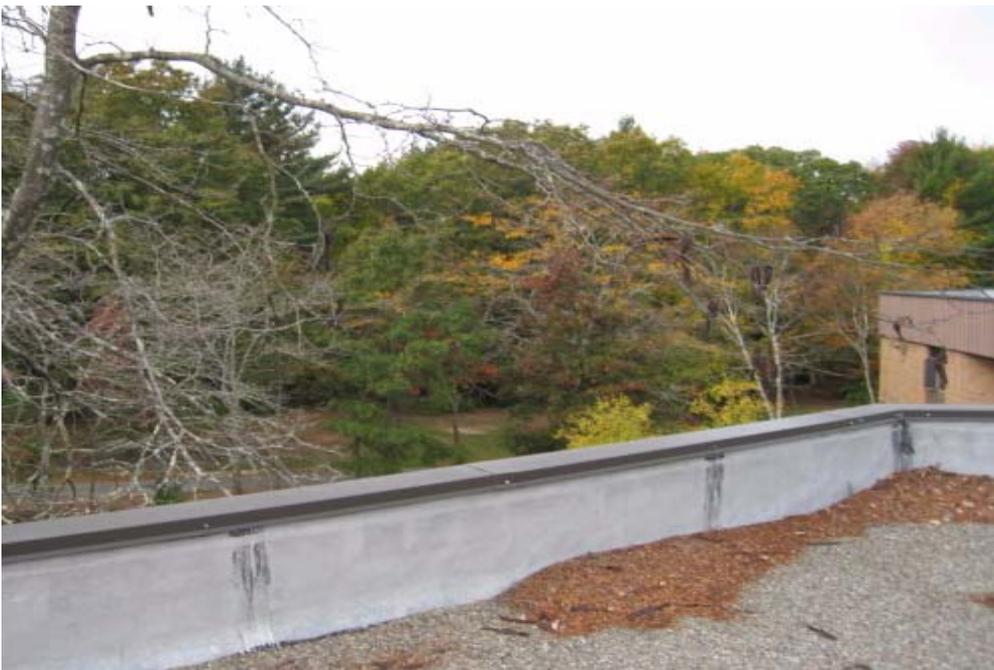
Picture 16

Overhanging Branches and Accumulated Plant Debris on Roof

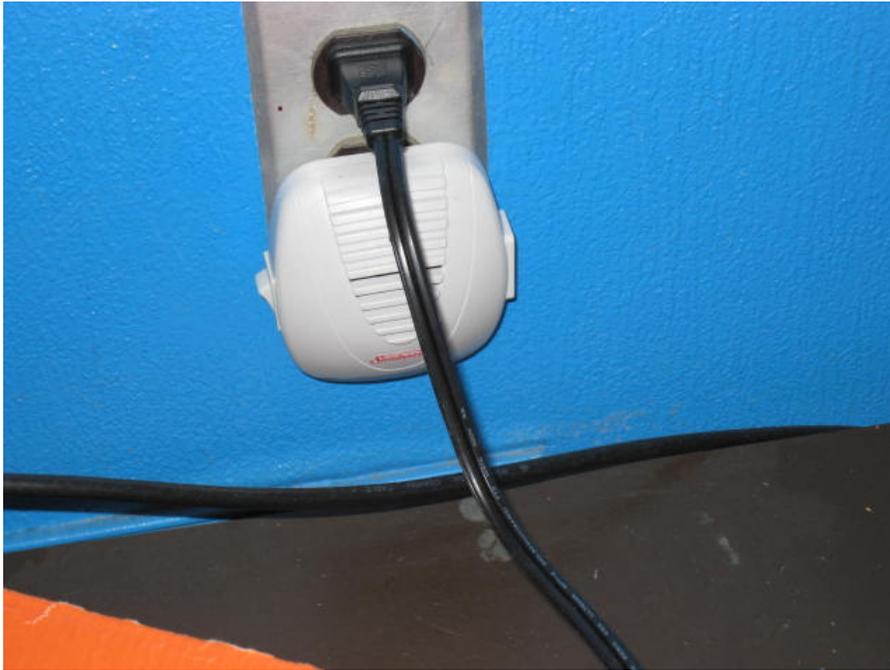
Picture 17

Plug-in air fresheners were in use in a few areas (Picture 17). Air fresheners contain chemicals that can be irritating to the eyes, nose and throat of sensitive individuals. Further, air fresheners do not remove materials causing odors, but rather mask odors which may be present in the area.

Plug-In Air Freshener

17. Clean personal fans periodically of accumulated dust.
18. Refrain from using strongly scented materials (e.g., plug-in air fresheners).
19. Remove carpeting from nurse's suite. Continue with carpet replacement throughout the building as funds become available.

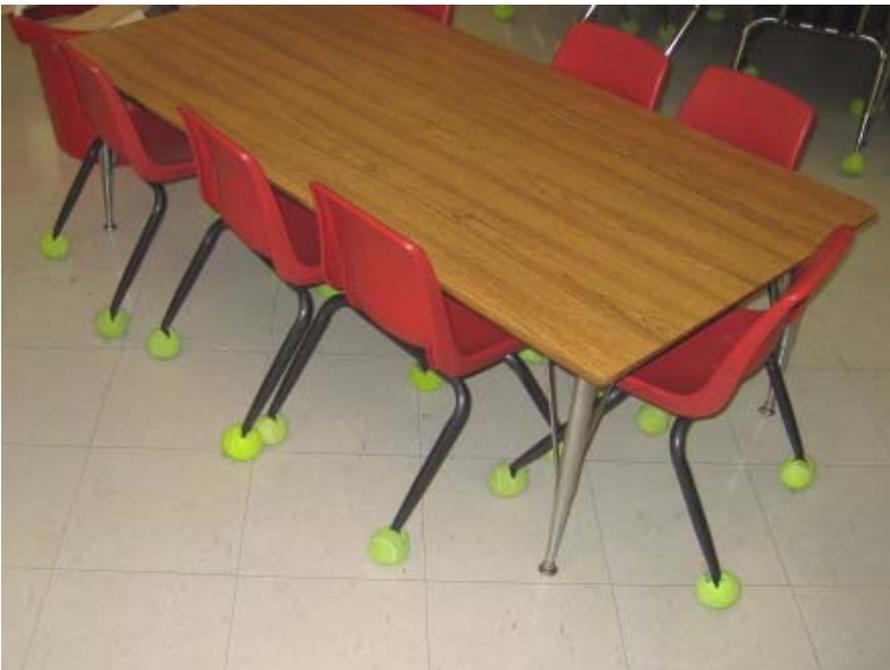
Picture 18

In an effort to reduce noise from sliding chairs, tennis balls had been sliced open and placed on chair legs (Picture 18). Tennis balls are made of a number of materials that are a source of respiratory irritants. Constant wearing of tennis balls can produce fibers and cause TVOCs to off-gas. Tennis balls are made with a natural rubber latex bladder, which becomes abraded when used as a chair leg pad. Use of tennis balls in this manner may introduce latex dust into the school environment. Some individuals are highly allergic to latex (e.g., spina bifida patients) (SBAA, 2001). It is recommended that the use of materials containing latex be limited

Tennis Balls on Chair Legs

in buildings to reduce the likelihood of symptoms in sensitive individuals (NIOSH, 1997). A question and answer sheet concerning latex allergy is attached as [Appendix B](#) (NIOSH, 1998).

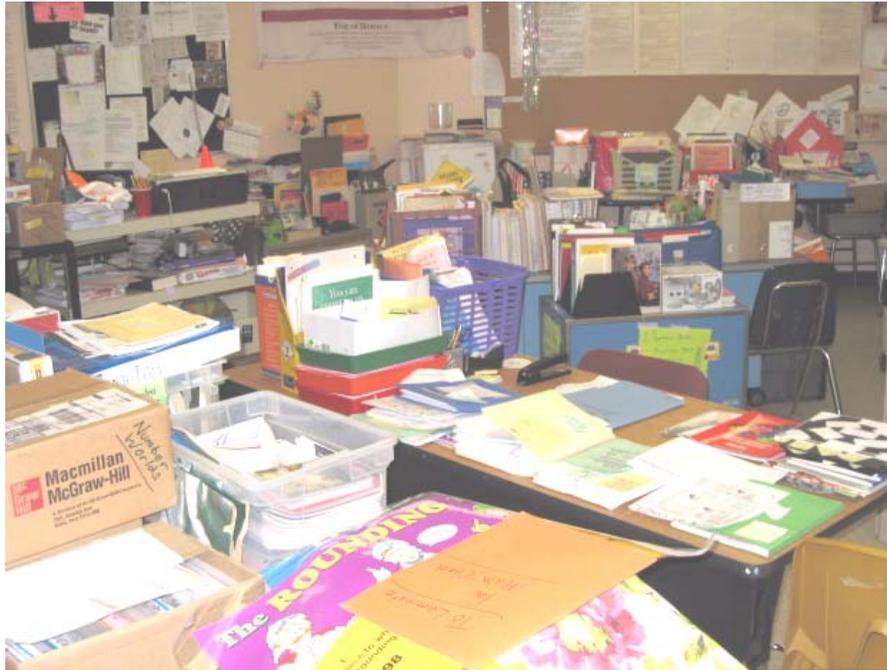
Picture 19

Other conditions that can affect indoor air quality were observed during the assessment. In several classrooms, items were observed on windowsills, tabletops, counters, bookcases and desks (Picture 19). The large number of items stored in classrooms provides a source for dusts to accumulate. These items (e.g., papers, folders, boxes) make it difficult for custodial staff to clean. Items should be relocated and/or be cleaned periodically to avoid excessive dust build up. In addition, these materials can accumulate on flat surfaces (e.g., desktops, shelving and carpets) in occupied areas and subsequently be re-aerosolized causing further irritation. A number of personal fans in classrooms were observed to have accumulated dust/debris. Re-activated supply fans can aerosolize dust accumulated on fan blades/housing.

Accumulated Items on Flat Surfaces in Classroom

16. Relocate or consider reducing the amount of materials stored in classrooms to allow for more thorough cleaning of classrooms. Clean items regularly with a wet cloth or sponge to prevent excessive dust build-up.
