INDOOR AIR QUALITY ASSESSMENT MOLD INVESTIGATION

**Essex Superior Court
34 Federal St.
Salem, Massachusetts 01970**

Prepared by:
Massachusetts Department of Public Health
Bureau of Environmental Health
Indoor Air Quality Program
April 2009

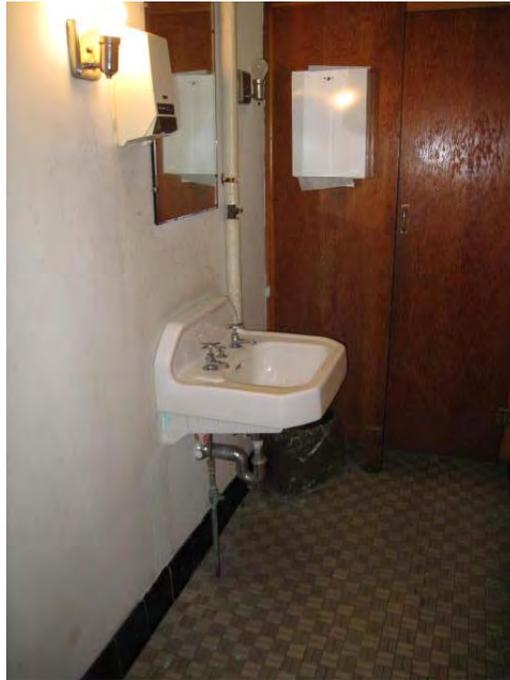
Picture 1

Several weeks prior to the assessment, a pipe supplying fresh water to a bathroom sink on the top floor of the building froze and subsequently burst due to extreme cold weather (Picture 1). The adjacent jury room wood floor became wet due to water from the pipe but reportedly dried quickly. Plaster walls as well as office carpeting in rooms and hallways below the pipe burst were damaged. Prior to the BEH assessment, the damaged carpet had been removed and replaced. Remediation efforts to repair water-damaged plaster walls had commenced.

Sink With Burst Pipe

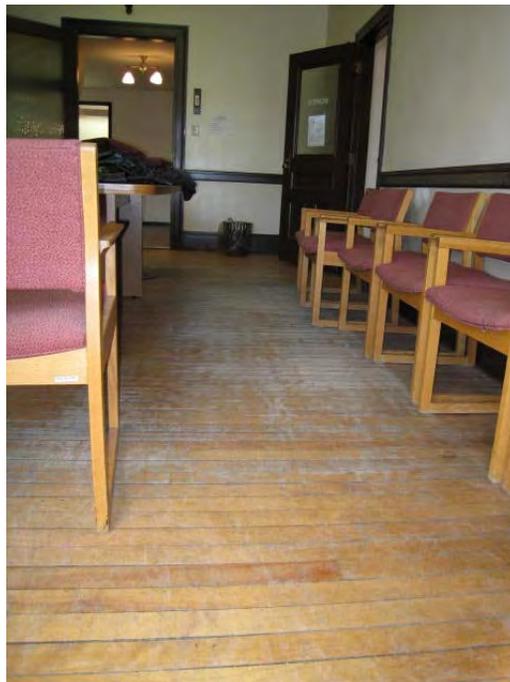
Picture 2

Juror Room Floor

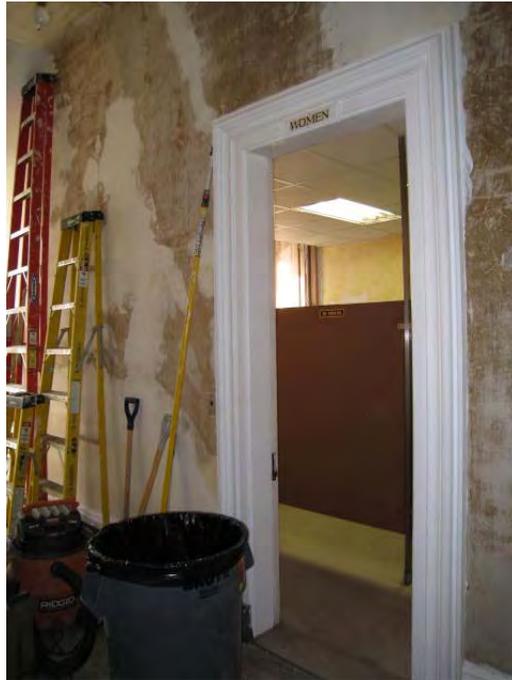
Picture 3

As discussed, prior to the BEH assessment, the water-damaged carpet from an office below the restroom had been removed and replaced. At the time of assessment, remediation of water-damaged plaster walls was in process. Plaster does not support mold growth. Due to the age of the building, it is extremely unlikely that insulation exists within the wall cavities; wall cavities are likely hollow and would dry rapidly. All areas examined were free of musty odors and visible mold growth. No porous building materials (i.e. carpeting, gypsum wallboard) or other materials (i.e. books) appeared to have been moistened as a result of this event.

Water Damaged Plaster below Restroom in Main Hallway

1. Continue with repairs to plaster walls..
2. Consult “Mold Remediation in Schools and Commercial Buildings” published by the US Environmental Protection Agency (US EPA, 2001) for more information on mold. This document can be downloaded from the US EPA website at:
http://www.epa.gov/iaq/molds/mold_remediation.html.
3. Refer to resource manuals and other related indoor air quality documents for further building-wide evaluations and advice on maintaining public buildings. These materials are located on the MDPH’s website at <http://mass.gov/dph/iaq>.
