INDOOR AIR QUALITY ASSESSMENT

**Massachusetts Department of Developmental Services
Fernald Center Wallace Building
200 Trapelo Road
Waltham, Massachusetts 02452**

Prepared by:
Massachusetts Department of Public Health
Bureau of Environmental Health
Indoor Air Quality Program
July 2009

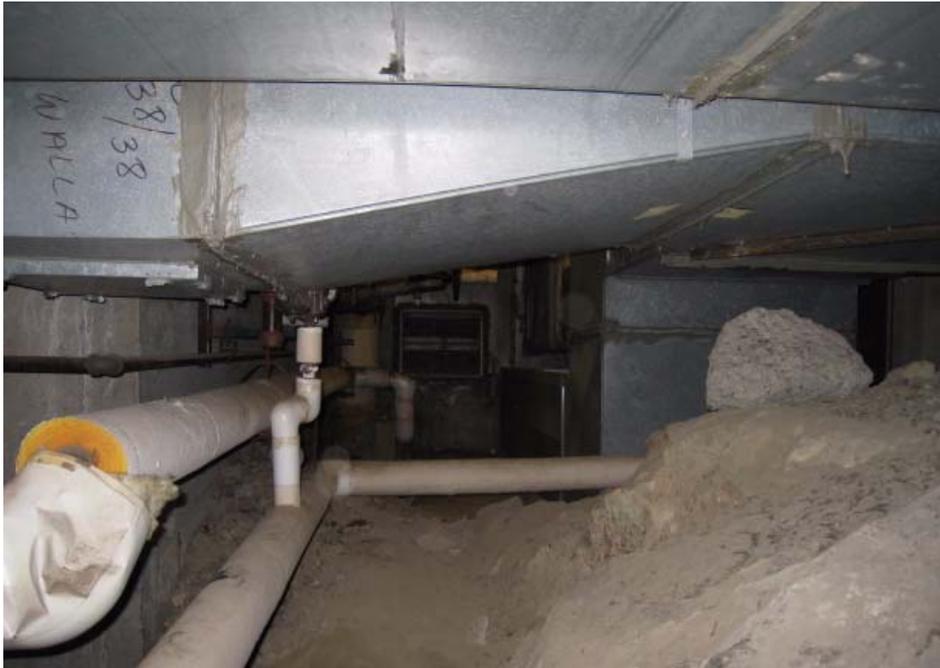
Picture 1

It can be seen from Table 1 that carbon dioxide levels were below 800 parts per million (ppm) in all areas surveyed, indicating adequate air exchange in the building at the time of the assessment. The WB was originally designed with a heating, ventilating and air conditioning (HVAC) system consisting of a large air handling unit (AHU) located in the basement (Picture 1) supplemented by openable windows and perimeter fan coil units (FCUs) in the rooms (Picture 2). A FCU does not introduce outside air; rather, it draws air from the room then filters, heats and re-circulates the air back to the room.

As previously mentioned, the assessment was prompted by a recommendation to clean the AHU ductwork. However, at the time of the assessment, the HVAC system did not appear to be operating. According to Mr. Robbilard, the system is unused and has not been activated in the five years that the WB has been used as a client residence. The building has been heated by FCUs and ventilated via openable windows during that time. Mr. Dunton and WB staff reported that the FCUs have been sufficient to maintain heat in the building.

AHU and Ductwork Located in Basement Crawlspace

Based on the lack of use of the original AHU, cleaning the ductwork would not be recommended. Sealing the various openings for this unused system to properly abandon the ductwork would be the most appropriate action. Duct cleaning of an unused system may result in increased indoor air quality problems. According to the United States Environmental Protection Agency (US EPA), knowledge about potential benefits and problems with duct cleaning is limited. Since conditions in every building are different, it is difficult to generalize whether or not duct cleaning will be beneficial. If occupants are not experiencing symptoms (e.g., allergies, exacerbation of asthma); detecting strange odors; or observing particulate/debris coming from vents/diffusers, it may be unnecessary to have ducts cleaned. It is also normal for supply diffusers and exhaust/return vents to accumulate dust, which does not indicate that the air ducts are contaminated. Supply, exhaust and return vents should be cleaned/vacuumed as needed. In addition, duct cleaning can damage ducts, fans, coils and other HVAC equipment if not done properly (US EPA, 2006a). Therefore, the most efficient manner to prevent pollutants from impacting the building population is to seal the openings of the unused HVAC system.

1. Seal the fresh air supply and exhaust vents with an appropriate material to abandon the non-operating HVAC system in place.
2. Continue with plans to make window repairs. Provide air exchange by using openable windows to control for comfort. Care should be taken to ensure windows are properly closed as needed to avoid the freezing of pipes and potential flooding.

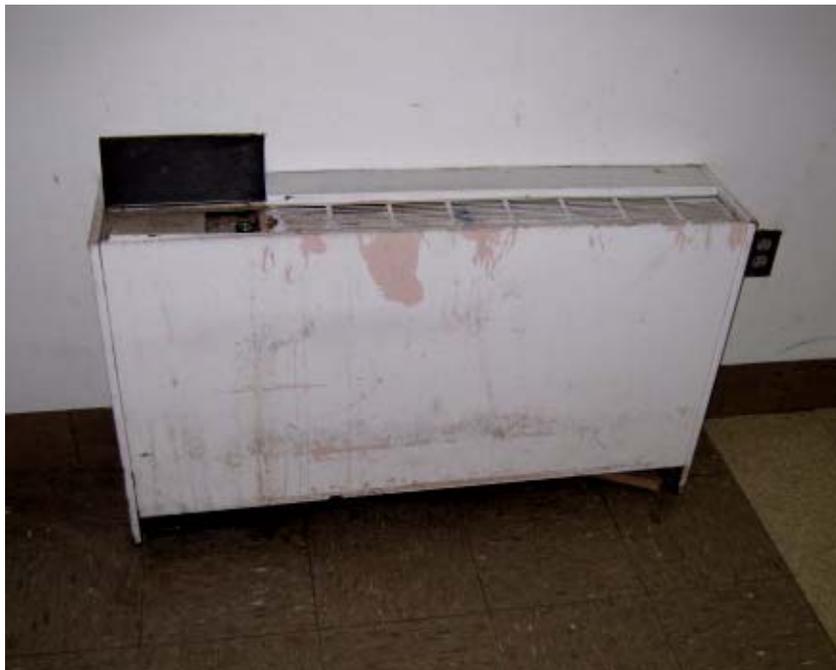
Picture 2

Fan Coil Unit

6. Operate FCUs continuously to facilitate airflow.
7. Clean FCU air handling chambers, return vents and air diffusers periodically of accumulated dust.

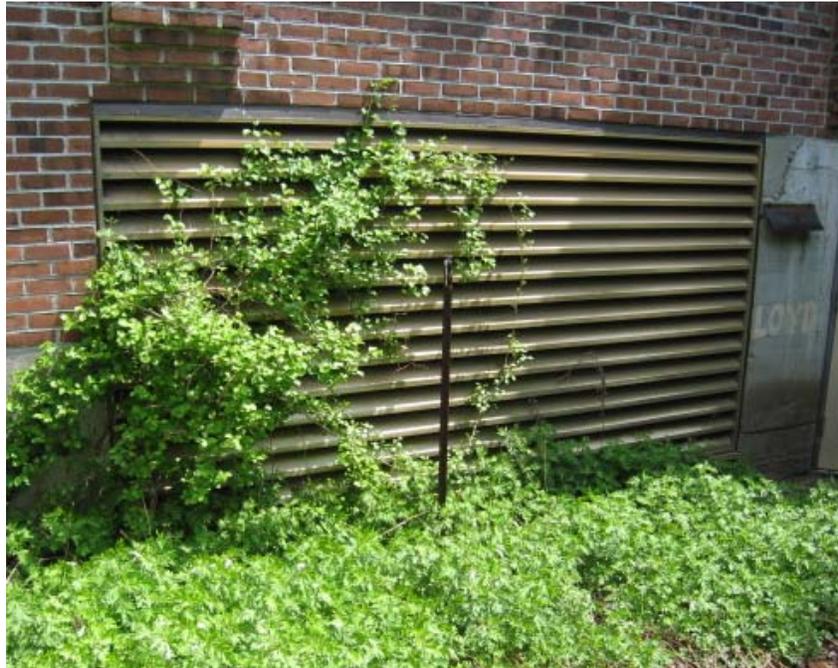
Picture 3

The AHU was designed to draw fresh air through an air intake on the exterior wall, then heat/filter and distribute it to occupied areas via ducted ceiling diffusers (Pictures 3 and 4). Air is ducted back to the AHU through ceiling-mounted return vents and exhausted out of the building from a vent on the exterior wall (Picture 5).

Fresh Air Intake for Abandoned Mechanical Ventilation System

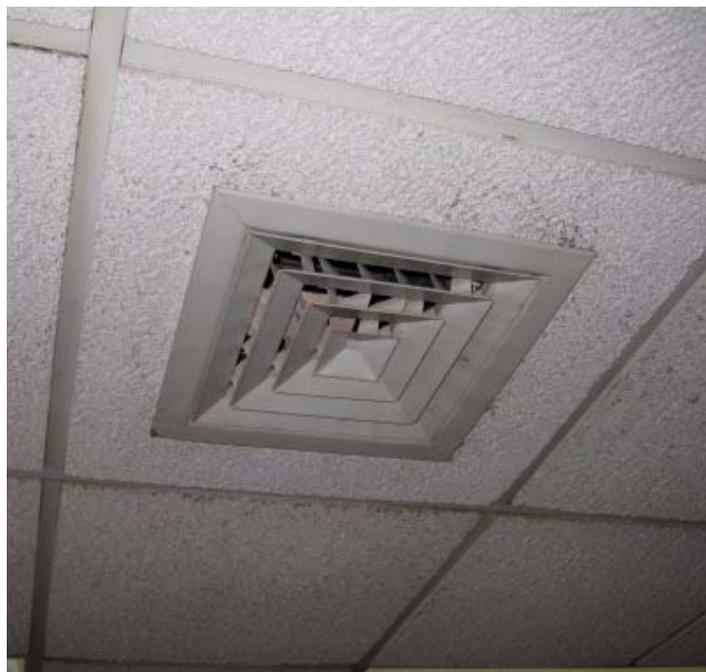
Picture 4

Ceiling-Mounted Supply Diffuser

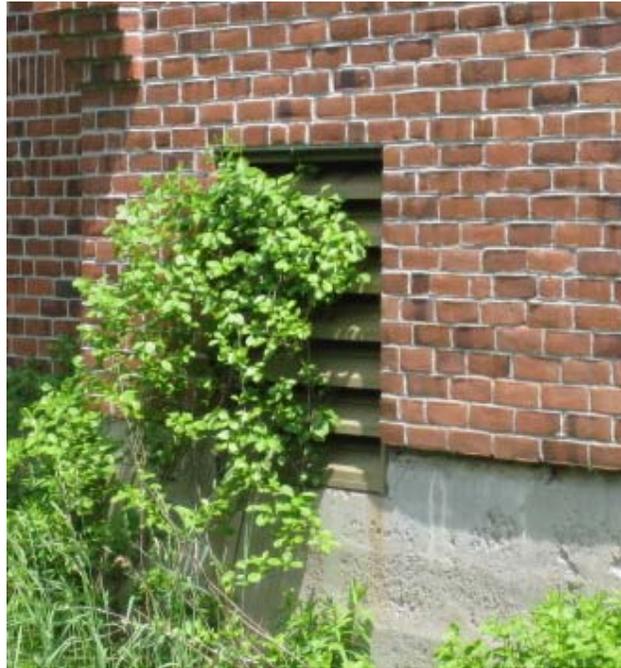
Picture 5

Exhaust Vent for Abandoned Mechanical Ventilation System

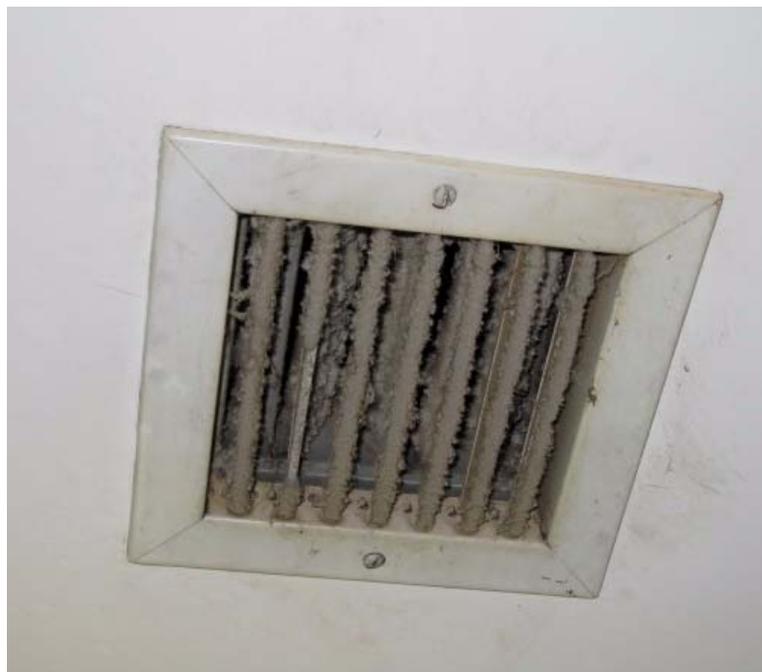
Picture 6

Restrooms are equipped with exhaust vents that operate via rooftop motors (Pictures 6 and 7). The vents were not drawing air at the time of the assessment. Mr. Dunton reported that

the repair/replacement of exhaust motors was on work order. Exhaust ventilation is necessary in restrooms to remove excess moisture and to prevent odors from penetrating into adjacent areas.

Restroom Exhaust Vent

4. Restore exhaust ventilation in restrooms to remove odors and moisture, make repairs as necessary.
5. Work with DDS staff/officials to develop a preventative maintenance program for all HVAC equipment department-wide.

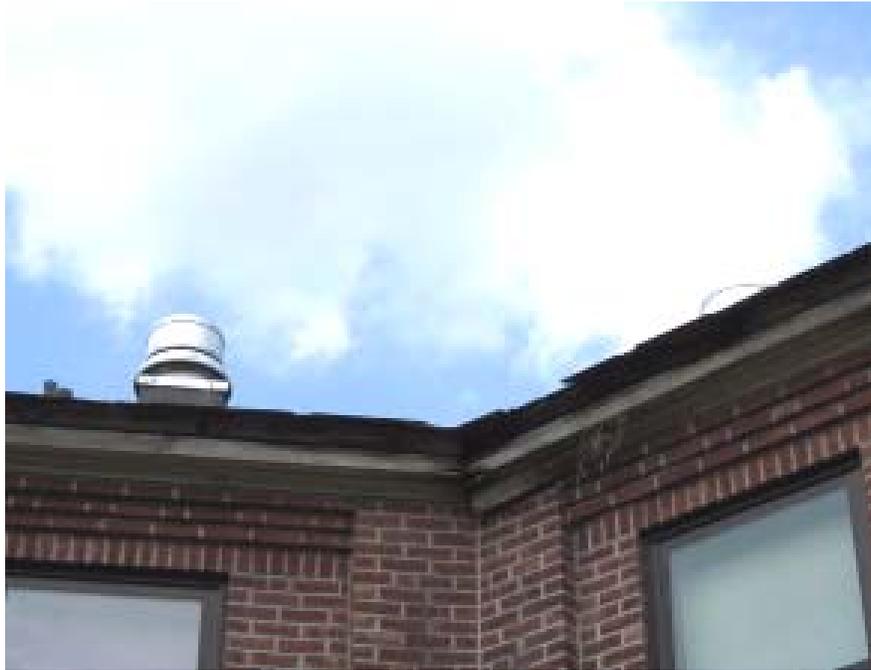
Picture 7

Rooftop Exhaust Motors

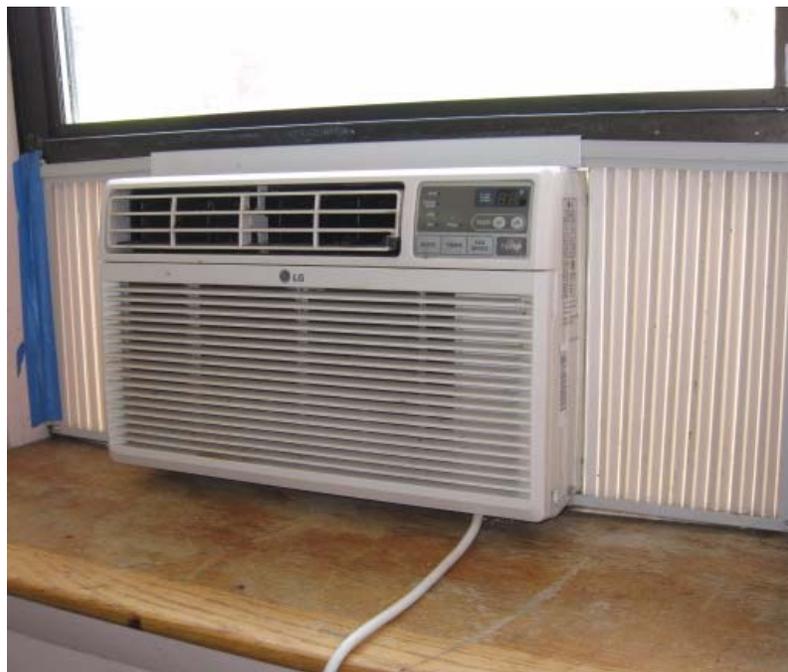
Picture 8

Window mounted air conditioners (ACs) provide cooling throughout the building (Picture 8). ACs examined were equipped with a “fan only” or “exhaust open” setting (Picture 9). In this mode of operation, ACs can provide air circulation by delivering outside air into space without cooling (i.e., air provided by unit equals that of outside temperature).

Window Mounted Air Conditioner

3. Supplement fresh air by operating window-mounted air conditioners in the "fan only" "fresh air" mode, which introduces outside air by mechanical means.

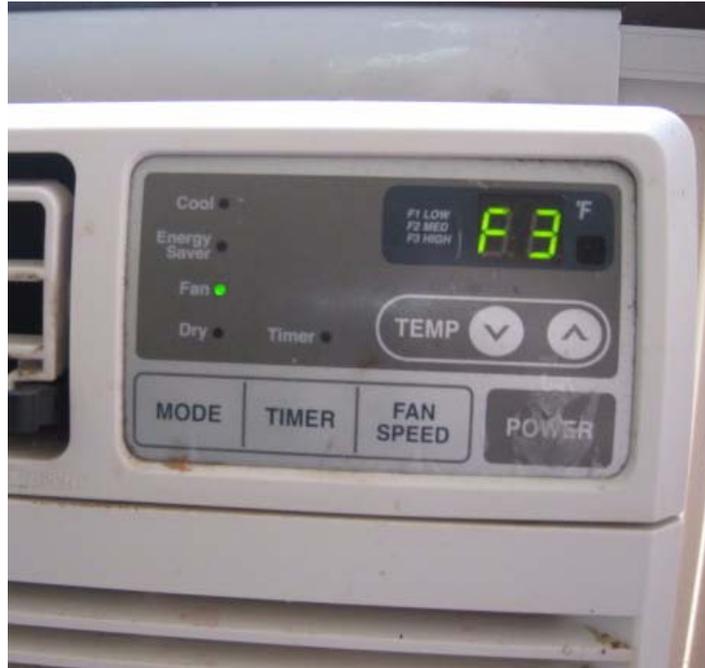
Picture 9

Close Up of Window Mounted Air Conditioner, Note Fan Function

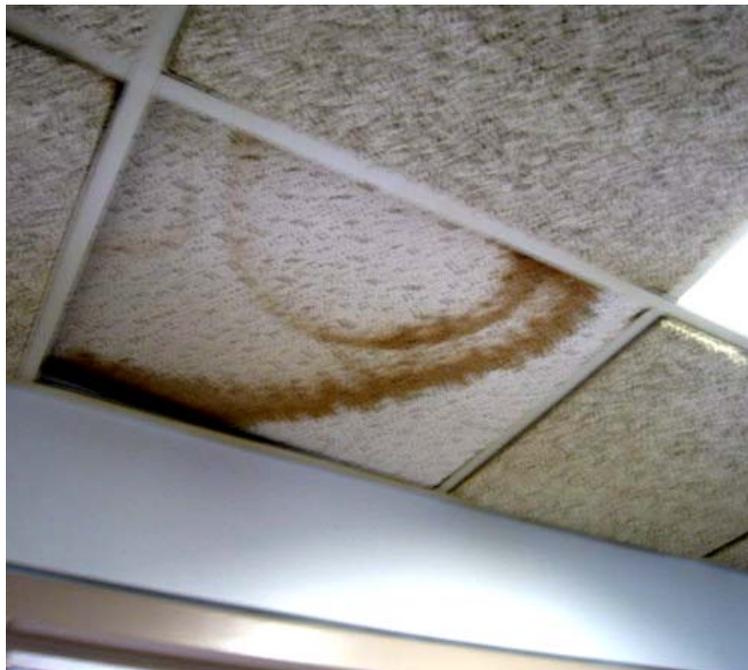
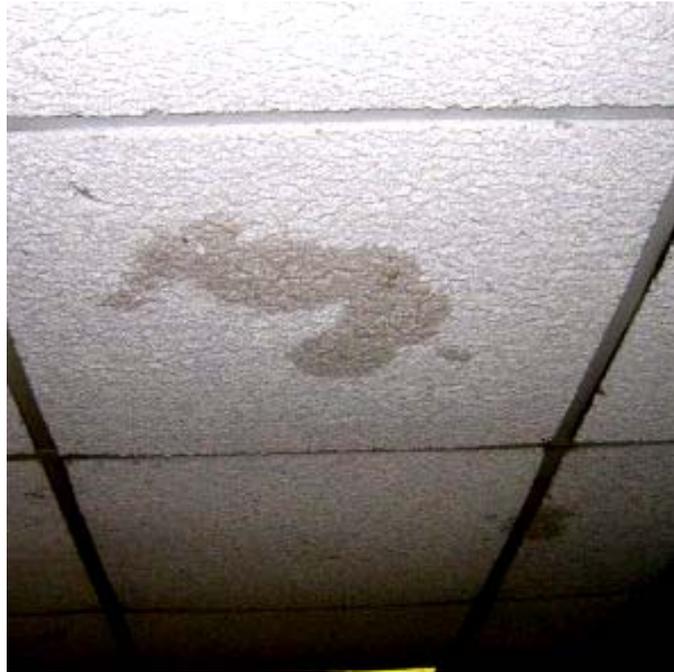
Water damaged ceiling tiles were noted in a few areas (Pictures 10 and 11). Water-damaged ceiling tiles can indicate sources of water penetration and provide a source of mold growth. Ceiling tiles should be replaced after a water leak is discovered and repaired. At the time of the assessment, Mr. Dunton reported that an active roof leak was being investigated for repairs by a roofing contractor.

Water-Damaged Ceiling Tiles

11. Remove/replace water damaged ceiling tiles. Examine the areas above and around for mold growth. Disinfect areas of water leaks with an appropriate antimicrobial.

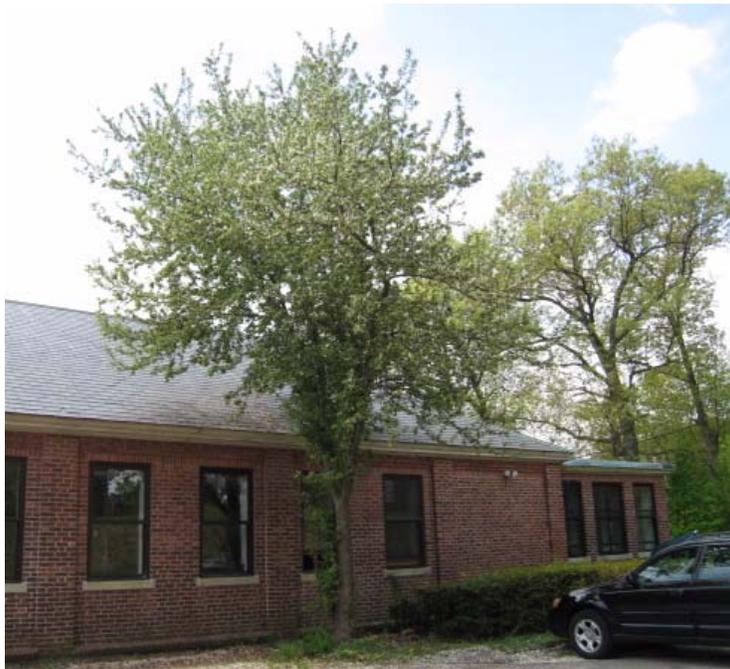
Picture 12

- Tree branches overhanging the roof (Picture 12);
- Plant growth against the building (Picture 13);
- A broken window in the rear of the building (Pictures 14); and
- Damage/breaches in wooden eaves along the roof's edge (Picture 15).

These conditions can undermine the integrity of the building envelope and provide a means of water entry by capillary action into the building through exterior walls, foundation concrete and masonry (Lstiburek & Brennan, 2001). In addition, breaches in exterior areas can provide a means of drafts and pest entry into the building.

Tree Branches Overhanging Roof

12. Remove clinging plants, trim overhanging branches or remove trees from close proximity to exterior walls.
13. Repair/replace damaged windows.
14. Refer to resource manuals and other related indoor air quality documents for further building-wide evaluations and advice on maintaining public buildings. Copies of these materials are located on the MDPH's website: <http://mass.gov/dph/iaq>.

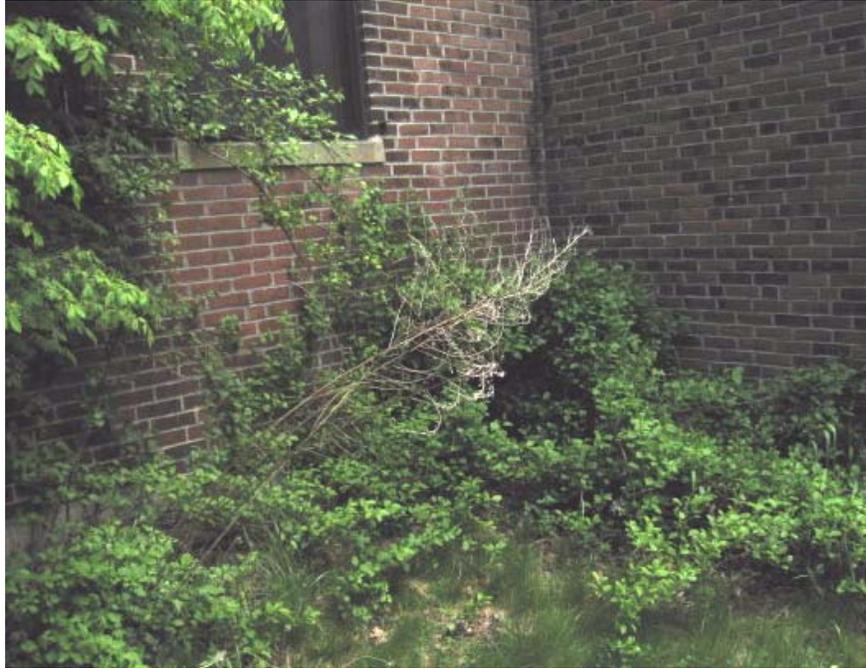
Picture 13

Plant Growth against the Exterior Brickwork

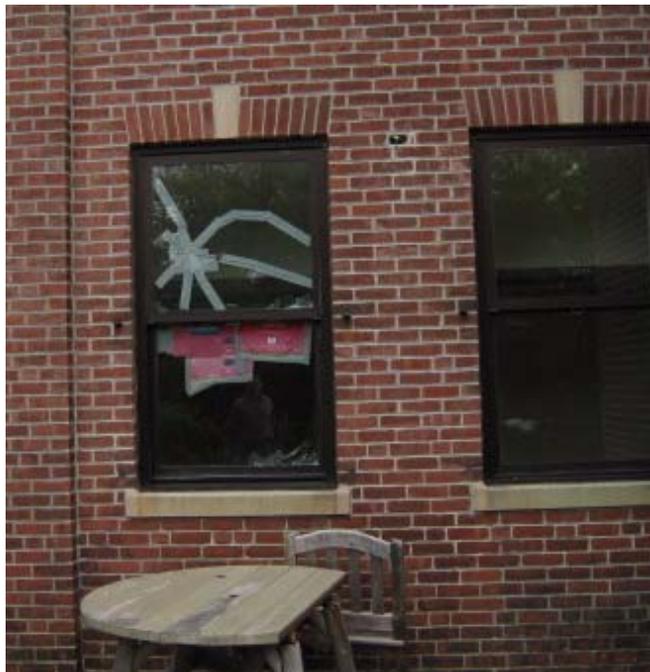
Picture 14

Broken Window at the Rear of Building

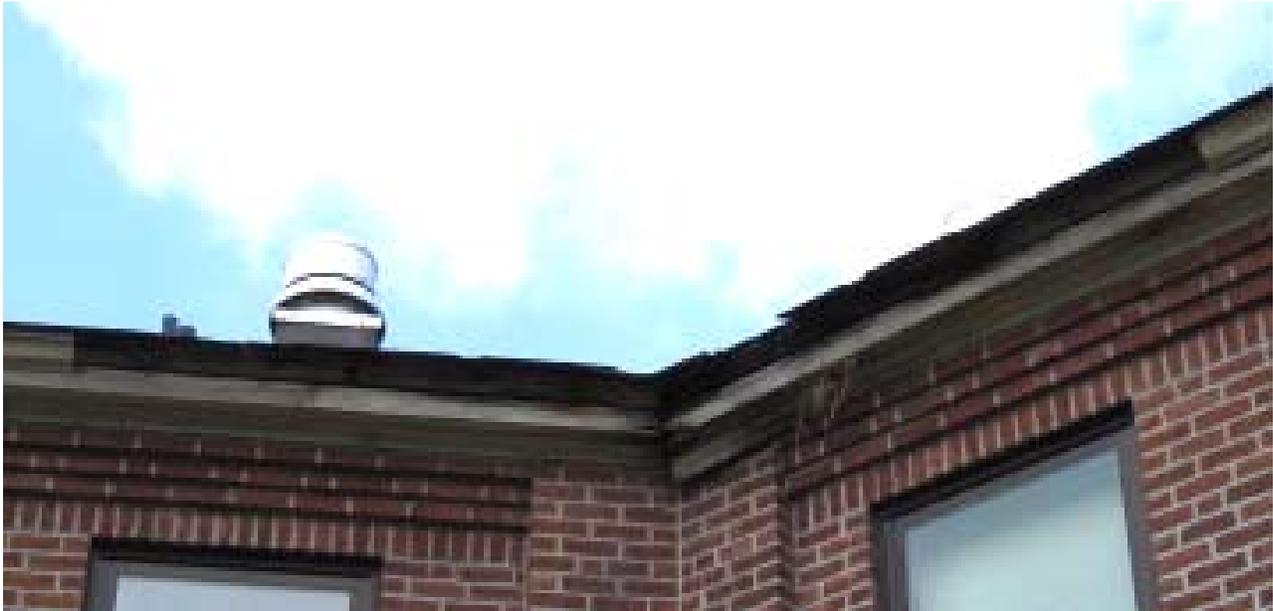
Picture 15

Missing/Damaged Wooden Roof Eaves at Rear of Building

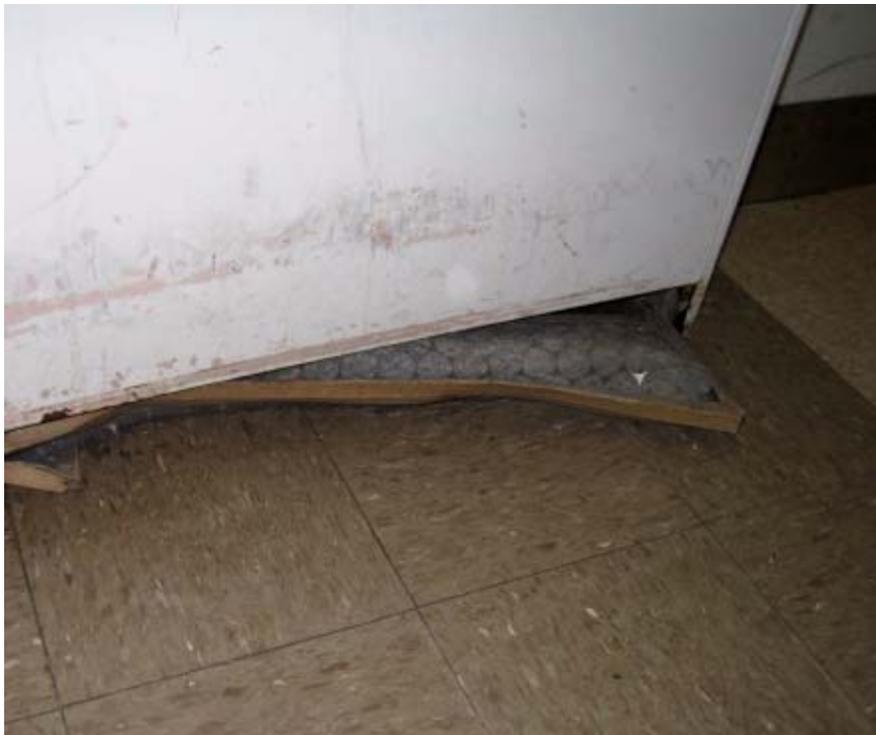
Picture 16

Other conditions that can affect indoor air quality were observed during the assessment. FCUs are normally equipped with filters that provide filtration to strain particulates from airflow. The FCU filters appeared to be ill-fitting and occluded with dust (Picture 16). In order to decrease aerosolized particulates, disposable filters with an increased dust spot efficiency can be installed. The dust spot efficiency is the ability of a filter to remove particulates of a certain diameter from air passing through the filter. Filters that have been determined by ASHRAE to meet its standard for a dust spot efficiency of a minimum of 40 percent (Minimum Efficiency Reporting Value equal to 9) would be sufficient to reduce many airborne particulates (Thornburg, 2000; MEHRC, 1997; ASHRAE, 1992). Note that increasing filtration can reduce airflow, a condition known as pressure drop, which can reduce the efficiency of the FCU due to increased resistance. Prior to any increase of filtration, a HVAC engineer should be consulted as to whether FCUs can maintain function with more efficient filters.

FCU Filter Protruding from Filter Rack

8. Change filters for FCUs and ACs as per the manufacturers' instructions or more frequently if needed. Consider increasing the dust-spot efficiency of FCU filters. Ensure filters fit flush in their racks to prevent filter bypass.

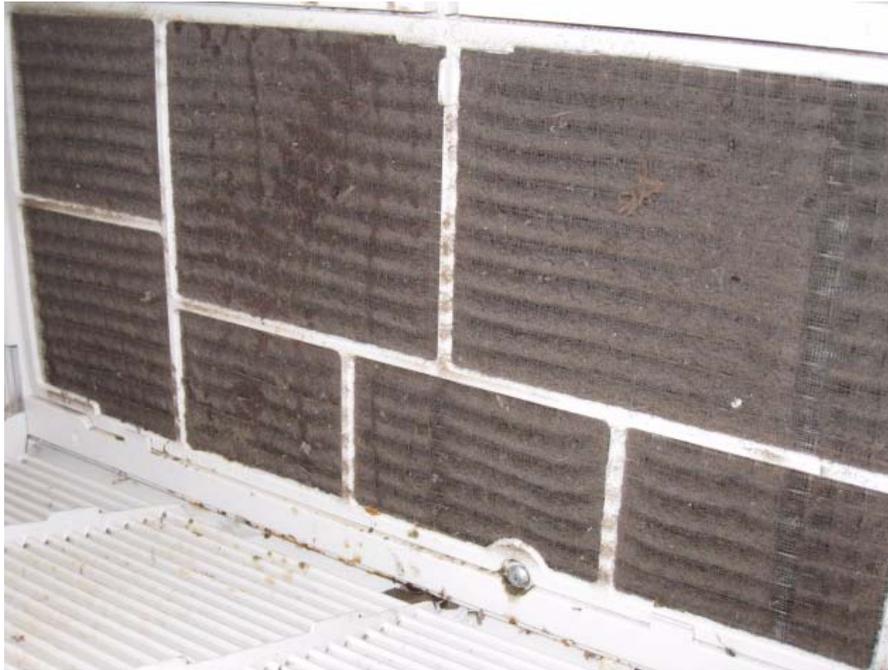
Picture 17

Finally, personal fans and AC filters had dirt, dust and debris accumulation (Pictures 17 and 18). In order to prevent equipment from serving as a source of aerosolized particulates, the fans and filters should be regularly cleaned (or changed) as needed.

AC Filter Occluded With Dust/Debris

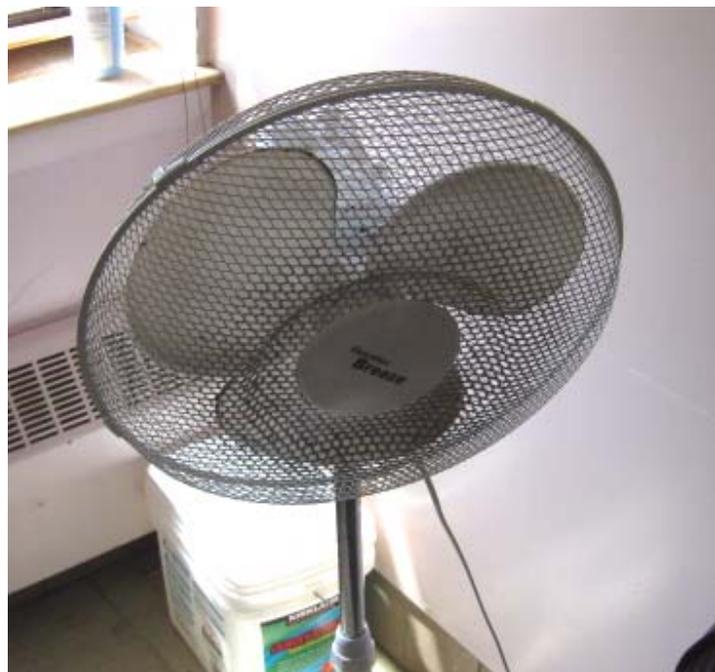
Picture 18

Dust/Debris Accumulation on Portable Fan
