# **INDOOR AIR QUALITY ASSESSMENT**

**Massachusetts Rehabilitation Commission  
40 Dimock Street, 3<sup>rd</sup> Floor  
Roxbury, Massachusetts**

Prepared by:  
Massachusetts Department of Public Health  
Bureau of Environmental Health  
Indoor Air Quality Program  
May 2011

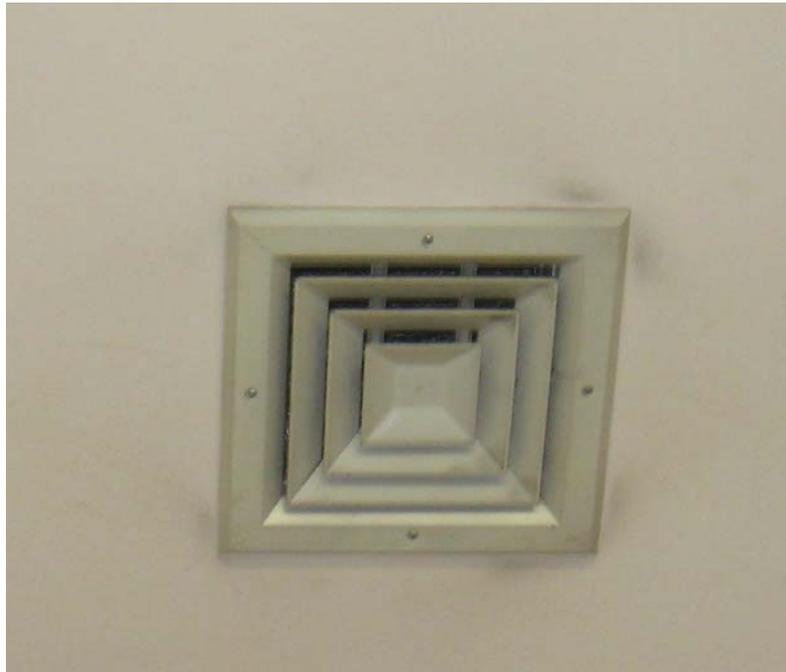
**Picture 1**

Chilled air is provided to occupied spaces via ceiling-mounted supply vents (Picture 1). This system is designed to create positive pressure in the office space to force air out of offices through undercut doors and into the hallway, where ceiling-mounted vents return air to the system. Filters are installed directly above return vents (Picture 2). The air handling units (AHUs) for the AC system are located in the attic.

A number of AC supply diffusers and return vents and ceiling tiles adjacent to supply diffusers were observed to have accumulated dust/debris (Pictures 3 and 4). Dust can be irritating to the eyes, nose and respiratory tract.

**Ceiling-mounted AC diffuser, note dust/debris accumulation on/around vent**

7. Clean AC diffusers and return vents periodically of accumulated dust/debris.
8. For buildings in New England, periods of low relative humidity during the winter are often unavoidable. Therefore, scrupulous cleaning practices should be adopted to minimize common indoor air contaminants whose irritant effects can be enhanced when the relative humidity is low. To control for dusts, a HEPA filter equipped vacuum cleaner in conjunction with wet wiping of all surfaces is recommended. Drinking water

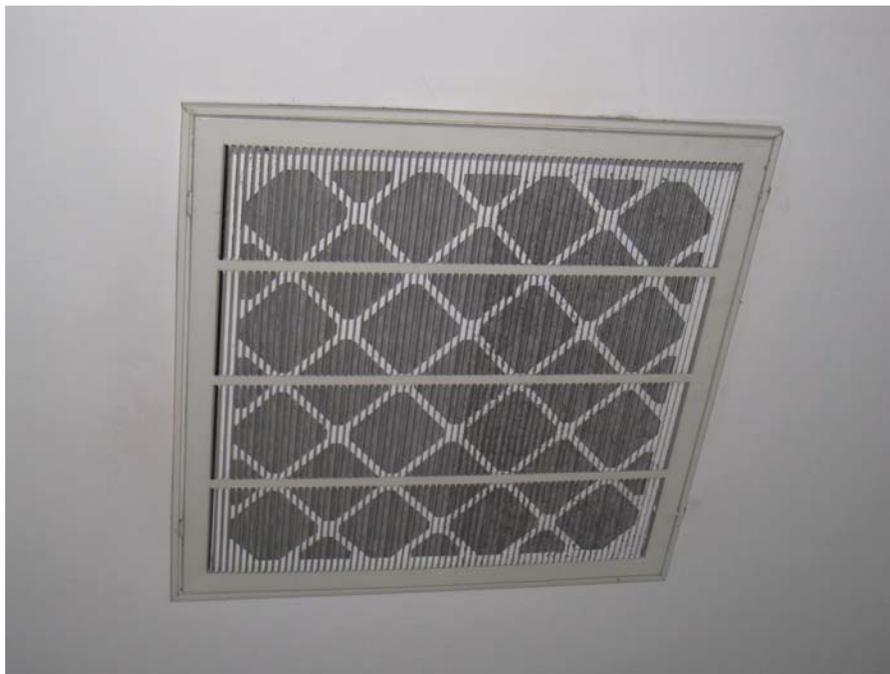
**Picture 2**

**Ceiling-mounted return vent**

4. Clean/change filters for ACs as per the manufacturer's instructions or more frequently if needed. Ensure filters fit properly and AHUs have filter access covers installed.

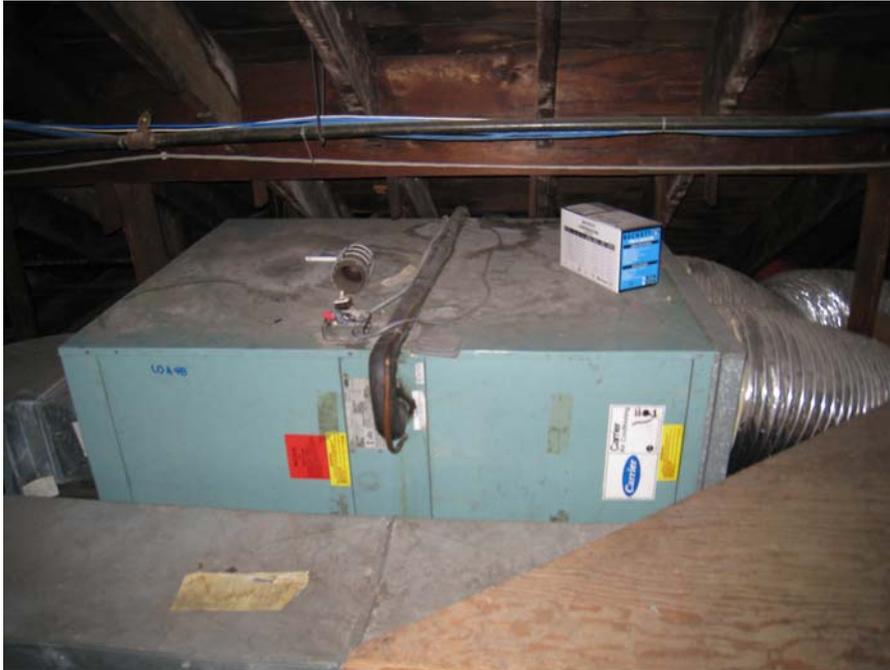
**Picture 3**

BEH staff observed two different AC systems in the attic (Pictures 3 and 4). It is unclear which system services the MRC. A number of small breaches were observed in the ductwork of one system (Picture 3). These breaches should be permanently sealed to prevent draw of air from the attic into the system and/or leakage of chilled air into the attic. The AHU for the other

**AHU in attic**

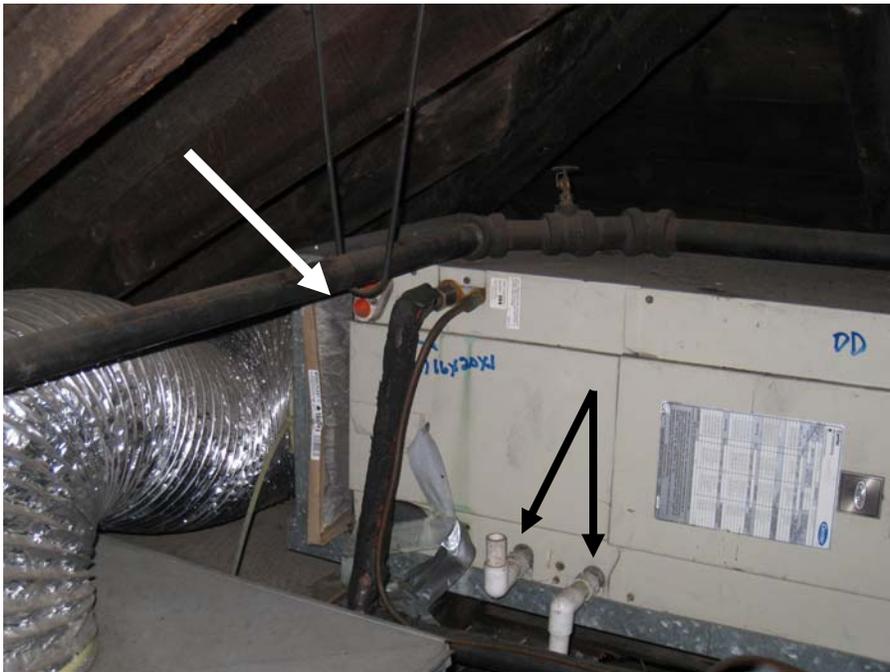
**Picture 4**

system had a missing filter access panel (Picture 4). Filters should be installed in a manner to prevent unfiltered air from being drawn into the system. Furthermore, condensate pipes did not appear to be appropriately fitted with drainage lines, and spaces were observed around them (Picture 4). These conditions can result in discharge of moisture into the environment, as well as entrainment of air (post-filtration) through breaches around pipes.

**AHU in attic, note missing filter access panel and condensation pipes**

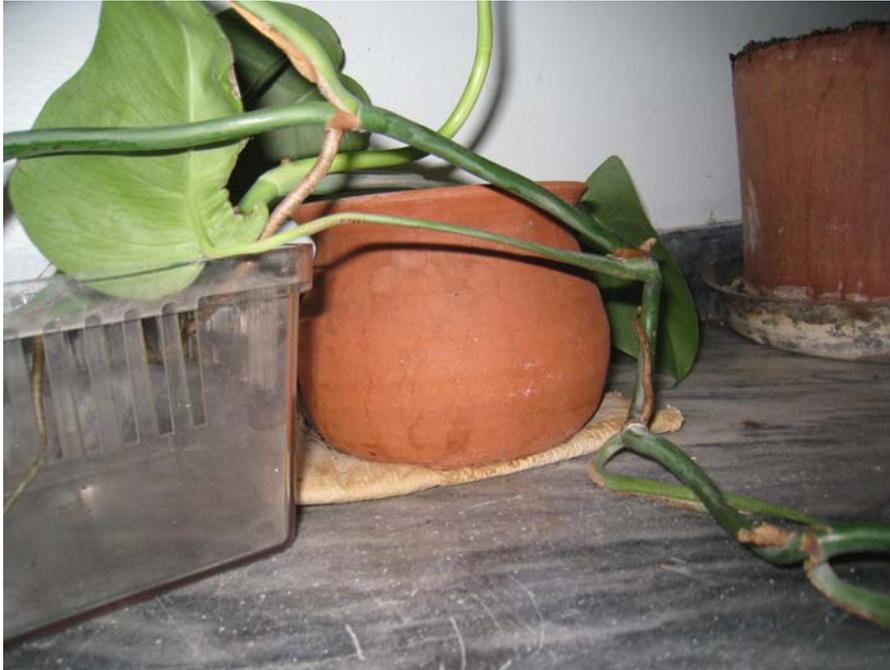
**Picture 5**

Plants were observed in several areas, some placed on porous materials (i.e., paper products). Plants, soil and drip pans can serve as sources of mold/bacterial growth. Plants should be properly maintained, over-watering of plants should be avoided and drip pans should be inspected periodically for mold growth (Pictures 5 and 6). Plants in one area were located on top of carpeting (Table 1). Carpeting is a porous material that can provide a medium for mold growth, especially if wetted repeatedly.

**Plant on water-stained paper towel**

9. Avoid overwatering of plants. Ensure flat surfaces around plants are free of potting soil and other plant debris. Examine drip pans periodically for mold growth and disinfect with an appropriate antimicrobial where necessary. Do not place plants on porous materials (e.g., paper/cardboard, carpeting). Consider reducing number of plants in some areas.

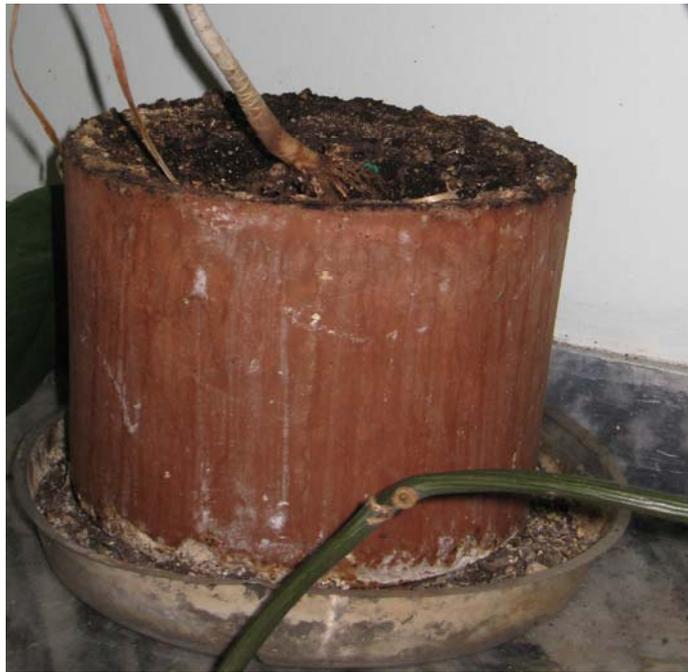
**Picture 6**

**Plant with mold growth in drip pan**

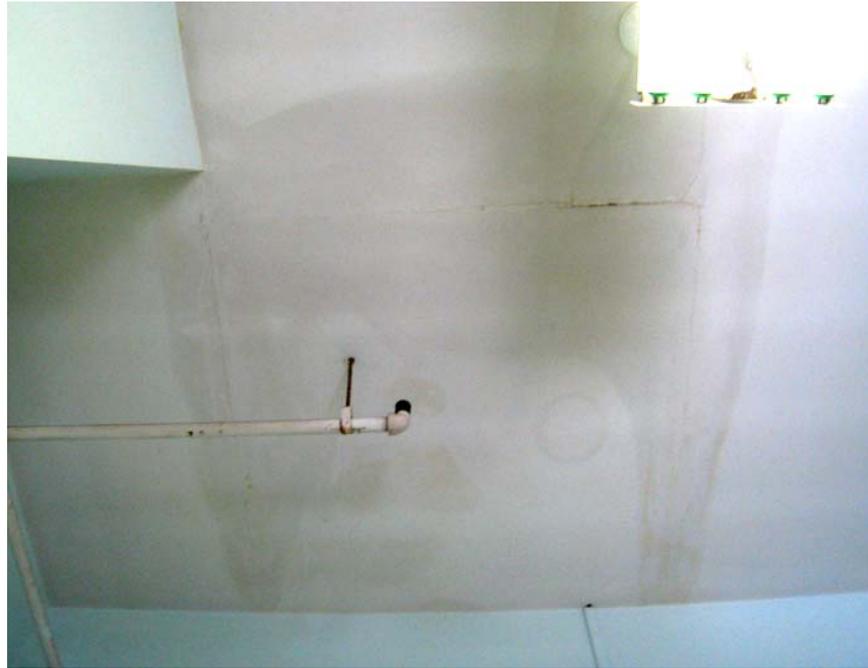
**Picture 7**

Although no current leaks were reported by building staff, evidence of historic water damage has resulted in peeling paint, efflorescence and water-damaged wall/ceiling plaster in a few areas (Pictures 7 and 8/Table 1). Efflorescence is a characteristic sign of water-damage to brick and mortar, but it is not mold growth. As moisture penetrates and works its way through mortar, brick or plaster, water-soluble compounds dissolve, creating a solution. As the solution moves to the surface of the material, the water evaporates, leaving behind white, powdery mineral deposits.

**Water-stained ceiling plaster in room 22**

5. Ensure leaks are repaired; clean efflorescence, loose paint and plaster debris using a vacuum with a brush attachment. Once repairs are completed, water-damaged plaster ceilings and walls should be prepped and refinished.

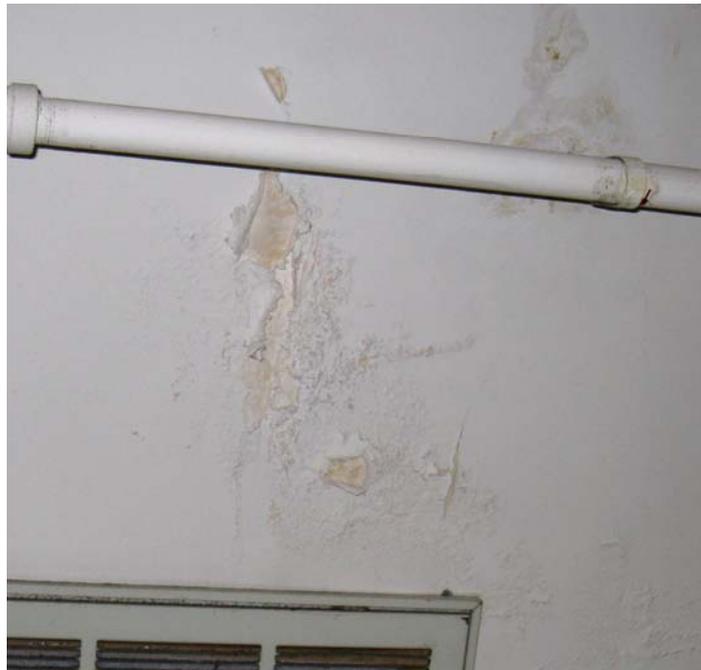
**Picture 8**

**Peeling paint/efflorescence on wall plaster**

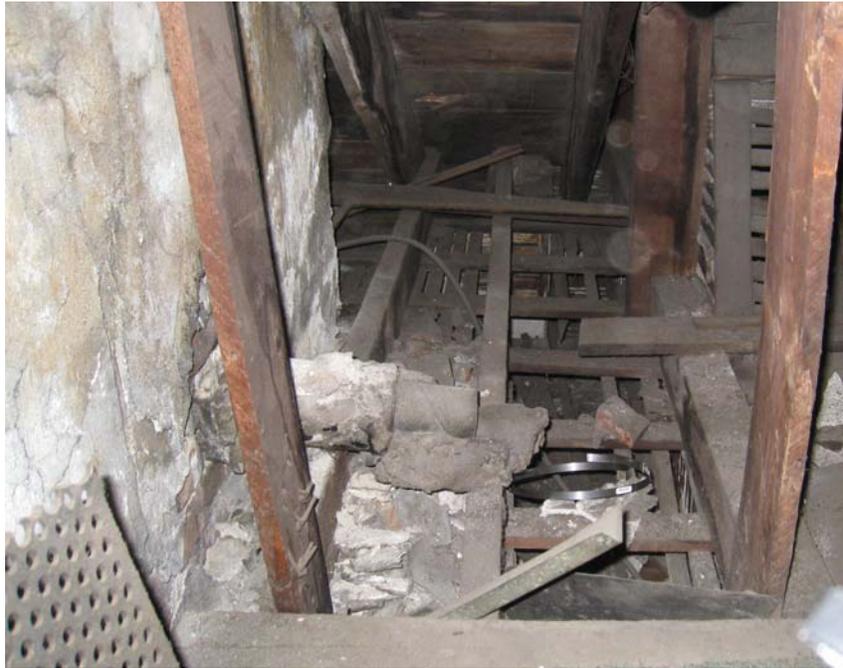
**Picture 9**

Other conditions that can affect indoor air quality were observed during the assessment. Damaged insulation material was observed in the attic on pipes and covering the chimney (Pictures 9 through 11). This material may contain asbestos. Intact asbestos-containing materials (ACM) do not pose a health hazard. If damaged, however, ACM can be rendered friable and become aerosolized. Friable asbestos is a chronic (long-term) health hazard, but will not produce acute (short-term) health effects (e.g., headaches) typically associated with buildings believed to have indoor air quality problems. If ACM are damaged, the materials should be removed or remediated in a manner consistent with Massachusetts asbestos remediation laws (MDLI, 1993). AHUs in the attic should be thoroughly inspected to ensure these materials have not been entrained into the systems. In addition, consideration should be given to thoroughly cleaning the ductwork for these systems.

**Damaged insulation material around pipe near chimney in attic**

1. Contact a licensed asbestos remediation firm to determine if damaged insulation and chimney covering in attic contains ACM. Remediate damaged ACMs in conformance with Massachusetts asbestos remediation and hazardous waste disposal laws and regulations.

2. If the presence of ACM is confirmed, AHUs in the attic and associated ductwork should be thoroughly inspected by a licensed asbestos remediation firm and/or HVAC engineering firm to ensure these materials have not been entrained into the systems.

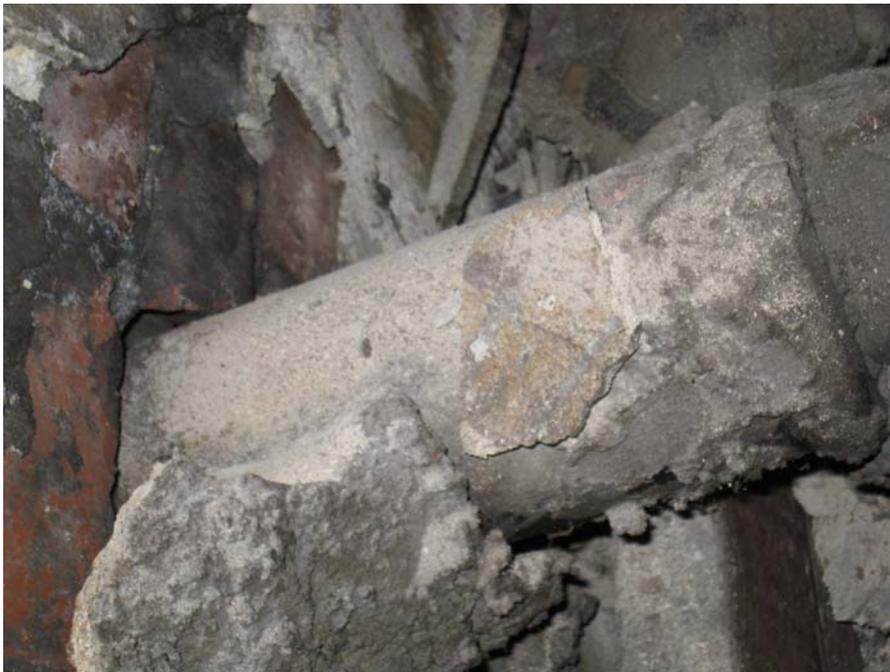
**Picture 10**

**Close-up of damaged insulation material around pipe near chimney in attic**

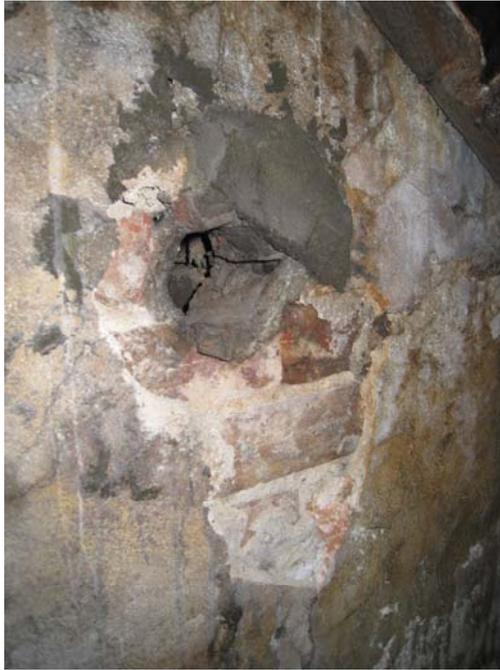
**Picture 11**

Also noted was a hole in the chimney, (Picture 11). It was not clear whether this chimney is actively being used to remove boiler exhaust from the building. Breaches compromise the ability of the system to properly remove exhaust/boiler emissions and may allow carbon monoxide and other combustion products to infiltrate occupied spaces. The function of the chimney should be confirmed, and if active, the hole should be repaired and the remainder of the chimney should be inspected for structural integrity.

**Hole and damaged material covering chimney in attic**

3. Contact licensed plumber or HVAC engineer and/or masonry firm to conduct a thorough inspection of the structural integrity of the chimneys to ensure proper removal of exhaust emissions (if active). Make repairs as needed.
