INDOOR AIR QUALITY ASSESSMENT

**Southworth Library
732 Dartmouth Street
South Dartmouth, Massachusetts**

Prepared by:
Massachusetts Department of Public Health
Bureau of Environmental Health
Indoor Air Quality Program
December 2010

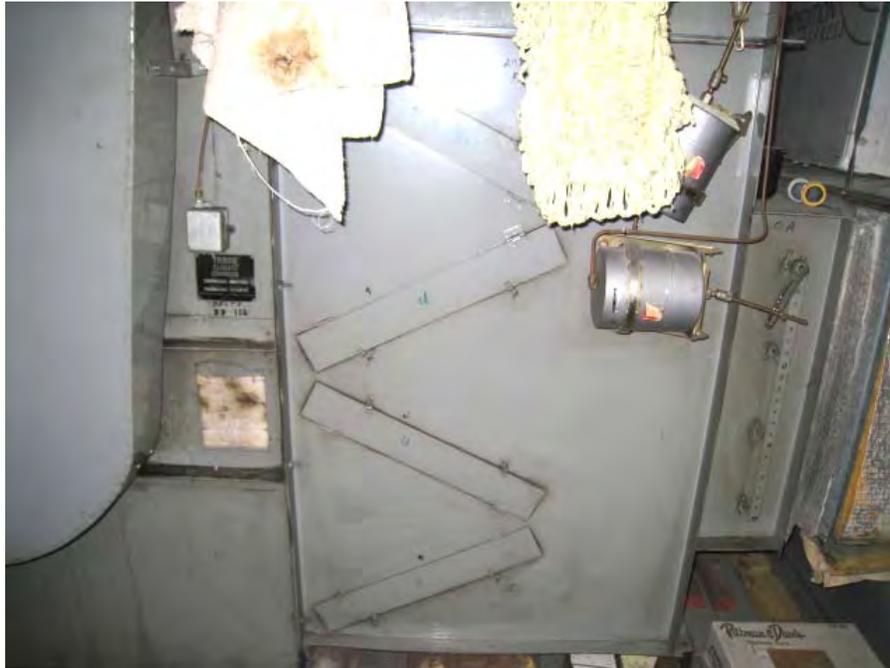
Picture 1

The HVAC system consists of a large air handling unit (AHU) located in the basement (Picture 1). Heated/cooled air is distributed to occupied areas via ducted supply diffusers (Picture 2). Air is returned back to the AHUs via ceiling or wall-mounted return vents (Pictures 3 and 4). It was reported that significant efforts were made to repair the HVAC system over the summer; however it is original to the building making it nearly 40 years old. Equipment of this age can be difficult to maintain because replacement parts are often unavailable. At the time of

Air Handling Unit Located in Basement

1. Continue with plans to conduct a full HVAC engineering/ventilation systems assessment, particularly the efficiency of AC components during the cooling season. Based on the age, physical deterioration and likely lack of availability of parts for ventilation components, such an evaluation is necessary to determine the operability and feasibility of repairing the equipment.

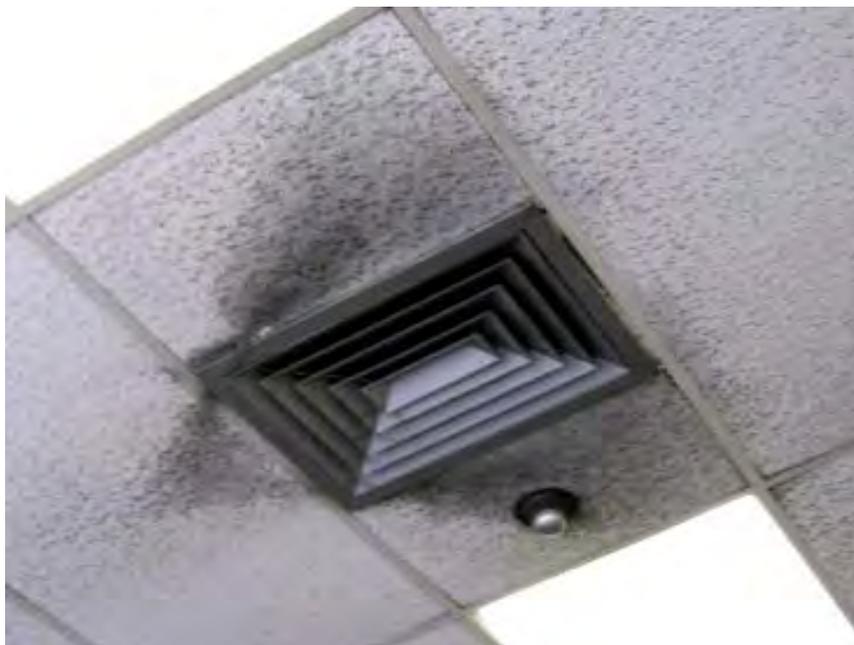
Picture 2

Other conditions that can affect indoor air quality were observed during the assessment. A number of air diffusers/surrounding ceiling tiles, exhaust and return vents were observed to have accumulated dust/debris (Pictures 2, 9 and 10). If exhaust/return vents are not functioning, backdrafting can occur, which can re-aerosolize accumulated dust particles. Re-activated supply vents can also aerosolize dust accumulated on vents louvers.

Ceiling-Mounted Supply Diffuser, Note Dust/Debris Accumulation on Vent and Surrounding Ceiling Tiles

8. Clean and maintain dehumidifiers as per manufacturer's instructions.
9. Clean accumulated dust and debris periodically from the surface of air diffusers, exhaust/return vents and surrounding ceiling tiles. If soiled ceiling tiles cannot be cleaned, replace.

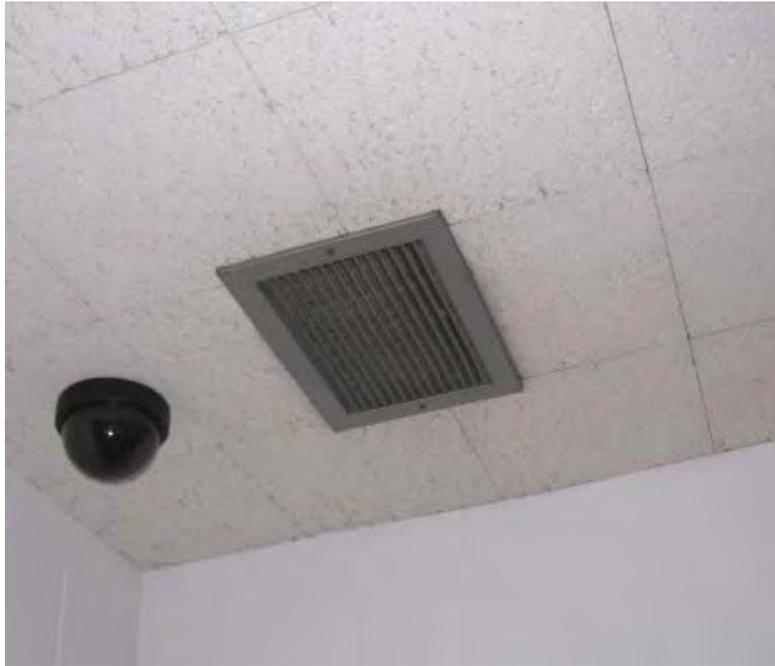
Picture 3

Ceiling-Mounted Return Vent

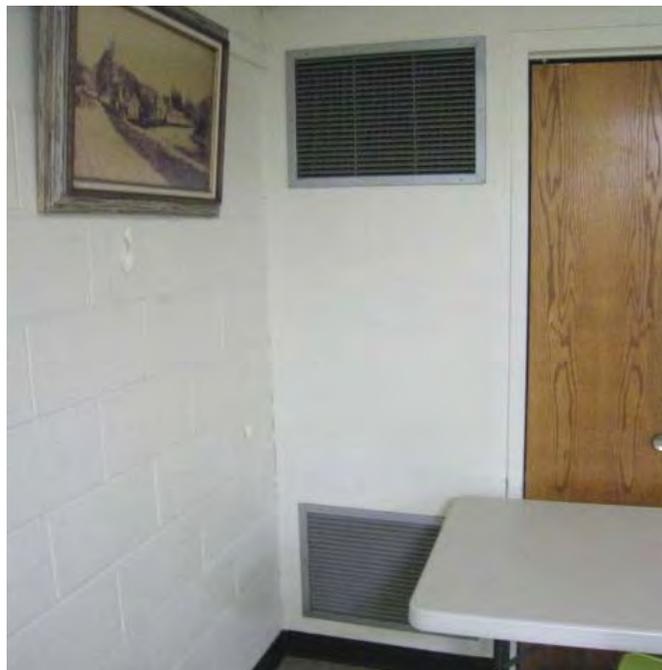
Picture 4

Wall-Mounted Supply and Return Vent (Bottom) in Auditorium

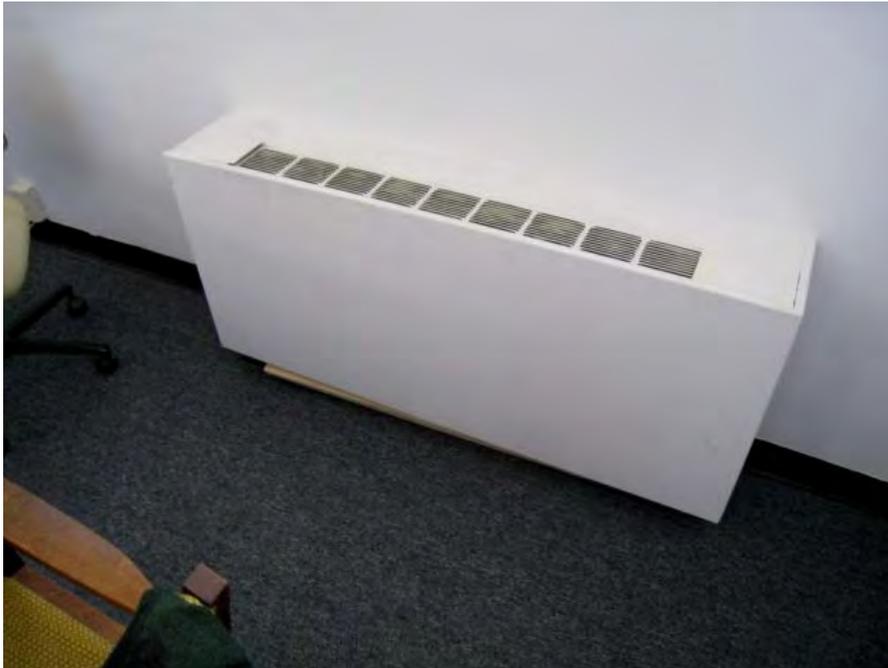
Picture 5

Fan coil units (FCUs) along exterior walls facilitate airflow and temperature control (Picture 5). FCUs do not provide fresh air to rooms; rather, FCUs re-circulate air and provide auxiliary heating and cooling. Each FCU is controlled by a switch with settings for “low”, “high” and “off”. Air is drawn into a return vent at the base of the unit. It is then conditioned, filtered and provided to the room via a diffuser atop the unit ([Figure 1](#)).

Fan Coil Unit

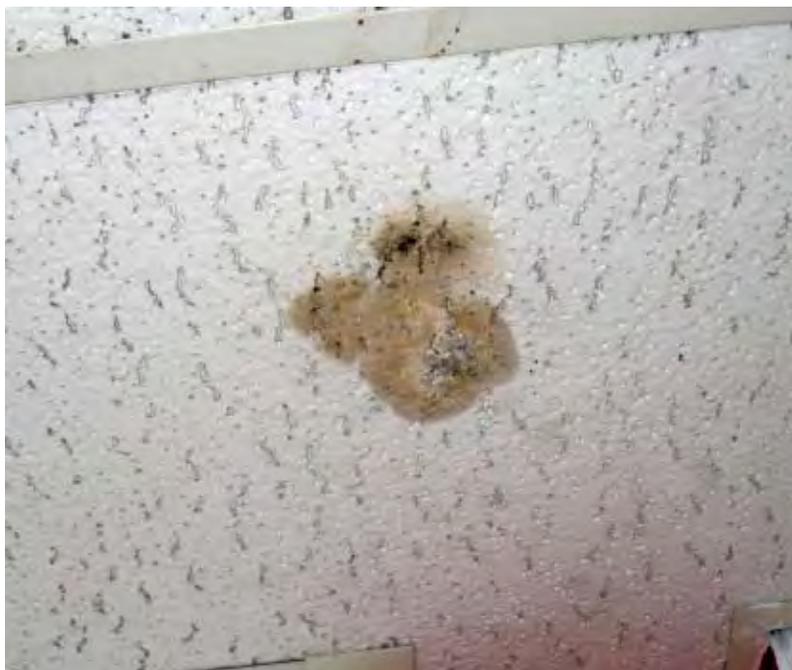
Picture 6

A water-damaged ceiling tile was observed in the children's library that appeared to be colonized by mold (Picture 6). BEH staff recommended that the damaged/mold colonized tile be removed. The source of moisture appeared to be a leaking pipe above the ceiling tile. At the time of the assessment, the pipe was not leaking and wrapped with a water proof media (Picture 7). Water-damaged ceiling tiles can provide a source of mold and should be replaced after a water leak is discovered and repaired.

Water-Damaged/Mold Colonized Ceiling Tile in Children's Library

6. Ensure leaking pipe above damaged ceiling tile in children's library is repaired. Replace water-damaged/mold-colonized ceiling tile below pipe.
7. Seal spaces between sink countertop and backsplash in staff lounge.

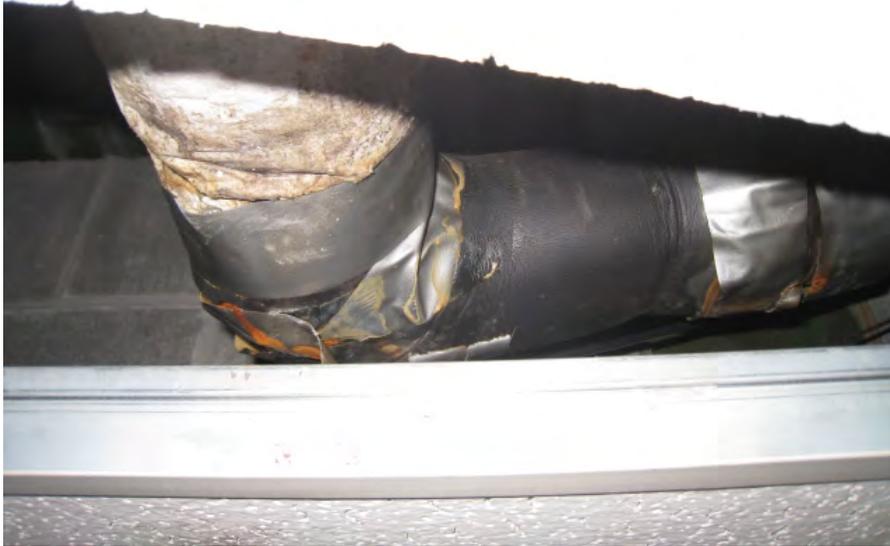
Picture 7

Wrapped Pipe Located above Water-Damaged Ceiling Tile in Preceding Picture

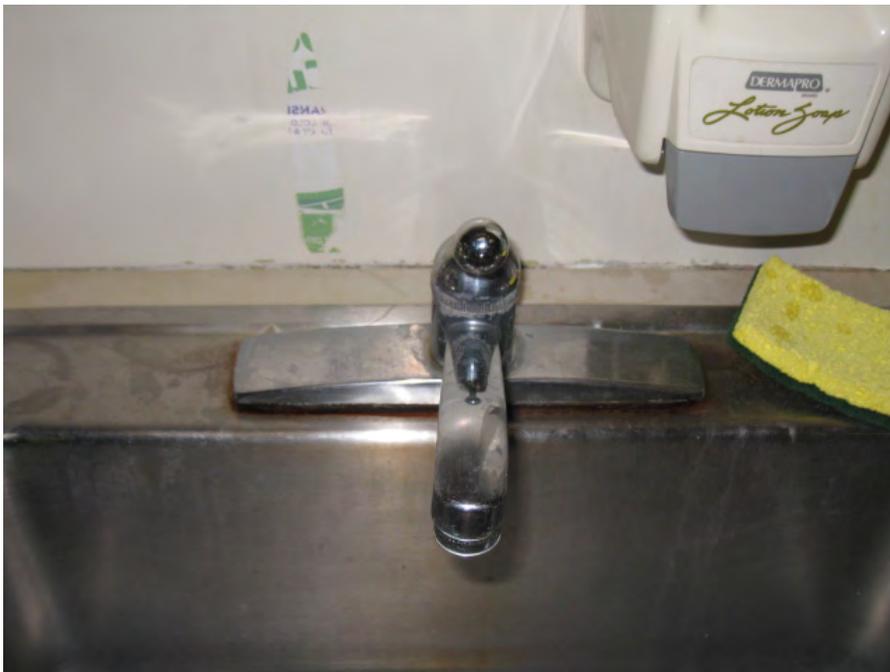
Picture 8

An open seam between the sink countertop and wall was observed in the staff lounge (Picture 8). Improper drainage or sink overflow can lead to water penetration into the countertop, cabinet interior and areas behind cabinets. If not watertight, moisture can penetrate through the seam, causing water damage and potential mold growth.

Space between Sink Countertop and Backsplash in Staff Lounge

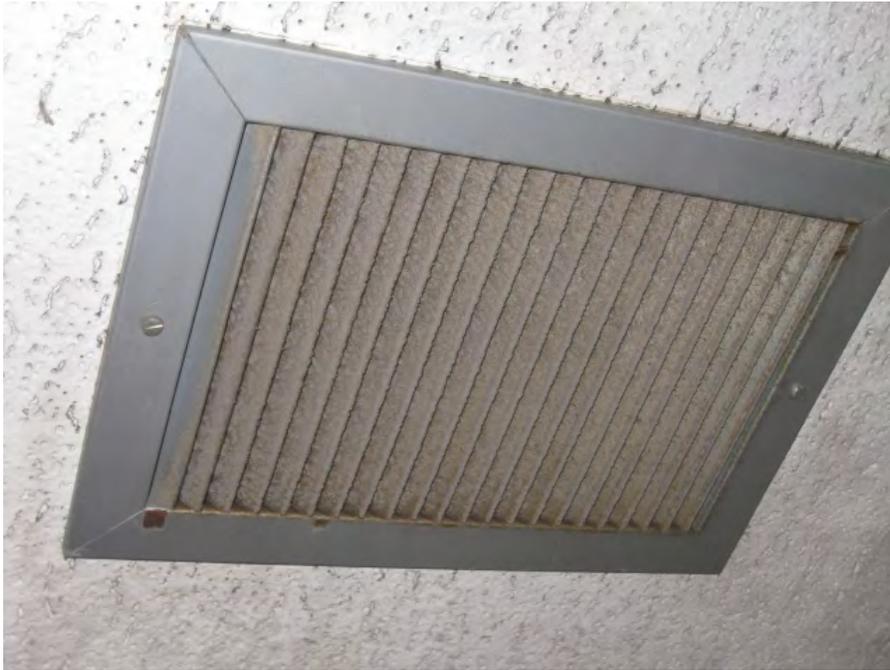
Picture 9

Exhaust Vent with Accumulated Dust/Debris

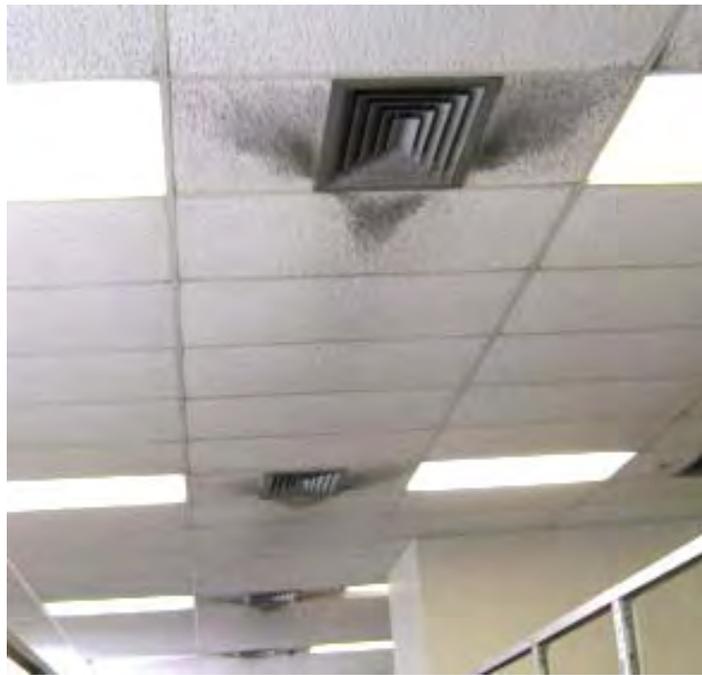
Picture 10

Accumulated Dust/Debris on Supply Diffusers and Surrounding Ceiling Tiles

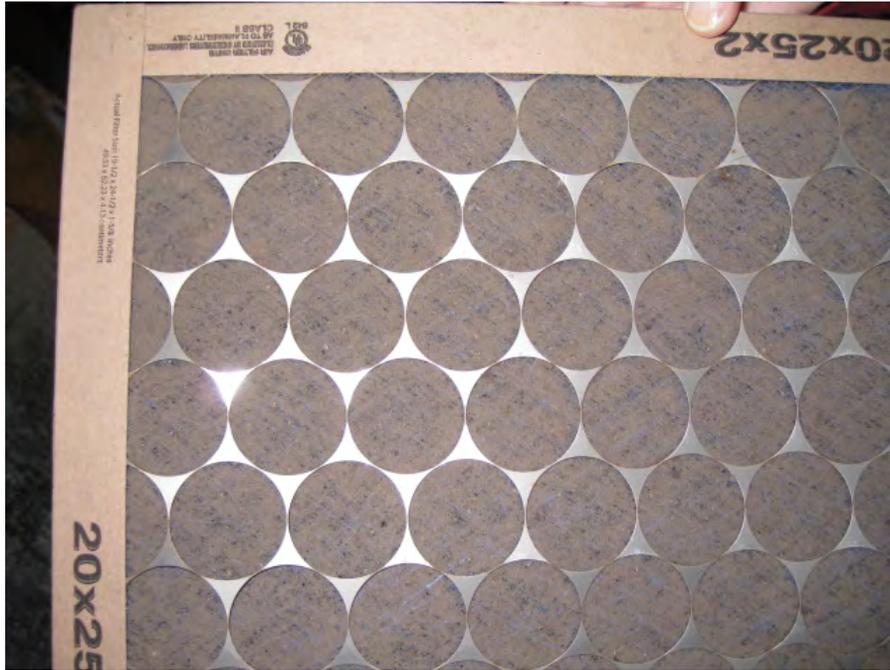
Picture 11

BEH staff inspected filters for AHUs and FCUs; they were found occluded with dust/debris and appeared not to have been changed for some time (Pictures 11 and 12). Debris-saturated filters can obstruct airflow and may serve as a reservoir of particulates that can be re-aerosolized and distributed to occupied areas via the ventilation system. In addition, the type of filters installed in AHUs and FCUs provide minimal filtration of respirable dusts. In order to decrease aerosolized particulates, disposable filters with an increased dust spot efficiency can be installed. The dust spot efficiency is the ability of a filter to remove particulates of a certain diameter from air passing through the filter. Filters that have been determined by ASHRAE to meet its standard for a dust spot efficiency of a minimum of 40 percent (Minimum Efficiency Reporting Value equal to 9) would be sufficient to reduce many airborne particulates (Thornburg, D., 2000; MEHRC, 1997; ASHRAE, 1992). Note that increasing filtration can reduce airflow (called pressure drop), which can subsequently reduce efficiency due to increased resistance. Prior to any increase of filtration, each piece of air handling equipment should be

Debris Saturated Filter for AHU

2. Change filters for air-handling equipment (e.g., AHUs, and FCU) as per the manufacturers' instructions or more frequently if needed. Vacuum interior of units prior to activation to prevent the aerosolization of dirt, dust and particulate matter. Ensure filters fit flush in their racks with no spaces in between allowing bypass of unfiltered air into the unit.

3. Consider upgrading the AHU and FCU filters to pleated MERV 9 (or higher) dust-spot efficiency. Prior to any increase of filtration, each unit should be evaluated by a ventilation engineer as to whether it can maintain function with more efficient filters.

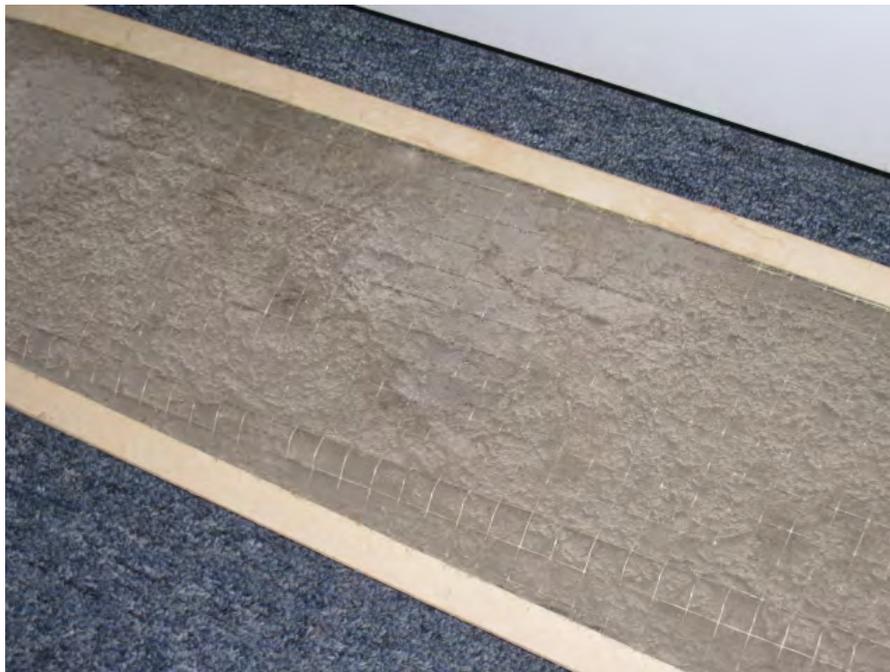
Picture 12

Debris Saturated Filter for FCU

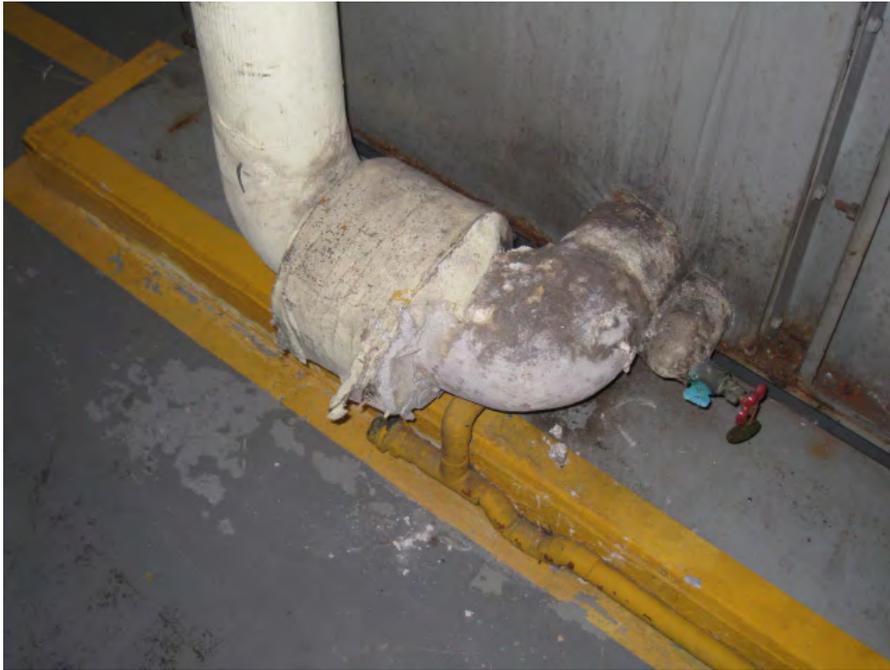
Picture 13

Finally, pipe insulation near the AHU in the boiler room was found damaged exposing a white chalky material that likely contains asbestos (Pictures 13 and 14). Upon discovery, BEH staff recommended that the insulation be inspected and remediated by a licensed member of the Dartmouth Maintenance Department or an asbestos abatement contractor. It subsequent correspondence with Ms. Henderson, it was reported that the material was remediated by a licensed asbestos abatement contractor.

Damaged Pipe Insulation in Boiler Room

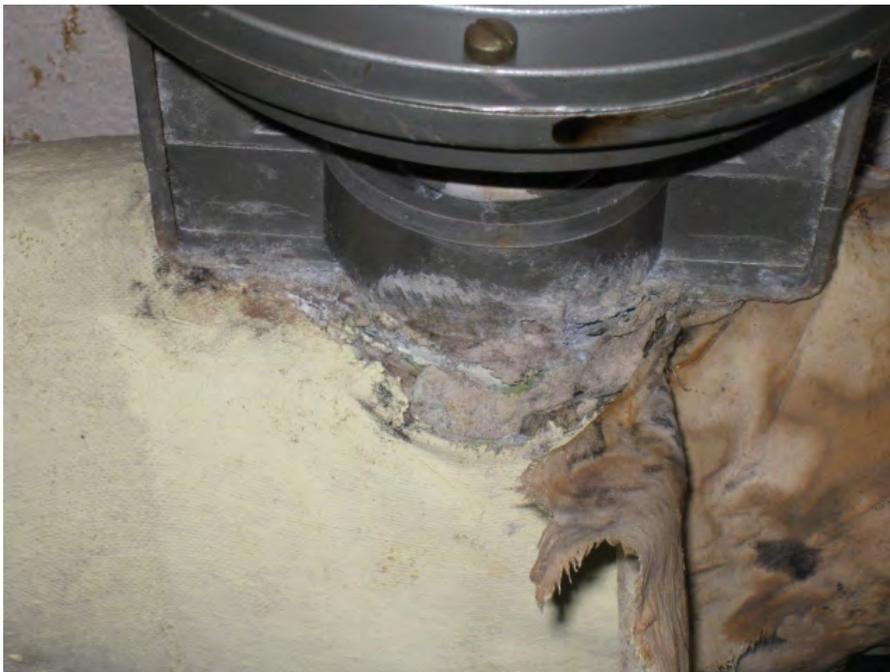
Picture 14

Damaged Pipe Insulation in Boiler Room
