INDOOR AIR QUALITY ASSESSMENT

**Elm Street School
160 Elm Street
Gardner, Massachusetts**

Prepared by:
Massachusetts Department of Public Health
Bureau of Environmental Health
Indoor Air Quality Program
June 2010

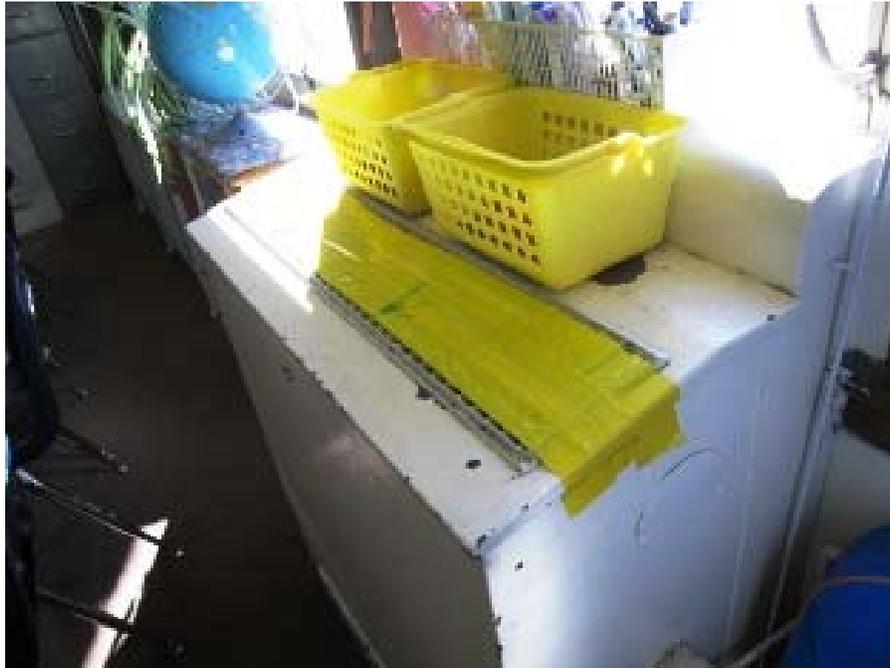
Picture 1

The heating/ventilation of classrooms in the original portion of the building were designed to use unit ventilators (univents) made by the Peerless Unit Ventilation Co., Inc. (Pictures 1 and 2). A univent draws air from the outdoors through a fresh air intake located on the exterior wall of the building and returns air through an air intake located at the base of the unit. Fresh and return air are mixed, filtered, heated and provided to classrooms through an air diffuser located in the top of the unit ([Figure 1](#)). At the present time, these 1920s vintage univents are not functioning as designed and many are disconnected. Therefore, the only means of introducing fresh air into the original building is via openable windows. Univents also provide mechanical ventilation to the majority of classrooms in the 1960s addition (Picture 3). These univents, though operational, are at least forty years old.

Efficient function of such aged equipment is difficult to maintain, since compatible replacement parts are often unavailable. According to the American Society of Heating, Refrigeration and Air-Conditioning Engineering (ASHRAE), the service life¹ for a unit heater, hot water or steam is 20 years, assuming routine maintenance of the equipment (ASHRAE, 1991). Despite attempts to maintain these univents, the operational lifespan of this equipment has been exceeded. Maintaining the balance of fresh air to exhaust air will be difficult with equipment of this vintage.

1920's Vintage Unit Ventilator in Disuse

2. Improve air exchange in classrooms. An increase in the percentage of fresh air supply and increased exhaust capabilities is recommended. Contact an HVAC engineering firm to evaluate the existing equipment in order to determine the best method of providing fresh air to the classroom and for removing stale classroom air.

1. Contact an HVAC engineering firm for an assessment of the building's mechanical ventilation systems (e.g., controls, air intake louvers, thermostats). Based on the age, physical deterioration and availability of parts for ventilation components, such an evaluation is necessary to determine the operability and feasibility of repairing/replacing the equipment.
2. Replace sections of roofing as necessary.

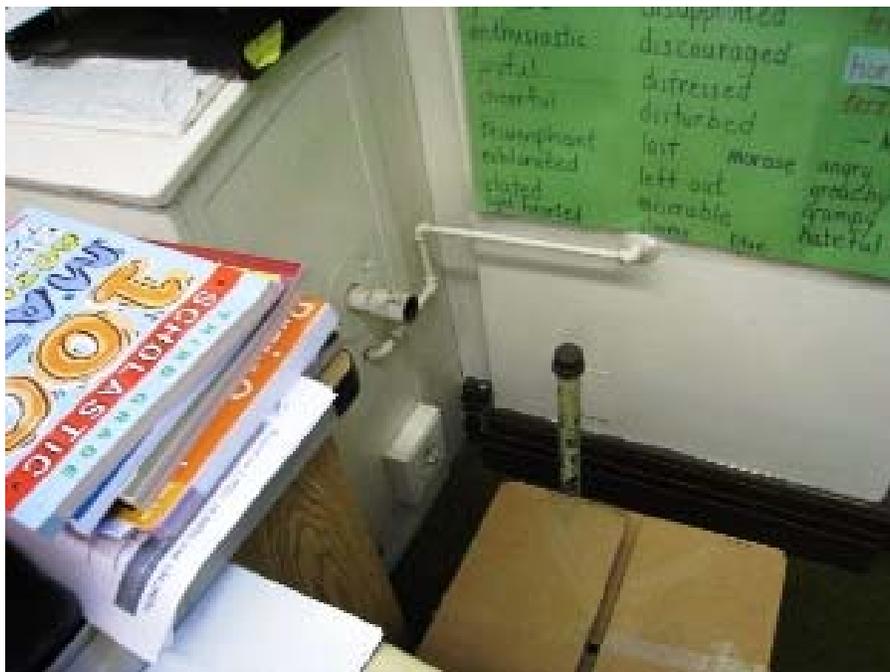
Picture 2

Disconnected 1920's Vintage Univent

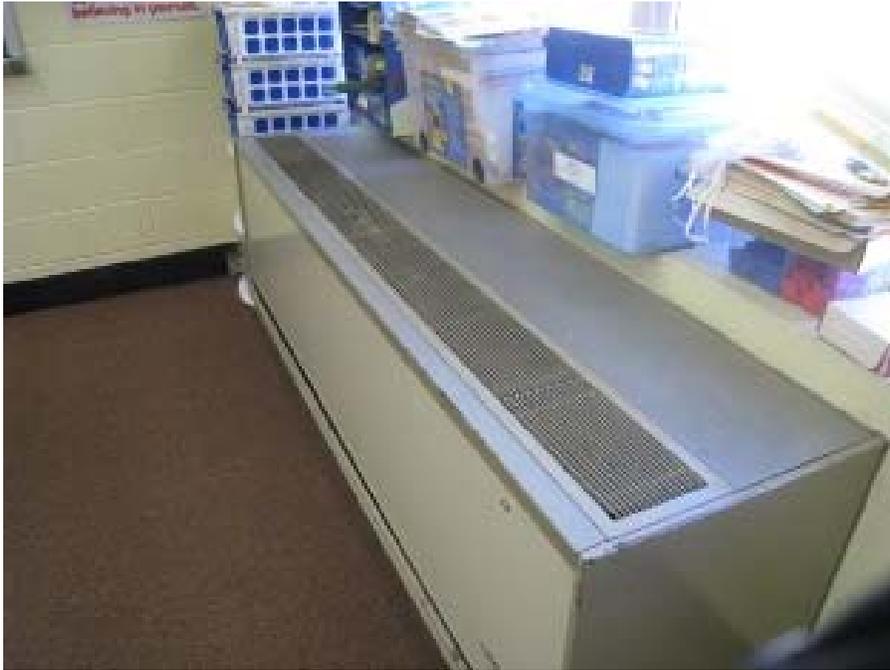
Picture 3

Unit Ventilator in Newer Addition

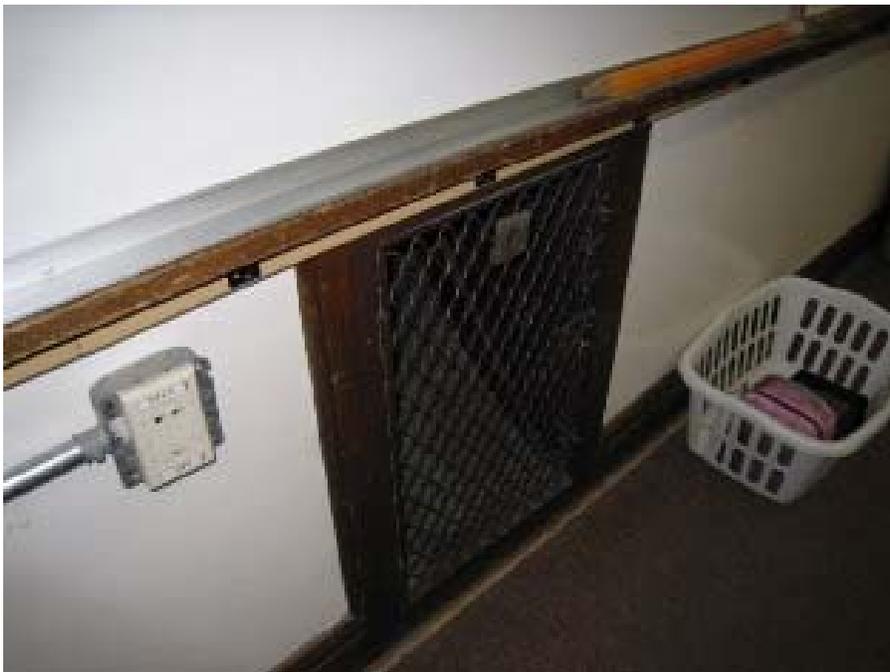
Picture 4

Stale air was originally designed to be exhausted from the building via mechanical means through wall mounted exhaust vents (Picture 4). It was reported to BEH that this exhaust system was disconnected in the 1960s. Once again, the only means at present to exhaust stale air is by means of openable windows.

Wall Mounted Exhaust Vent

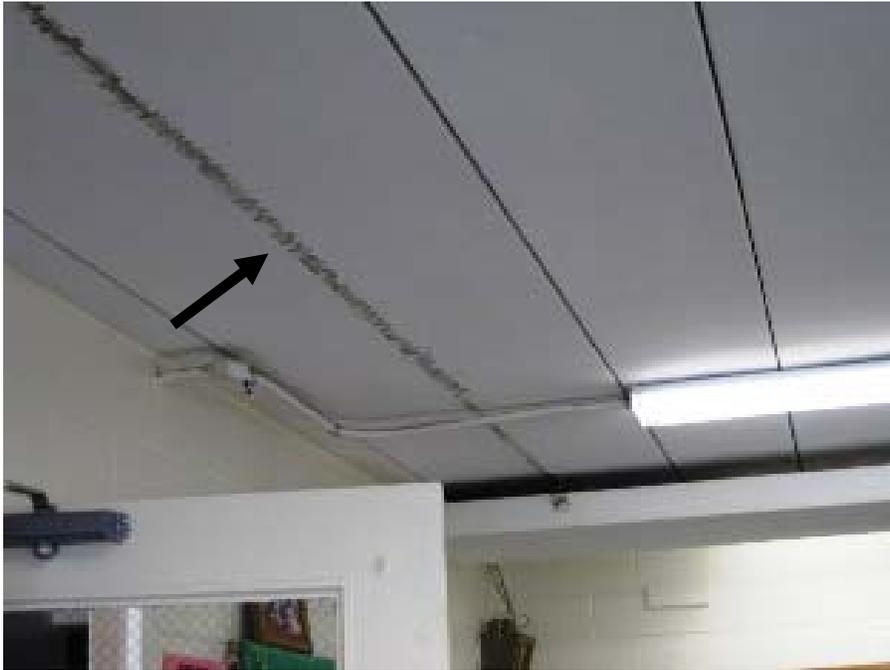
Picture 5

Water-damaged ceiling tiles and panels were observed in a number of areas, which indicate current/historic plumbing and/or roof leaks (Pictures 5 and 6). Water-damaged ceiling tiles can provide a source of mold and should be replaced after a water leak is discovered and repaired.

Stained Ceiling Panels

5. Repair any existing water leaks and replace any remaining water-damaged ceiling tiles. Examine the area above these tiles for mold growth. Disinfect areas of water leaks with an appropriate antimicrobial, as needed. Repair plaster as necessary.

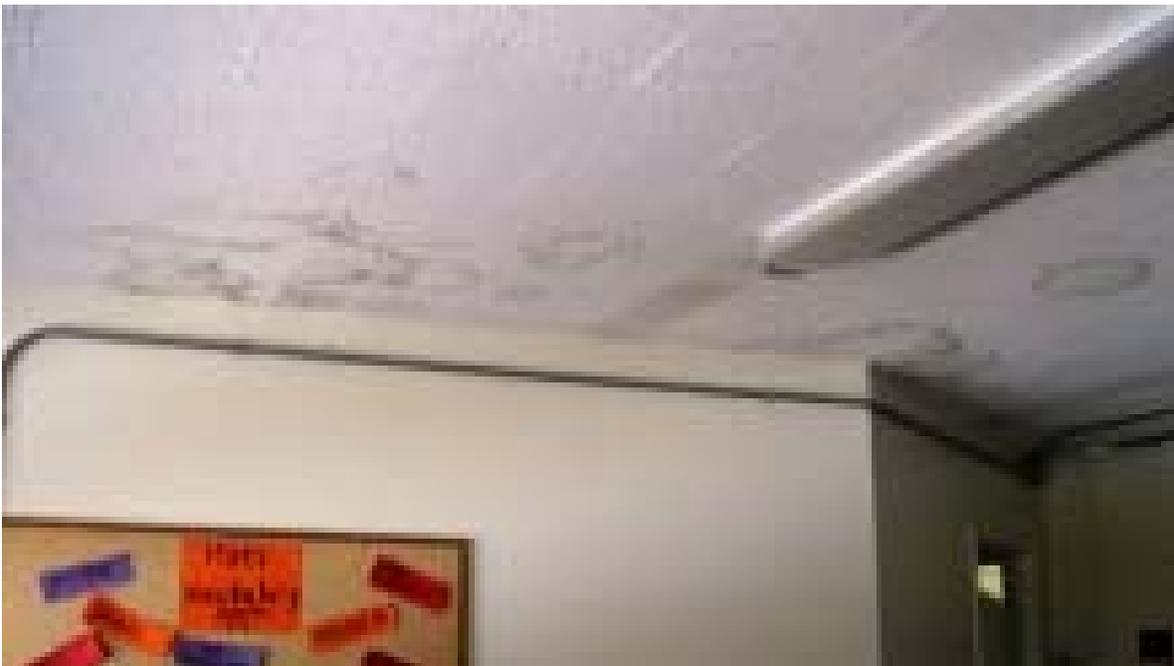
Picture 6

Water-Damaged Ceiling Tiles

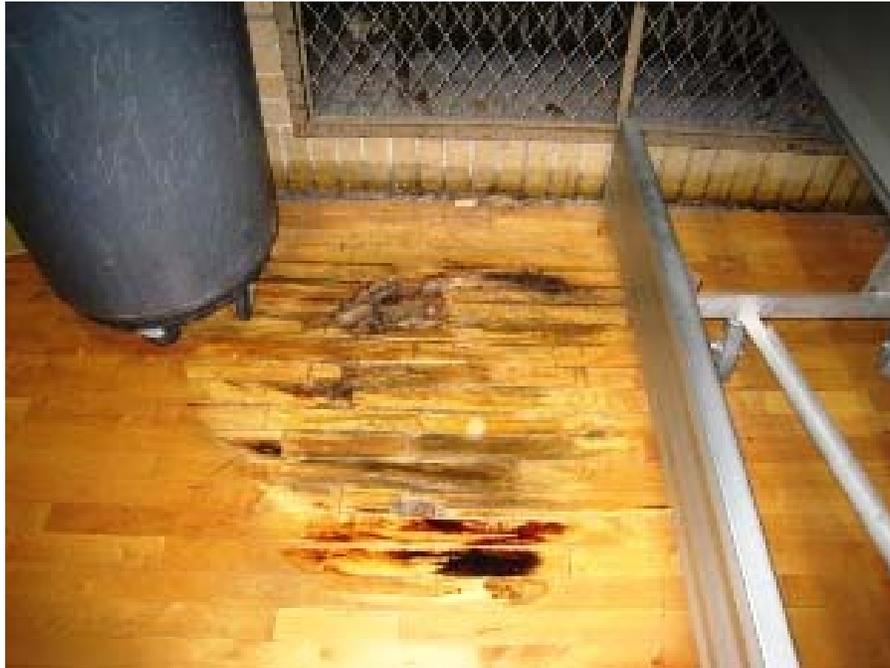
Picture 7

A section of the gymnasium floor was rotted due to a chronic roof leak around a drain line (Pictures 7 and 8). A section of the plumbing was missing below a hand sink in the janitor's closet, which likely caused water to leak onto the floor (Picture 9). Window sills in at least one classroom (Room 101) exhibited water damage (Picture 10).

Water-Damaged Floor of Gymnasium

6. Repair gymnasium floor.
7. Contact a plumber to repair drain line below hand sink in janitor's closet.
8. Investigate and remediate source of water-damaged windowsills.

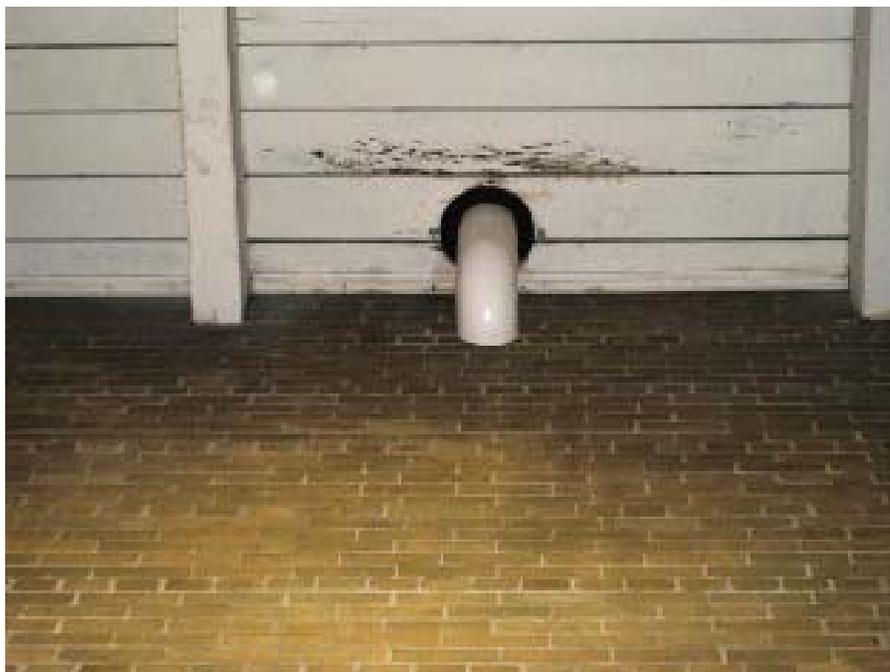
Picture 8

Drain Line Above Gymnasium Floor

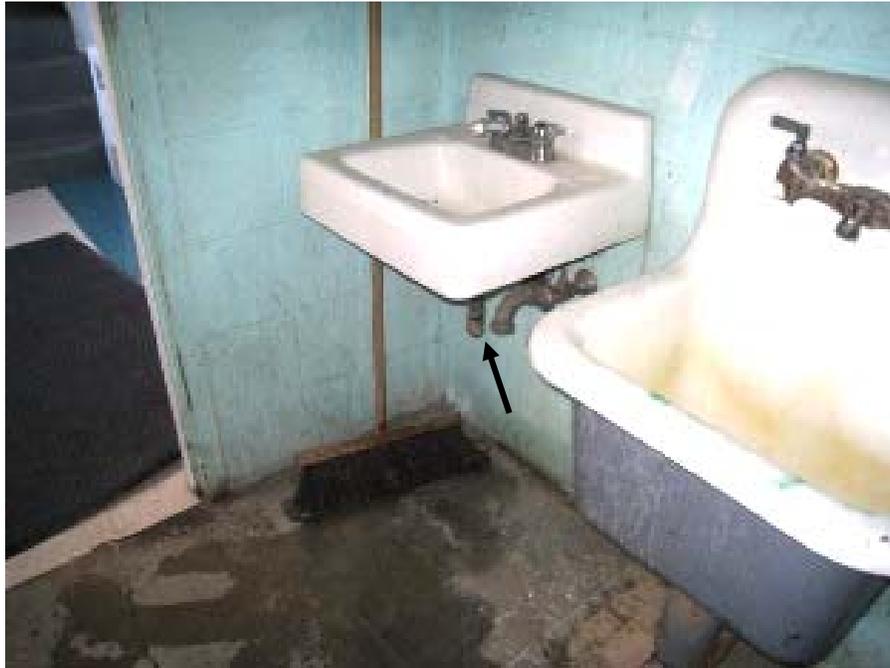
Picture 9

**Hand Sink in Janitorial Closet Lacking Portion of Drain Line
Note Water on Floor**

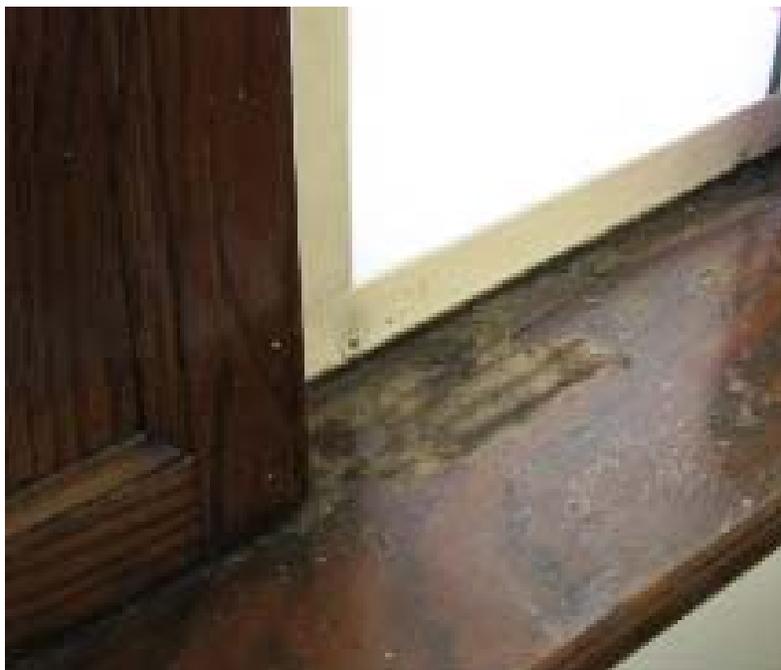
Picture 10

Water-Damaged Window Sill

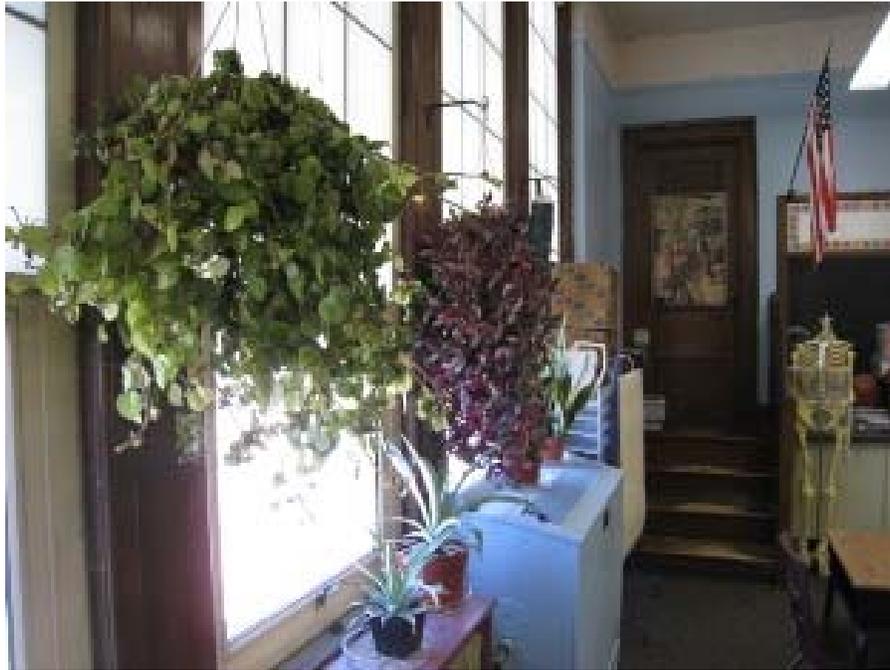
Picture 11

Plants were noted in several classrooms (Picture 11). Plants can be a source of pollen and mold which can be respiratory irritants to some individuals. Plants should be properly maintained and equipped with drip pans and should be located away from univents to prevent the aerosolization of dirt, pollen and mold.

Numerous Plants in Classroom

9. Ensure plants are equipped with drip pans. Examine drip pans periodically for mold growth and disinfect with an appropriate antimicrobial, as needed.

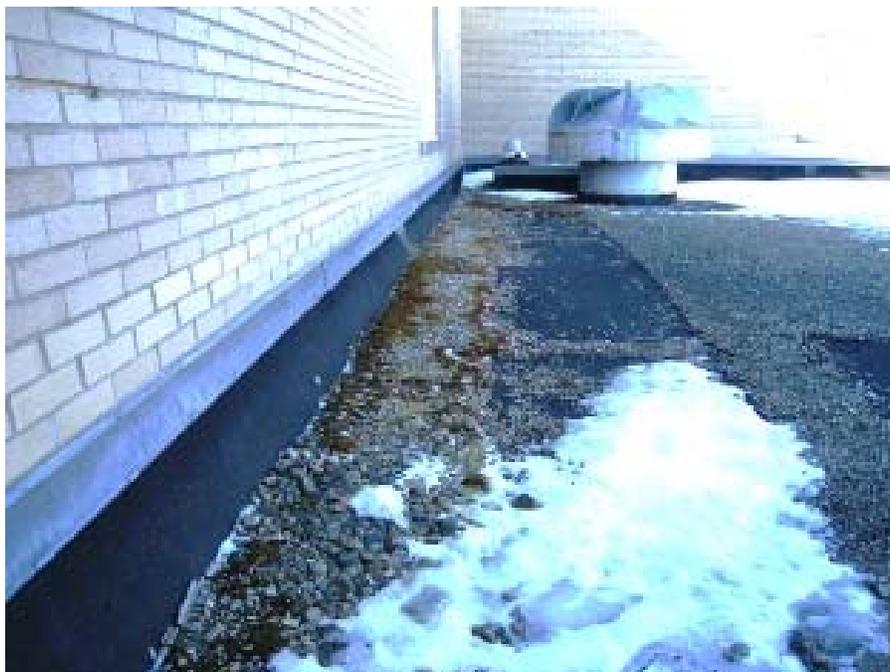
- Moss growth was observed on the roof (Picture 12). The presence of moss on the roof shown in Picture 12 is indicative of repeated water exposure. Moss is a sign of chronic dampness and can hold moisture against building components, which can subsequently accelerate its decomposition. “The two main requirements of a moss are sufficient moisture and accessible nutrients. For example, the moist environment of a rooftop shaded by trees seems just fine for mosses, [which] prefer to colonize shingles above the eaves, on detritus that builds up in the eaves’ troughs or other depressions. Mosses will be at their best in the winter when there is plenty of water, little light, and low temperatures” (OSU, 2000).
- Mortar was loose or missing in some locations (Picture 13).

Moss Growth on Roof

10. Routinely check roof drains to ensure water does not accumulate on the roof.
11. Repair loose and missing mortar.
12. Ensure plants on the exterior of the building do not come within 5 feet of the building.

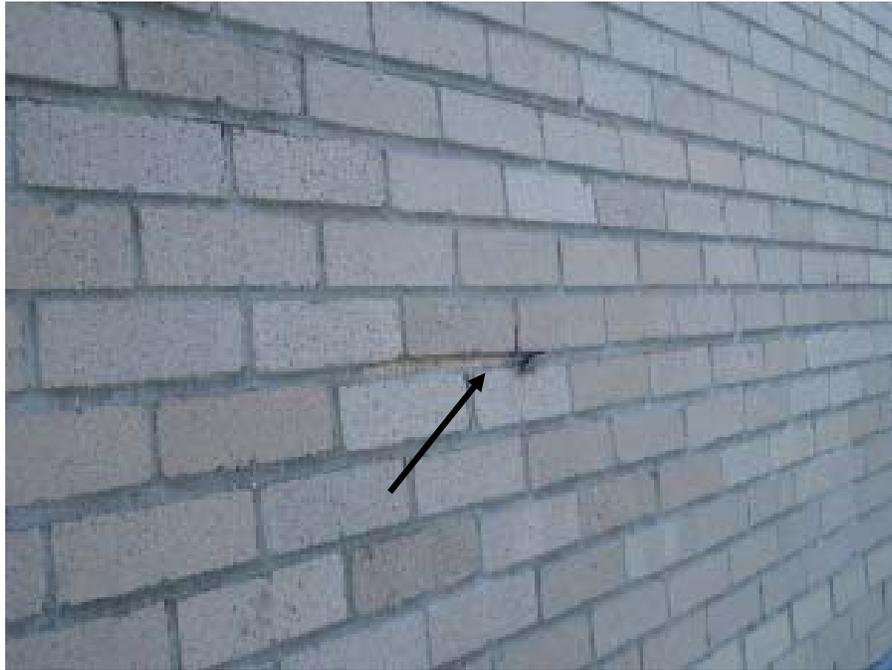
Picture 13

Missing Mortar

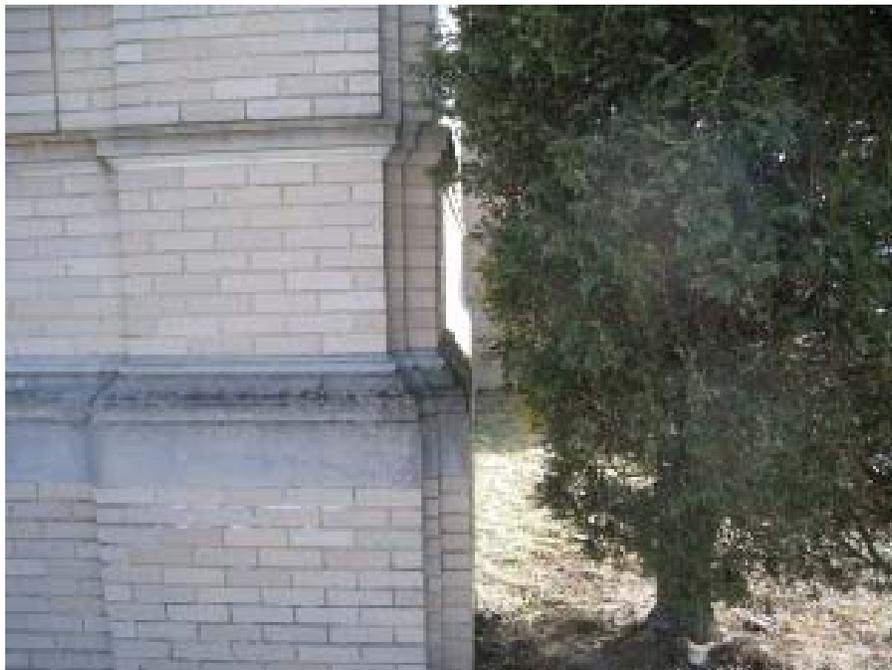
Picture 14

- Shrubs were located in close proximity to the building in some areas (Picture 14). The growth of roots against exterior walls can bring moisture in contact with the foundation. Plant roots can eventually penetrate, leading to cracks and/or fissures in the sublevel foundation.

Portion of Shrub Resting Against Exterior Wall

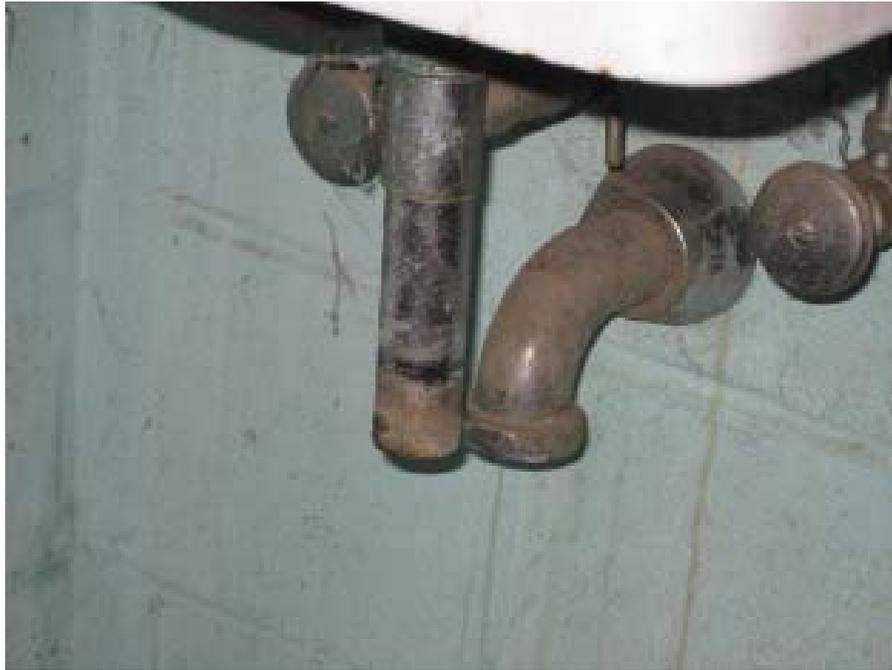
Picture 15

Other conditions that can affect indoor air quality were observed during the assessment. As previously reported, a hand sink in the janitor's closet lacked the trap portion of the drain line (Picture 15). Without a wet trap, the room was open to the drainage system. If a mechanical device (e.g., a fan) depressurizes the room, air, gas and odors can be drawn from the drainage system into the room. The effect of this phenomenon can be increased if heavy rains cause an air backup in the drainage system.

Missing Portion of Drain Line Allows Sewer Gas to Enter Janitorial Room

15. If hand sink and/or mop sink in janitor's closet are not often utilized, routinely pour water down drain to maintain seal in drain traps.
16. Evaluate bathroom exhaust fans and repair/replace as necessary.

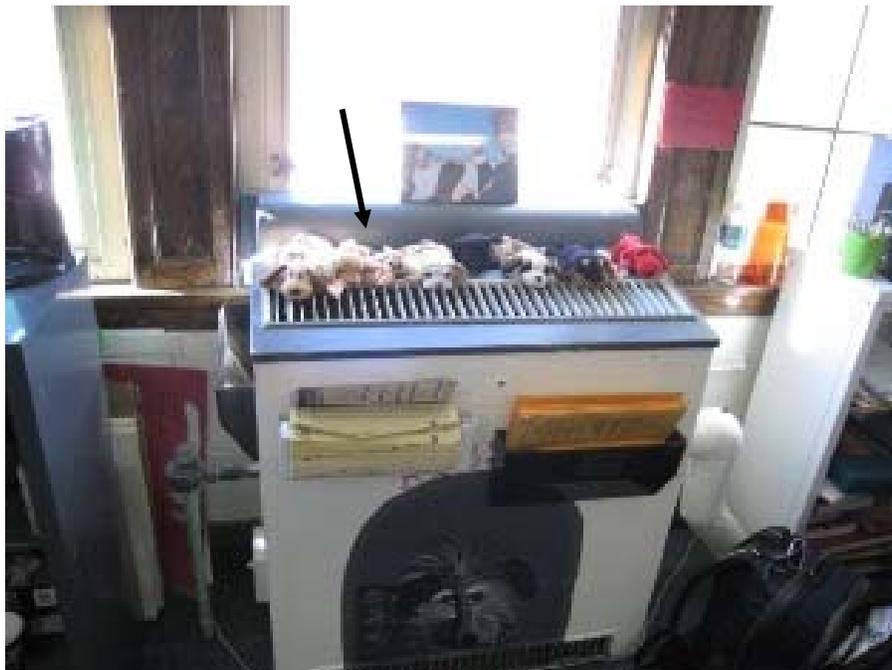
Picture 16

Stuffed toys and pillows were observed in the classroom (Picture 16). Stuffed pillows/toys can be a point source for dust collection. Stuffed toys used by an individual child should be washed on a weekly basis to prevent disease (Hale and Polder, 1996). Close contact with such items can leave oils, perspiration, hair and skin cells. Dust mites feed upon human skin cells and excrete waste products that contain allergens. Dust can be irritating to the eyes, nose and respiratory system. Dust accumulation was also noted on canvas window shades

Stuffed Toys in Classroom

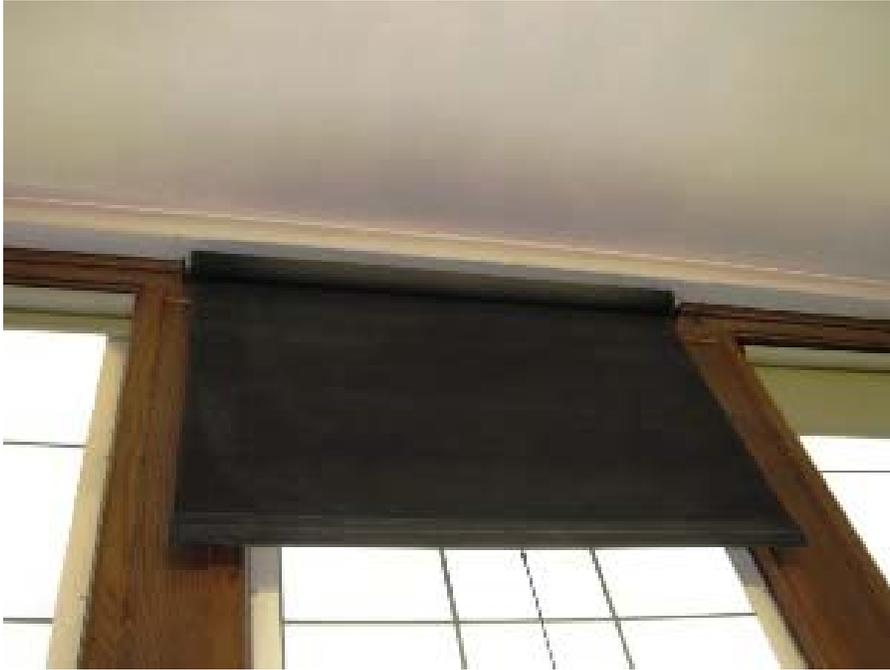
Picture 17

(Picture 17). These window shades reportedly were installed when the building was constructed in 1926. Disintegrating textiles can be a source of airborne particulates, which can be irritating to the eyes, nose and throat. In addition, dust accumulation was noted on the blades of the ceiling fan in the gym.

Dust Accumulation Visible on Canvas Window Shade

3. Consider developing a plan to systematically replace older carpets. Replace sub-level carpets with nonporous floor covering (e.g., tile).
4. Consider replacing old canvas window shades.
5. Consider providing dedicated exhaust for laminating machine.

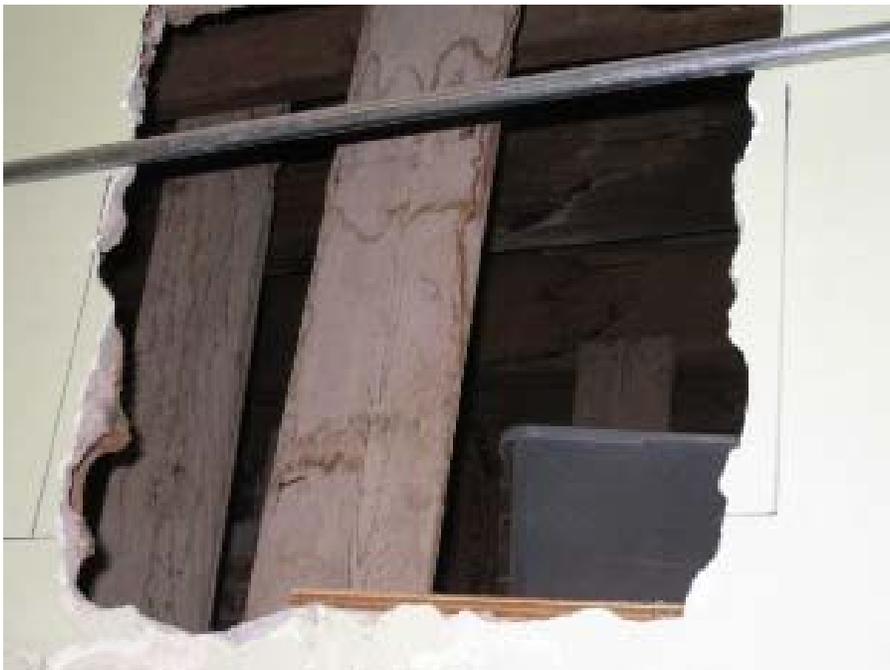
Picture 18

Open utility holes and large penetrations were noted in some areas (Picture 18). Open utility holes can provide a means of egress for odors, fumes, dusts and vapors between rooms and floors.

Open Penetration into the Framing of the Building

19. Seal spaces around utility holes and breaches in walls/floors and ceilings with an appropriate fire rated sealant. Repair larger penetrations into the framing.

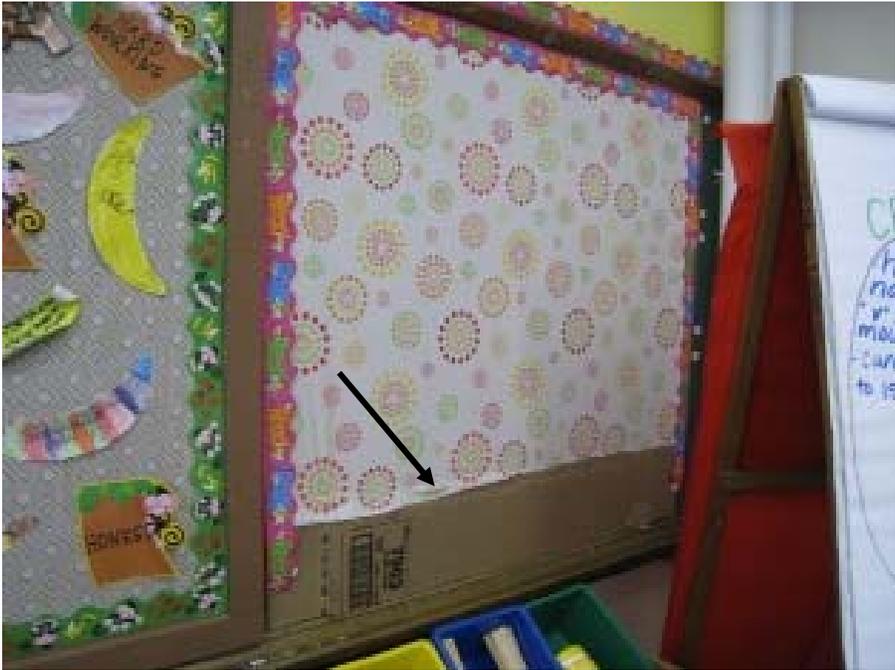
Picture 19

One classroom (Room 101) exhibited a slight musty odor upon entering. In addition to the water-damaged window sills previously mentioned, this room contained a number of older books, which had a musty odor. Books can absorb moisture and emit odors. In this room, (and perhaps in others as well) cardboard is being placed on top of old chalkboards and is being used as a bulletin board (Picture 19). Cardboard, like paper, can absorb moisture and odors. Although no visible mold colonization was observed on the exposed cardboard, it may be prudent to remove it from the classroom.

Cardboard Placed on Chalkboard
