INDOOR AIR QUALITY FOLLOW-UP ASSESSMENT

**Georgetown Middle/High School
11 Winter Street
Georgetown, MA**

Prepared by:
Massachusetts Department of Public Health
Bureau of Environmental Health
Indoor Air Quality Program
July 2010

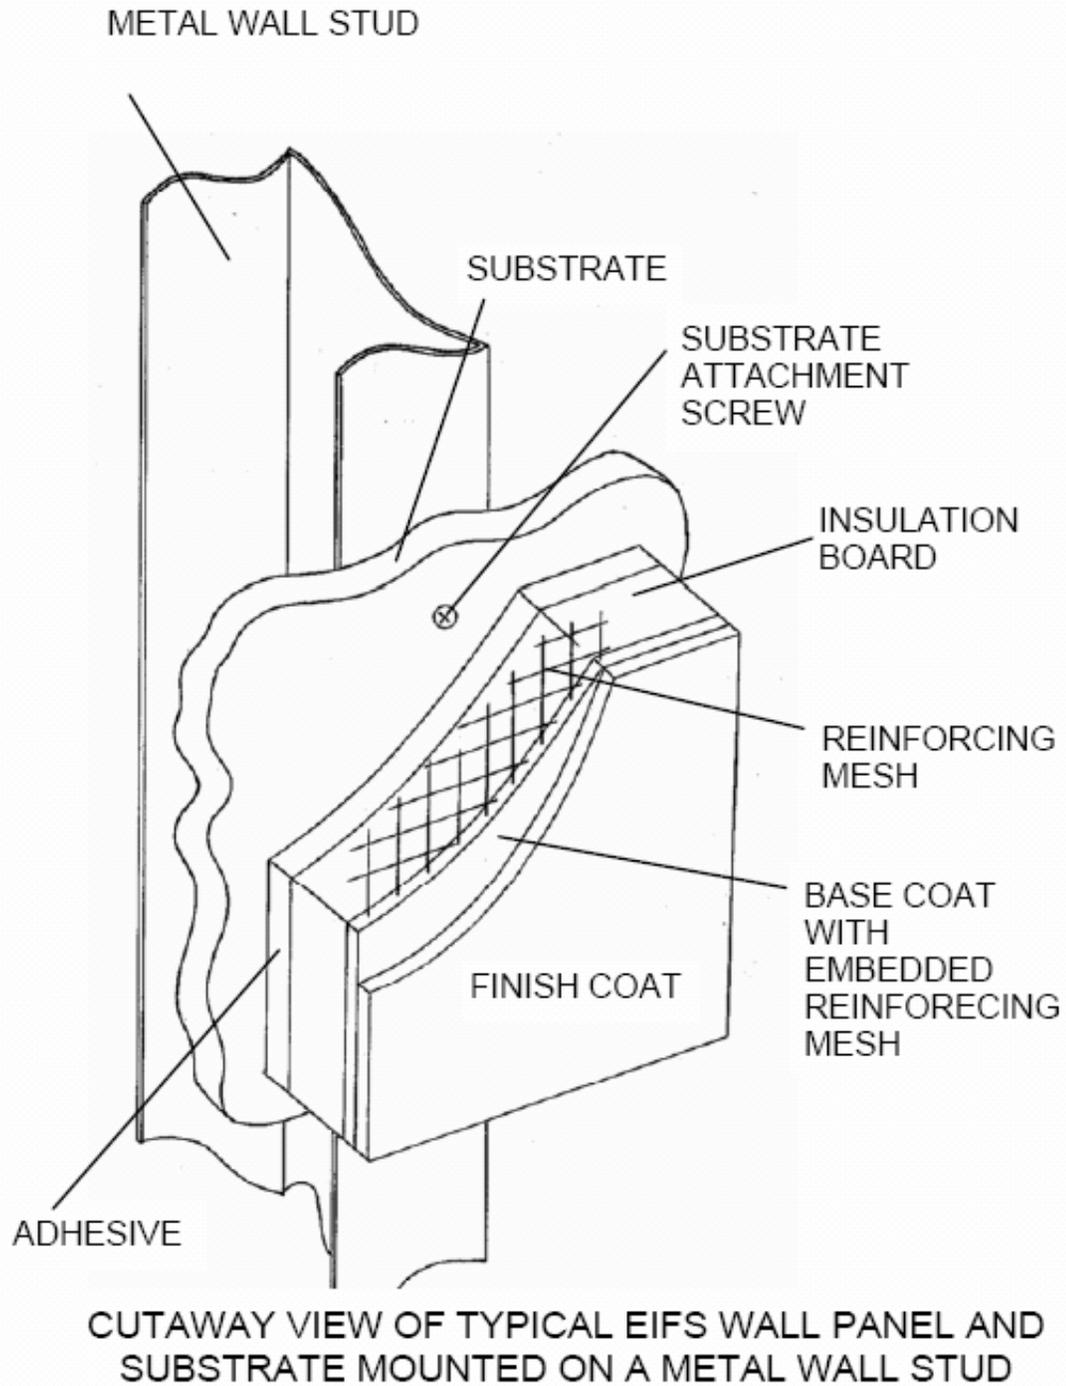
Figure 1

skin” (Zwayer, 2007). “An EIFS wall typically consists of several layers of materials sandwiched together into a single panel, which is attached to a substrate mounted on the wall studs” (Figure 1) (FEMA, Unknown). In buildings constructed with a curtain wall, water is intercepted by a drainage plane once it penetrates through the brickwork; the drainage plane allows water to exit the wall system through weep holes (Figure 2). The EIFS system on the band room wing appears to be a barrier wall system. The “barrier EIFS wall systems rely primarily on the base coat portion of the exterior skin to resist water penetration” (Zwayer, 2007). In essence, the rainwater is shed by the exterior “stucco” surface, which functions as drainage plane (Figure 1). However, a number of problems exist with such a system:

**Configuration of an EIFS Wall Panel
(FEMA, Unknown)**

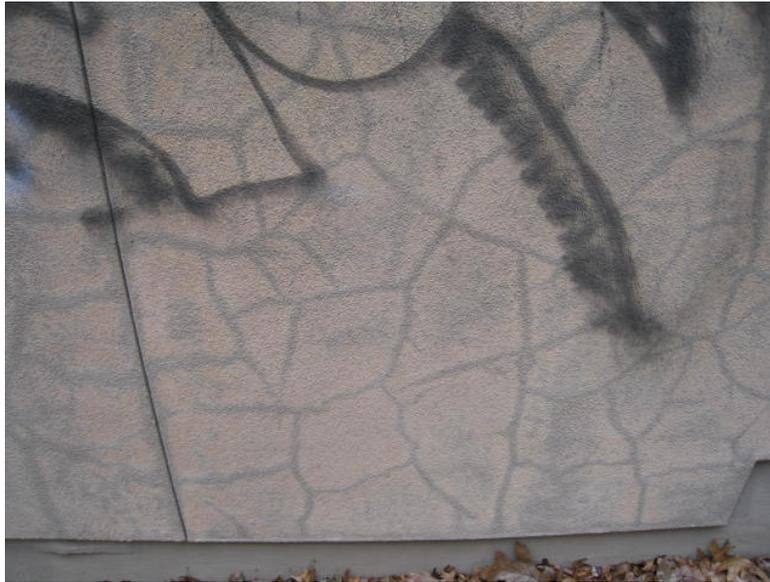
Picture 1

A material installed on exterior walls of the band wing is enhancing humidity levels in the band room. The exterior wall material in this area appears discolored in an asymmetrical pattern (Picture 1). This patterning of the wall system may indicate that rainwater is being held between the exterior wall system and the original cement block exterior wall. In this configuration, moisture is likely to pass into the interior of the band room, resulting in increased relative humidity and moistening of carpets and other materials susceptible to mold colonization. In addition, it appears that this wall system has been chronically damaged by moisture resulting from pipes that drain water from the band room's flat roof onto the exterior wall (Pictures 2 and 3).

Asymmetrical Pattern in Exterior Wall System, Which May Indicate Moisture Attempting to Pass/Evaporate Through the Material

2. Ensure all exhaust vents are repaired and are operating. Close classroom doors to maximize exhaust capabilities.
3. Install downspouts on pipes that drain the flat roof of the band room to prevent further water damage to the EIFS exterior wall. Consideration should be given to removing the EIFS exterior wall system on the band room. If this is done, the exterior of the cement block should be sealed with an appropriate material. Consideration should be given to consulting a building engineer on the most appropriate method for repairing the band room exterior wall.

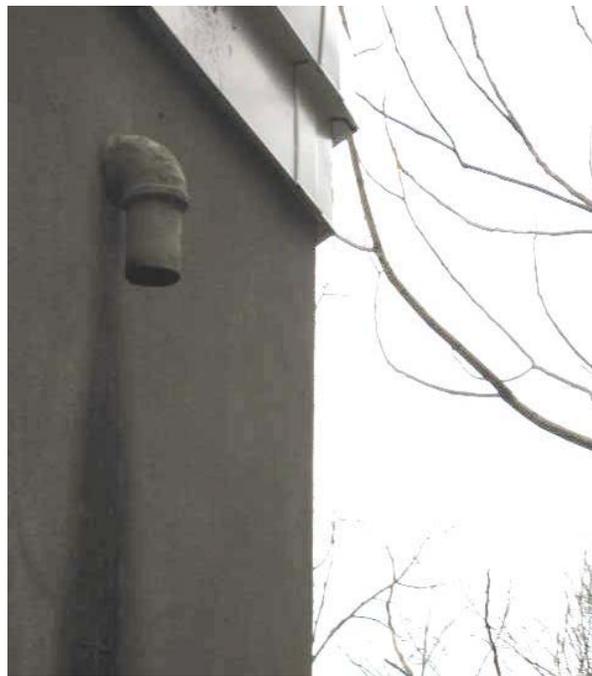
Picture 2

Pipe That Drains Water From Band Room Roof

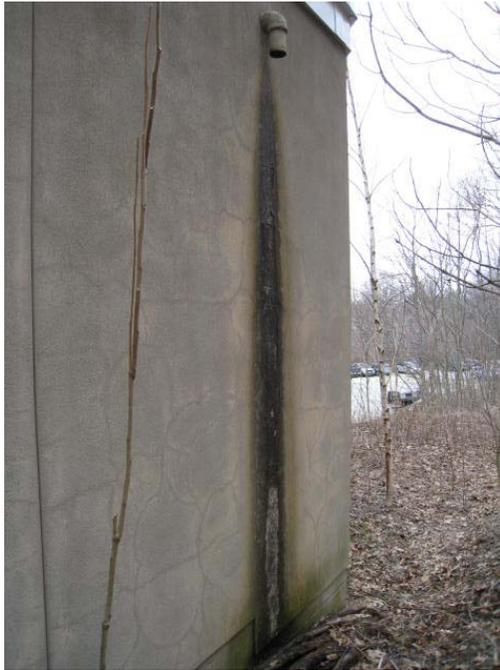
Picture 3

- Failure to install or properly install sealant joints around windows, doors, pipes, conduits, and other penetrations of the field of the EIFS;
- Failure to flash window and door openings in the field of the EIFS to divert leakage through the window or door to the exterior;
- Failure to properly backwrap edges of EIFS at terminations and penetrations in the field of the EIFS (Picture 4); and
- Water erosion damage that has not been repaired (Picture 3).

Pipe That Drains Water From Band Room Roof, Note Damage to Exterior Wall

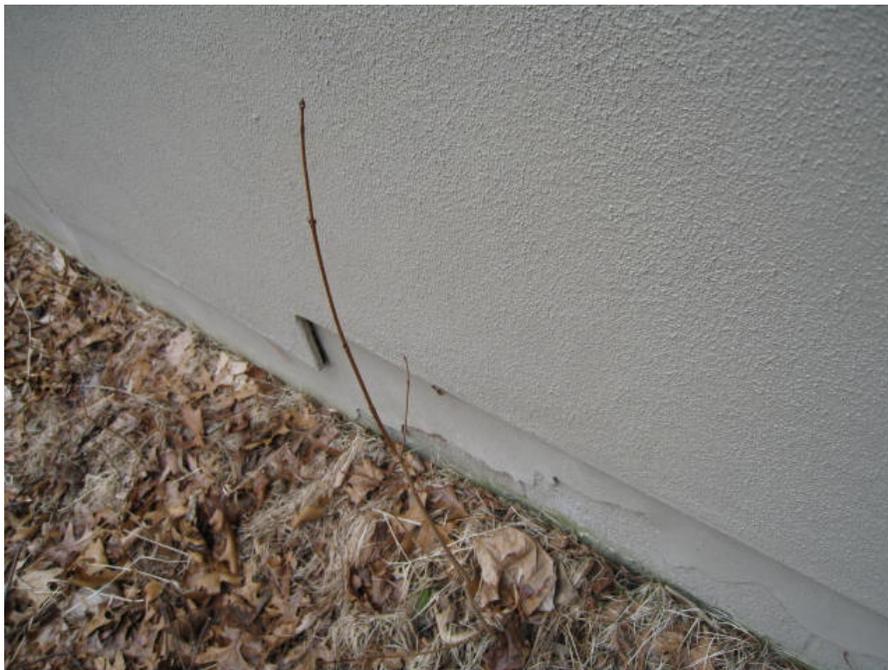
Picture 4

Each of these conditions can allow for water to penetrate through the EIFS, causing water damage to carpet and interior walls in the band wing. It is also important to note that significant portions of the main building are also clad with EIFS, which have a similar type of pattern on the wall surface which may indicate water penetration through the installed wall system. While this condition does not appear to currently affect the main building, it should be closely monitored for water penetration.

Lack of Back Wrap or Flashing on EIFS Edge
