INDOOR AIR QUALITY ASSESSMENT

**Grafton Elementary School
105 Millbury Street
Grafton, Massachusetts**

Prepared by:
Massachusetts Department of Public Health
Bureau of Environmental Health
Indoor Air Quality Program
January 2010

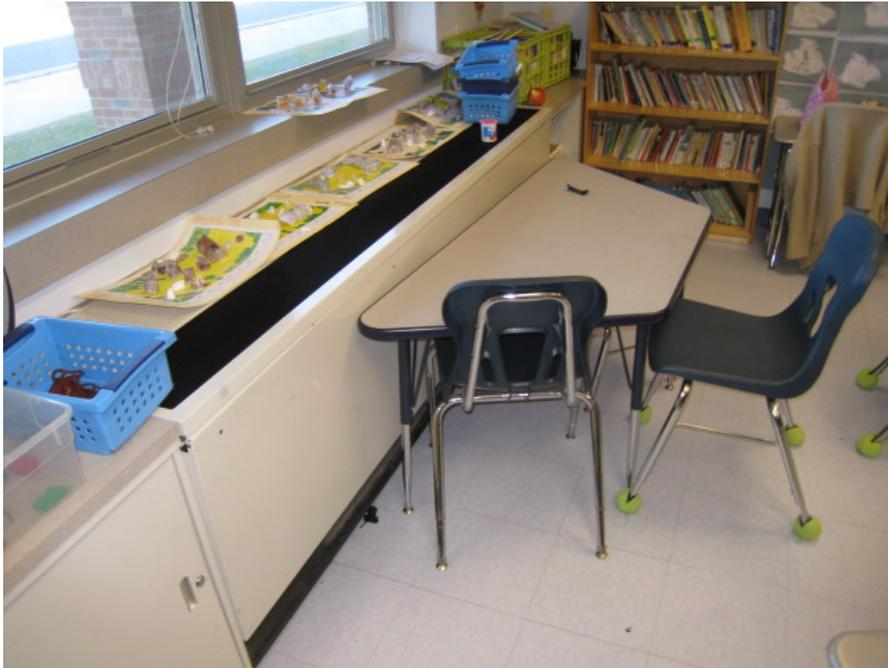
Picture 1

Fresh air is supplied to most classrooms by unit ventilators (univent) systems (Picture 1). A univent draws air from the outdoors through a fresh air intake located on the exterior wall of the building (Picture 2). Return air from the classroom is drawn through an air intake located at the base of the unit ([Figure 1](#)). Fresh and return air are mixed, filtered, heated and provided to classrooms through an air diffuser located in the top of the unit. Univents were found deactivated in several areas (Table 1); therefore, no means to provide mechanical ventilation to these classrooms was available at the time of the assessment. In several cases, univents were found obstructed by furniture and other items on top of air diffusers and/or in front of return vents along the bottom front of the units (Pictures 3 and 4). In order for univents to provide fresh air as designed, intakes/returns must remain free of obstructions. Importantly, these units must remain “on” and be allowed to operate while rooms are occupied.

In an effort to reduce noise from sliding desks/chairs, tennis balls had been sliced open and placed on the base of the legs (Pictures 1 and 6). Tennis balls are made of a number of

materials that are a source of respiratory irritants. Constant wearing of tennis balls can produce fibers and cause VOCs to off-gas. Tennis balls are made with a natural rubber latex bladder, which becomes abraded when used as a chair leg pad. Use of tennis balls in this manner may introduce latex dust into the school environment. Some individuals are highly allergic to latex (e.g., spina bifida patients) (SBAA, 2001). It is recommended that the use of materials containing latex be limited in buildings to reduce the likelihood of symptoms in sensitive individuals (NIOSH, 1997).

Classroom Univent, Also Note Tennis Balls on Chair Legs

1. Operate all ventilation systems (e.g., AHUs, exhaust vents, and univents) throughout the building continuously during occupied periods. To increase airflow in classrooms, set univent controls to “high”.

14. Refrain from using air fresheners and deodorizers to prevent exposure to VOCs.
 15. Replace latex-based tennis balls with latex-free tennis balls or glides.

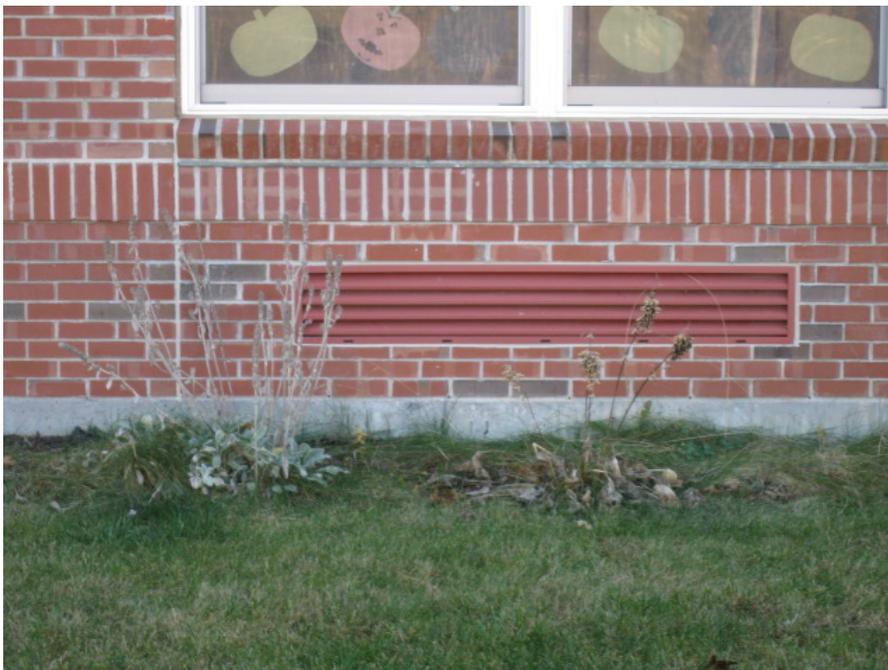
Picture 2

Univent Fresh Air Intake

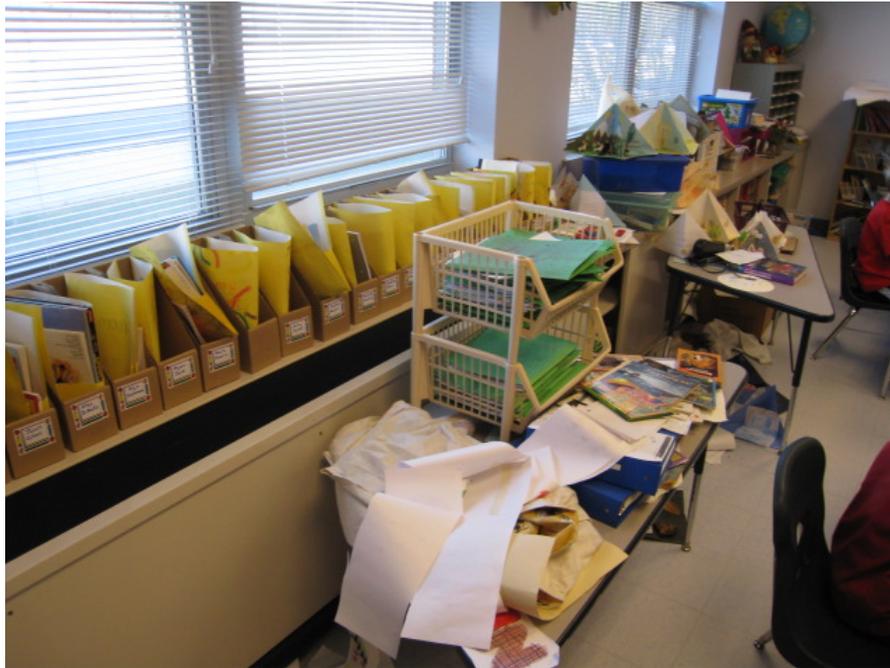
Picture 3

Univent Return Vent (Bottom Front) Obstructed by Furniture

2. Continue with plans to repair exhaust motors for proper function.
3. Remove all blockages from univents and exhaust vents to ensure adequate airflow.

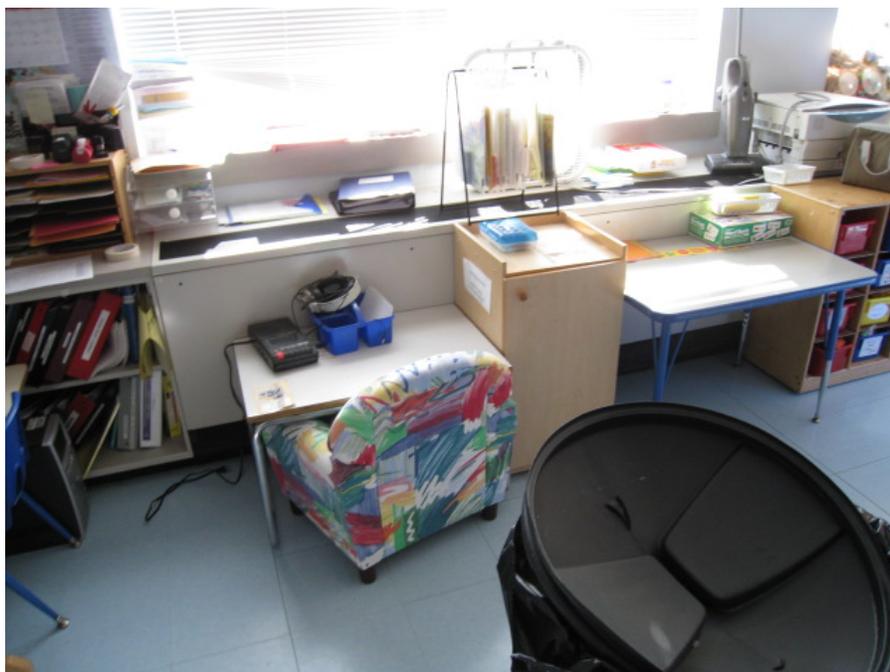
Picture 4

Univent Return Vent (Bottom Front) Obstructed by Furniture

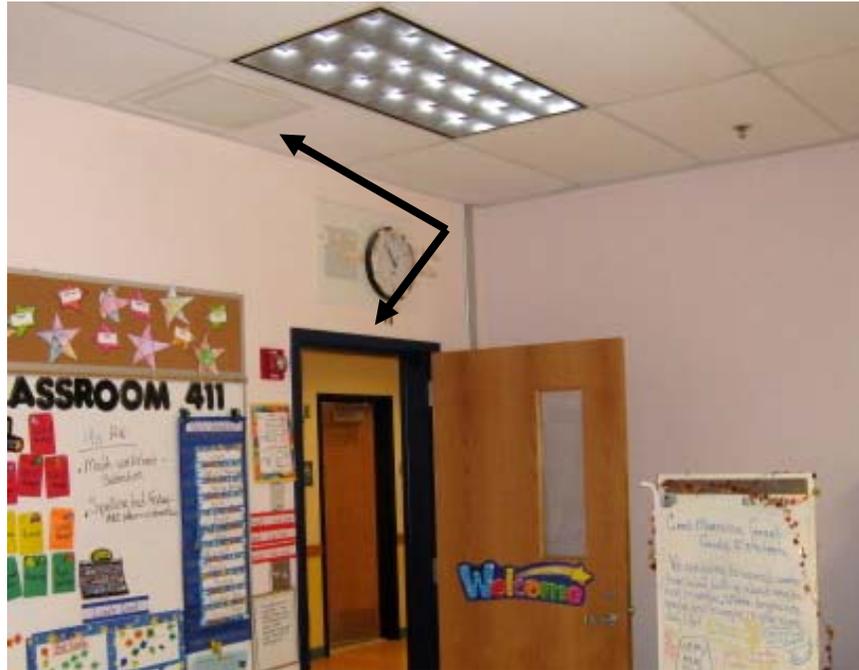
Picture 5

Exhaust ventilation in classrooms is provided by gridded ceiling vents ducted to rooftop motors (Picture 5). Exhaust vents in the music rooms were reportedly deactivated due to noise. In one wing, Mr. LeMay reported that the exhaust vents were not functioning and that parts were on order to repair (Table 1). In several classrooms, exhaust vents are located near hallway doors (Picture 5). When these classroom doors are open, exhaust vents will tend to draw air from both the hallway and the classroom, reducing the effectiveness of the exhaust vents to remove common environmental pollutants. As with univents, in order to function properly, exhaust vents must be activated and allowed to operate while rooms are occupied. Without adequate supply and exhaust ventilation, excess heat and environmental pollutants can build up and lead to indoor air/comfort complaints.

Proximity of Ceiling Exhaust Vent to Open Hallway Door

4. Close classroom doors to maximize air exchange.
5. Use openable windows in conjunction with mechanical ventilation to facilitate air exchange. Care should be taken to ensure windows are properly closed at night and weekends to avoid the freezing of pipes and potential flooding.

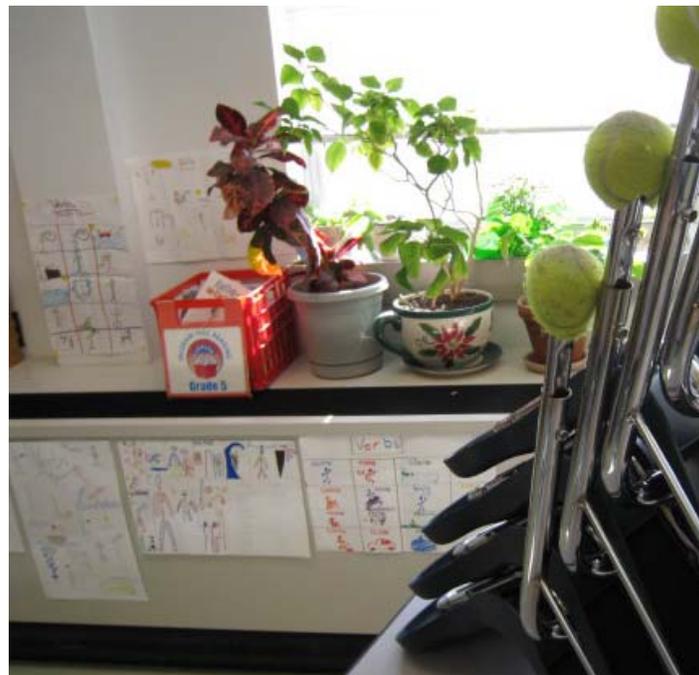
Picture 6

Plants were observed in several areas (Table 1). Plants should be properly maintained and equipped with drip pans. Plants should also be located away from ventilation sources to prevent aerosolization of dirt, pollen or mold (Picture 6). Finally, they should not be placed on porous materials, since water damage to porous materials may lead to microbial growth.

Plants on Classroom Univent, Also Note Tennis Balls on Chair Legs

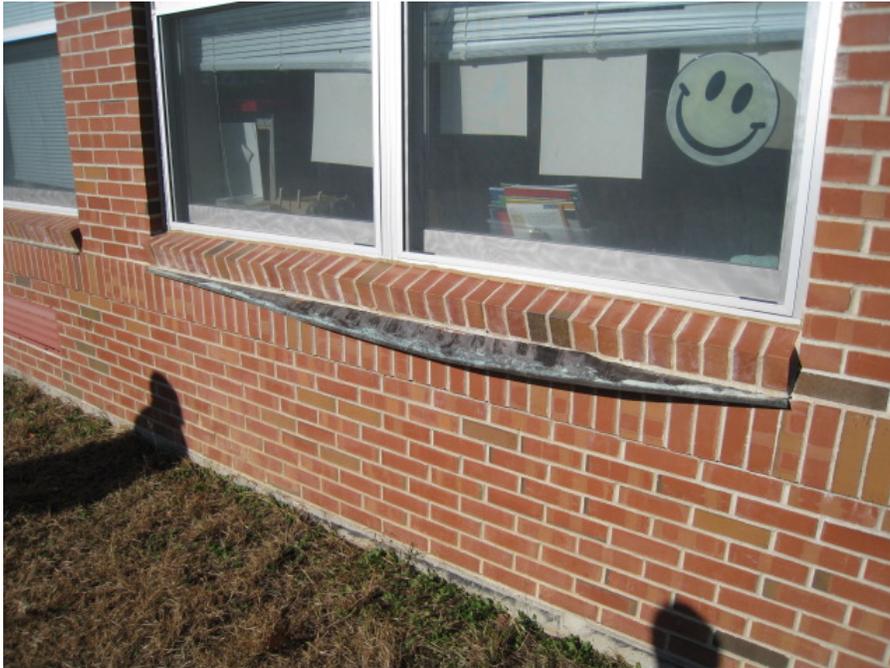
Picture 7

Missing/damaged flashing was observed beneath a window at the rear of the school (Picture 7). Flashing around windows is designed to collect water and drain it away from the interior of the building. The flashing should be repaired to prevent water infiltration and damage to interior building components.

Missing/Damaged Flashing beneath Classroom Window at Rear of Building

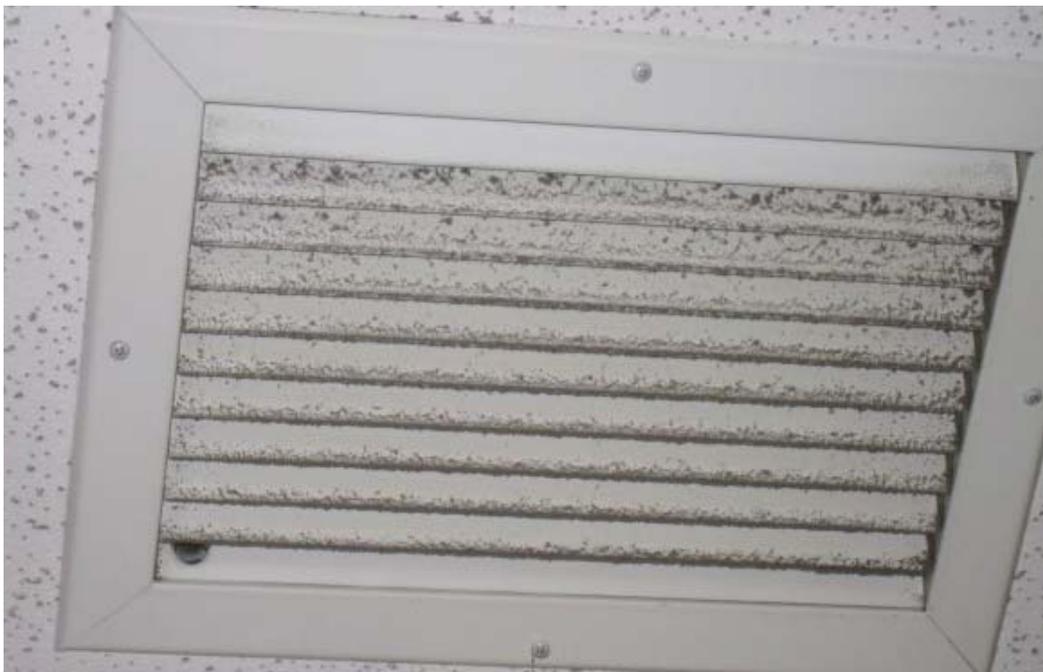
Picture 8

Finally, a number of air diffusers, exhaust vents and personal fans in classrooms were observed to have accumulated dust/debris (Pictures 8 through 10). Re-activated supply vents/fans can aerosolize dust accumulated on fan blades/housing. If exhaust vents are not functioning, backdrafting can occur, which can re-aerosolize dust particles.

Accumulated Dust/Debris on Exhaust Vent

12. Consider relocating lamination machine in media center to an area below an exhaust vent.
 13. Clean personal fans, univent air diffusers, return vents and exhaust vents periodically of accumulated dust.

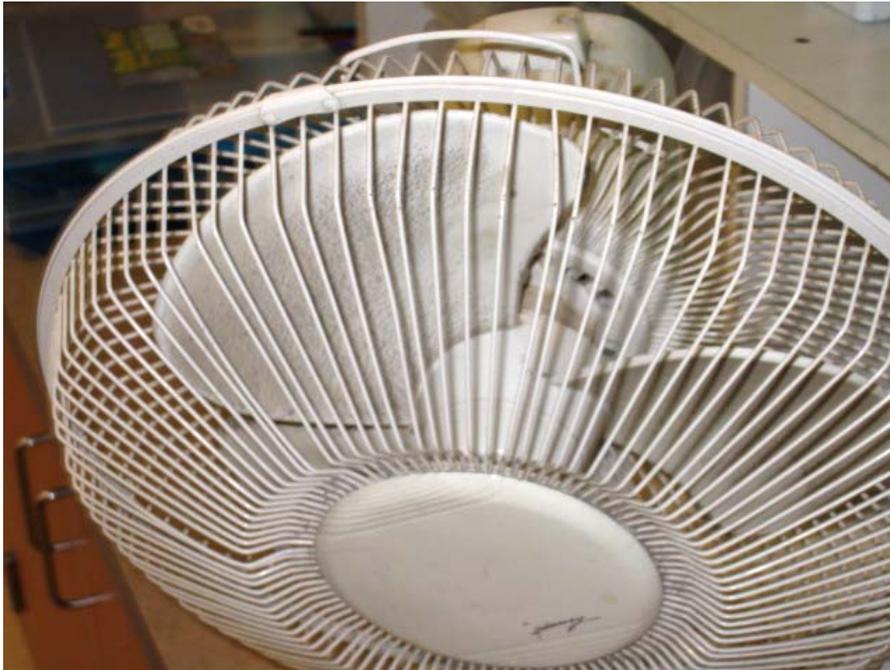
Picture 9

Accumulated Dust/Debris on Personal Fan

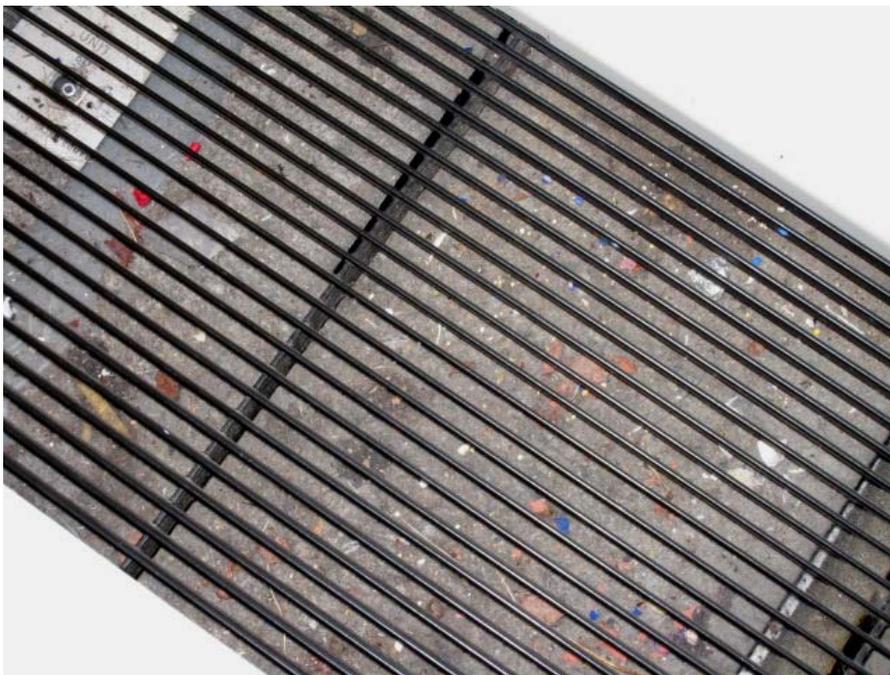
Picture 10

Accumulated Dust/Debris in Univent Air Diffuser
