# **INDOOR AIR QUALITY POST-OCCUPANCY ASSESSMENT**

**Massasoit Community College  
at Middleborough Center  
49 Union Street  
Middleborough, Massachusetts**

Prepared by:  
Massachusetts Department of Public Health  
Bureau of Environmental Health  
Indoor Air Quality Program  
November 2010

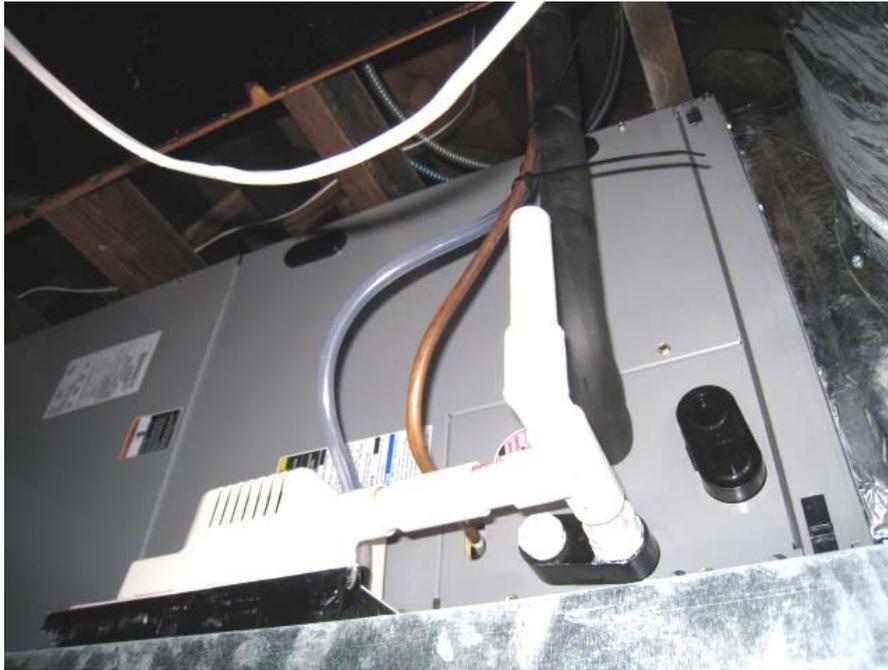
**Picture 1**

Fresh air and AC is provided by air handling units (AHU) located above the ceiling tile system in each classroom (Picture 1). Fresh air is drawn into the AHU through an air intake vent located on the roof (Picture 2), heated or cooled and delivered to occupied areas via ducted air diffusers (Picture 3). Return air is drawn into ceiling-mounted vents and ducted back to AHUs.

**Air Handling Unit above Ceiling Tile System in Classroom**

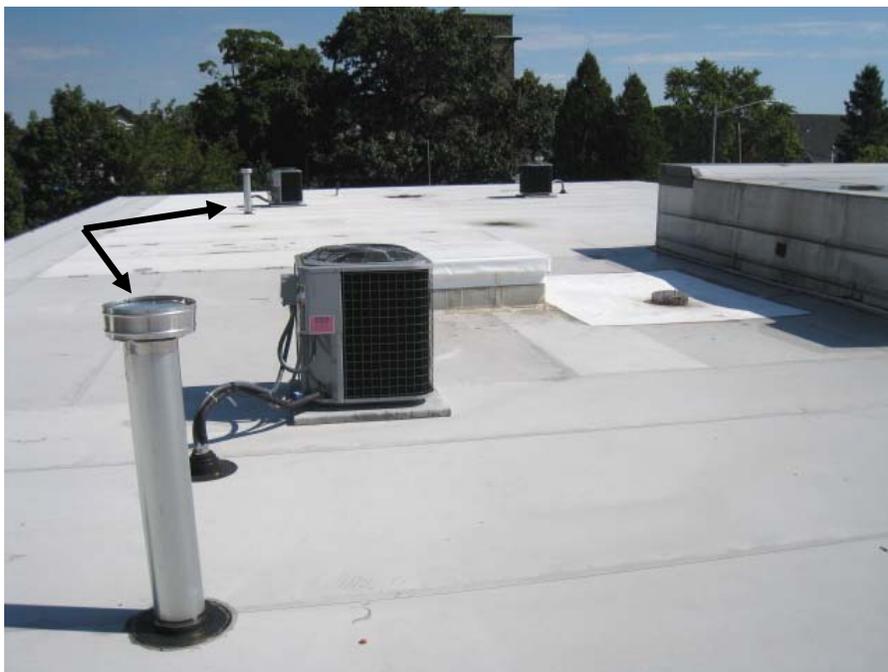
**Picture 2**

**Fresh Air Intakes for Air Handling Units**

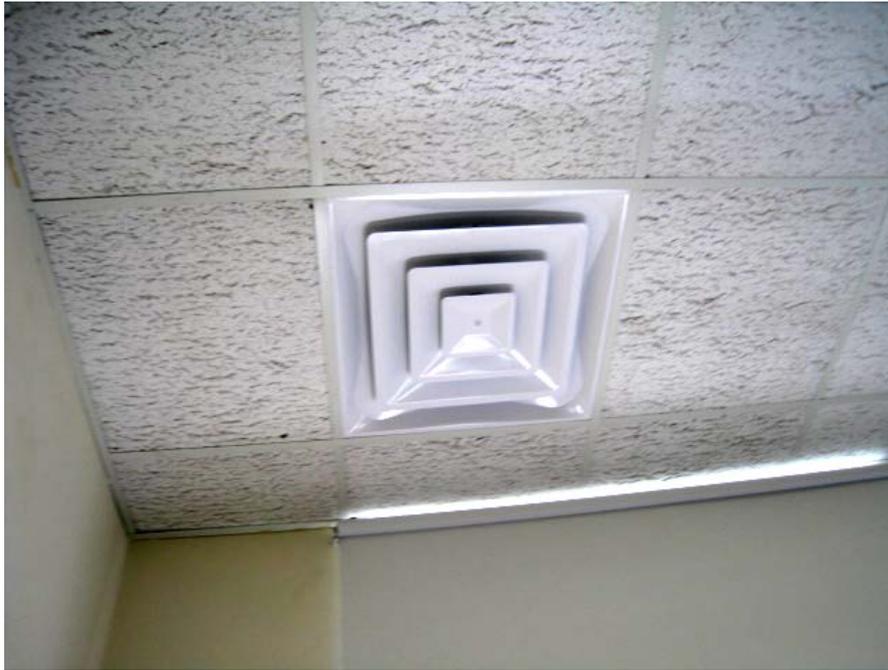
**Picture 3**

**Ceiling-Mounted Supply Diffuser**

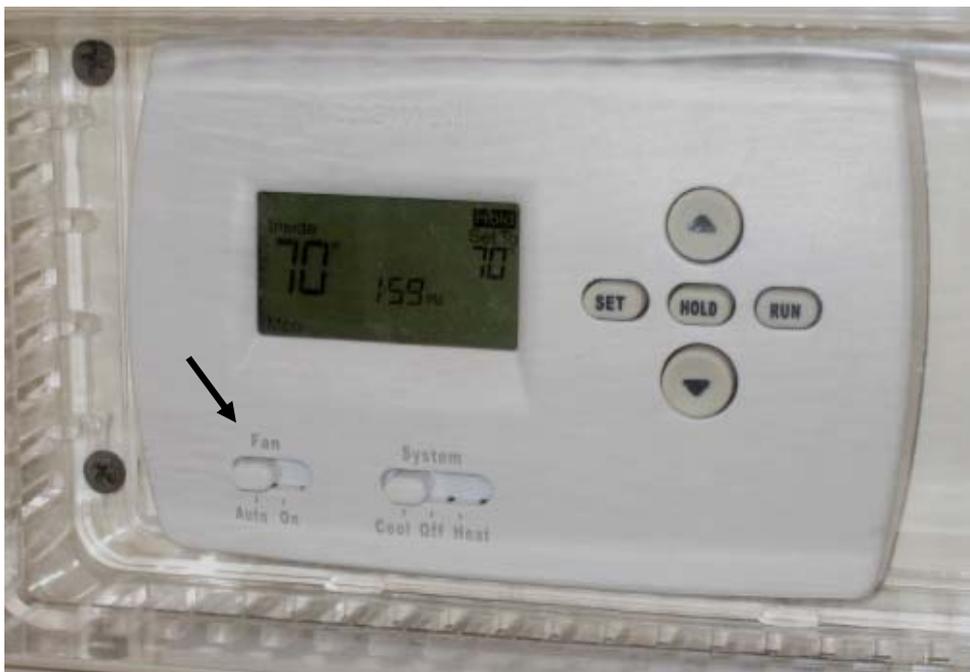
**Picture 4**

Digital wall-mounted thermostats control the AC/ventilation system and have fan settings of “on” and “automatic”. Thermostats were found set to the “automatic” setting at the time of assessment (Picture 4). The automatic setting on the thermostat activates the system at a preset temperature. Once the preset temperature is reached, the system is deactivated. Therefore, no mechanical ventilation is provided until the thermostat re-activates the system. Without a

continuous source of fresh outside air and removal via the exhaust/return system, indoor environmental pollutants can build-up and lead to indoor air quality/comfort complaints.

**Digital Thermostat in Classroom for AHU, Note Fan in “Auto” Position**

1. Set the thermostat to the fan “on” position to operate the ventilation system continuously during full occupancy.
2. Change filters for air handling equipment as per the manufacturers’ instructions or more frequently if needed.
  - Examine AHUs for filtration, upgrade to pleated MERV 9 (or higher) dust-spot efficiency if not currently installed.

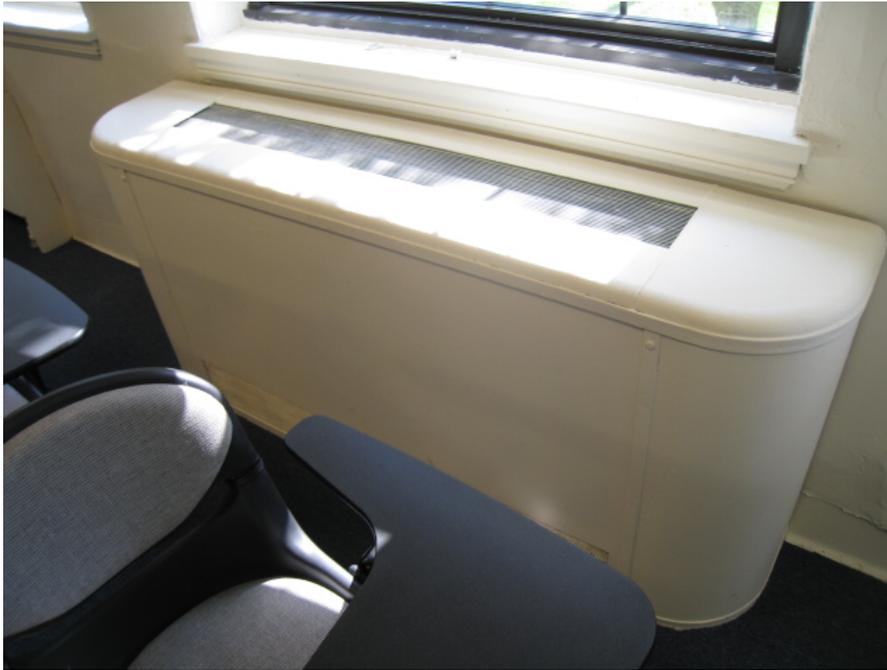
**Picture 5**

Fresh air and heat is provided during fall/winter months by unit ventilator (univent) systems (Picture 5). A univent draws outdoor air through an air intake located on the exterior wall of the building (Picture 6) and return air from the room through an air intake located at the base of the unit ([Figure 1](#)). Fresh and return air are mixed, filtered, heated, and then delivered to the room through an air diffuser located in the top of the unit.

**Classroom Univent 1930's Vintage**

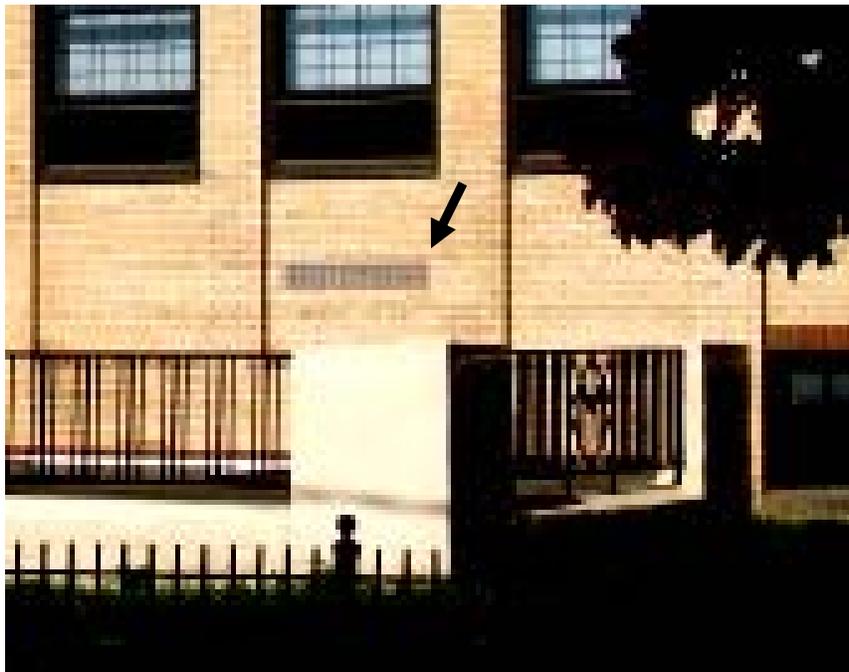
**Picture 6**

**Univent Fresh Air Intake**

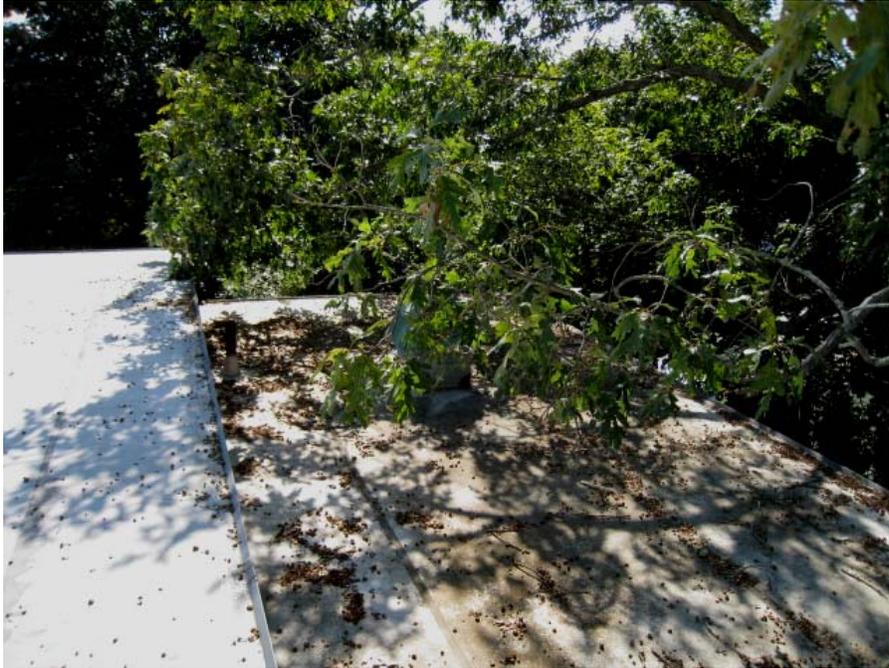
**Picture 7**

- Branches overhanging the roof (Picture 7);
- A roof drain was obstructed by leaves/debris (Picture 8); and
- Trees against the building (Picture 9), which can hold moisture against exterior brick leading to accelerated degradation.

**Tree Branches Overhanging Roof**

4. Restore restroom exhaust ventilation. Inspect motors and belts for proper function, and perform repairs and adjustments as necessary.
  5. Trim tree branches from overhanging roof and exterior brick.

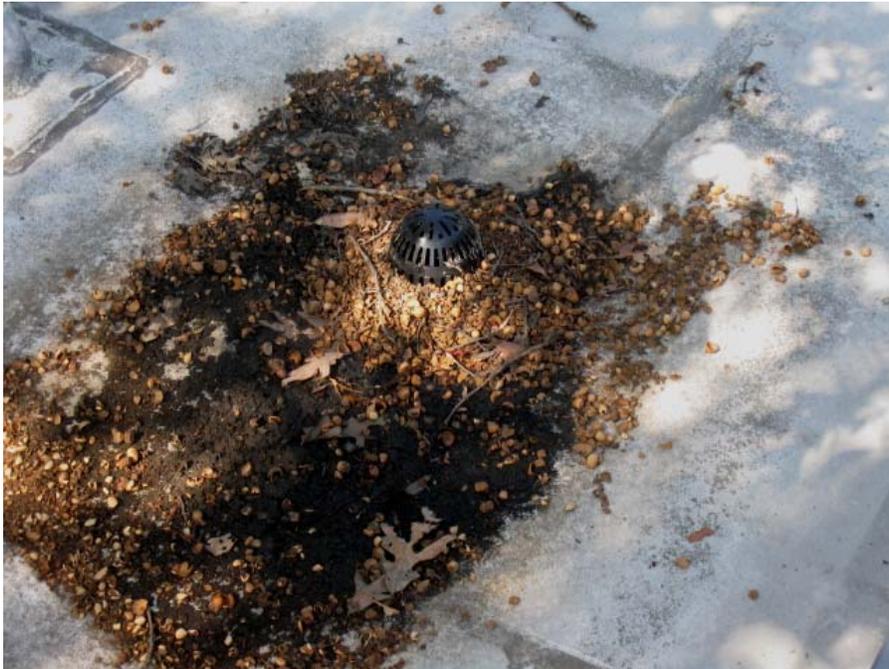
**Picture 8**

**Roof Drain Clogged with Leaves and Debris**

6. Clear roof drains and inspect periodically for proper drainage.
  7. Refer to resource manual and other related indoor air quality documents located on the MDPH's website for further building-wide evaluations and advice on maintaining public buildings. These documents are available at: [http://mass.gov/dph/indoor\\_air](http://mass.gov/dph/indoor_air).

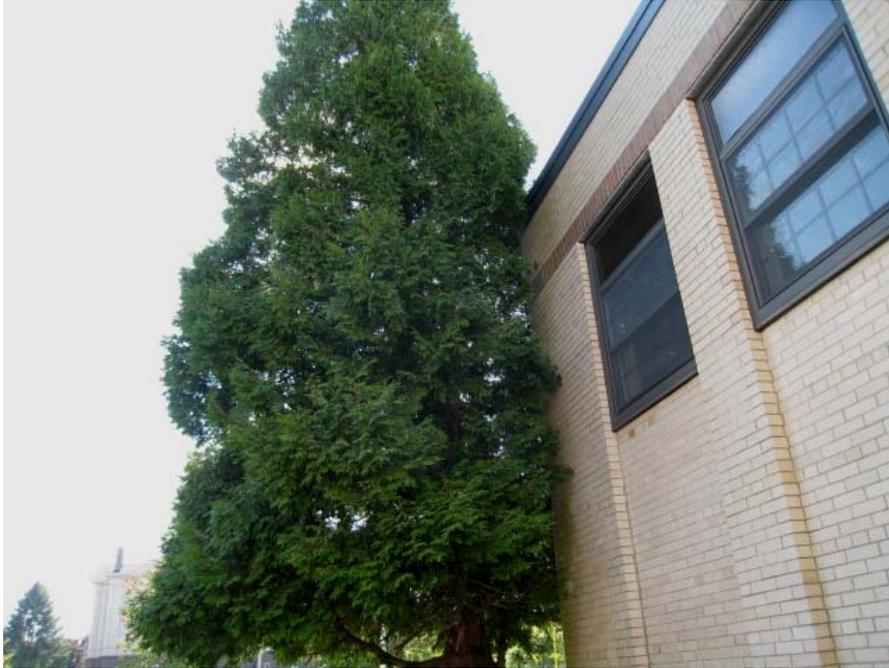
**Picture 9**

**Trees Growing against Exterior Brick**

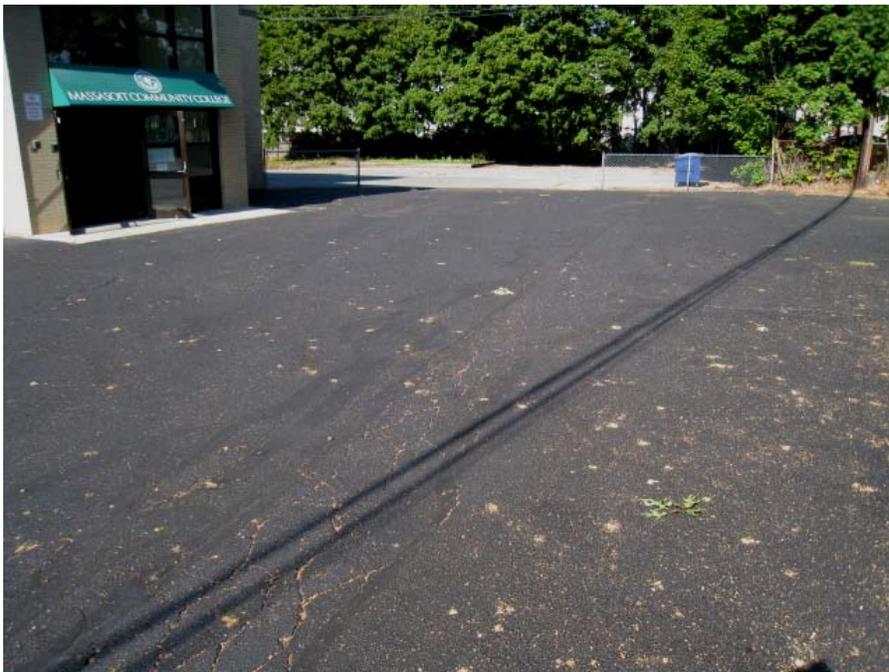
**Picture 10**

Indoor air concentrations can be greatly impacted by the use of products containing volatile organic compounds (VOCs) within the building. VOCs are carbon-containing substances that have the ability to evaporate at room temperature. Frequently, exposure to low levels of total volatile organic compounds (TVOCs) may produce eye, nose, throat and/or respiratory irritation in some sensitive individuals. For example, chemicals evaporating from a paint can stored at room temperature would most likely contain VOCs. In an effort to determine whether VOCs were present in the building, air monitoring for TVOCs was conducted. Outdoor air samples were taken for comparison. A slight TVOC measurement of 0.5 ppm was measured outdoors (Table 1), which was attributed to fresh asphalt that was poured 10 days prior to the assessment (Picture 10). No measurable levels of TVOCs were detected in the building during the assessment (Table 1).

**Recently Paved Asphalt in MCC Parking Lot**

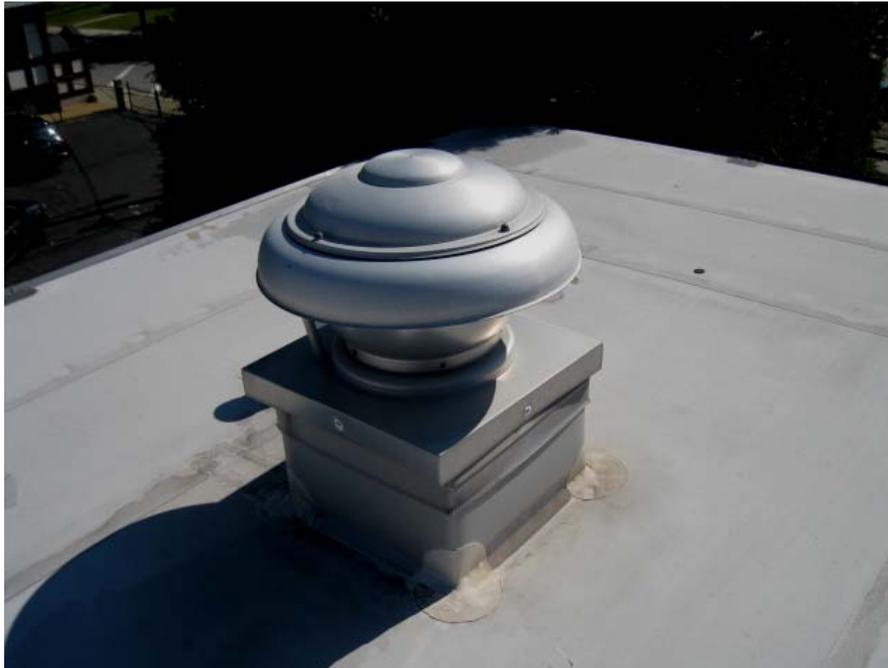
**Picture 11**

Other conditions that can affect indoor air quality were observed during the assessment. Restrooms are equipped with mechanical exhaust vents that are ducted to rooftop exhaust motors. Exhaust ventilation is necessary in restrooms to remove excess moisture and to prevent odors from penetrating into adjacent areas. The vents were not drawing air at the time of the assessment. BEH staff examined restroom exhaust vents on the roof; the exhaust vent for the men's room appeared to be a modern vent that was reportedly deactivated (Picture 11). The exhaust vent for the women's restroom was antiquated, in disrepair and appeared not to have operated for some time (Pictures 12 and 13).

**Modern Exhaust Vent for Men's Restroom**

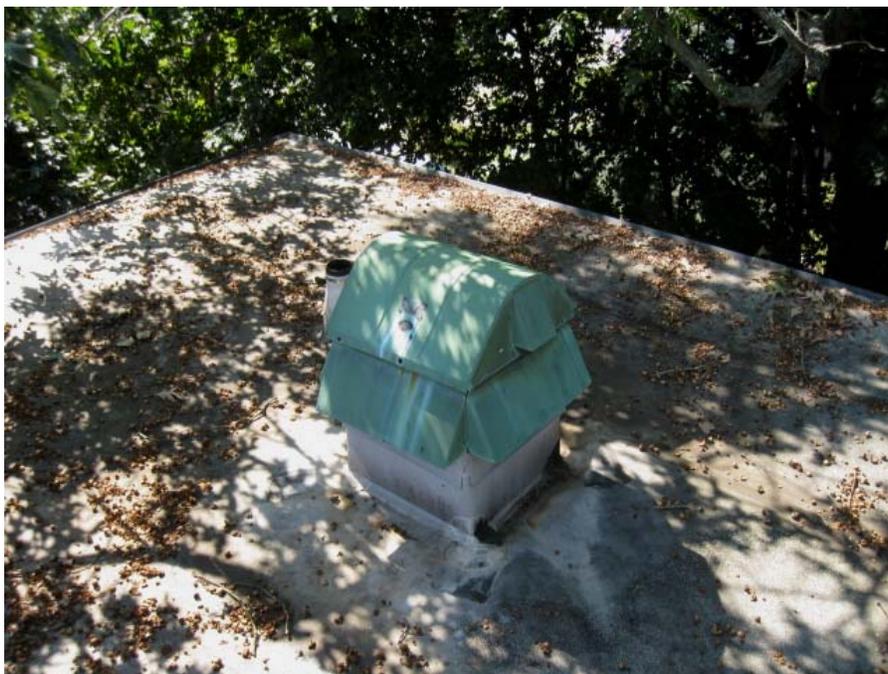
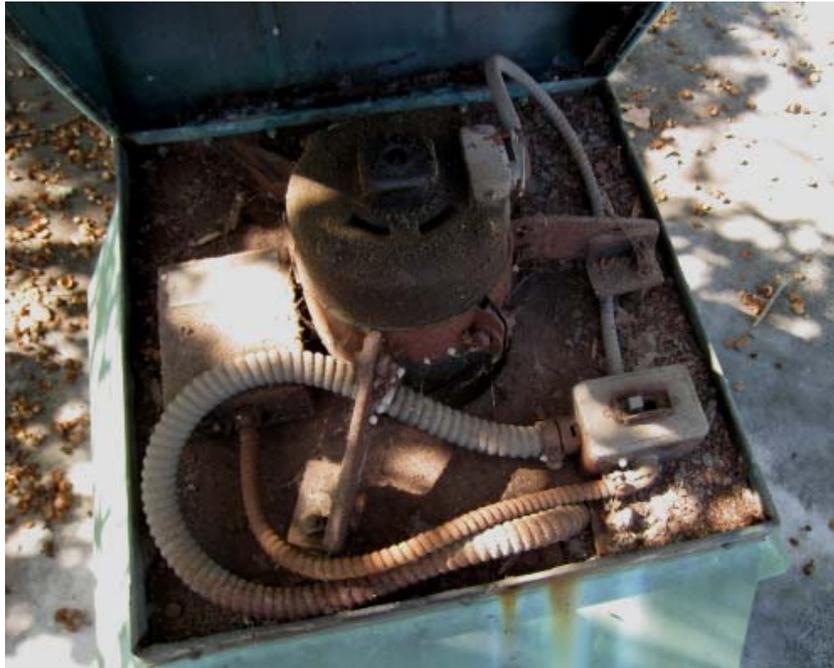
**Picture 12**

**Vintage Exhaust Vent for Women's Restroom**

**Interior of Women's Restroom Exhaust Vent/Motor, Note Accumulated Rust and Debris**

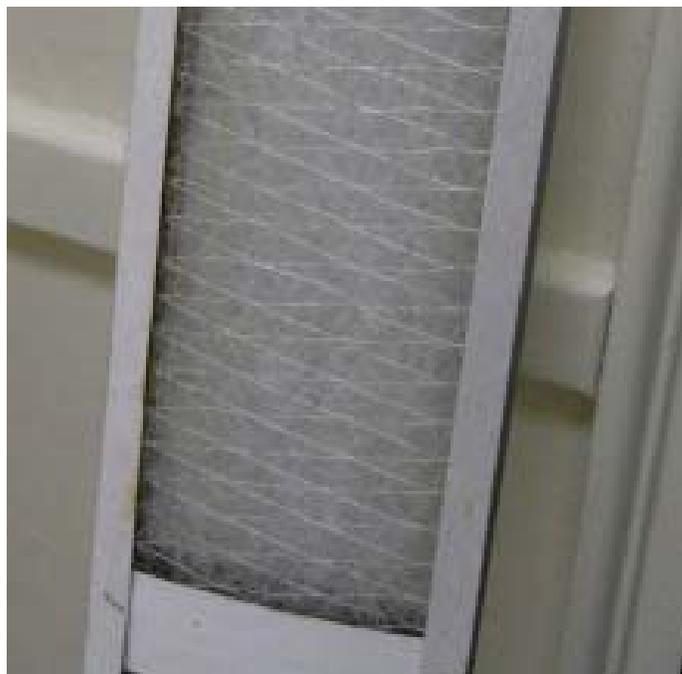
**Picture 14**

Finally, the type of filters installed in univents provide minimal filtration of respirable dusts (Picture 14). In order to decrease aerosolized particulates, disposable filters with an increased dust spot efficiency can be installed. The dust spot efficiency is the ability of a filter to remove particulates of a certain diameter from air passing through the filter. Filters that have been determined by ASHRAE to meet its standard for a dust spot efficiency of a minimum of 40 percent would be sufficient to reduce many airborne particulates (Thornburg, D., 2000; MEHRC, 1997; ASHRAE, 1992). Note that increasing filtration can reduce airflow (called pressure drop), which can subsequently reduce the efficiency of the unit due to increased resistance. Prior to any increase of filtration, each univent should be evaluated by a ventilation engineer to ascertain whether it can maintain function with more efficient filters. Filters for the AHUs could not be examined due to access (e.g., above ceiling tiles). Pleated filters with a Minimum Efficiency Reporting Value dust-spot efficiency of 9 or higher, should be installed in AHUs.

**Fibrous Mesh Filters Installed in Univents**

- Consider increasing the dust-spot efficiency of univent filters. Prior to any increase of filtration, univents should be evaluated by a ventilation engineer as to whether it can maintain function with more efficient filters.
