INDOOR AIR QUALITY REASSESSMENT

**LaLiberte Elementary School
777 Pleasant Street
Raynham, Massachusetts**

Prepared by:
Massachusetts Department of Public Health
Bureau of Environmental Health
Indoor Air Quality Program
June 2010

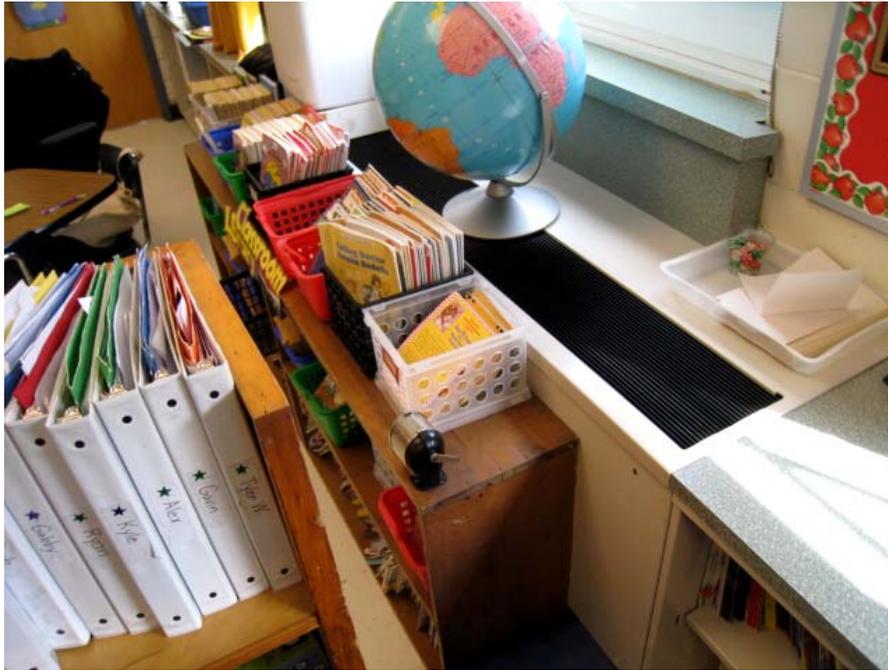
Picture 1

Bookcase Obstructing Univent Return Vent (along bottom front)

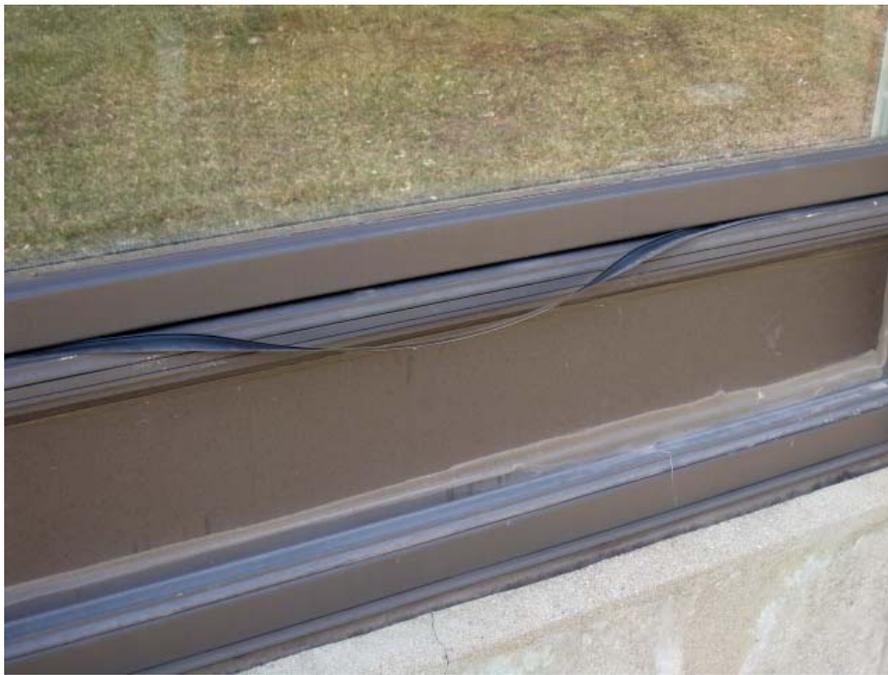
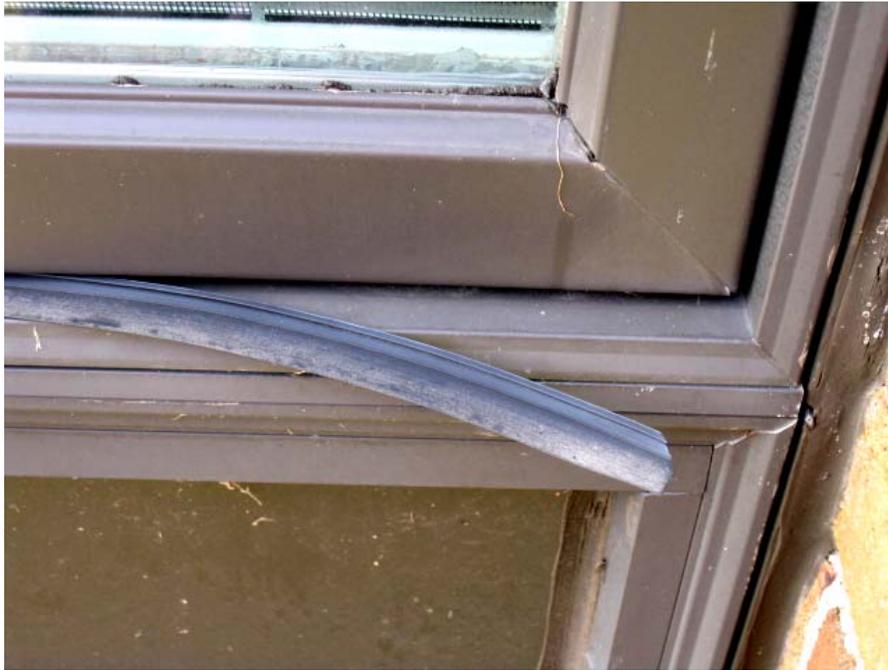
A number of windows along the rear of the building had missing and/or damaged exterior strip caulking (Pictures 2 and 3). Missing/damaged caulking around windows can allow moisture and drafts into the building, which can lead to water damage (Picture 4) and/or possible mold growth.

Missing/Damaged Exterior Strip Caulking around Windows

Missing/Damaged Rubber Exterior Strip Caulking around Windows

8. Repair/replace missing/damaged strip caulking to exterior windows.
 9. Repair water damaged window frames.
 10. Repair/re-point any damage to exterior brickwork.

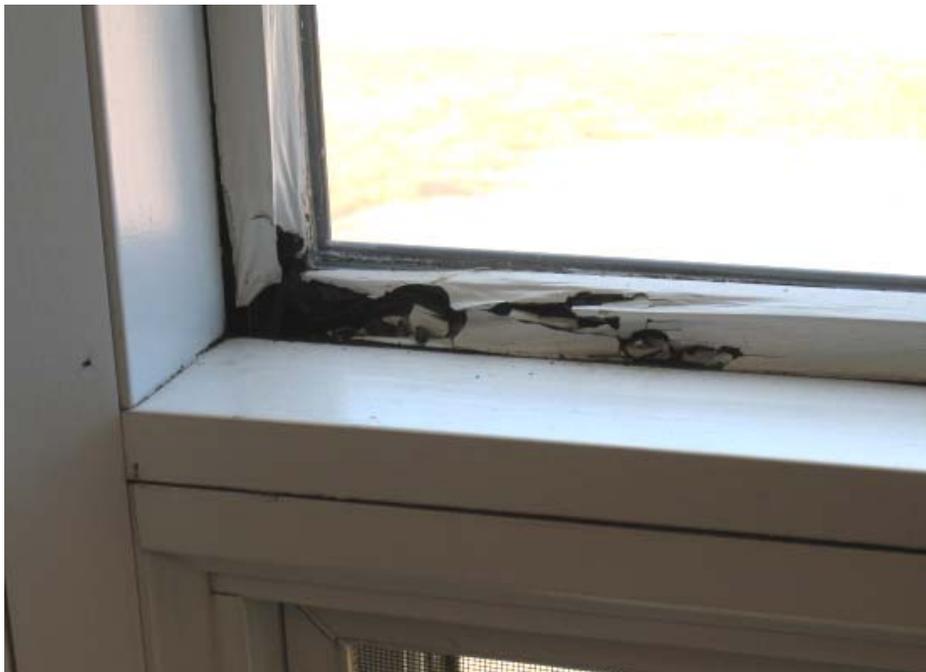
Picture 4

Interior Water Damage to Classroom Windowsill

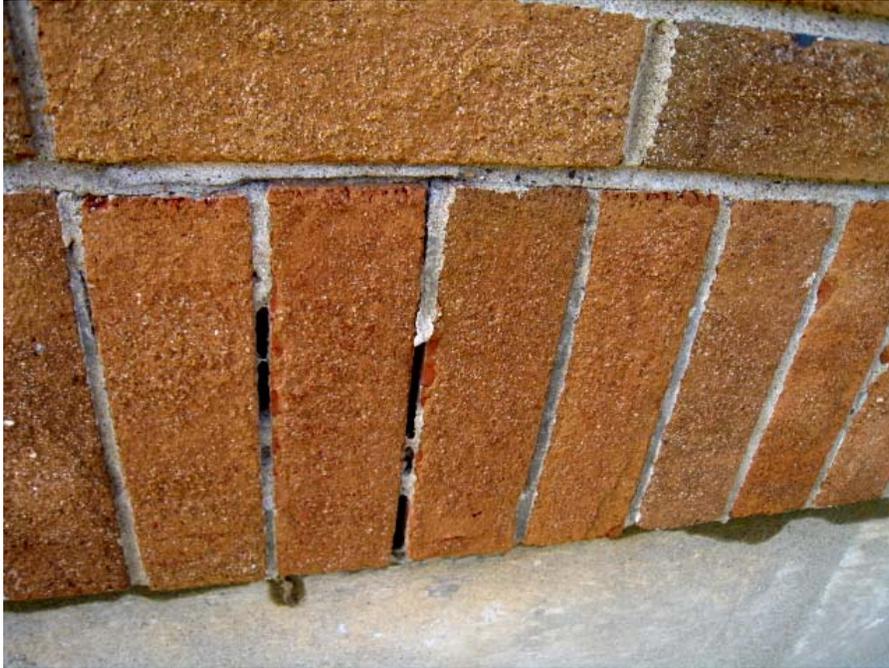
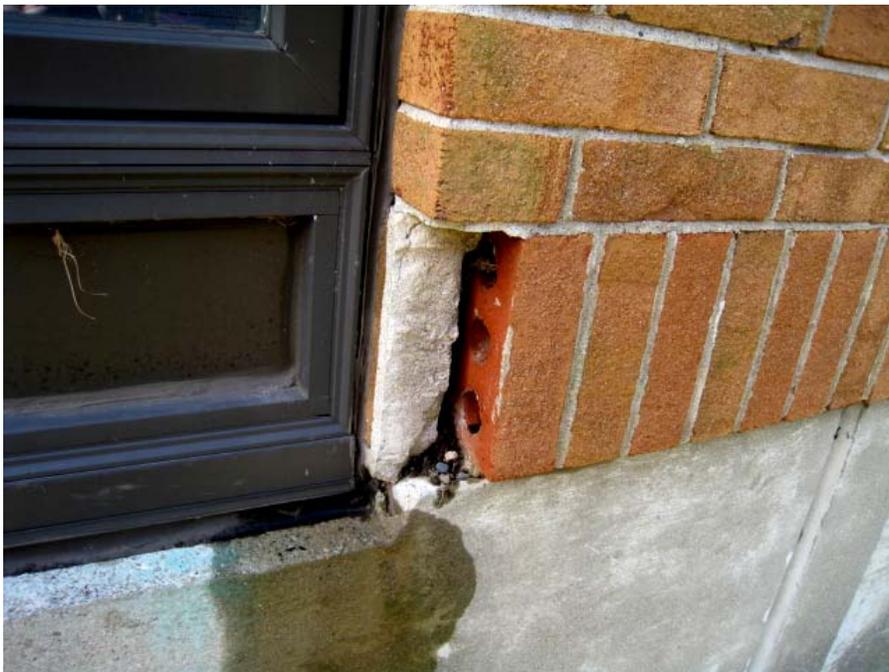
Missing/damaged mortar was observed around exterior brick (Pictures 5 and 6). The freezing and thawing of water during winter months can lead to accelerated damage. Over time, these conditions can undermine the integrity of the building envelope and provide a means of water entry into the building via capillary action through masonry (Lstiburek & Brennan, 2001).

Missing/Damaged Mortar around Exterior Brick

Missing/Damaged Mortar and Exterior Brick

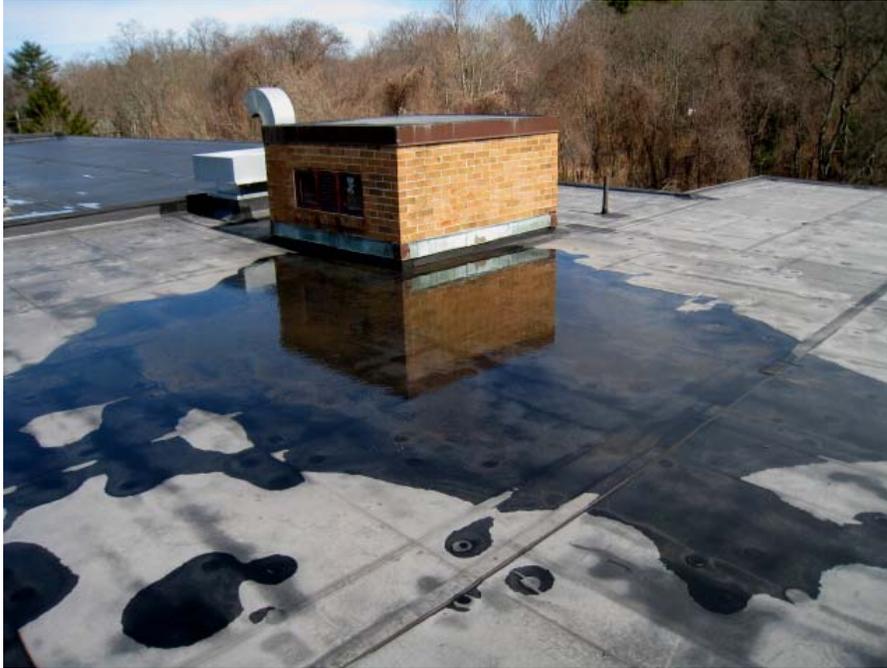
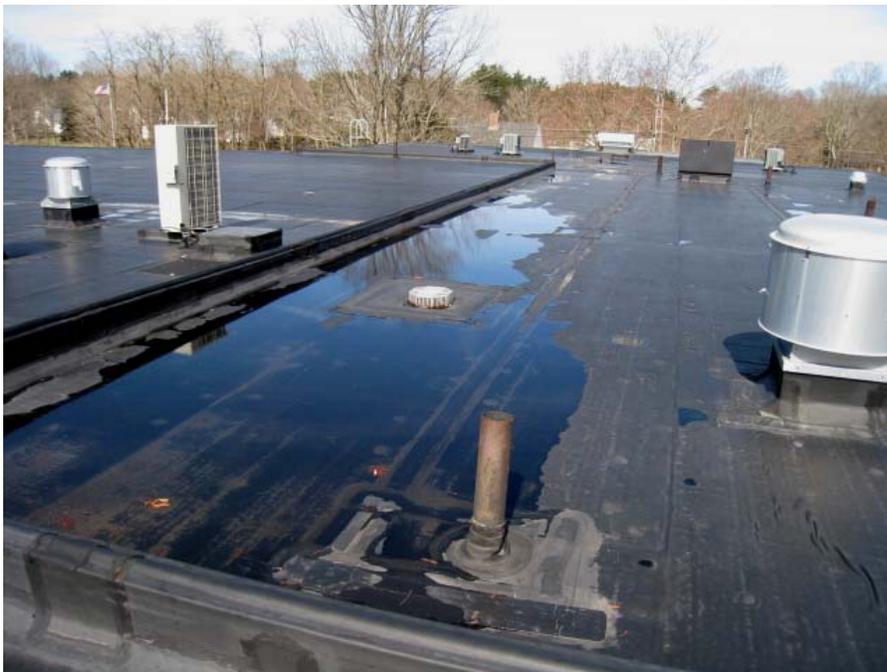
Pooling water was observed on the roof due to poor drainage (Pictures 7 and 8). Although a drain was present, the height of the drain was such that water could not flow into it (Picture 9). The freezing and thawing of water during winter months can lead to roof leaks and subsequent water penetration into the interior of the building. Pooling water can also become stagnant, which can lead to mold and bacterial growth, and serve as a breeding ground for mosquitoes. Numerous patches were observed on many areas of the roof (Pictures 10 and 11); although current leaking throughout the building appears limited, consideration of a roof replacement plan should be made for the future.

Pooling Water on Roof

Pooling Water on Roof, Note Roof Drain

11. Contact a roofing firm to modify pitch to roof drains to prevent water pooling on roof.
 12. Consider long-term plans for roof replacement including the removal of historical “patches” originally intended for temporary repair. Until the roof can be replaced, continue to make roof repairs as needed to prevent water penetration.

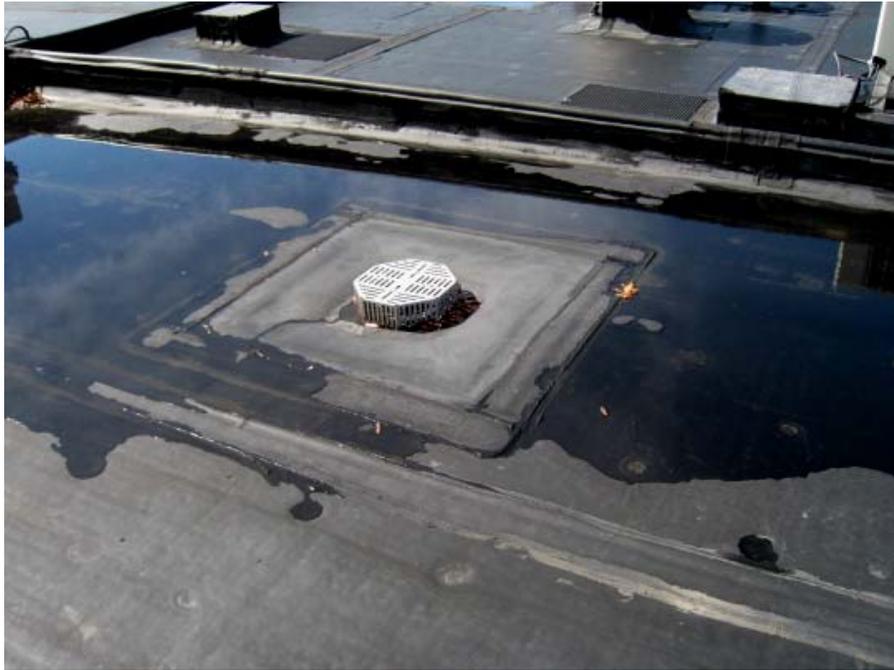
Picture 9

Pooling Water on Roof, Note Dry Membrane around Roof Drain

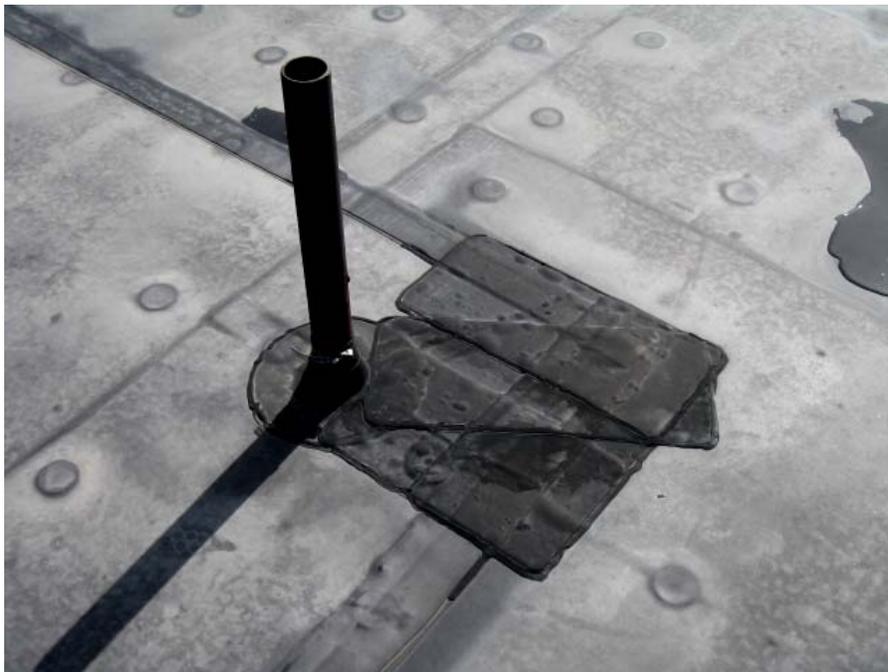
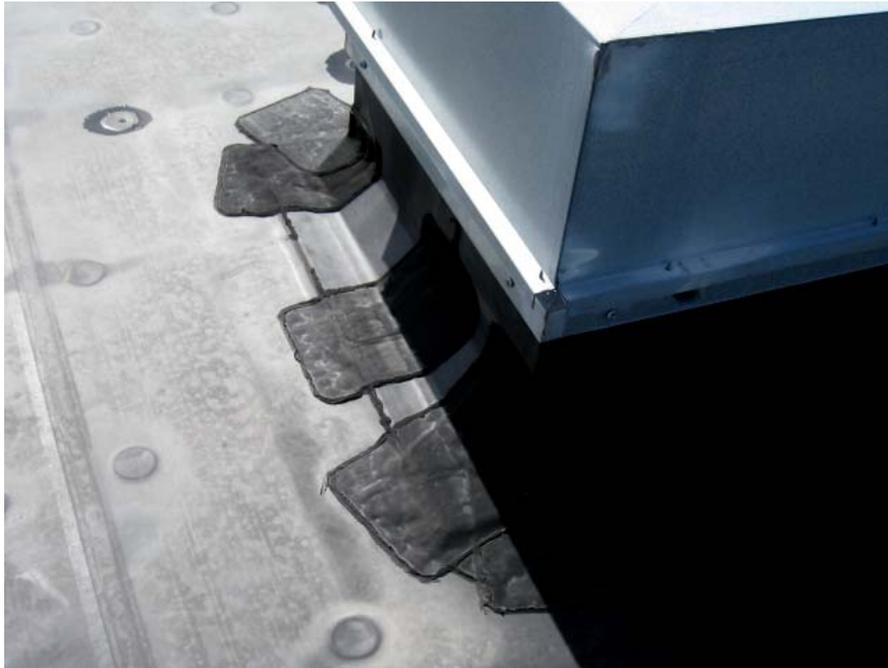
Numerous Roof Patches

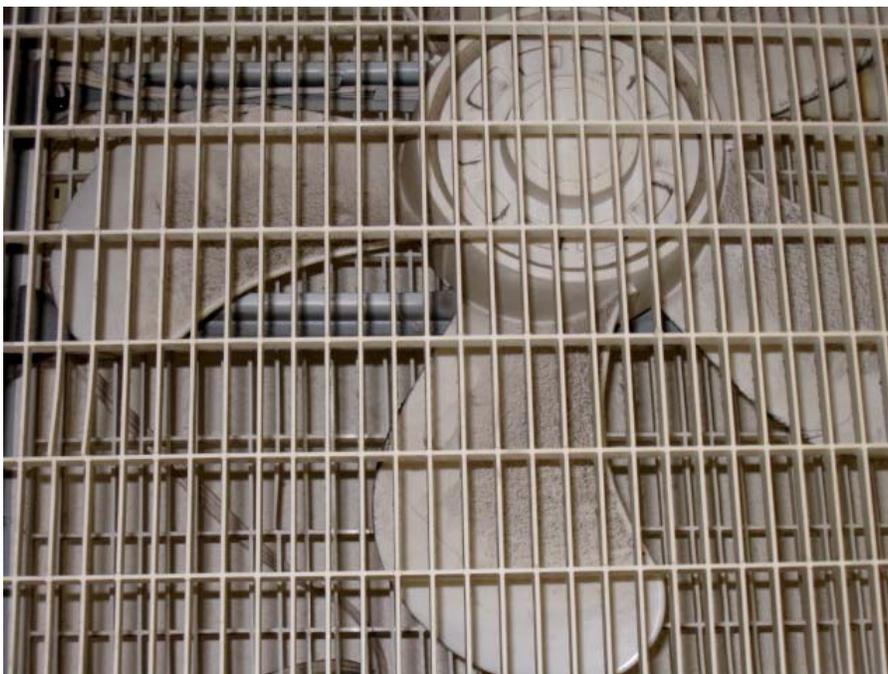
Picture 12

Finally, several personal fans were found to be occluded with dust and debris (Picture 12). Dust can be a source for eye and respiratory irritation. Fan housings and blades should be cleaned periodically with a wet paper towel or cloth in order to avoid the redistribution of accumulated dust into classrooms.

Accumulated Dust and Debris on Personal Fan in Classroom

18. Clean personal fans periodically to prevent excessive dust build-up.
19. Ensure local exhaust ventilation in the teacher's workroom is functioning to remove excess heat and odors.
