# **INDOOR AIR QUALITY REASSESSMENT**

**L.B. Merrill Elementary School  
687 Pleasant Street  
Raynham, Massachusetts**

Prepared by:  
Massachusetts Department of Public Health  
Bureau of Environmental Health  
Indoor Air Quality Program  
April 2010

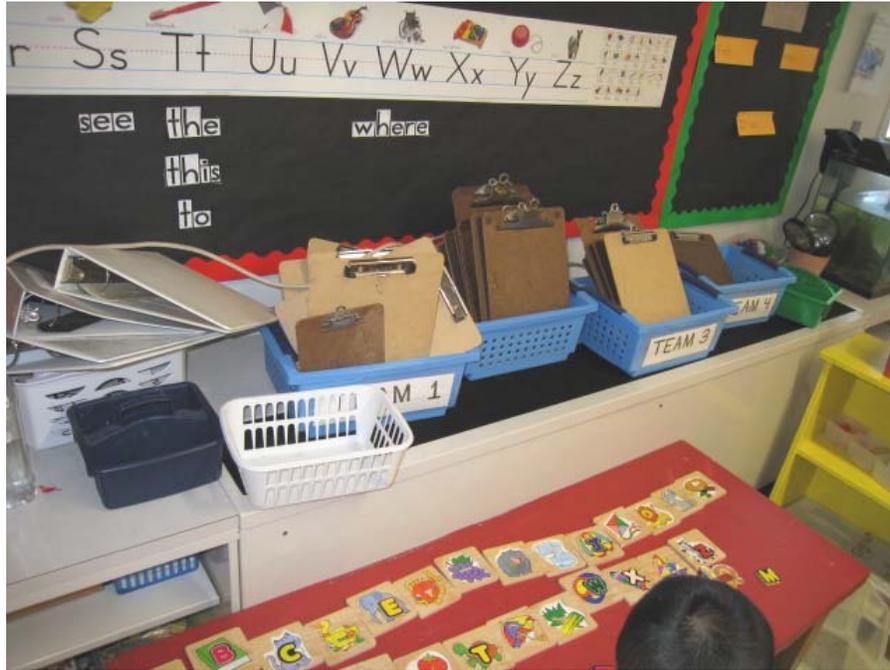
**Picture 1**

It can be seen from Table 1 that carbon dioxide levels were below 800 parts per million (ppm) in all areas surveyed, indicating adequate air exchange throughout the building the day of the assessment. Fresh air in classrooms is supplied by unit ventilator (univent) systems ([Figure 1](#)). A univent draws air from the outdoors through a fresh air intake located on the exterior wall of the building and returns air through an air intake located at the base of the unit. Fresh and return air are mixed, filtered, heated and provided to classrooms through an air diffuser located in the top of the unit. Adjustable louvers control the ratio of outside to recirculated air. Items were seen on top of univents in some areas, which can restrict airflow (Picture 1).

**Various Items on top of Univent Air Diffuser**

4. Remove all blockages in classrooms from univents to ensure adequate airflow.
5. Consider adopting a balancing schedule of every 5 years for all mechanical ventilation systems, as recommended by ventilation industrial standards (SMACNA, 1994).

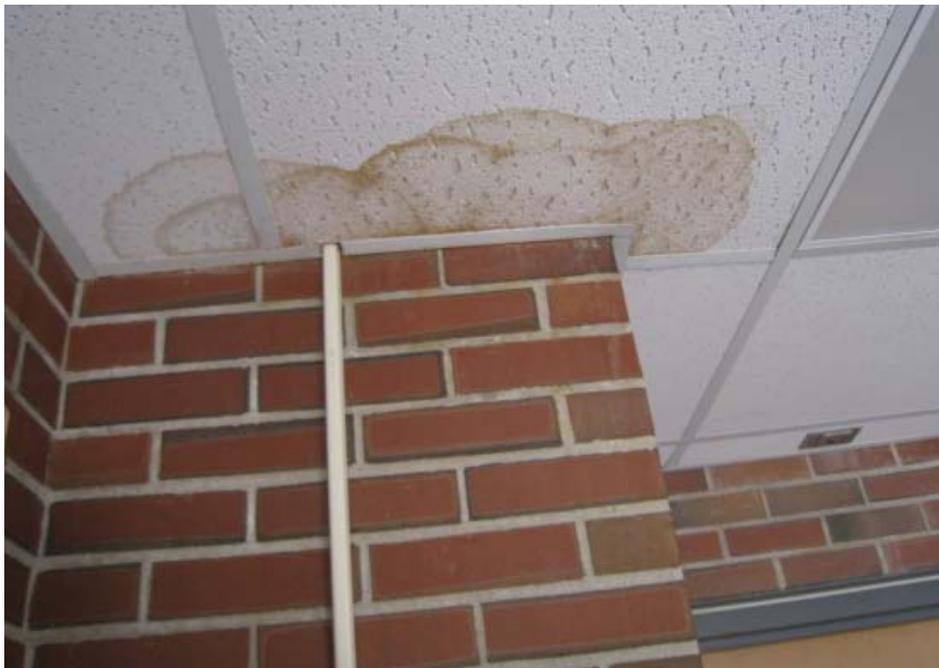
**Picture 2**

Water damaged ceiling tiles were observed in a number of areas, which indicate current/historic plumbing or roof leaks (Pictures 2 and 3/Table 1). Water damaged ceiling tiles can provide a source of mold and should be replaced after a water leak is discovered and repaired. Missing tiles were observed in classroom 9, where the occupant reported a current roof leak (Picture 4).

**Water Damaged Ceiling Tiles in Gym Hallway**

9. Ensure all roof leaks are repaired (e.g., classroom 9), and replace water damaged ceiling tiles. Examine the area above and around water-damaged areas for mold growth. Disinfect areas with an appropriate antimicrobial as needed.

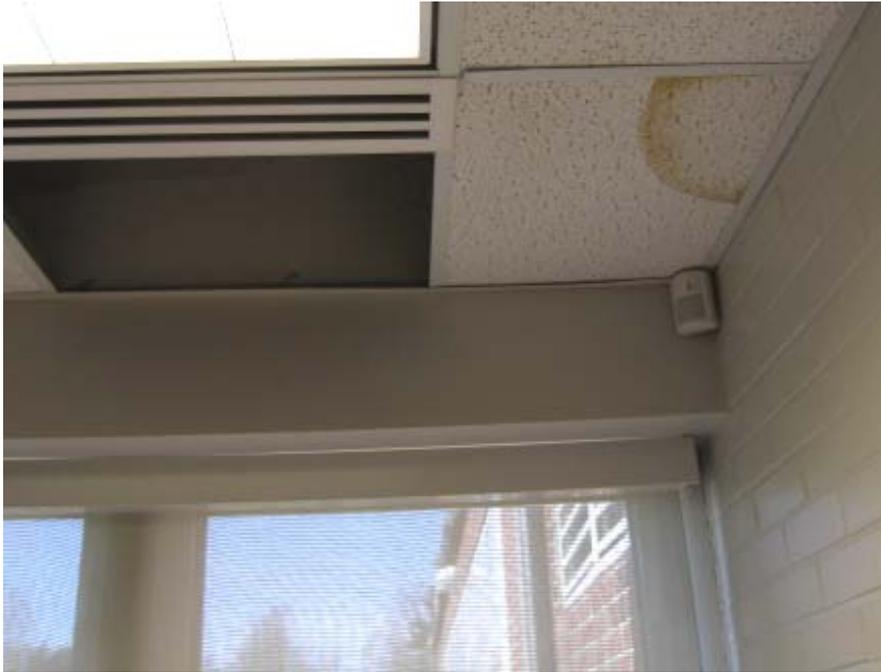
**Picture 3**

**Water Damaged/Missing Ceiling Tiles in Classroom**

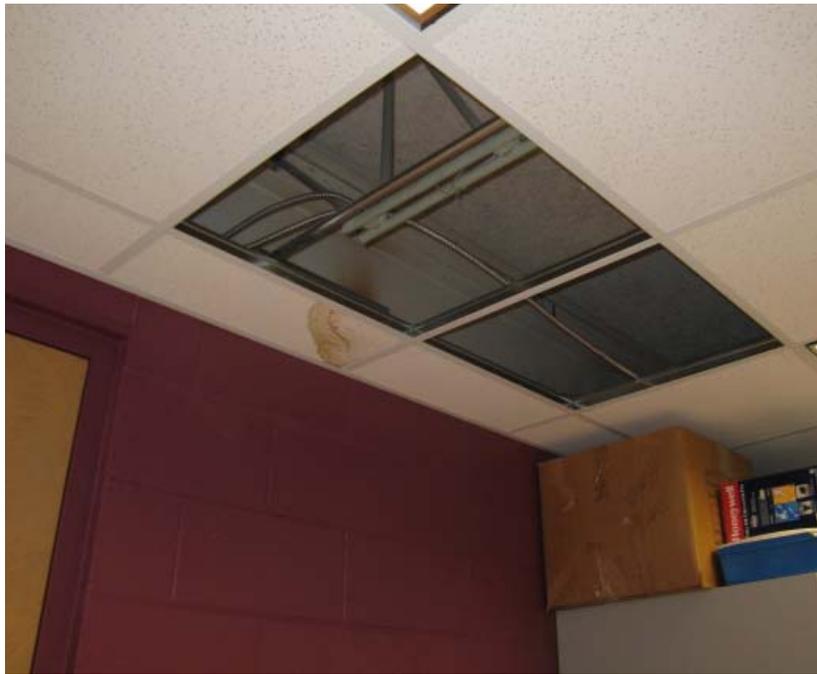
**Picture 4**

**Active Leak Reported in Classroom 9, Note Water Damaged/Missing Ceiling Tiles**

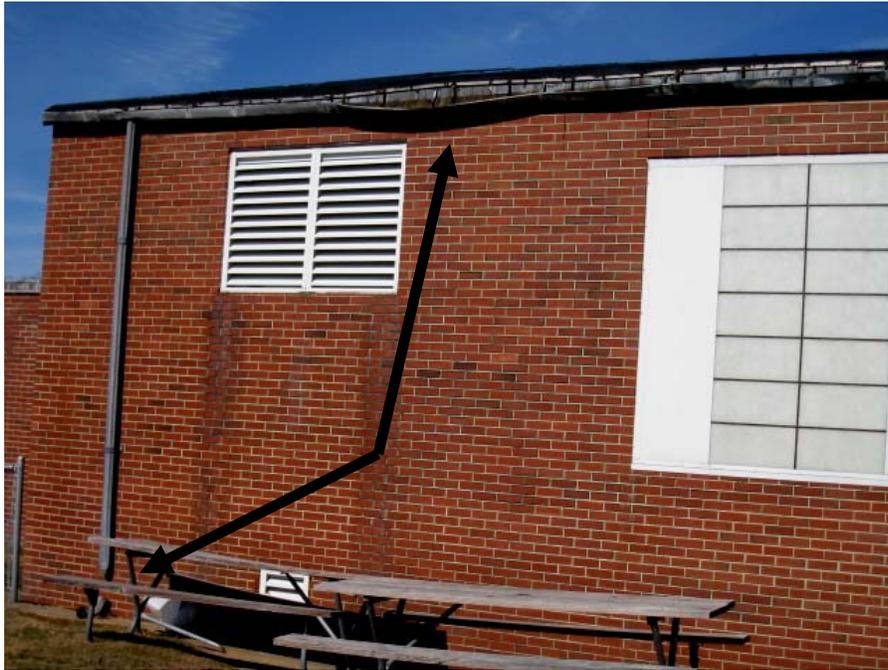
**Picture 5**

BEH staff examined conditions on the exterior of the building for potential sources of water pooling/penetration. Gutters and downspouts along the rear of the cafeteria were observed damaged, disconnected and/or in disrepair (Picture 5), which can allow water to accumulate against the building. Also observed on the exterior of the building was missing/damaged brick and mortar around masonry (Picture 6). Over time, these conditions can undermine the integrity of the building envelope and provide a means of water entry into the building via capillary action through foundation concrete and masonry (Lstiburek & Brennan, 2001).

**Damaged Gutter and Disconnected Elbow at Base of Downspout to Rear of Cafeteria**

7. Repair/replace damaged gutters and downspouts, particularly along the rear of the cafeteria.
8. Repoint/repair damaged brick/masonry around the exterior of the building.

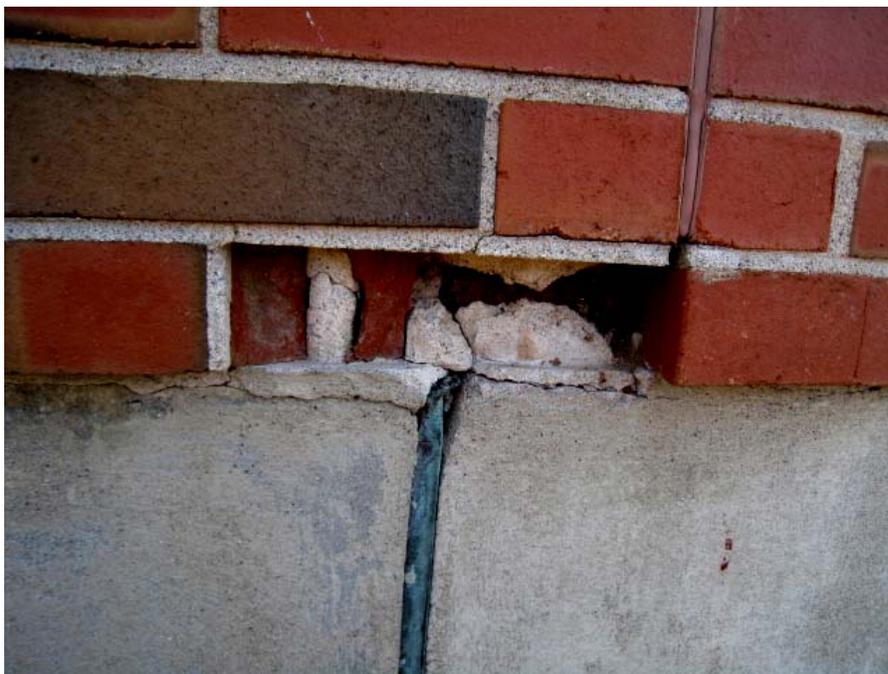
**Picture 6**

**Missing/Damaged Brick/Mortar**

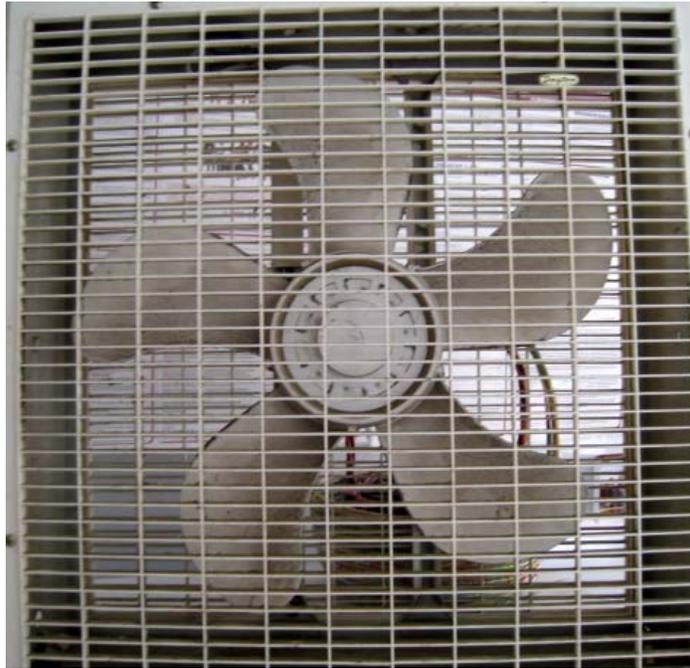
**Picture 7**

Other conditions that can affect indoor air quality were observed during the assessment. A number of personal fans were observed to have accumulated dust/debris (Picture 7). These fans should be cleaned in order to prevent dust/debris from being aerosolized and redistributed throughout the room when activated. **This observation was documented previously by MDPH (MDPH, 2008).**

**Fan in Classroom with Accumulated Dust and Debris**

11. Clean accumulated dust and debris periodically from the surface of personal fans.
12. Consider adopting the US EPA (2000) document, “Tools for Schools”, as an instrument for maintaining a good indoor air quality environment in the building. This document is available at: <http://www.epa.gov/iaq/schools/index.html>.
