INDOOR AIR QUALITY ASSESSMENT

**West Boylston Middle/High School
125 Crescent Street
West Boylston, Massachusetts**

Prepared by:
Massachusetts Department of Public Health
Bureau of Environmental Health
Indoor Air Quality Program
January 2010

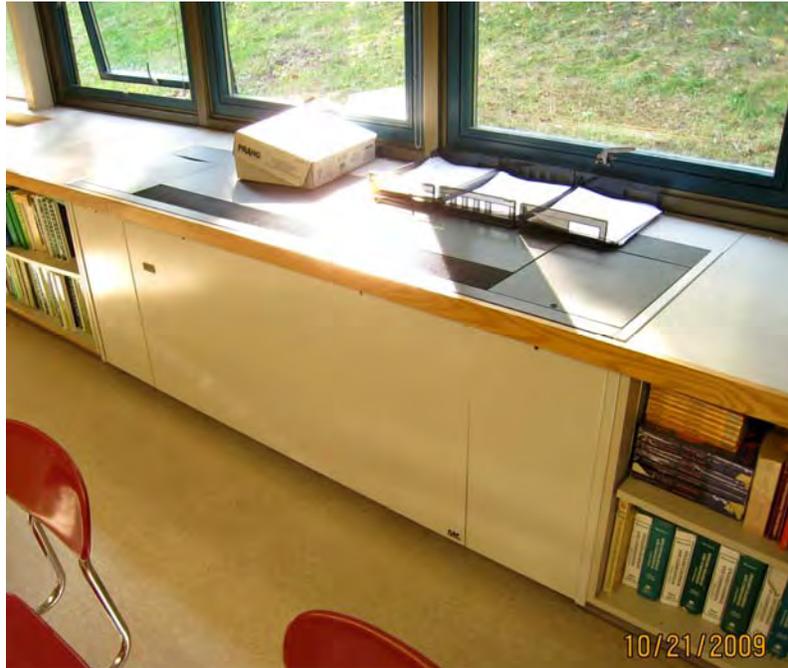
Picture 1

Fresh air is supplied to classrooms by unit ventilator (univent) systems (Picture 1). A univent draws outdoor air through an air intake located on the exterior wall of the building (Picture 2) and return air from the room through an air intake located at the base of the unit

Classroom Univent

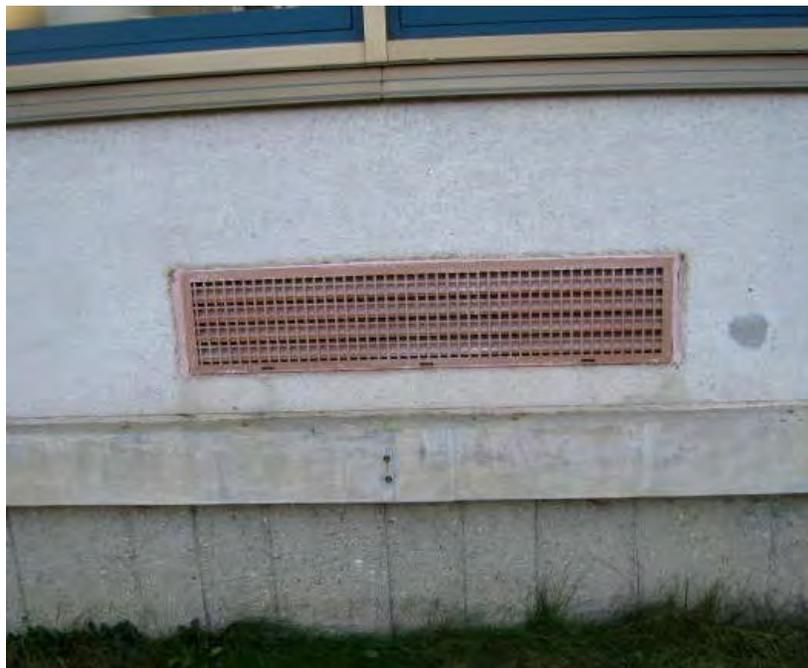
Picture 2

Univent Fresh Air Intake on Exterior Wall

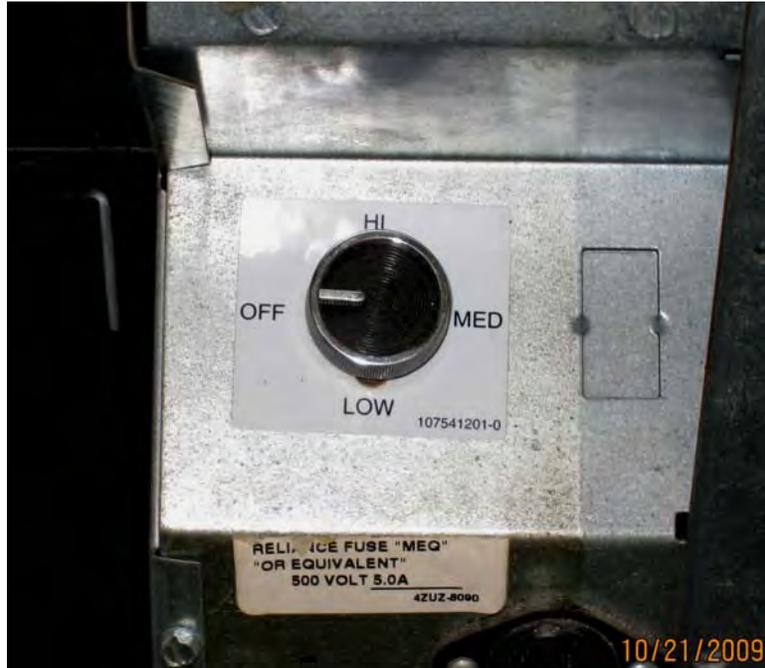
Picture 3

Univents have control settings of ‘off, low, medium and high’ (Picture 3). At the time of the assessment, BEH staff found univents switched ‘off’ in the majority of rooms, preventing fresh air from being introduced into these rooms (Table 1). Univent air diffusers and return intakes were also blocked by books, furniture and other stored items in front and on top of the unit, thereby limiting airflow in the rooms (Picture 4). In science room 201, BEH staff found the front panels of a univent removed and placed on top of the unit (Picture 5). In order for univents to provide fresh air as designed, air diffusers and intakes must remain free of obstructions. Importantly, these units must remain “on” and be allowed to operate while rooms are occupied.

Univent Control Settings

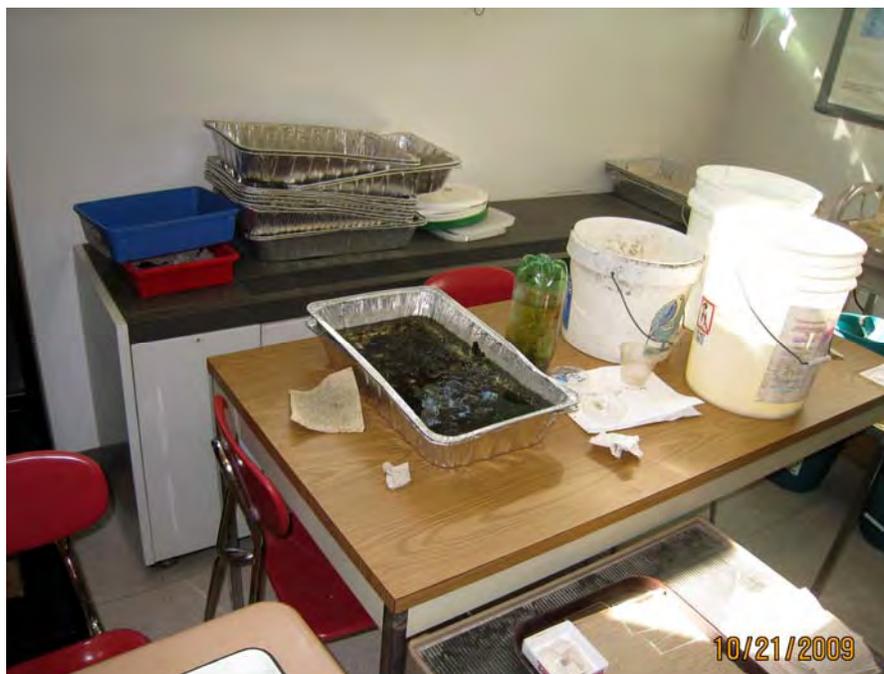
Picture 4

Items Stored in Front and on Top of Univent

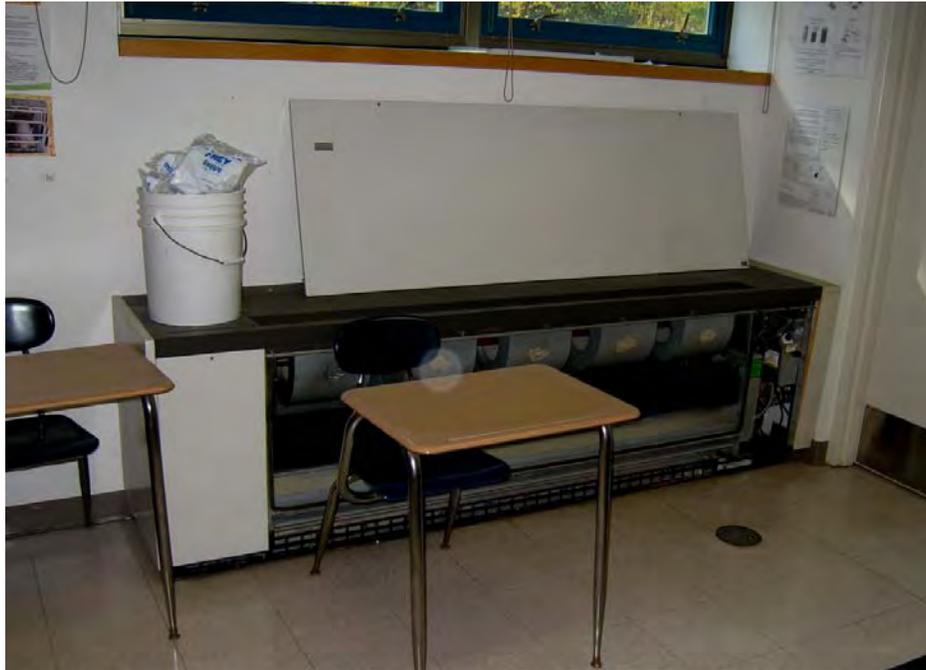
Picture 5

Univent Front Panels Removed

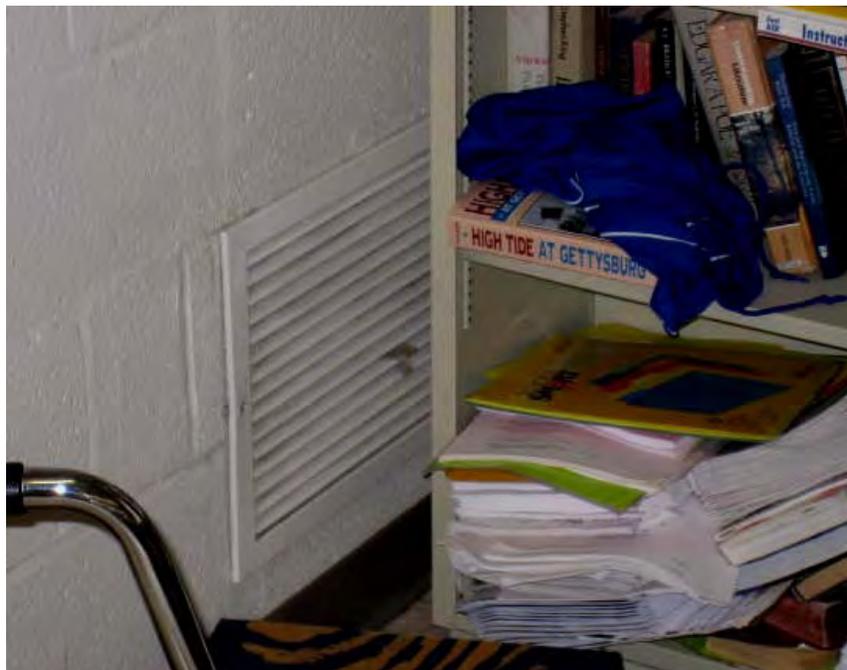
Picture 6

Exhaust ventilation in classrooms is provided by ceiling or wall-mounted vents ducted to rooftop motors (Pictures 6 through 8). The exhaust ventilation system is designed to continuously remove moisture, odors, and pollutants from the indoor environment. Exhaust vents were not functioning in the majority of areas surveyed at the time of the assessment. BEH staff also found several exhaust vents blocked by furniture and other stored items (Pictures 9 and 10). In order to function properly, exhaust vents must be activated and allowed to operate without obstruction while rooms are occupied. Without adequate exhaust ventilation, excess heat and environmental pollutants can build up leading to indoor air/comfort complaints.

Exhaust Vents on Wall; Note Furniture in Front of Vent

3. Restore exhaust ventilation throughout the building. Inspect motors and belts for proper function, and perform repairs and adjustments as necessary.

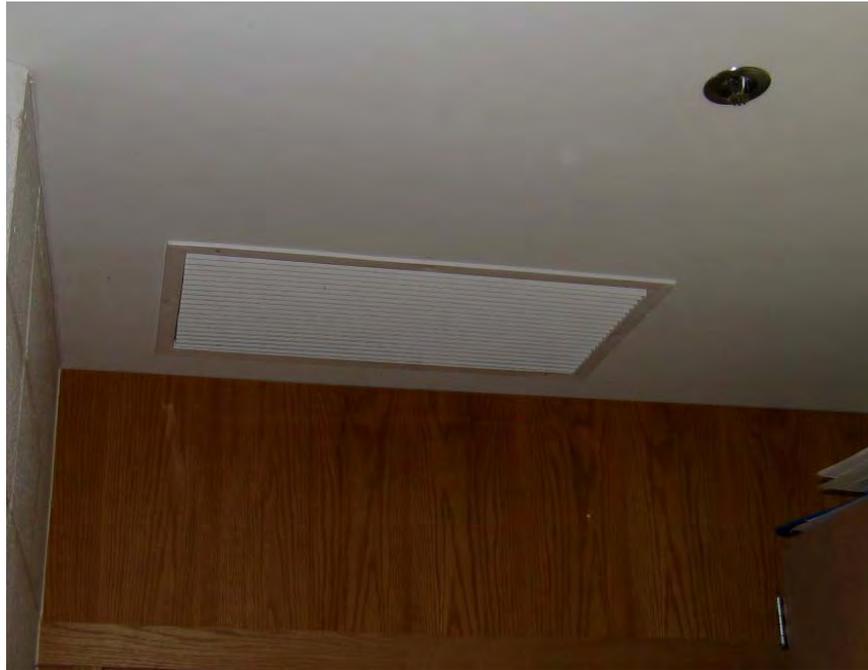
Picture 7

Exhaust Vent on Ceiling

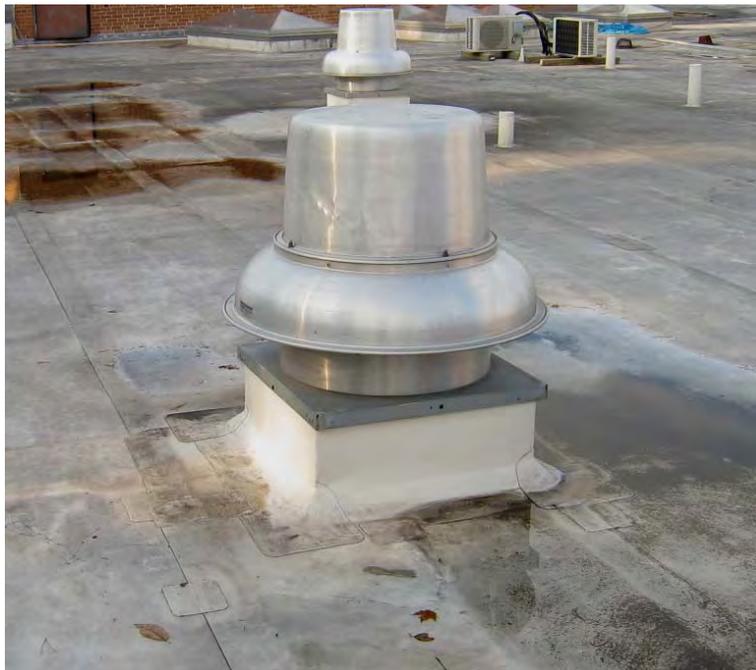
Picture 8

Rooftop Exhaust Vent Motor

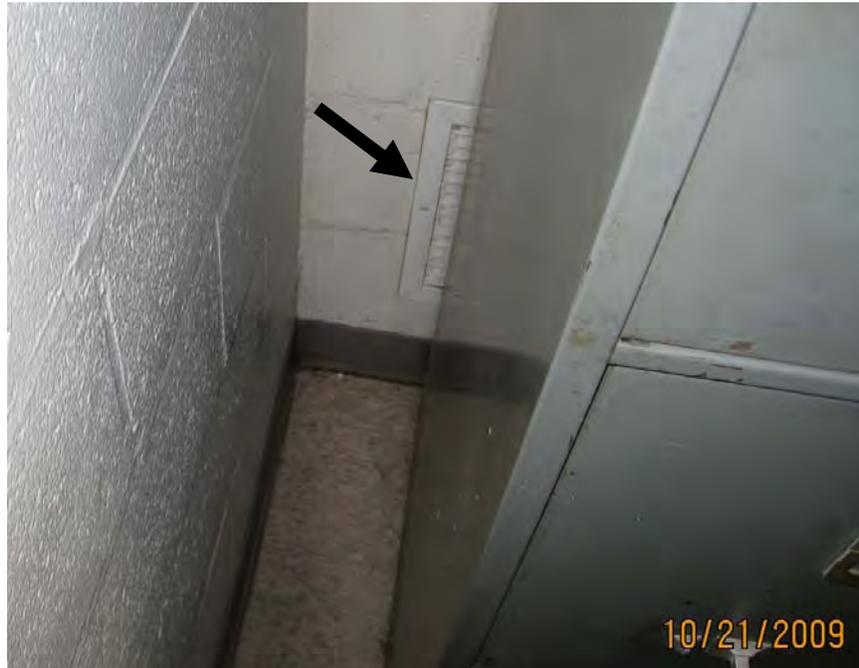
Picture 9

Exhaust Vent Blocked by Furniture

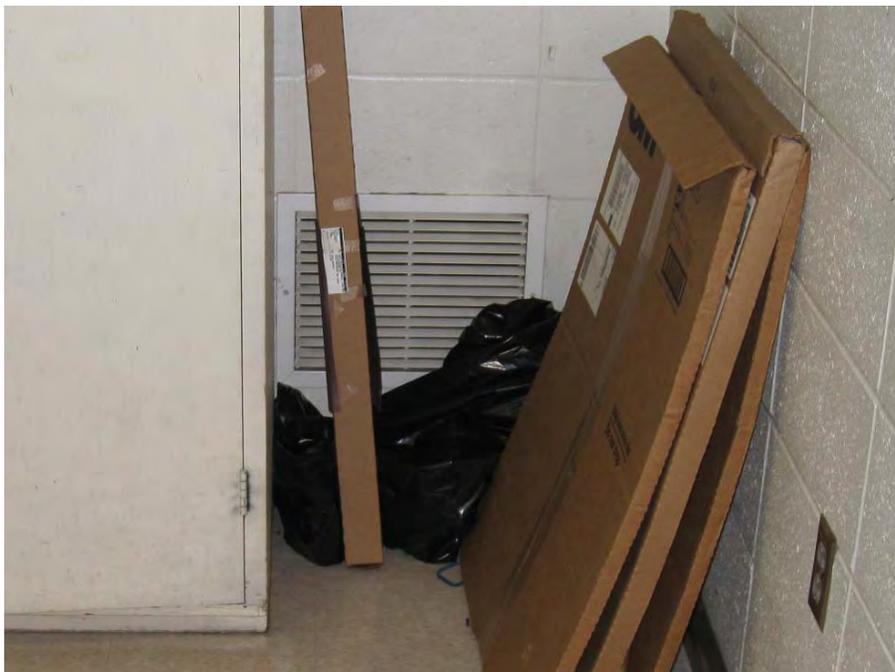
Picture 10

Exhaust Vent Blocked by Stored Items

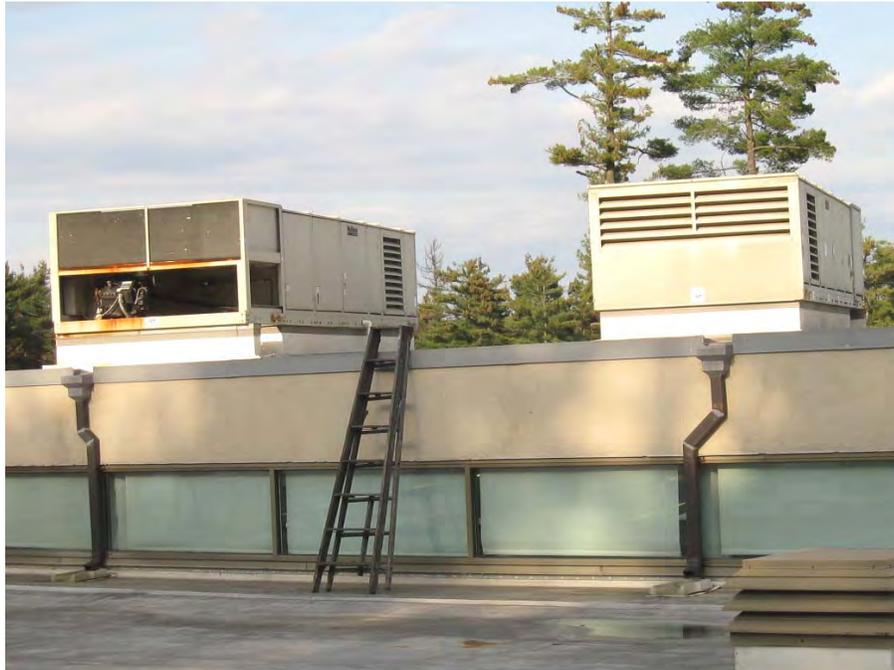
Picture 11

The heating, ventilating and air conditioning (HVAC) systems for areas such as the auditorium, computer rooms, gymnasium, main office and library consist of rooftop or ceiling-mounted air handling units (Picture 11). Air handling units (AHUs) draw in outdoor air through intakes, filter, heat and/or cool the air, and distribute it to occupied areas via ceiling or wall-

Air Handling Units on Roof

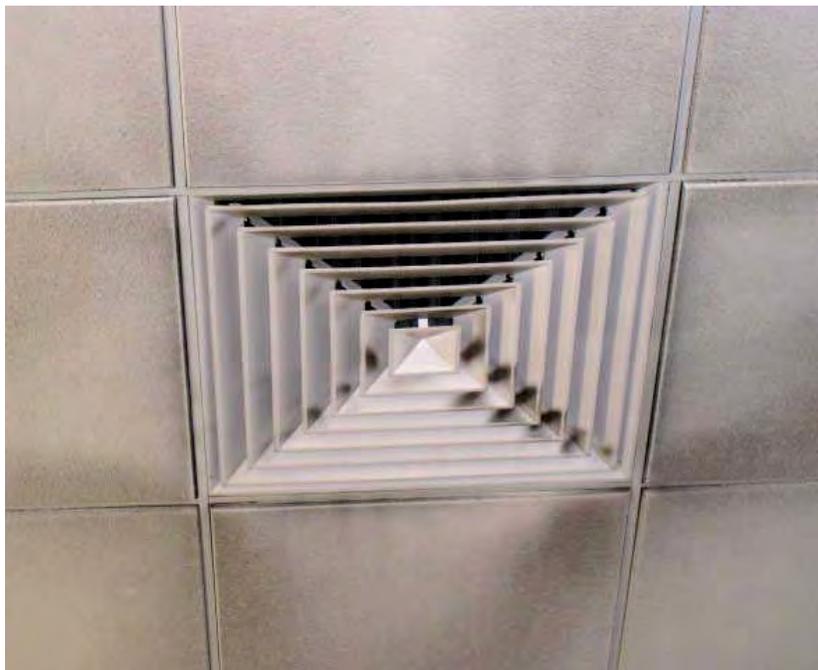
Picture 12

Air Diffuser in Ceiling; Note Accumulated Dust/Debris on Ceiling Tiles

23. Clean chalkboards and dry erase board trays regularly to avoid the build-up of dust and particulates.
24. Clean air diffusers, exhaust vents and personal fans periodically of accumulated dust. If stained ceiling tiles cannot be cleaned, replace.

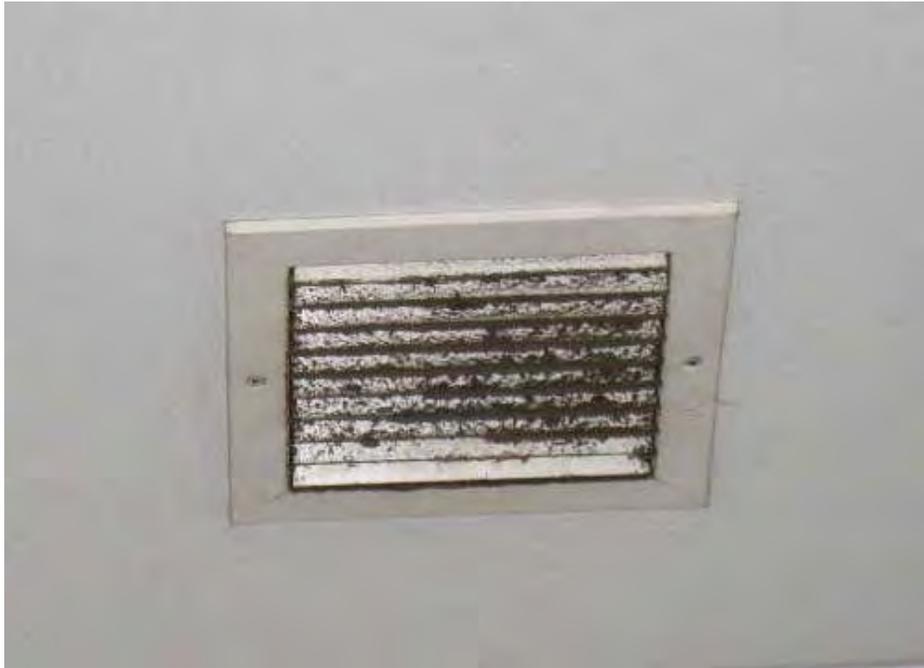
Picture 13

Lastly, a number of personal fans, exhaust vents, air diffusers and surrounding ceiling tiles were observed to have accumulated dust/debris (Pictures 13 and 51). Re-activated diffusers, vents or fans can aerosolize accumulated dust. If exhaust vents are not functioning, backdrafting can occur, which can re-aerosolize dust particles.

Exhaust Vent in Ceiling; Note Accumulated Dust/Debris on Vent

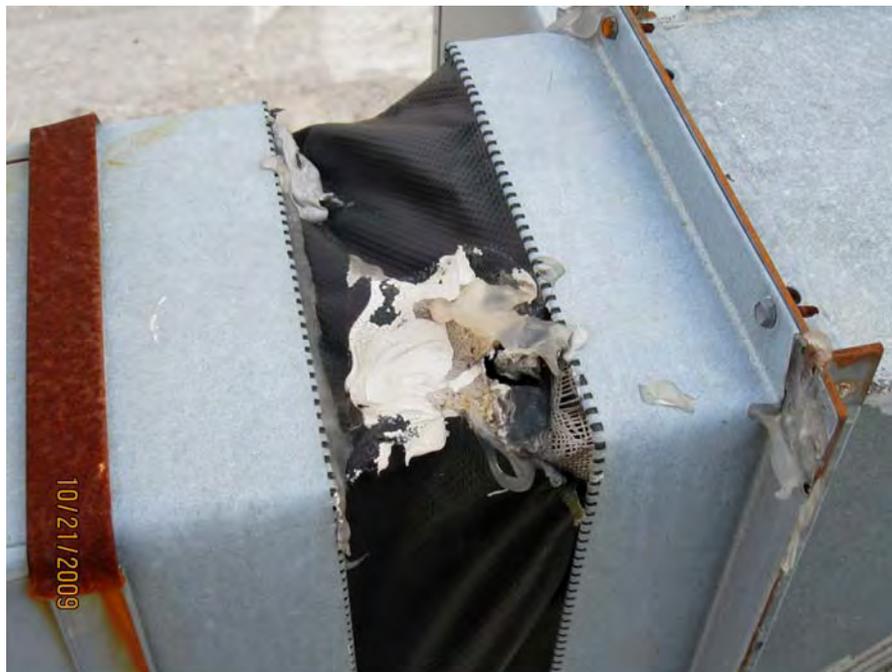
Picture 14

BEH staff examined the AHUs on the roof. A number of AHUs appeared to be original equipment, and nearing the end of their useful life cycle. AHU casings and ductwork were severely corroded, weathered and physically damaged (Picture 14). In one instance, ductwork was not attached to the roof (Picture 15). This ductwork was reportedly taken apart during the installation of the new roof, and never re-attached.

Damaged Ductwork on Roof

2. Consider contacting a ventilation engineer to inspect HVAC equipment and control system for proper function. Repair or replace components as necessary to ensure adequate air supply and exhaust capability throughout the school's classrooms, offices and common areas.

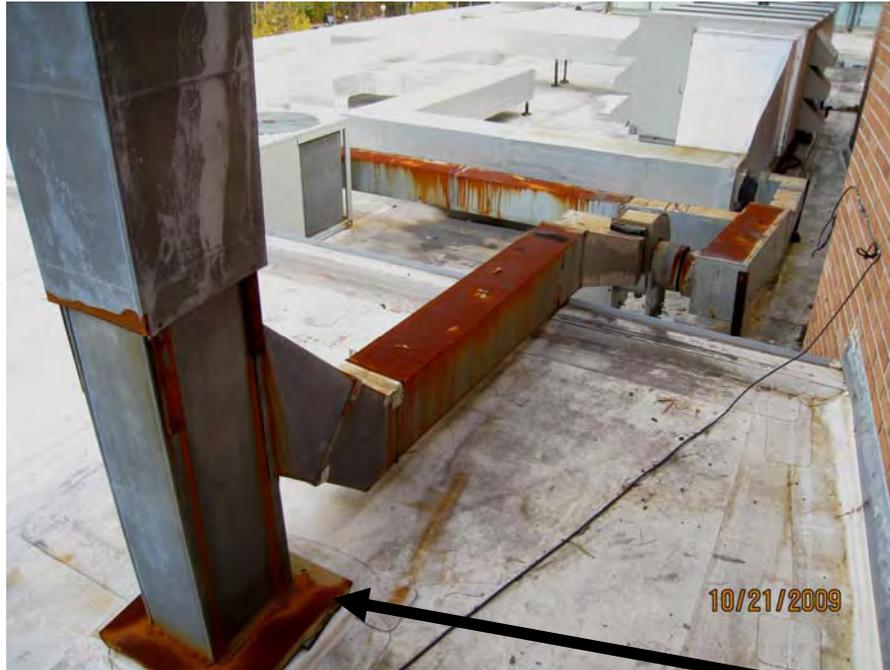
Picture 15

Damaged and Corroded Ductwork; Arrow Indicates where Ductwork Detached

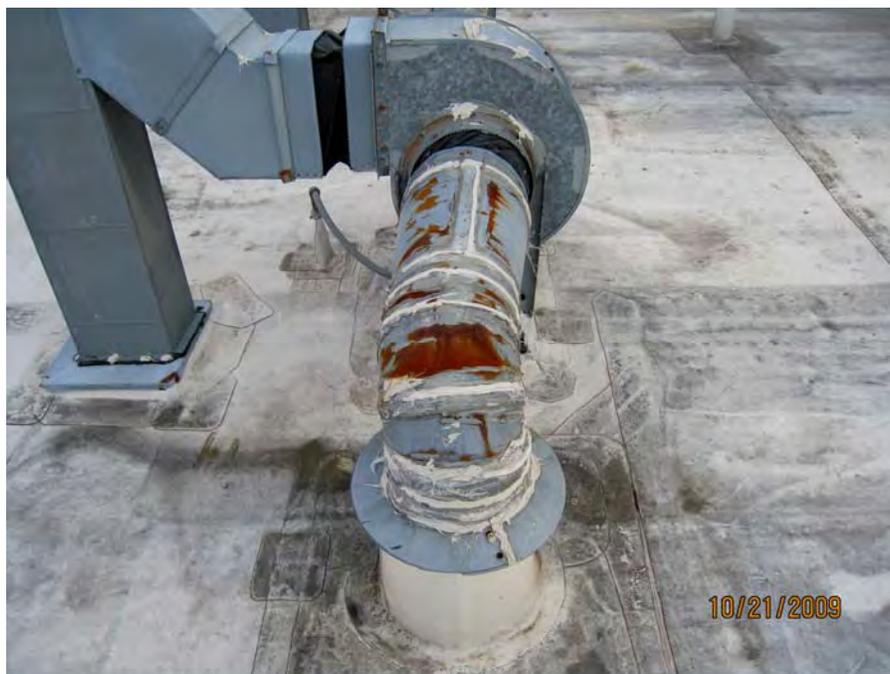
Picture 16

Science classrooms are equipped with chemical fume hoods ducted to the roof. Like the AHUs, this ductwork appeared to be original equipment. Ductwork for the fume hoods was damaged and glued together with caulking (Picture 16). The chemical hoods were not operating at the time of the assessment. No record of the last date of calibration/inspection of the hoods was readily apparent. A chemical hood should be recalibrated on an annual basis or as recommended by the manufacturer to ensure proper function.

Damaged Chemical Fume Hood Ductwork

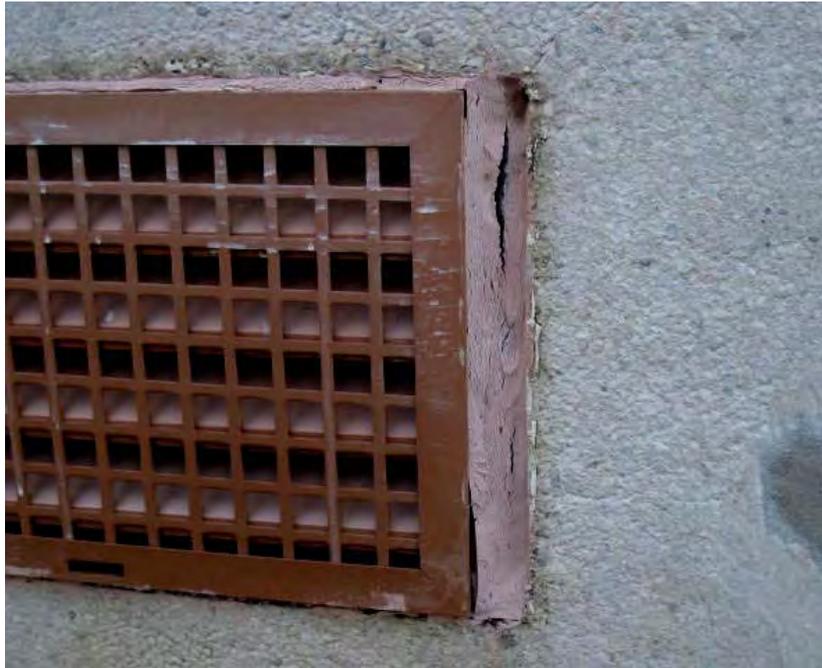
Picture 17

- Cracked and damaged caulking around fresh air intakes on exterior wall (Picture 17).
- Blocked weep holes (Pictures 18 and 19); weep holes serve a drainage function allowing moisture inside the building to move outside.
- Shrubs growing against the building and in front of fresh air intakes (Picture 20), which can hold moisture against exterior brick and allow moisture-laden air to be drawn in by the fresh air intakes.
- Damaged and/or missing exterior brick and mortar (Picture 21).
- Damaged downspouts, which allow water to pool at the base of the building (Picture 22).

Damaged Caulking Around Air Intake

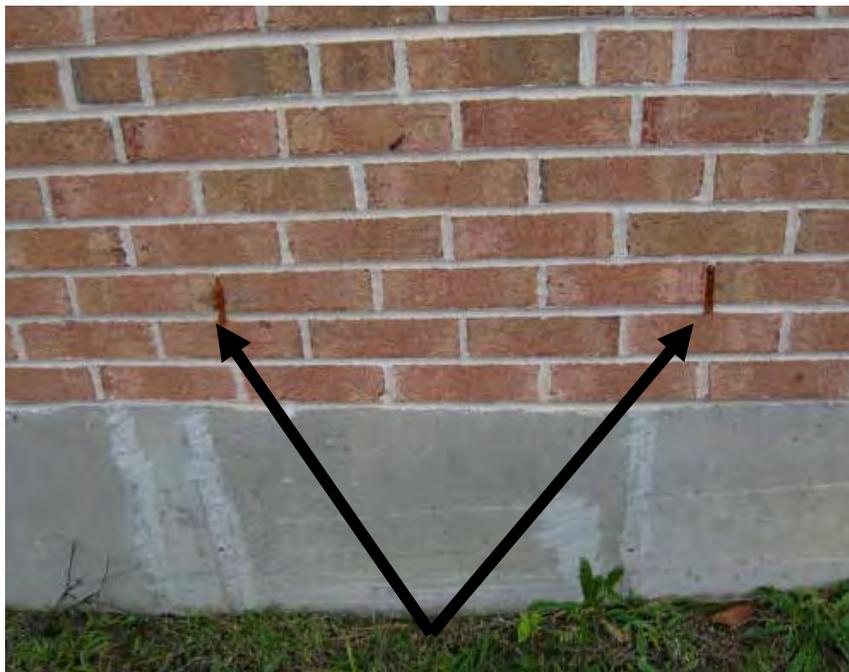
Picture 18

Blocked Weep Holes on Exterior Wall

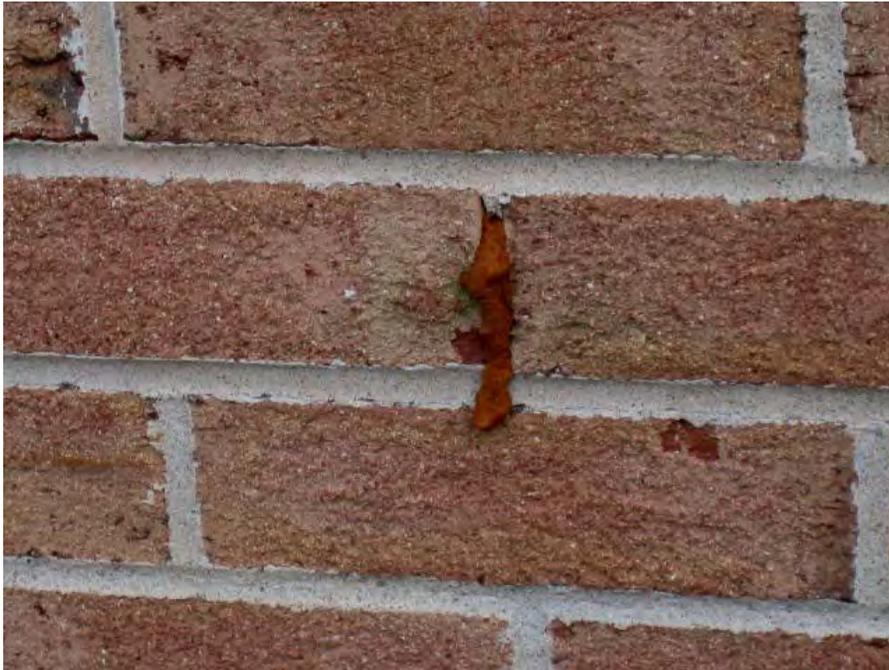
Picture 19

Blocked Weep Hole

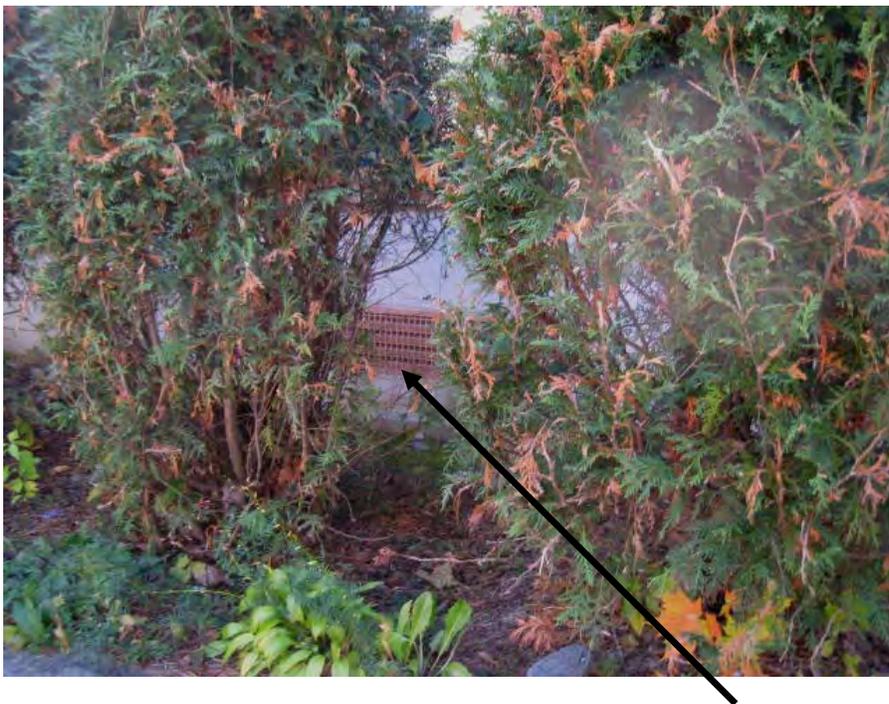
Picture 20

Shrubs Growing against Building and in Front of Air Intake

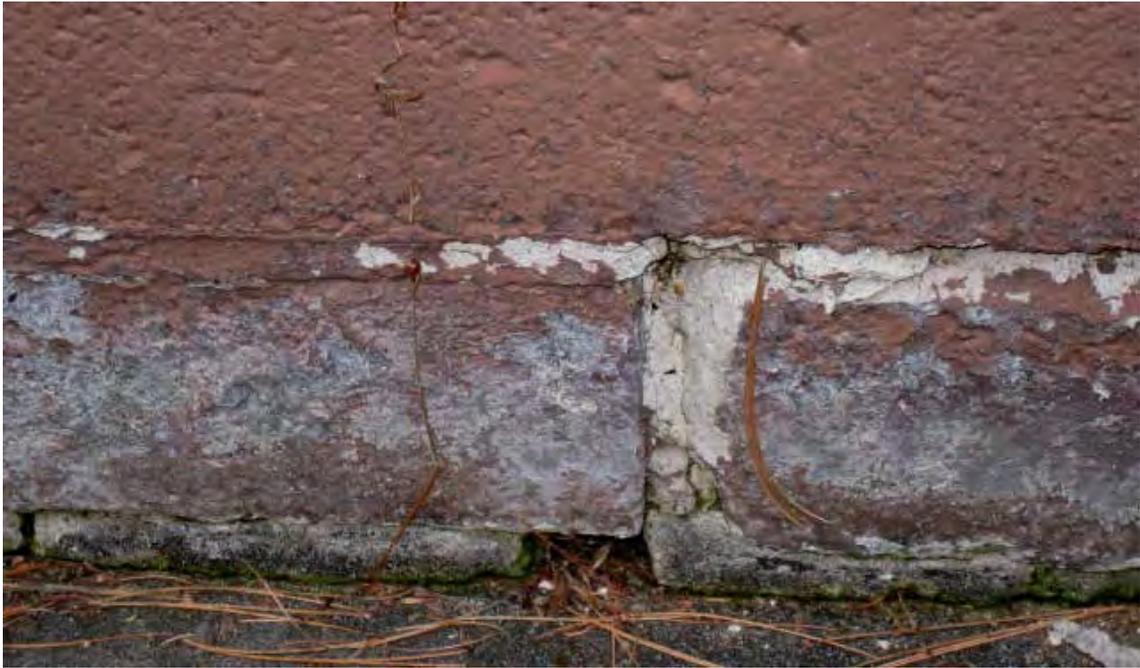
Picture 21

Damaged and/or Missing Exterior Brick and Mortar

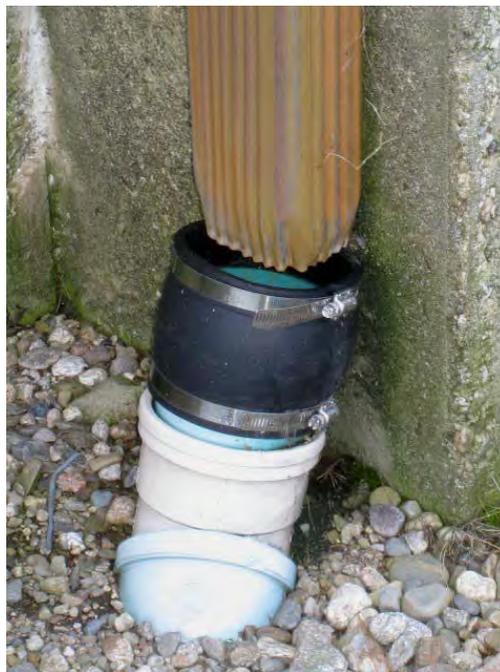
Picture 22

Disconnected Downspout

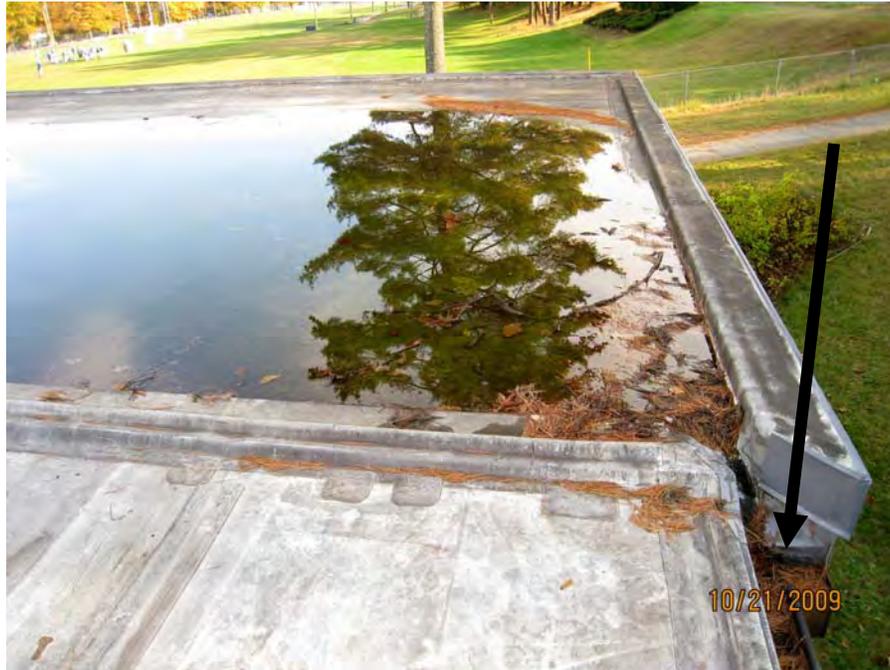
Picture 23

- Gutters clogged with debris including leaves and pine needles, preventing proper drainage (Picture 23).
- Pooling water was observed in a number of areas on the roof due to lack of drainage (Picture 23). The freezing and thawing of water during winter months can lead to roof leaks and subsequent water penetration into the interior of the building. Pooling water can also become stagnant, which can lead to mold and bacterial growth, and serve as a breeding ground for mosquitoes.

Gutters Clogged with Debris Causing Pooling Water on Roof

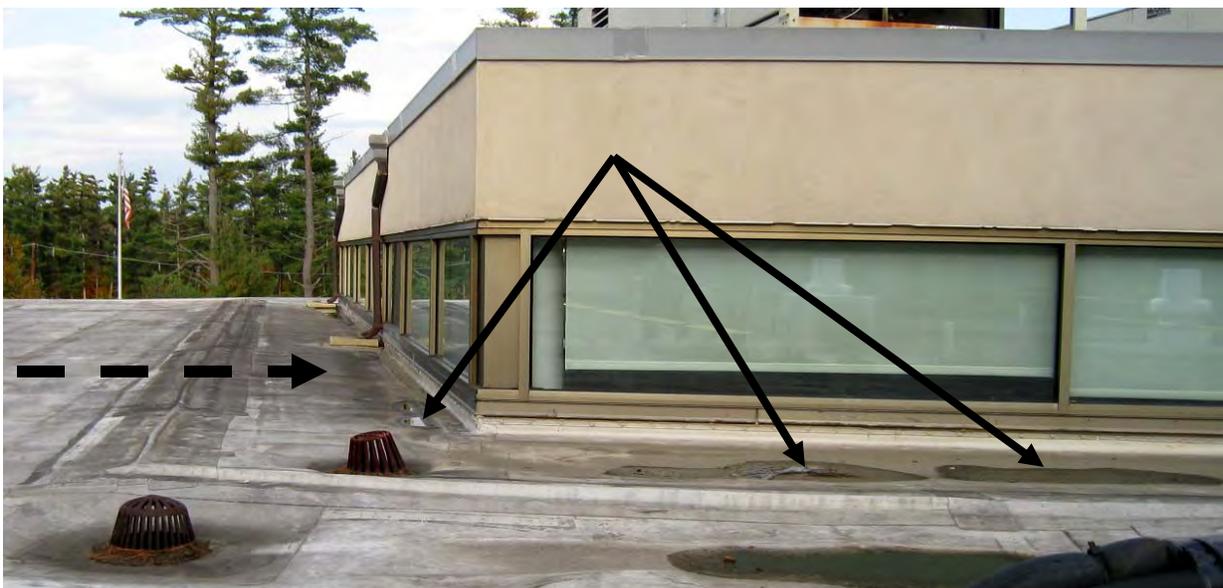
Picture 24

- The slope of the roof adjacent to the library windows directs water toward the library windows, allowing water to pool (Picture 24).
- Roof drains clogged with debris and/or missing.

**Slope of Roof Directs Water Toward the Library Windows, Where the Water Pools
Arrows Point to Areas Where Water has Pooled**

1. Contact an HVAC engineering firm for an assessment of the ventilation system's control system (e.g., controls, air intake louvers, thermostats). Based on the age, physical deterioration and availability of parts for ventilation components, such an evaluation is necessary to determine the operability and feasibility of repairing/replacing the equipment.
2. Consider having exterior walls re-pointed and waterproofed to prevent water intrusion. This measure should include a full building envelope evaluation.
3. Re-grade roof to slope toward drains in the library area to prevent water pooling/infiltration.

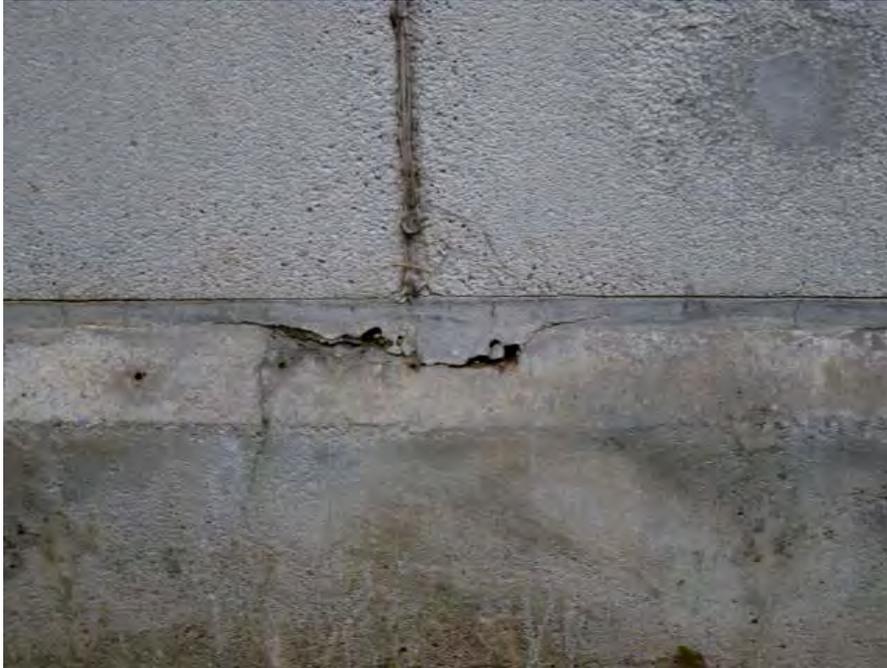
Picture 25

- Cracks and holes in exterior walls (Picture 25).
- Damaged/missing sealant between expansion joints (Picture 26).
- Breaches in the building foundation (Picture 27).

Cracks and Holes in Exterior Wall

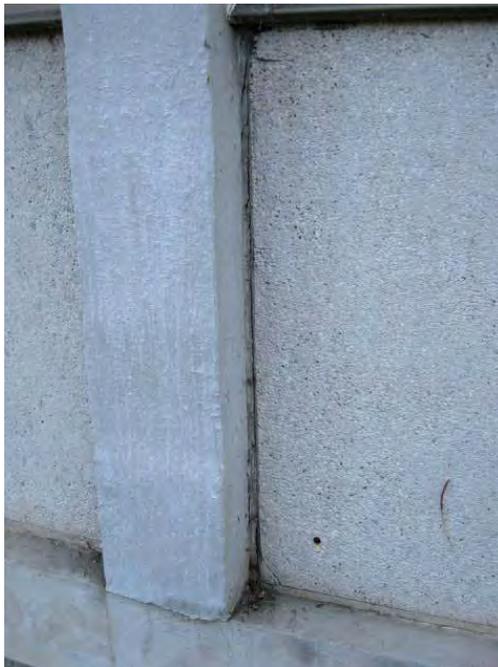
Picture 26

Damaged/Missing Sealant Between Expansion Joints

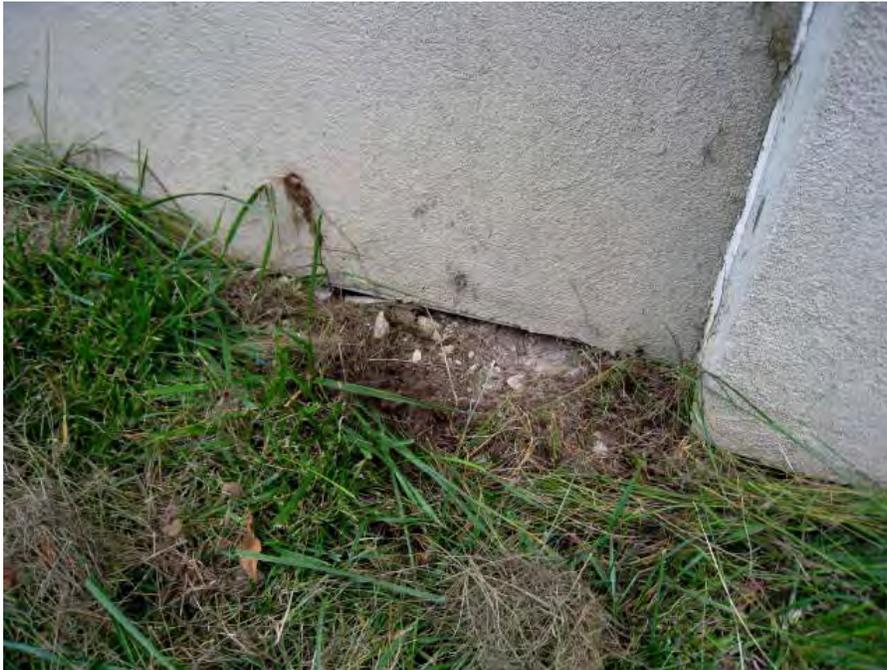
Picture 27

Breach in Building Foundation

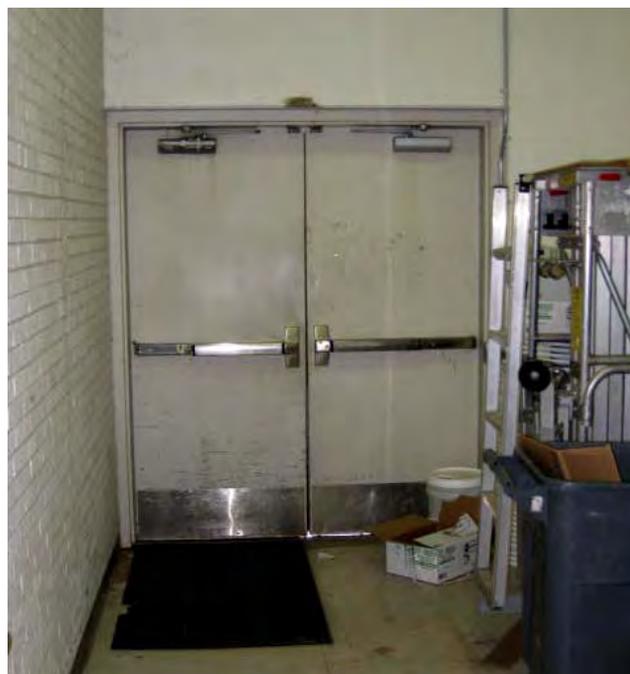
Picture 28

- Several exterior doors had damaged weather stripping, and light could be seen penetrating through the spaces underneath the door from the outdoors (Picture 28).

Light Penetrating Beneath Exterior Door

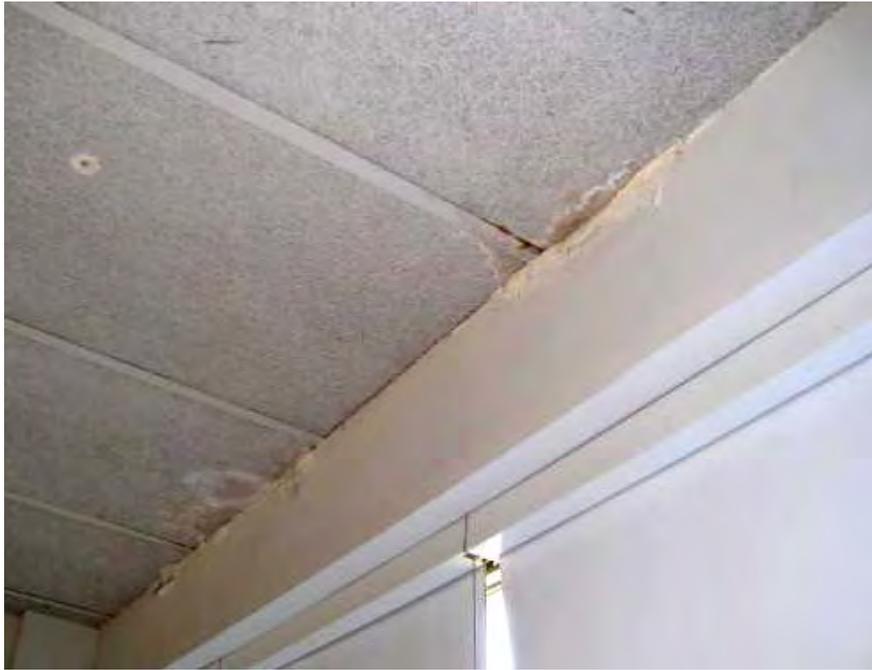
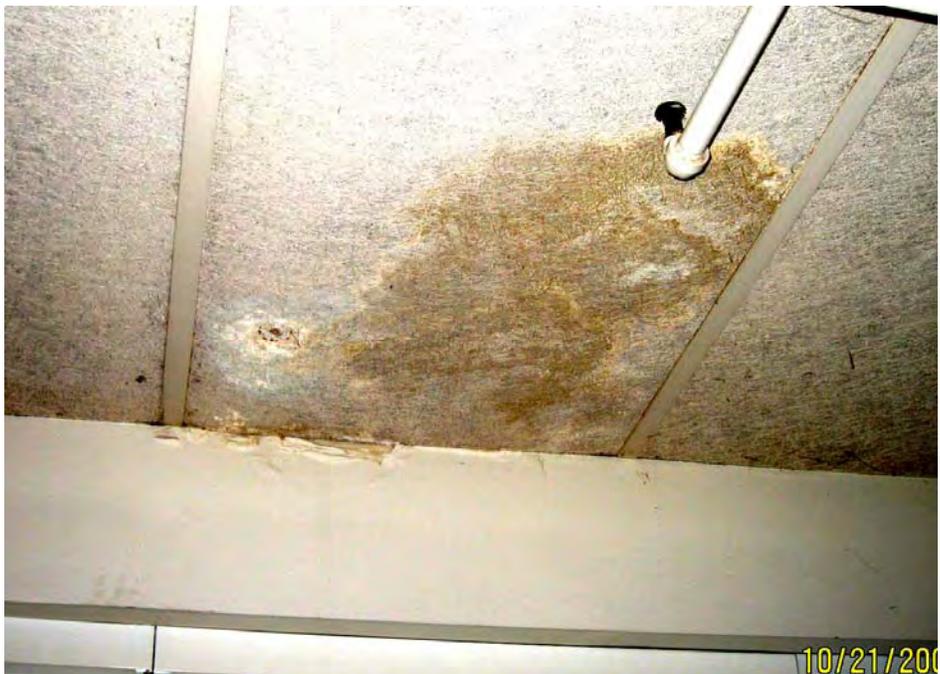
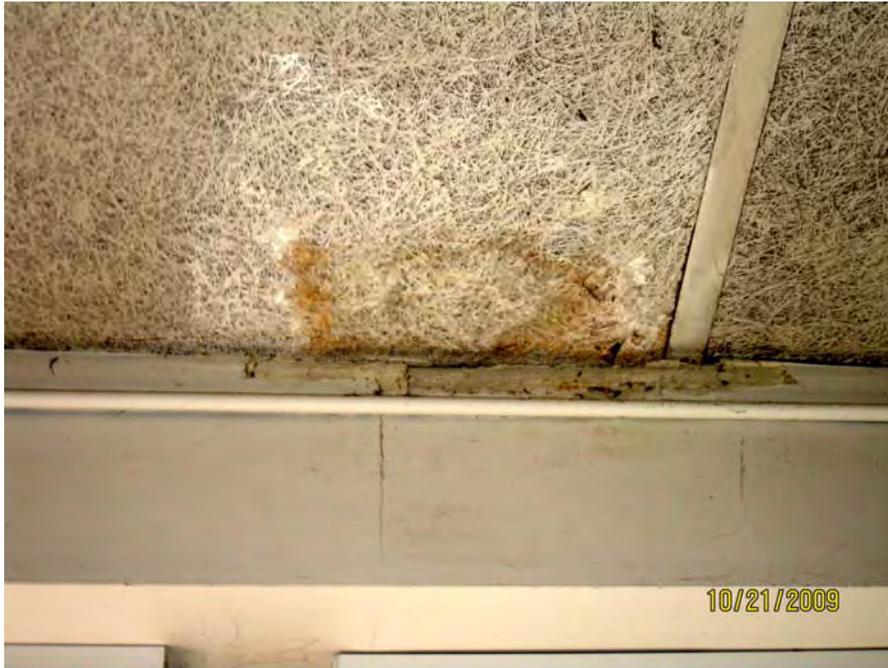
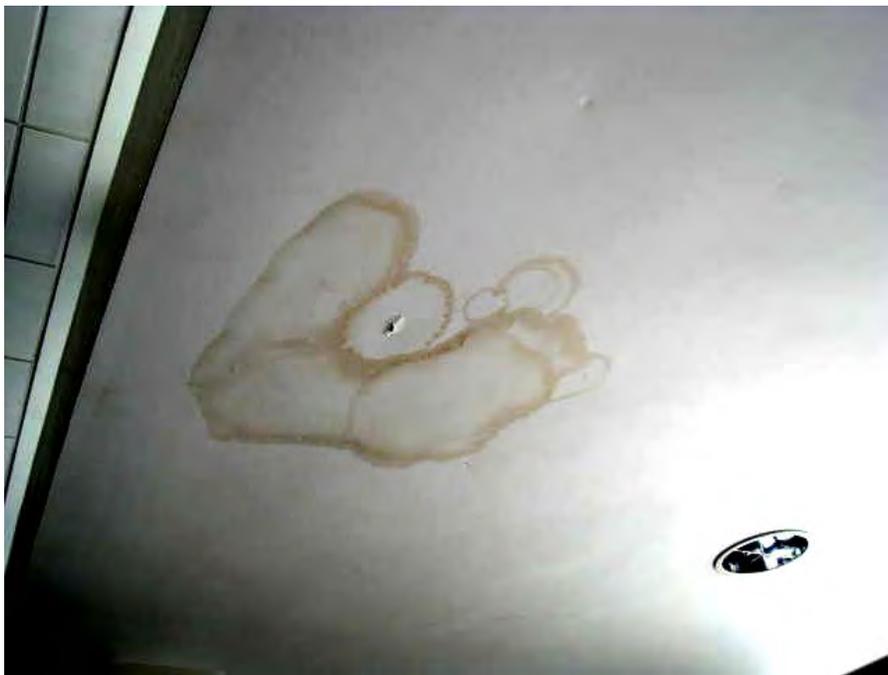
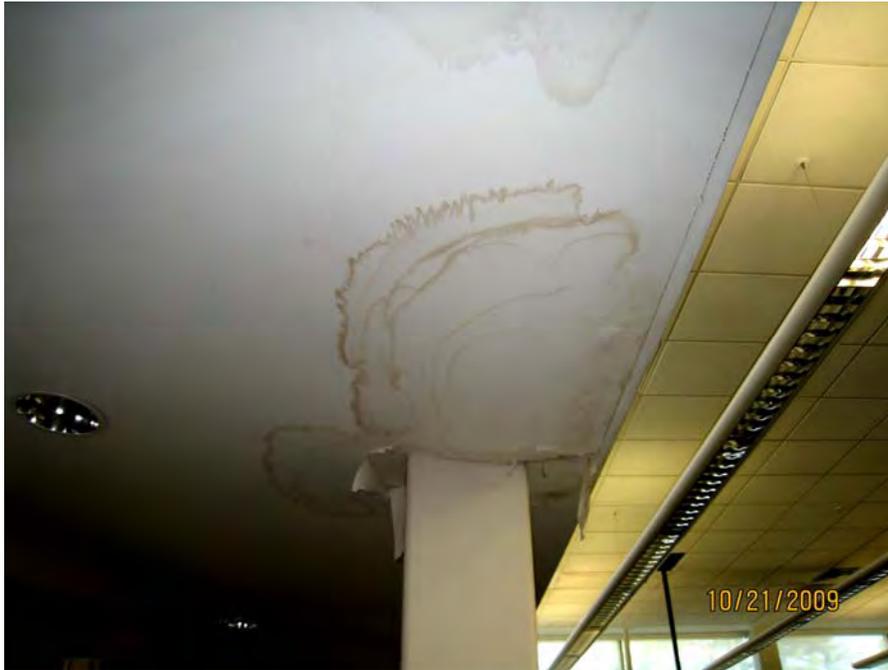
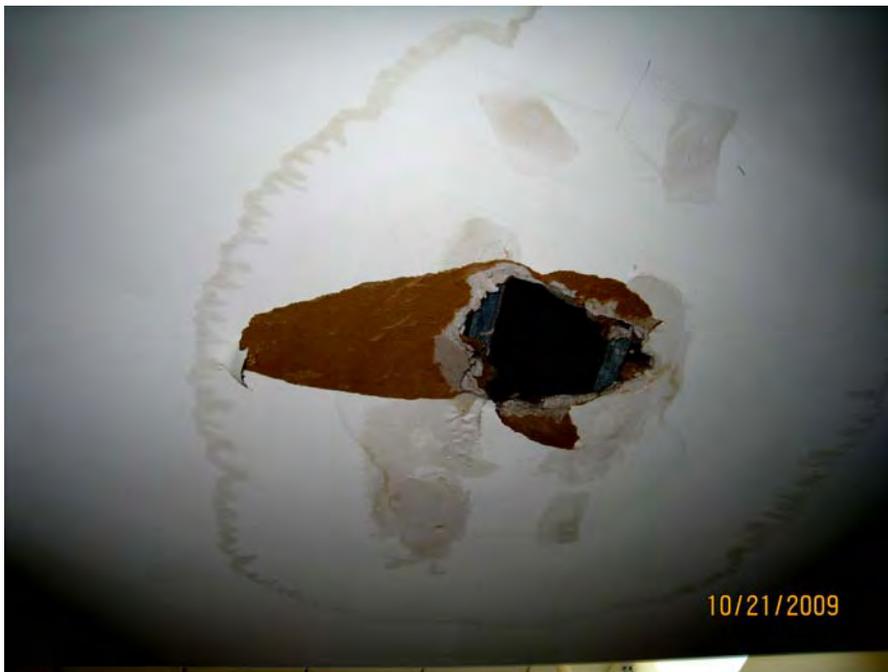
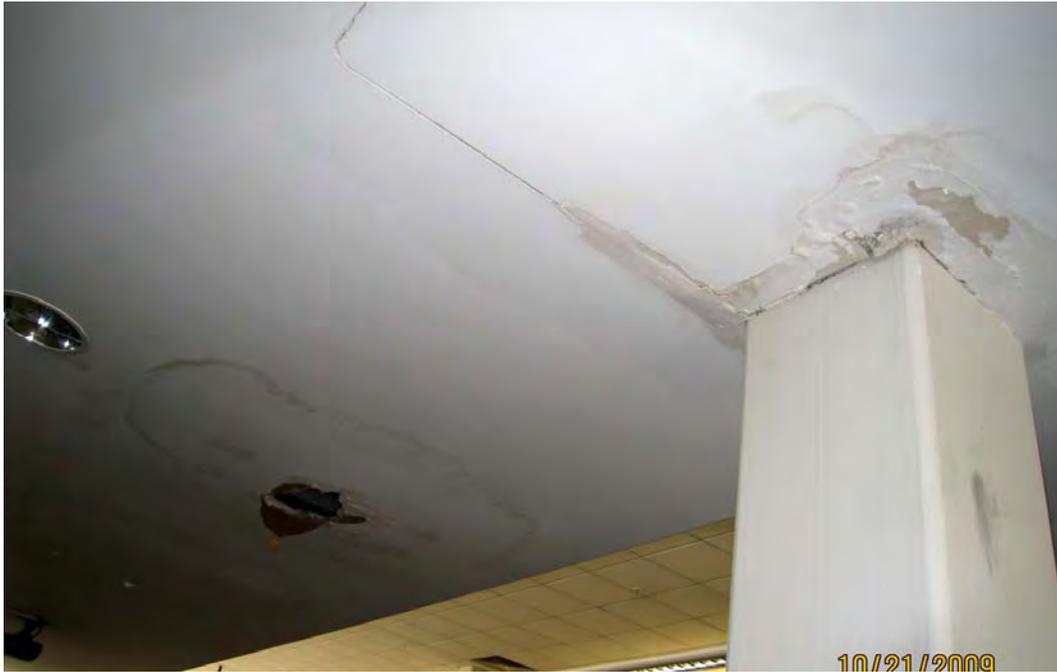
from the roof, plumbing system or water penetration through the building envelope (Pictures 29 through 35/Table 1). Water damage was visible on ceilings and walls, and above windows. BEH also noted water-damaged ceiling tiles in hallways and rooms. Ceiling tiles should be replaced after a water leak is discovered and repaired.

Water Damage on Ceiling and Wall Along Windows

Water Damage on Ceiling and Wall Above Windows

Water Damage on Ceiling

Water Damaged Ceiling
