INDOOR AIR QUALITY ASSESSMENT

**West Boylston Middle/High School
125 Crescent Street
West Boylston, Massachusetts**

Prepared by:
Massachusetts Department of Public Health
Bureau of Environmental Health
Indoor Air Quality Program
January 2010

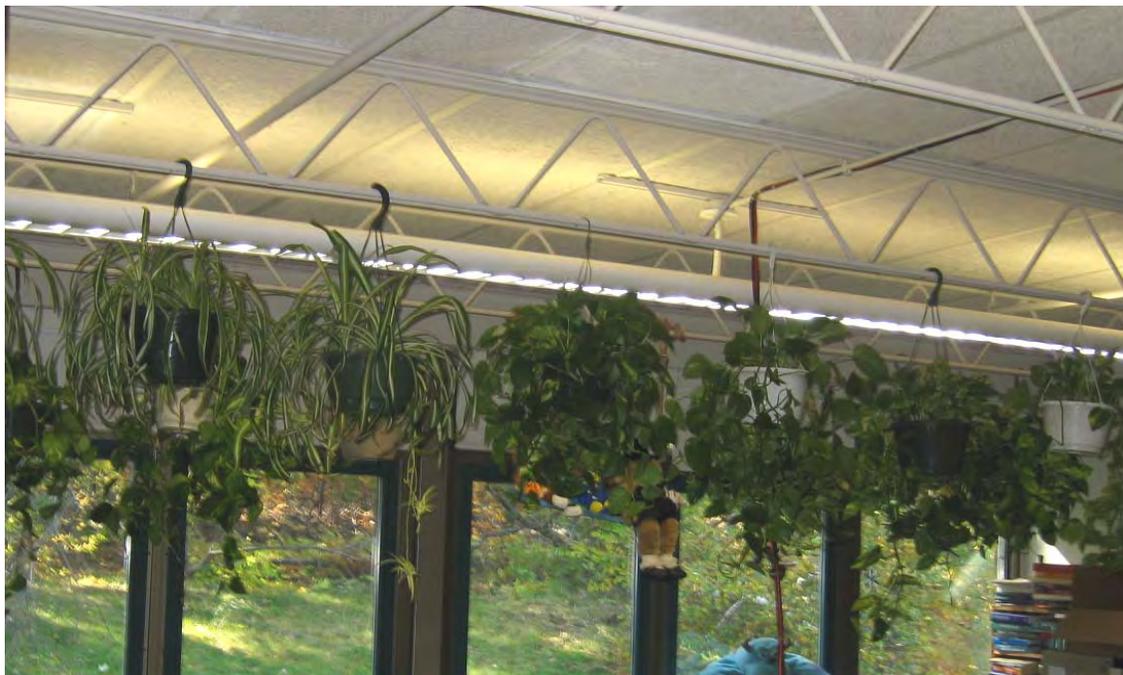
Picture 36

A number of classrooms had plants (Picture 36). Plants can be a source of pollen and mold, which can serve as respiratory irritants for some sensitive individuals. Plants should be properly maintained and equipped with drip pans to prevent water damage to porous building materials. Plants should also be located away from ventilation sources (e.g., univent air diffusers) to prevent the aerosolization of dirt, pollen or mold.

Hanging Plants in Classroom

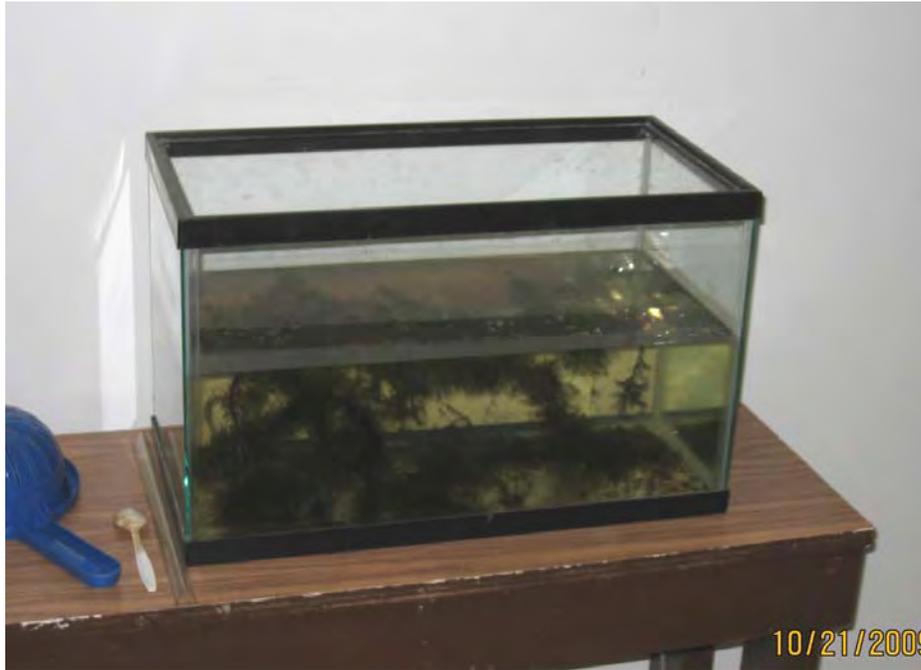
Picture 37

Aquarium in Room

Aquariums were also located in some classrooms (Picture 37). Aquariums should be properly maintained to prevent microbial/algae growth, which can emit unpleasant odors.

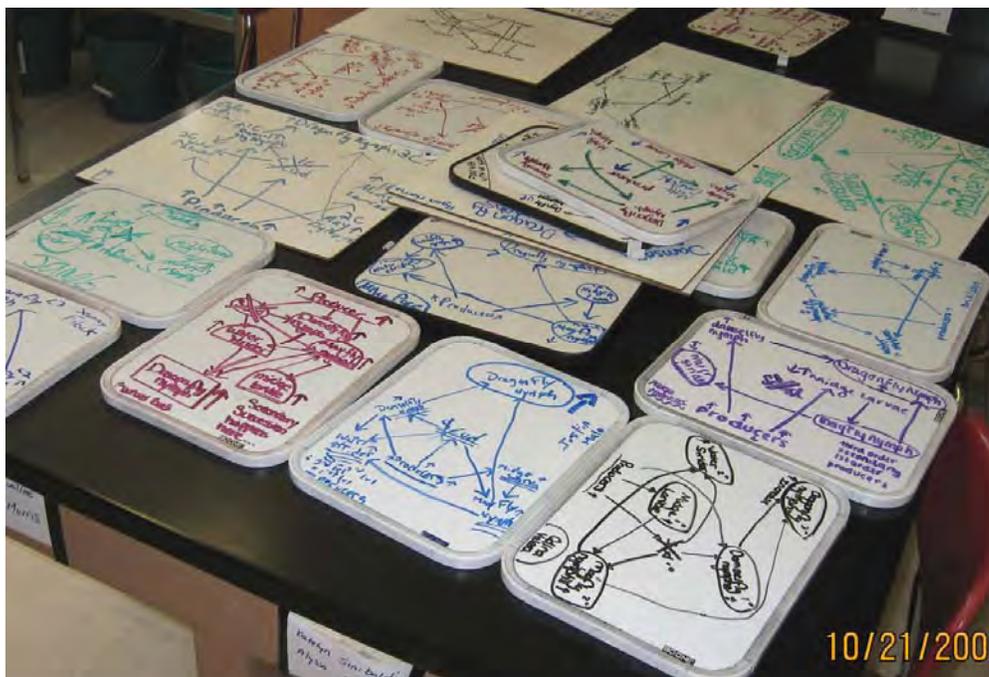
Picture 38

Dry Erase Materials

Several classrooms contained dry erase boards and related materials (Picture 38). Materials such as dry erase markers and dry erase board cleaners may contain VOCs, such as methyl isobutyl ketone, n-butyl acetate and butyl-cellusolve (Sanford, 1999), which can be irritating to the eyes, nose and throat.

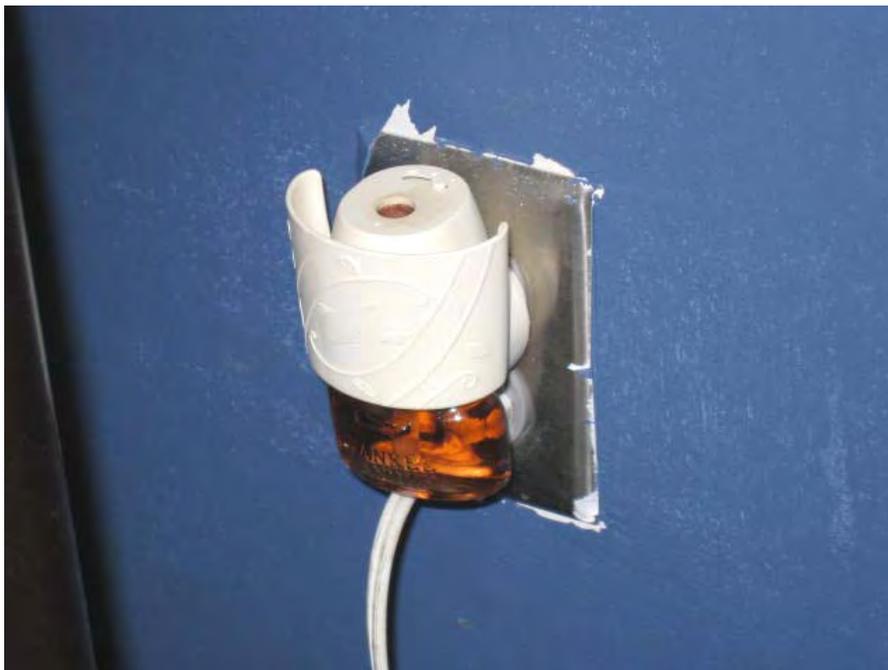
Picture 39

Plug-in air fresheners were observed in several areas (Picture 39). Air fresheners contain chemicals that can be irritating to the eyes, nose and throat of sensitive individuals. Many air fresheners contain 1,4-dichlorobenzene, a VOC which may cause reductions in lung function (NIH, 2006). Further, air fresheners do not remove materials causing odors, but rather, mask odors which may be present in the area.

Plug-in Air Freshener

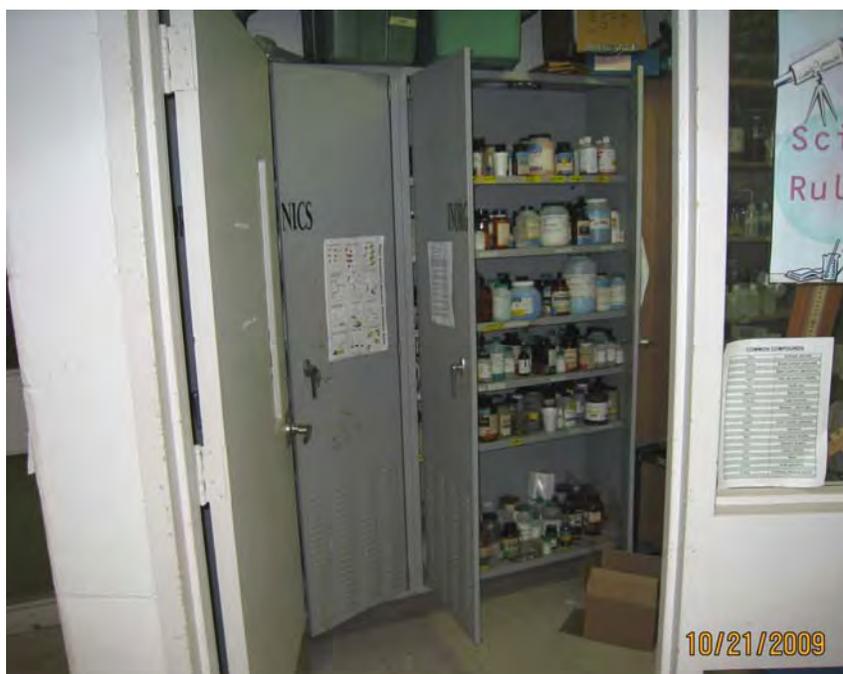
Picture 40

- Both the chemistry classroom and chemical prep room were accessible to students when the room was not occupied (Picture 40).
- Shelves were observed to be overstored with chemical containers (Picture 41), so much so that labels could not be seen without moving bottles.

Chemical Prep Room and Chemical Storage Cabinet Open

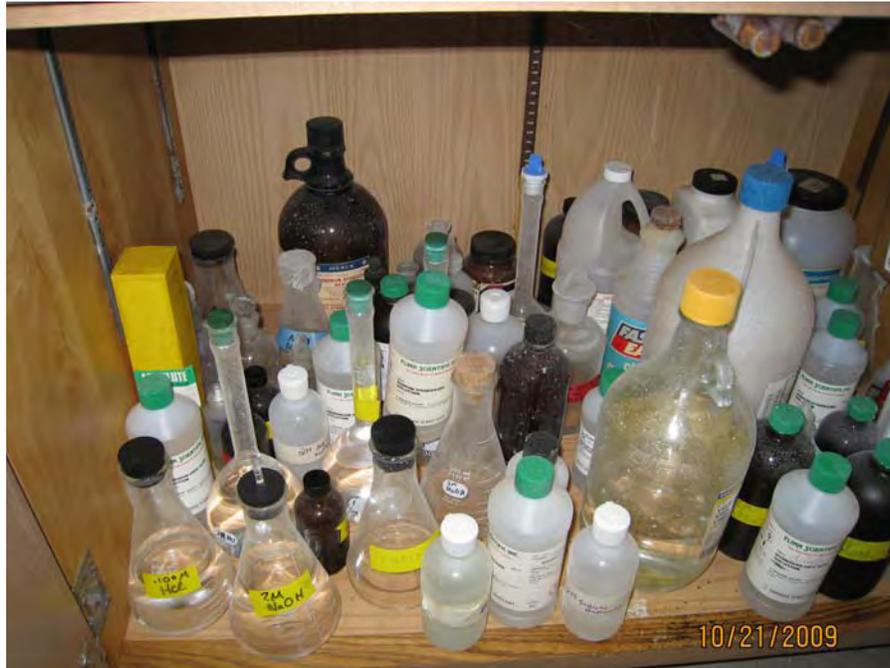
Picture 41

Shelves Overloaded With Chemicals

16. Provide anti-roll-off lips or guardrails along the edge of shelving to prevent accidental spillage.
 17. Properly label all chemicals. Labels should include: Chemical name, concentration, target organ, effect, and date prepared; Hazards, both physical and health; and, Name and address of manufacturer.

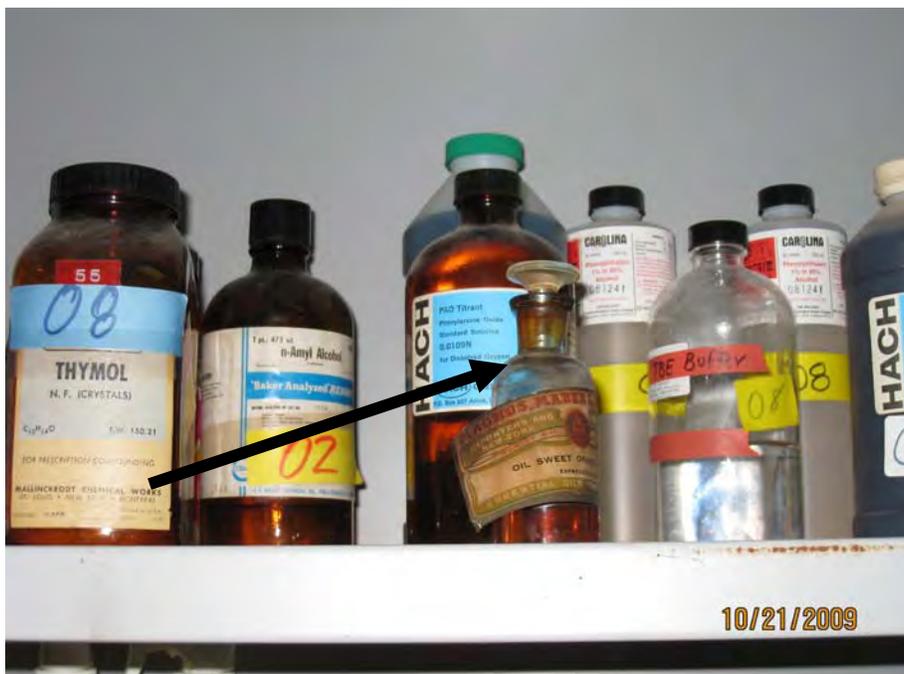
Picture 42

Chemicals of Extreme Age, Note Label Falling Off

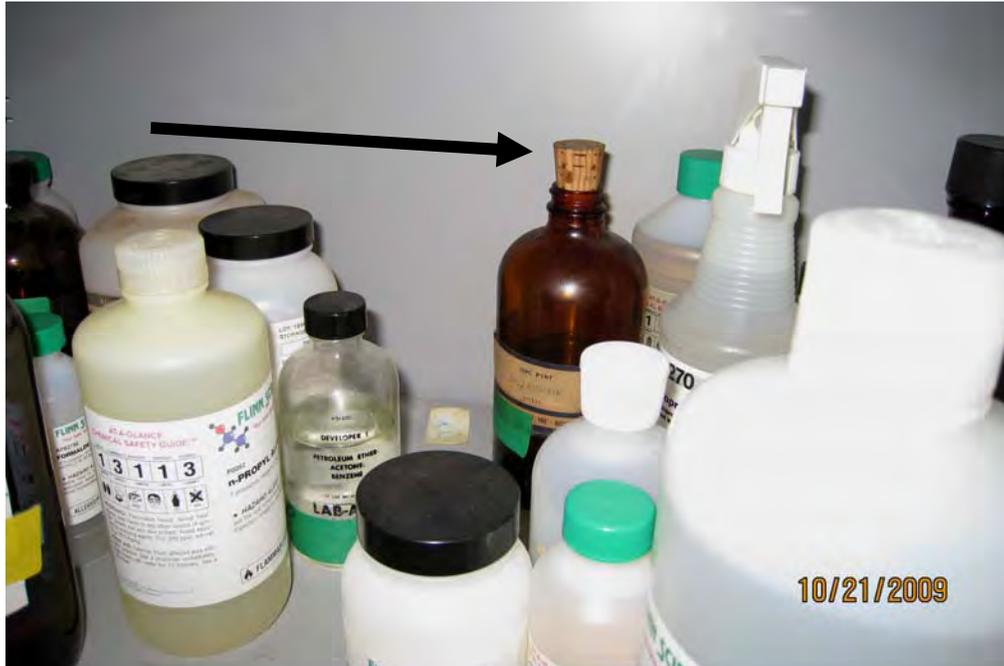
Picture 43

Cork Bottle Stopper

- A number of containers were not properly labeled.
- Stored materials appeared to be of extreme age (Picture 42).
- Chemical(s) containers were not properly sealed. Some bottle stoppers were made of cork material (Picture 43). Cork is not an appropriate material for sealing chemical(s) bottles and/or containers.

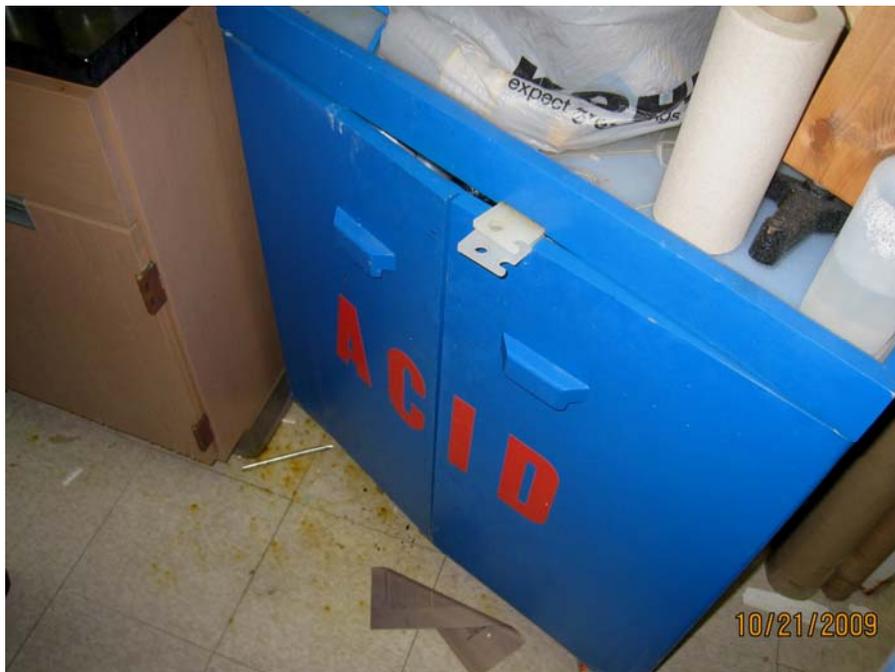
Picture 44

- A spill was noted on the floor surrounding the 'Acids' cabinet (Picture 44).
- Chemicals were stored in fume hoods that were not operating (Picture 45).

Spill on Floor Around Acid Cabinet

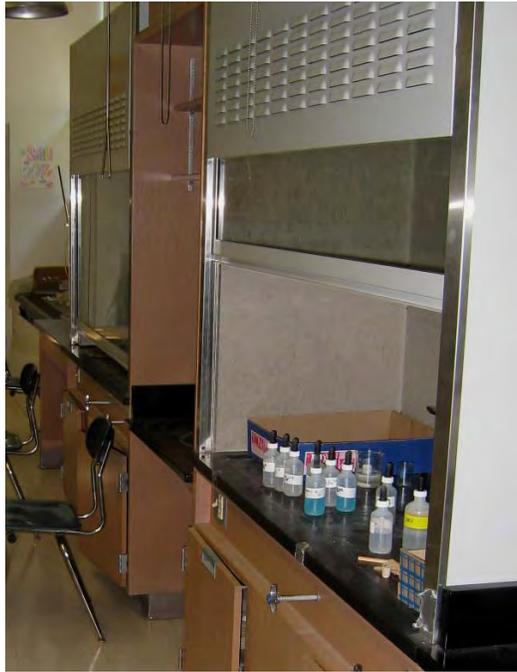
Picture 45

Chemicals Stored in Deactivated Fume Hood

20. Remove and properly store chemicals in chemical fume hoods upon completion of experiments. Chemical hoods should not be used to store chemicals.
21. Restore operation of the local wood dust collection system in the wood shop, make repairs as needed. Ensure that excess wood dust is cleaned after completion of projects.

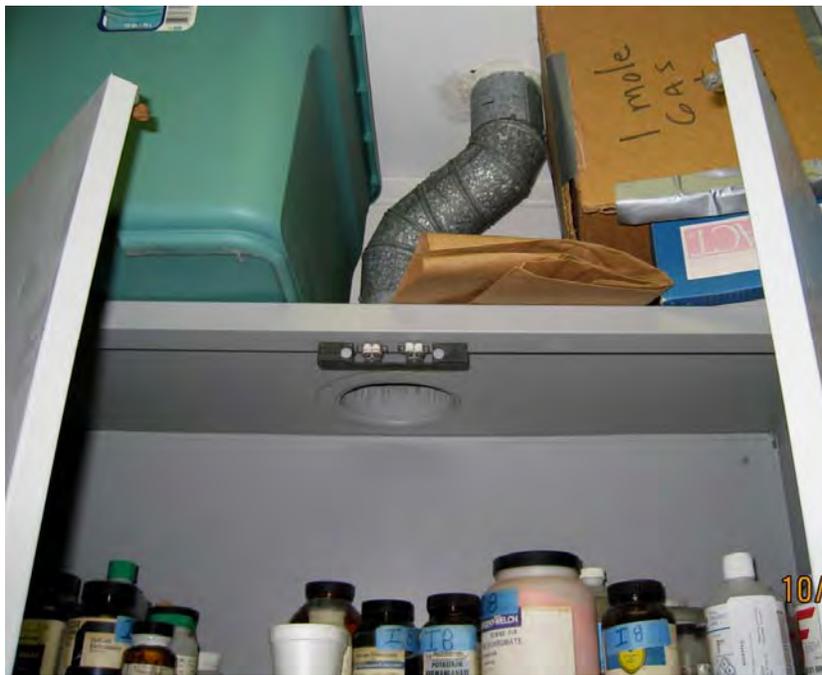
Picture 46

Passive Duct at the Top of Chemical Cabinet

A passive duct at the top of the chemical cabinets connects to a non-motorized exhaust vent on the roof (Picture 46). Without a motorized roof vent, this duct can backdraft, resulting in off-gassing chemicals from stored containers being forced through the cabinet doors into the chemical prep room. Exposure to vapors of off-gassing chemicals can be irritating to the eyes, nose and respiratory system.

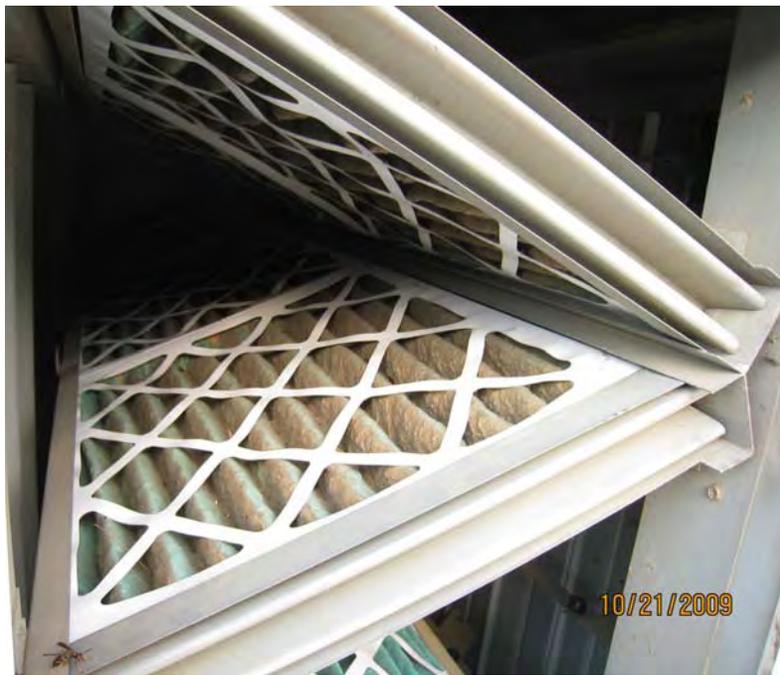
Picture 48

Pleated Filters in Rooftop Air Handling Unit

Filters for ventilation equipment (AHUs and univents) strain particulates from the air (Pictures 47 and 48). Filters are reportedly changed once per year; however, the experience of BEH staff reveals that most schools change filters 2 to 4 times per year, usually during school vacations. Filters should be changed as per the manufacturer's instructions or more frequently to avoid the build up and re-aerosolization of dirt, dust and particulate matter.

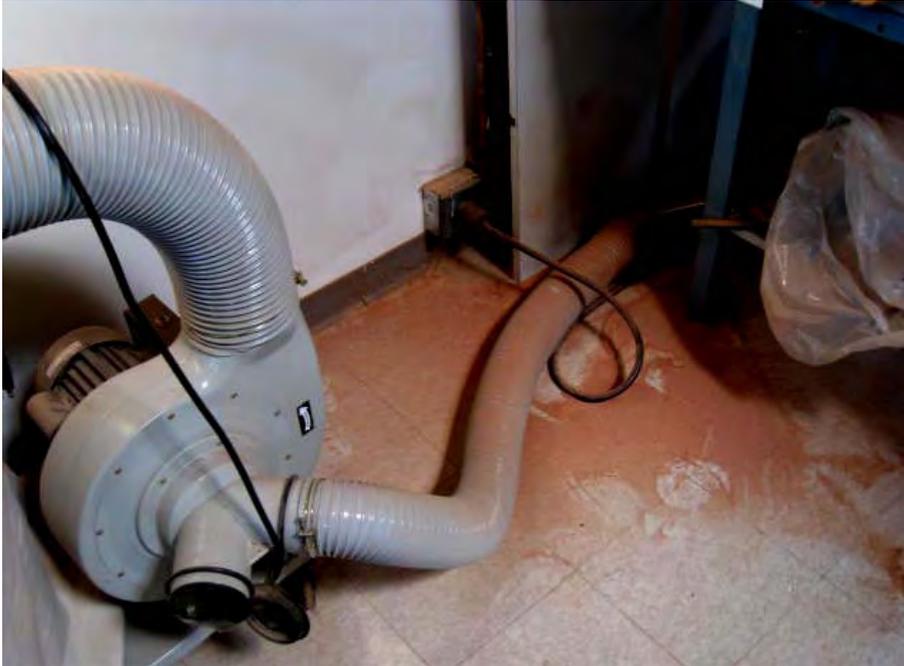
Picture 49

BEH staff observed wood dust and debris accumulated on wood cutting machines and flat surfaces throughout the woodshop (Picture 49). The woodshop has general exhaust ventilation. The shop also has a local exhaust system dedicated to collecting dust from equipment; however, the hoses are not connected to the equipment. Other machines completely lacked exhaust systems, allowing dust and debris to spread freely throughout the shop. Wood dust is a fine particulate, which can be easily aerosolized, irritating the eyes, nose, throat and respiratory system. In addition, under certain conditions, wood dust can be a fire hazard.

Wood Dust on Floor near Dust Collecting System

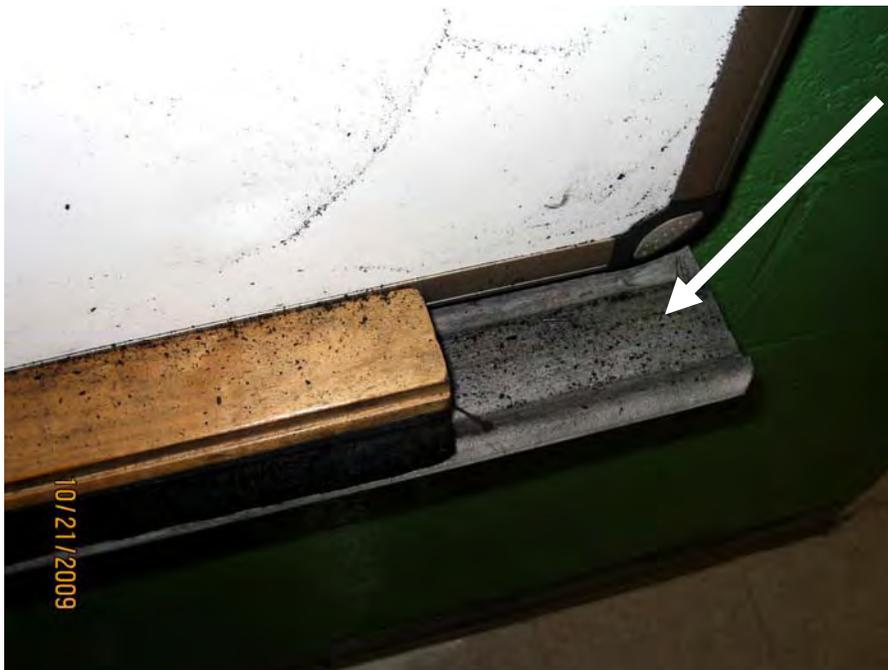
Picture 50

An accumulation of chalk dust and dry erase particulates was observed in some classrooms (Picture 50). When windows are opened or univents are operating, these materials can become airborne. Once aerosolized, they can act as irritants to the eyes and respiratory system.

Accumulated Dry Erase Particulate in Board Tray

23. Clean chalkboards and dry erase board trays regularly to avoid the build-up of dust and particulates.
24. Clean air diffusers, exhaust vents and personal fans periodically of accumulated dust. If stained ceiling tiles cannot be cleaned, replace.

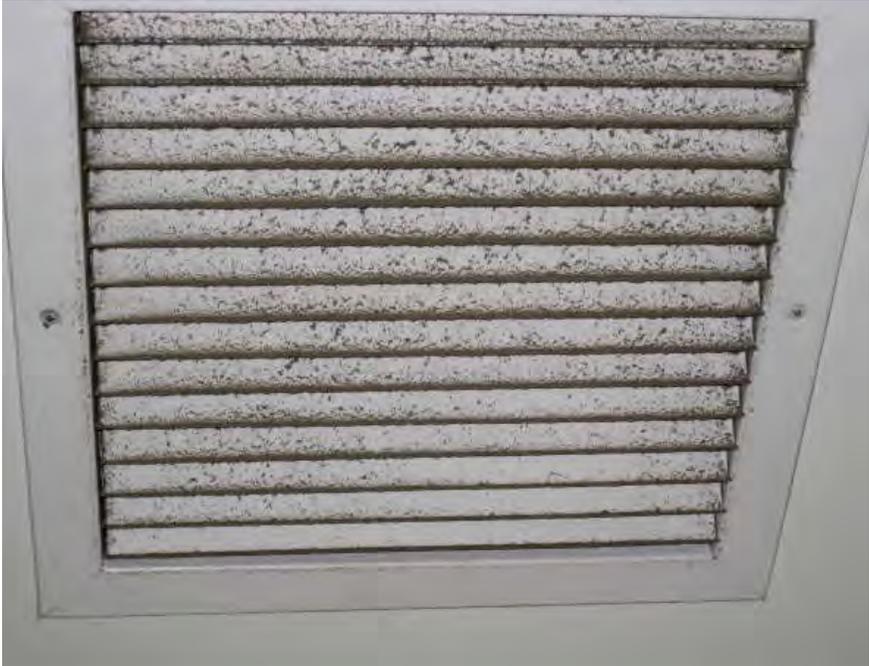
Picture 51

Lastly, a number of personal fans, exhaust vents, air diffusers and surrounding ceiling tiles were observed to have accumulated dust/debris (Pictures 13 and 51). Re-activated diffusers, vents or fans can aerosolize accumulated dust. If exhaust vents are not functioning, backdrafting can occur, which can re-aerosolize dust particles.

Accumulated Dust on Vent
