# INDOOR AIR QUALITY ASSESSMENT

**Commonwealth of Massachusetts  
EOHHS Center  
500 Main Street  
Hyannis, Massachusetts**

Prepared by:  
Massachusetts Department of Public Health  
Bureau of Environmental Health  
Indoor Air Quality Program  
May 2011

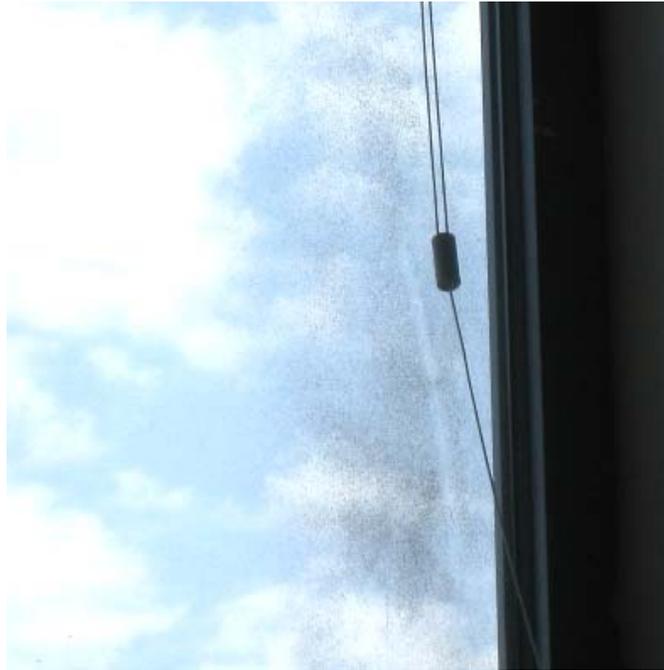
**Picture 1**

Employees expressed concerns of possible mold growth on the interior of windows in the DTA area but did not report any leaks or other evidence of water. BEH staff observed the

windows in this area and noted a dark deposition of debris on the window surface (Picture 1). In order for building materials to support mold growth, a source of water exposure is necessary. Identification and elimination of the source of water moistening building materials is necessary to control mold growth. BEH staff did not observe water-damaged ceiling tiles, wallboard or staining around window frames. Glass in a non-porous surface is generally not conducive to mold growth, however it is possible that dust on the surface of the glass, if moistened by condensation (water droplets), can serve as a mold growth medium. At the time of the assessment BEH recommended that the glass be cleaned and monitored to determine if the staining occurs.

**Dark Debris/Material on Glass Window Panes in DTA Area**

1. If not done previously, clean dark material/debris off windows shown in Picture 1.  
Monitor for reoccurrence and clean as needed.
2. Upgrade vacuum cleaning equipment. To control for dusts, a high efficiency particulate arrestance (HEPA) filter equipped vacuum cleaner in conjunction with wet wiping of all surfaces is recommended.
3. Clean accumulated dust and debris periodically from the surface of air diffusers, exhaust vents and blades of personal fans.
4. If natural gas odors reoccur, contact the AHU manufacturer and/or HVAC engineering firm for further evaluation/guidance.
5. Refer to resource manual and other related indoor air quality documents located on the MDPH's website for further building-wide evaluations and advice on maintaining public buildings. These documents are available at: <http://mass.gov/dph/iaq>.

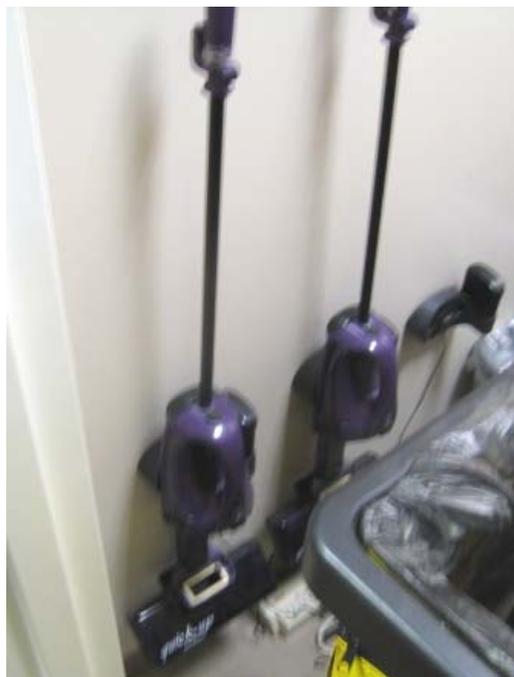
**Picture 2**

Other conditions that can affect indoor air quality were observed during the assessment. Cobwebs were observed along window wells. A number of air diffusers, exhaust/return vents and personal fans were observed with accumulated dust/debris. If exhaust vents are not functioning, backdrafting can occur, which can re-aerosolize accumulated dust particles. Re-activated supply vents and fans can also aerosolize dust accumulated on vents/fan blades. In addition, BEH staff noted that vacuum cleaners used in the building (Picture 2) are not equipped with high efficiency particulate arrestance (HEPA) filters, which is recommended by the MDPH to maintain dust control and reduce airborne particulates.

**Vacuum Cleaners in Custodial Closet**

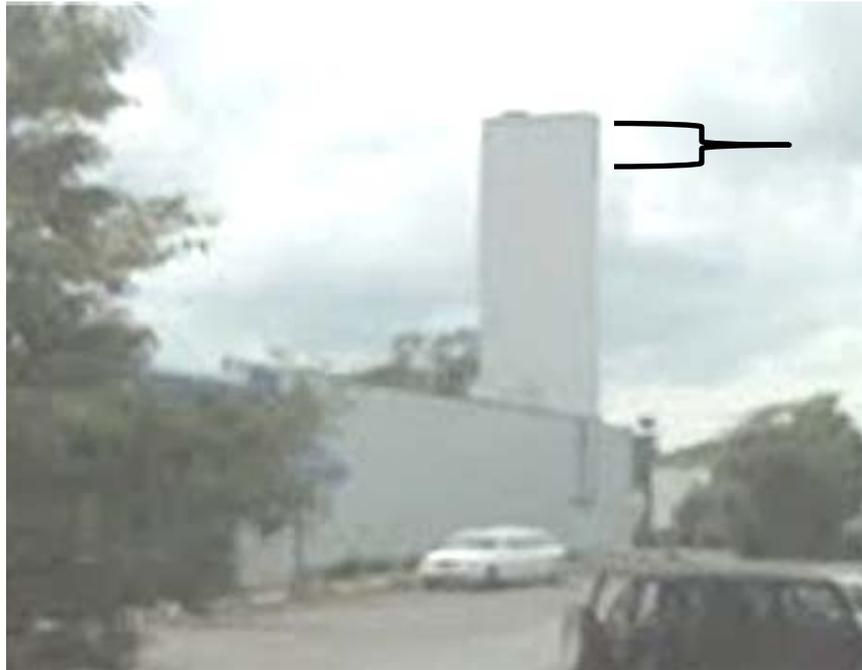
**Picture 3**

Finally, it was expressed to BEH staff at the time of the assessment that occupants had concerns regarding exposure to radio frequency signals or RFs, generated from a cell phone tower on top of the building. It was reported by building maintenance personnel that the cell phone transmitter is located approximately five-feet from the top of the twenty to twenty-five foot tower/chimney on top of the building (Pictures 3 and 4). These types of transmitters use

**Tower/Chimney on top of EOHHS Center and General Location of Cell Phone Transmitter**

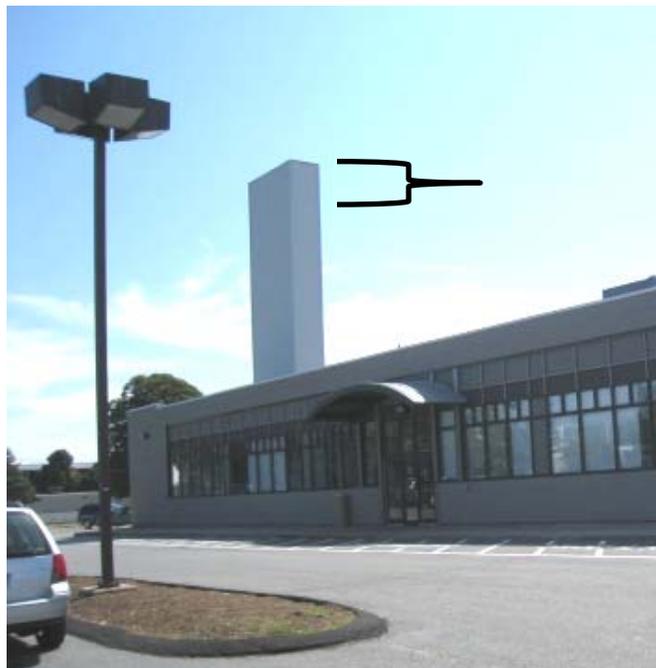
**Picture 4**

**Tower/Chimney on top of EOHHS Center and General Location of Cell Phone Transmitter**
