# **INDOOR AIR QUALITY ASSESSMENT**

**Arnone Community School  
135 Belmont Street  
Brockton, Massachusetts**

Prepared by:  
Massachusetts Department of Public Health  
Bureau of Environmental Health  
Indoor Air Quality Program  
June 2011

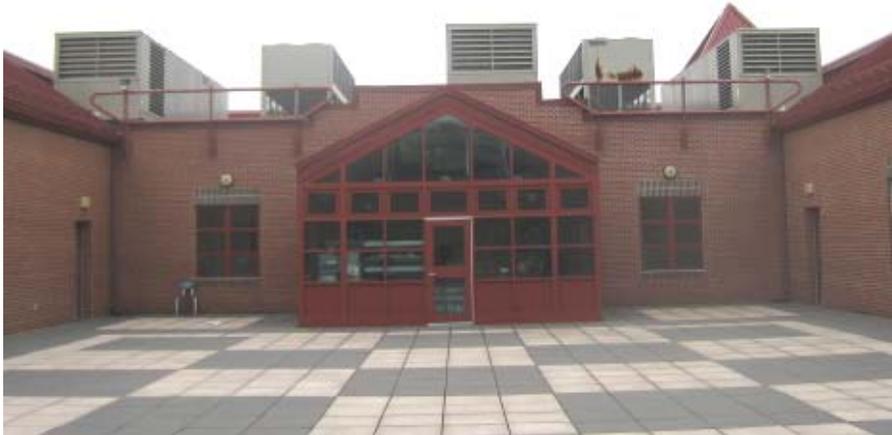
**Picture 1**

It can be seen from Table 1 that carbon dioxide levels were below 800 parts per million (ppm) in 54 of 57 areas, indicating adequate air exchange in the majority of areas surveyed at the time of the assessment. Mechanical ventilation is provided by a computer-controlled heating, ventilating and air conditioning (HVAC) system, which utilizes rooftop air-handling units (AHUs) (Picture 1). AHUs draw air in via fresh air intakes where it is heated/cooled and filtered before being distributed to occupied areas via ceiling-mounted supply diffusers (Picture 2). Exhaust air is drawn into ceiling or wall-mounted return vents (Picture 3) and ducted back to the AHUs.

**Rooftop Air Handling Units (AHUs), Also Note Rooftop Courtyard in Foreground**

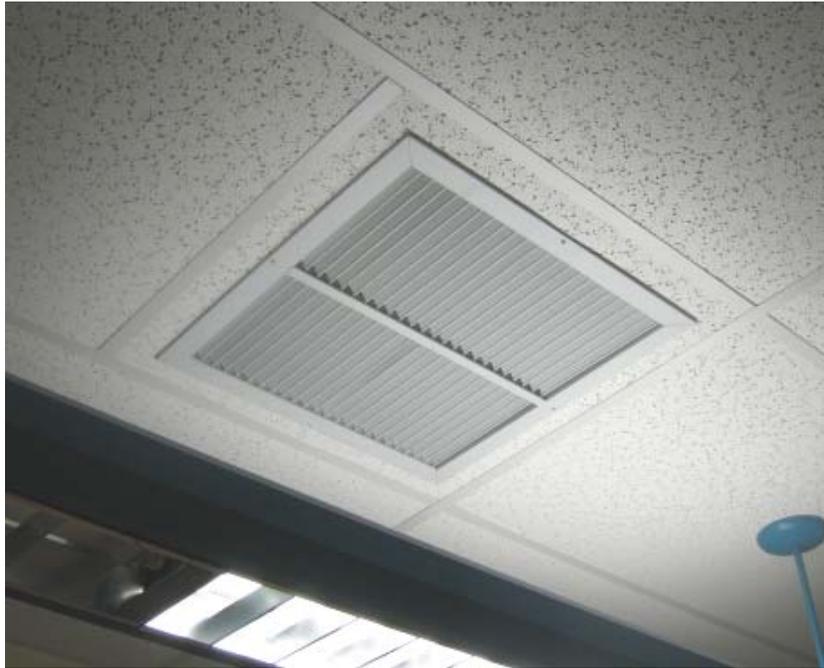
**Picture 3**

**Ceiling-Mounted Return Vent**

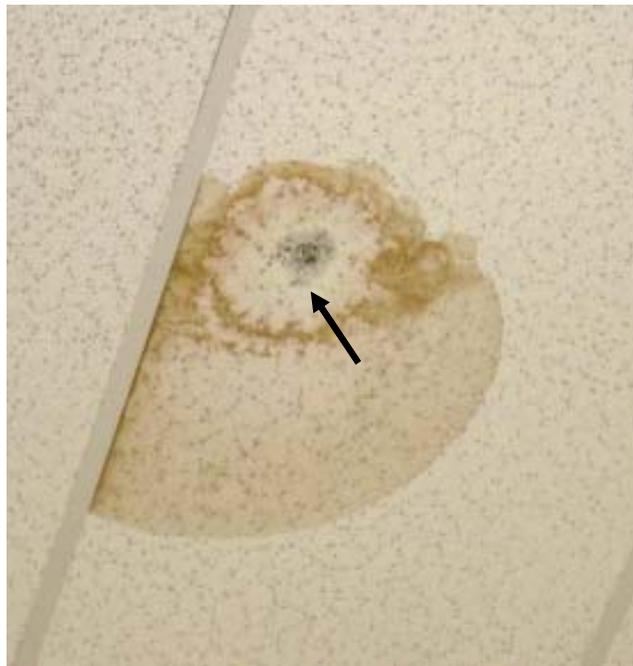
**Picture 4**

In order for building materials to support mold growth, a source of water exposure is necessary. Identification and elimination of the source of water moistening building materials is necessary to control mold growth. Signs of roof leaks were observed in many areas throughout the school as evidenced by water-damaged ceiling tiles (Pictures 4 and 5/Table 1), peeling paint and stains on gypsum wallboard (GW) walls/ceilings (Pictures 6 through 8/Table 1). Routes of water penetration exist along multiple roof surfaces, primarily the junction of the 1<sup>st</sup> floor roof and 2<sup>nd</sup> floor exterior walls, as well as around architectural formations [e.g., the outcropped library window (Pictures 9 through 11)]. School maintenance staff reported that they are working with a roofing contractor to identify and repair leaks.

**Water-Damaged Ceiling Tile, Dark Stain (Arrow) Indicates Mold Growth**

7. Continue to work with roofing contractor to repair roof leaks. Once repaired, replace any remaining water-stained ceiling tiles and make repairs to water-damaged GW and peeling paint.

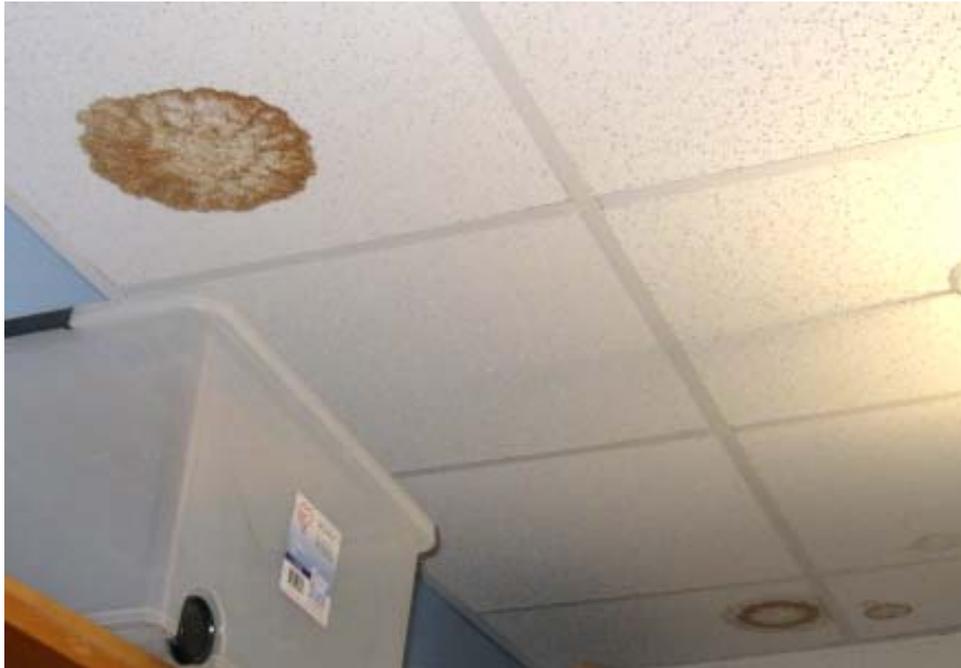
**Picture 5**

**Water-Damaged Ceiling Tiles**

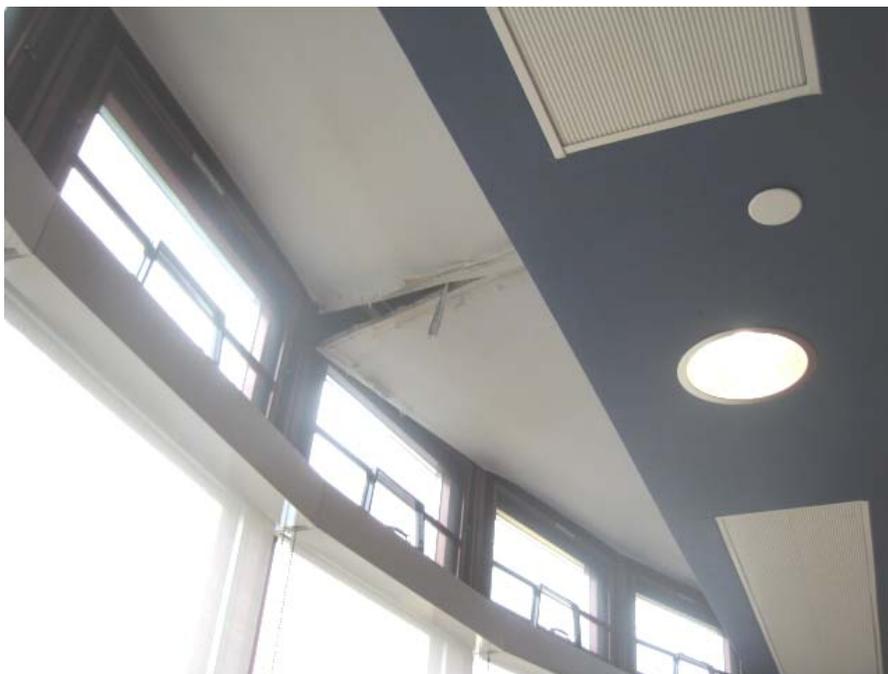
**Picture 6**

**Water-Damaged Gypsum Wallboard Ceiling in Library**

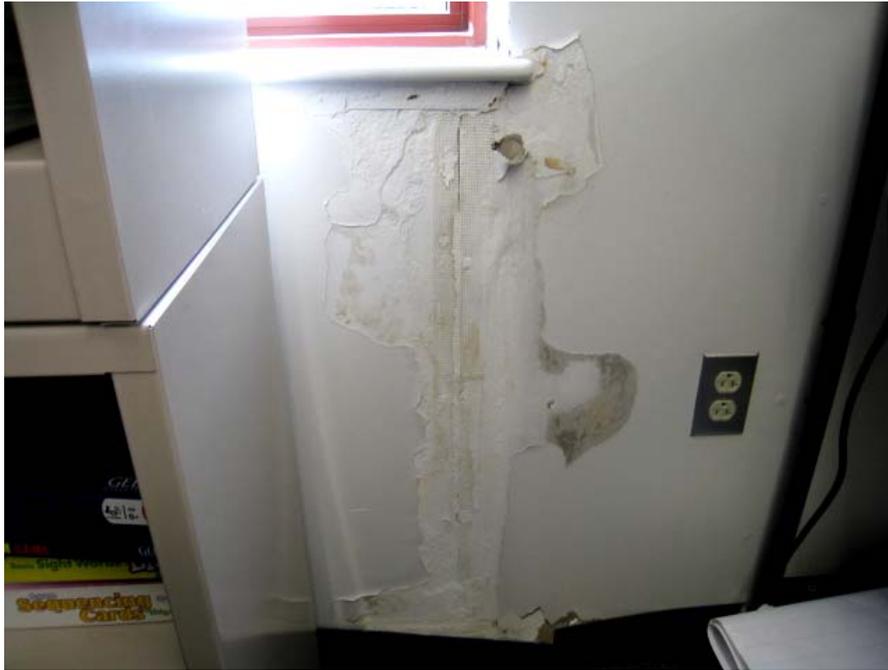
**Picture 7**

porous materials, they are difficult to clean and should be removed. Moisture testing of various porous materials throughout the building were all normal (i.e., dry) at the time of testing (Table 1). However, visible mold growth was observed at the base of GW beneath vinyl base coving in room 228 (Picture 8). Vinyl base coving can serve to trap moisture and preventing drying.

**Peeling Paint and Water-Damaged Gypsum Wallboard in Room 228**

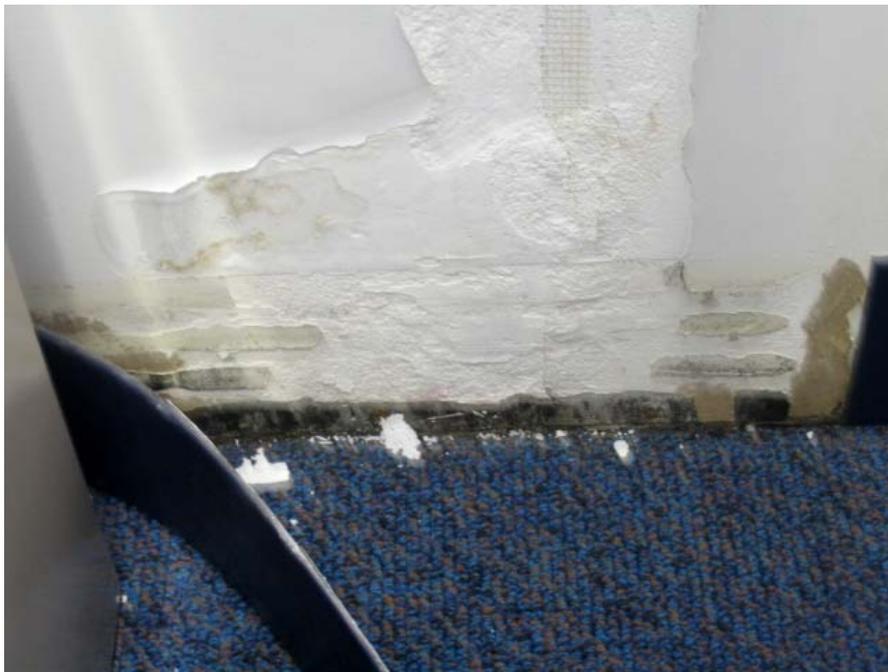
**Picture 8**

**Mold Growth on Surface of Gypsum Wallboard beneath Vinyl Coving in Room 228**

4. Remove water-damaged/mold colonized GW at base of wall beneath vinyl base coving in classroom 228 in a manner consistent with US EPA's (2001) guidance. Consider leaving a ½ to 1-inch space along floor to prevent wicking moisture.

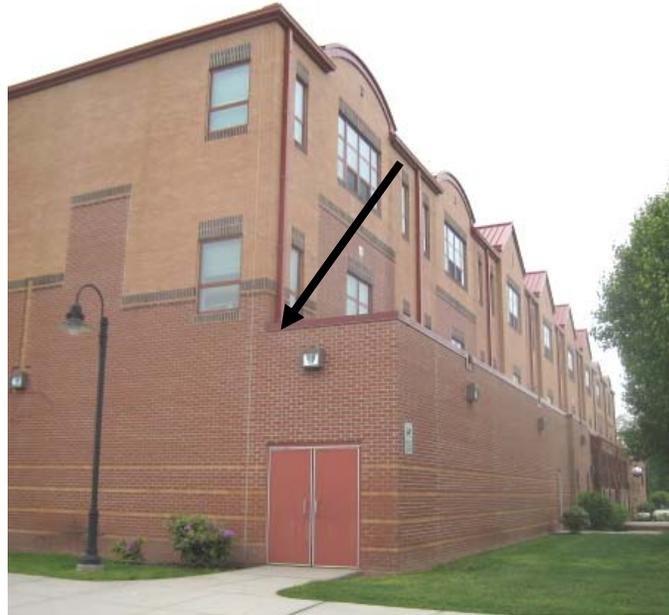
**Picture 9**

The school has a paneled rooftop courtyard that is used as a play area (Picture 1). Standing water was observed beneath the majority of the panels (Picture 12); indicating roof drains were likely obstructed. The freezing and thawing of water during winter months can lead to roof leaks and subsequent water penetration into the interior of the building. Pooling water can also become stagnant, which can serve as a breeding ground for mosquitoes. Other potential sources of water penetration were missing/failing window gaskets noted in room 107 and in the hallway outside room 304, and a space beneath the music room door in which light could be seen penetrating. These breaches can allow for uncontrolled air drafts as well as moisture to enter the building.

**Junction Where 2<sup>nd</sup> Floor Exterior Walls Meet 1<sup>st</sup> Floor Roof Prone to Water Penetration (Arrow)**

5. Remove furniture placed against the exterior wall in 2<sup>nd</sup> floor classrooms susceptible to water penetration. Consider removing carpeting approximately 2-feet from exterior walls in these areas and replace with a non-porous material (e.g., tile) to prevent further moistening and potential mold growth on carpeting.

6. In the event of further water penetration through exterior walls, remove vinyl coving along base of walls and carpeting. This should be done within 24 to 48 hours of water penetration.

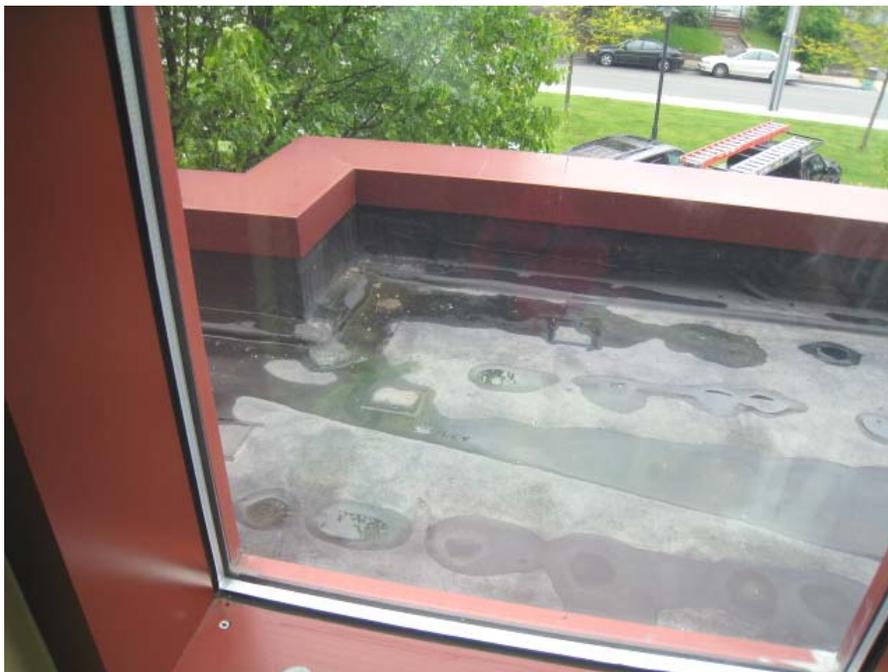
**Picture 10**

**Interior View from 2<sup>nd</sup> Floor Classroom of 1<sup>st</sup> Floor Roofs Prone to Leakage**

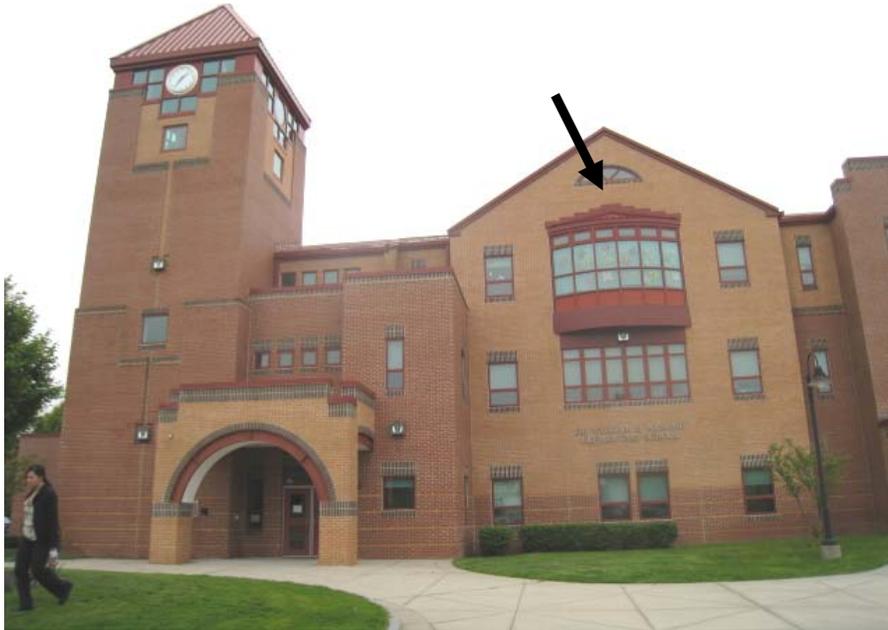
**Picture 11**

**Multiple Roof Surfaces and Outcropped Library Window (Arrow)  
Susceptible to Water Penetration**

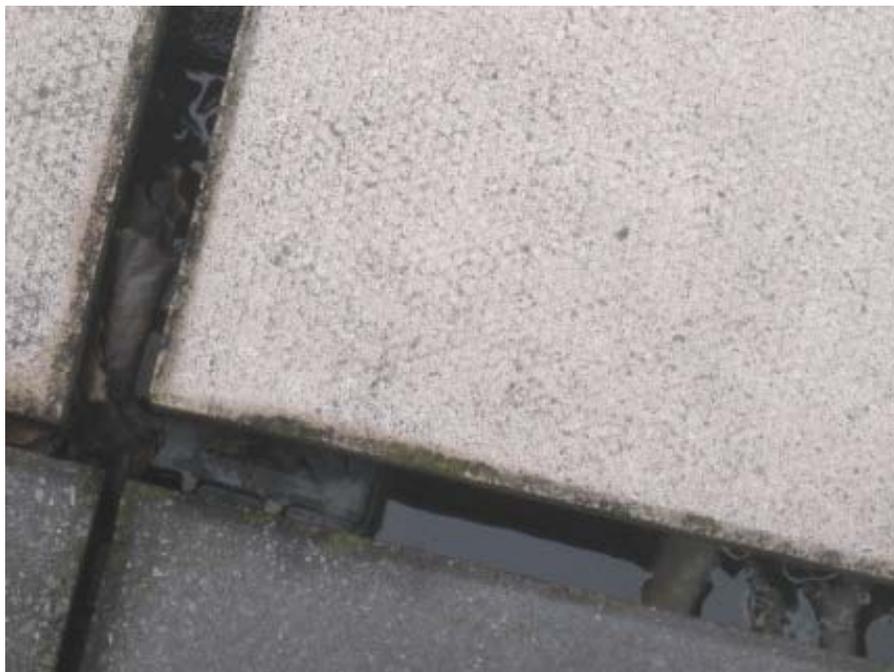
**Picture 12**

**Standing Water beneath Rooftop Courtyard Panels**

8. Refrain from storing porous items (boxes, papers, books, etc.) in areas prone to water leaks.
9. Ensure roof drains for the rooftop courtyard are clear to prevent water pooling.

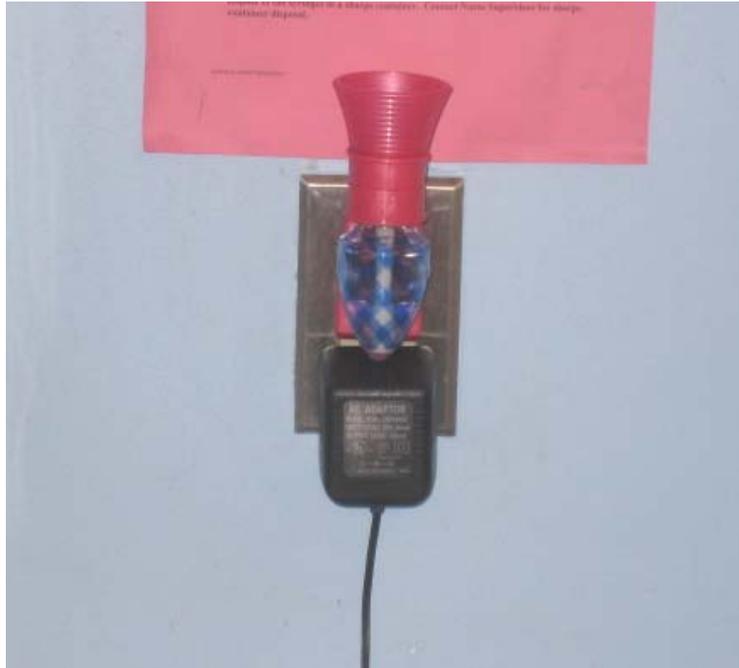
**Picture 13**

Plug-in air deodorizers were observed in use (Picture 13). Air deodorizers contain chemicals that can be irritating to the eyes, nose and throat of sensitive individuals. Many air fresheners contain 1,4-dichlorobenzene, a VOC which may cause reductions in lung function

**Plug-in Air Deodorizer**

14. Refrain from using strongly scented materials (e.g., air deodorizers) in classrooms.
15. Relocate or consider reducing the amount of materials stored in classrooms to allow for more thorough cleaning of classrooms. Clean items regularly with a wet cloth or sponge to prevent excessive dust build-up.

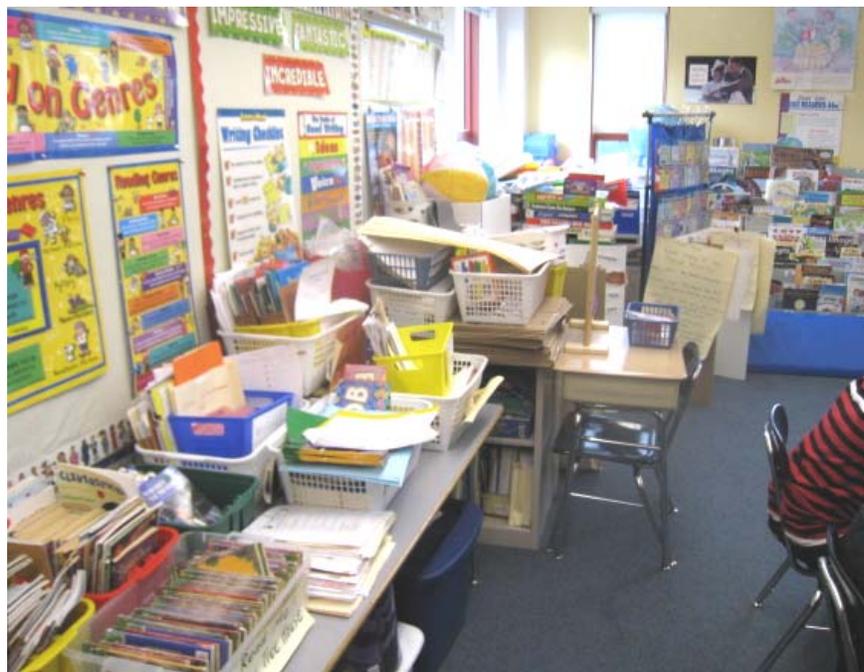
**Picture 14**

Other conditions that can affect indoor air quality were observed during the assessment. In many classrooms, items were observed on the floor, windowsills, tabletops, counters, bookcases and desks (Picture 14). The large number of items stored in classrooms provides a source for dusts to accumulate. These items (e.g., papers, folders, boxes) make it difficult for custodial staff to clean. Items should be relocated and/or be cleaned periodically to avoid excessive dust build up. In addition, these materials can accumulate on flat surfaces (e.g., desktops, shelving and carpets) in occupied areas and subsequently be re-aerosolized causing further irritation.

**Accumulated Classroom Items**

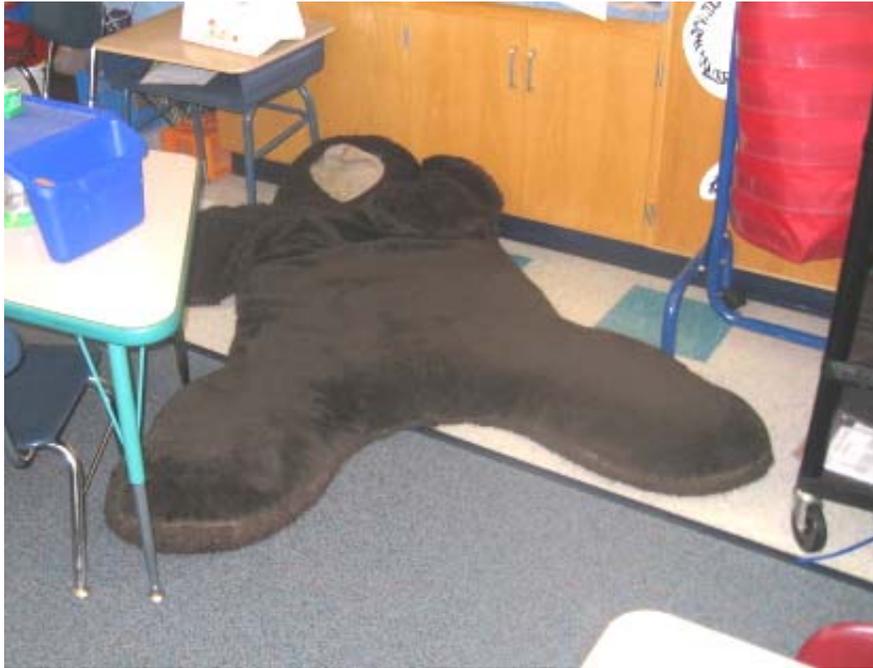
**Picture 15**

Stuffed animals, pillows, and cushions were noted in many classrooms (Picture 15). Old mattresses were observed in room 235 which appears to be used for physical therapy/occupational therapy (PT/OT) (Picture 16). Stuffed toys should be washed on a weekly basis to prevent disease (Hale and Polder, 1996). Furthermore, stuffed animals, pillows/cushions and mattresses can be a point for dust collection. Close contact with such items can leave oils, perspiration, hair and skin cells. Dust mites feed upon human skin cells and excrete waste products that contain allergens. As discussed, dust can be irritating to the eyes, nose and respiratory system.

**Large Pillow on Floor of Classroom**

16. Clean accumulated dust and debris periodically from the surface of air diffusers, exhaust/return vents and blades of personal and ceiling fans.
17. Clean pillows, cushions, and stuffed animals on a regular basis. If not possible/practical, consider removing from classrooms.
