# **INDOOR AIR QUALITY ASSESSMENT**

**West Villages Elementary School  
760 Osterville West Barnstable Road  
Marston Mills, Massachusetts**

Prepared by:  
Massachusetts Department of Public Health  
Bureau of Environmental Health  
Indoor Air Quality Program  
July 2012

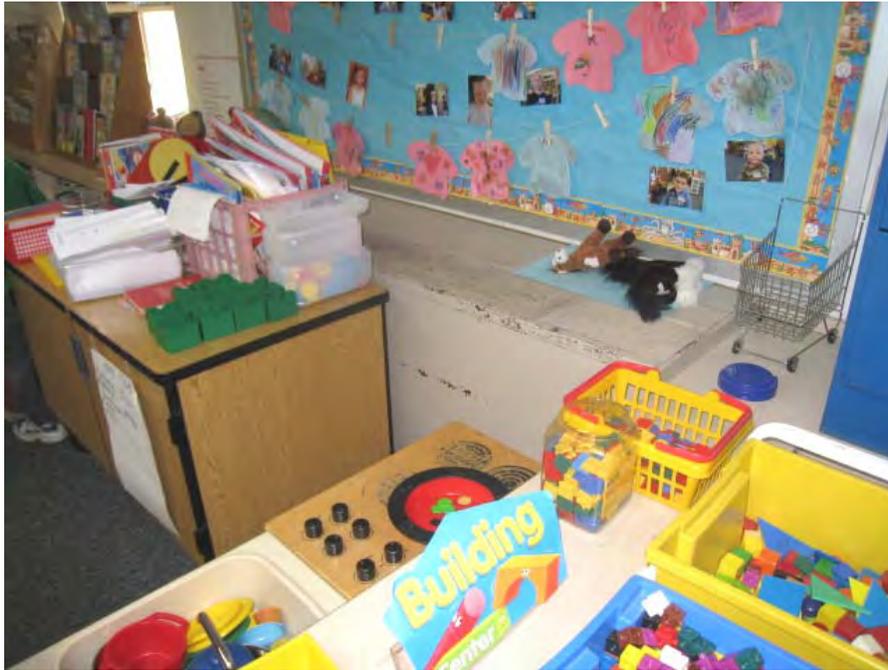
**Picture 1**

Fresh air in classrooms is supplied by unit ventilators (univents) (Picture 1). A univent is designed to draw air from outdoors through a fresh air intake located on the exterior wall of the building (Picture 2). Return air is drawn through an air intake located at the base of each unit where fresh and return air are mixed, filtered, heated or cooled and provided to classrooms through an air diffuser located in the top of the unit ([Figure 1](#)).

Univents were found deactivated or obstructed with classroom items in a number of areas (Picture 1; Table 1). In order for univents to provide fresh air as designed, intakes/returns must remain free of obstructions. Importantly, these units must remain “on” and be allowed to operate while rooms are occupied. It was reported by school officials that the mechanical ventilation

**Classroom univent, note blockage of unit by furniture**

4. Remove all blockages/items from the surface of univent air diffusers and return vents (along front/bottom) to ensure adequate airflow.
5. Ensure classroom exhaust vents are operating during occupancy; make repairs as needed.

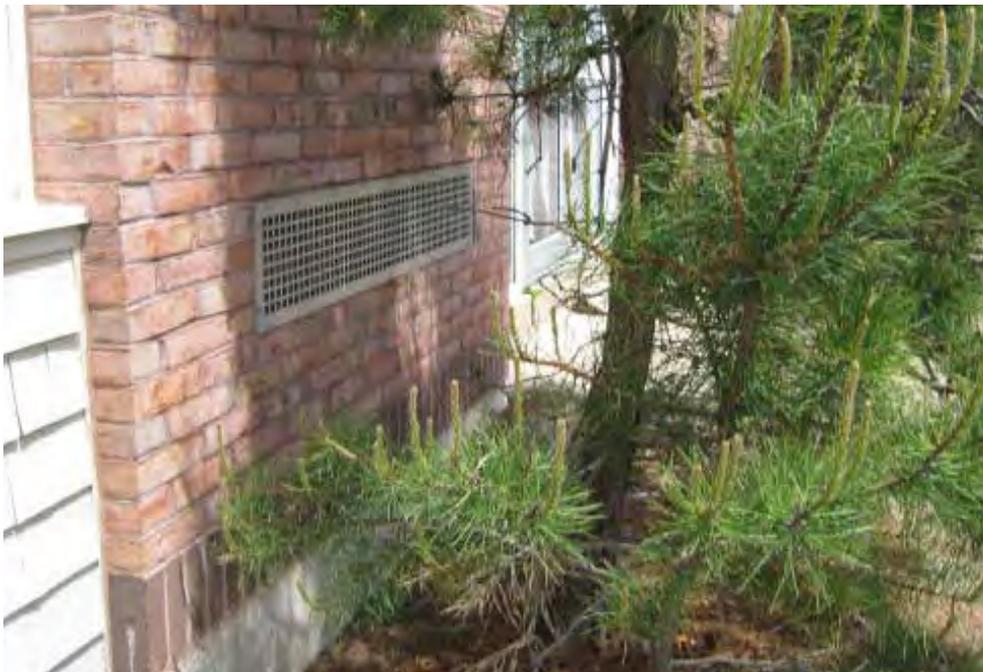
**Picture 2**

**Univent air intake on outside of building; note that this one has a tree directly in front of it**

11. Ensure plants, trees and shrubs are located at least five feet away from exterior walls/foundation of the building.
12. Repair bird screens.
13. Check integrity of gutter and downspout systems and repair as needed.

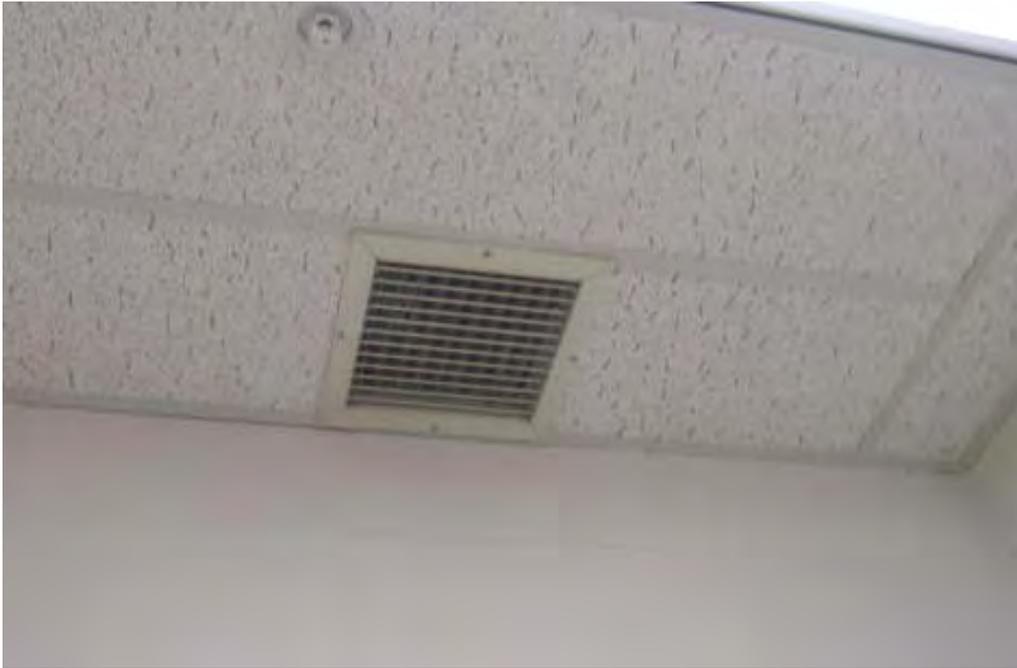
**Picture 3**

Exhaust ventilation in classrooms is provided by wall or ceiling vents ducted to rooftop motors (Picture 3). Exhaust ventilation was found deactivated in a number of areas during the assessment (Table 1), which may indicate that they were shut off or in need of repair. As with univents, in order to function properly, exhaust vents must be activated and allowed to operate while rooms are occupied. Without adequate supply and exhaust ventilation, excess heat and environmental pollutants can build up and lead to indoor air/comfort complaints.

**Typical classroom exhaust vent**

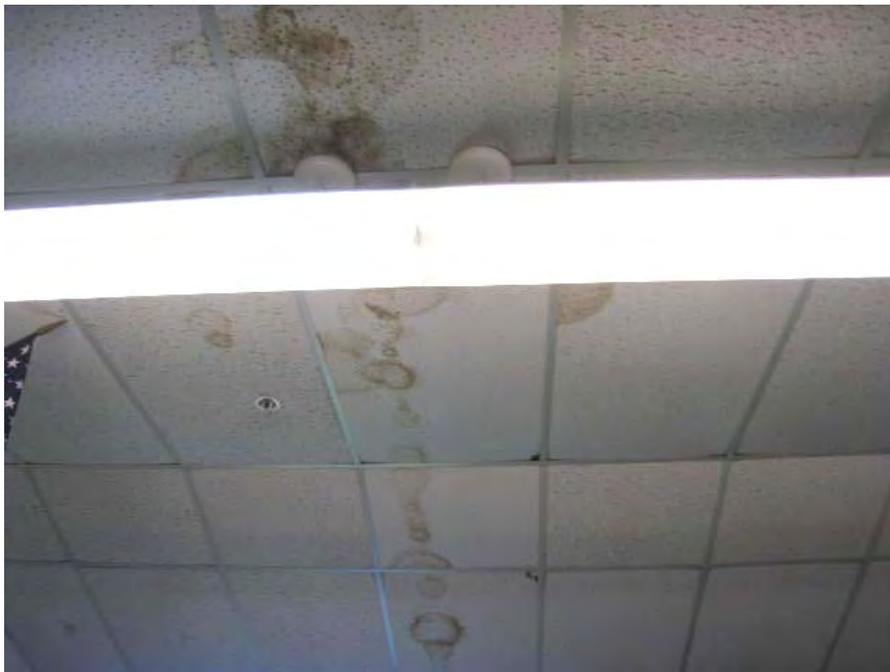
**Picture 4**

Water-damaged ceiling tiles were observed in a number of areas (Table 1). These indicate current/historic roof leaks, plumbing leaks or other water infiltration (Pictures 4 and 5). Water-damaged ceiling tiles can provide a source of mold and should be replaced after a water leak is discovered and repaired. Water damage around ventilation components in the library (Picture 5) may indicate that the tiles are being moistened by condensation due to use of the air conditioning. When the HVAC system parts are cold (in cooling mode) and in contact with humid air, water may condense on the metal components and then moisten adjacent porous materials (i.e., ceiling tiles). This occurrence can be minimized through control of the infiltration of warm, humid outside air into the building during cooling season by keeping doors and windows closed and sealing any breaches in the building envelope. The temperature of the cooling system may also need to be adjusted.

**Water-damaged ceiling tiles**

9. Do not open windows if HVAC system is in its *air-conditioning* setting to avoid condensation.
10. Ensure roof/plumbing leaks are repaired and replace any remaining water-damaged ceiling tiles. Examine the area above these tiles for mold growth. Disinfect areas of water leaks with an appropriate antimicrobial, as needed.

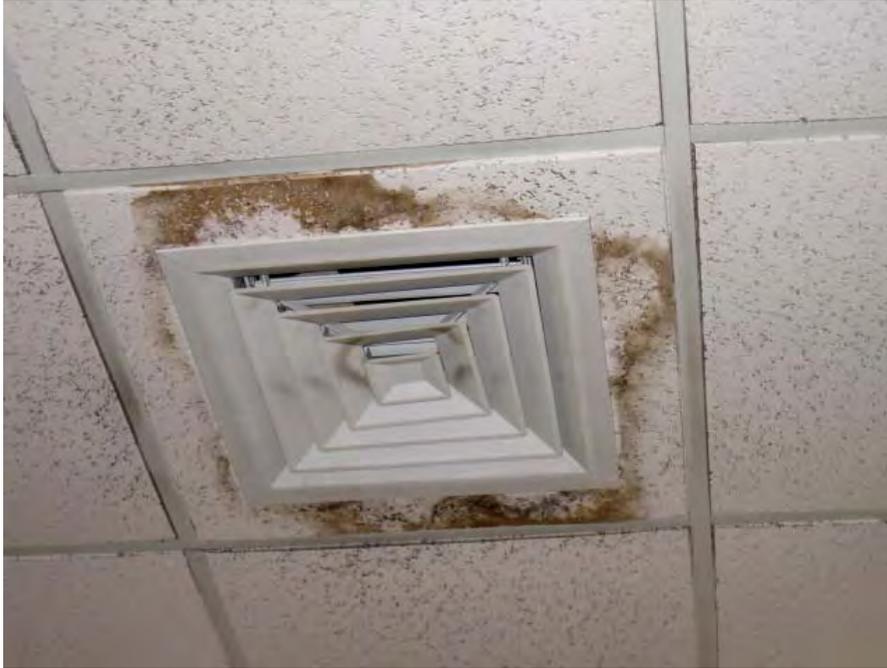
**Picture 5**

**Water-damaged ceiling tile around air diffuser component**

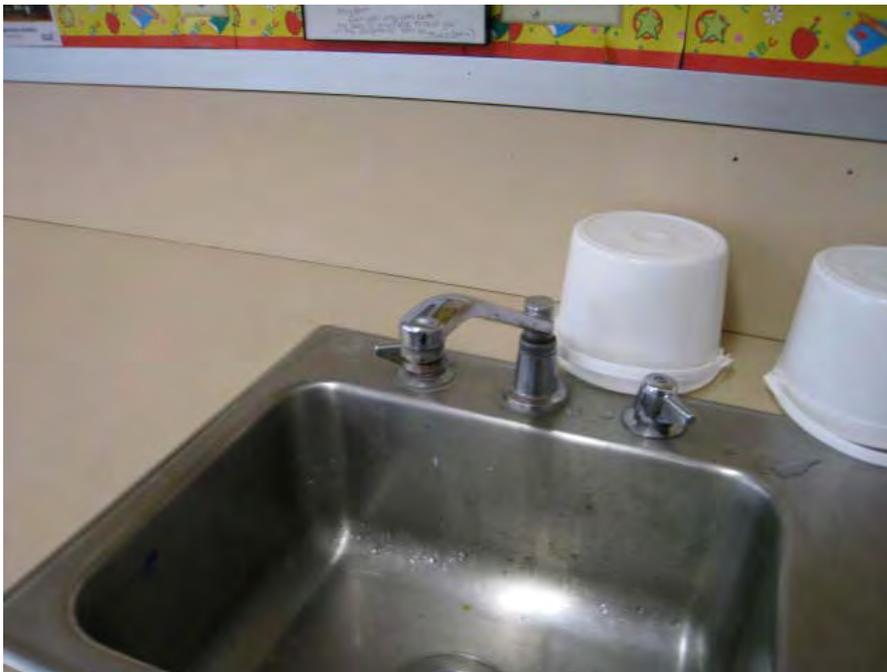
**Picture 6**

Breaches exist between countertops and sink backsplashes in a number of classrooms (Picture 6; Table 1). Water can penetrate through backsplash seams if they are not watertight. Water penetration and chronic exposure of porous and wood-based materials can cause these materials to swell and show signs of water damage. Porous materials were found stored under many sinks (Picture 7; Table 1). Materials stored under sinks may make leaks harder to detect and repeated moistening of porous materials can result in mold growth. Many of the sinks were also found to be dripping and could not be turned completely off, providing additional moisture. As discussed, moistened materials that are not dried within 24 to 48 hours can become potential sources for mold growth.

**Classroom sink with weakly-sealed backsplash and faucet leak**

15. Seal breaches, seams and spaces between sink countertops and backsplashes to prevent water damage and repair/adjust leaking sinks.
16. Store cleaning products properly and out of reach of students. All cleaning products used at the facility should be approved by the school department with MSDS' available at a central location.

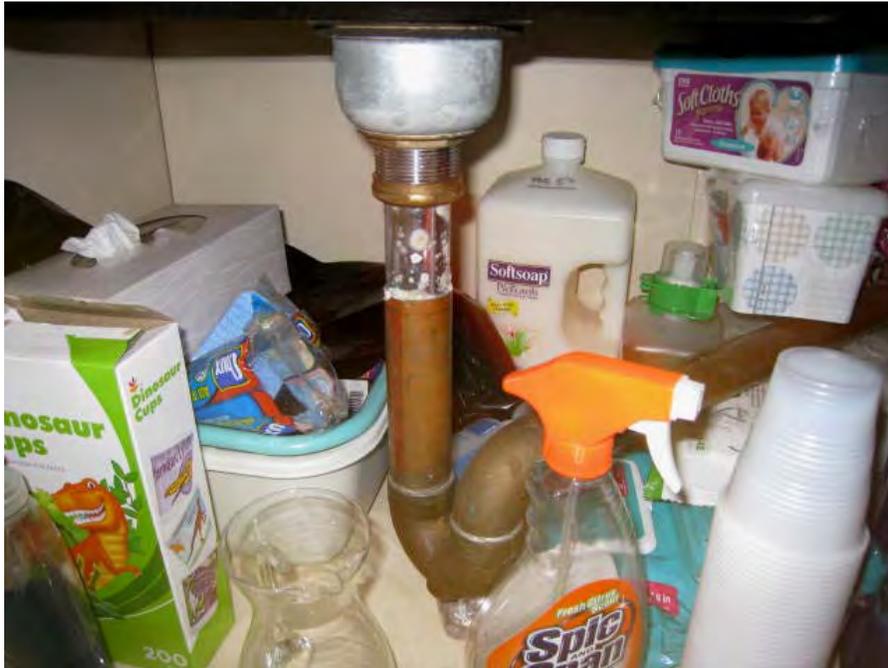
**Picture 7**

Cleaning and sanitizing products were observed in some rooms (Picture 7; Table 1). These products contain chemicals that can be irritating to the eyes, nose and throat of sensitive individuals. Cleaning products should be properly labeled and stored in an area inaccessible to children. In addition, a Material Safety Data Sheets (MSDS) should be available at a central location for each product in the event of an emergency. Consideration should be given to providing teaching staff with school issued cleaning products and supplies to prevent any potential for adverse chemical interactions between residues left from cleaners used by the facilities staff and those left by cleaners brought in by others.

**Items, including cleaning products and porous paper and cardboard stored under sink**

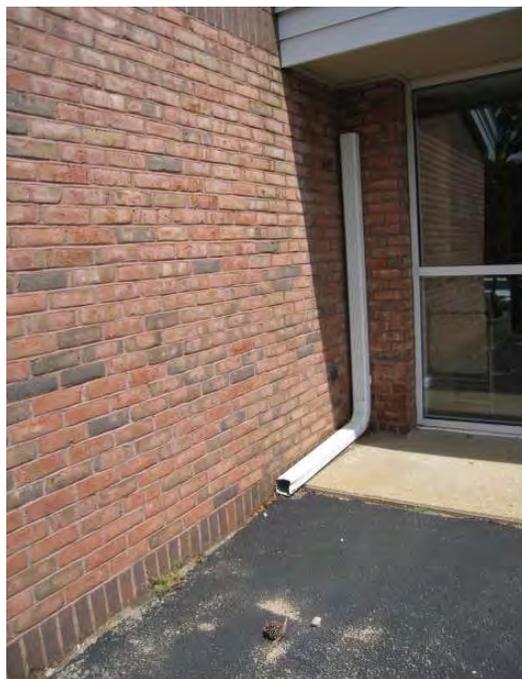
**Picture 8**

BEH staff conducted a perimeter inspection of the building's exterior to identify potential sources of water penetration. A gutter downspout was found detached from the building (Picture 8). Missing/damaged gutters/downspouts can allow water to moisten the side of the building or pool at the base of the foundation where it may penetrate into the building. A pine tree was noted growing close to the building exterior directly in front of a univent fresh air intake (Picture 2). This and other tree/plant roots may penetrate the building foundation, creating and widening cracks there. In addition, pollen and dirt/debris from the tree are likely to be drawn into the univent system, and from there prematurely occlude the filter or enter the indoor air.

Over time, these conditions can undermine the integrity of the building envelope and provide a means of water entry into the building via capillary action through foundation concrete and masonry (Lstiburek & Brennan, 2001). The freezing and thawing action of water during the winter months can create cracks and fissures in the foundation. In addition, these breaches may provide a means for pests/rodents to enter the building.

**Disconnected gutter downspout**

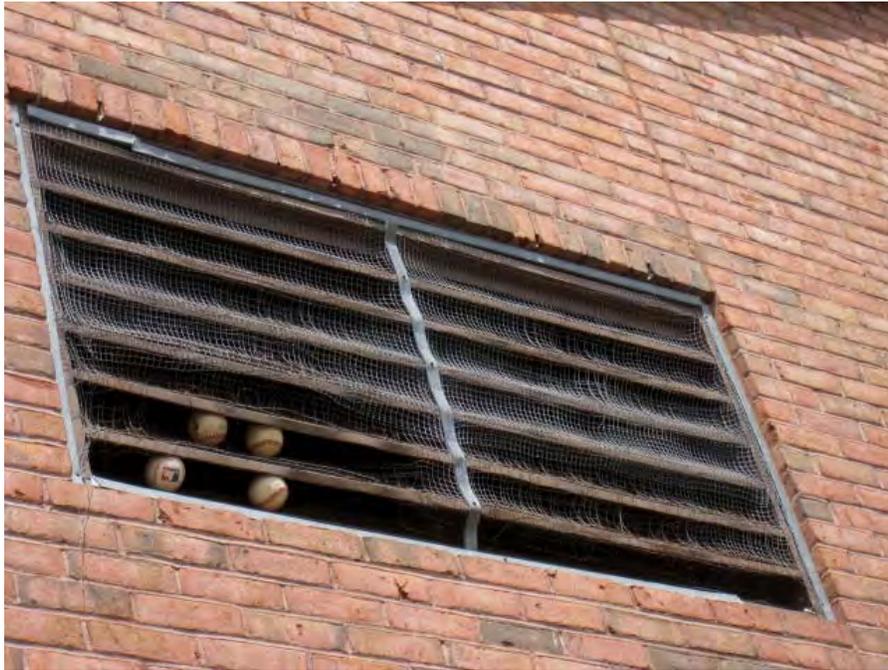
**Picture 9**

Some of the screening on air intake vents were found to be broken, and one had baseballs lodged in it (Picture 9). These screens are needed to keep birds and other pests out of the ventilation systems and should be repaired.

**Damaged bird screen on ventilation air intake**

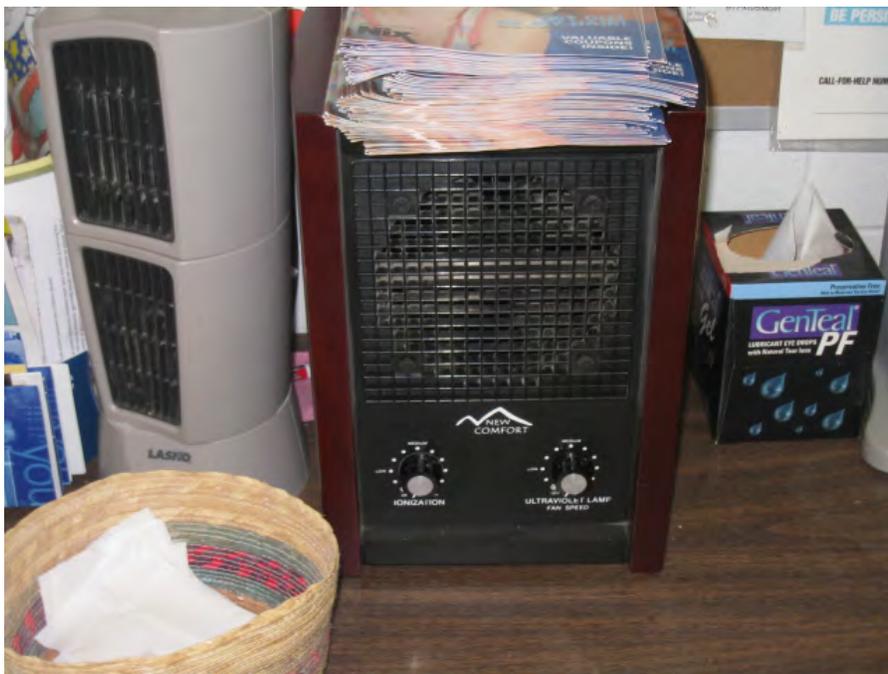
**Picture 10**

An air purifier was found in the nurse's office (Picture 10). Based on product literature found for this product, it contains a high-efficiency particulate arrestance (HEPA) filter and uses ultraviolet (UV) light for its germicidal properties and a carbon filter to remove odors. It is

important that if such devices are used, they are maintained properly, including cleaning or changing the HEPA filter as recommended. Note that air purifiers are not a substitute for appropriate ventilation.

**“New Comfort” air purifier with ionization and UV**

19. Maintain the air purifier in the nurse's office in accordance with manufacturer's instructions.
20. Store used food containers only as long as necessary, and keep in tightly-sealed containers when possible, to prevent pests and odors.

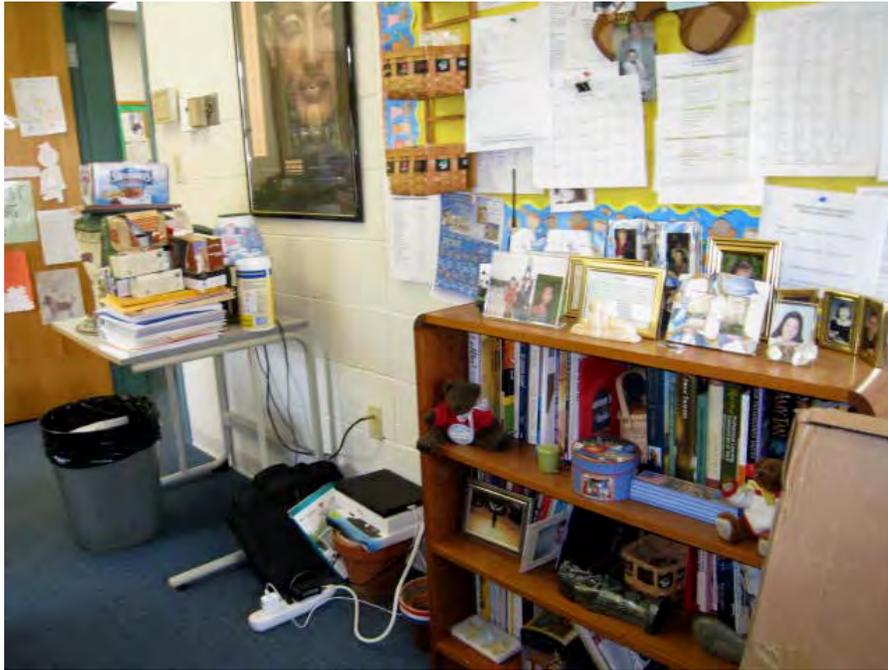
**Picture 11**

In many classrooms, large numbers of items were on floors, windowsills, tabletops, counters, bookcases and desks, which provide a source for dusts to accumulate (Picture 11). These items (e.g., papers, folders, boxes) make it difficult for custodial staff to clean. Items should be relocated and/or be cleaned periodically to avoid excessive dust build up. In addition, dust and debris can accumulate on flat surfaces (e.g., desktops, shelving and carpets) in occupied areas and subsequently be re-aerosolized causing further irritation.

**Items in classroom**

21. Relocate or consider reducing the amount of materials stored in classrooms to allow for more thorough cleaning of classrooms. Clean items regularly with a wet cloth or sponge to prevent excessive dust build-up.

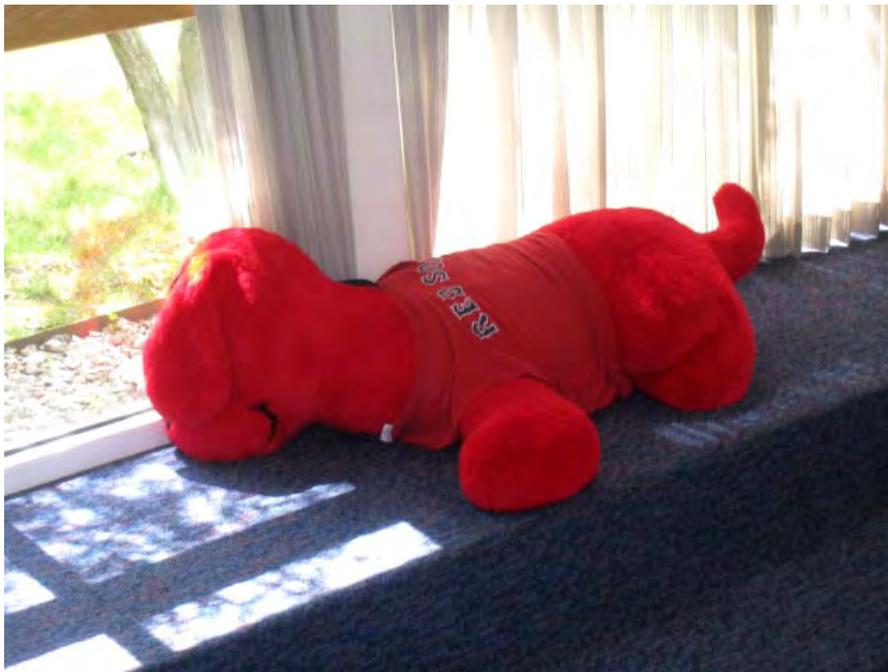
**Picture 12**

Plush toys were observed in several classrooms and the library (Picture 12; Table 1). Upholstery and plush toys are covered with fabrics that may be exposed to human skin. This type of contact can leave oils, perspiration, hair and skin cells. Dust mites feed upon human skin cells and excrete waste products that contain allergens. In addition, if relative humidity levels increase above 60 percent, dust mites tend to proliferate (US EPA, 1992). In order to remove dust mites and other pollutants, frequent vacuuming of upholstered furniture is recommended (Berry, 1994). It is also recommended that upholstered furniture (if present in schools), be professionally cleaned on an annual basis. If an excessively dusty environment exists due to outdoor conditions or indoor activities (e.g., renovations), cleaning frequency should be increased (every six months) (IICRC, 2000).

**Plush toy in the library**

22. Clean air diffusers, exhaust/return vents and personal fans periodically of accumulated dust.
23. Clean plush toys, upholstered furniture and area rugs frequently to remove dust and dust mites.

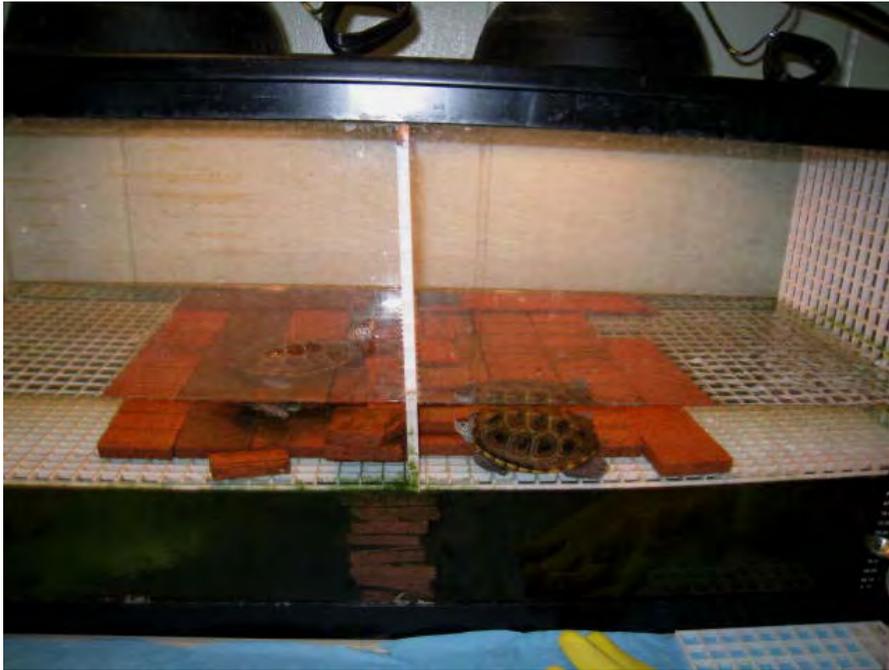
**Picture 13**

Several aquariums containing turtles were located in hallways (Picture 13). Aquariums should be properly maintained to prevent bacterial/mold/algal growth and associated nuisance odors.

**Turtles in an aquarium in the hallway**

17. Refrain from using air fresheners and deodorizers to prevent exposure to VOCs.
18. Monitor aquariums throughout school to maintain cleanliness and reduce associated odors.

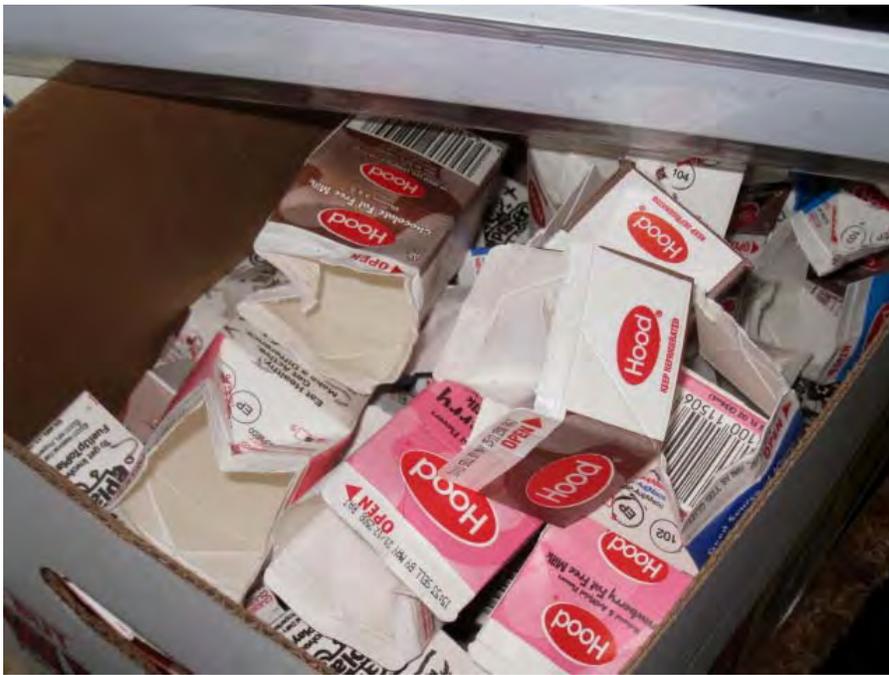
**Picture 14**

A box filled with used milk cartons was found in a classroom (Picture 14). Food containers, even when emptied, can contain food residues that can cause odors or be attractive to pests.

**Milk cartons**

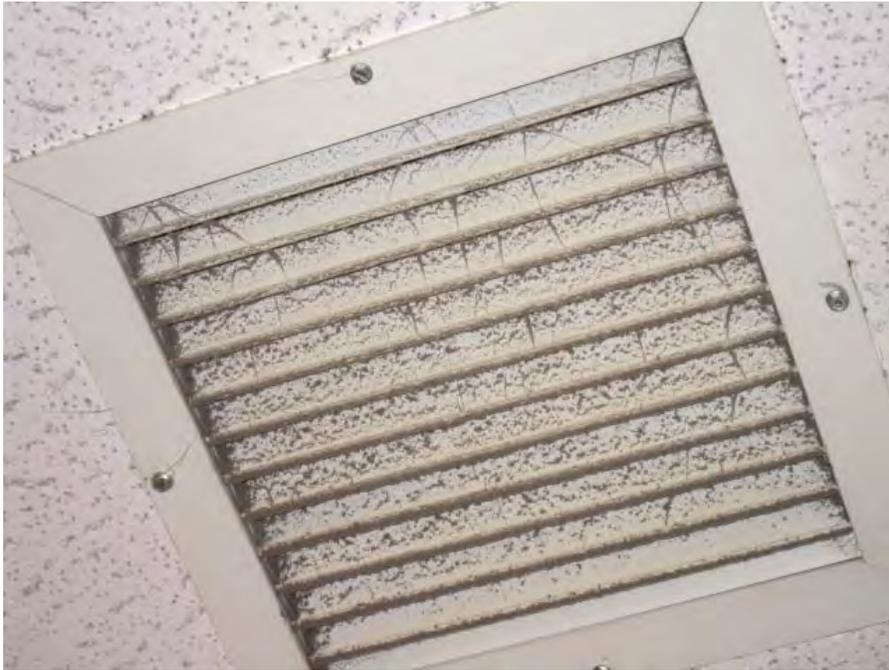
**Picture 15**

A number of air diffusers, exhaust/return vents and personal fans were found to have accumulated dust/debris (Picture 15). If exhaust vents are not functioning, backdrafting can occur, which can re-aerosolize accumulated dust particles. Re-activated supply, exhaust/return vents and fans can also aerosolize dust accumulated on vents/fan blades.

**Dusty exhaust vent**

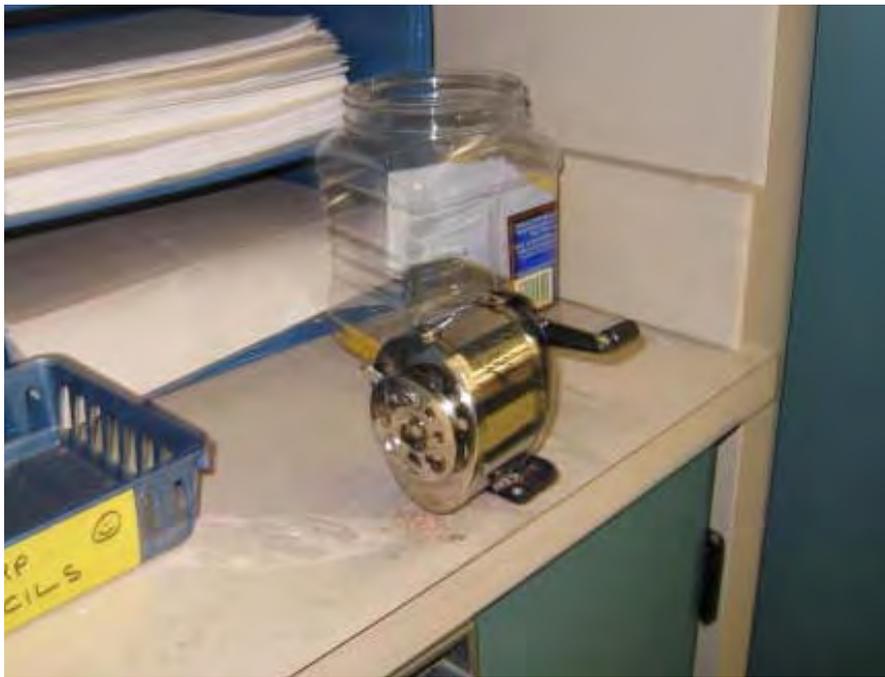
**Picture 16**

Accumulations of pencil shavings were observed in several classrooms (Table 1, Picture 16). These materials can be aerosolized by air movement from the ventilation system, doors opening and closing, or foot traffic and may present an eye or respiratory irritant.

**Pencil sharpener with accumulation of shavings next to it**

24. Clean chalk and dry erase marker trays and pencil sharpening areas regularly with a wet cloth or sponge to prevent excessive build-up of dusts.
25. Clean carpeting annually or semi-annually in soiled high traffic areas as per the recommendations of the Institute of Inspection, Cleaning and Restoration Certification (IICRC). Copies of the IICRC fact sheet can be downloaded at:  
[http://www.cleancareseminars.com/carpet\\_cleaning\\_faq4.htm](http://www.cleancareseminars.com/carpet_cleaning_faq4.htm) (IICRC, 2005).
