# **ODOR INVESTIGATION**

**O'Maley Middle School  
32 Cherry Street  
Gloucester, Massachusetts**

Prepared by:  
Massachusetts Department of Public Health  
Bureau of Environmental Health  
Indoor Air Quality Program  
February 2012

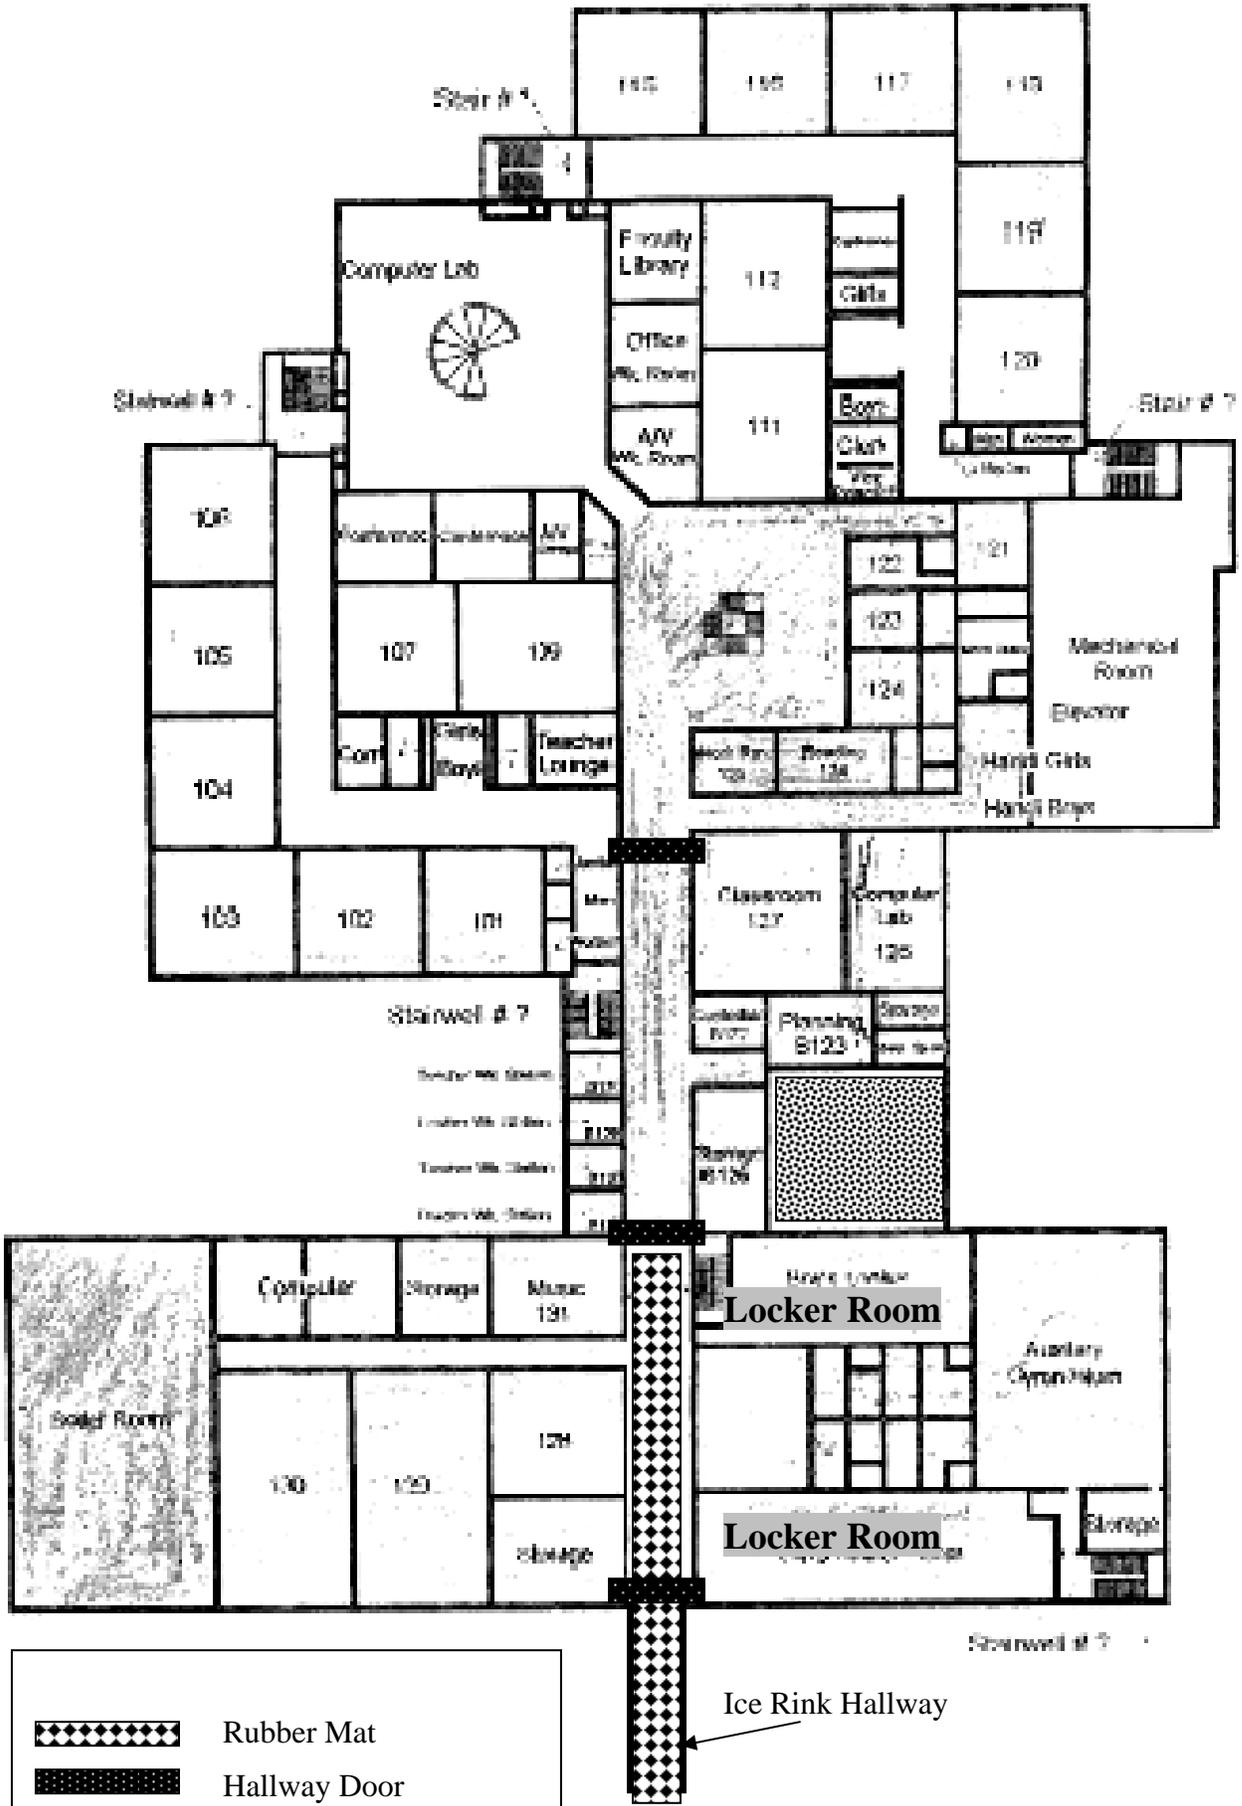
# Map 2

The locker rooms have recently been repurposed for the high school hockey teams. As a part of this, rubber mats were placed on the hallway floor in this area (Map 2, Picture 7). At the time of the assessment, the mats had a distinct rubber odor; it was reported that when the mats were first placed down, the odor was much stronger and caused symptoms of irritation. Depending on the materials used to make the rubber mats (e.g., natural rubber, virgin synthetic rubber, or recycled rubber materials including used tires), these materials can off-gas a variety of VOCs including naphthalene, ethylene glycol monobutyl ether, 1-methyl-2-pyrrolidinone, 1,2,4-trimethylbenzene and other VOCs (CAIWMB, 2003), all of which can be irritating to the eyes, nose and respiratory system. Depending on the conditions of use and ventilation, these materials can build up enough to contribute to symptoms in sensitive people as well as producing irritating odors.

## Rubber Mat Leading from Ice Rink to Locker Rooms inside Building

15. For future reference, air out rubber mats outdoors for an extended period of time to reduce irritating odors.
16. Consider adopting the US EPA (2000) document, “Tools for Schools”, as an instrument for maintaining a good indoor air quality environment in the building. This document is available at: <http://www.epa.gov/iaq/schools/index.html>.

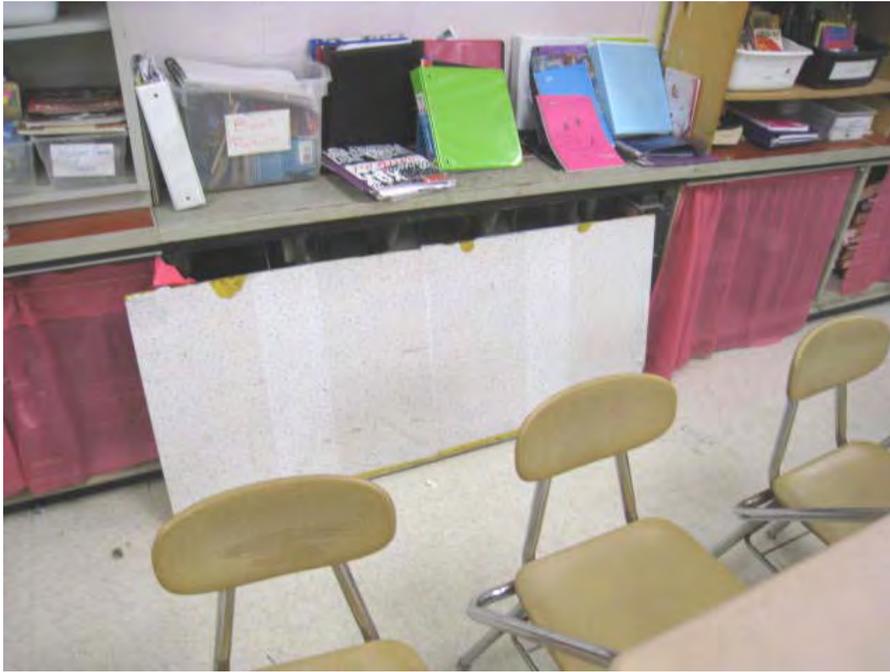
**Picture 1**

Fresh air to some classrooms (e.g., 201, 219) is supplied by unit ventilator (univent) systems. A univent draws air from the outdoors through a fresh air intake located on the exterior wall of the building. Return air from the classroom is drawn through an air intake located at the base of the unit ([Figure 1](#)). Fresh and return air are mixed, filtered, heated and provided to classrooms through an air diffuser located in the top of the unit. The univent in room 219 was found to be running but open (Picture 1), which not only impedes proper function but may also be a safety hazard. In order for univents to provide fresh air as designed, they must remain “on” and operating while rooms are occupied. Furthermore, units must remain intact and free of obstructions.

**Univent in room 219 open while running**

3. Operate all ventilation systems throughout the building continuously during occupied periods. However, do not operate univents while they are open, as this may impede function and serve as a safety hazard.

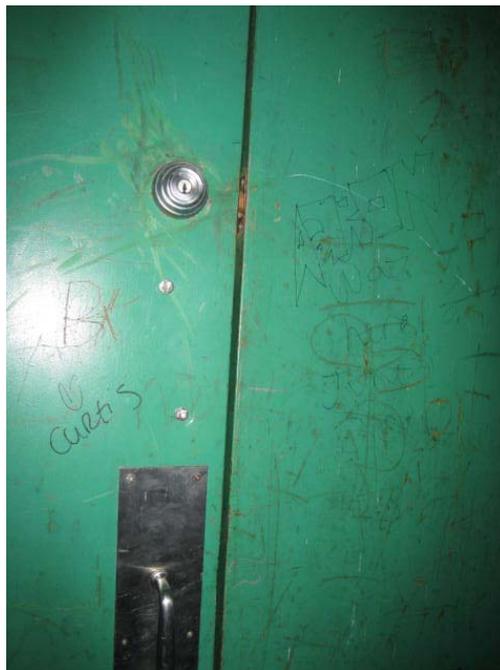
**Picture 2**

- The doors to the ice rink (Picture 2) do not seal completely, and the passage of cold air was noted through gaps in the doorway during the investigation. The air from the ice rink is influenced by the presence of the ice and contains significant amounts of moisture, which can draw air/moisture/odors from the ice rink through the hallway and into the main building.
- Signs of water damage and mold were noted on ceiling tiles, wallboard and insulation adjacent to the doors leading from the main school building into the ice rink hallway (Pictures 3 and 4). It is likely that roof leaks at the joint in the roof between the two building segments are responsible for this damage but it also may be related to condensation of moist air from the ice rink.

**Ice rink doors (note gap where airflow could be detected)**

2. Isolate the ice rink from the rest of the school through the following actions:
  - a. Repair the doors leading to the ice rink to reduce/eliminate gaps allowing airflow, including weather stripping as needed;

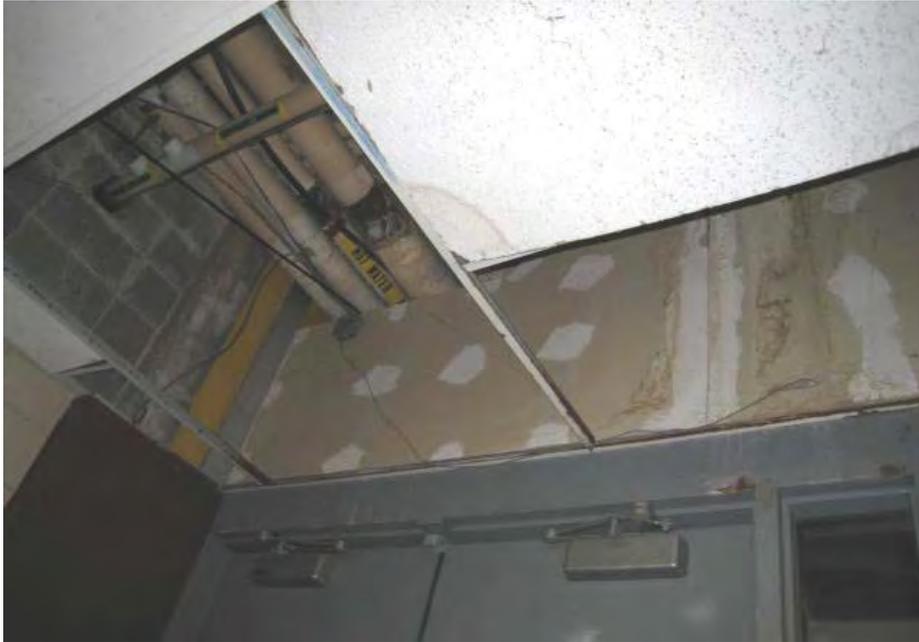
**Picture 3**

- It was also noted that above the suspended ceiling tile system, pipes connect the main school building with the hallway; the plenum is therefore a continuous pathway for odors and moisture to enter the main school building.

**Open ceiling plenum next to ice rink hallway doors, note water-damaged wallboard and ceiling tiles**

1. Examine roofs and repair/patch portions of the roofs to prevent/reduce leaks.  
Repair/replace water-damaged building materials (e.g., wallboard, insulation, ceiling tiles).

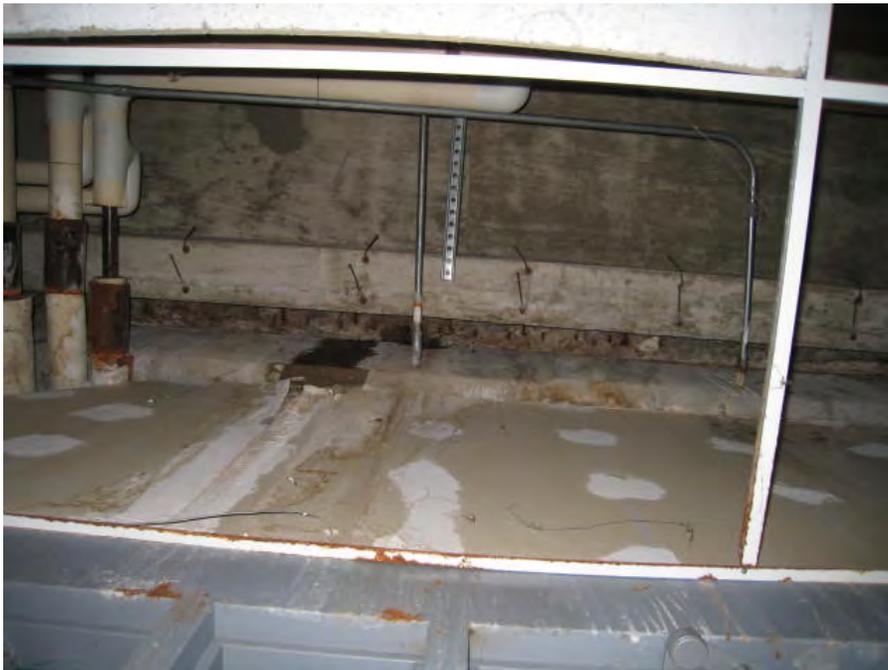
**Picture 4**

**Water-damaged wallboard, wood and insulation above ice rink hallway doors**

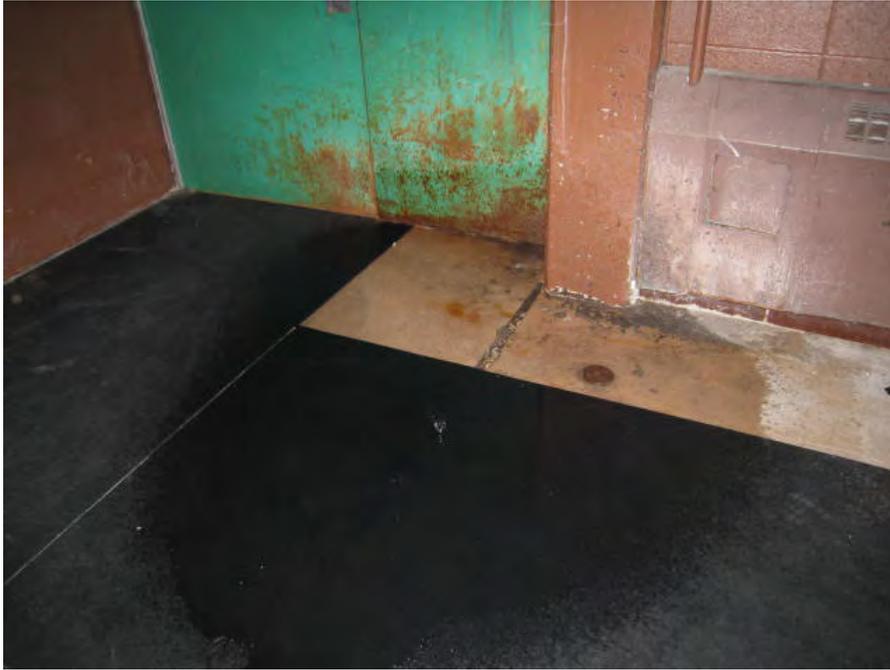
**Picture 5**

- There was an active water leak noted from above the hallway next to the ice rink door (Picture 5) and additional signs of water damage on the door itself.

**Active water leak adjacent to ice rink doors, note water-damaged door and flooring.**

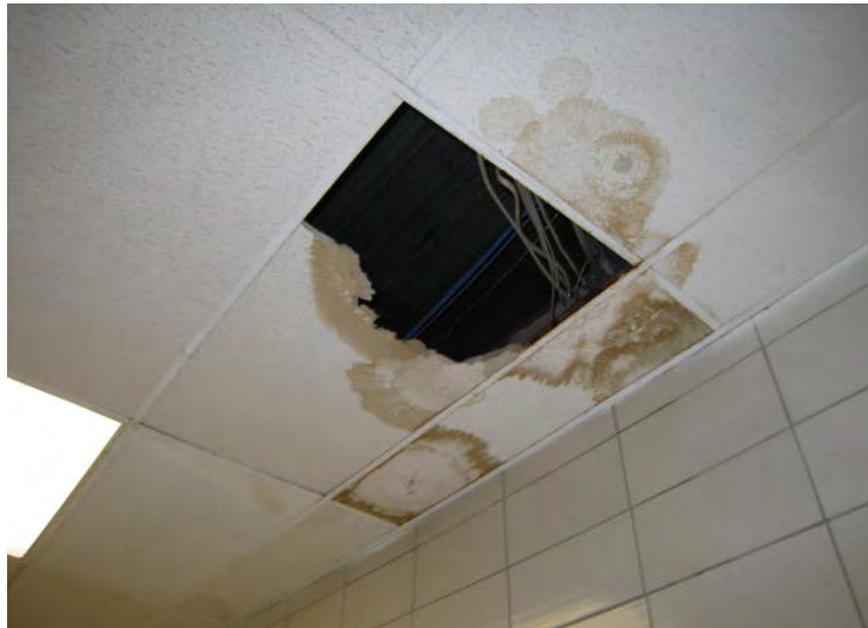
**Picture 6**

- Signs of water infiltration and water damage were also noted in other areas of the school, including:
  - Active water leaks and damaged ceiling tiles in the “island house” hallway (Picture 6);

**Site of active water leak in “Island House” wing hallway showing water-damaged/broken ceiling tiles**

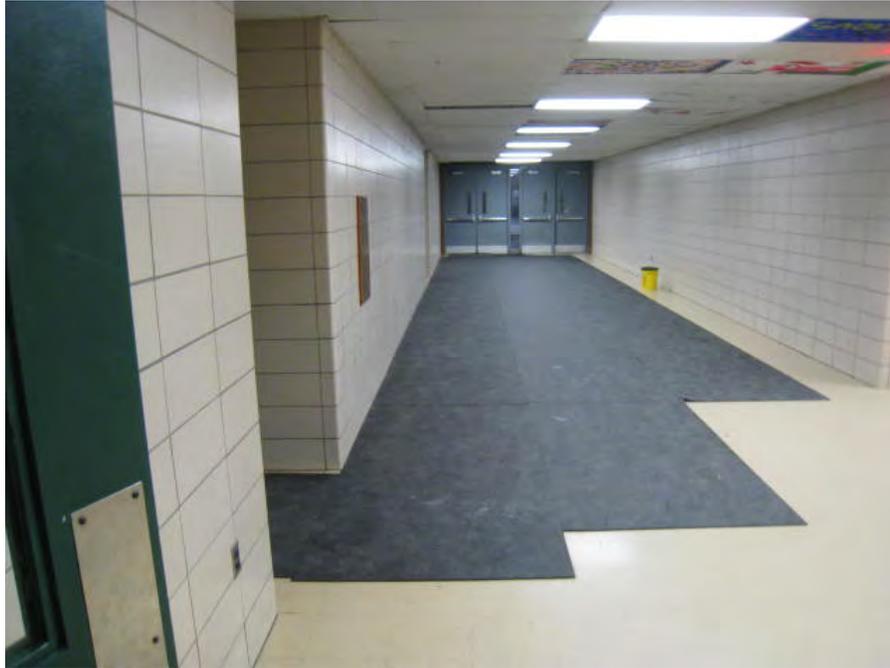
**Picture 7**

**Rubber mat material placed in hallway to ice rink**

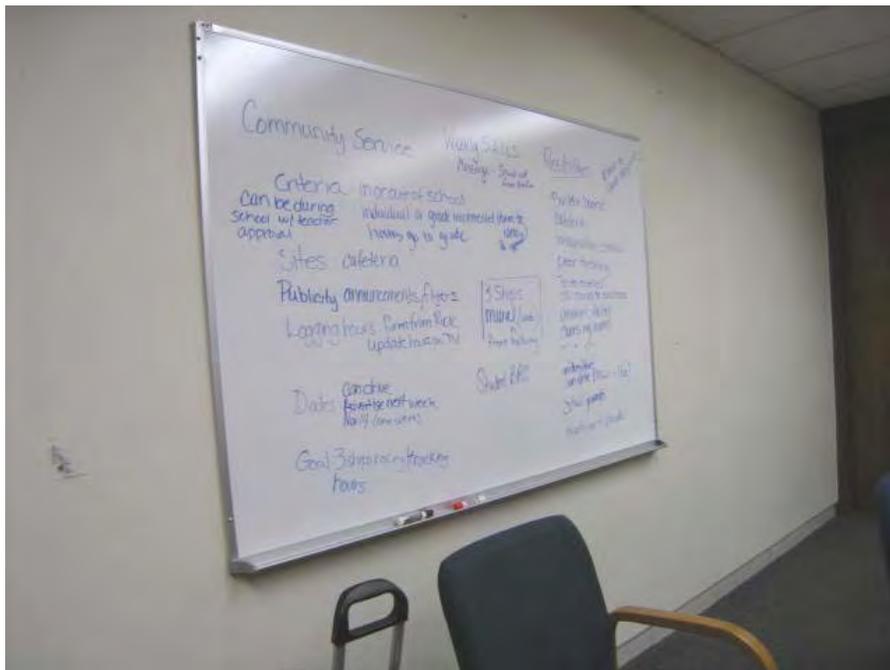
**Picture 8**

Several classrooms contained dry erase boards and related materials (Picture 8). Materials such as dry erase markers and dry erase board cleaners may contain VOCs, such as methyl isobutyl ketone, n-butyl acetate and butyl-cellusolve (Sanford, 1999), which can be irritating to the eyes, nose and throat.

**Dry erase board**

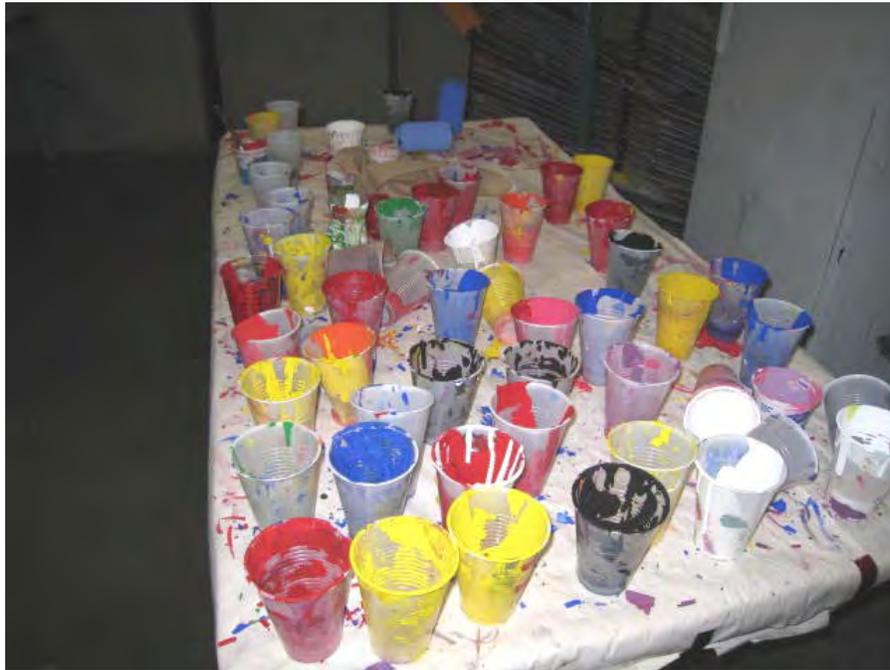
**Picture 9**

Other conditions that can affect IAQ were observed during the assessment. Art materials were stored and in use on many surfaces in the art rooms (Picture 9). These materials can be a source of odors, particulates and allergens if not properly stored and/or used without proper ventilation.

**Art supplies in the art room**

13. Return unused art supplies (i.e., paints) to proper storage container or properly discard when not in use.
14. Clean univent air diffusers, return vents/exhaust vents and personal fans, periodically of accumulated dust/debris.

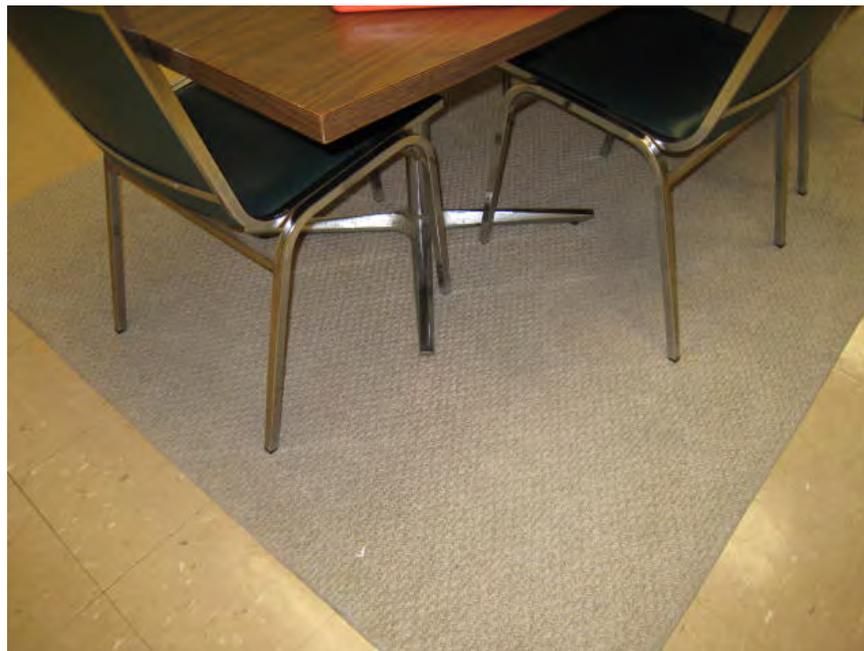
**Picture 10**

The conference room/office in room 121 had an area rug, which was in somewhat poor condition (Picture 10). Carpeting should be cleaned regularly to prevent it from becoming a source of dust. The Institute of Inspection, Cleaning and Restoration Certification (IICRC), recommends that carpeting be cleaned annually (or semi-annually in soiled high traffic areas) (IICRC, 2005).

**Area rug in 121/122 conference room**

11. Consider replacement of area carpet in conference room 121.
12. Relocate or consider reducing the amount of materials stored in classrooms to allow for more thorough cleaning of classrooms. Clean items regularly with a wet cloth or sponge to prevent excessive dust build-up.

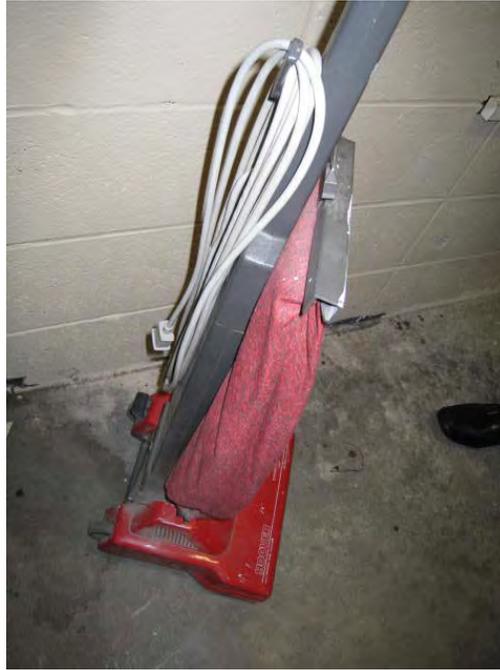
**Picture 11**

The storage room attached to this conference room had a vacuum cleaner that was not equipped with a high efficiency particle arrestance (HEPA) filter (Picture 11). Vacuum cleaners without HEPA filtration tend to re-aerosolize fine particulate matter rather than removing it. Use of HEPA-equipped vacuum cleaners is recommended.

**Non HEPA-filtered vacuum cleaner**
