INDOOR AIR QUALITY ASSESSMENT MOLD INVESTIGATION

**North Shore Community College
Lynn Campus, 300 Broad Street
Lynn, Massachusetts**

Prepared by:
Massachusetts Department of Public Health
Bureau of Environmental Health
Indoor Air Quality Program
April 2012

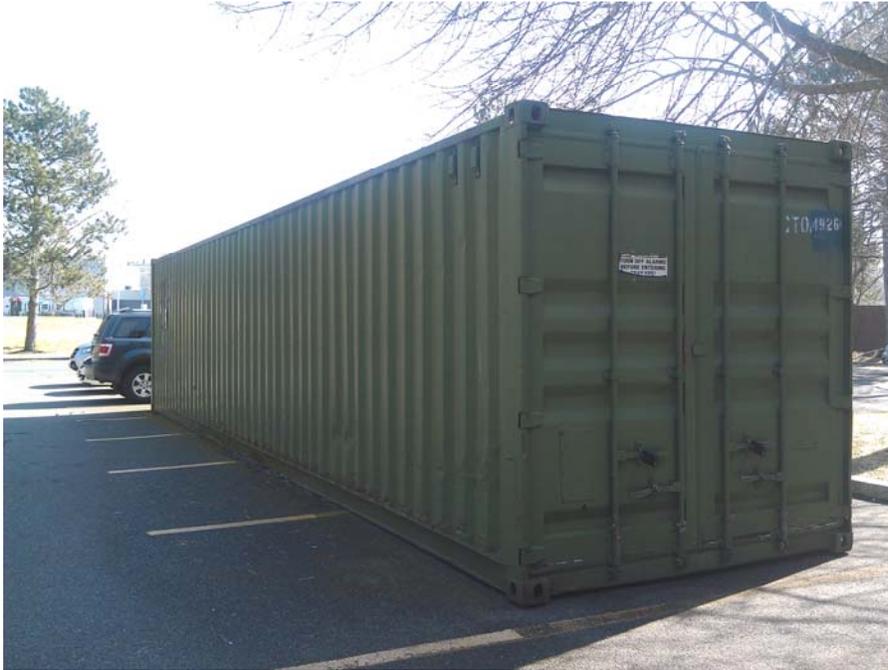
Picture 1

The storage unit is an un-insulated metal container that is currently located in a parking lot behind the main school building (Picture 1). Its primary function is for housing older, unused computer equipment. Most recently, IT staff have been accessing the storage unit for inventory purposes.

Storage unit

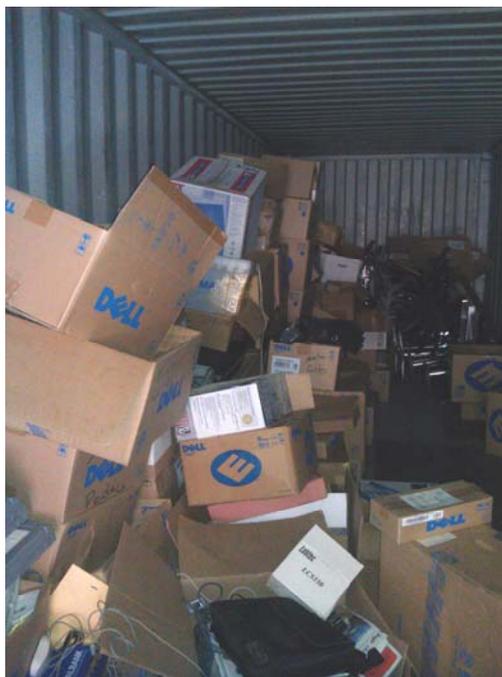
Picture 2

access, BEH staff detected a strong musty odor within the unit, which contained a number of cardboard boxes, approximately 10 older laptop units, and an assortment of IT-related equipment (Picture 2). A fine, white growth was observed on a number of flat surfaces (Picture 3 and 4), as well as the wooden floor (Picture 5). Some items also appeared water-damaged (Picture 6).

Items stored inside storage unit

1. Discontinue use of this storage unit for porous materials and/or consider alternative storage methods.
2. Discard porous materials (i.e., paper, cardboard) and any other materials that cannot be readily cleaned sufficiently to remove mold growth.
3. Clean/scrub non-porous surfaces with an appropriate disinfectant.

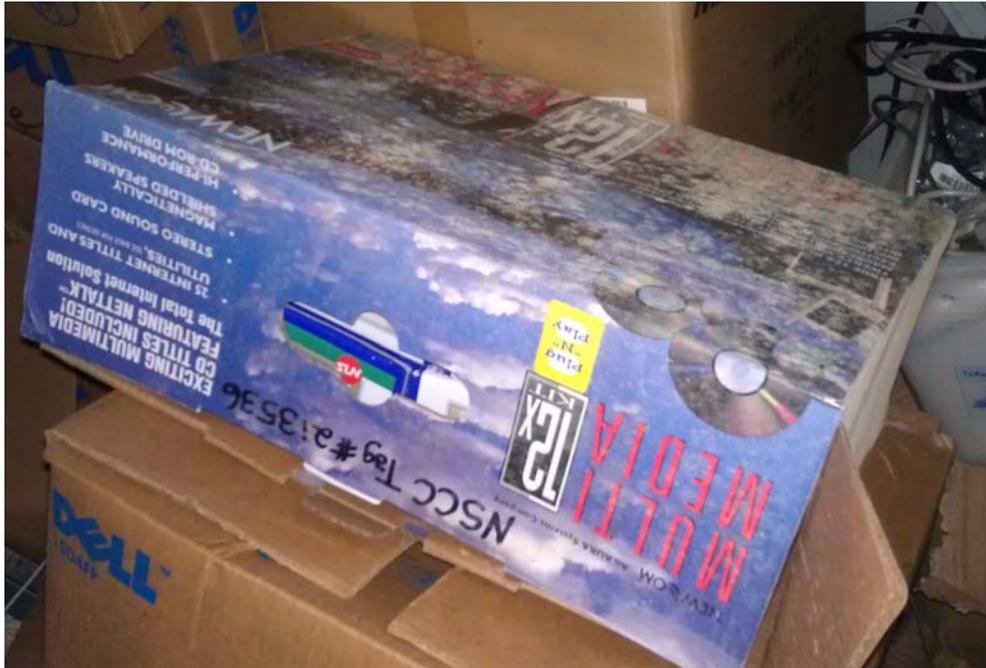
Picture 3

Since the trailer is not insulated, it is very susceptible to temperature changes. On sunny days, the interior temperature of the storage unit rises significantly due to solar gain. During evenings, particularly during winter months, the interior temperatures are reduced. Because the trailer is not airtight, it is susceptible to humidity/moisture infiltration; dust and other particulates can also penetrate through openings and breaches in the unit. The combination of temperature changes and moisture penetration into the unit creates conditions allowing moisture to dampen porous materials or condense on cool surfaces. Over time, moistened materials and/or dust/debris can become a source for mold growth. Without proper ventilation and/or moisture control, the potential for exposure to mold growth/spores exists when the unit is entered.

Mold growth on cardboard box

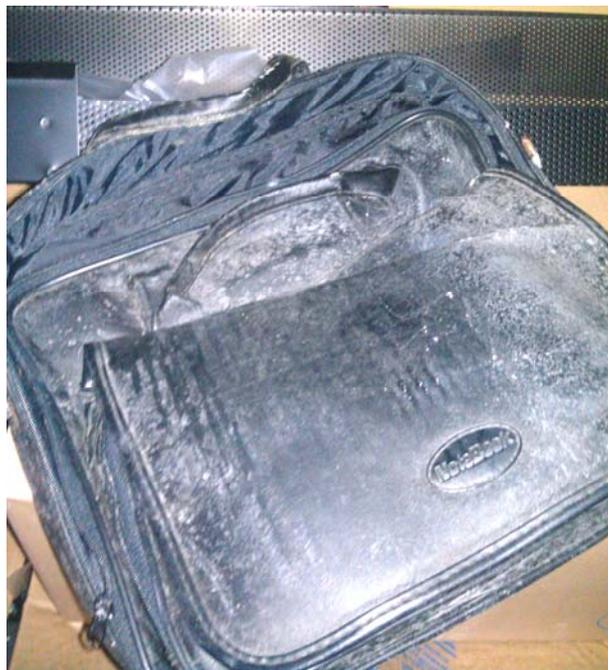
Picture 4

Mold growth on laptop case

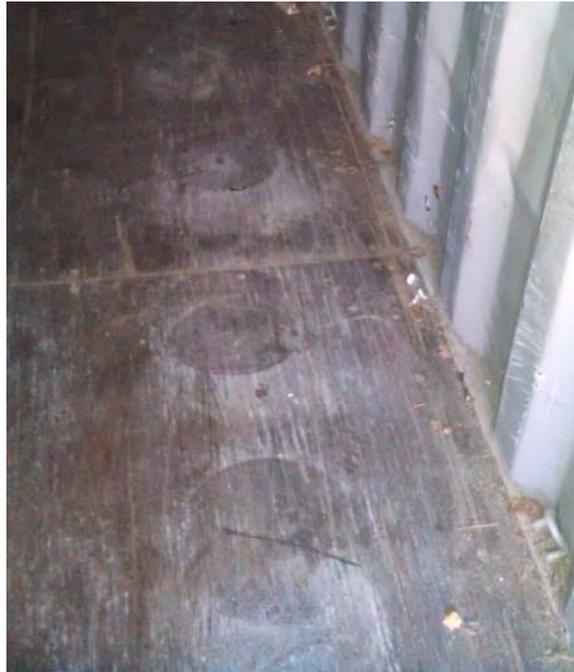
Picture 5

Mold growth on wooden floor
