# **INDOOR AIR QUALITY ASSESSMENT**

**Attorney General's Southeastern Office  
105 William Street  
New Bedford, Massachusetts**

Prepared by:  
Massachusetts Department of Public Health  
Bureau of Environmental Health  
Indoor Air Quality Program  
September 2012

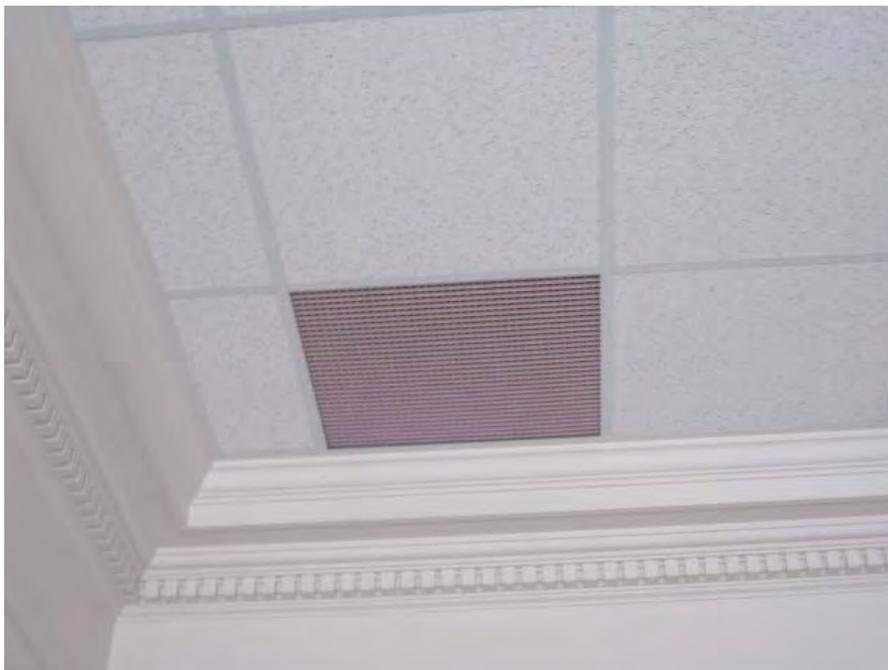
**Picture 2**

It can be seen from Table 1 that carbon dioxide levels were below 800 parts per million (ppm) in all areas indicating optimal air exchange at the time of testing (Table 1). Mechanical ventilation is provided by a heating, ventilation and air conditioning (HVAC) system. The air handling units (AHUs) are located in the ceiling plenum. Fresh air is drawn through vents on the exterior of the building. Ductwork connects the AHU to ceiling-mounted supply diffusers (Picture 1). By design, diffusers are equipped with fixed louvers that direct air along the ceiling to flow down the walls and create airflow. Air returns to the AHUs through ceiling or wall-mounted return vents via ductwork (Pictures 2 and 3).

**Ceiling-mounted return vent/grill**

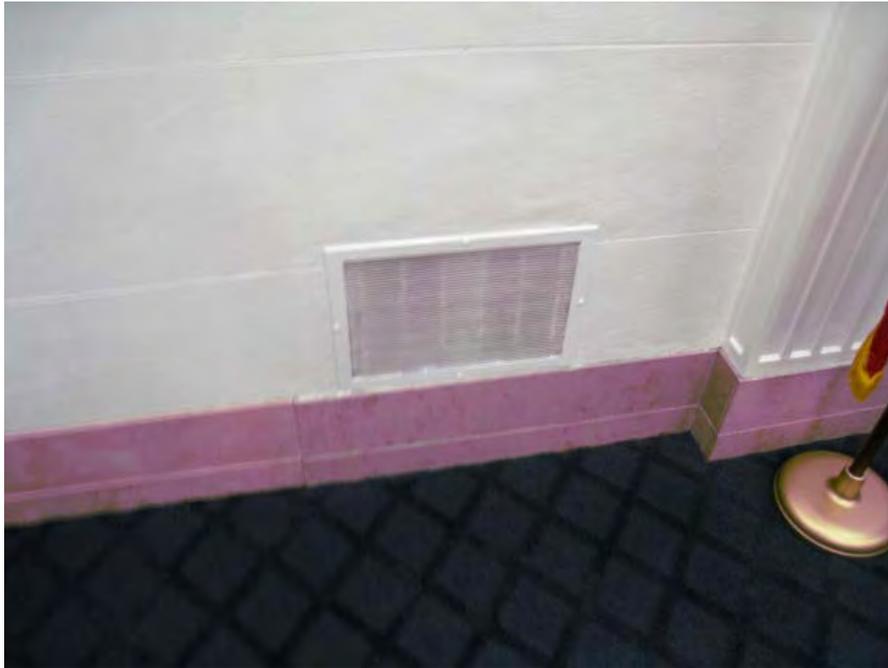
**Picture 3**

**Wall-mounted return vent**

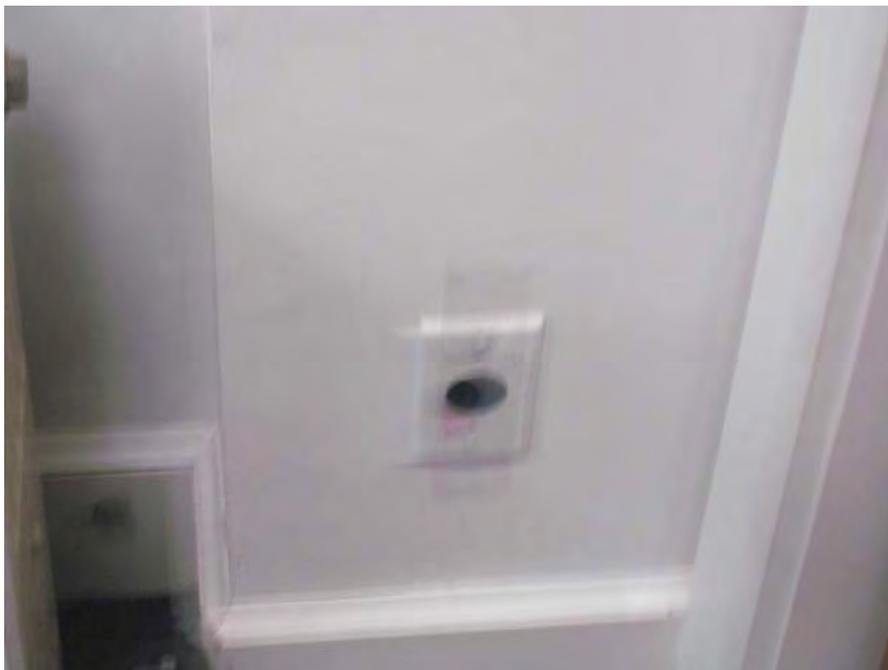
**Picture 4**

In area 4 (Figure 1), BEH/IAQ staff observed a hole in the wall temporarily sealed with clear tape (Picture 4). This breach into the wall cavity can provide a pathway for drafts, dust, odors and particulates to migrate into occupied areas.

**Hole in wall temporarily sealed with clear tape in area 4 (Figure 1)**

1. Ensure any leaks are repaired and replace water-damaged ceiling tiles. Examine the area above these tiles for mold growth. Disinfect areas of water leaks with an appropriate antimicrobial, as needed.
2. Clean air diffusers, exhaust/return vents and personal fans periodically of accumulated dust.
3. Seal any open holes/breaches in interior walls (Picture 4) to prevent the migration of drafts, odors, particulates from wall cavities into occupied areas.
