INDOOR AIR QUALITY ASSESSMENT

**Department of Early Education and Care
Metro Boston Regional Office
1250 Hancock Street, Suite 120-S
Quincy, MA**

Prepared by:
Massachusetts Department of Public Health
Bureau of Environmental Health
Indoor Air Quality Program
April 2012

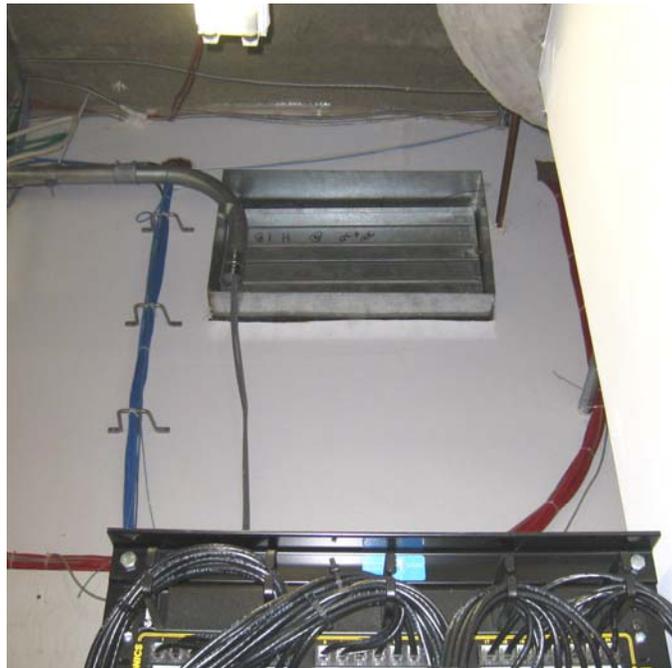
Picture 1

It can be seen from Table 1 that carbon dioxide levels were below 800 parts per million (ppm) in all but one area surveyed, indicating adequate air exchange at the time of the assessment. Fresh air is drawn (Picture 1) into an air-mixing closet where the air-handling unit (AHU) is located (Picture 2). Passive return vents in the open work areas (i.e., cubicles and reception) return air back to the air-mixing room (Picture 3). The AHU draws air from the air-mixing room then heats/cool and filters it for distribution into the occupied space via ceiling-mounted air diffusers (Picture 4). Please note, the AHU air intake was occluded with dust and debris at the time of assessment (Picture 5). Control boxes located above the suspended ceiling system regulate distribution of air to occupied areas. In general, offices are not designed to have return vents. Offices have fresh air diffusers that pressurize the space, forcing air into hallways via undercut doors.

Fresh air intake

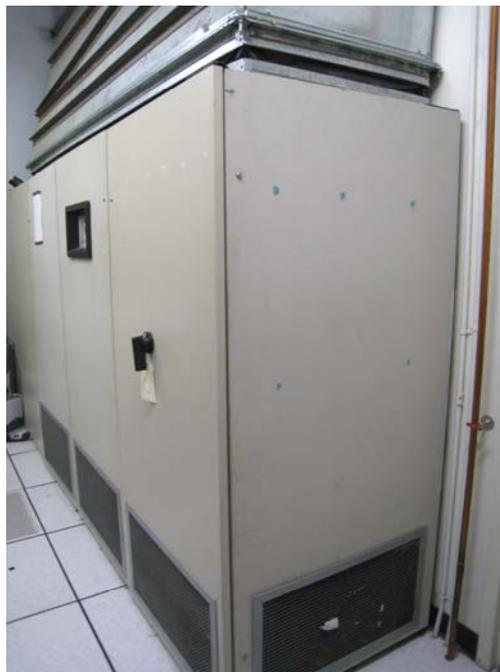
Picture 2

MDEEC staff expressed concerns regarding uneven temperature control and excess heat. When examining the AHU in the air mixing room, MDPH/BEH staff observed computers and other electronic equipment, indicating that this room also functions as an IT room. Such equipment produces a significant amount of waste heat, which can increase the temperature of air within the air mixing room. As warm air is drawn into the AHU, it is further tempered

AHU

2. Consider methods for reducing temperature of air provided to the occupied space.
 - a. Lower thermostat temperature to reduce heating of air pre-heated by the IT equipment that is also housed in the air-mixing room.

- b. Consider partitioning a portion of the air-mixing room to create a dedicated IT room to prevent pre-heating of air being drawn into the AHU. Please note, a means for cooling the IT room is typically necessary to prevent overheating of equipment.

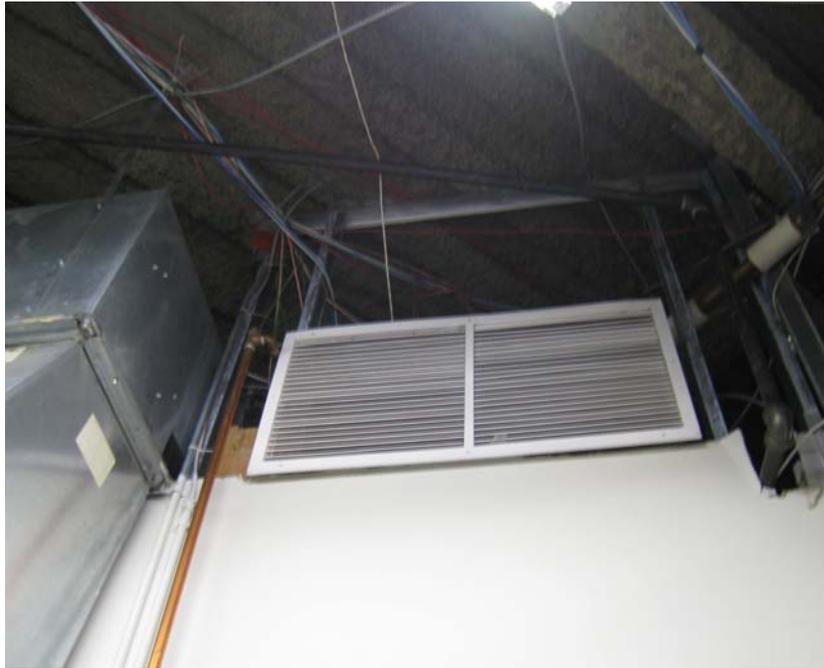
Picture 3

Return vent for air returned to air-mixing room

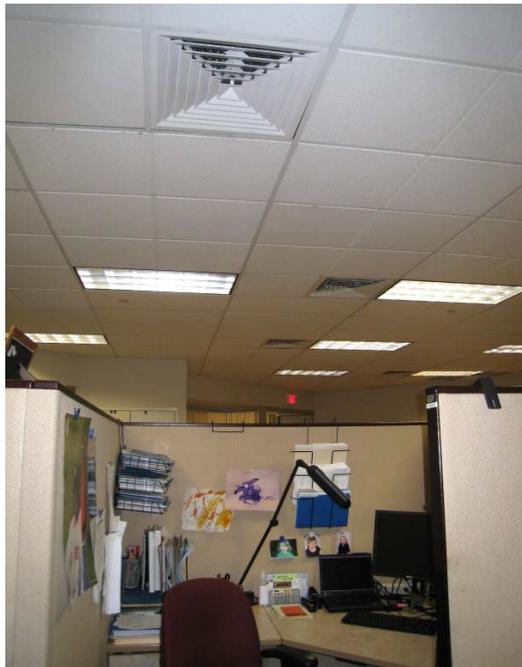
Picture 4

Staff also expressed concerns about air blowing directly onto their workspaces. In a number of areas, air diffusers are located directly above work stations (Picture 4). Since reconfiguration of cubicles is difficult, consideration should be given to either moving supply diffusers or replacing currently existing four-way diffusers with those that distribute air in only two or three directions.

Ceiling-mounted air diffusers, note location above desk

5. Consider relocating supply diffusers or replacing the current four-way diffusers, where necessary, with those that direct air bi-laterally or in three directions to limit the amount of air blowing directly onto occupants.

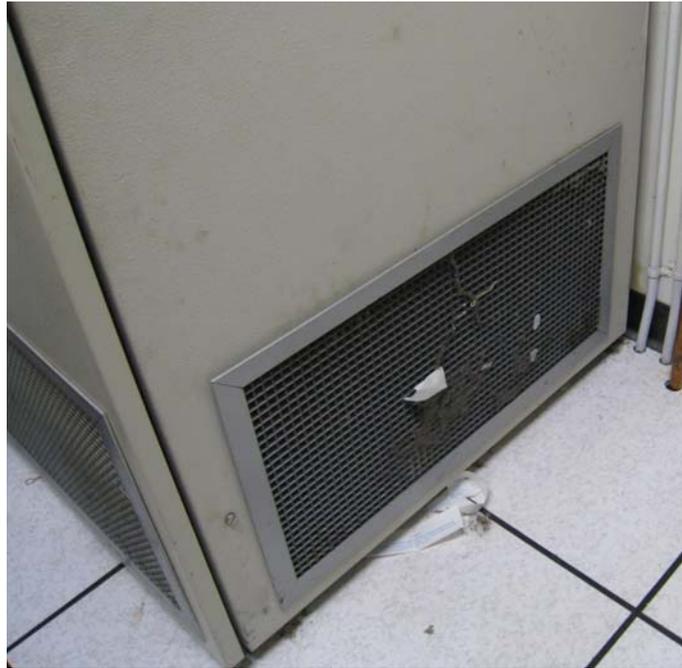
Picture 5

AHU air intake, note debris against intake vent

3. Change filters regularly to ensure proper filtration. Ensure filters are in place and that they fit properly.
4. Clean AHU air intake, air diffusers, return vents and personal fans periodically of accumulated dust/debris.

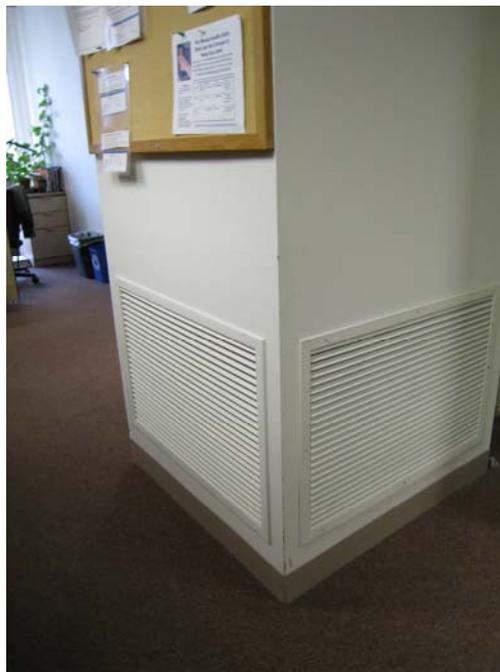
Picture 6

Dedicated exhaust ventilation appeared to be provided by vents on a column (Picture 6). This type of exhaust vent is designed to remove normally occurring waste heat and pollutants from the workspace. A dedicated switch-activated exhaust is located in the bathroom. Consideration should be given to ensuring the bathroom exhaust operates at all times that the office is occupied as a means to prevent odors and moisture from penetrating into the office space.

Dedicated exhaust vent

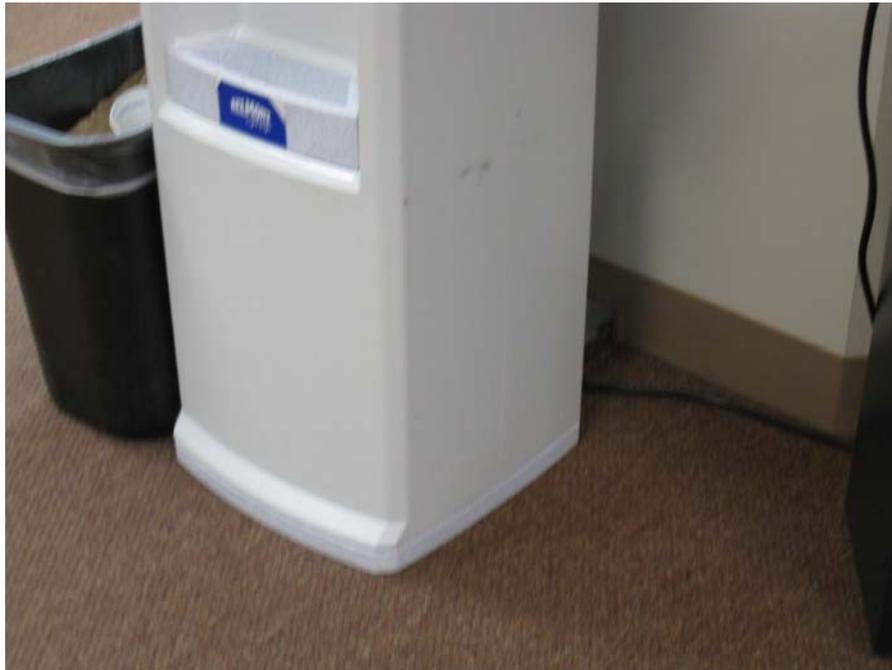
Picture 7

A water dispenser was located in a carpeted area (Picture 7); spills/leaks from such appliances can be a source of moisture in carpeting that can lead to water damage and mold growth. These units should be located in tiled areas or placed on a waterproof mat.

Water cooler on carpeting

9. Consider installing a waterproof mat beneath the water cooler to collect water spill/overflow and prevent moistening of carpeting.
10. Reseal around toilet to prevent water damage below tiled floor.

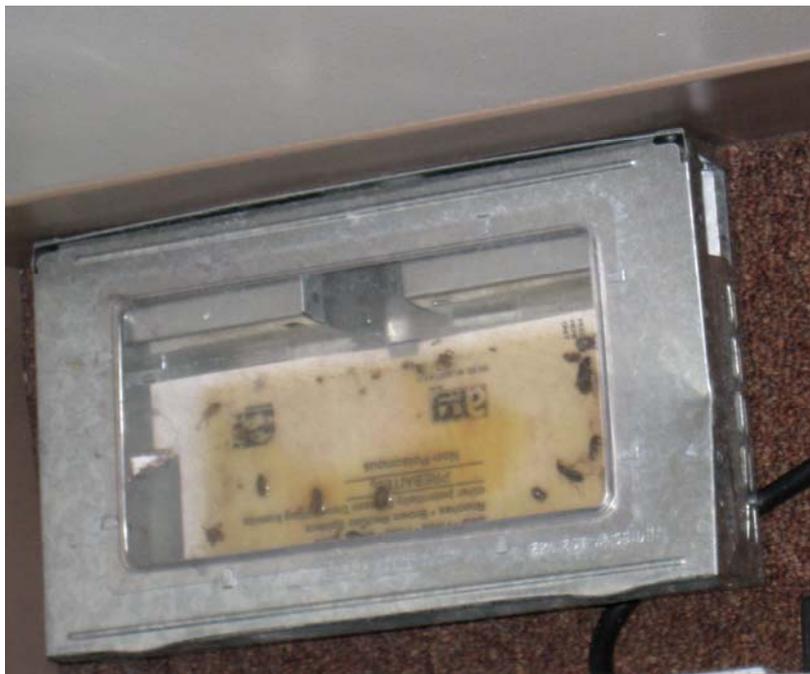
Picture 8

Food should be stored in an airtight container, and crumbs should be cleaned frequently to avoid attraction of pests. Evidence of rodent activity, including a glue trap with fecal matter was observed behind the cooler in the reception area (Picture 8). Rodent infestation can result in indoor air quality related symptoms due to materials in their wastes. Mouse urine contains a protein that is a known sensitizer (US EPA, 1992). A sensitizer is a material that can produce allergic symptoms (e.g., running nose or skin rashes) in sensitive individuals following repeated exposures. A three-step approach is necessary to eliminate rodent infestation:

Rodent droppings in glue trap

1. removal of the rodents;
2. cleaning of waste products from the interior of the building; and
3. reduction/elimination of pathways/food sources that are attracting rodents.

To eliminate exposure to allergens, rodents must be removed from the building. Please note that removal, even after cleaning, may not provide immediate relief since allergens can exist in the interior for several months after rodents are eliminated (Burge, 1995). Once the infestation is eliminated, a combination of cleaning and increased ventilation and filtration should serve to reduce allergens associated with rodents.

11. It is highly recommended that the principles of integrated pest management (IPM) be used to rid the building of pests. A copy of the IPM recommendations can be obtained from the Massachusetts Department of Food and Agriculture (MDFA) website:

- a. Rinse out recycled food containers. Seal recycled containers in a tight-fitting lid to prevent rodent access.
- b. Remove non-food items that rodents are consuming.
- c. Store food in tight-fitting containers.

- d. Avoid eating at workstations. In areas where food is consumed, periodic vacuuming to remove crumbs is recommended.
 - e. Regularly clean crumbs and other food residues from ovens, toasters, toaster ovens, microwave ovens, coffee pots and other food preparation equipment.
 - f. Examine each room and the exterior walls of the building for means of rodent egress and seal. Holes as small as ¼ inch are enough space for rodents to enter an area. If doors do not seal at the bottom, install a weather strip as a barrier to rodents. Reduce harborages (cardboard boxes) where rodents may reside (MDFFA, 1996).
12. Refer to resource manuals and other related indoor air quality documents for further building-wide evaluations and advice on maintaining public buildings. Copies of these materials are located on the MDPH's website: <http://mass.gov/dph/iaq>.
