INDOOR AIR QUALITY ASSESSMENT

**Squantum Elementary School
50 Huckins Avenue
Quincy, MA**

Prepared by:
Massachusetts Department of Public Health
Bureau of Environmental Health
Indoor Air Quality Program
October 2012

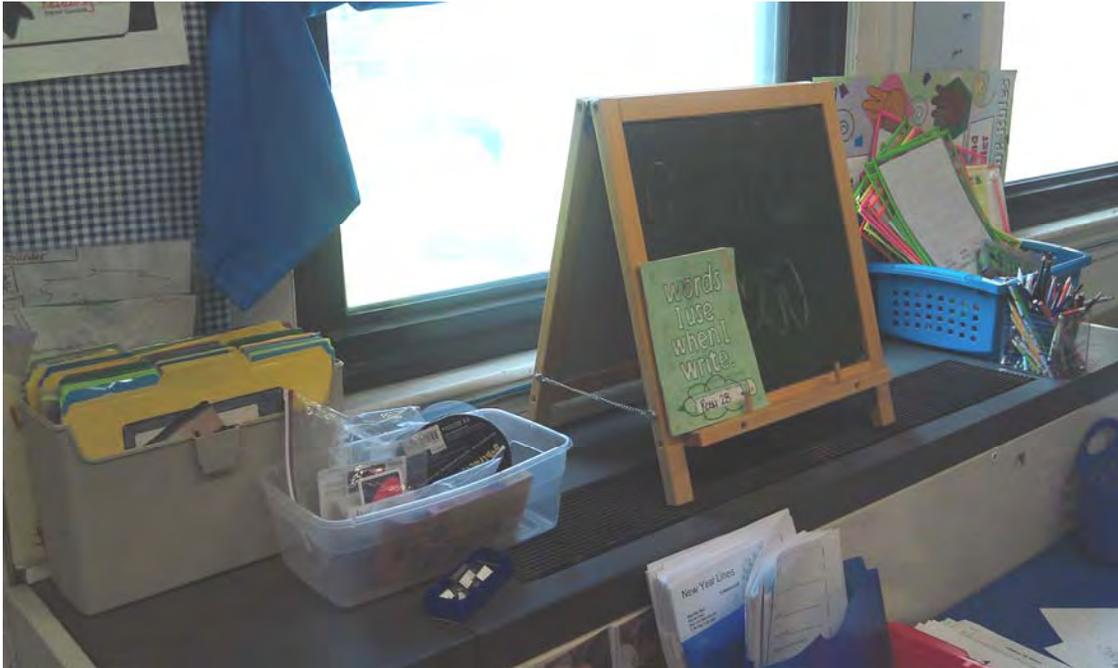
Picture 1

Fresh air is supplied to classrooms by unit ventilator (univent) systems (Picture 1). A univent draws outdoor air through an air intake located on the exterior wall of the building and returns air from the room through an air intake located at the base of the unit ([Figure 1](#)). Fresh and return air are mixed, filtered, heated and then delivered to the room through an air diffuser located in the top of the unit.

Univents have control settings of “off”, “low” and “high”. At the time of assessment, BEH/IAQ staff found univent cabinets opened and in the “off” position in a number of areas. When univents are deactivated, no fresh air is introduced (Table 1). In addition, univent air diffusers and return intakes were blocked by books, furniture and other items placed in front and on top of the unit, thereby limiting airflow (Picture 1). In order for univents to provide fresh air

Classroom unit, note items on top and in front of unit

1. Operate all ventilation systems (e.g., univents, exhaust vents and AHUs) throughout the building *continuously* during periods of occupancy. To increase airflow in classrooms, set univent controls to “high”. School staff should be encouraged not to deactivate classroom univents and to report any temperature/comfort complaints to the facilities department.
2. Remove all blockages from the top and front of univents and exhaust vents to ensure adequate airflow. Ensure plants and dust generating items (i.e., pencil sharpeners) are located away from univents.

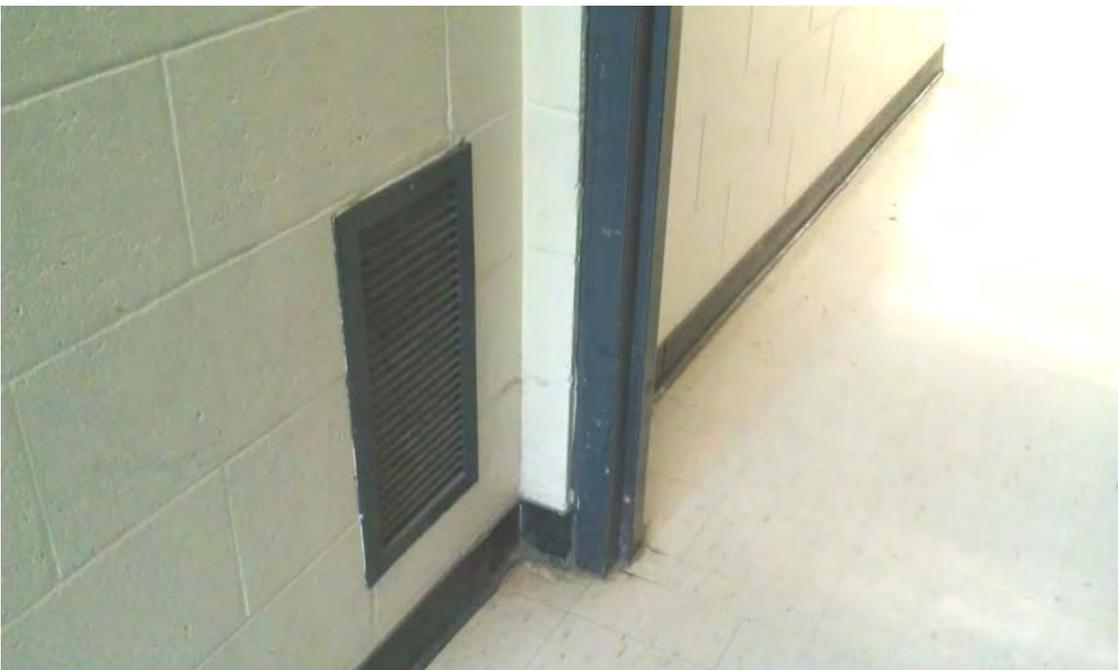
Picture 2

Exhaust ventilation is provided by passive exhaust vents located in classroom walls or ceilings (Picture 2). Some exhaust vents were found sealed at the time of assessment. As originally designed, fresh air was intended to be mechanically introduced into classrooms via the univents, which “pressurized” the room forcing stale classroom air and excess heat into the exhaust vents and up the ventilation shaft to an exhaust terminus on the roof. As the air rose up the ventilation shaft, negative pressure was created in the room, facilitating the draw of air from the room into the exhaust shaft resulting in air exchange. Without properly functioning supply and exhaust ventilation systems, normally occurring environmental pollutants can build up.

Classroom exhaust vent

15. Consider installing a mechanical exhaust ventilation system. Determine if existing airshafts, vents, ductwork, etc. can be retrofitted for (modern) mechanical ventilation.

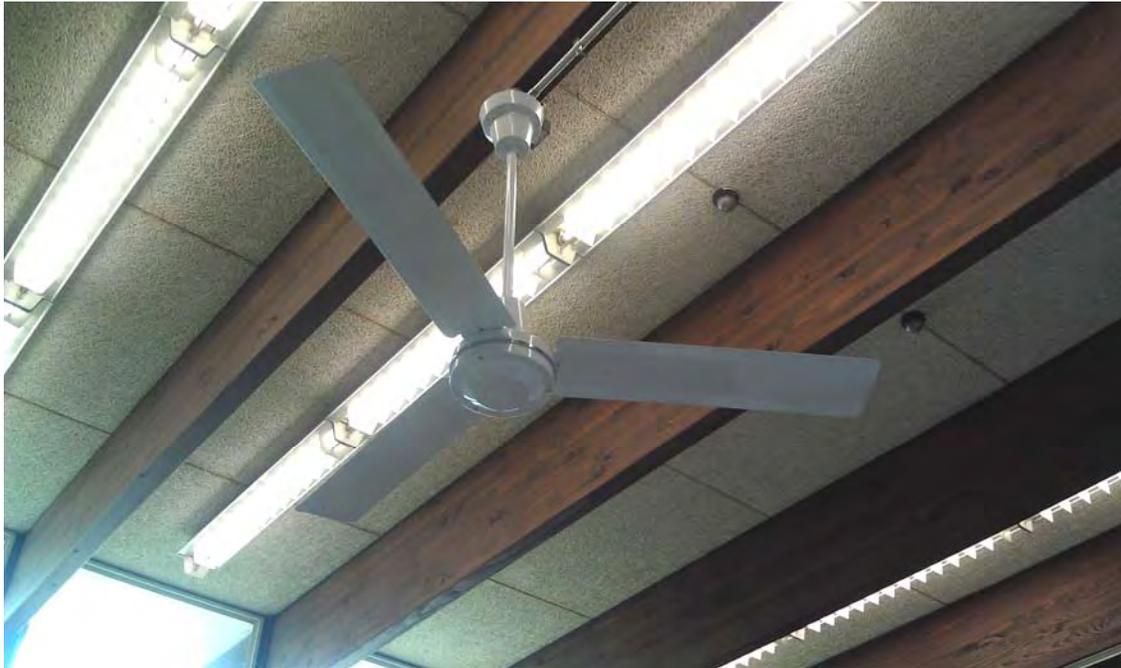
Picture 3

Ceiling fans were noted in a number of classrooms (Picture 3). These ceiling fans enhance air circulation within the room, especially during warmer months when windows are open. At the time of assessment, classroom ceiling fans were not operating.

Ceiling fan in classroom

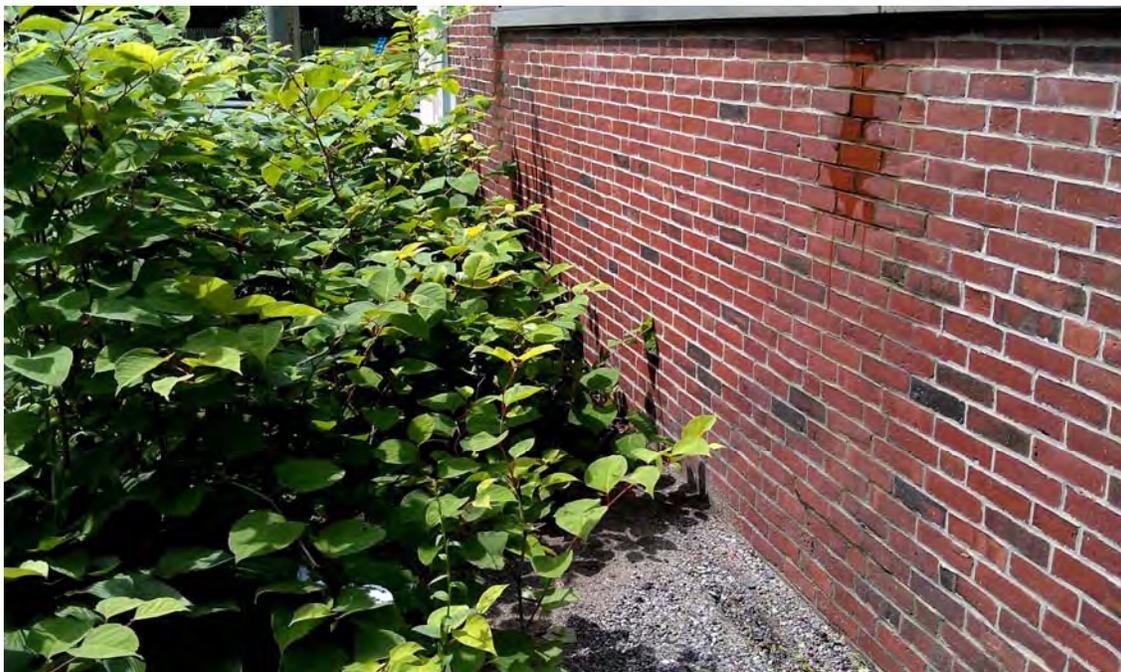
Picture 4

In order for building materials to support mold growth, a source of water exposure is necessary. Identification and elimination of the source of water moistened building materials is necessary to control mold growth. Water-damaged ceiling and wall plaster was observed in a number of areas, indicating roof leaks and/or water penetration through the brick exterior. Water penetration has resulted in staining and some efflorescence on both interior and exterior walls (Picture 4). Efflorescence is a characteristic sign of water damage to brick and mortar, but it is not mold growth. As moisture penetrates and works its way through mortar, brick or plaster, water-soluble compounds dissolve, creating a solution. As the solution moves to the surface of the material, the water evaporates, leaving behind white, powdery mineral deposits. At the time of the assessment, missing mortar and cracks in the building's foundation were observed, which can contribute to water penetration to the building. Since a new roof was installed over the original portion of the building, this should have removed/repared the major source of water leaks and the water-damaged ceiling tiles should be replaced.

Signs of water damage on exterior bricks

8. Consider repointing damaged mortar and sealing any breaches/cracks to prevent water intrusion.
9. Remove plants close to the exterior of the school.
10. Examine exterior doors and repair damage to prevent water and pest entry.

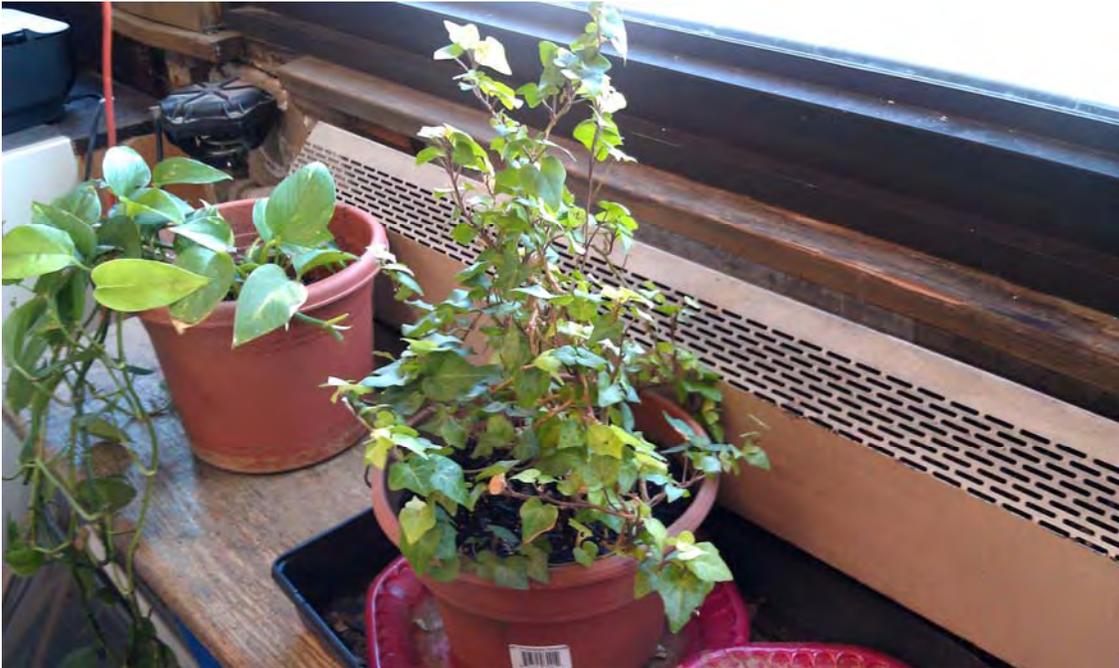
Picture 5

A number of classrooms had plants (Picture 5; Table 1), some of which were flowering. Plants can be a source of pollen and mold, which can serve as respiratory irritants for some sensitive individuals. Plants should be properly maintained and equipped with drip pans to prevent water damage to porous building materials. Plants should also be located away from ventilation sources (e.g., univent air diffusers) to prevent the aerosolization of dirt, pollen or mold.

Plants in classroom

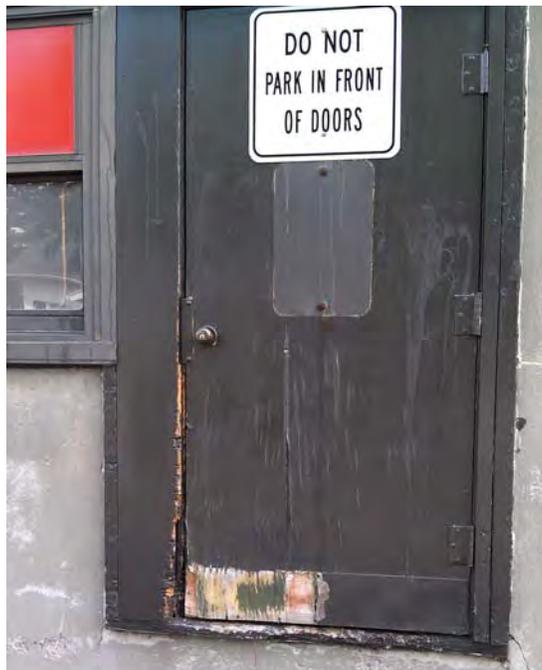
Picture 6

An exterior door frame appeared to be corroded and damaged at the time of assessment (Picture 6). Consideration should be given to replacing this doorframe to prevent moisture and pests from entering the building. A hole as small as a quarter inch in diameter is sufficient for rodents to enter (MDFFA, 1996).

Corroded exterior door

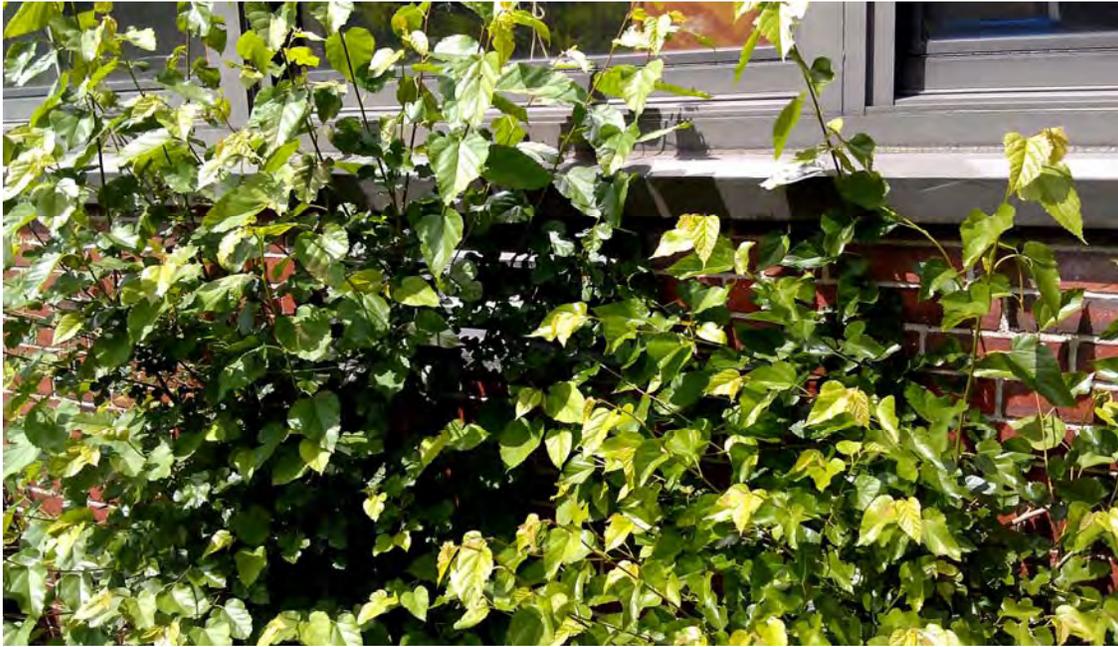
Picture 7

A number of plants were growing in close proximity to the building's exterior (Picture 7). In some areas, plants were in front of univent fresh air intakes, which can entrain and distribute plant pollen into a classroom. The growth of roots against exterior walls can bring moisture in contact with the foundation. Plant roots can eventually penetrate the wall, leading to cracks and/or fissures in the sublevel foundation. The freezing and thawing action of water during the winter months can also create cracks and fissures in the foundation resulting in additional water penetration points. These breaches in exterior areas can also provide a means of drafts and pest entry into the building. In concert, conditions can undermine the integrity of the building envelope and provide a means of water entry by capillary action into the building through exterior walls, foundation concrete and masonry (Lstiburek & Brennan, 2001).

**Plants growing in close proximity to building exterior,
note univent fresh air intake behind plant**

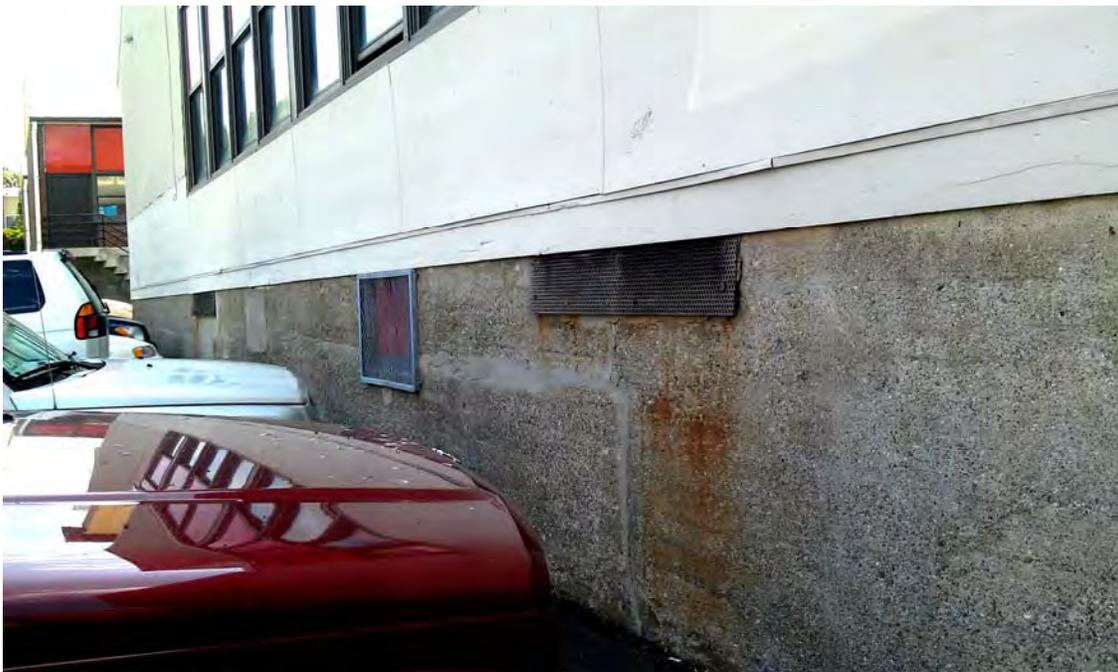
Picture 8

Please note, some parking spots were in close proximity to a univent fresh air intake (Picture 8). Carbon monoxide from idling vehicles can become entrained by univents and distributed to classrooms. School personnel should refrain from idling vehicles in order to prevent classroom occupants from being exposed to vehicle exhaust.

Car parked near univent fresh air intake

11. Ensure vehicles parked near univent intakes refrain from idling.

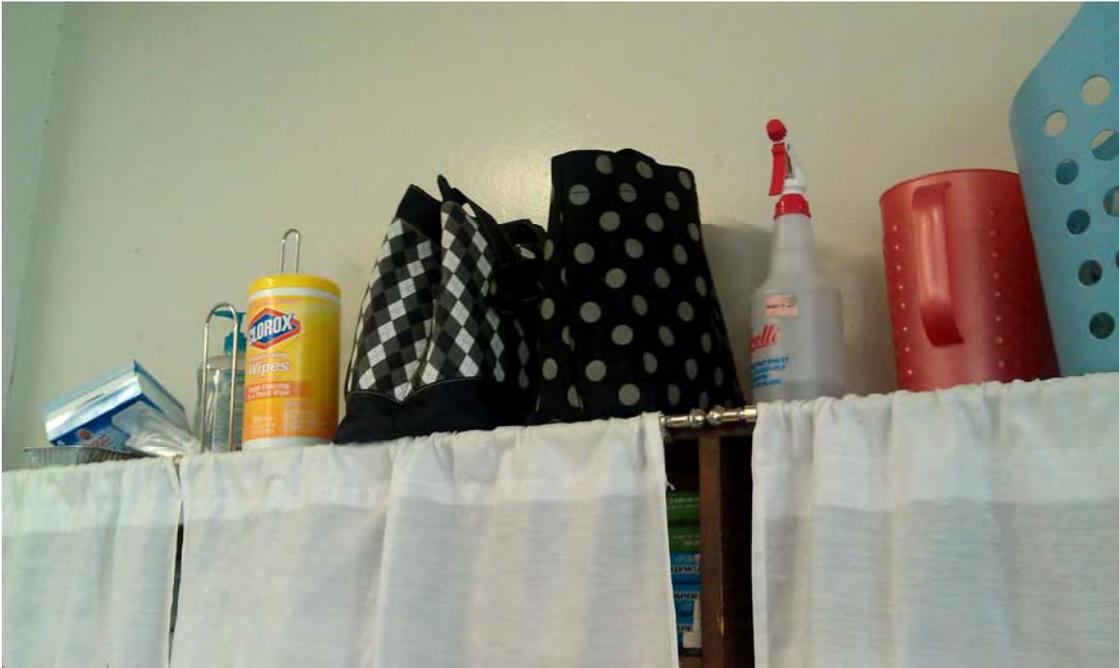
Picture 9

Cleaning products were found on countertops in several rooms (Picture 9; Table 1). Cleaning products contain chemicals that can be irritating to the eyes, nose and throat of sensitive individuals. These products should be properly labeled and stored in an area inaccessible to children. Additionally, an MSDS should be available at a central location for each product in the event of an emergency. Consideration should be given to providing teaching staff with school issued cleaning products and supplies to ensure that MSDS information is available for all products used at the school.

Cleaning products in classroom

12. Store cleaning products properly and out of reach of students. Ensure spray bottles are properly labeled. All cleaning products used at the facility should be approved by the school department with MSDS' available at a central location.

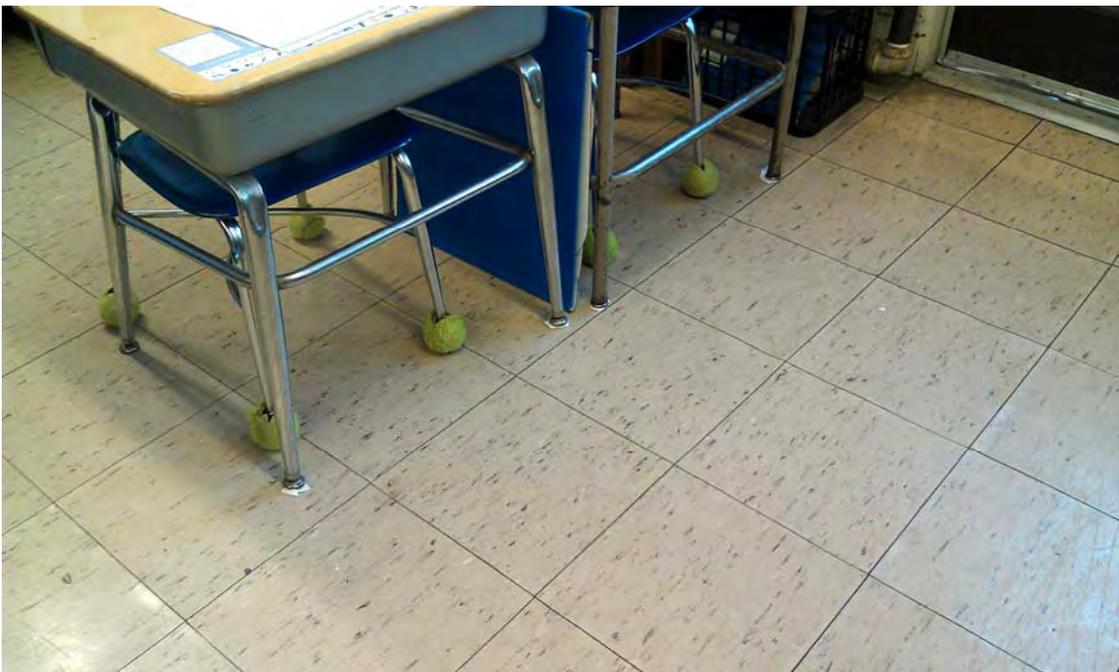
Picture 10

In an effort to reduce noise from sliding chairs, tennis balls were found sliced open and placed on chair legs in some classrooms (Picture 10). Tennis balls are made of a number of materials that are a source of respiratory irritants. Constant wearing of tennis balls can produce fibers and off-gas VOCs. Tennis balls are made with a natural rubber latex bladder, which becomes abraded when used as a chair leg pad. Use of tennis balls in this manner may introduce latex dust into the school environment. Some individuals are highly allergic to latex (e.g. spina bifida patients) (SBAA, 2001). It is recommended that the use of materials containing latex be limited in buildings to reduce the likelihood of symptoms in sensitive individuals (NIOSH, 1997).

Chairs with tennis balls used as glides

17. Replace tennis balls on chair legs with latex-free tennis balls or glides.
18. Relocate or consider reducing the amount of materials stored in classrooms to allow for more thorough cleaning of classrooms. Clean items regularly with a wet cloth or sponge to prevent excessive dust build-up.

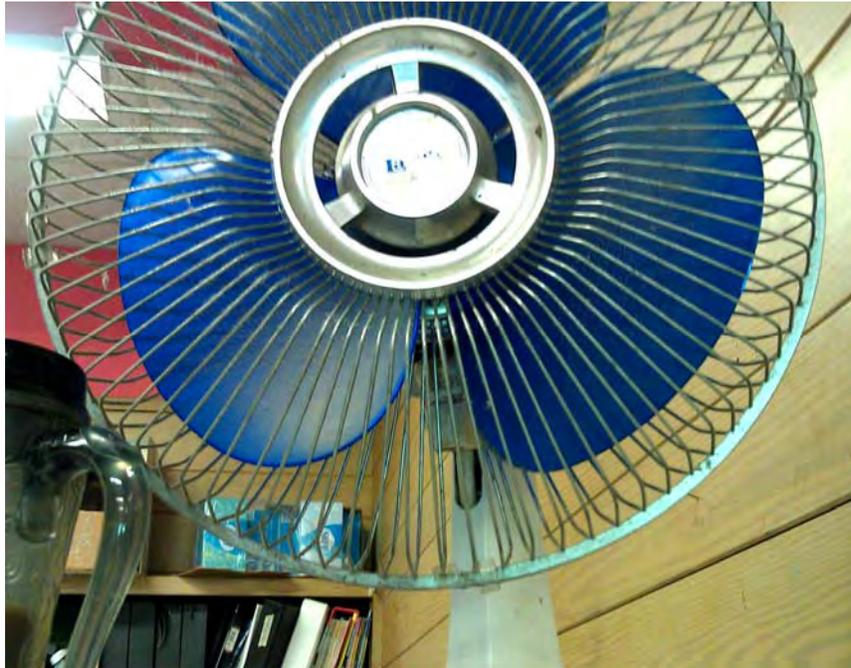
Picture 11

A number of personal fans, exhaust vents, air diffusers and surrounding ceiling tiles were observed to have accumulated dust/debris (Picture 11; Table 1). Re-activated diffusers, vents or fans can aerosolize accumulated dust. If exhaust vents are not functioning, backdrafting can occur, which can re-aerosolize dust particles.

Dusty personal fan

19. Clean air diffusers, exhaust vents and personal fans periodically of accumulated dust.
20. Consider adopting the US EPA document, "Tools for Schools" to maintain a good indoor air quality environment on the building (US EPA, 2000). This document can be downloaded from the Internet at: <http://www.epa.gov/iaq/schools/index.html>.

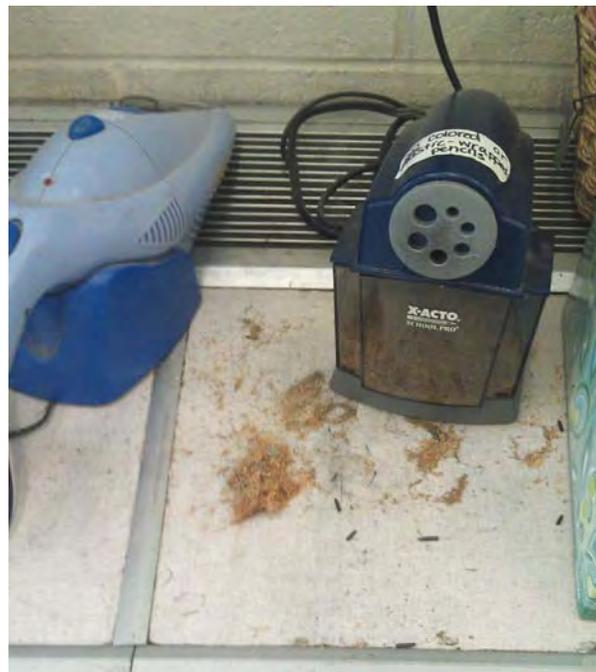
Picture 12

In addition to blockages and dust observed in/around univents, other debris occluding/on univents could become aerosolized. For example, a pencil sharper was observed on a univent

(Picture 12). Pencil shavings that settle on/into the univent can be aerosolized when the univent is activated, resulting in eye and respiratory irritation. When the system is operating in the heating mode, such debris could also create odors. The univent air return at the base of the univent was observed to be occluded with debris, including crayons (Picture 13), which could also contribute to noxious odors. Such material can reduce airflow, cause damage to the univent, and give off odors when heated.

Pencil sharpener and shavings near univent

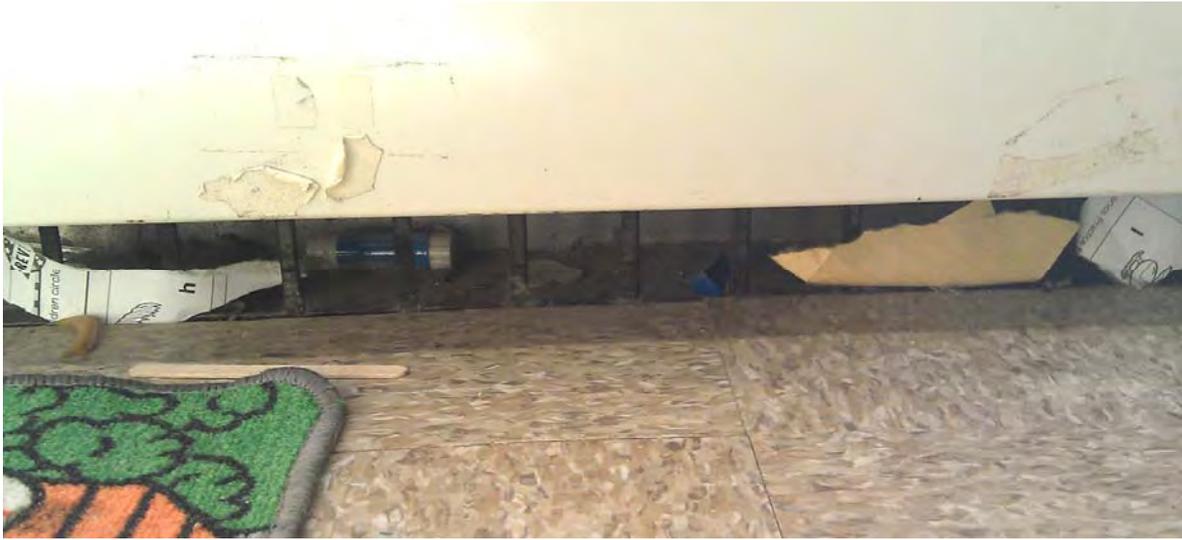
Picture 13

Base of univent with debris inside

3. Clean and vacuum univent main and side compartments to remove dust/debris that may be occluding or entrained in the system.
4. Use openable windows in conjunction with mechanical ventilation to facilitate air exchange. Care should be taken to ensure windows are properly closed at night and weekends to avoid the freezing of pipes and potential flooding.
