INDOOR AIR QUALITY ASSESSMENT

**Reay E. Sterling Middle School
444 Granite Street
Quincy, Massachusetts**

Prepared by:
Massachusetts Department of Public Health
Bureau of Environmental Health
Indoor Air Quality Program
February 2012

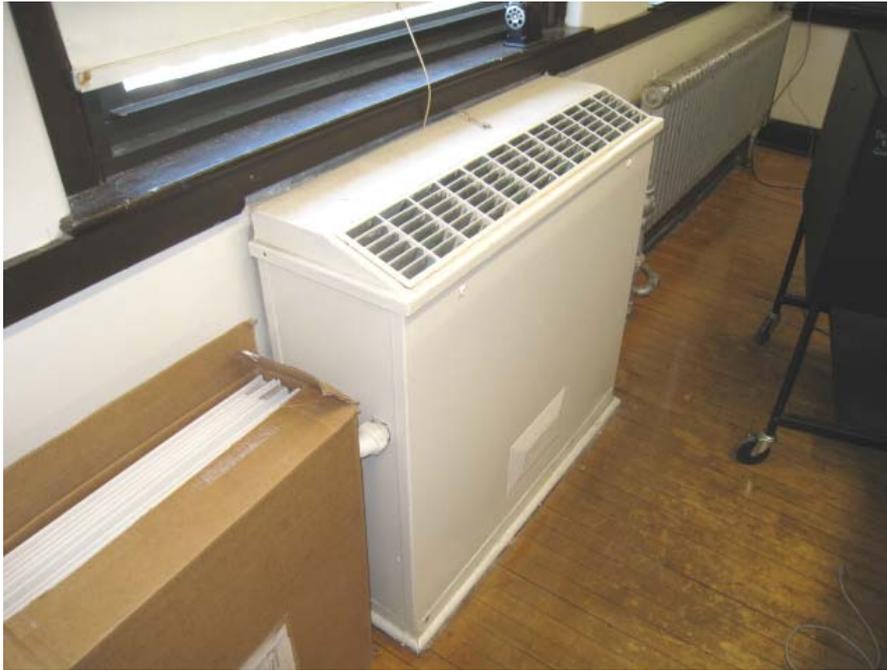
Picture 1

Fresh air in classrooms was originally designed to be mechanically supplied by unit ventilator (univent) systems (Pictures 1 and 2). Univents are designed to draw air from outdoors through a fresh air intake located on the exterior walls of the building (Picture 3) and return air through an air intake located at the base of each unit ([Figure 1](#)). Fresh and return air are typically mixed, filtered, heated and provided to classrooms through a fresh air diffuser located in the top of the unit. The 1927 vintage univents at SMS have no capabilities for filter installation (Picture 2). In modern univents, the mixture of fresh to return air is controlled mechanically or pneumatically. In contrast, the louvers in the univents at SMS were designed to be adjusted by hand (Picture 4).

Original 1920's Vintage Classroom Univent

1. Based on the age, physical deterioration and availability of parts, the BEH recommends that an HVAC engineering firm evaluate options for providing adequate ventilation school-wide. Since restoration the original unit ventilation system is not a likely option, consideration should be given to replacing them with modern univents and installing a mechanical exhaust ventilation system. Determine if existing airshafts, vents, ductwork, etc. can be retrofitted for (modern) mechanical ventilation.
2. Consider creating a centrally-located teacher's workroom equipped with local exhaust ventilation for photocopiers and lamination machines.

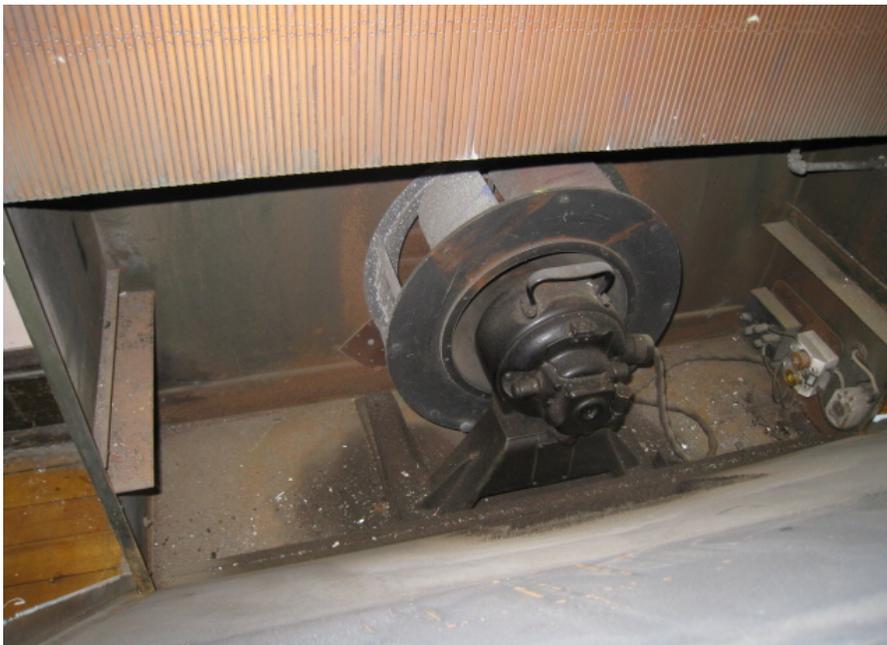
Picture 2

As mentioned, univents are original to the construction of the building. Function of equipment of this age is difficult to maintain, since compatible replacement parts are often unavailable. According to the American Society of Heating, Refrigeration and Air-Conditioning Engineers (ASHRAE), the service life¹ for a unit heater, hot water or steam is 20 years, assuming routine maintenance of the equipment (ASHRAE, 1991). Despite attempts to maintain the univents, the operational lifespan of the equipment has been exceeded by over 60 years. Maintaining the balance of fresh air to exhaust air will become more difficult as the equipment ages and as replacement parts become increasingly difficult to obtain. Currently, ventilation in the school is controlled by the use of openable windows and/or passive infiltration of air via the univent fresh air intakes (when louvers are opened by hand).

**Original 1920's Vintage Motor in Univent,
Note no Capabilities for Filters to be Installed in Units**

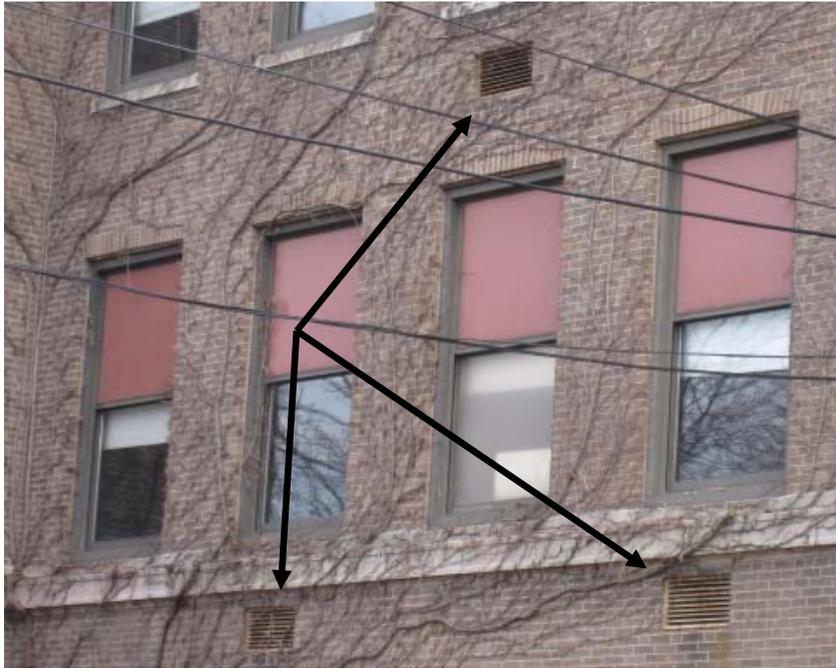
Picture 3

Clinging plants were observed growing on exterior brick (Pictures 3 and 18). Clinging plants can cause water damage to brickwork through insertion of tendrils into brick and mortar. Water can penetrate into the brick along the tendrils. Water trapped in brick can subsequently freeze and thaw during the winter. This freezing/thawing action can weaken bricks and mortar, resulting in wall damage.

Univent Fresh Air Intakes (Arrows), Also Note Clinging Plants on Brickwork

8. Remove clinging plants, trim overhanging branches, and remove trees from close proximity to exterior walls.
9. Move plants away from univents in classrooms. Avoid over-watering and examine drip pans periodically for mold growth. Disinfect with an appropriate antimicrobial where necessary.

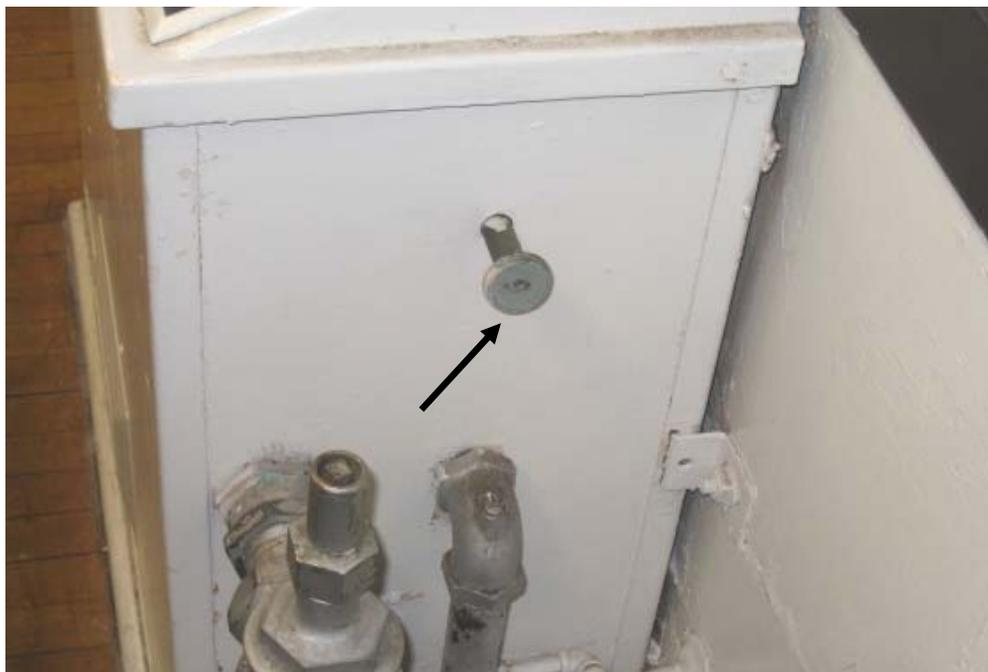
Picture 4

Fresh/Return Air Adjustment Control (Arrow)

1. Regulate airflow in classrooms using windows, exhaust vents and hand adjusted univent damper controls. Care should be taken to ensure windows are properly closed at night and weekends to avoid the freezing of pipes and potential flooding.

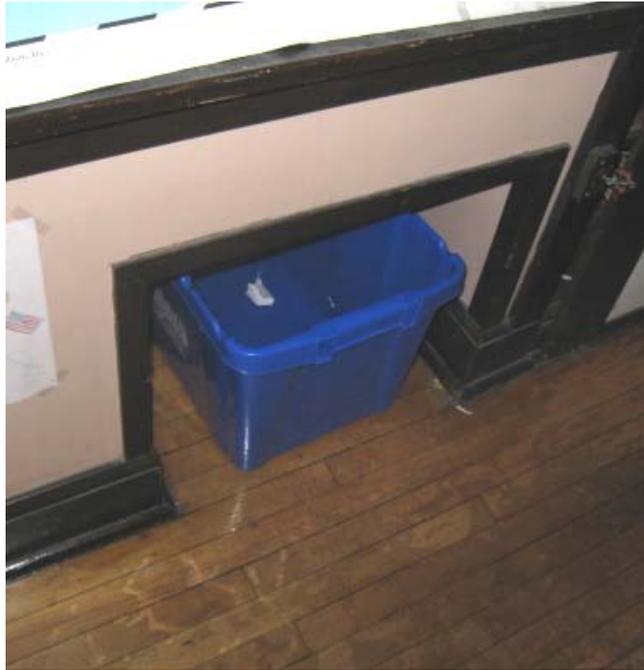
Picture 5

Exhaust ventilation is provided by passive exhaust vents located in “cubby holes” at floor level (Picture 5). As originally designed, fresh air was mechanically introduced into classrooms via the univents, which “pressurized” the room forcing stale classroom air and excess heat into the exhaust vents and up the ventilation shaft to an exhaust terminus on the roof (Picture 6). As the air rises up the ventilation shaft, negative pressure is created in the room, which facilitates the draw of air from the room into the exhaust shaft resulting in air exchange. The area of the exhaust vent available is adjusted by a louver attached to a pull chain (Picture 7). These exhaust vents remain functional, however, at the time of the inspection many of them had louvers shut or were obstructed by the storage of classroom items (Pictures 5 and 8). Without properly functioning supply and exhaust ventilation systems, normally occurring environmental pollutants can build up.

**Classroom Exhaust Vent “Cubby” Located at Floor Level,
Note Storage of Classroom Items**

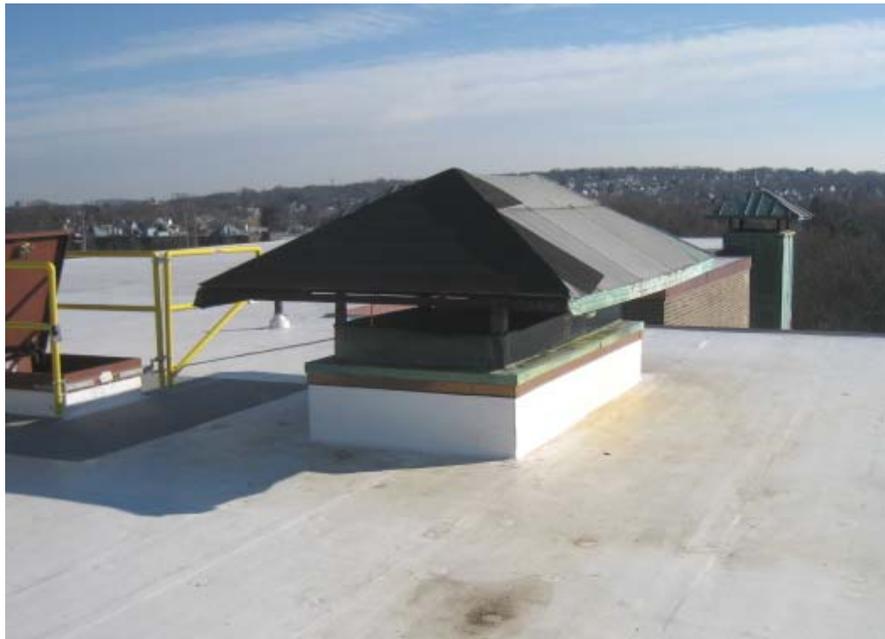
Picture 6

Covered Exhaust Vent Terminus on Roof

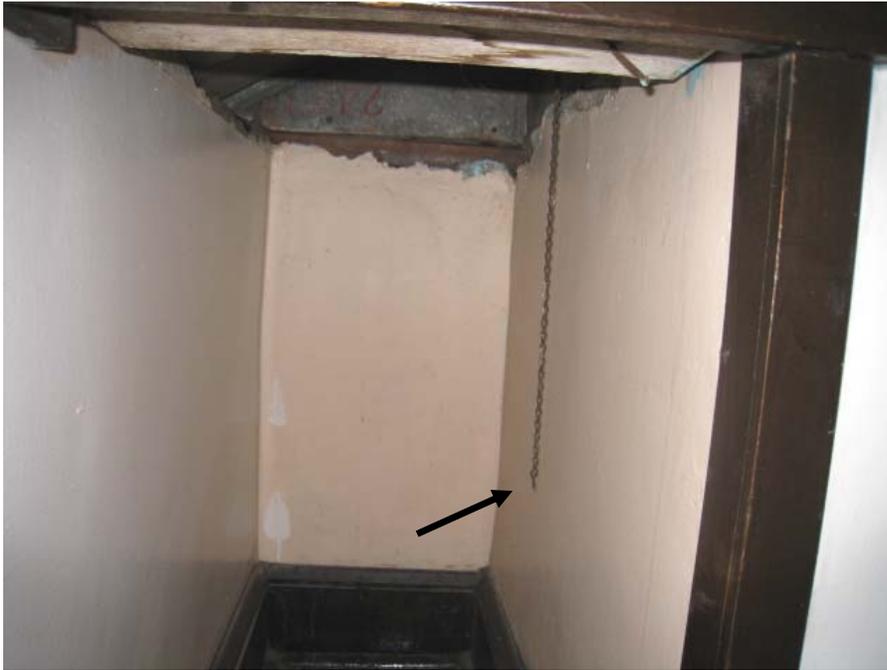
Picture 7

Pull Chain/Louver System for Classroom Exhaust Vent (Arrow)

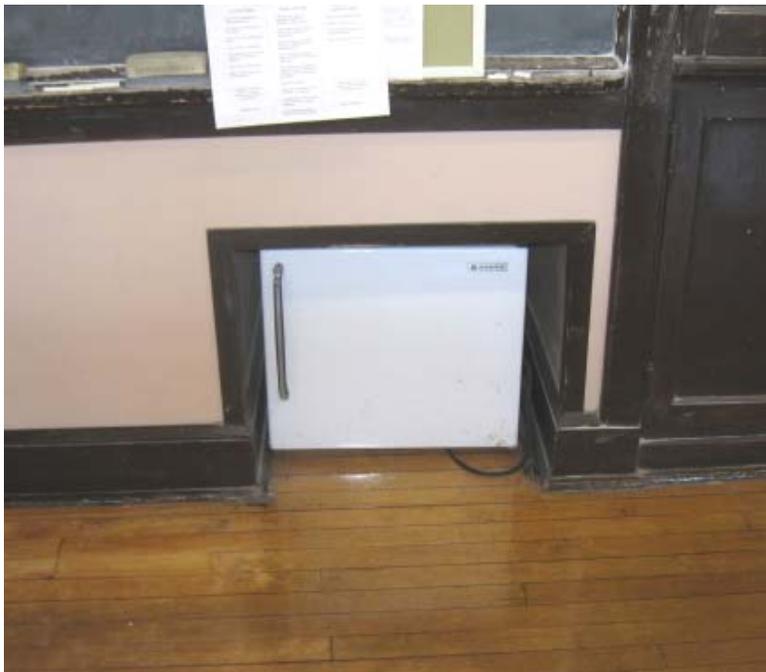
Picture 8

Classroom Exhaust Vent Obstructed by Classroom Items

- b. Ensure exhaust vents are free of obstructions and louvers are open to facilitate the removal of excess heat.
 - c. Consider mounting portable fans to facilitate air circulation.

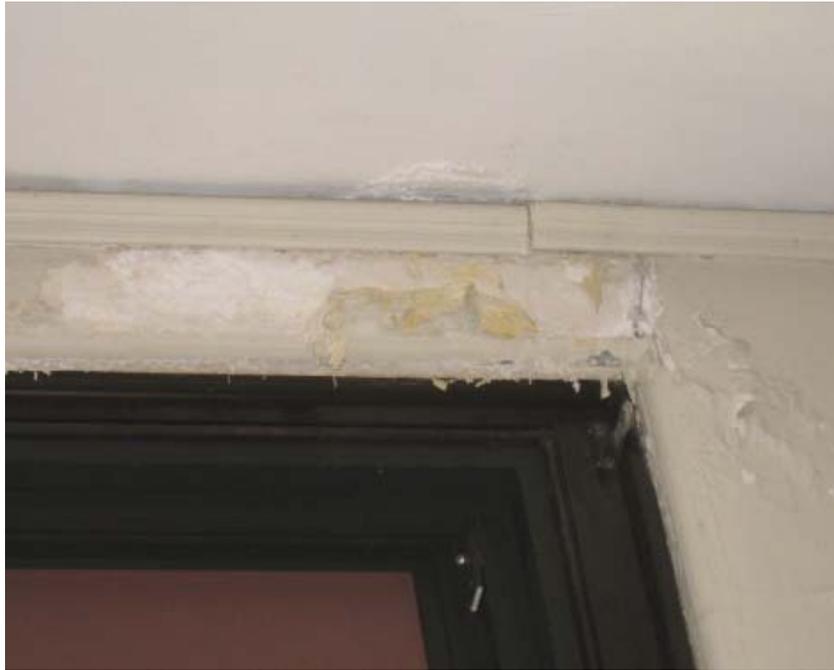
Picture 9

Moderate water damage to wall/ceiling plaster, peeling paint, and efflorescence were observed in a number of areas throughout the building (Pictures 9 through 12, Table 1). Water damage on the upper floors is most likely the result of historical water penetration through the roof, which was replaced in 2011. Efflorescence is a characteristic sign of water damage to brick

and mortar, but it is not mold growth. As moisture penetrates and works its way through mortar, brick or plaster, water-soluble compounds dissolve, creating a solution. As the solution moves to the surface of the material, the water evaporates, leaving behind white, powdery mineral deposits. In addition, while brick is a porous material that allows moisture to evaporate, a layer of paint can serve as a water-impermeable barrier, which can trap moisture causing bubbling and peeling (Picture 12). A water-damaged corkboard was observed in room 207 (Picture 13). Corkboard can give off unpleasant odors if it becomes wet, consideration should be made for removal/replacement.

Water-Damaged Plaster, Peeling Paint and Efflorescence on Classroom Wall

5. Ensure any remaining roof/window leaks are repaired.
6. Scrape and clean efflorescence and loose paint from ceiling/wall plaster and brick. Do not repaint brick. Monitor and clean periodically as needed.

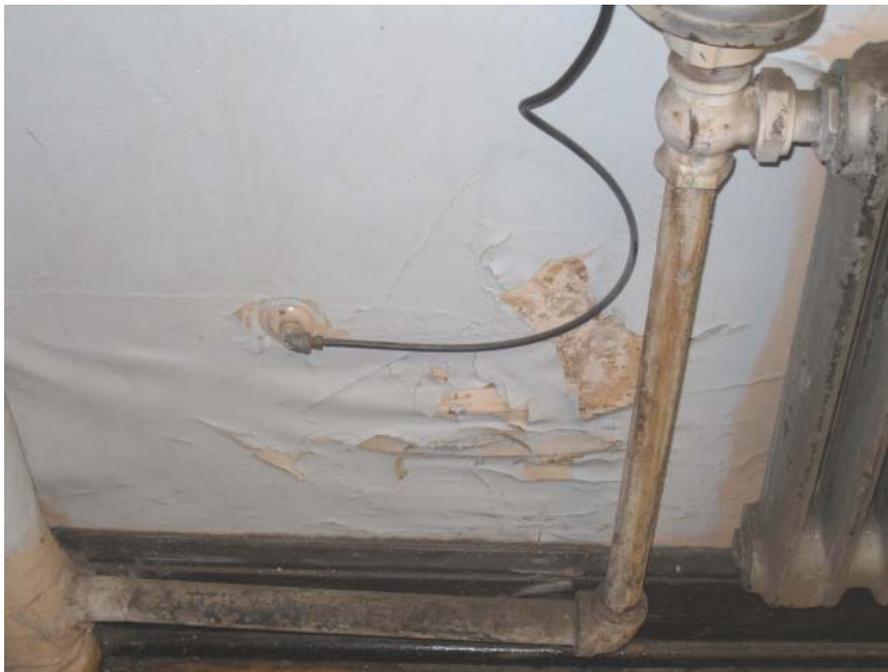
Picture 10

Water-Damaged Plaster and Peeling Paint on Classroom Wall

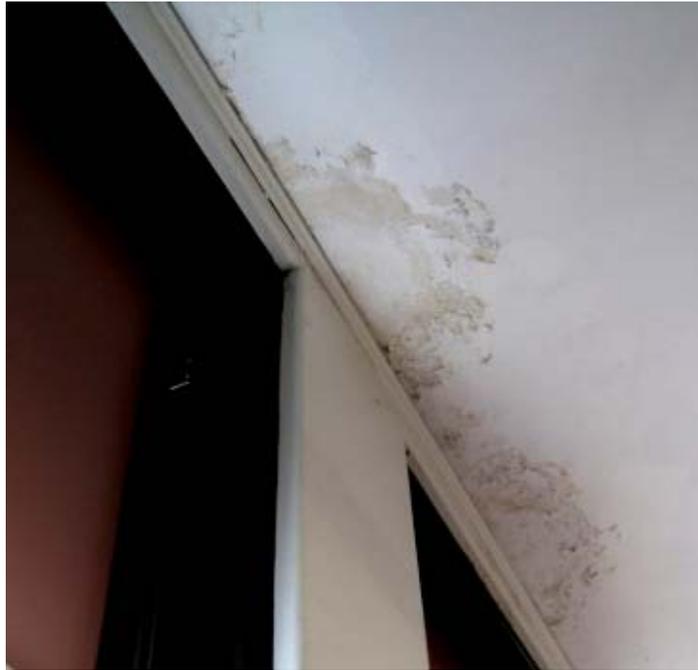
Picture 11

Water-Damaged Plaster, Peeling Paint and Efflorescence on Classroom Ceiling

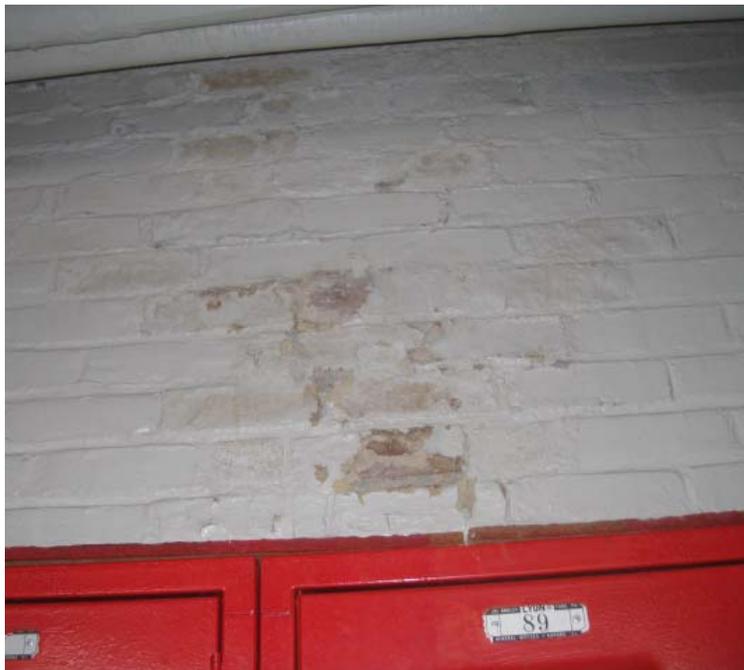
Picture 12

Peeling Paint and Efflorescence on Painted Brick Wall in Hallway

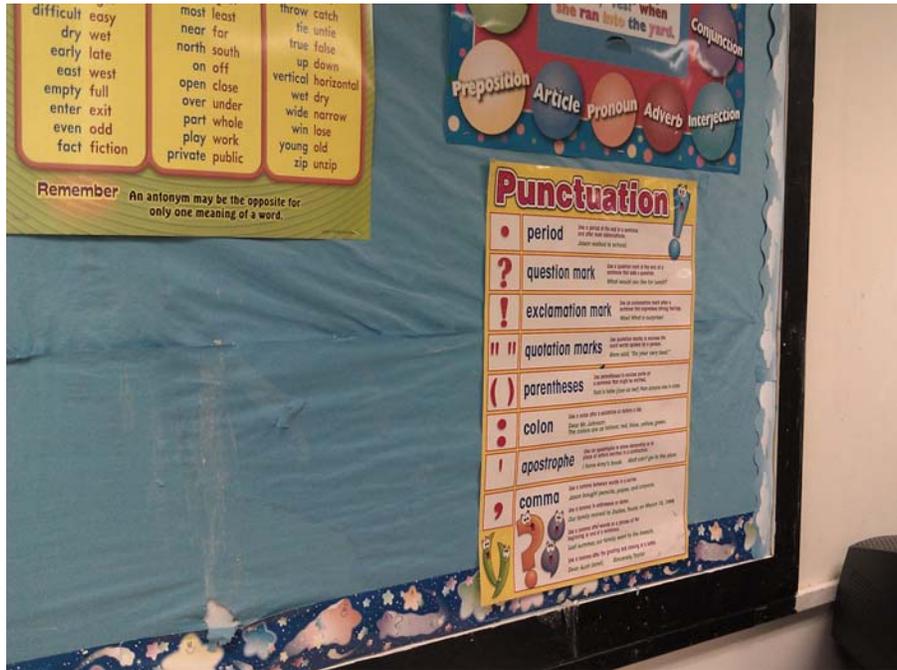
Picture 13

Water-damaged Corkboard and Papers

10. Clean and maintain aquariums and terrariums to prevent mold growth and associated odors.
11. Remove/replace water-damaged corkboard in room 207.
12. Refrain from using air fresheners and deodorizers to prevent exposure to VOCs.

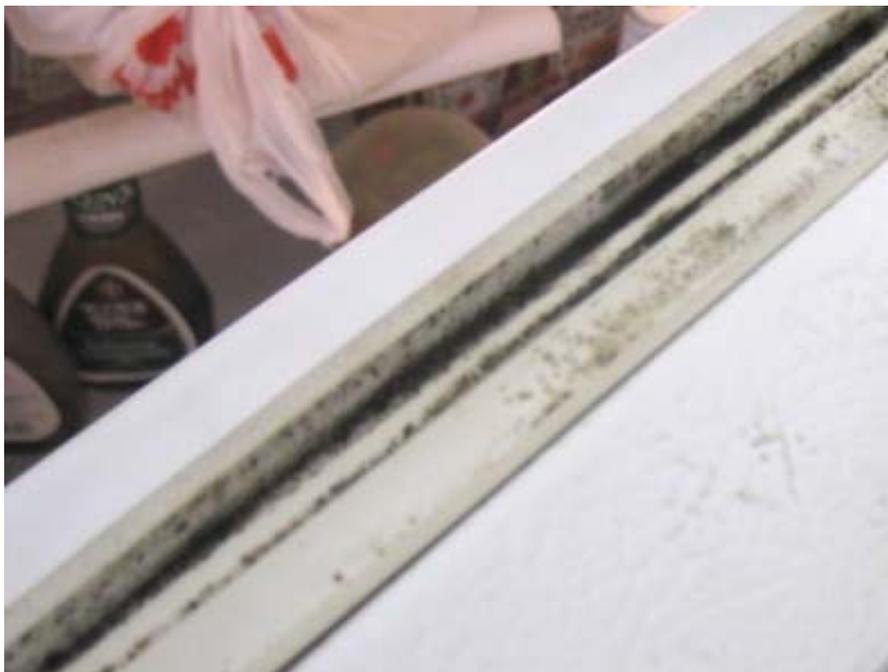
Picture 14

Visible mold growth was observed in the refrigerator in the teacher's lunchroom. Upon opening the refrigerator used by staff for food storage, BEH staff found both the refrigerator and freezer door gaskets to be colonized with mold (Pictures 14 through 17). The refrigerator was a source of noticeable odor, had spillage of unknown origin and appeared not to have been cleaned for some time.

Teacher's Lunchroom Refrigerator Colonized with Mold (Dark Staining)

7. Clean and disinfect interior of refrigerators and freezers with mild detergent or antimicrobial agent. Consider replacing mold-contaminated gaskets. Clean spilled food promptly, and clean out the refrigerator of expired items on a regular schedule.

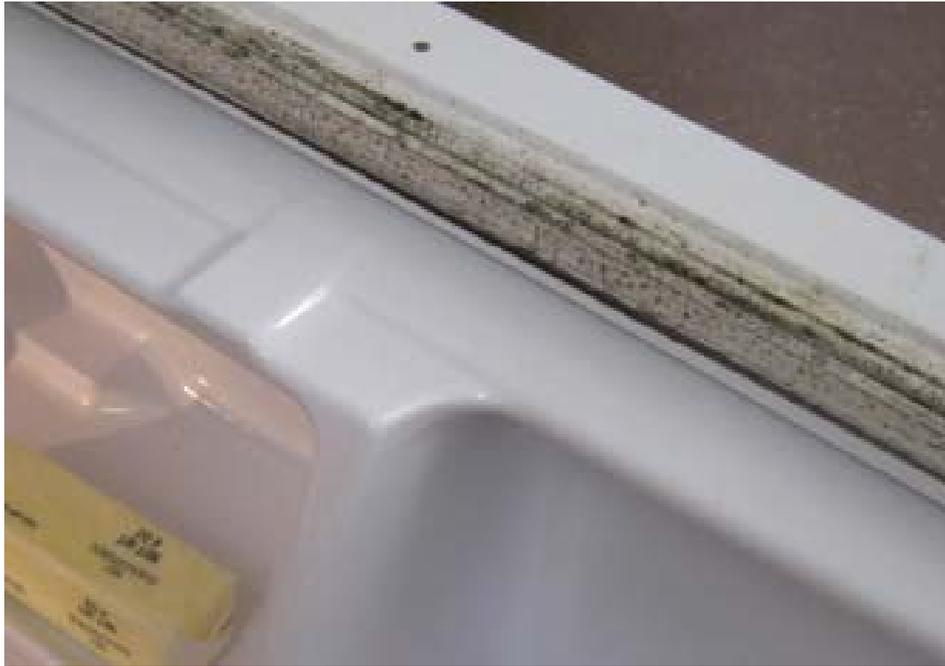
Picture 15

Teacher's Lunchroom Refrigerator Colonized with Mold (Dark Staining)

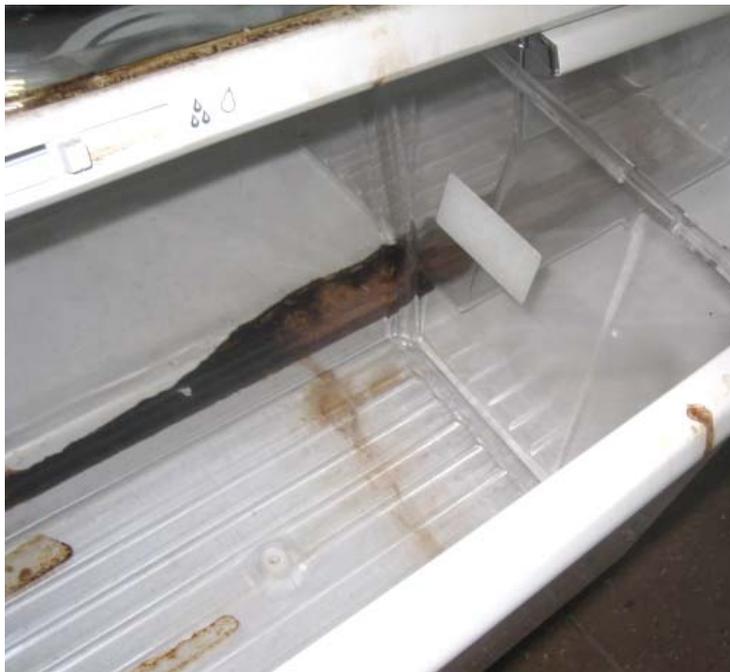
Picture 16

Teacher's Lunchroom Refrigerator Colonized with Mold (Dark Staining)

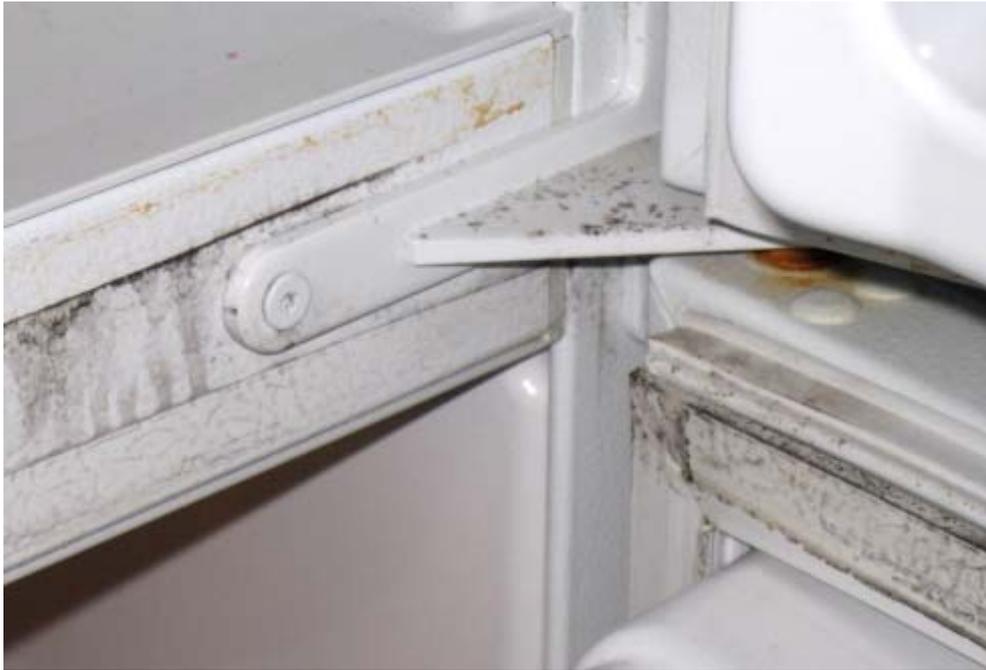
Picture 17

Teacher's Lunchroom Refrigerator Colonized with Mold (Dark Staining)

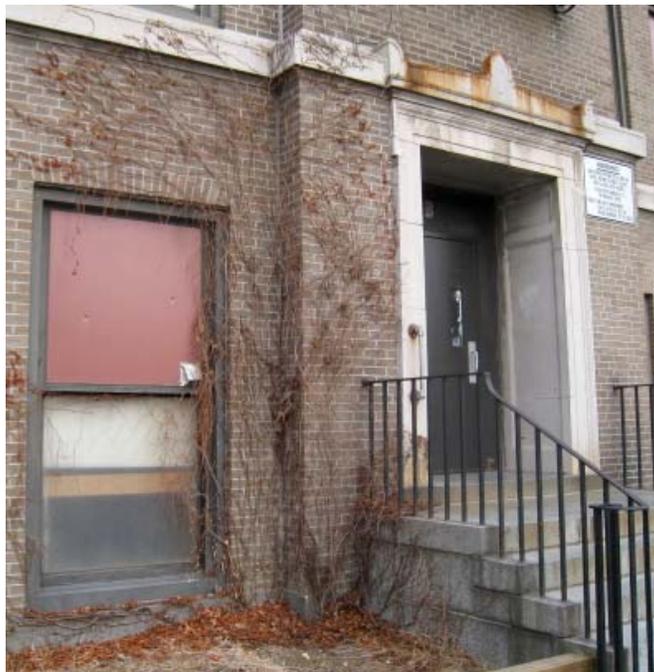
Picture 18

Clinging Plants Growing on Exterior Brick

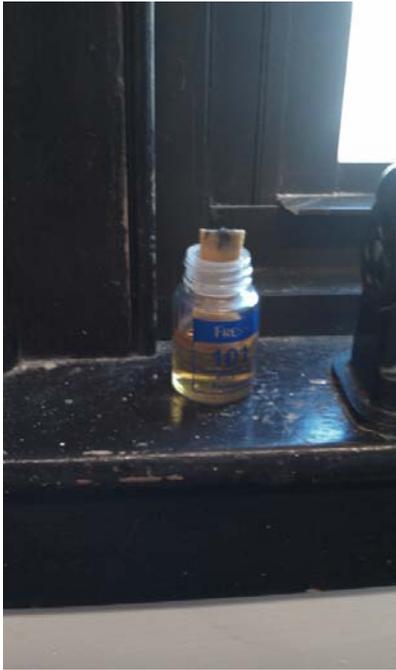
Picture 19

Air fresheners/scented oils were found to be in use in some areas (Picture 19, Table 1). Air fresheners contain chemicals that can be irritating to the eyes, nose and throat of sensitive individuals. Many air fresheners contain 1,4-dichlorobenzene, a VOC which may cause reductions in lung function (NIH, 2006). Furthermore, deodorizing agents do not remove materials causing odors, but rather mask odors that may be present in the area.

Air Deodorizer in Classroom

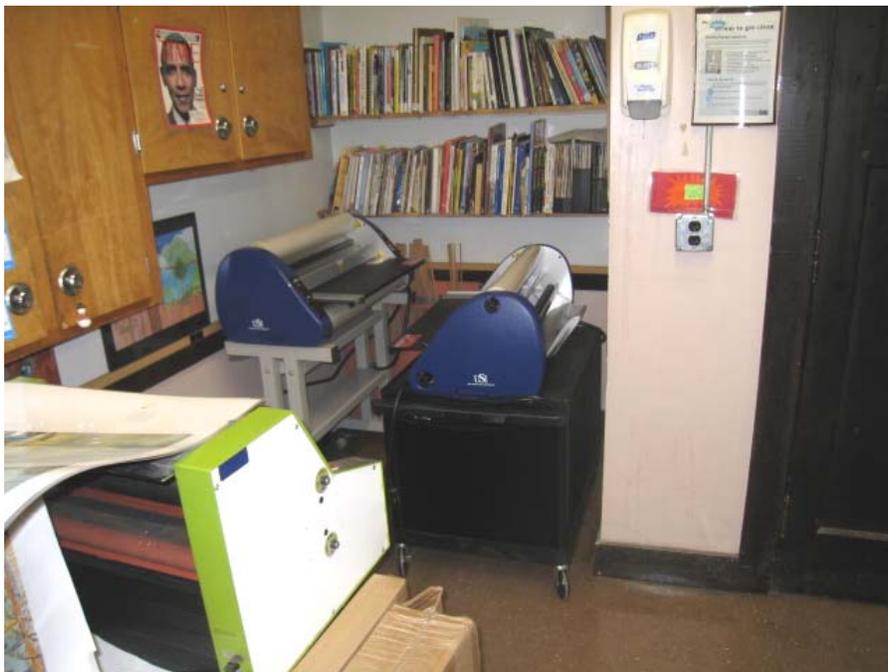
Picture 20

Several areas that contain photocopiers and laminators are not equipped with local mechanical exhaust ventilation to help reduce excess heat and odors (Table 1). Three lamination machines are located in room 112 (Picture 20). Lamination machines melt plastic and give off

odors and VOCs. VOCs and ozone can be produced by photocopiers, particularly if the equipment is older and in frequent use. Ozone is a respiratory irritant (Schmidt Etkin, 1992).

Lamination Machines in Room 112

13. Provide mechanical local exhaust for lamination machines in room 112 or relocate to well-ventilated area.

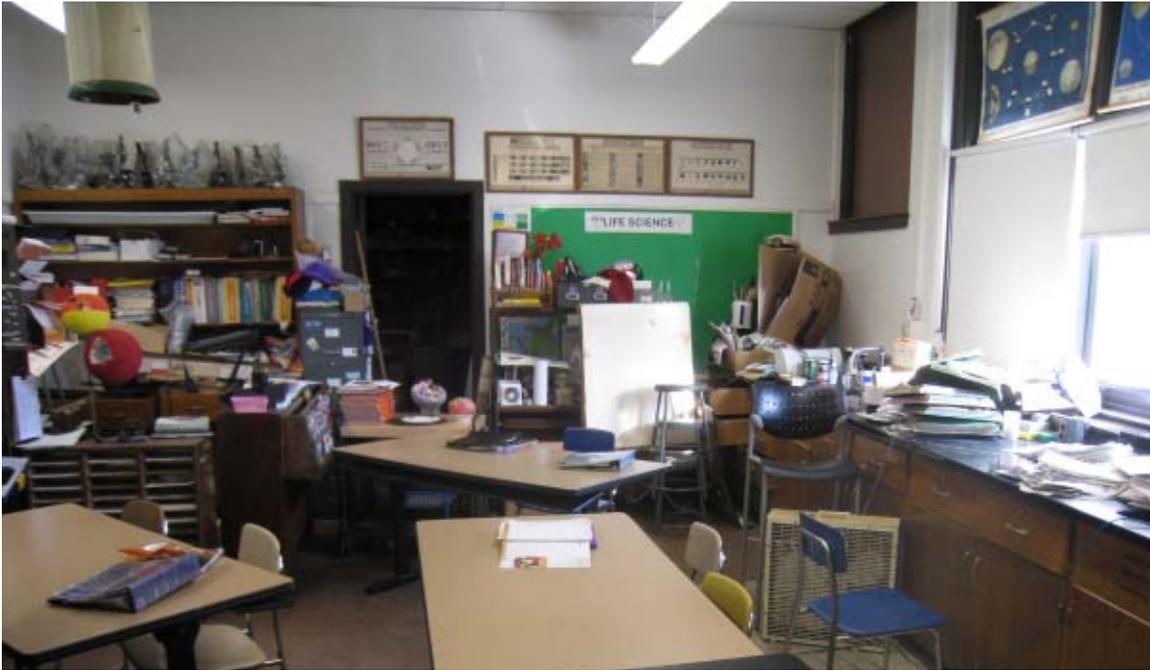
Picture 21

In several classrooms, items were observed on windowsills, tabletops, counters, bookcases and desks (Picture 21). The large number of items stored in classrooms provides a source for dusts to accumulate. These items (e.g., papers, folders, boxes) make it difficult for custodial staff to clean. Items should be relocated and/or be cleaned periodically to avoid excessive dust build up (Picture 22). In addition, these materials can accumulate on flat surfaces (e.g., desktops, shelving and carpets) in occupied areas and subsequently be re-aerosolized causing further irritation. Also noted was an accumulation of chalk dust in some classrooms (Table 1), which can become airborne and act as irritants to the eyes and respiratory system.

Accumulated Items in Classroom

15. Replace latex-based tennis balls with latex-free tennis balls or glides.
16. Relocate or consider reducing the amount of materials stored in classrooms to allow for more thorough cleaning of classrooms. Clean items regularly with a wet cloth or sponge to prevent excessive dust build-up.

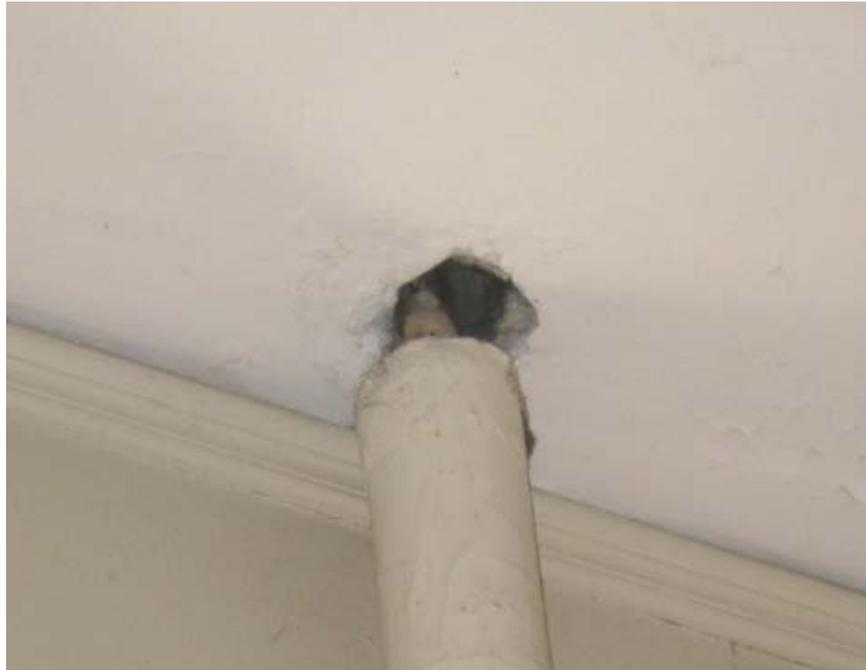
Picture 23

Open utility holes and wall cracks observed in some rooms (Picture 23, Table 1). Open utility holes and wall cracks can provide a means of egress for odors, fumes, dusts and vapors between rooms and floors.

Open Utility Hole in Classroom Ceiling

19. Seal all open utility holes and wall cracks in the building.
20. Professionally clean upholstered furniture and cushions annually or more frequently as needed. If not feasible, consider removal.

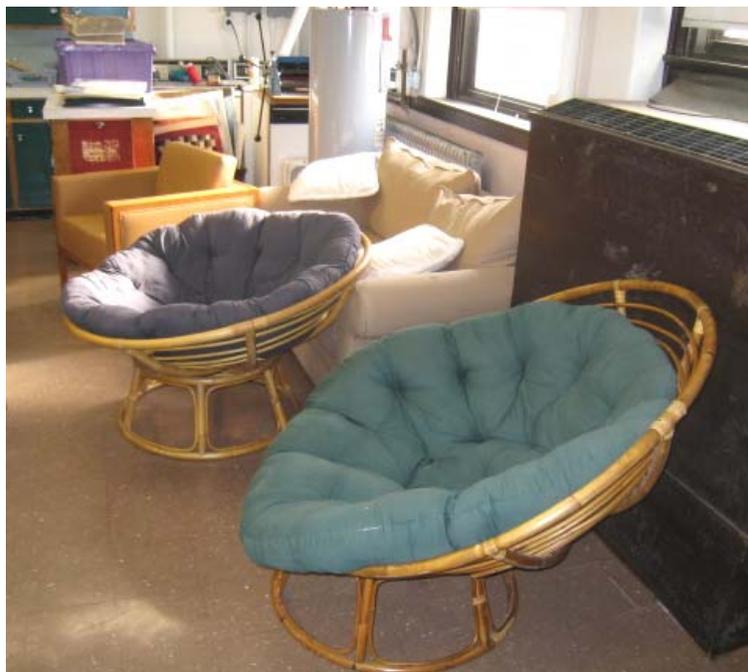
Picture 24

Upholstered furniture and cushions were observed in some classrooms (Picture 24, Table 1). Upholstered furniture and cushions are covered with fabric that comes in contact with human skin. This type of contact can leave oils, perspiration, hair and skin cells. Dust mites feed upon human skin cells and excrete waste products that contain allergens. These materials can be irritating to the eyes, nose and respiratory system. In addition, if relative humidity levels increase above 60 percent, dust mites tend to proliferate (US EPA, 1992). In order to remove dust mites and other pollutants, frequent vacuuming of upholstered furniture is recommended (Berry, M.A., 1994). It is also recommended that upholstered furniture (if present in schools), be professionally cleaned on an annual basis.

Upholstered Furniture and Cushions in Classroom

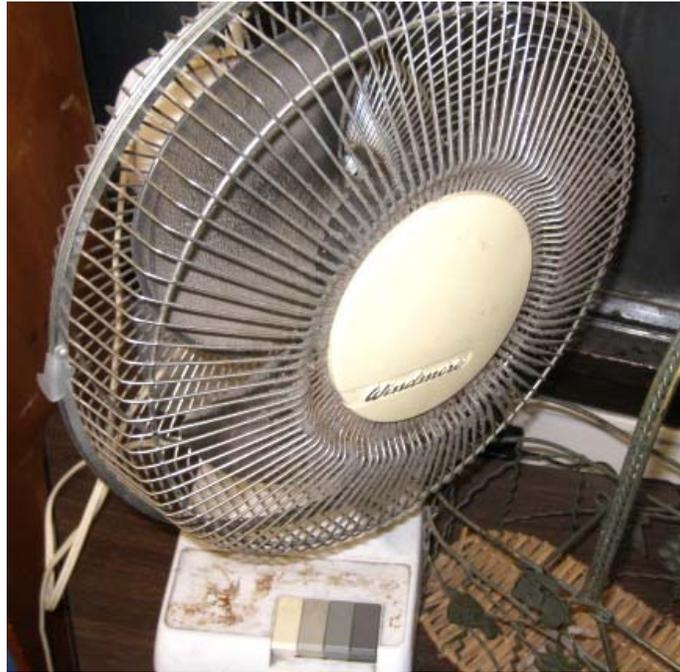
Picture 25

Finally, personal fans, air diffusers and exhaust vents were observed to have accumulated dust/debris (Pictures 25 and 26). Re-activated fans can aerosolize dust accumulated on fan blades. If exhaust vents are not functioning, backdrafting can occur, which can re-aerosolize dust particles.

Accumulated Dust/Debris on Personal Fan in Classroom

17. Clean personal fans, univent air diffusers, return vents and exhaust vents periodically of accumulated dust.
18. Clean chalk and dry erase trays to prevent accumulation of materials.

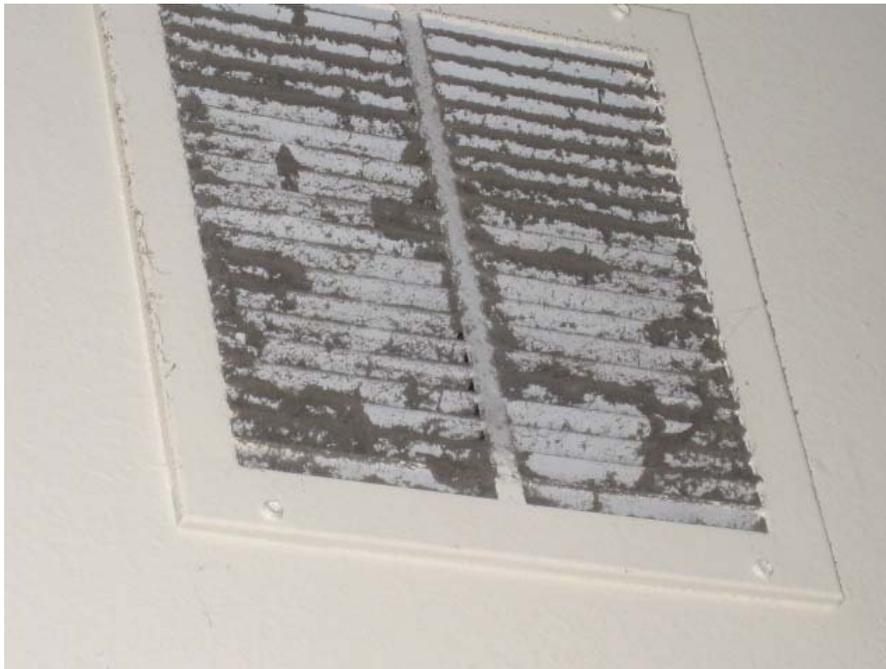
Picture 26

Accumulated Dust/Debris on Exhaust Vent
