# **INDOOR AIR QUALITY POST-OCCUPANCY ASSESSMENT**

**Commonwealth of Massachusetts  
State Office Building  
21 Spring Street  
Taunton, MA**

Prepared by:  
Massachusetts Department of Public Health  
Bureau of Environmental Health  
Indoor Air Quality Program  
July 2012

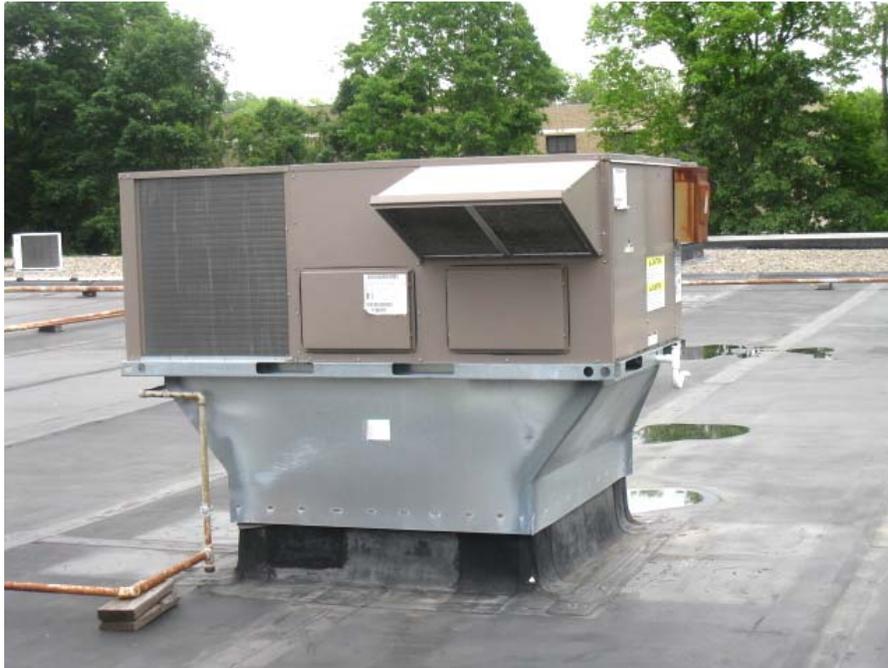
**Picture 1**

It can be seen from Table 1 that carbon dioxide levels were below 800 parts per million (ppm) in all areas tested at the time of assessment, indicating good air exchange throughout the building. Fresh air is provided by rooftop air-handling units (AHUs) (Picture 1). Fresh air is drawn into the AHUs through a bank of high efficiency pleated air filters, heated or cooled and delivered to occupied areas via ducted air diffusers (Picture 2). Return air is drawn into ceiling or wall-mounted vents and ducted back to the rooftop AHUs (Pictures 3 and 4).

**One of Several Rooftop Air Handling Units**

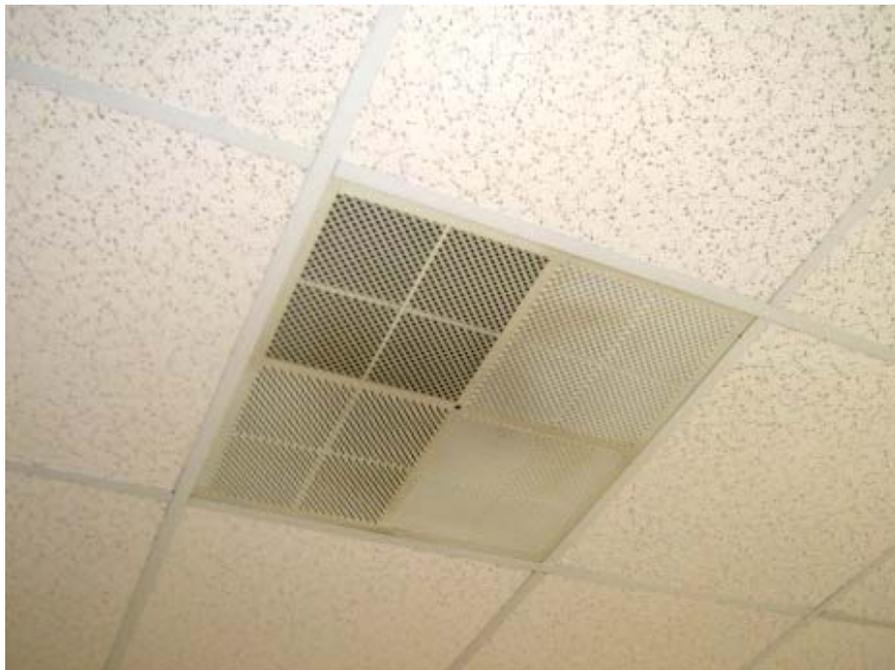
**Picture 2**

**Ceiling-Mounted Air Diffuser**

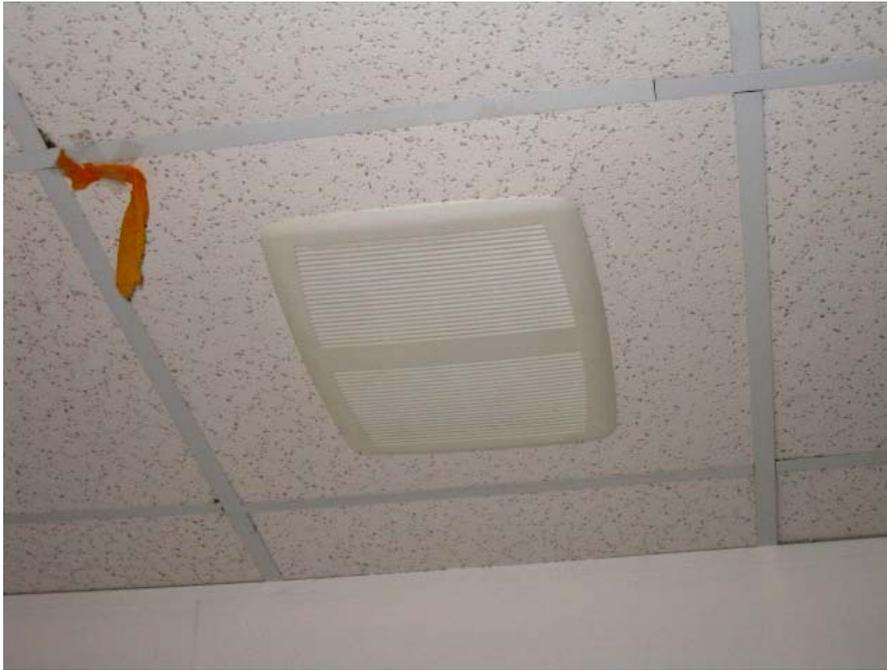
**Picture 3**

**Ceiling-Mounted Return Vent**

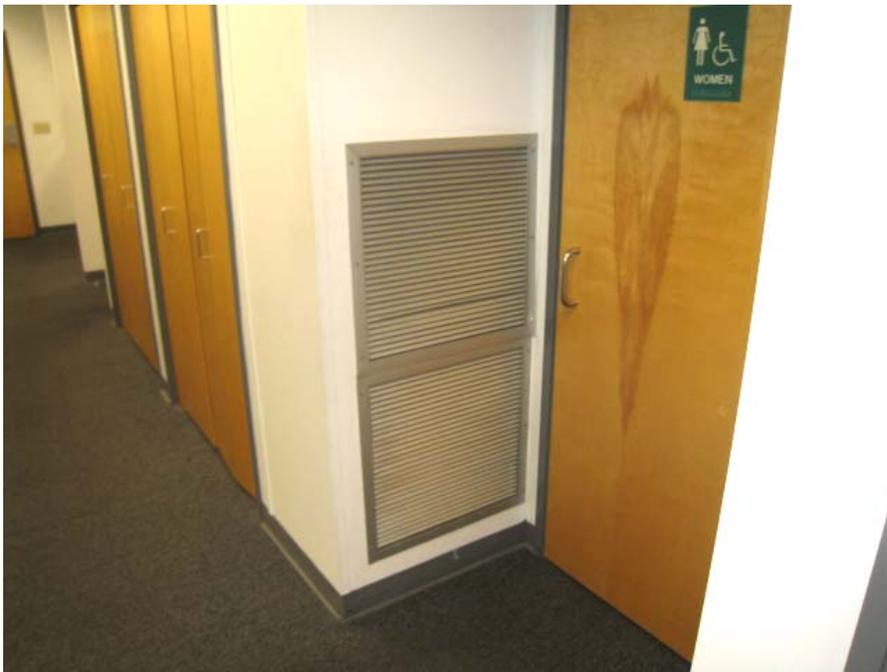
**Picture 4**

**Wall-Mounted Return Vent**

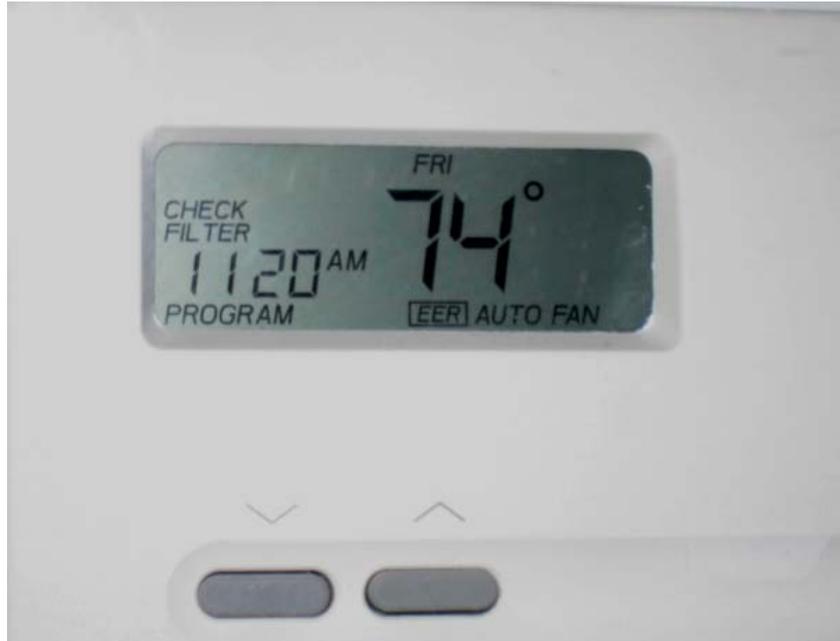
**Picture 5**

The HVAC system is controlled by digital thermostats. Thermostats examined had a fan switch with two settings, *on* and *auto* (Picture 5). When the fan is set to *on*, the system provides a continuous source of air circulation and filtration. The *automatic* setting on the thermostat activates the HVAC system at a preset temperature. Once the preset temperature is reached, the HVAC system is deactivated. Therefore, no mechanical ventilation is provided until the thermostat re-activates the system. The MDPH typically recommends that thermostats be set to the fan *on* setting during occupied hours to provide continuous air circulation. Most of the thermostats throughout the building were set to the fan *on* setting. The thermostat in the MRC

conference room had a “check filter” message indicating, that the filter for that AHU may be in need of changing (Picture 5).

**Digital Wall Thermostat in MRC Conference Room, Note Fan in *Auto* and *Check Filter* Message**

1. Ensure that all thermostats are set to the fan “on” position to operate the ventilation system continuously in occupied areas during business hours.

2. Change filters for air handling equipment as per the manufacturers’ instructions or more frequently if needed.
3. Adjust HVAC system settings to provide comfort and reduce relative humidity conditions as needed.

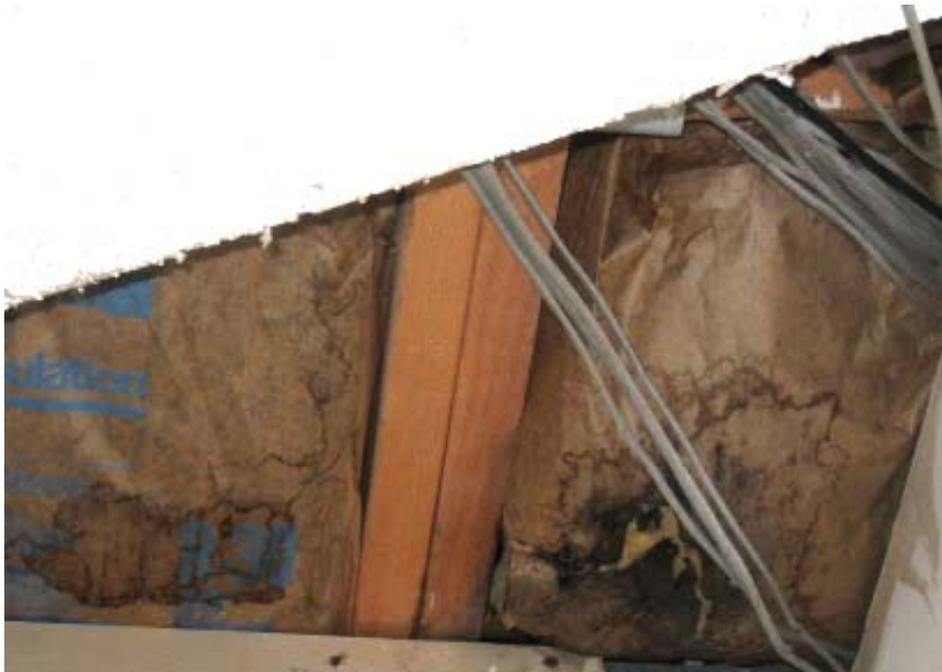
**Picture 6**

In order for building materials to support mold growth, a source of water exposure is necessary. Water-damaged ceiling tiles were observed in a few areas (Table 1), which indicate current/historic plumbing or roof leaks. Water-damaged ceiling tiles can provide a source of mold and should be replaced after a water leak is discovered and repaired. Occasional leaks were reported by occupants directly inside the 2<sup>nd</sup> floor entrance of the MRC. At the time of the assessment, water-damaged ceiling tiles had been changed. However water-damaged fiberglass insulation located above the ceiling was observed in this area (Picture 6). The US Environmental Protection Agency (US EPA) and the American Conference of Governmental Industrial Hygienists (ACGIH) recommend that porous materials (e.g., carpeting, fiberglass insulation) be

**Water-Damaged Fiberglass Insulation above Ceiling 2<sup>nd</sup> Floor MRC Entrance**

4. Ensure roof/plumbing leaks are repaired once discovered. Replace any remaining water-damaged ceiling tiles and fiberglass insulation (e.g., MRC). Monitor for further leaks. If wetting of ceiling tiles recurs, report to building management for prompt remediation.

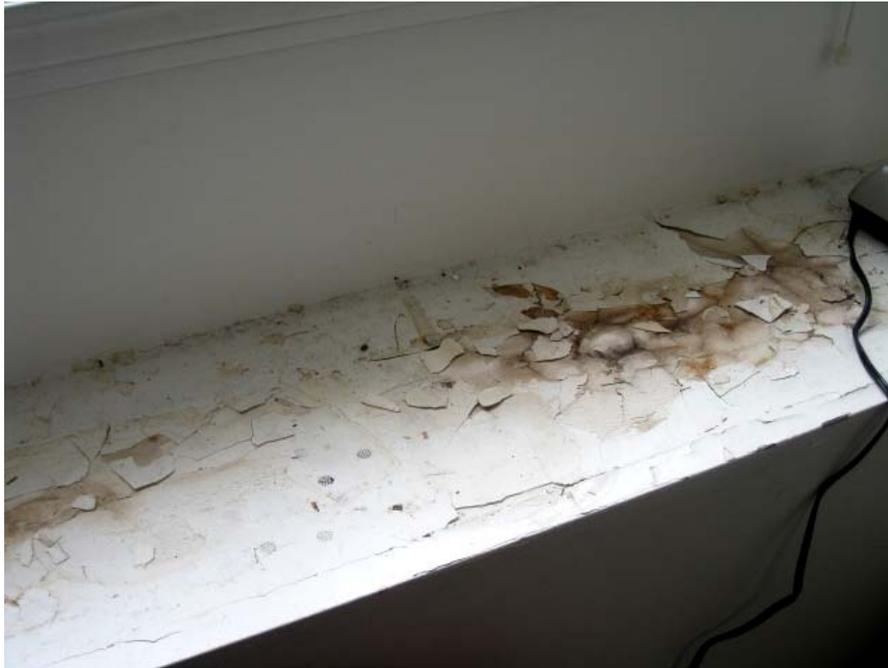
**Picture 7**

Plants were observed in several areas. Plants, soil and drip pans can serve as sources of mold/bacterial growth. Plants should be properly maintained, over-watering of plants should be avoided and drip pans should be inspected periodically for mold growth. Mold growth/water damage was observed on shelving in the 2<sup>nd</sup> floor of the MRC as a result of over-watering or leaking drip pans (Picture 7).

**Water-Damaged Shelving near Window 2<sup>nd</sup> Floor MRC**

5. Avoid over watering of plants. Ensure flat surfaces around plants are free of potting soil and other plant debris. Examine drip pans periodically for mold growth and disinfect with an appropriate antimicrobial where necessary. Do not place plants on porous materials (e.g., paper/cardboard).

6. Make repairs/refinish water-damaged shelving in the MRC (Picture 7).
7. Clean black debris from floor tiles in MassHealth break room (102). Monitor for further accumulation and/or water penetration.

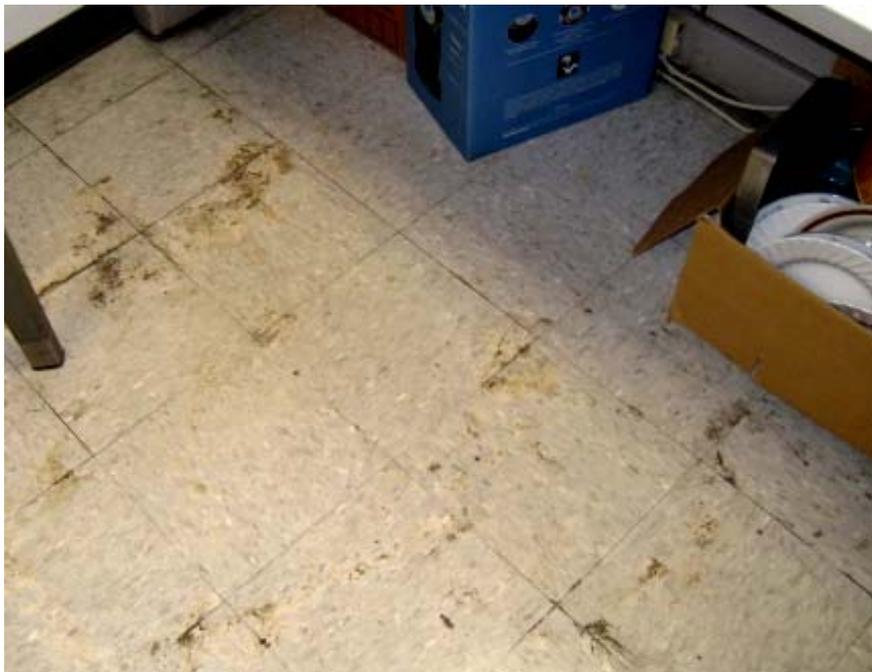
**Picture 8**

Accumulated debris was observed on floor tiles in the MassHealth break room (102) on the 1<sup>st</sup> floor (Picture 8). Occupants and building management could not recall issues with water penetration, therefore it could not be concluded if this material was mastic around floor tiles that had become softened by water infiltration or material stuck to the floor from stored items (e.g., cardboard boxes).

**Accumulated Debris on Floor Tiles in 1<sup>st</sup> Floor MassHealth Break Room (102)**
