# **INDOOR AIR QUALITY ASSESSMENT**

**Department of Early Education and Care  
Central Regional Office  
10 Austin Street  
Worcester, Massachusetts**

Prepared by:  
Massachusetts Department of Public Health  
Bureau of Environmental Health  
Indoor Air Quality Program  
December 2012

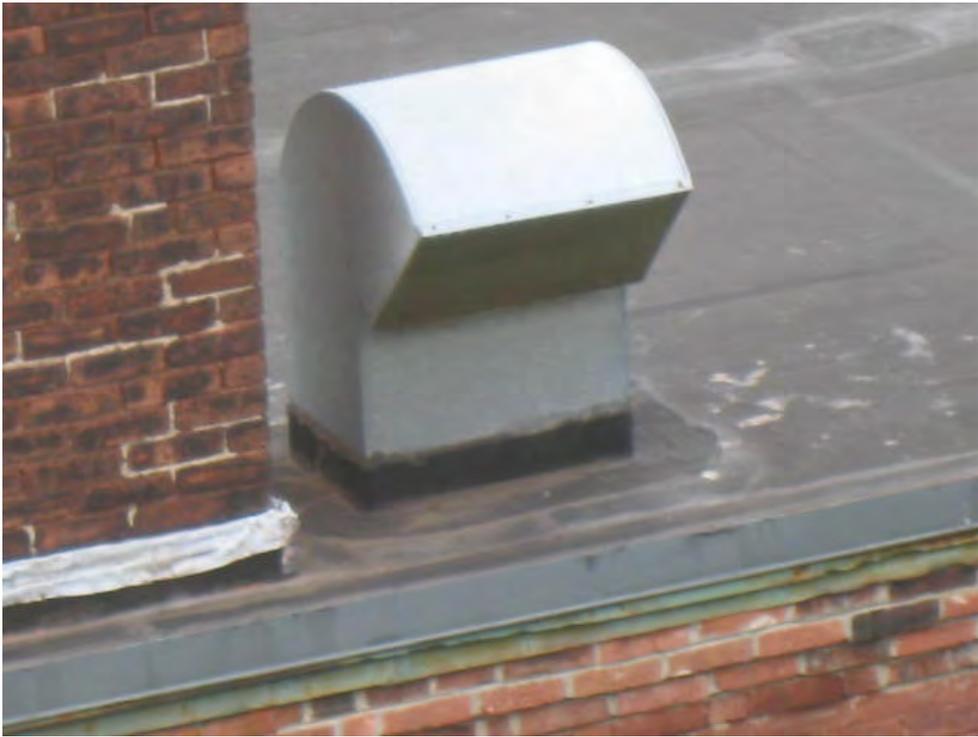
**Picture 1**

The heating, ventilation and air-conditioning (HVAC) system consists of air handling units (AHUs) located in the ceiling plenum above the offices. The ceiling plenum is the space located between a roof/floor decking and a suspended ceiling system. The AHUs draw outside air through a fresh air intake located on the roof of the building (Picture 1) and distribute it to occupied areas via ceiling-mounted air diffusers (Picture 2) connected via ductwork. Return air is drawn through grates and ducted back to the AHUs.

**HVAC Fresh Air Intake**

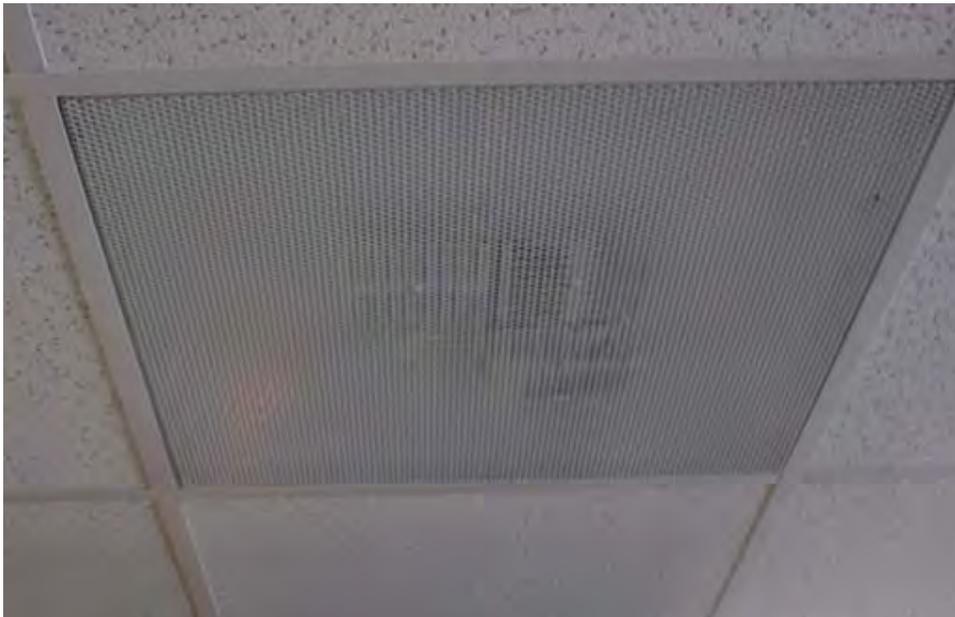
**Picture 2**

**Fresh Air Supply Diffuser**

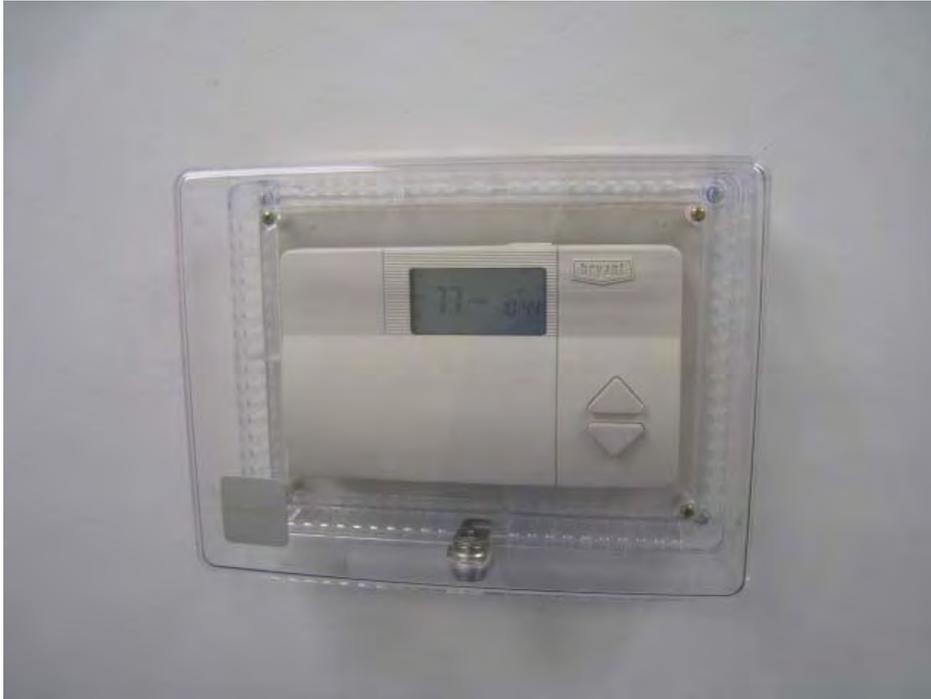
**Picture 3**

Digital wall-mounted thermostats control the heating, ventilation and air-conditioning (HVAC) system (Picture 3). These thermostats have fan settings of *on* and *automatic*. All thermostats examined were set to the *automatic* setting. The automatic setting on the thermostat activates the heating, ventilation and air-conditioning (HVAC) system for a preset temperature. Once a preset temperature is reached by the thermostat, the HVAC system is deactivated.

Therefore, no mechanical ventilation is provided until the thermostat re-activates the system.

**Digital Thermostat**

MDPH recommends that thermostats be set to the *on* position during occupied periods, as this setting provides a continuous source of air circulation.

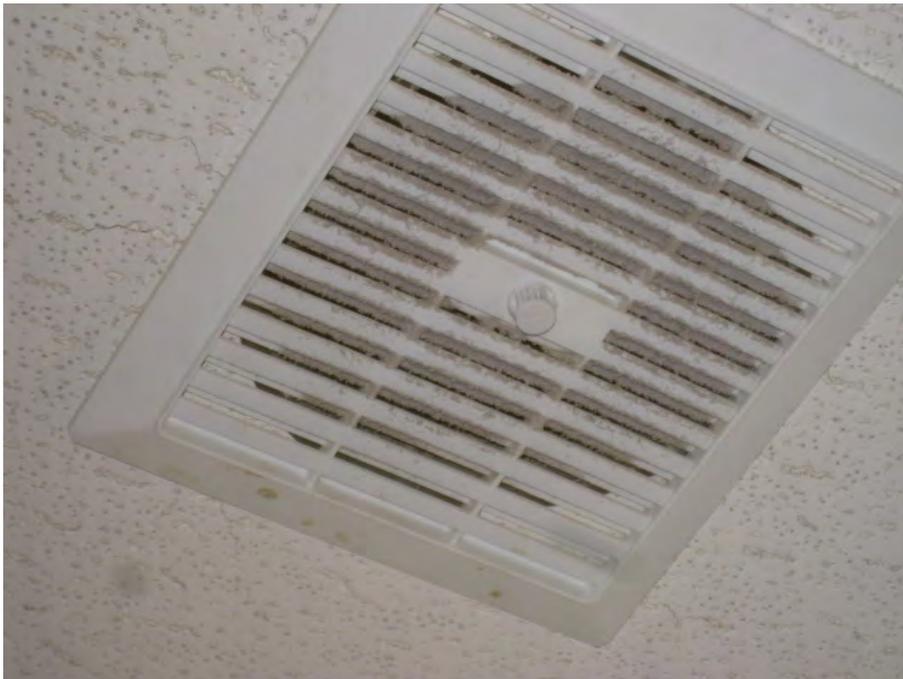
**Picture 4**

A number of vents, personal fans and windowsills were observed to have accumulated dust/debris (Picture 4). Diffusers, vents and fans should be cleaned in order to prevent dust/debris from being aerosolized and redistributed throughout the room.

**Restroom Exhaust Vent: Note Dirt and Debris**

11. Clean air diffusers, return vents and personal fans periodically of accumulated dust/debris.
12. Clean carpeting annually (or semi-annually in soiled high traffic areas) as per the recommendations of the Institute of Inspection, Cleaning and Restoration Certification (IICRC). Consider a schedule for replacing worn carpeting that is beyond its service life.

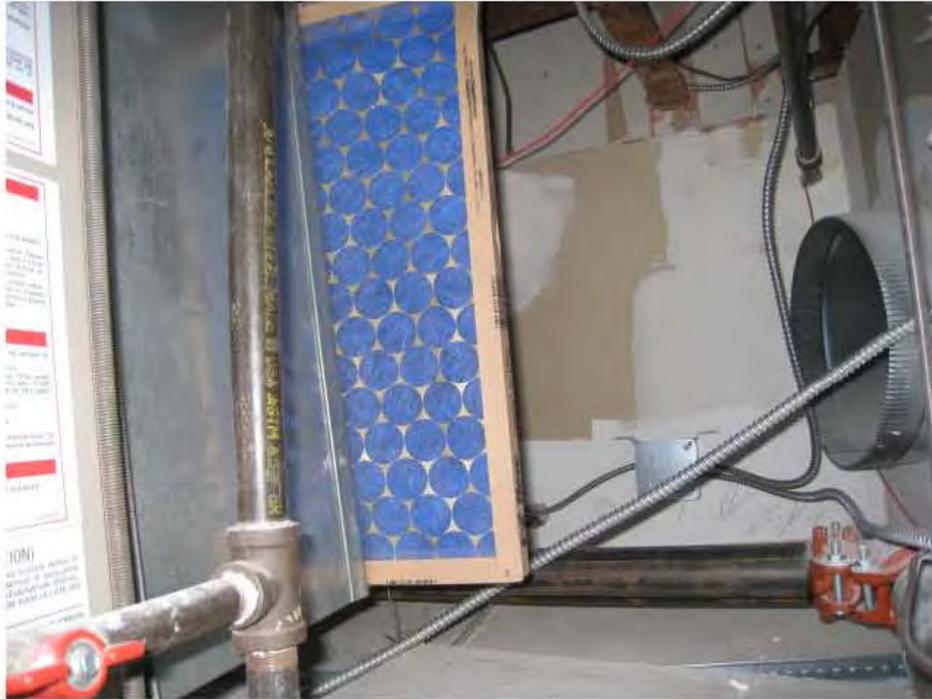
**Picture 5**

BEH/IAQ staff also noted a filter protruding from the AHU (Picture 5). Air filters are configured to remove particulates from the system's air stream. These filters should be sized to fit flush inside the system. When filters do not fit properly, dust and smoke particles can be drawn into the AHU and distributed around the occupied areas of the building.

**Ill-fitting, Protruding AHU Filter**

2. Ensure filters are in place and that they fit properly. Change filters regularly to ensure proper filtration.
3. To increase the circulation of air and increase comfort, operate the thermostats with the fan in the *on* setting during occupied hours. If possible, restroom exhaust vents should also be on at all times the building is occupied.

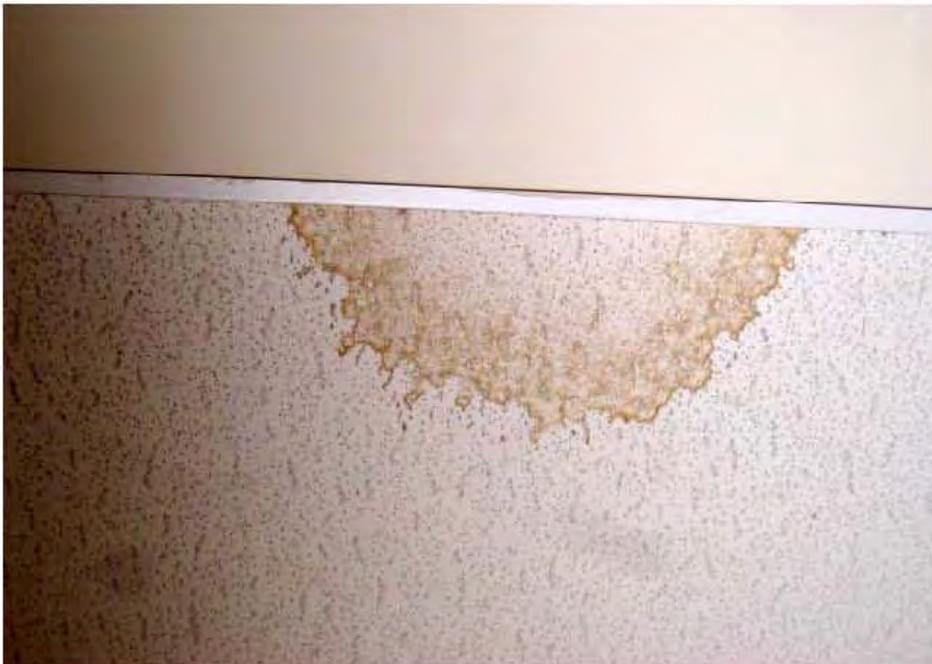
**Picture 6**

Water-damaged ceiling tiles were observed in some areas, such as the training rooms and cubicle spaces on the second floor (Picture 6). Water-damaged ceiling tiles can stem from roof leaks, leaks in the plumbing system and/or leaks and condensation from air-conditioning systems

and can provide a source of mold. These tiles should be replaced after a water leak is discovered and repaired.

**Water-damaged Ceiling Tile**

6. Remove water-damaged ceiling tiles and examine for source of water. Replace all missing and ajar ceiling tiles and monitor for future leaks. Ensure all ceiling tiles are flush to prevent movement of materials from the plenum.

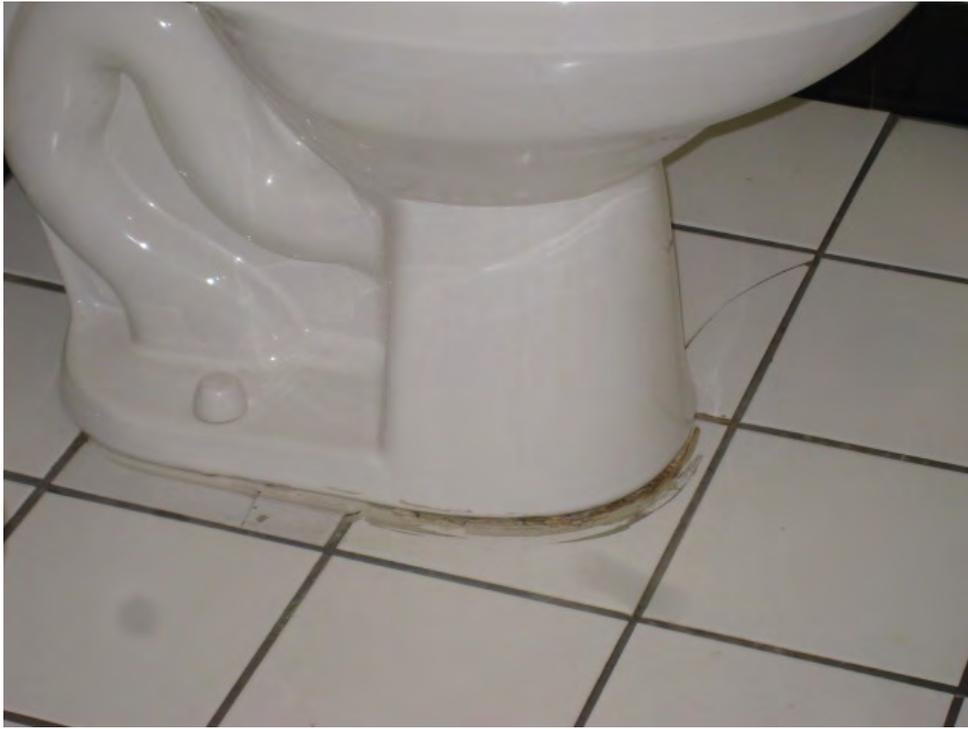
**Picture 7**

Caulking/sealant around the toilet in the restroom appeared to be failing at the time of assessment (Picture 7). Water/condensation can result in moistening of materials beneath the tiled floor. Over time, this can undermine the integrity of the grout and mastic adhering tiles to the floor. Measures should be taken to ensure the spaces around the toilet are watertight to prevent damage to flooring.

**Deteriorated Sealant Around Toilet**

7. Reseal around toilet to prevent water damage below tiled floor.
8. Ensure all plants are equipped with drip pans. Examine drip pans for mold growth and disinfect areas of water leaks with an appropriate antimicrobial where necessary.

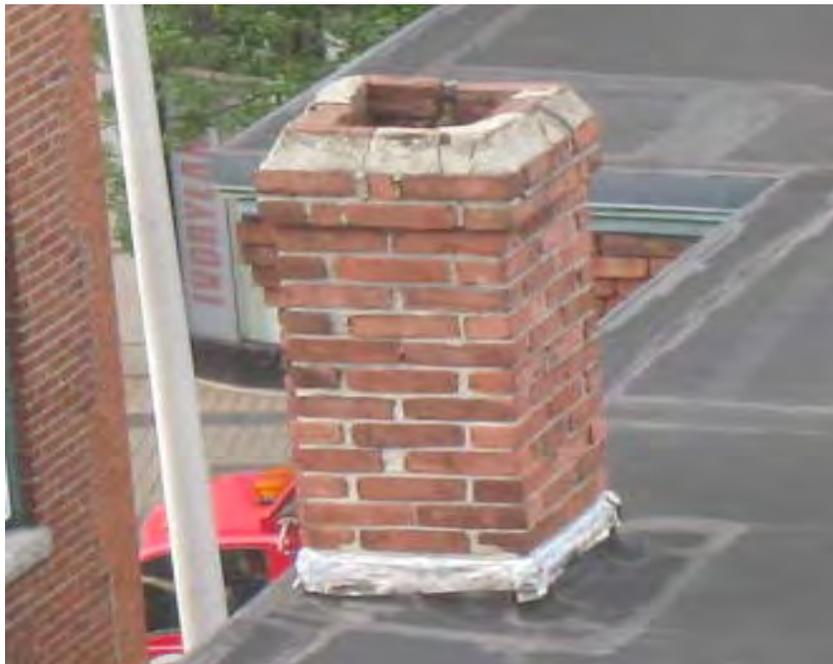
**Picture 8**

BEH/IAQ staff observed damaged chimney brick, mortar and flashing (Picture 8). The purpose of flashing is to create a surface that allows water to roll down and away from the building. Where mortar and/or flashing are damaged, these breaches can allow water to collect and penetrate into the building. In addition, efflorescence was observed on brick and pipes in the basement (Picture 9). Efflorescence is a characteristic sign of water damage to brick and mortar, but it is not mold growth. As moisture penetrates and works its way through mortar, brick or plaster, water-soluble compounds dissolve, creating a solution. As the solution moves to the surface of the material, the water evaporates, leaving behind white, powdery mineral deposits.

**Chimney with Damaged Brick, Mortar and Flashing**

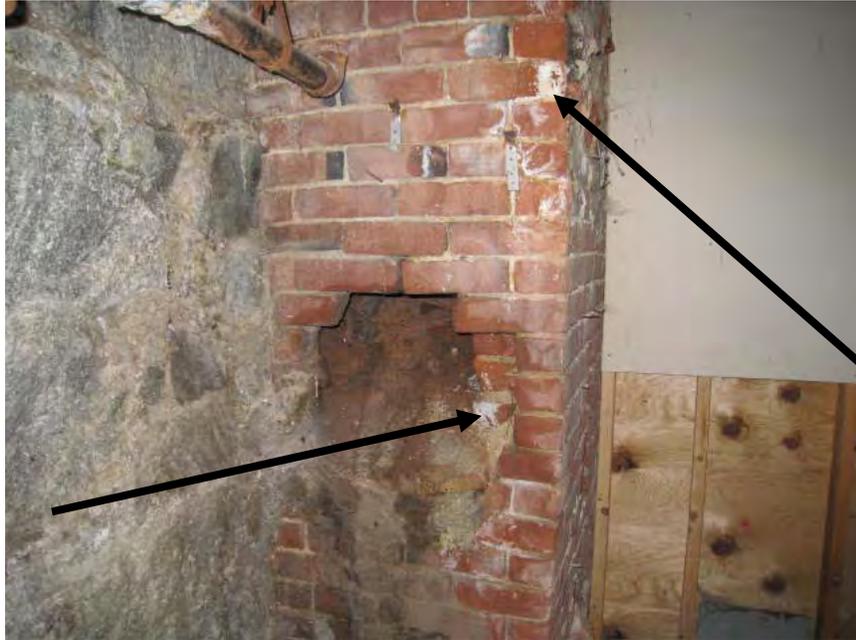
**Picture 9**

**Efflorescence in Basement (Note Arrows)**

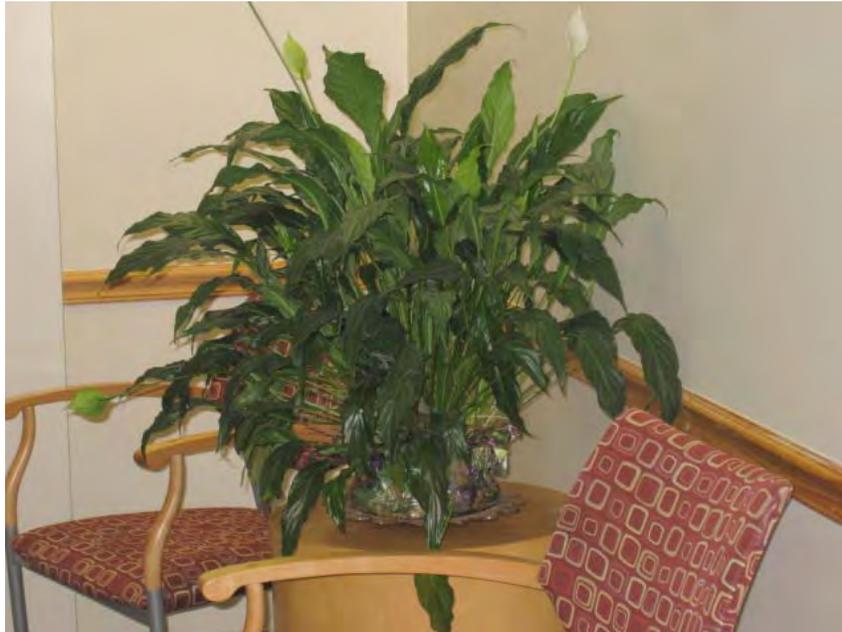
**Picture 10**

Plants were observed in some cubicles/offices (Picture 10). Plants can be a source of pollen and mold, which can serve as respiratory irritants for some sensitive individuals. Plants should be properly maintained and equipped with drip pans to prevent water damage to porous

building materials. Plants should also be located away from ventilation sources (e.g., air diffusers, portable fans) to prevent the aerosolization of dirt, pollen or mold.

**Plant in Reception Area**

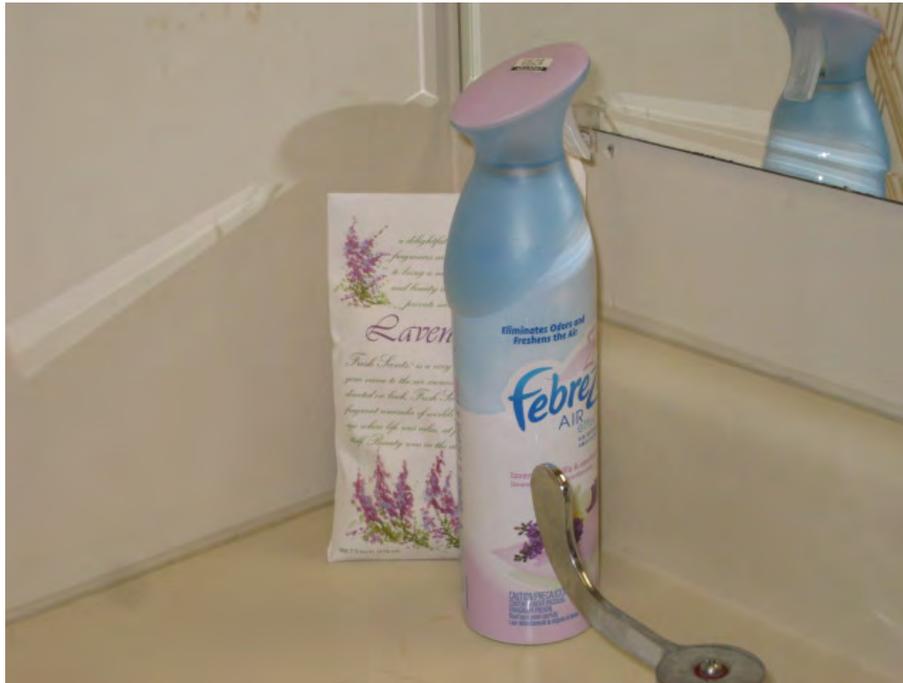
**Picture 11**

Scented incense candles and deodorizing materials were found in the second and third floor restrooms (Picture 11, Table 1). Of note, air-fresheners and deodorizers released very strong odors which migrated into the hallway and adjacent office spaces when the exhaust fan was activated. Cleaning products and air deodorizers contain chemicals that can be irritating to the eyes, nose and throat of sensitive individuals. Many air fresheners contain 1,4-dichlorobenzene, a VOC which may cause reductions in lung function (NIH, 2006). Furthermore, deodorizing agents do not remove materials causing odors, but rather mask odors that may be present in the area.

**Air Freshener and Deodorizers in Restroom**

9. Refrain from having scented candles or using air fresheners/deodorizers to prevent exposure to VOCs.
10. The configuration of the AHU furnace exhaust drainage system should be changed to reduce/eliminate pathways for combustion entrainment. MDPH recommends that the flexible hose be extended to empty at the terminus of the condensation drains at the exterior wall of the building.

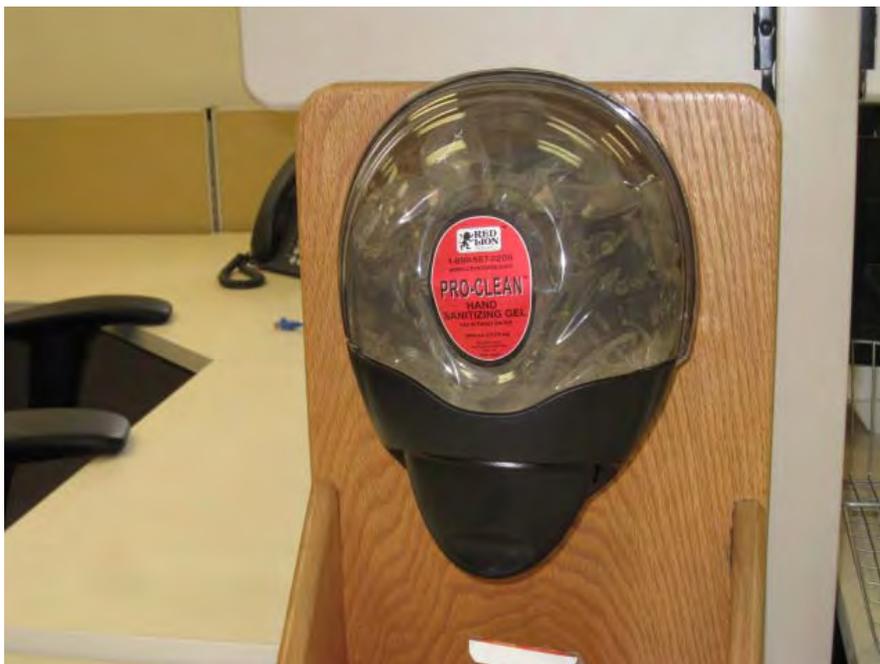
**Picture 12**

Hand sanitizer was also found in the office (Picture 12). Hand sanitizer products may contain ethyl alcohol and/or isopropyl alcohol which are highly volatile and may be irritating to the eyes and nose, and may also contain fragrances to which some people may be sensitive.

**Hand Sanitizer in Cubicle Office Space**

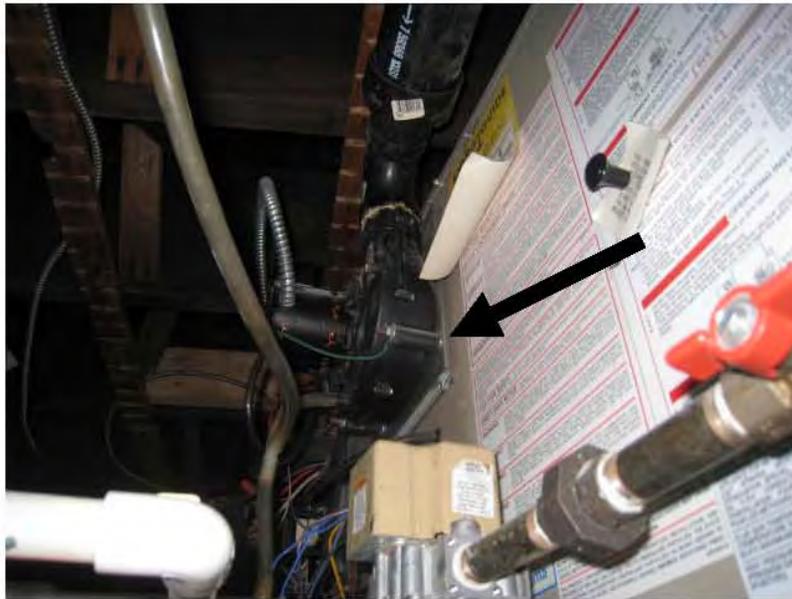
**Picture 13**

Occupants reported periodic odors in and around the Supervisor 1 office and restroom hallways after the heating system is activated (Table 1). Since activating the heating system appears to trigger reports of odor, components of the ventilation system servicing the office and surrounding areas were examined. In addition to providing fresh air, each AHU has its coils internally heated by combustion of natural gas. The combustion products are removed from the

AHU by a power vent (Picture 13), which is connected to a series of horizontal PVC pipes that terminate through exterior of the building (Pictures 14 and 15). As natural gas is combusted, products of combustion (carbon monoxide, carbon dioxide, particulates, etc.) are generated. Another by-product of combustion is water. The horizontal configuration would make the PVC pipe prone to accumulation of condensed water, which requires drainage. In an effort to provide such drainage, a plastic hose was installed (Picture 16). The plastic hose is connected to the AHU drip pan condensation pipe in close proximity to the AHU (Picture 17). During the heating season, when the drainage hose is dry, products of combustion are likely to be drawn into the AHU from the drip pan condensation drain when the power vent is activated, leading to the reported periodic odors in the DEEC offices. In general, it is not good practice to connect a furnace exhaust vent condensation drain to the plumbing of the AHU condensation drain pipes.

**Power Vent Installed on Furnace Portion of AHU**

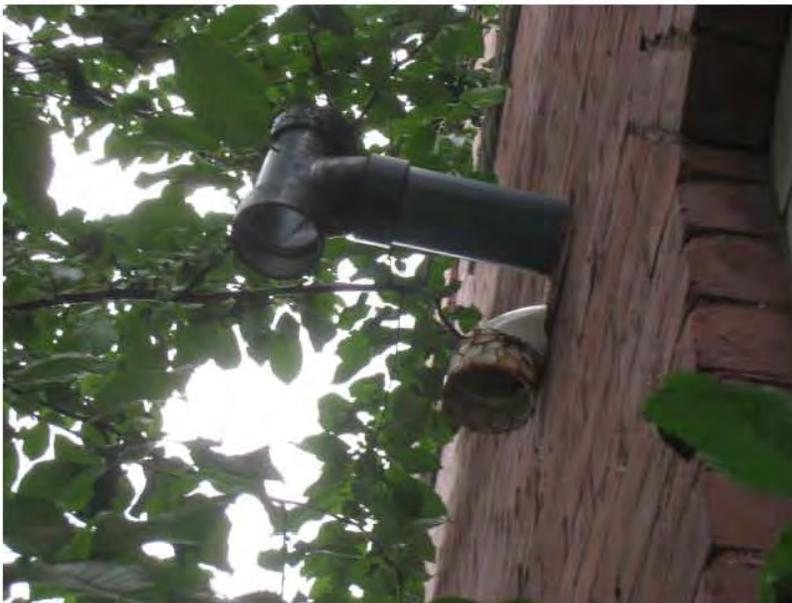
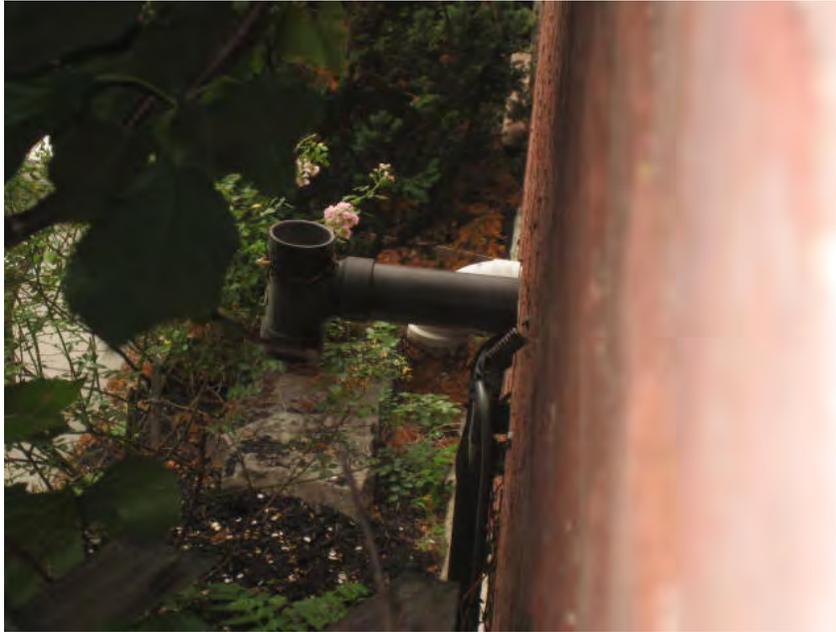
**Picture 14**

**HVAC System PVC Vent Pipes  
White for Fresh Air Intake  
Black for Exhaust of Furnace Products of Combustion**

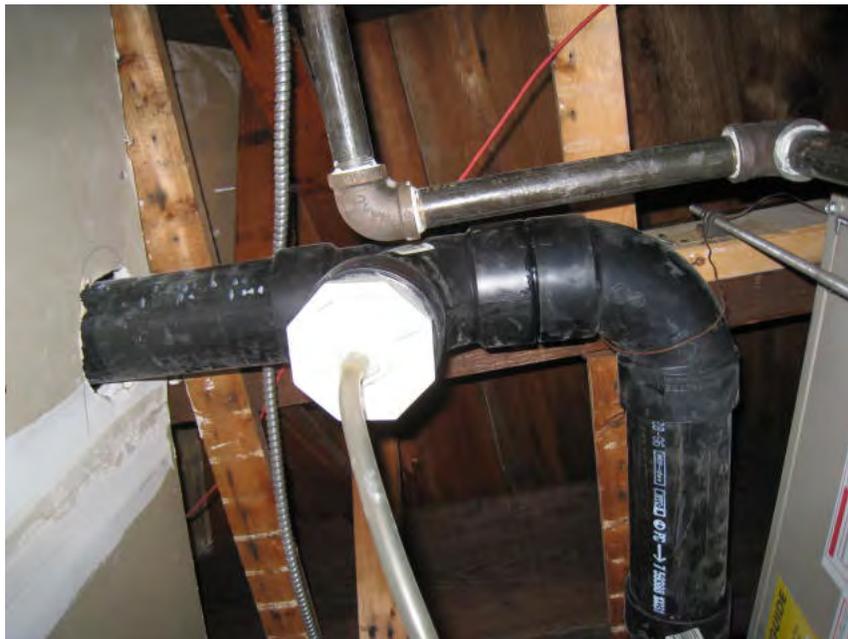
**Picture 16**

**Plastic Drainage Hose for AHU Furnace Exhaust Vent**

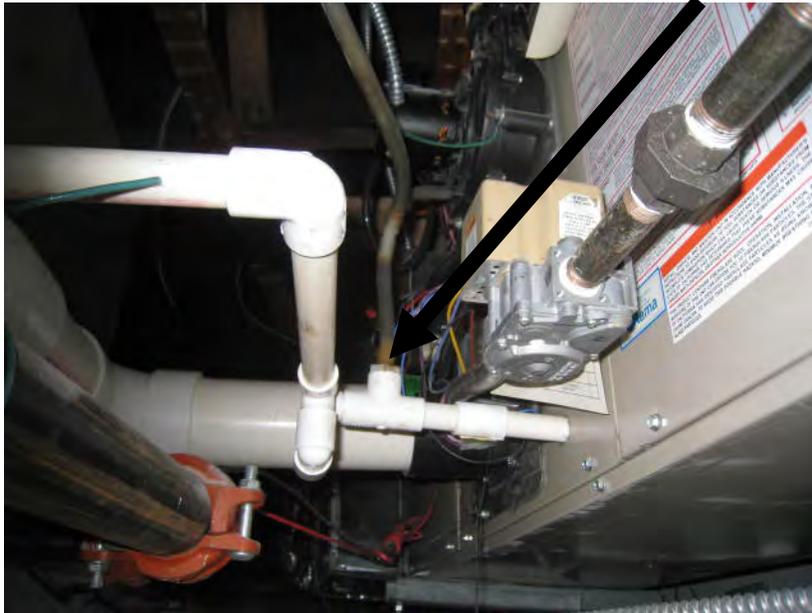
**Picture 17**

**Plastic Hose Connected to the PVC Condensation  
Drain Pipe in Close Proximity to the AHU Cabinet (arrow)**
