# **INDOOR AIR QUALITY ASSESSMENT ODOR INVESTIGATION**

**North Shore Community College  
Health Professions Building  
Danvers Campus  
1 Ferncroft Road  
Danvers, Massachusetts**

Prepared by:  
Massachusetts Department of Public Health  
Bureau of Environmental Health  
Indoor Air Quality Program  
June 2013

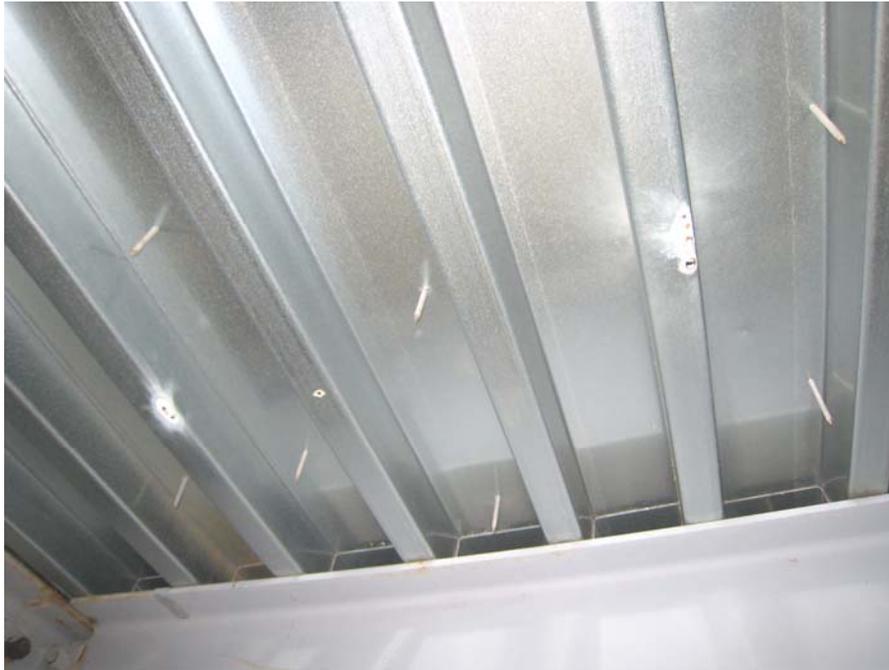
**Picture 1**

As mentioned, the assessment was prompted by musty odors in a third floor office suite. As reported by NSCC staff, a leak was experienced in room 338 in the spring of 2011. At that time, repairs were made. No leaks have been reported by staff or observed by maintenance since repairs were completed.

No water-damaged ceiling tiles or other building materials were observed. BEH/IAQ staff examined conditions above the ceiling tile (Pictures 1 and 2). No signs of recent water penetration were evident, and materials near the reported leak were dry at the time of assessment.

**Roof decking near area of reported leak**

1. Continue monitoring for leaks to ensure proper actions are taken to prevent mold growth. Office staff should report all leaks to the facilities department as soon as a leak is discovered for prompt remediation.

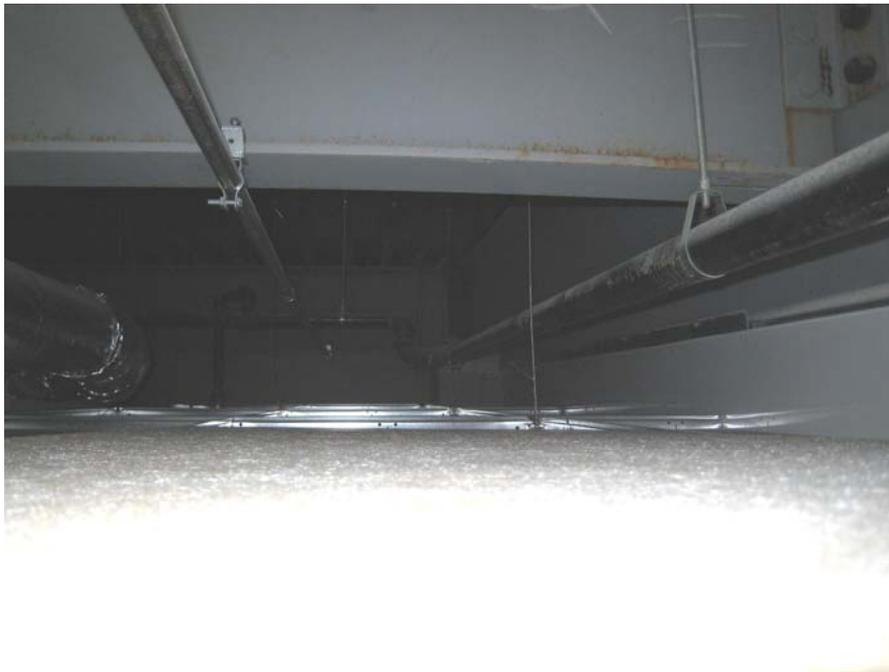
**Picture 2**

**Plenum of area of reported leak**

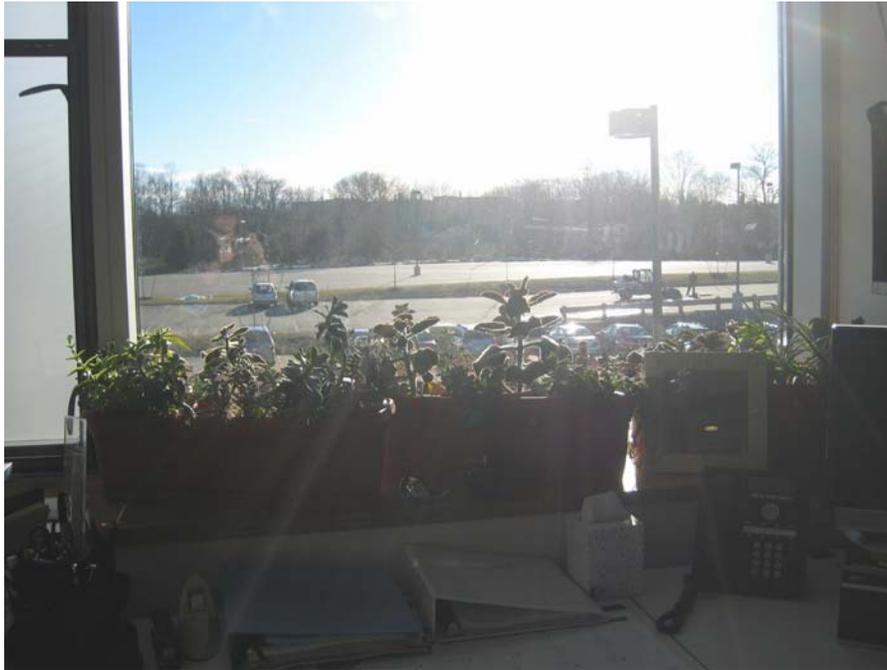
**Picture 3**

Please note, plants were observed by the window (Picture 3; Table 1). Plants should be properly maintained and equipped with drip pans. Plants should also be located away from ventilation sources to prevent aerosolization of dirt, pollen, or mold. Plants should not be placed on porous materials, since water damage to porous materials may lead to microbial growth.

**Plants in office**

2. Remove standing water (i.e. open water containers) that can be a source for odors.
3. Ensure plants are appropriately maintained to prevent mold growth and standing water.

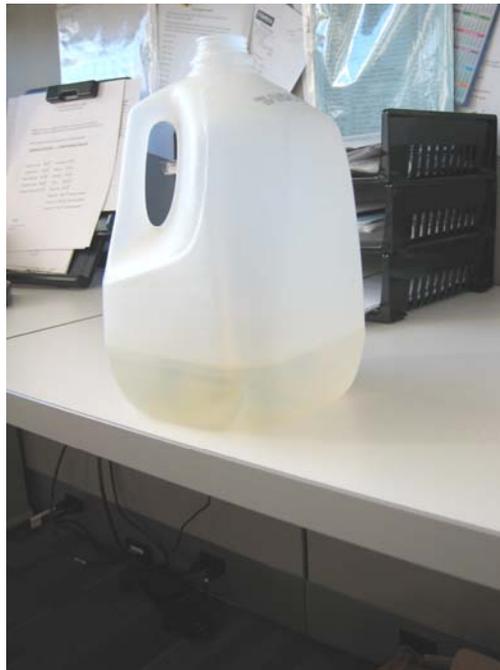
**Picture 4**

An uncovered water jug containing discolored water was also observed in office 338 (Picture 4). The container was placed directly on carpet. While no odors were observed from the jug, stagnant water can be a source of odors and bacterial growth.

**Container of discolored water**
