INDOOR AIR QUALITY ASSESSMENT

**Oxford Elementary School
347 Main Street
Fairhaven, MA**

Prepared by:
The Massachusetts Department of Public Health
Bureau of Environmental Health
Indoor Air Quality Program
February 2013

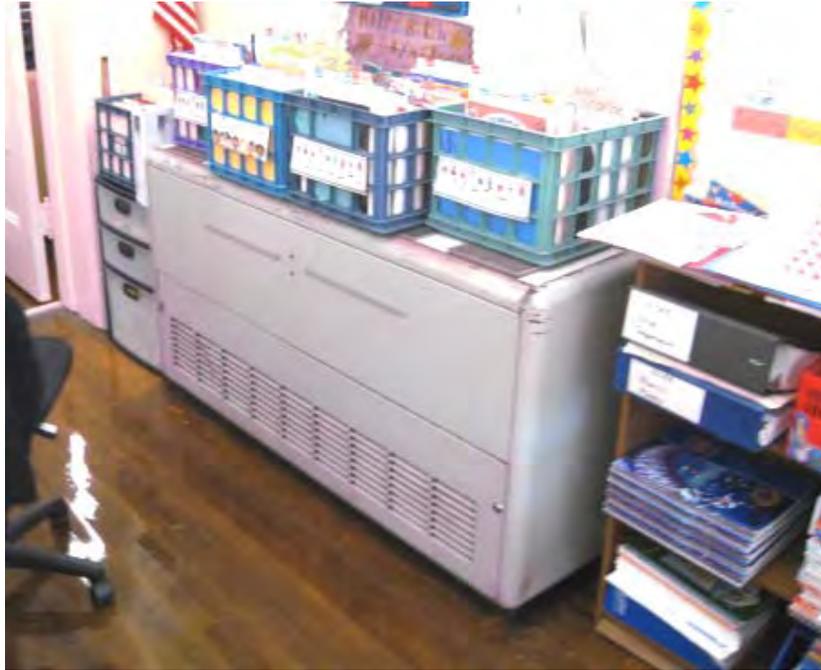
Picture 1

Fresh air in classrooms throughout the school is supplied by unit ventilator (univent) systems (Picture 1). It appears that univents were retrofitted into the original 1896 building at

the time of the 1951 addition. A univent draws air from the outdoors through a fresh air intake located on the exterior wall of the building (Picture 2) and returns air through an air intake located at the base of the unit. Fresh and return air are mixed, filtered, heated and provided to classrooms through an air diffuser located in the top of the unit ([Figure 1](#)). At the time of the September 11, 2012 visit, univents were found deactivated throughout the building (several were reportedly on a repair list). As a result, there was no means to mechanically introduce fresh air in classrooms occurring at the time of assessment. Univents were also obstructed by items such as boxes, papers and books (Picture 1). In order to function as designed, univents must be activated and allowed to operate free of obstructions. At the time of the January 31, 2013 visit, all univents appeared to be operational, however many were obstructed and/or deactivated, including those in the cafeteria.

Classroom univent (1950's vintage), note items on top of air diffuser

2. Remove all blockages from univents and exhaust vents to ensure adequate airflow.
3. Use openable windows in conjunction with classroom univents and exhaust vents to facilitate air exchange until repairs that are more permanent can be made. Care should be taken to ensure windows are properly closed at night and weekends to avoid the freezing of pipes and potential flooding.

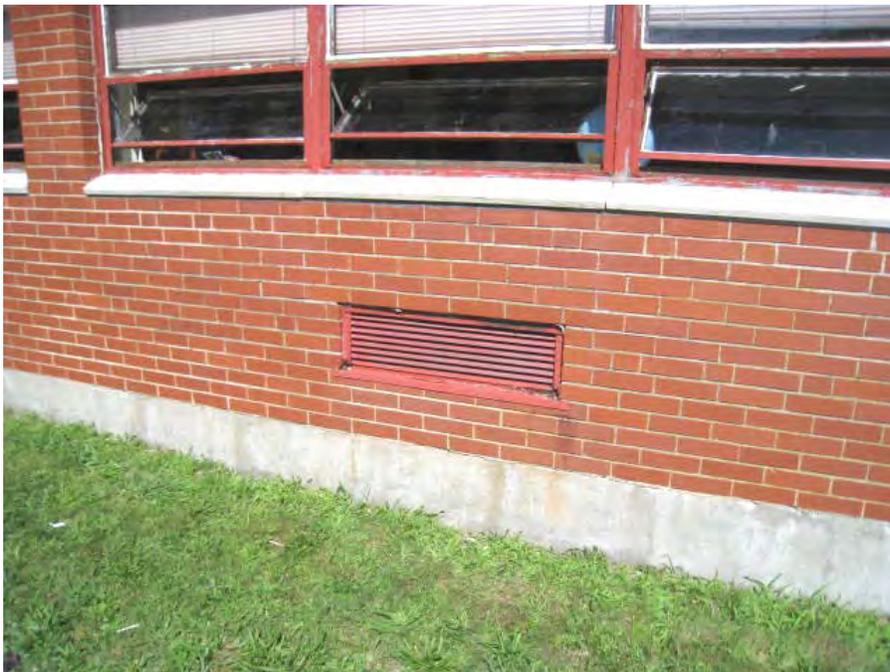
Picture 2

Univent fresh air intake

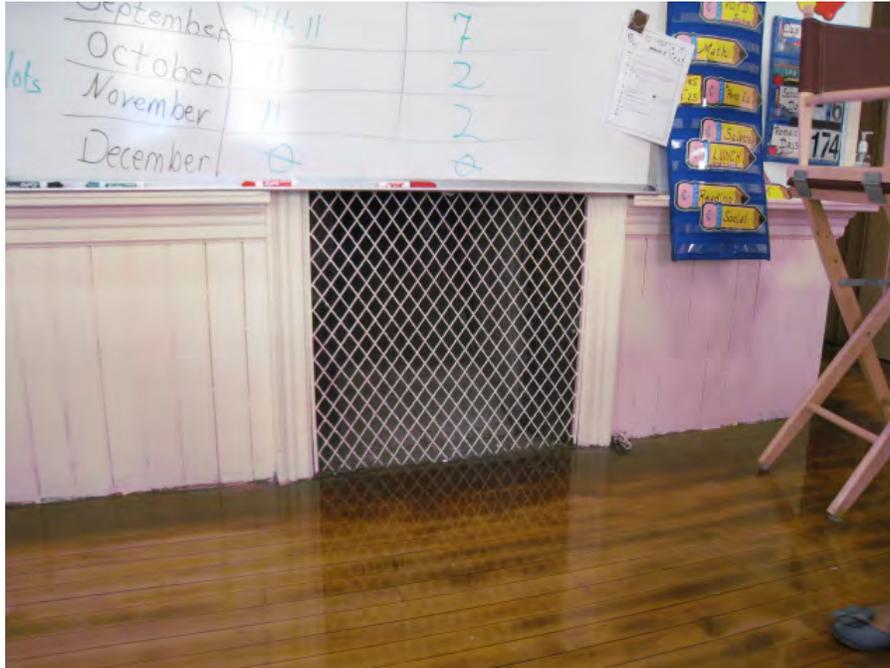
Picture 3

Exhaust ventilation for the original 1896 building was provided by a gravity-feed system that worked on heated air rising called the “stack effect”. This system has been largely abandoned with the wall grates sealed in the majority of classrooms (Pictures 3 and 4). The mechanical exhaust ventilation system in the 1951 wing consists of powered exhaust vents located in the ceiling of coat closets (Picture 5). Some exhaust vents were observed occluded with dust (Picture 5), which can impede airflow and reduce the effectiveness of the vent to exchange air. At the time of the September 11, 2012 assessment, the motor for the exhaust vents was being repaired by a heating, ventilation and air conditioning (HVAC) technician; therefore the vents were not functioning in classrooms. As with the univents, exhaust vents need to be activated to function as designed. Exhaust vents should also be free of debris to prevent re-aerosolization of these materials, particularly if backdrafting occurs when exhaust vents are not functioning as designed. Without adequate supply and exhaust ventilation, excess heat and

Wall-mounted gravity-feed exhaust vent in classroom

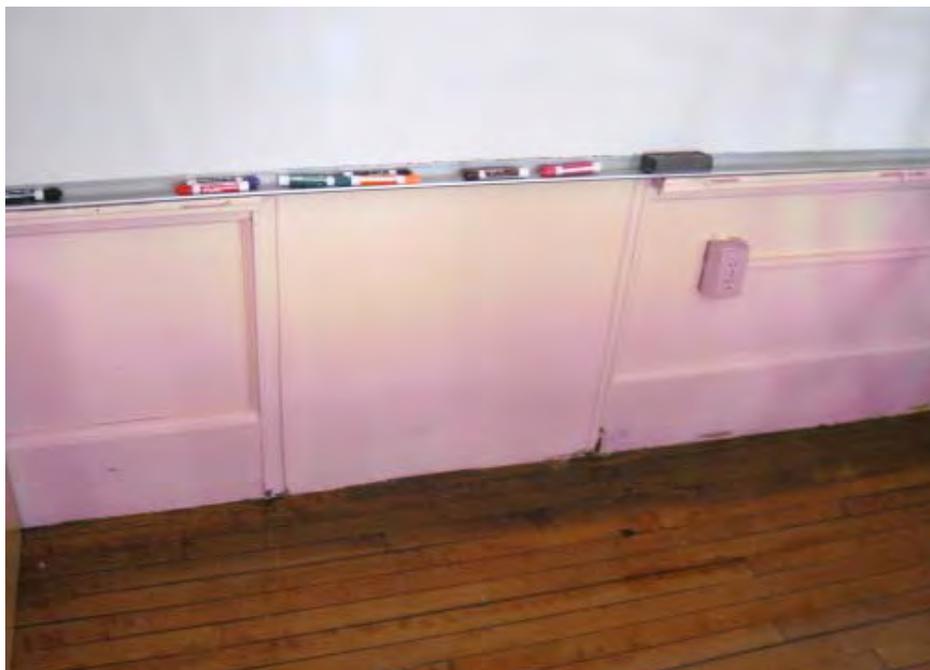
Picture 4

Wall-mounted gravity-feed exhaust vent sealed

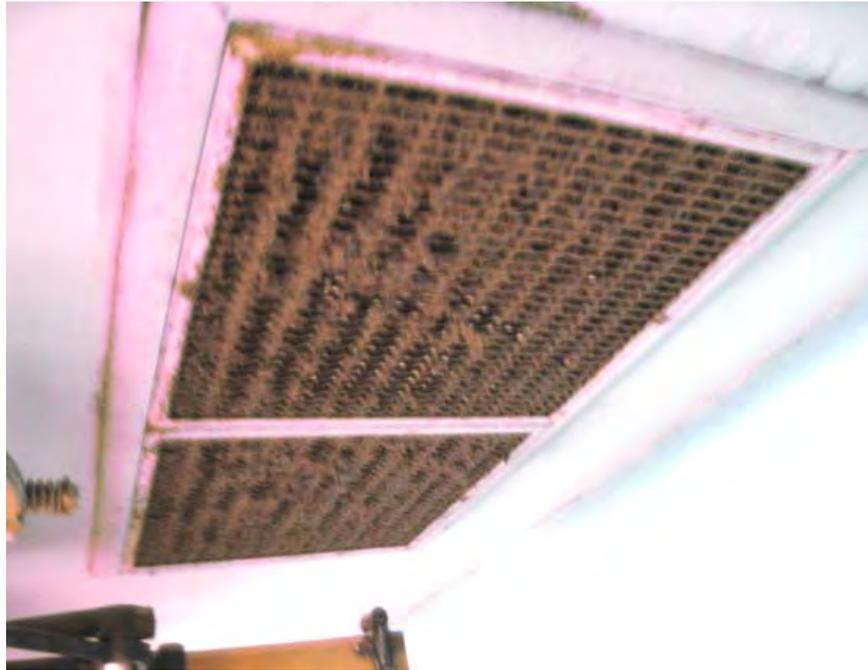
Picture 5

Exhaust vent for 1951 wing, note dust/debris accumulation

4. Ensure exhaust vents and the interiors of univent cabinets are thoroughly cleaned of dirt, dust and loose debris on a regular basis (e.g., during regular filter changes). As mentioned, univent interiors, particularly room 2L, should be thoroughly cleaned over the February vacation break, using high pressure air and/or high efficiency particulate arrestance (HEPA) filter equipped vacuum cleaners.

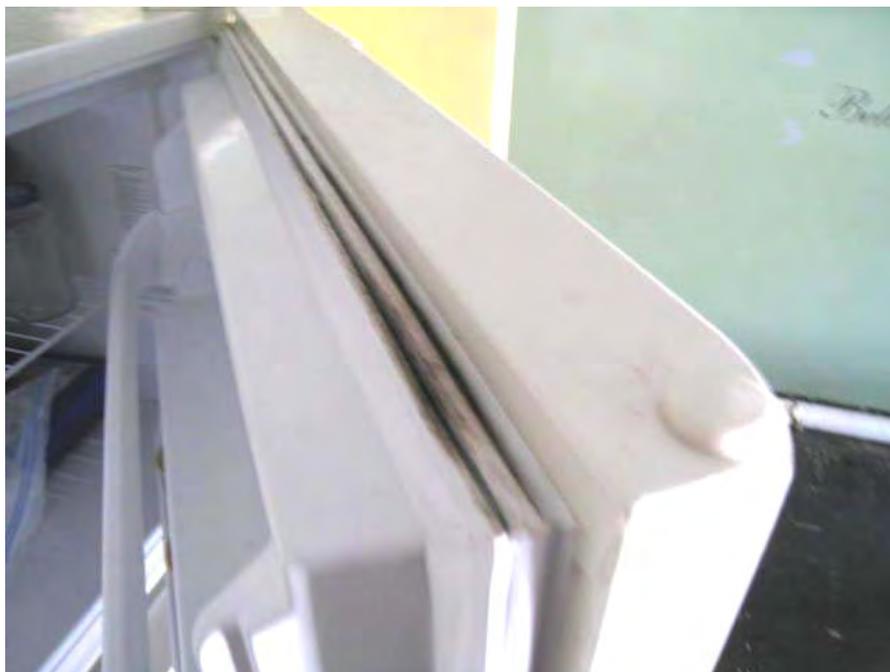
Picture 6

As mentioned previously, the request for assessment was originally prompted by mold concerns that occurred over the summer of 2012. At the time of the September 11, 2012 visit, BEH/IAQ staff found all classrooms, offices and the gymnasium free of mold-contaminated materials, mold-colonized building components/structures and musty odors. However, visible mold growth was observed in the gaskets of the refrigerator and freezer in the teacher's lounge (Picture 6).

Visible mold growth in gasket of freezer in teacher's lounge

8. Decommission the sink in the computer room as recommended.
9. Clean mold from refrigerator/freezer in teacher's lounge with an appropriate antimicrobial, then rinse with clean water. If cannot be adequately cleaned, replace.

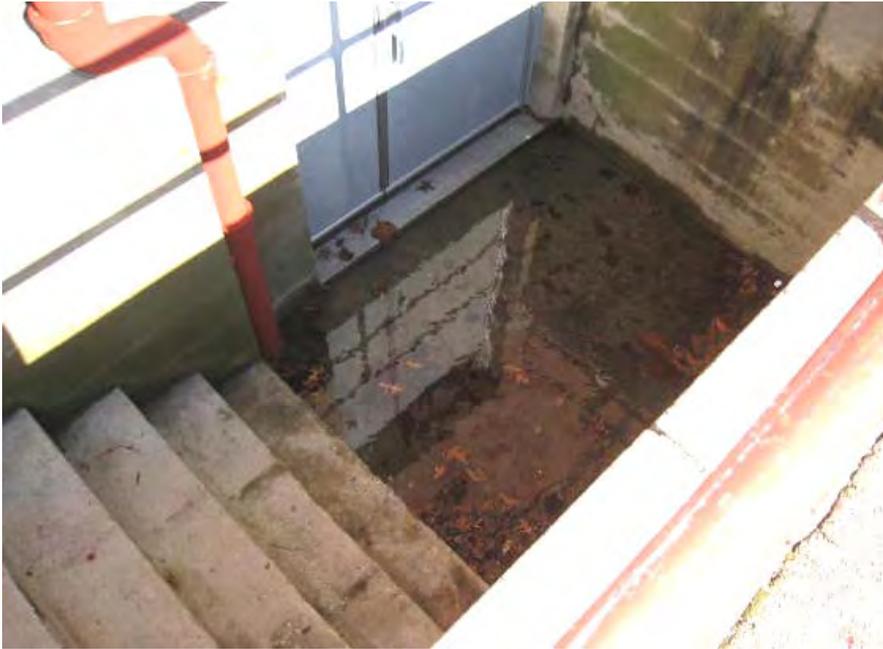
Picture 7

The January 31, 2013 visit occurred after a period of heavy wind and rain. Pooling water was observed in the landing at the bottom of the exterior stairwell to the learning lab (Picture 7). Accumulated leaves and debris were noted at the bottom of the stairwell, likely clogging the drain. At the conclusion of the assessment, BEH/IAQ staff recommended that the drain be

Pooling water and accumulated leaves/debris at bottom of stairwell outside the learning lab

cleared to prevent rising water from entering the building underneath the exterior door to the learning lab.

10. Inspect exterior drains periodically and clear as needed to ensure proper drainage.

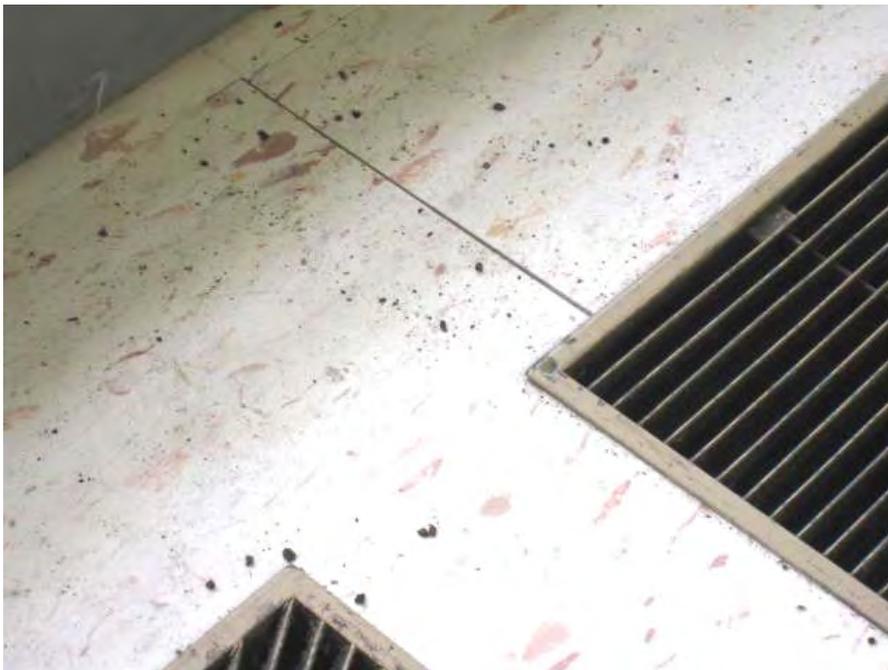
Picture 8

During the January, 31, 2013 assessment, the occupant of classroom 2L expressed concern over dark debris/particles found on flat surfaces near the univent diffusers (Picture 8). BEH/IAQ staff opened the univent to examine conditions and found accumulated dirt, dust and debris inside the univent cabinet and in particular, the cages that house the fans (Pictures 8 through 11). As the fans operate, this material would become aerosolized. At the time of the assessment BEH/IAQ staff recommended that the univent(s) be thoroughly cleaned over the upcoming February break. While the particles are unsightly and require cleaning, no elevated levels of PM2.5 were found in locations where the particles were present. Therefore, it appears

that the particles are too heavy to be a source of airborne (i.e., respirable) pollutants. If the interiors of univents and internal components are cleaned thoroughly, this issue should likely be resolved.

Debris/particles on surface of univent near air diffuser

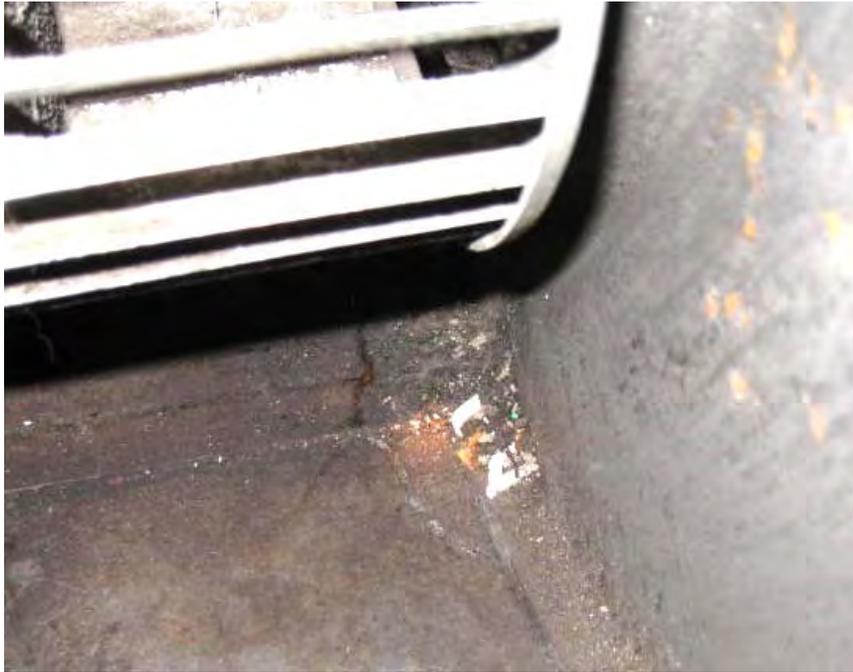
Picture 9

Small pile of dirt, dust and debris inside univent fan cage

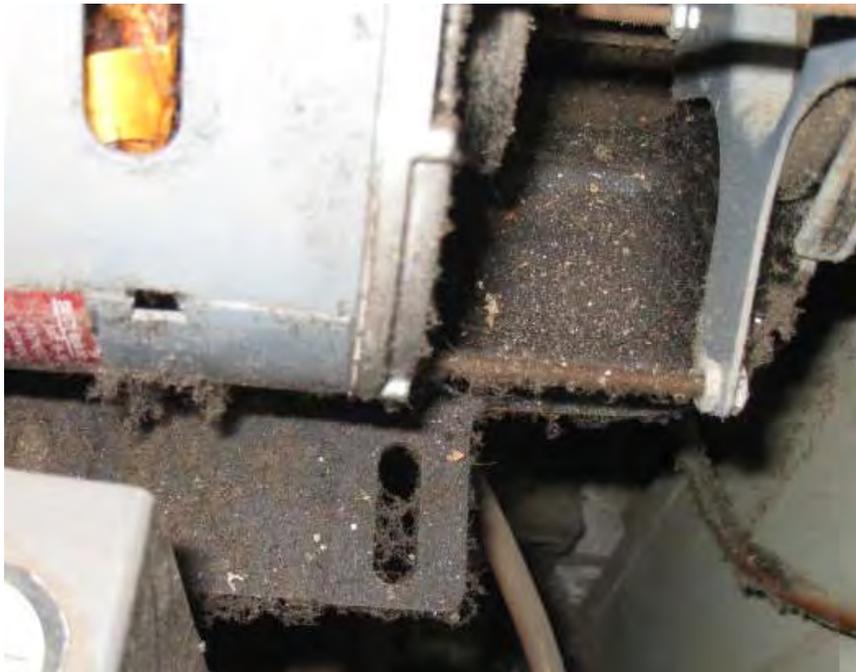
Picture 10

Accumulated dirt, dust and debris in univent

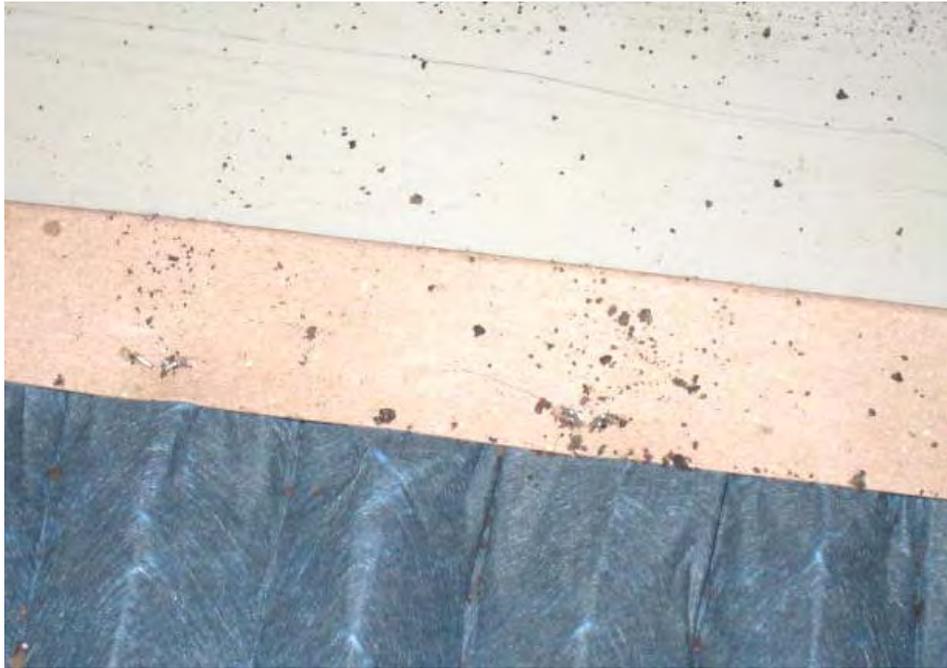
Picture 11

Debris/particles in univent

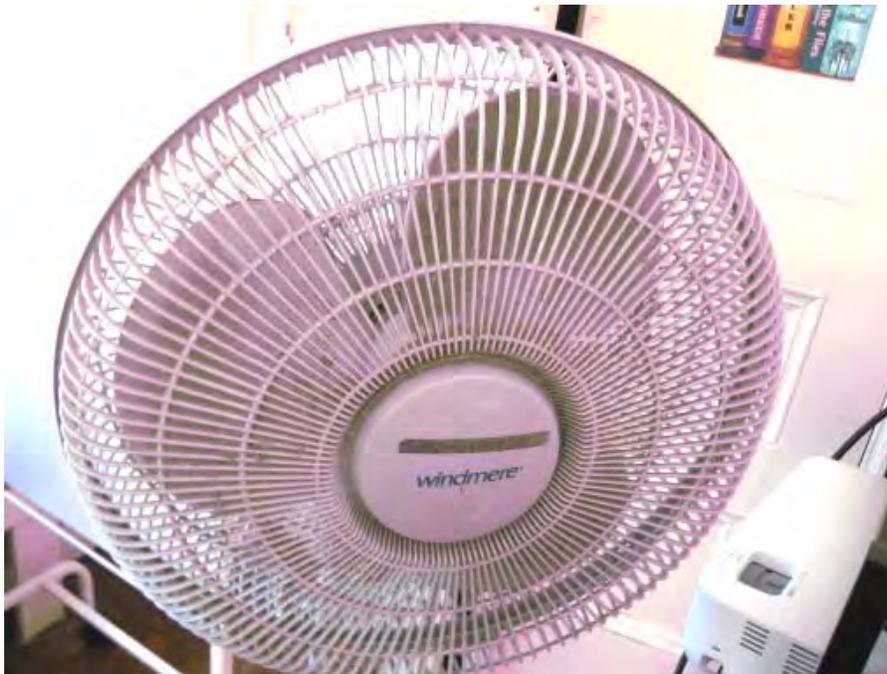
Picture 12

Other conditions that can affect indoor air quality were observed during the assessment. In several classrooms, items were observed on the floor, windowsills, tabletops, counters, bookcases and desks. The large number of items stored in classrooms provides a source for dusts to accumulate. These items (e.g., papers, folders, boxes) make it difficult for custodial staff to clean. Items should be relocated and/or cleaned periodically to avoid excessive dust build up. A number of personal fans in classrooms were observed to have accumulated dust/debris (Picture 12). Re-activated fans can aerosolize dust accumulated on fan blades/housing.

Accumulated dust/debris on fan blades

6. Consider replacing tennis balls with latex-free tennis balls or glides.
7. Clean accumulated dust and debris periodically from the blades of personal fans.
